Asset #A1747(Routine)

Sh-1/Sec-6/L-9.08 over Big Cypress Bayou

Team Lead: Drew Melton, Inspection Date: 10/31/2022

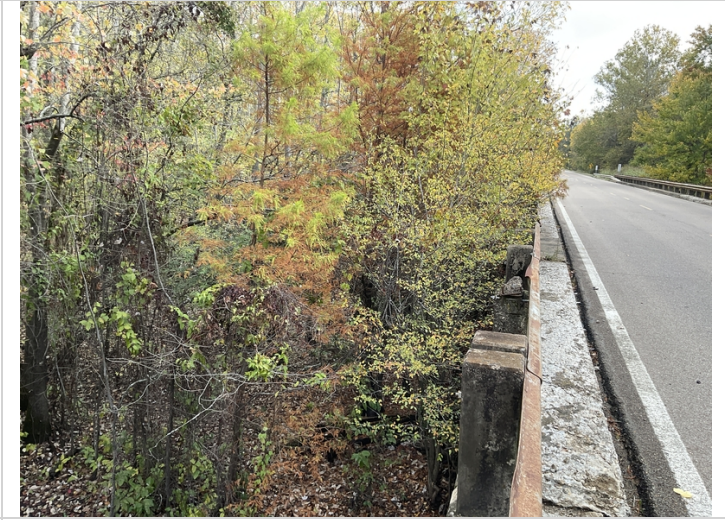
Side view-elevation

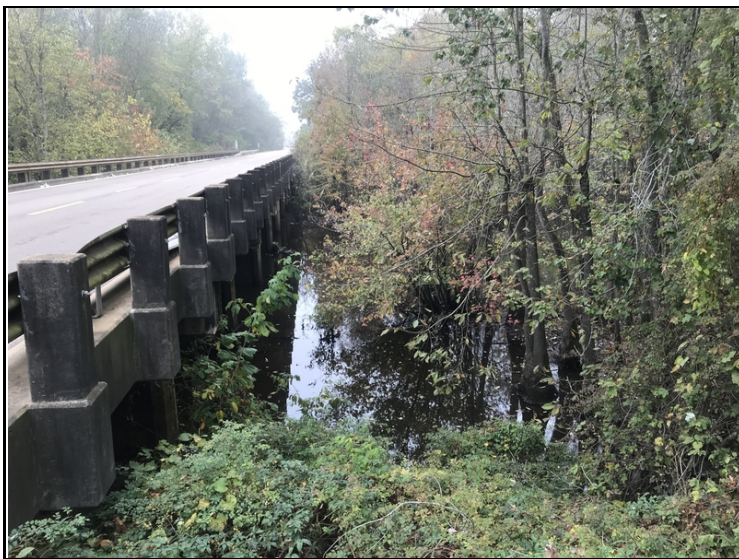
Trees and vegetation are growing beside and under bridge.

Trees and vegetation growing beside and under bridge.

Date Reported: 10/23/2018
Priority: C - Important
Type of Work: (Inactive) (Inactive) 1 - Clean
Status: Monitor
Component: Channel

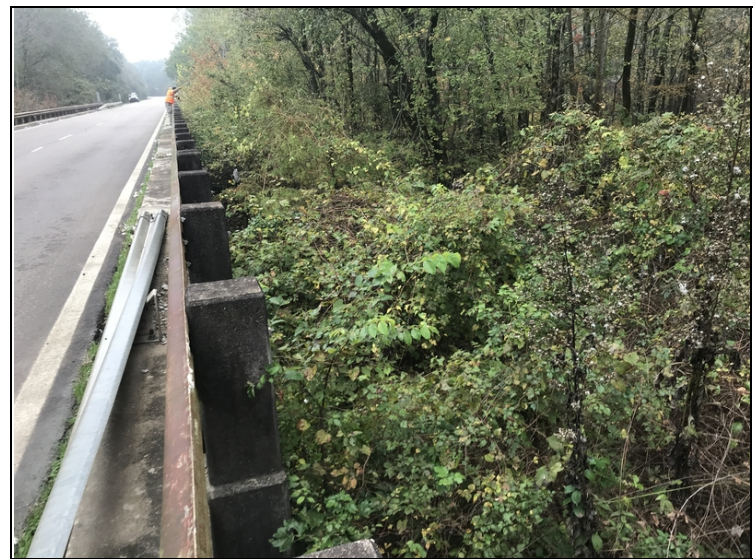
Trees and vegetation growing beside and under bridge.

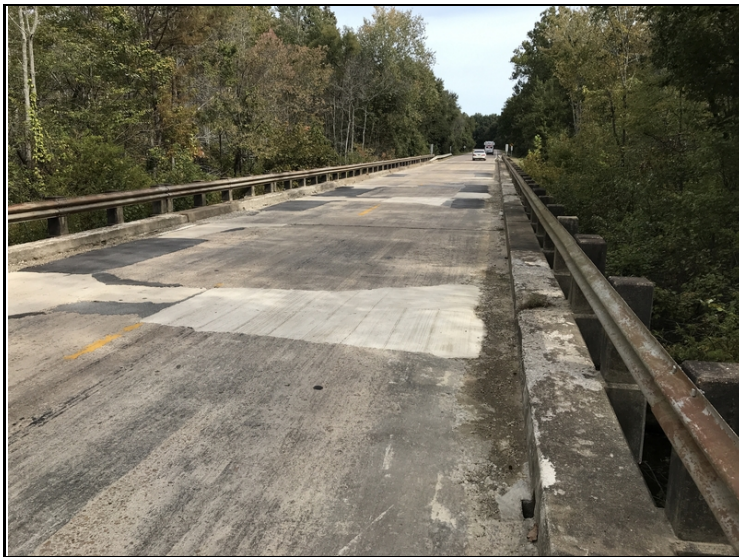
Gutters have moderate scaling full length.

10/31/2022 deck has had an asphalt overlay cannot see gutter scaling

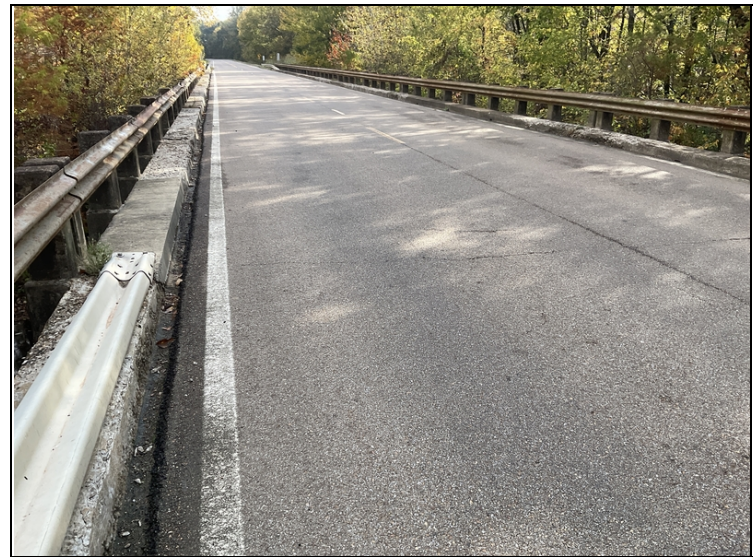
Typical deck asphalt overlay

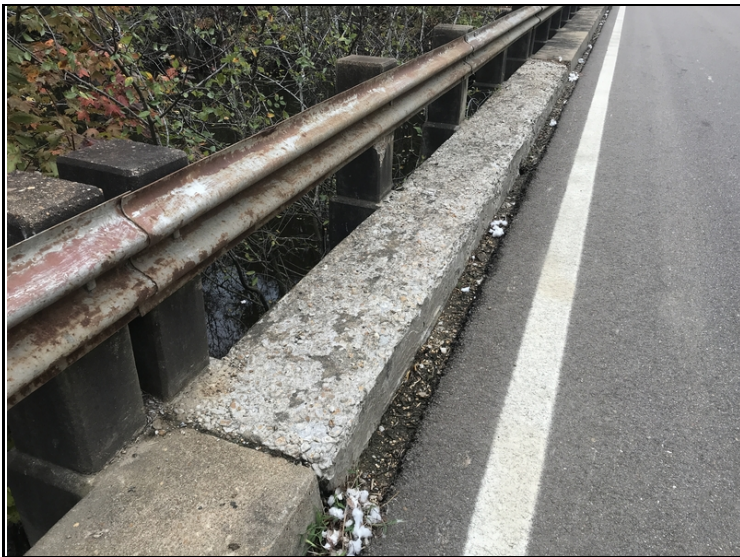
Bridge curbs spans #2,3,4,5,6,7 have areas of spalling and deterioration.

Heavy scaling on curbs.

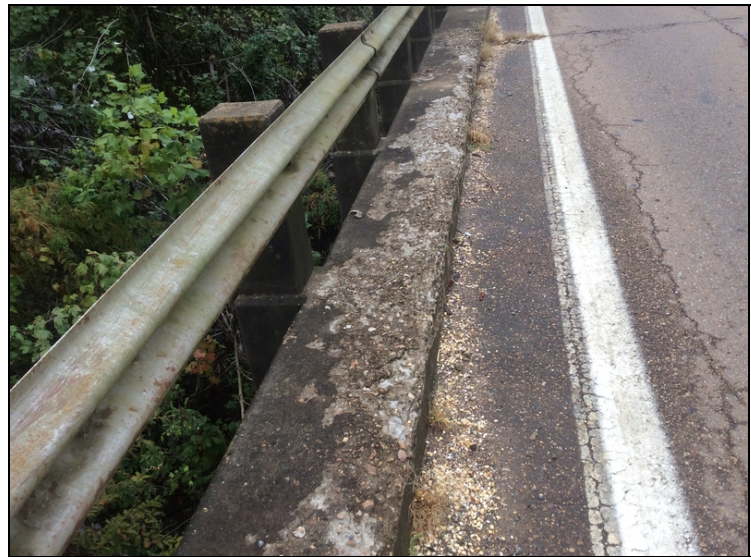
Typical curb condition spans #1-7 left and right
sideline

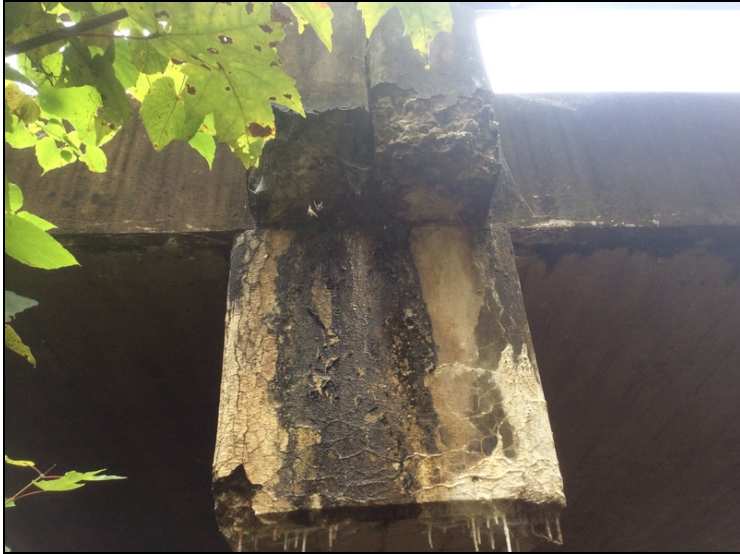
Typical cap end and bent #2 guard rail post bottoms

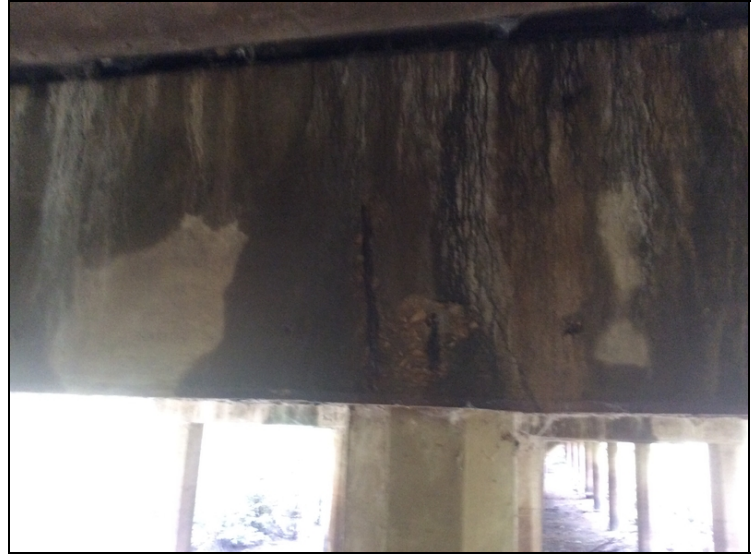
Bent #2 cap back face in center has a one foot piece of exposed rebar with moderate section loss, and ahead face has two six inch pieces of exposed rebar with moderate section loss, right end has 1' of cracking and delamination.
Bent #3 cap left end is cracking with delamination, spalling.
Bent #4 cap ahead face has one piece of rebar one foot exposed, one piece two foot long, and a two foot delamination.
Bent #5 cap right end bottom corner is spalled with exposed rebar with moderate section loss.
Bent #7 cap left end at top has a six inch spall with no rebar exposed.
Bent #7 cap ahead face has a six inch piece of exposed rebar between piles #3,4 with moderate section loss.
Bent #7 cap back face right side has cs3 crack/delaminated area.
Bent #8 cap ahead face at top right end corner is delaminated.
Bent #8 cap back face above pile #3 has a one foot spall with exposed rebar with moderate section loss.

Bent #2 cap back face

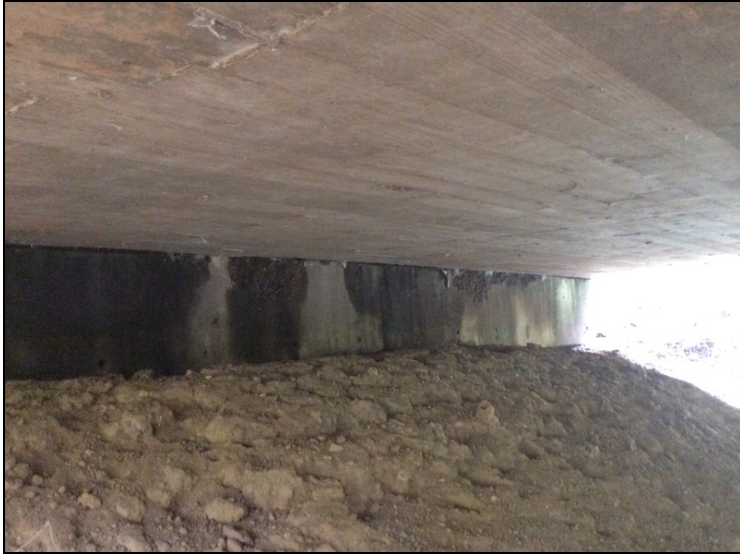
(215) Abutment #1 cap ahead face has eight feet of spalls at top no rebar exposed. Abutment #2 cap back face has three two foot spalls at top no rebar exposed.							
227	Reinforced Concrete Pile	EA	45	9	36	0	0
1190	Abrasion/Wear (PSC/RC)	EA	36	0	36	0	0

Abutment #1 cap

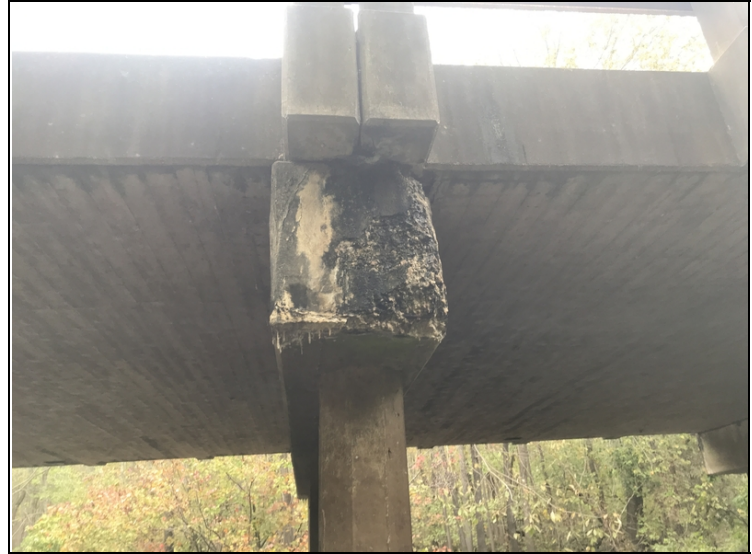
Bent #11 cap right end.

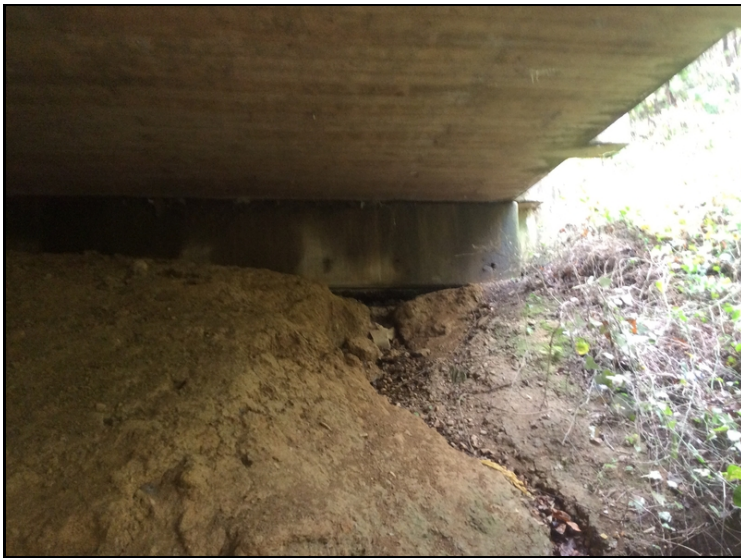
Abutment #1 slope is eroded undermining cap on left end and exposing one pile.

Abutment #1 left side erosion

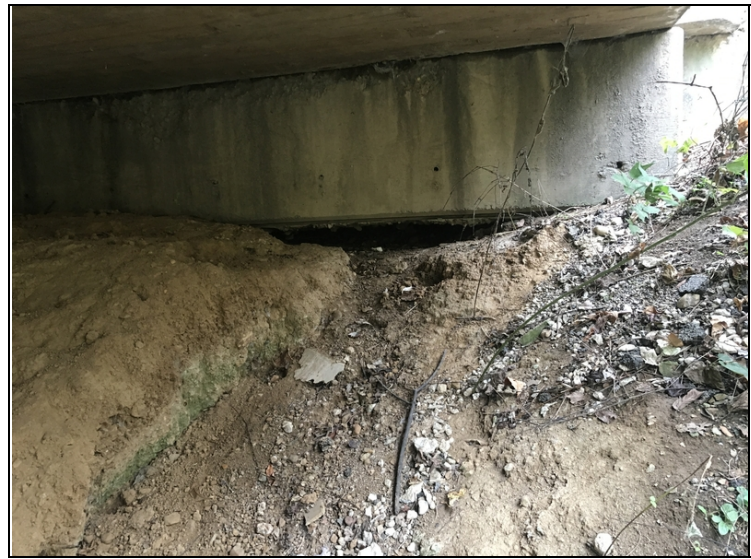
Abutment #1 cap left side undermined.

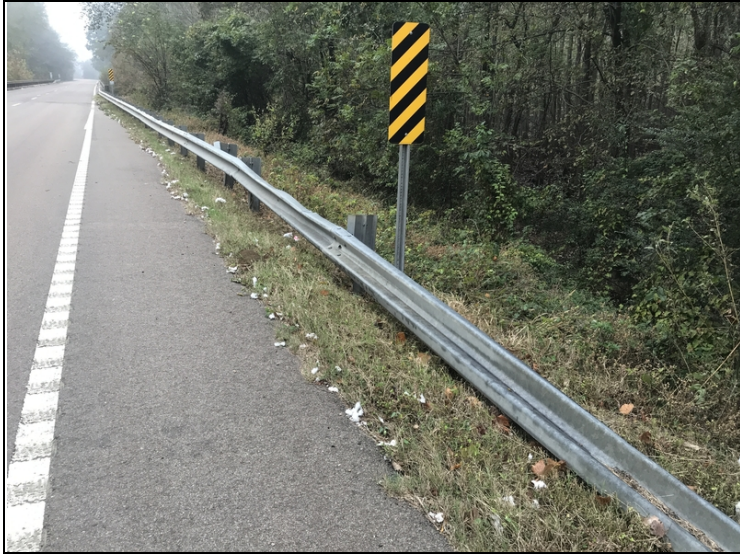
Approach rails have minor damage both abutments.

Abutment #2 left approach rail damage and 2 rail posts not connected.

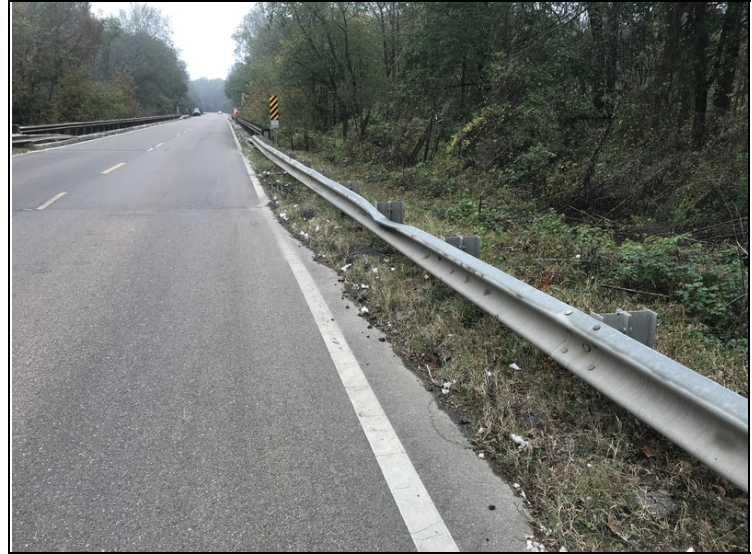
Abutment #1 right approach rail.

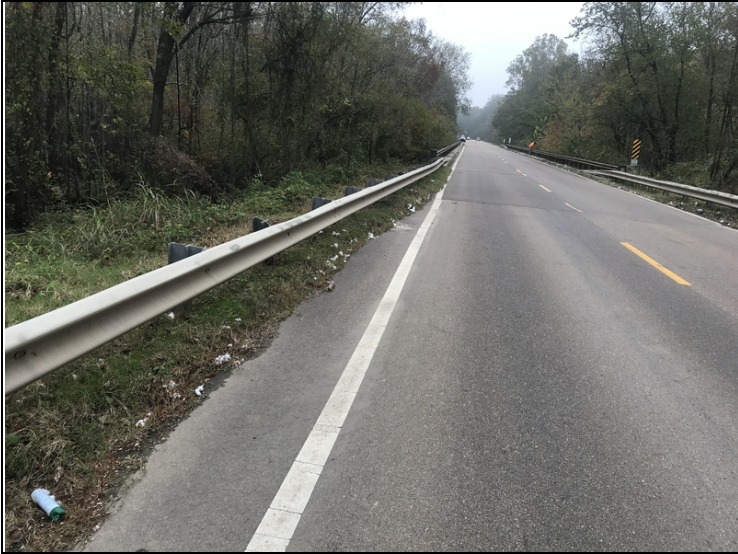
Abutment #1 left approach rail.

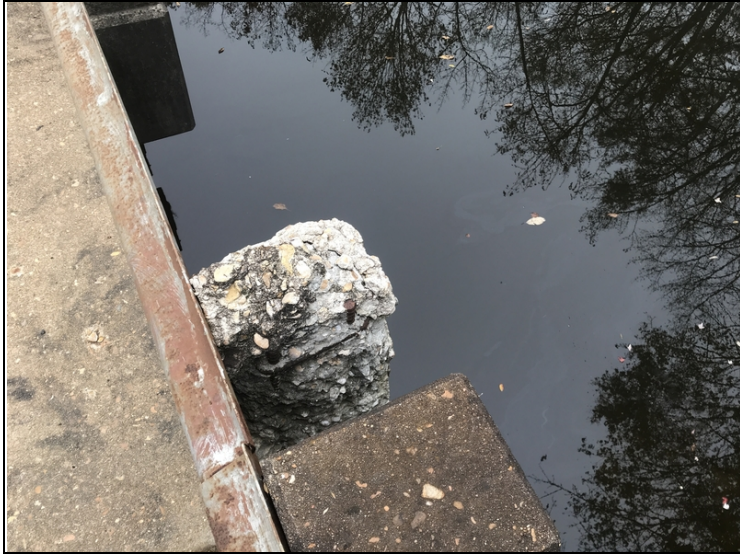
Span #9 at bent #10 left rail post spalled with exposed rebar.

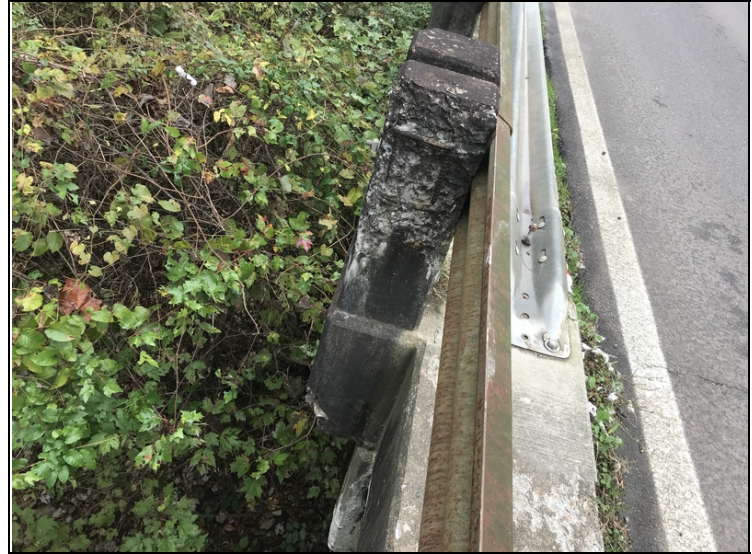
Span #2 bent #2 right rail post.

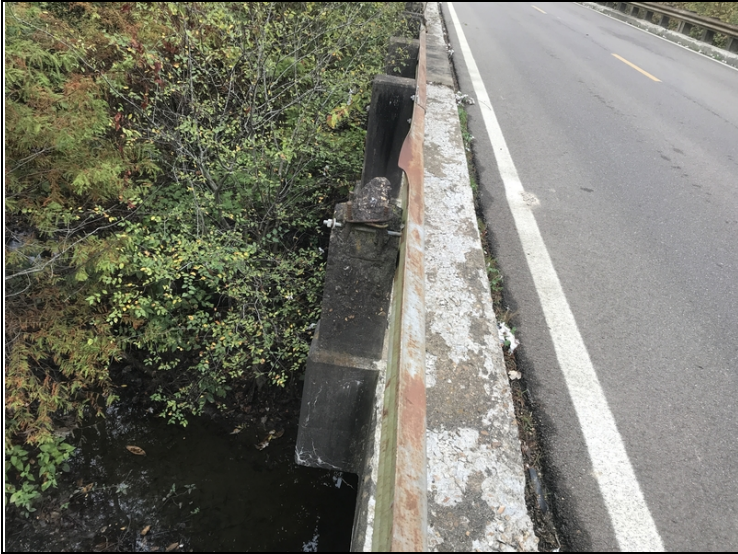
Span #3 second rail post on left side.
