Asset #A1748(Routine)

Sh-1/Sec-6/L-6.24 over Cypress Creek

Location: 1 Mile Ne Jct Sh 17 & 1

Team Lead: Drew Melton, Inspection Date: 10/31/2022

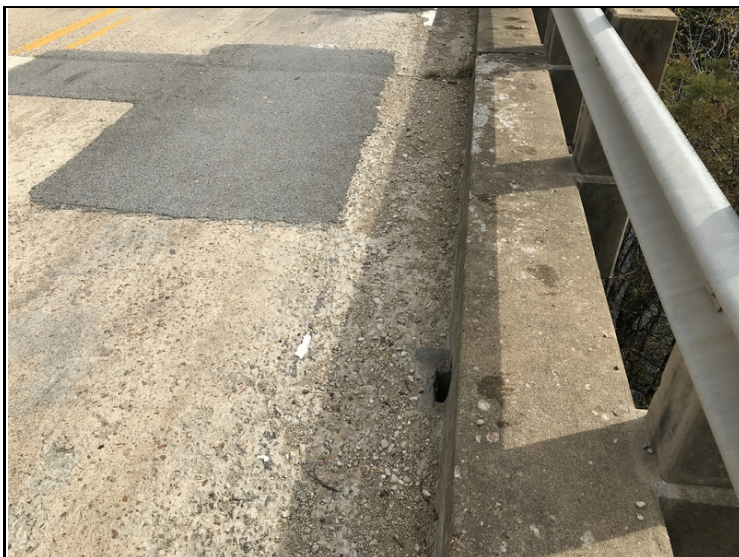
Right shoulder full length has moderate scaling with loose aggregate.

10/31/2022 deck has been overlaid.

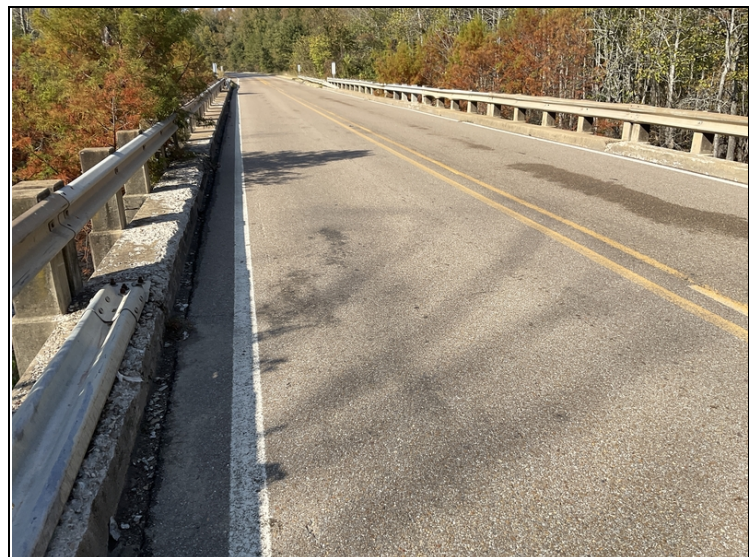
Typical deck overlay

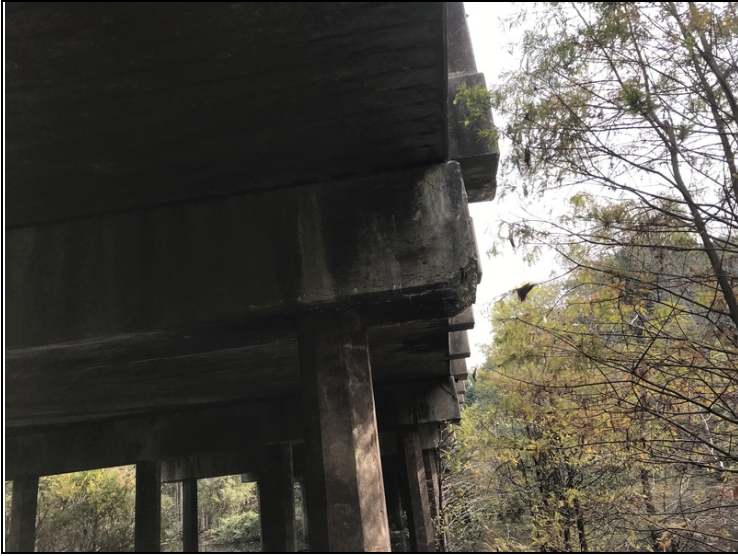
Bent #3 cap both ends are spalled with exposed rebar with moderate section loss.
Bent #3 cap right end back face has 4' of cracking with light efflorescence.
Bent #4 cap right back face top corner is spalled with 3" of exposed rebar with no section loss.
Bent #5 cap left end front and back face have 3' of cracking with light efflorescence.
Bent #6 cap right back face corner is spalled off no rebar exposed.
Bent #7 cap left ahead face has a one foot piece of exposed rebar with moderate section loss.
Bent #8 cap right bottom corner is spalled with no rebar exposed.

Bent #3 right end.

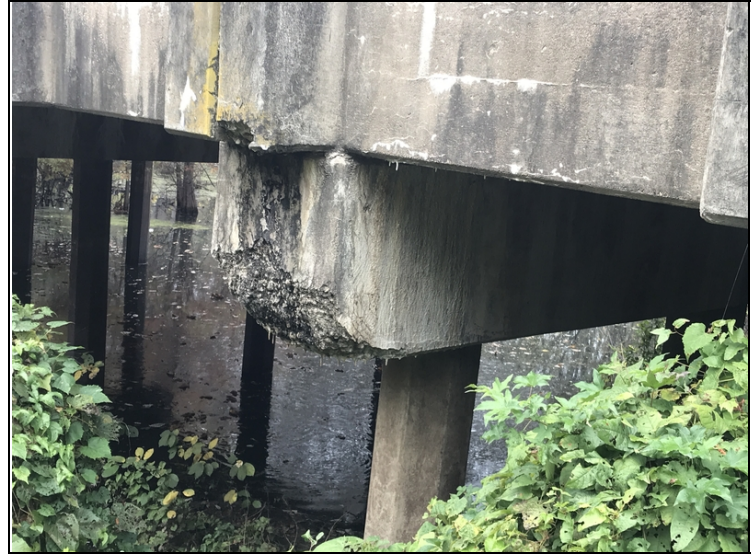
Bent #8 cap right end.

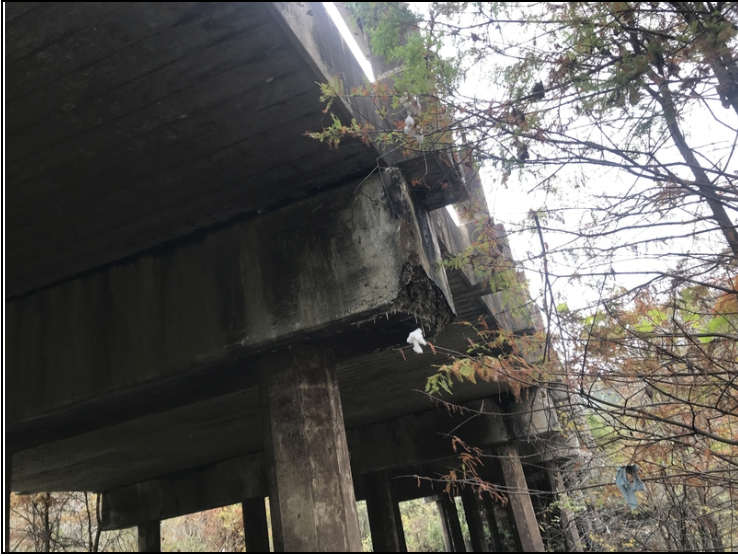
Bent #3 cap right end.

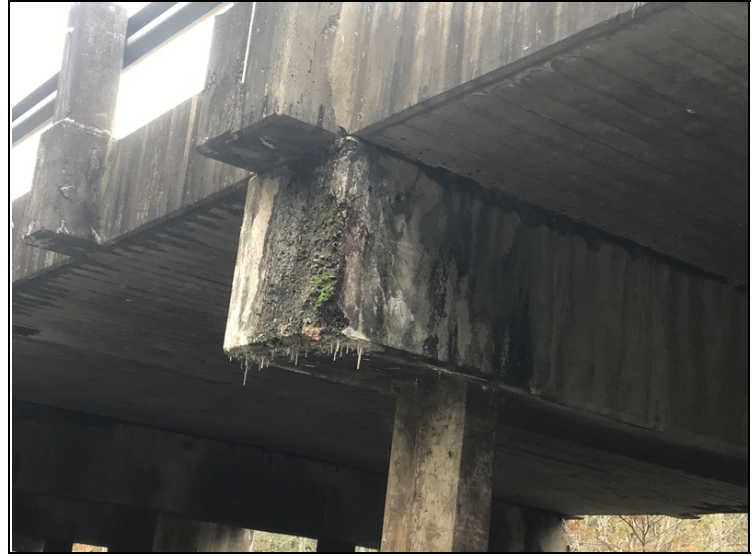
Bent #3 cap left end.

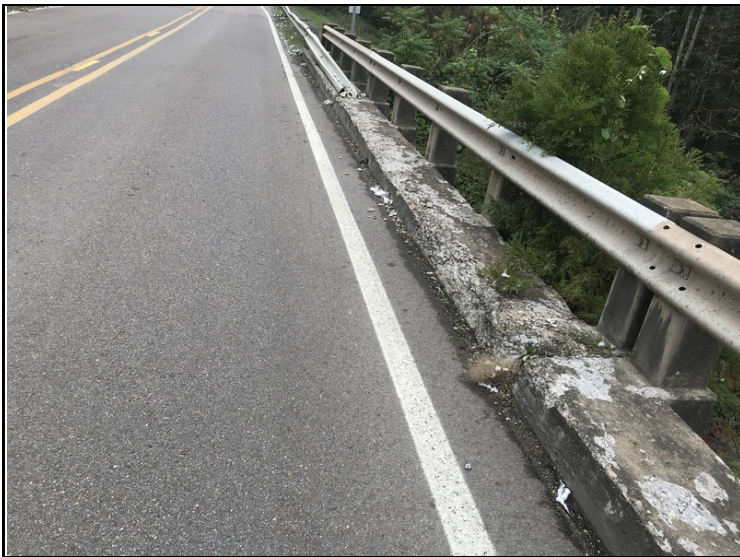
Curbs both sides of bridge span #5,7,8 each have areas of spalling and deterioration.

Typical heavily scaled curb.

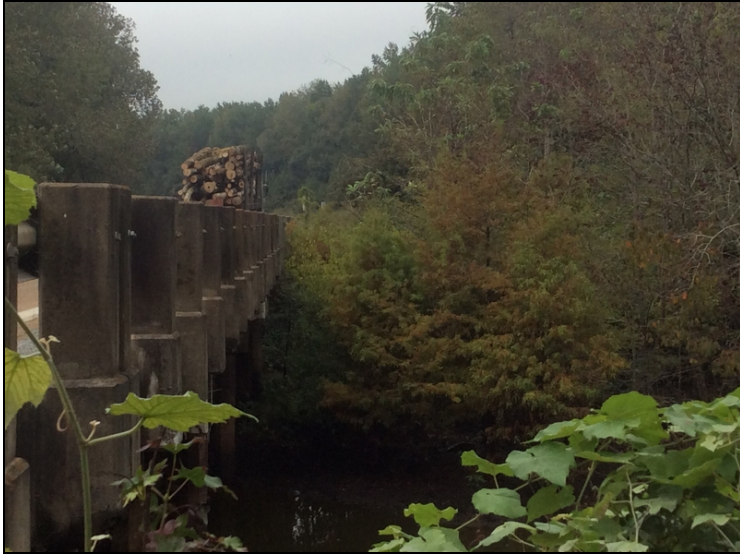
Vegetation growing beside and under edge of bridge

Date Reported: 10/23/2018
Priority: C - Important
Type of Work: (Inactive) (Inactive) 1 - Clean
Status: Monitor
Component: Channel

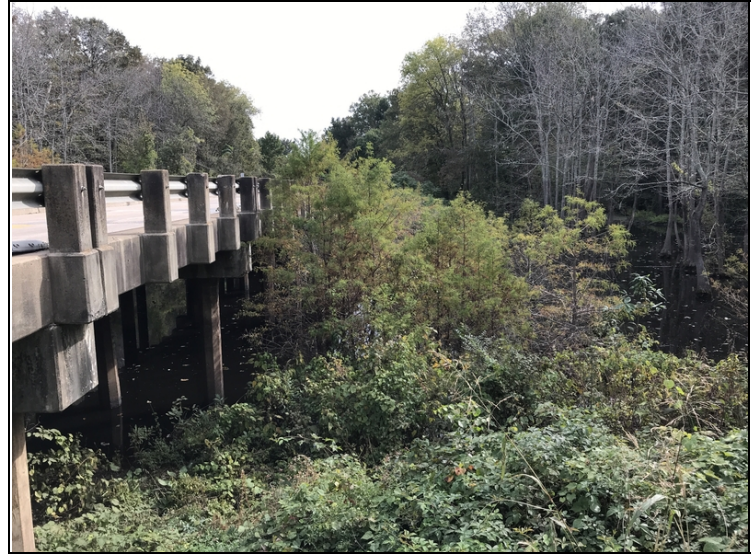
Trees and vegetation are growing beside and under bridge.

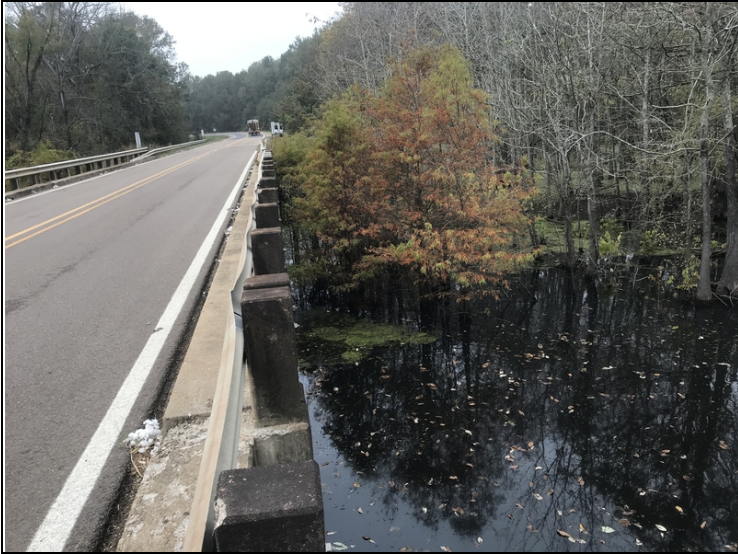
Trees and vegetation growing beside and under bridge.

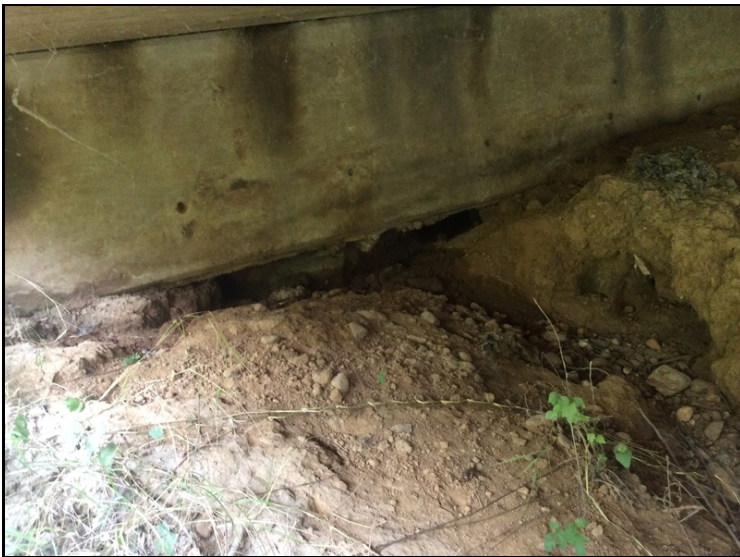
(215) Abutment #2 left end moderate erosion with pile #1 exposed.							
227	Reinforced Concrete Pile	EA	29	9	20	0	0
1190	Abrasion/Wear (PSC/RC)	EA	20	0	20	0	0

Slope abutment #2 left side cap is undermined four feet and up to one foot deep exposing pile #1.

Abutment #2 left side erosion.

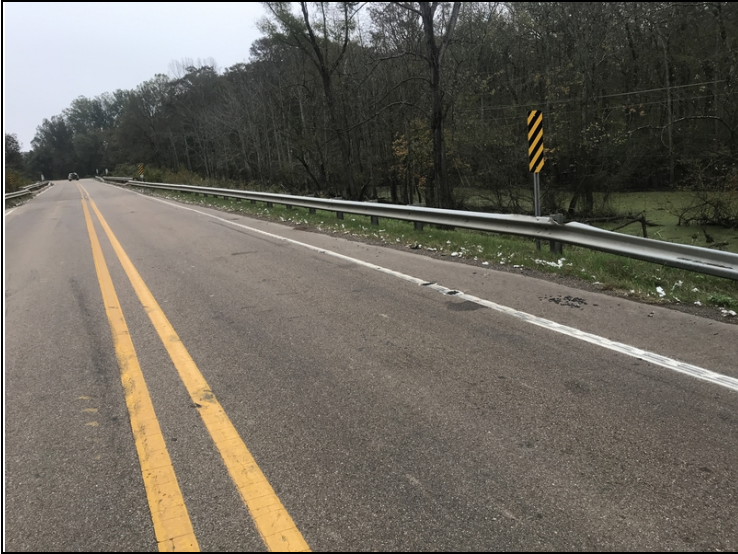
Abutment #1 right approach rail.

Approach rails, both abutments have minor collision damage.
