Asset #05134(Routine, Underwater type 2)

Sh-147/Sec1/L12.81 over Ditch Number 49

Location: 2.4 Miles South Jct Us 70

Team Lead: Drew Melton Inspection Date: 01/08/2024

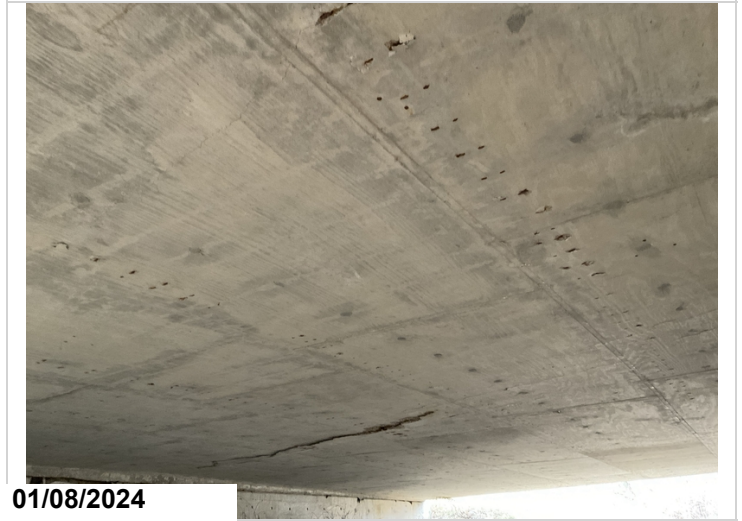
Deck is a slab so deck and superstructure are rated the same. Deck is in satisfactory condition with a hydro blasted deck with soffit-under surface having some large delaminated areas and cracks.

Typical soffit-under surface

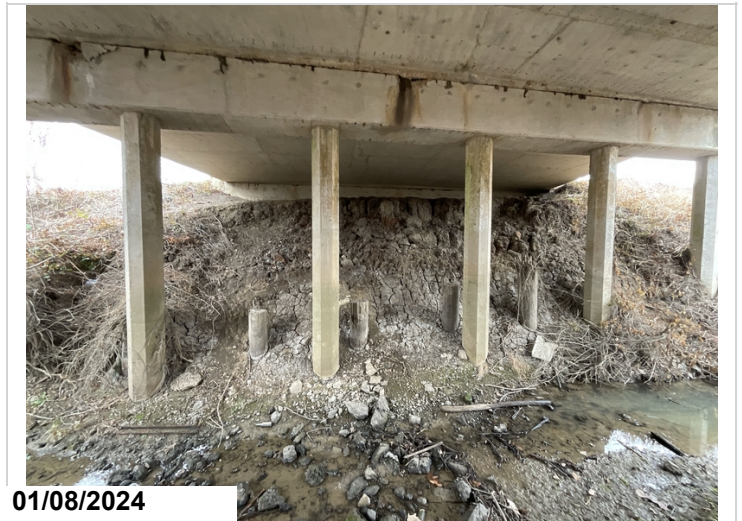
Channel has good alignment with structure. Banks are vegetated with some areas of erosion with Abutment #2 slope eroding and slumping nearing cap. Channel has some debris restrictions reducing water flow rates.

Abutment 2 slope has eroded to a 5' tall vertical face 4'-8' from abutment cap.

Abutment #2 slope

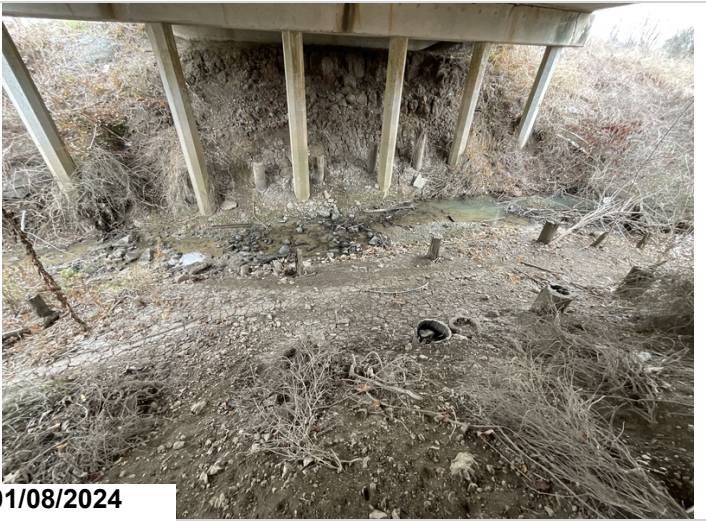
Channel under bridge

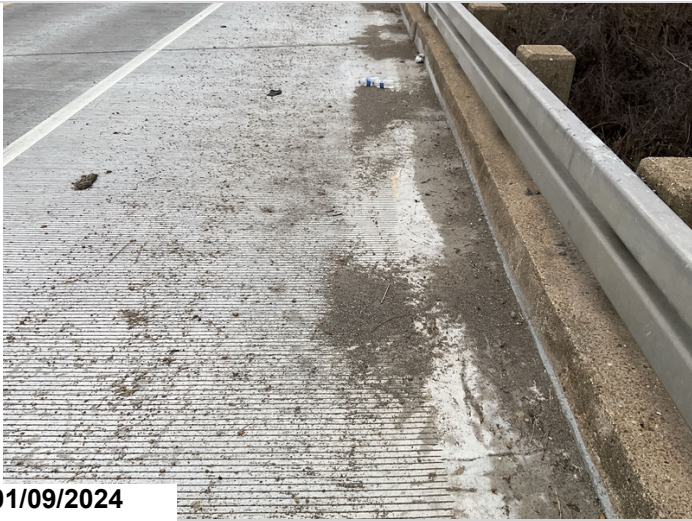
Gutters have dirt and debris in them.

Typical debris in gutters

A-55 - Deck Washing Needed (Y)

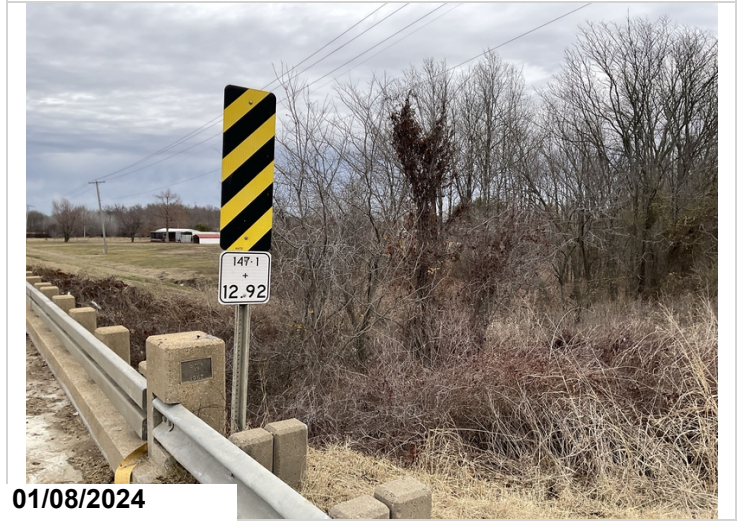
Log mile sign is incorrect should read Sh-147, Section-1, Log mile 12.81.

Typical log mile sign

A-63 - Missing/Incorrect Log Mile Signage (Y)

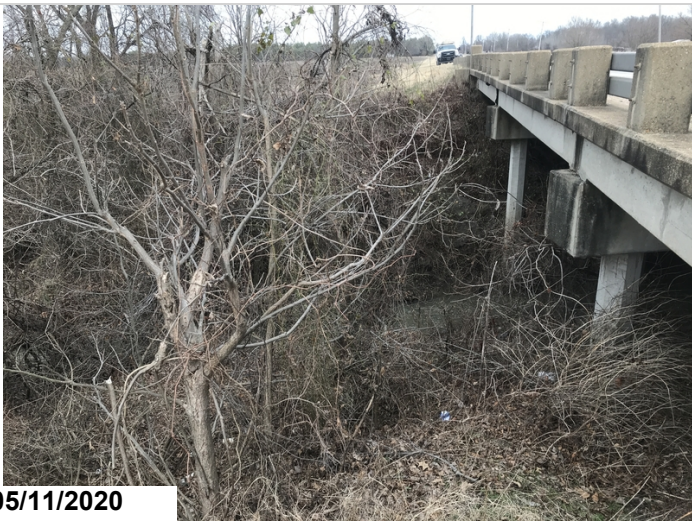
Vegetation is growing under and beside bridge left and right sides.

Typical vegetation

A-64 - Vegetation Removal Requested (Y)

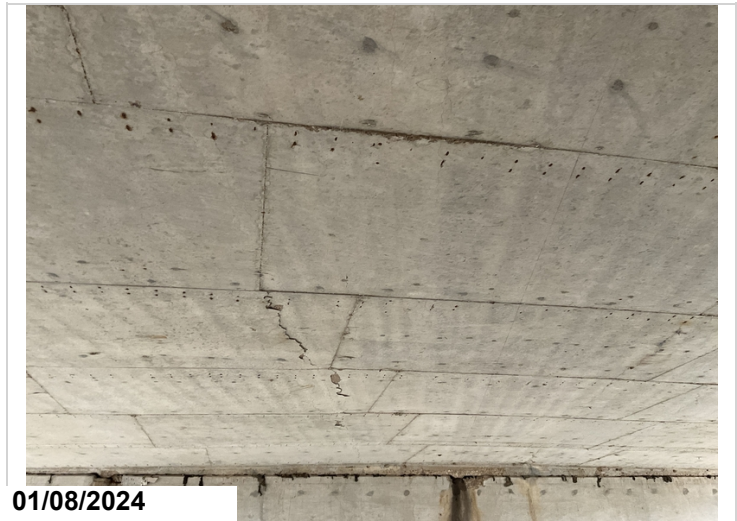
Span #2 soffit-under surface delaminated area.

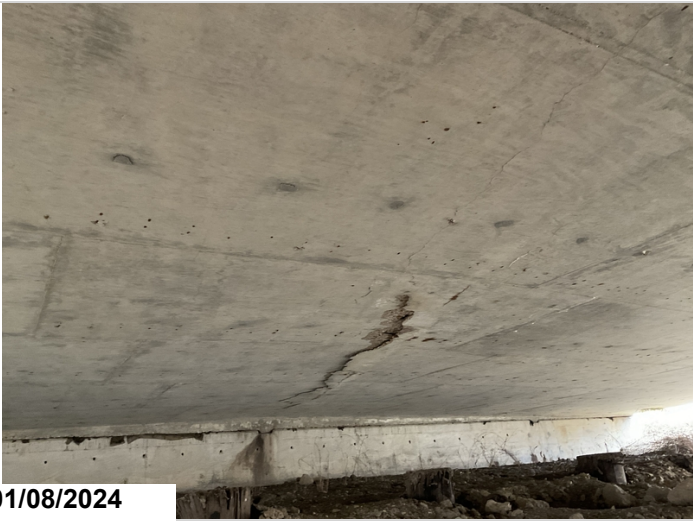
Span #1 soffit-under surface delaminated area and spall.

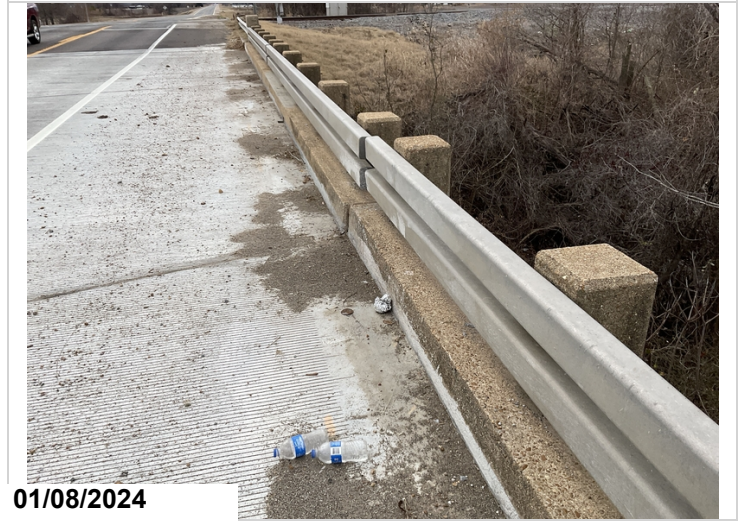
Misalignment from span #2 to span #3.

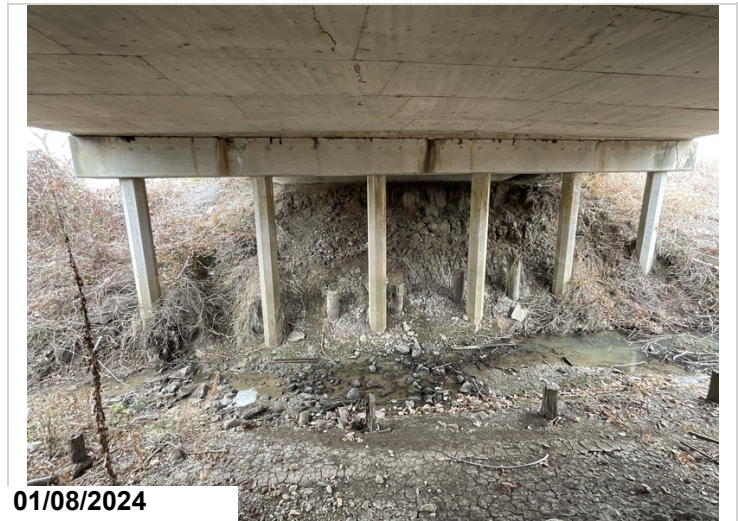
Substructure is in good condition with some minor spalls and delaminated areas at top of caps.

Bent #3 cap back face.

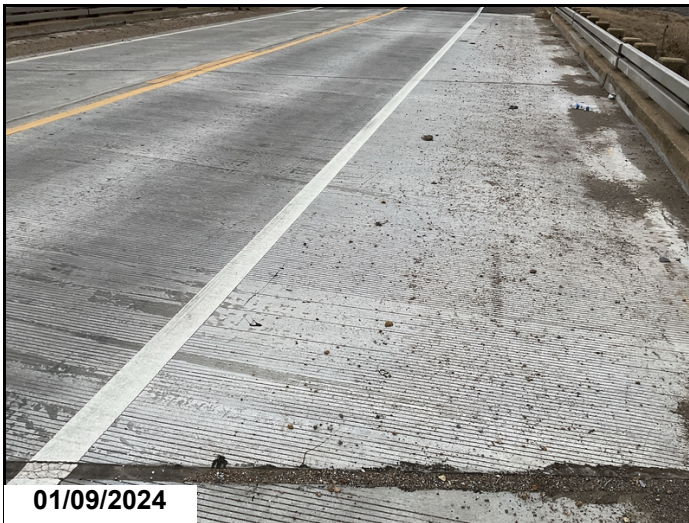
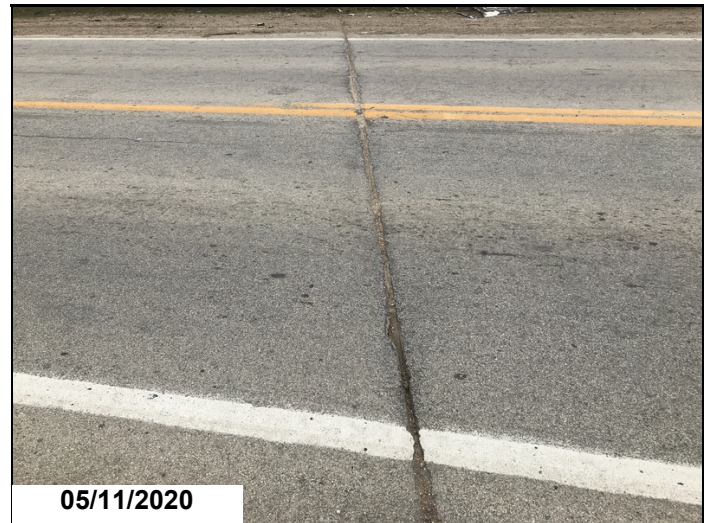
All deck joints are full of non-compressible material.

Typical joint replaced

Typical joint.

01/08/2024 Deck has had joints replaced.

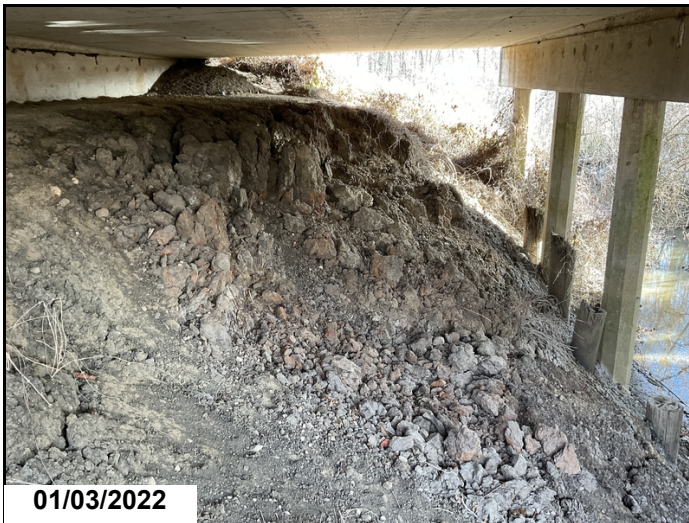
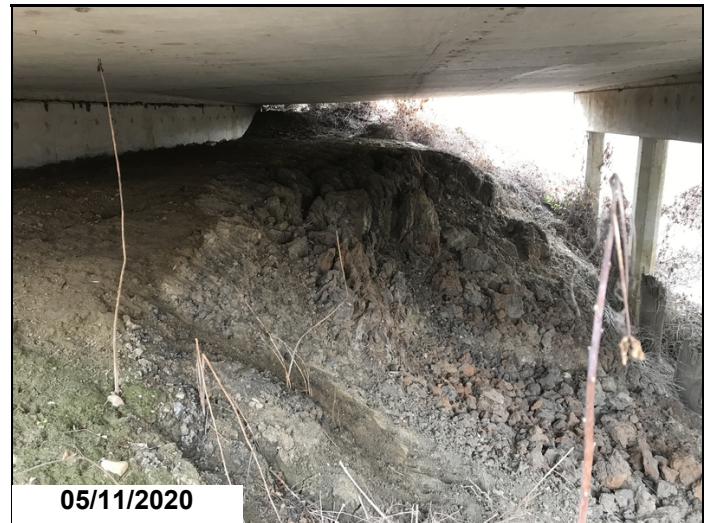
Abutment 2 slope has eroded to a 5' tall vertical face 4'-8' from abutment cap.

Abutment #2 slope erosion

Abutment #2 slope erosion.

Type of Work: Repair (General)

Status: Monitor

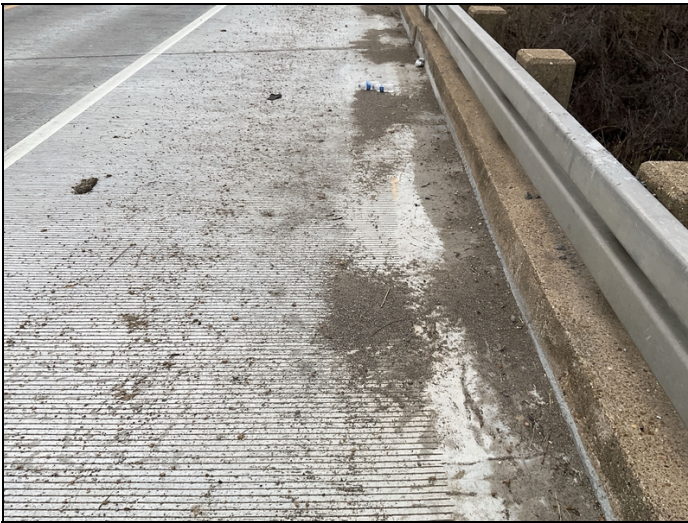
Gutters have dirt and debris in them.

Typical debris in gutters

A-55 - Deck Washing Needed (Yes)

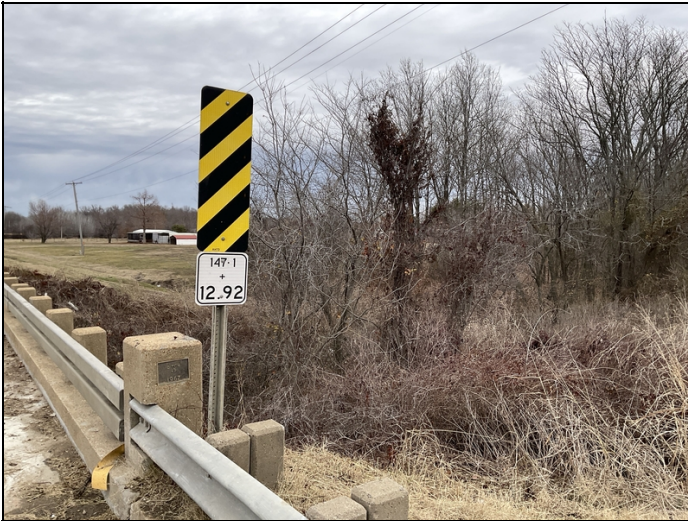
Log mile sign is incorrect should read Sh-147, Section-1, Log mile 12.81.

Typical log mile sign

A-63 - Missing/Incorrect Log Mile Signage (Yes)

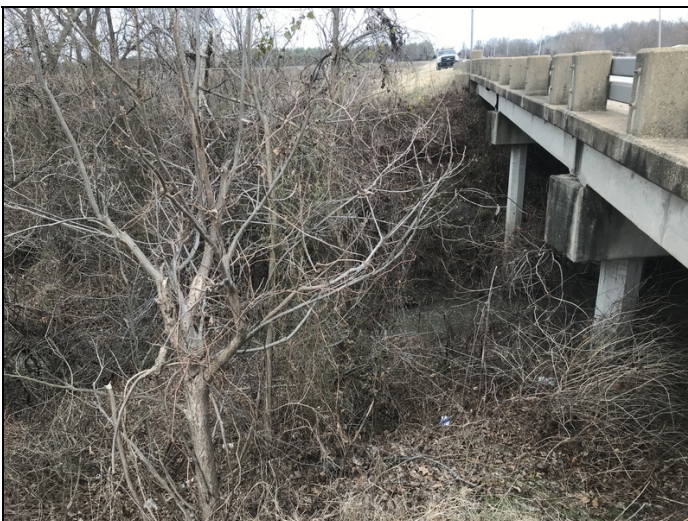
Vegetation is growing under and beside bridge left and right sides.

Typical vegetation

A-64 - Vegetation Removal Requested (Yes)
