Asset #05135(Routine, Underwater type 2)

Sh-147/Sec1/L13.85 over Ditch Number 50

Location: 1.6 Miles South Jct Us 70

Team Lead: Drew Melton Inspection Date: 01/08/2024

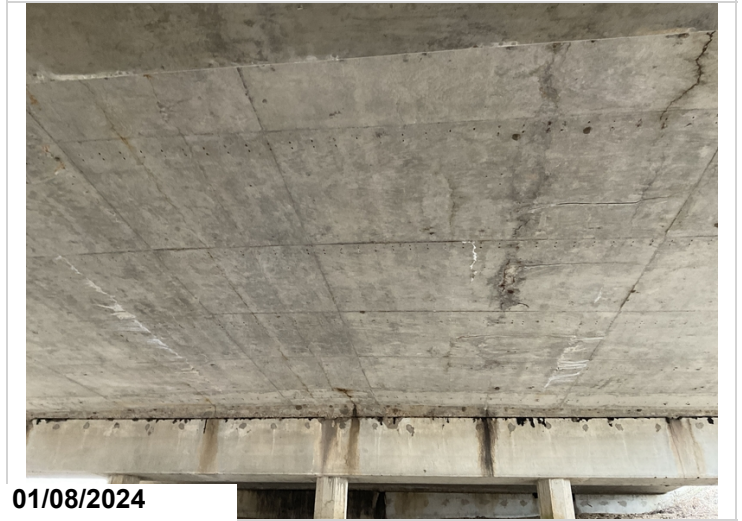
Deck is a slab so deck and superstructure is rated the same. Deck is in satisfactory condition with a hydro blasted deck with soffit-under surface having large delaminated areas and cracks.

(38) Soffit-under surface all spans have several open longitudinal cracks with areas of light to moderate efflorescence and rust staining. Soffit-under surface has some graffiti on it. Span #1 soffit-under surface has two four foot wide by twenty foot long delaminated areas left and right of center line. Span #3 soffit-under surface has a two foot wide by twenty foot long delaminated area near center line. Span #1 slab right side at bent #2 has vertical crack and minor spalling at end of slab.							
215	Reinforced Concrete Abutment	LF	100	85	15	0	0
6000	Scour	LF	15	0	15	0	0

Typical soffit-under surface

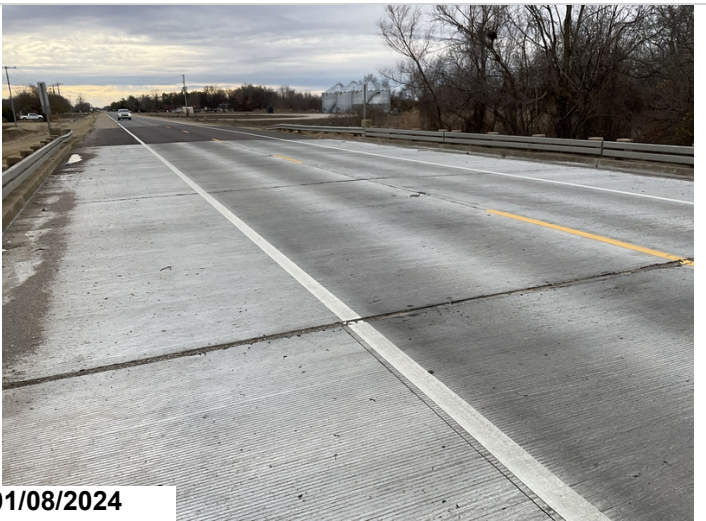
Typical deck

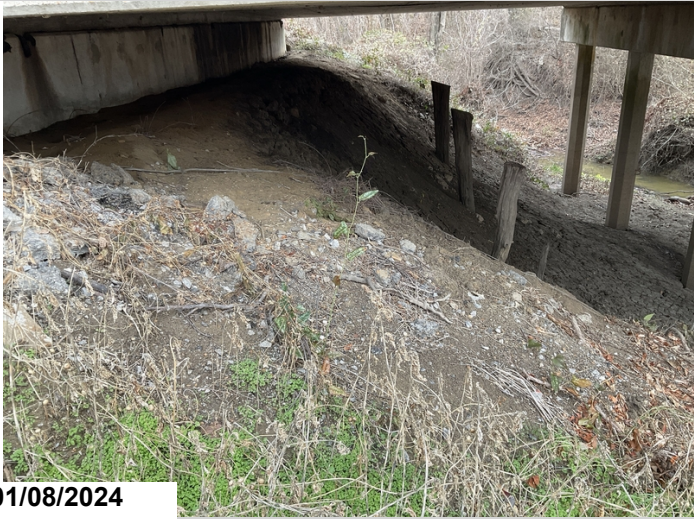
Bent #3 slope is eroded to a vertical face exposing pile #2,3 up to four feet.
Abutment #1 slope as eroded within two feet of abutment #1.

Abutment #1 slope

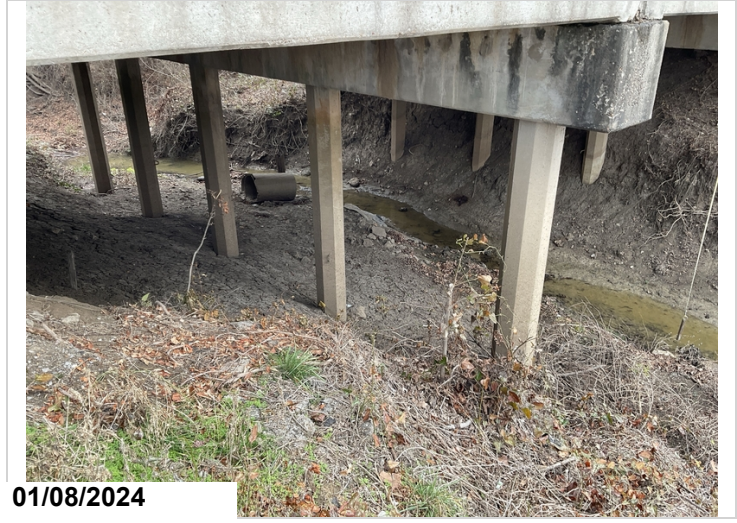
Channel has good alignment with structure. Banks have areas of erosion and slumping including abutment slopes. Channel has debris restrictions causing water flow restrictions.

Channel under bridge

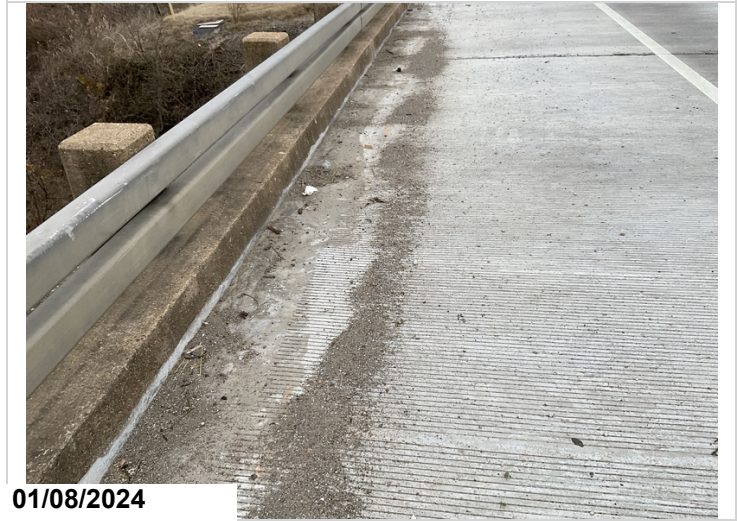
Gutters have dirt and debris in them.

Typical debris in gutters

A-55 - Deck Washing Needed (Y)

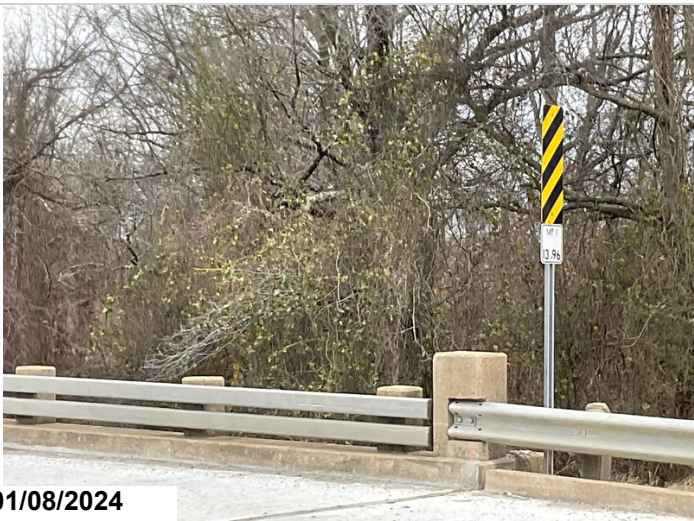
Log mile signs are incorrect should read Sh-147, Section-1, Log mile 13.85.

Typical log mile sign

A-63 - Missing/Incorrect Log Mile Signage (Y)

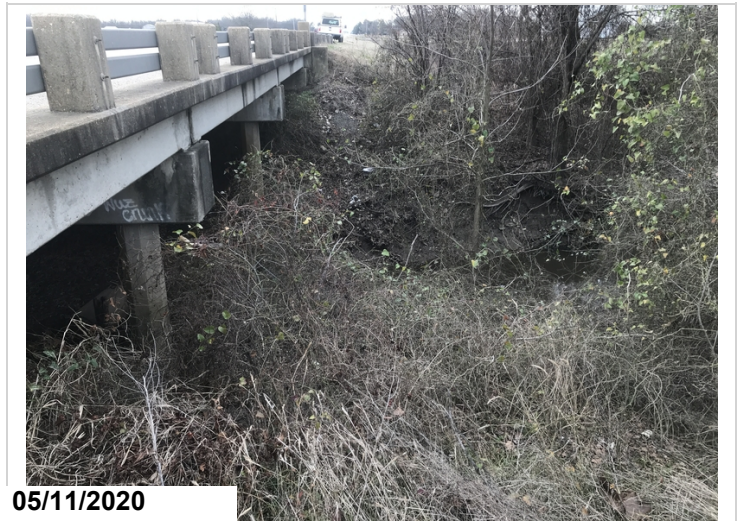
Vegetation is growing under and beside bridge left and right sides.

Typical trees and vegetation.

A-64 - Vegetation Removal Requested (Y)

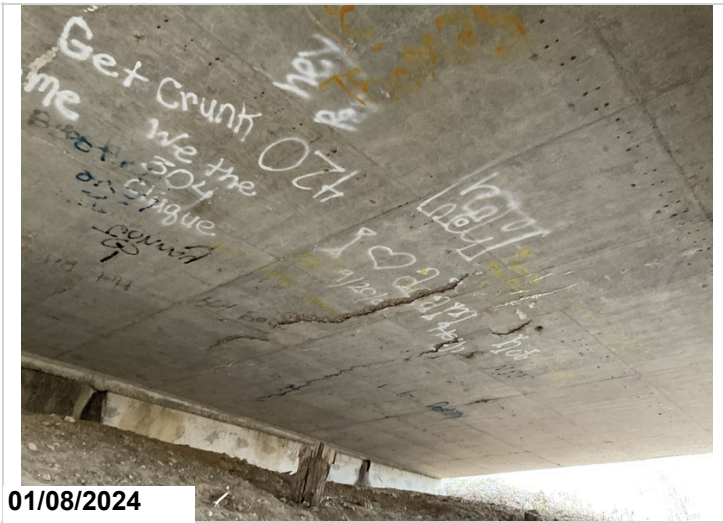
Span #3 soffit-under surface delaminated area

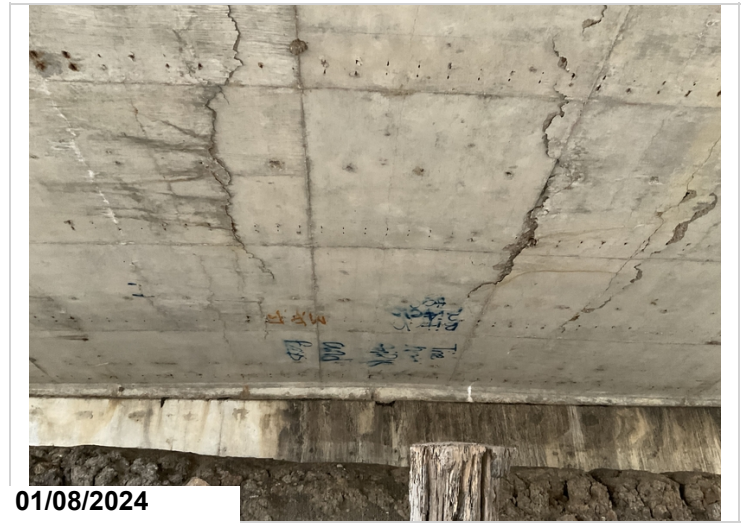
Soffit-under surface has some graffiti on it.

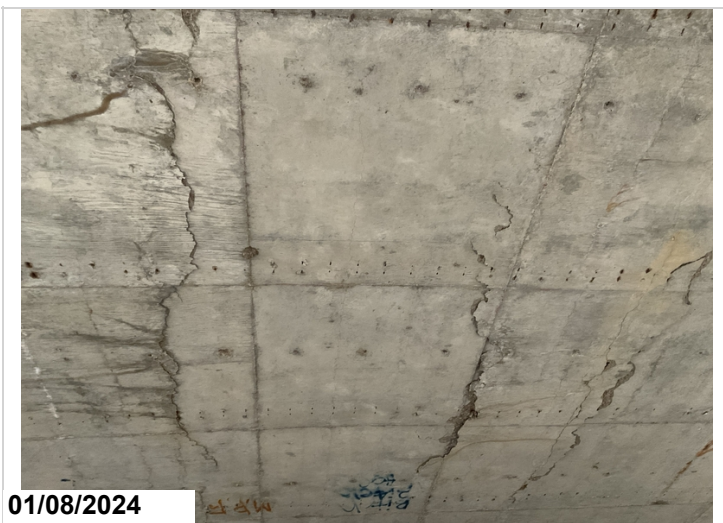
Span #1 soffit-under surface delaminated areas.

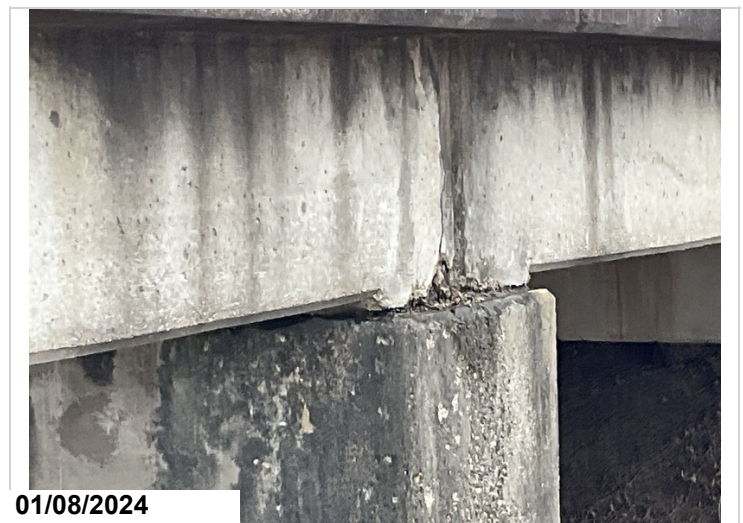
Span #1 slab right side at bent #2 has vertical crack and minor spalling at end of slab

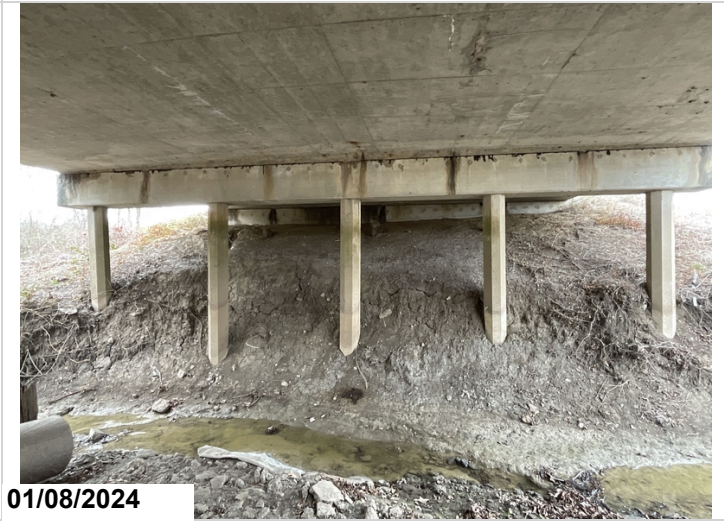
(234) Bent #2 cap has a 6" delaminated area over pile #3 ahead face. Bent #3 cap on left end has a three foot spall with exposed rebar with minor section loss area on back face. Bent #3 cap back face near centerline has two one foot spalls with no exposed rebar.							
301	Pourable Joint Seal	LF	185	185	0	0	0
330	Metal Bridge Railing	LF	150	150	0	0	0

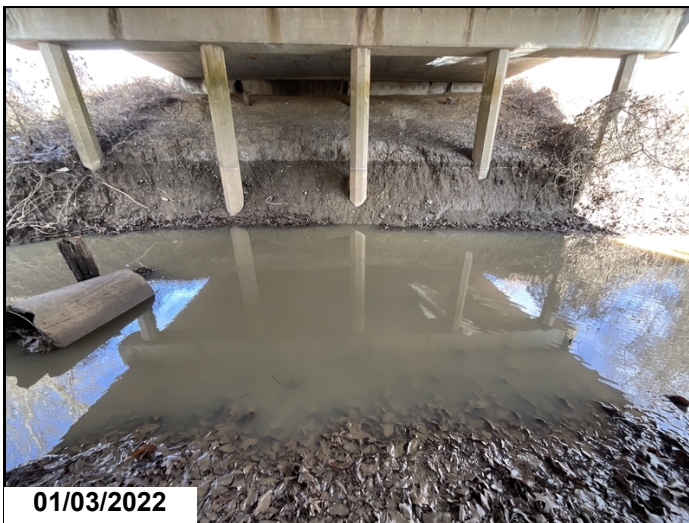
Bent #3 slope is eroded to a vertical face exposing pile #2,3 up to four feet.
Abutment #1 slope as eroded within two feet of abutment #1.

Erosion at bent #3.

Type of Work: Repair (General)

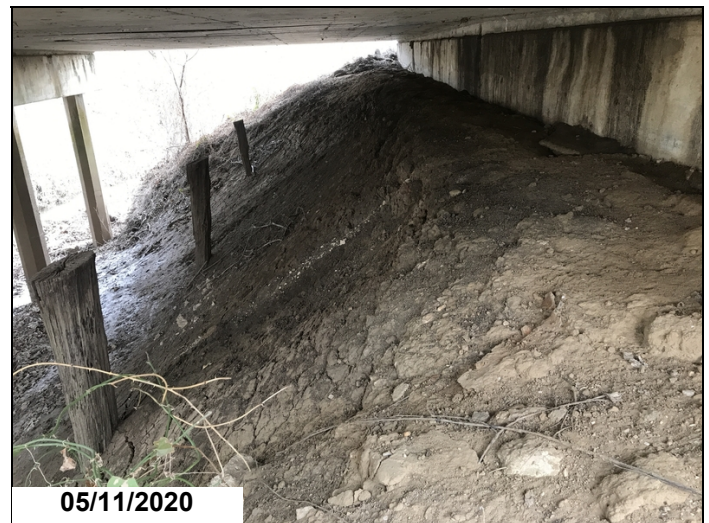
Abutment #1 slope erosion.

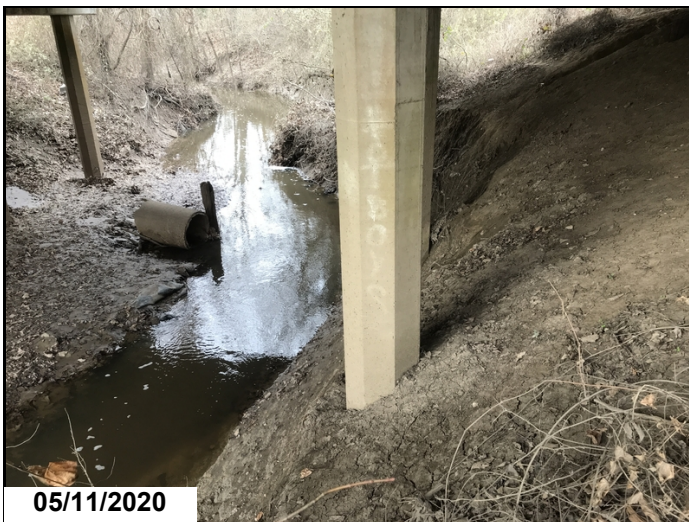
Bent #3 slope erosion.

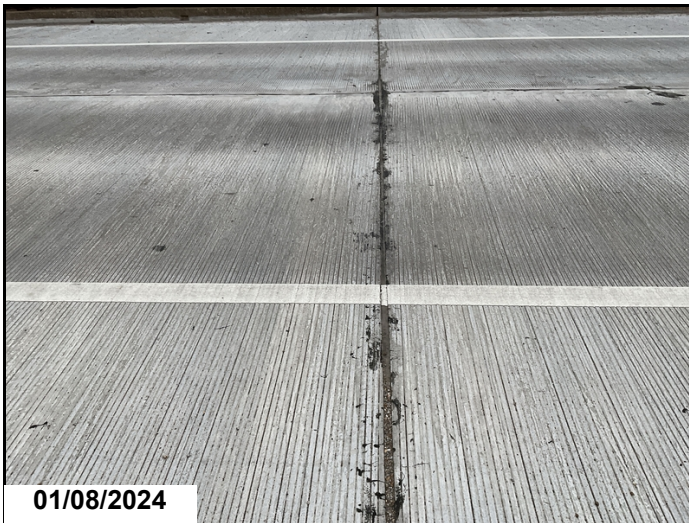
Joint material has failed allowing non-compressibles to enter.

Joints have been replaced since last inspection.

01/08/2024 Joints have been replaced since last inspection

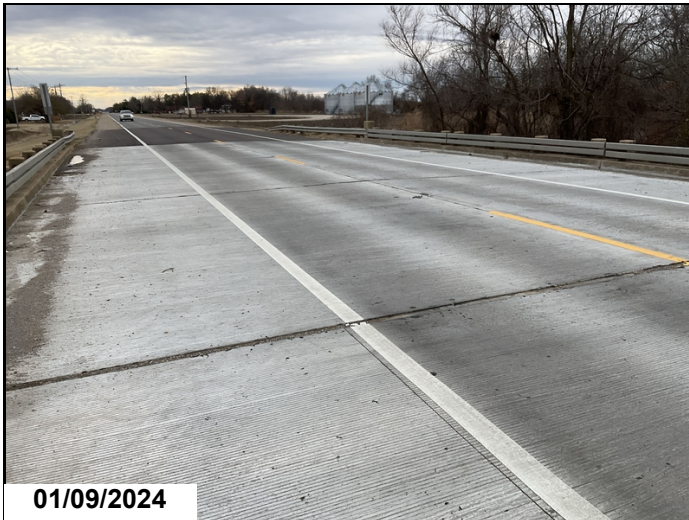
01/09/2024

Span #2 has a one foot by four foot spall with no exposed rebar in left lane at bent #2.
Span #2 mid span, right lane has 1' x 2' spall in deck.

Deck has been replaced since last inspection

01/08/2024 Deck has been replaced since last inspection.

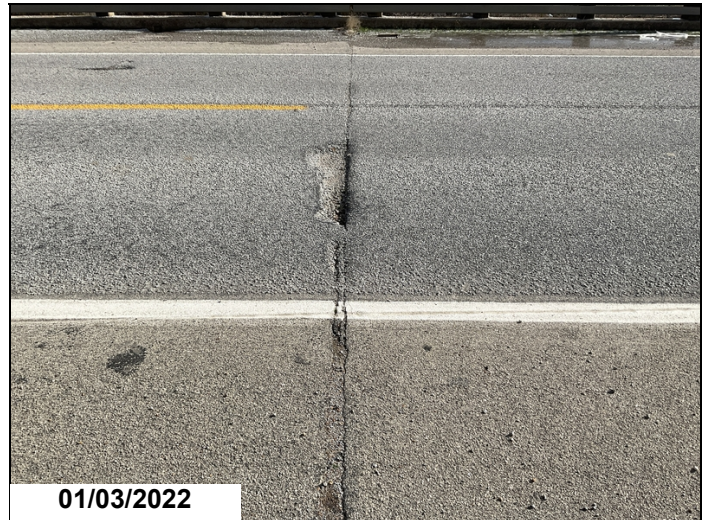
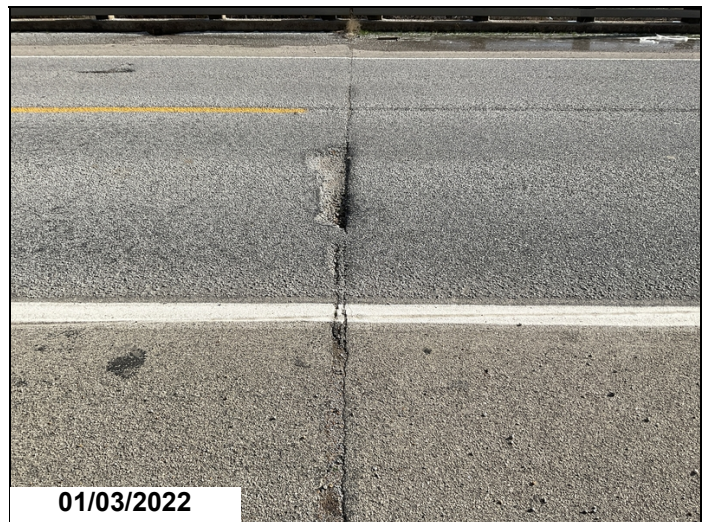
Span #2 bent #2 left lane spalled one foot by four feet

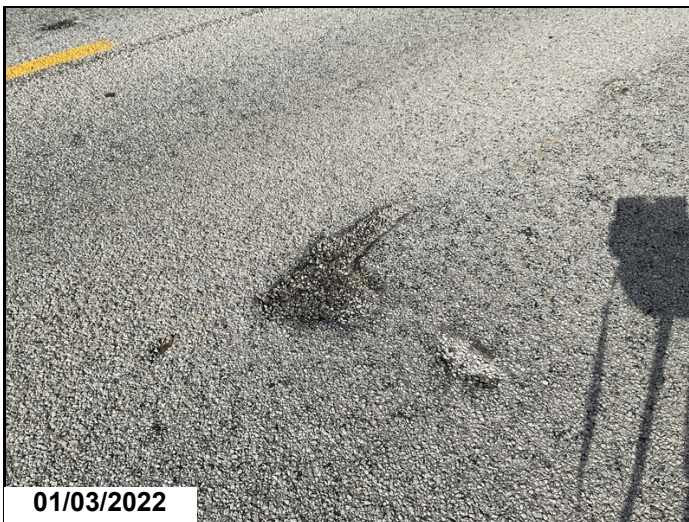
01/03/2022

Span #2 right lane mid span has one foot by two foot spall.

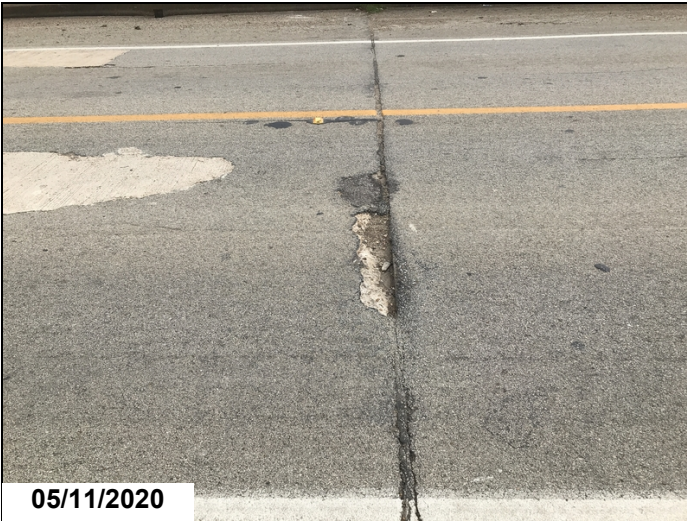
Span #2 has a two foot spall with no exposed rebar in left lane at bent #2.

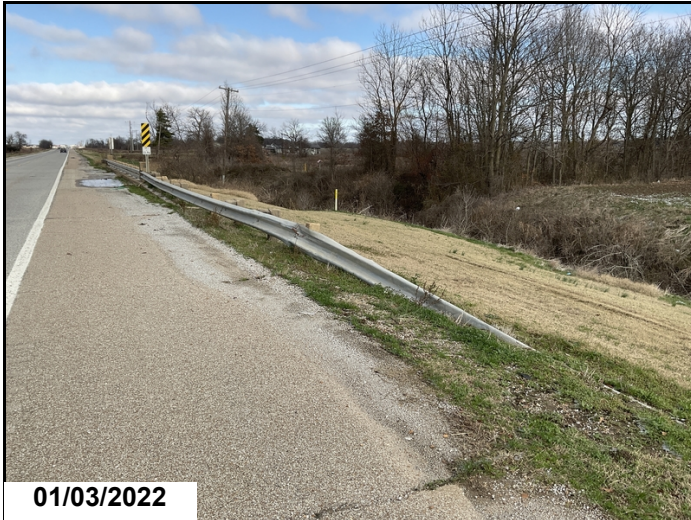
Abutment #1 right approach rail has collision damage.

Abutment #1 right approach rail

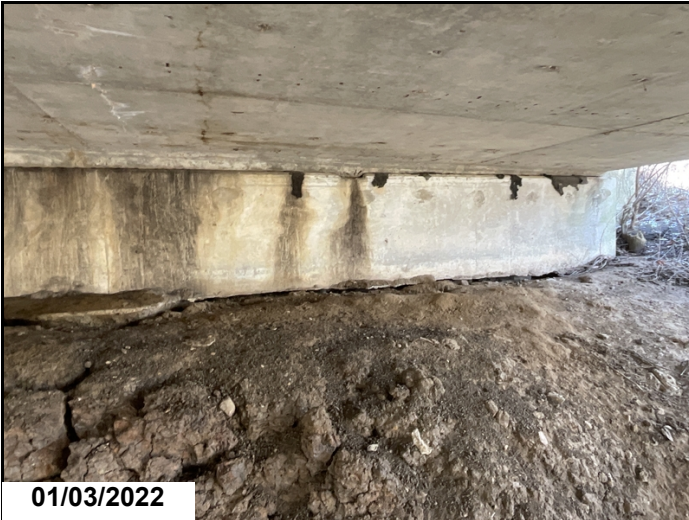
(215) Abutment #1 cap left side undermined up to four inches for fifteen feet exposing pile #1.							
227	Reinforced Concrete Pile	EA	11	11	0	0	0
(227) Abutment #1 cap left side undermined up to four inches for fifteen feet exposing pile #1							
234	Reinforced Concrete Pier Cap	LF	93	87	0	6	0
1080	Delamination/Spall/Patched Area	LF	3	0	0	3	0
1090	Exposed Rebar	LF	3	0	0	3	0

Abutment #1 cap left side undermined up to four-inches for fifteen-feet exposing pile #1

Abutment #1 cap left side undermined up to four inches
for fifteen feet exposing pile #1

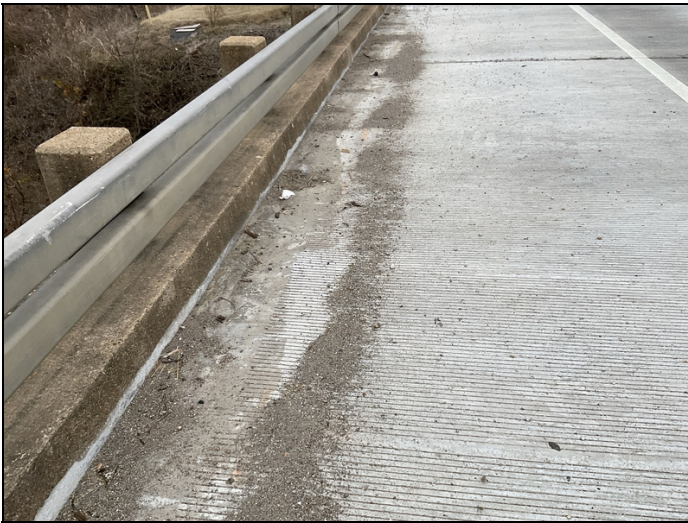
Gutters have dirt and debris in them.

Typical debris in gutters

A-55 - Deck Washing Needed (Yes)

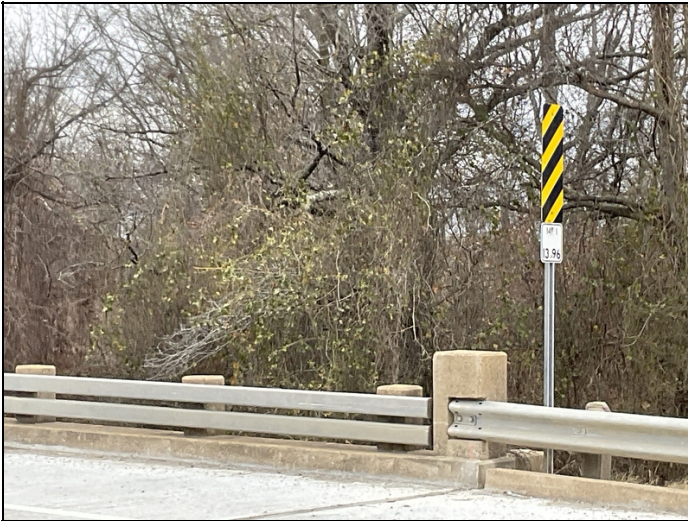
Log mile signs are incorrect should read Sh-147, Section-1, Log mile 13.85.

Typical log mile sign

A-63 - Missing/Incorrect Log Mile Signage (Yes)

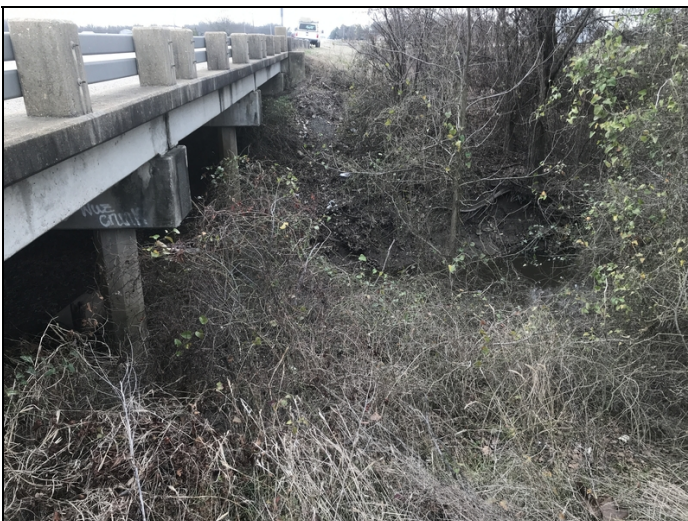
Vegetation is growing under and beside bridge left and right sides.

Typical trees and vegetation.

A-64 - Vegetation Removal Requested (Yes)
