Asset #07173(Routine, Underwater type 2)

Sh147/Sec-1/L11.84 over 10 Mile Bayou Cutoff Di

Location: 11.84 Miles Ne Jct Sh 131

Team Lead: Drew Melton Inspection Date: 06/15/2023

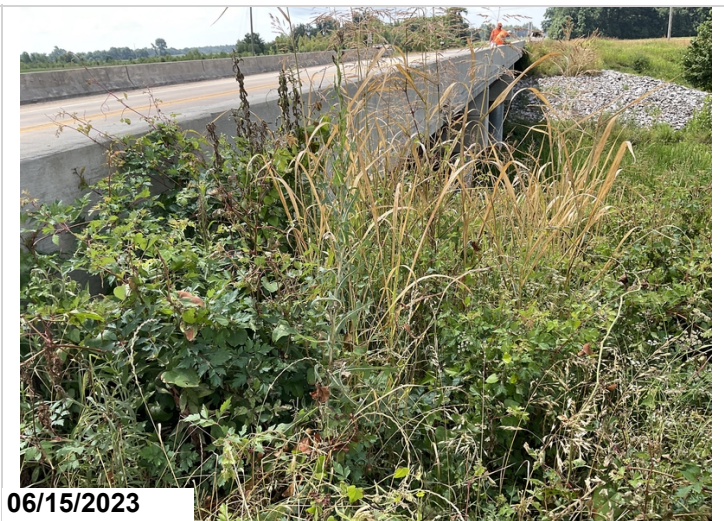
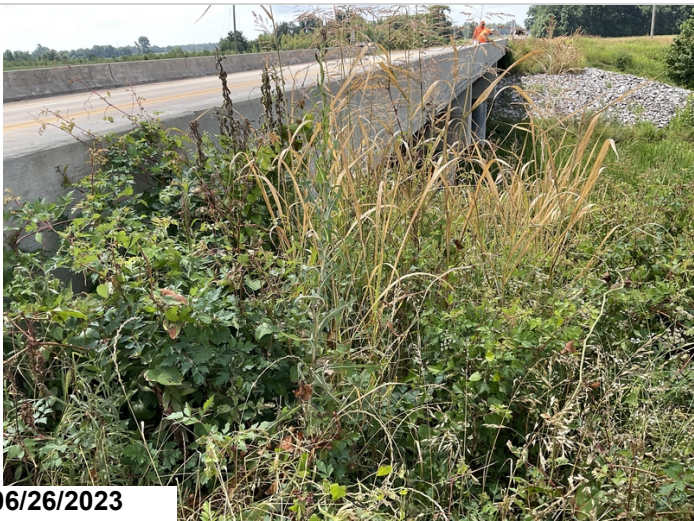
Trees and vegetation are growing beside and under bridge.

Typical vegetation

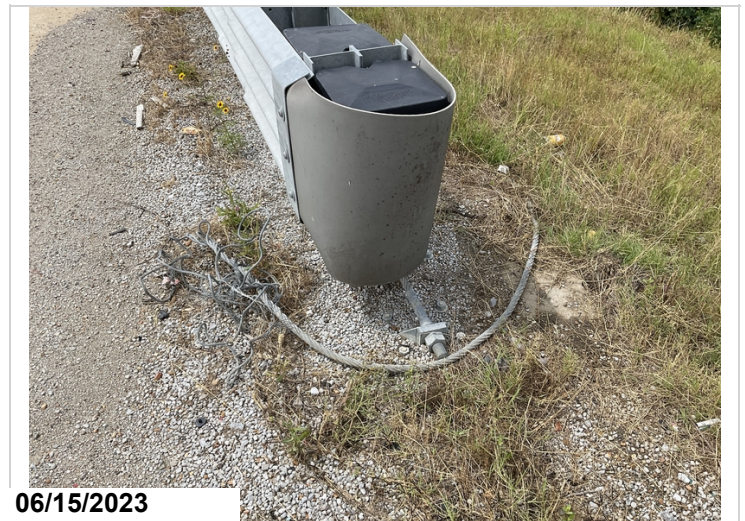
-Abutment #2 left approach rail cable broken.

Abutment #2 left approach rail cable broken.

Abutment #2 left approach rail cable broken.

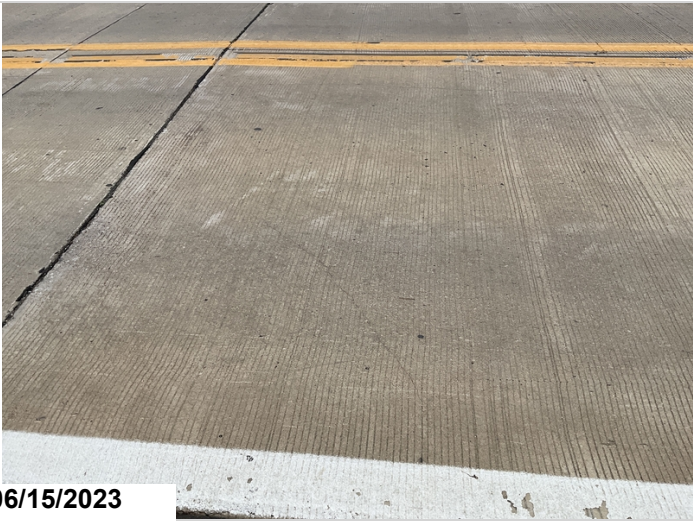
(321) -All approach slabs and gutters have hairline and cs2 cracks.							
331	Reinforced Concrete Bridge Railing	LF	318	238	80	0	0
1120	Efflorescence/Rust Staining	LF	40	0	40	0	0
1130	Cracking (RC and Other)	LF	40	0	40	0	0

All approach slabs and gutters have hairline and cs2 cracks.

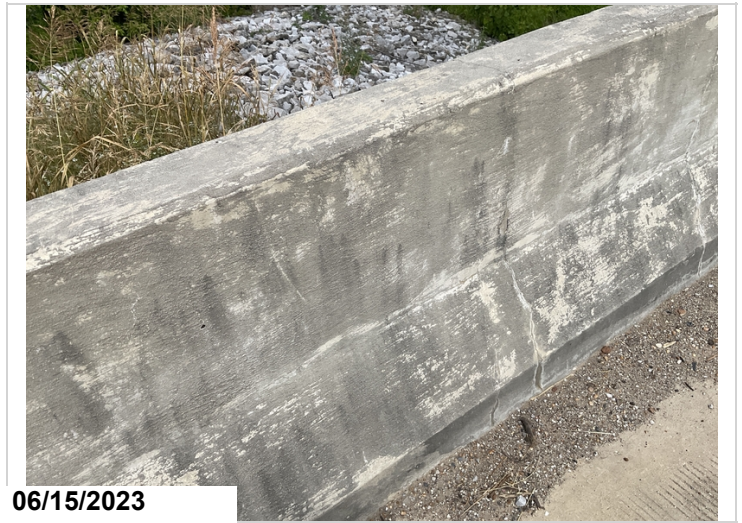
(331) -Bridge rails have vertical cracks spaced every 4' some with light efflorescence.

Bridge rails have vertical cracks spaced every 4' some with light efflorescence.

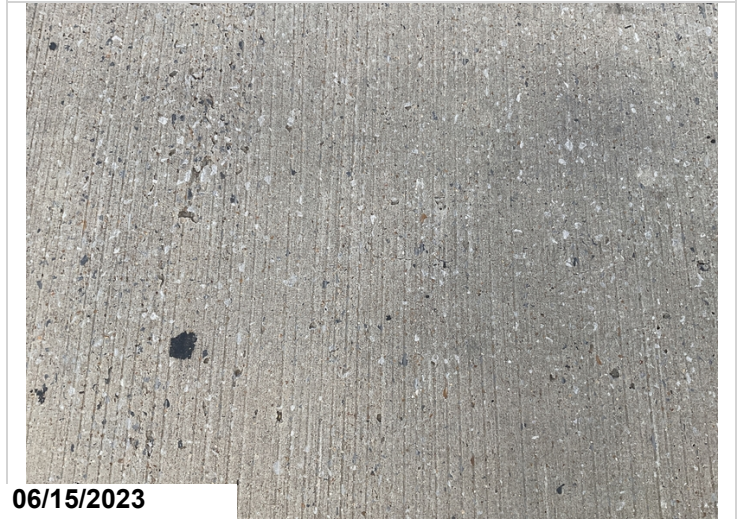
Deck has unsealed transverse and longitudinal cracks each span.

Typical deck crack.

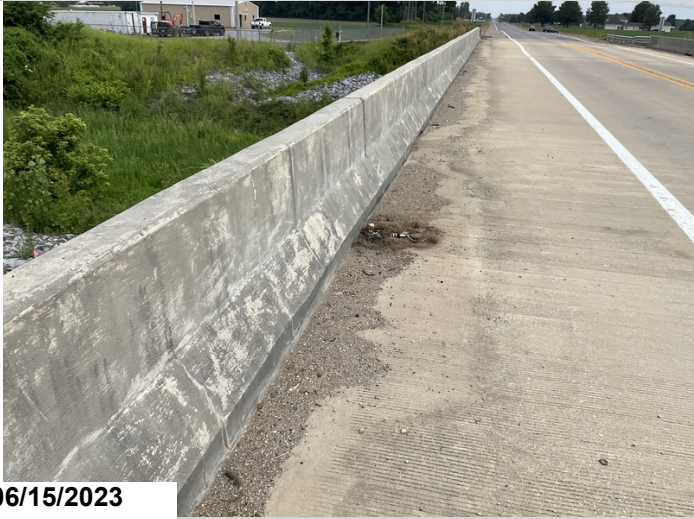
Gutters have dirt and debris.

Typical debris in gutters

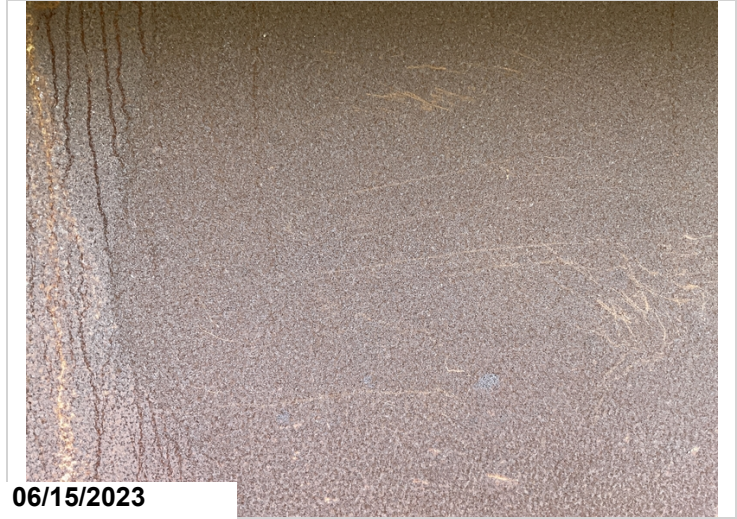
6/8/2021-Lowered superstructure from 9 to 8 due to steel protective coating having granular texture.

Superstructure is in very good condition with the steel girder surface having a grainy feel to the surface.

Typical girder condition

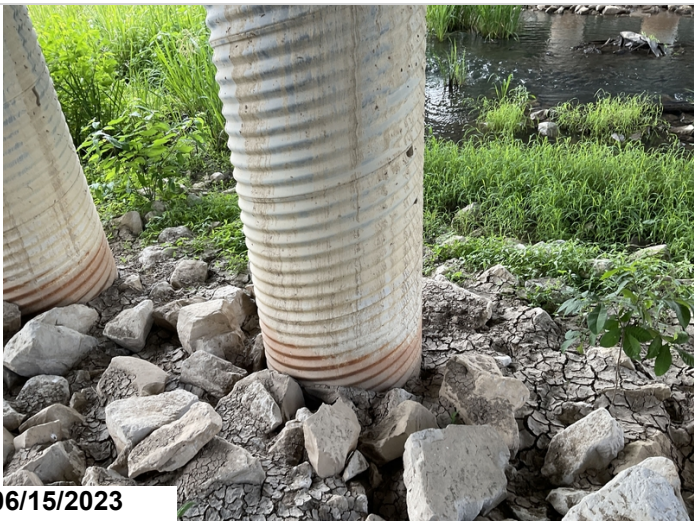
(225) -CMP encasements have light rust forming on bents #2 and 3 near waterline.							
234	Reinforced Concrete Pier Cap	LF	86	78	8	0	0
1120	Efflorescence/Rust Staining	LF	8	0	8	0	0

Typical rust on cmp around steel piles

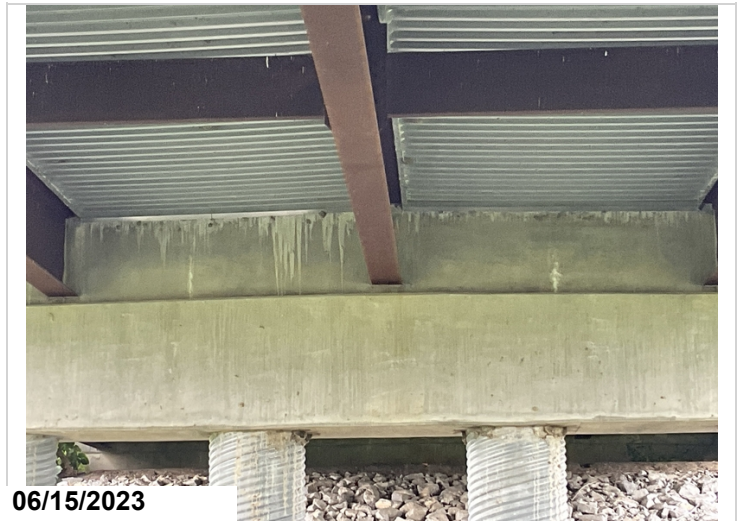
(234) -Concrete above caps at bents have a few vertical cracks with light efflorescence.							
321	Reinforced Concrete Approach Slab	SF	1752	1402	350	0	0
1130	Cracking (RC and Other)	SF	350	0	350	0	0

concrete above caps at bents have a few vertical cracks with light efflorescence.

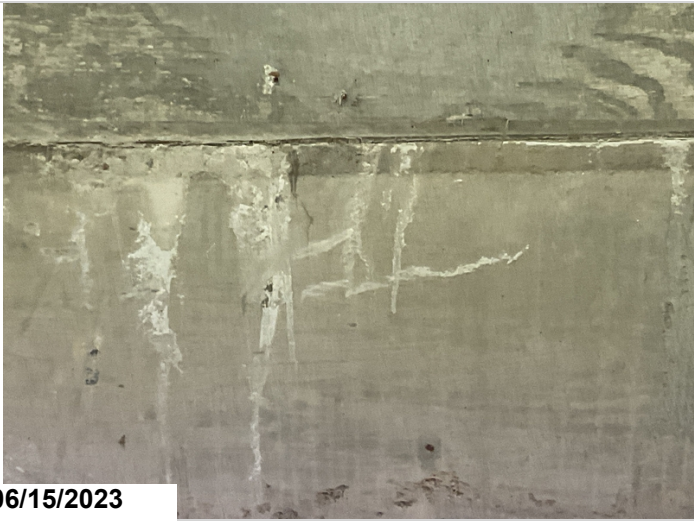
(107) -Steel protective coating has granular texture.							
215	Reinforced Concrete Abutment	LF	90	90	0	0	0
(215) -Both abutment backwalls have vertical hairline cracks.							
225	Steel Pile	EA	12	12	0	0	0
515	Steel Protective Coating	SF	258	223	35	0	0
3430	Oxide Film Degradation Color/Texture Adherence(Steel Protective Coatings)	EA	35	0	35	0	0

Typical abutment crack

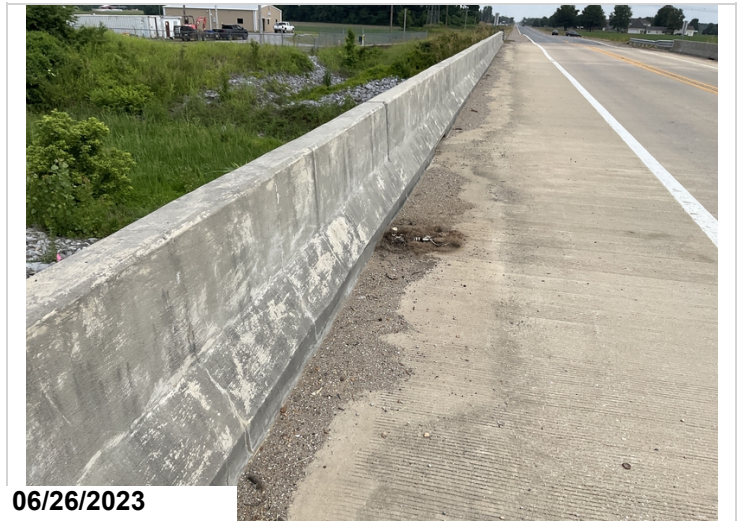
Typical debris in gutters

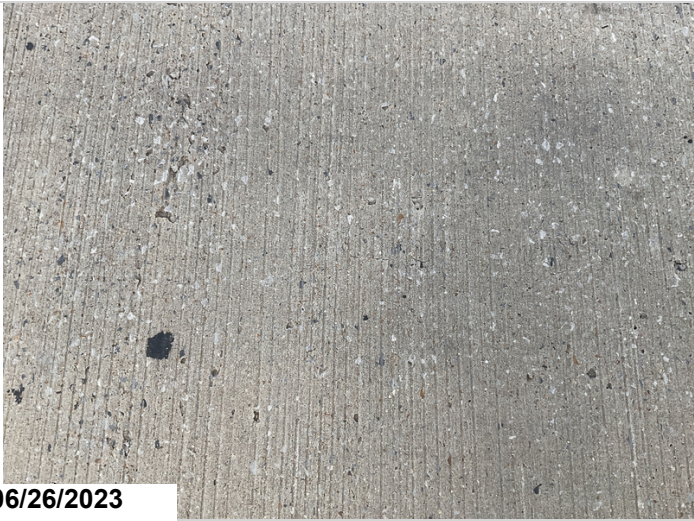
Typical deck crack.

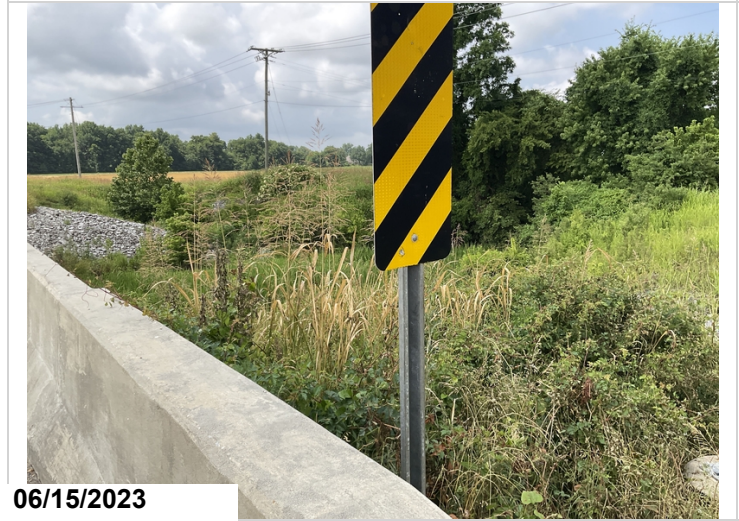
No log mile signs in place should read 11.84.

Bridge has no log mile signs.

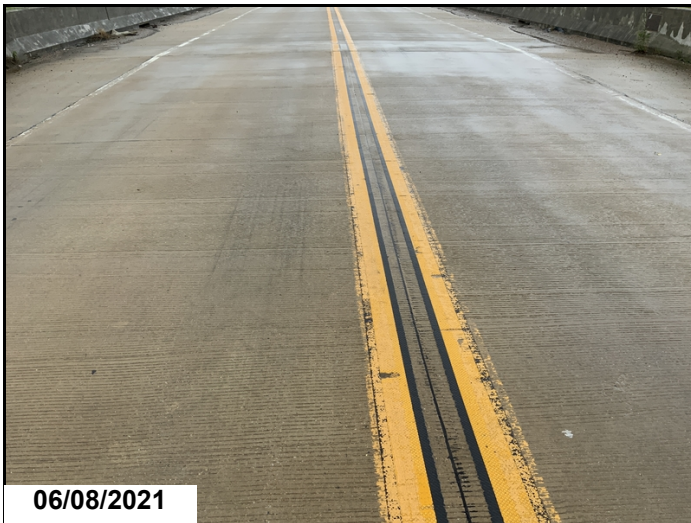
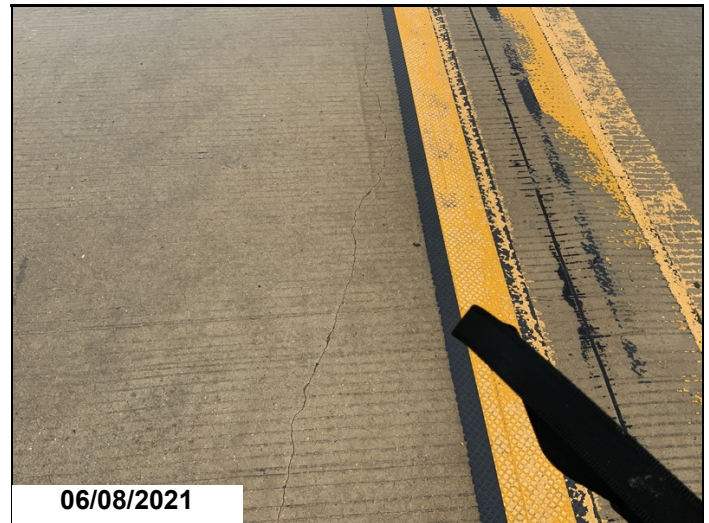
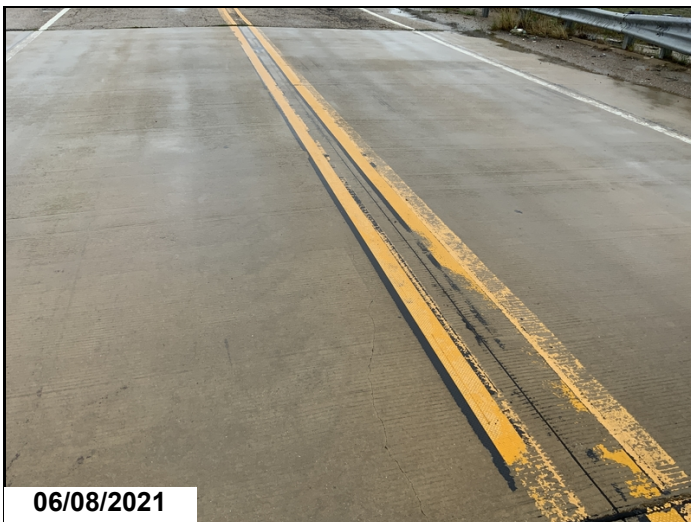
Abutments #1,2 approach slabs have unsealed cracks.

Typical longitudinal crack in approach slab.

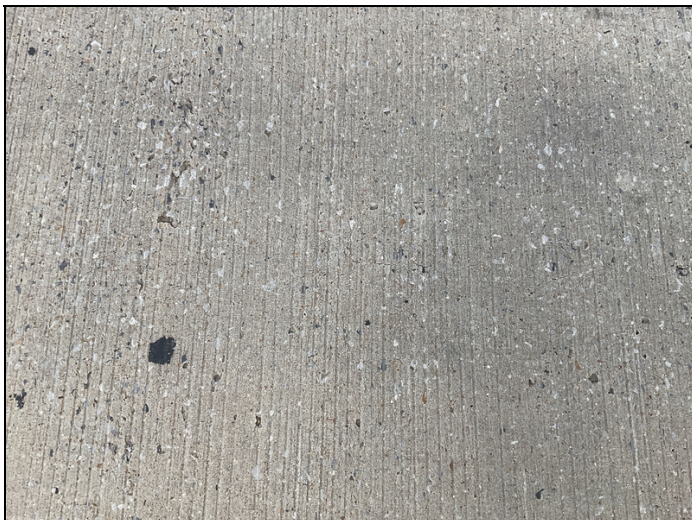
Deck has unsealed transverse and longitudinal cracks each span.

Typical deck crack.

A-54 - Sealable Deck Cracks (Yes)

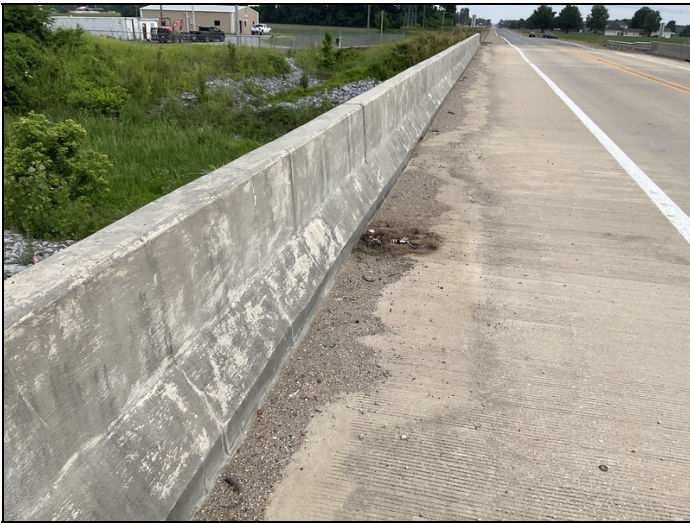
Typical debris in gutters

A-55 - Deck Washing Needed (Yes)
Gutters have dirt and debris.

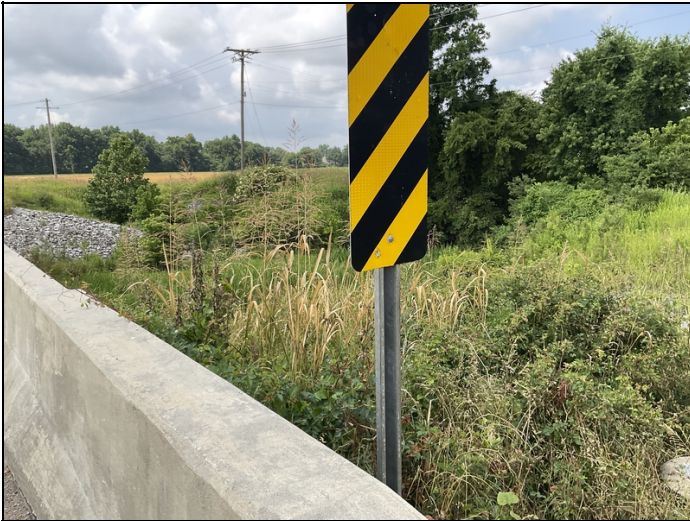
Bridge has no log mile signs.

A-63 - Missing/Incorrect Log Mile Signage (Yes)
No log mile signs in place should read 11.84.

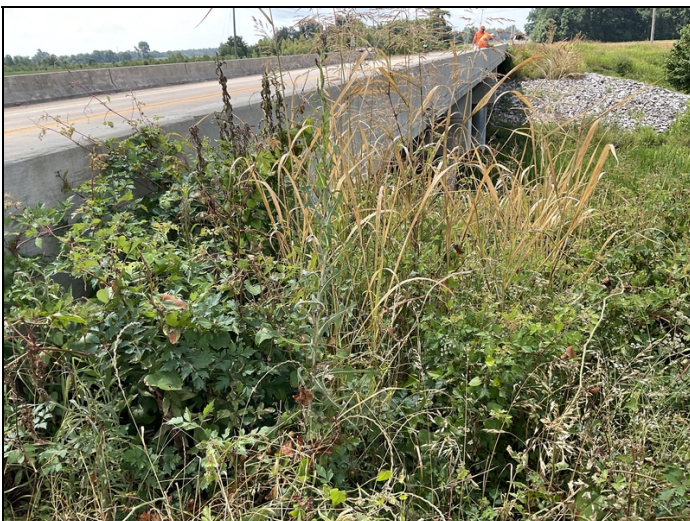
Typical vegetation

A-64 - Vegetation Removal Requested (Yes)
Trees and vegetation are growing beside and under bridge.
