Asset #07183(Routine, Underwater type 2)

Sh-147/Sec1/L14.09 over Fifteen Mile Bayou

Team Lead: Myron Futrell Inspection Date: 07/26/2022

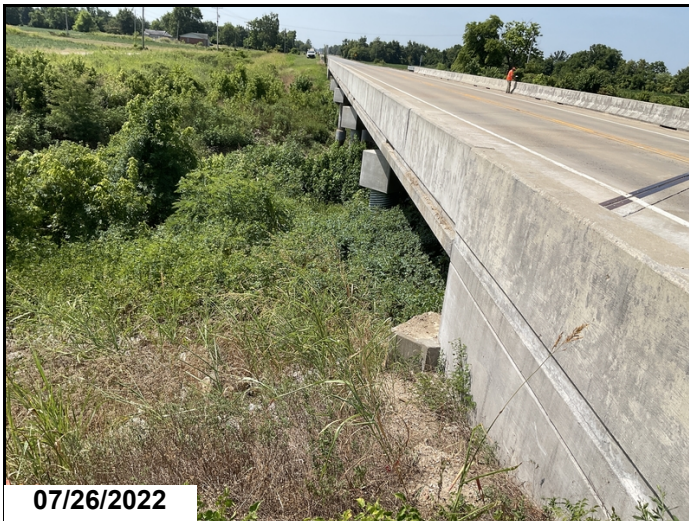
Trees and vegetation growing under and beside bridge.

Vegetation growing beside and under bridge

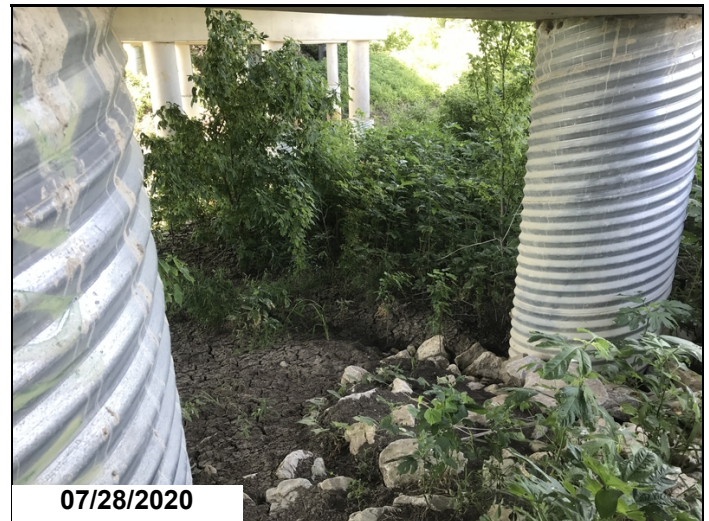
Typical trees and vegetation.

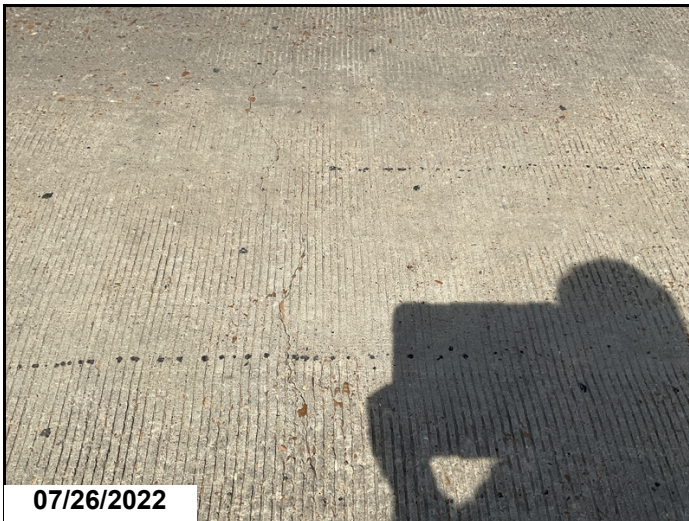
(321) Approach slabs have longitudinal and transverse cracks.							
331	Reinforced Concrete Bridge Railing	LF	448	299	149	0	0
1130	Cracking (RC and Other)	LF	149	0	149	0	0

Approach slabs have unsealed transverse and longitudinal cracks

Typical transverse crack in approach slab

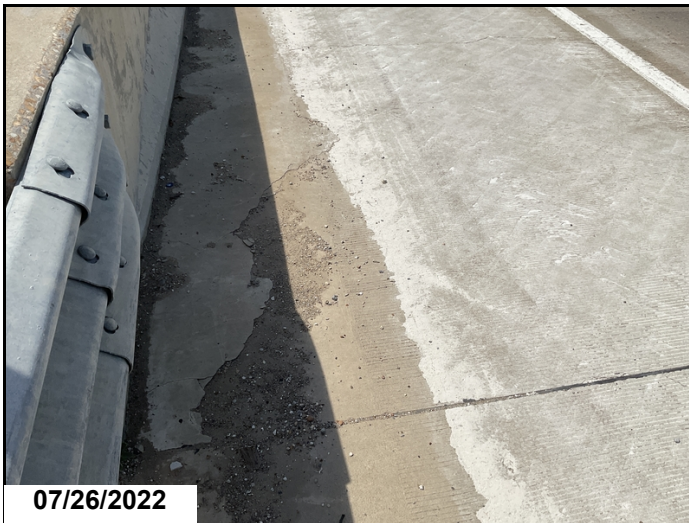
Abutment #2 right approach gutter has 2' x 6' cracked / delaminated area

Abutment #2 right approach gutter has 2' x 6' cracked /
delaminated area

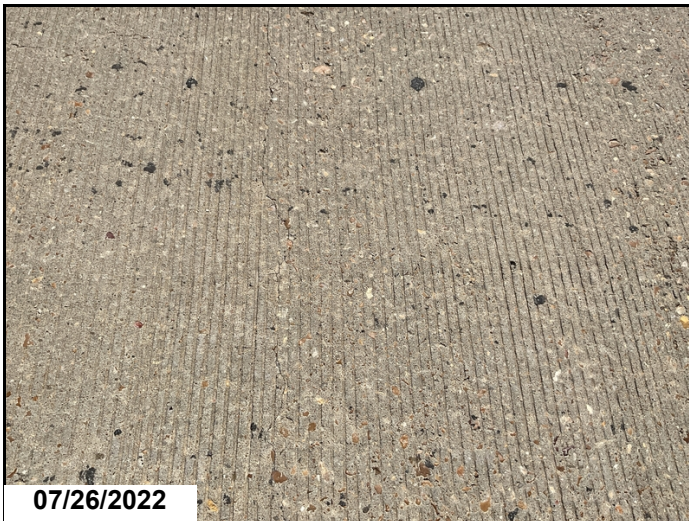
07/28/2020 lowered deck from 8 to 7 due to a few cs2 cracks.

Deck has several unsealed transverse and longitudinal cracks.

Typical transverse deck crack

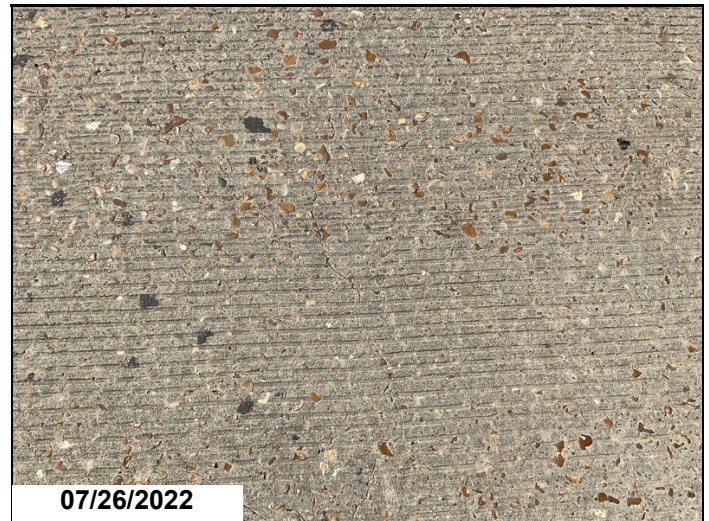
Typical longitudinal deck crack

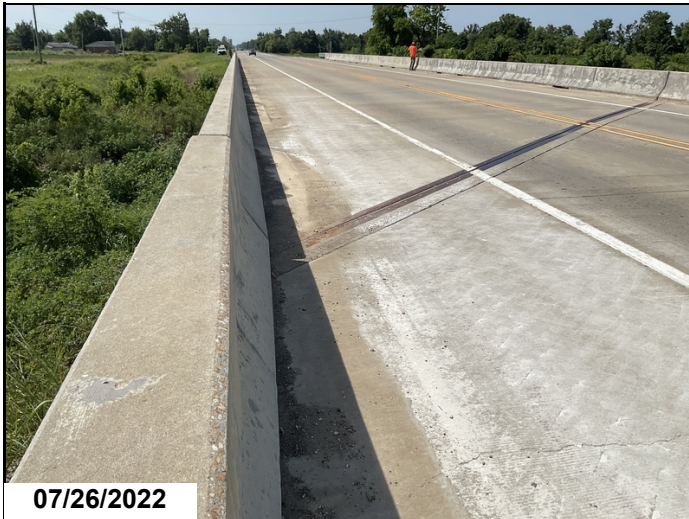
7/26/2022-Gutters have been cleaned, small amount of dirt has started to accumulate at time of inspection.

Gutters have been cleaned at time of inspection

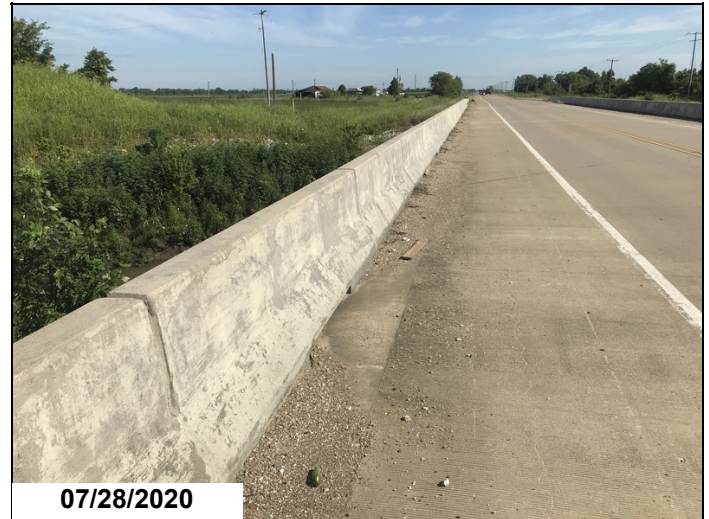
Gutters are full of debris.

Dirt and debris in gutters.

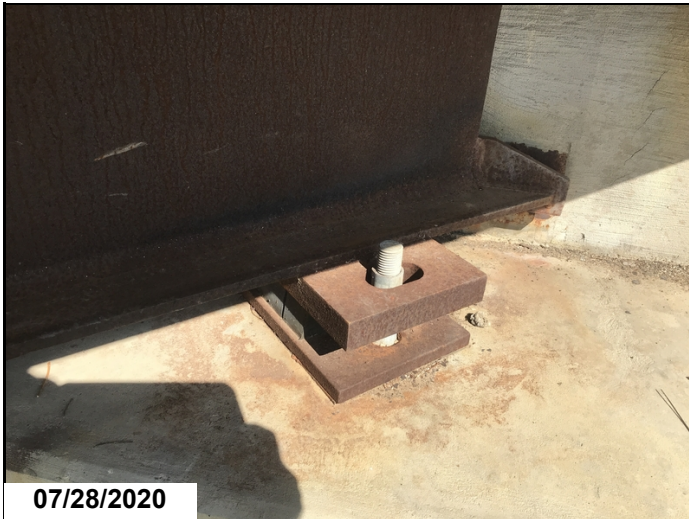
Girder #2 at abutment #2 is missing right bearing nut.

Girder #3 at abutment #2 is missing right & left bearing nut.

Girder #5 at abutment #2 is missing right bearing nut.

Abutment #2 typical missing bearing nut.

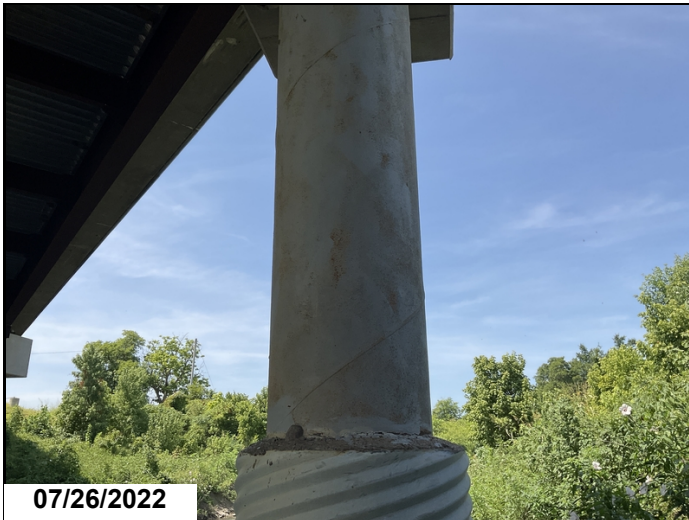
(225) Steel piles have spotty rust though out paint 5% effected.							
234	Reinforced Concrete Pier Cap	LF	226	226	0	0	0
301	Pourable Joint Seal	LF	119	118	0	0	1
2310	Leakage	LF	1	0	0	0	1

Paint system on piles beginning to fail.

Typical paint on piles

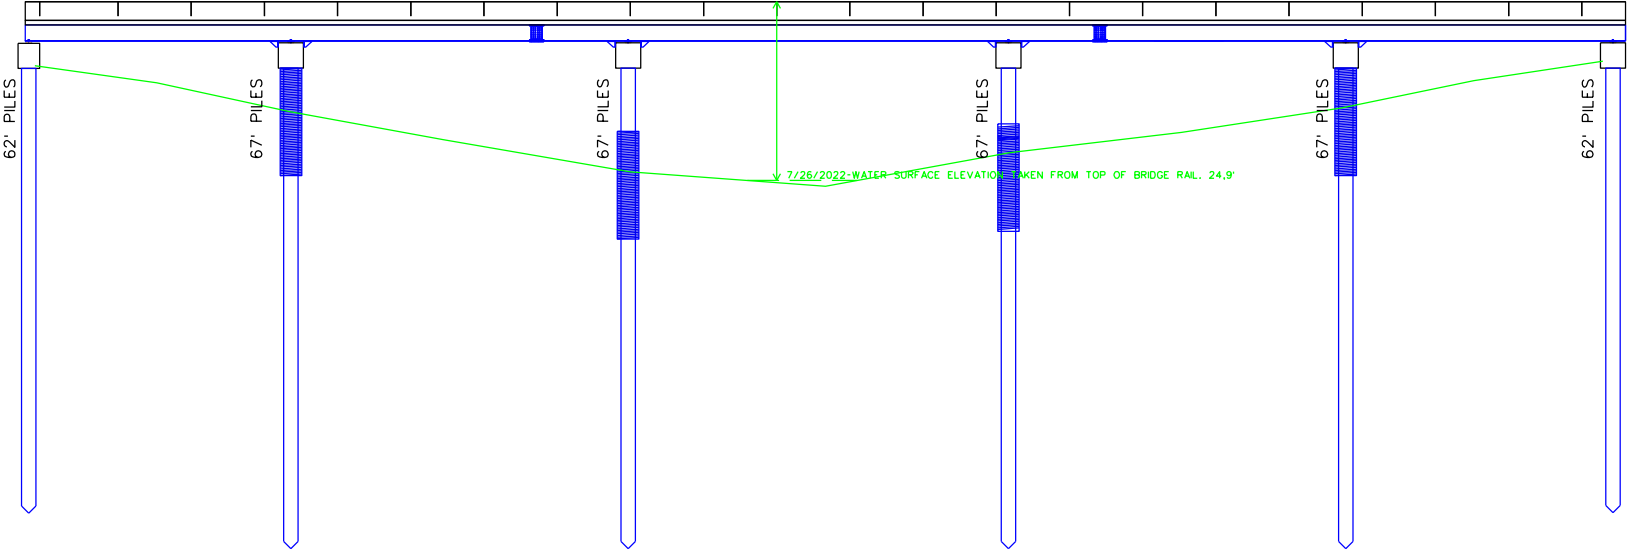
BRIDGE #07183
CHANNEL PROFILE
RIGHT SIDE

07/26/2022 8.9' 11.3' 15.3' 19.2' 23.7' 25.7' 21.0' 18.2' 14.8' 11.0' 8.3'

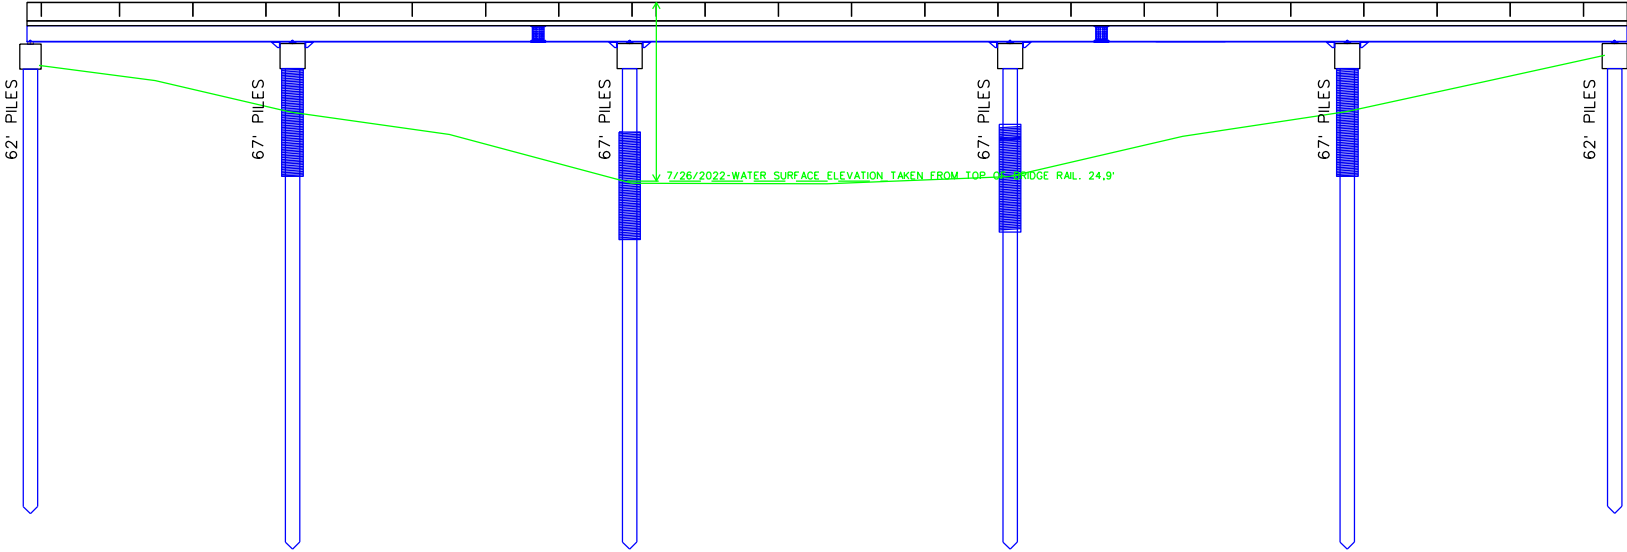
BRIDGE #07183
CHANNEL PROFILE
LEFT SIDE

07/26/2022 BENT 1 8.8' 10.9' BENT 2 15.3' 18.4' BENT 3 25.2' 25.3' BENT 4 24.3' 18.7' BENT 5 15.2' 11.1' BENT 6 7.3'
