Asset #01791(Other Special Recurring)

Sh-42/Sec-2/L-5.63 over Gum Slough

Location: 4.5 Miles East Jct Us 49

Team Lead: Myron Futrell, Inspection Date: 11/30/2022

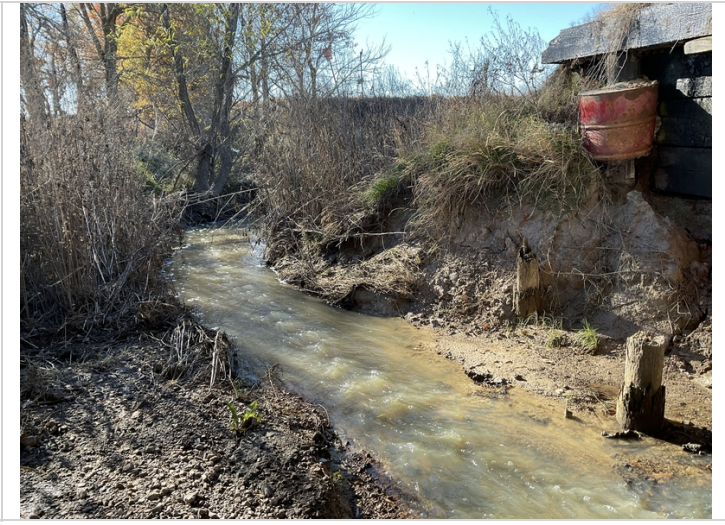
Channel left side

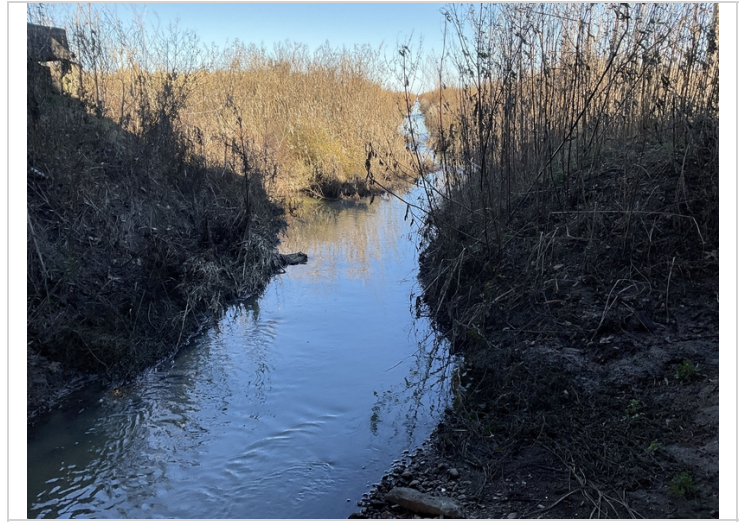
Channel right side

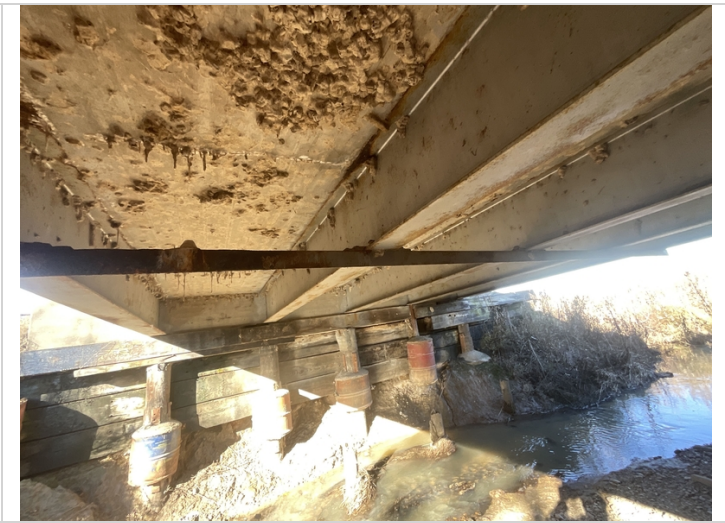
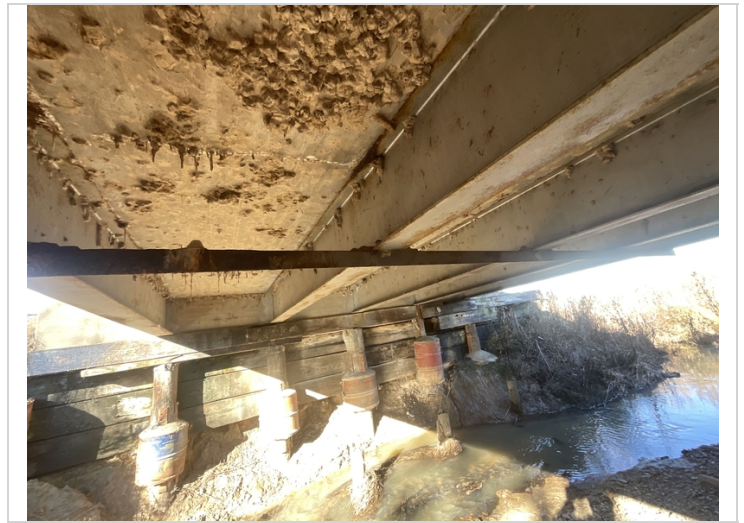
Typical soffit

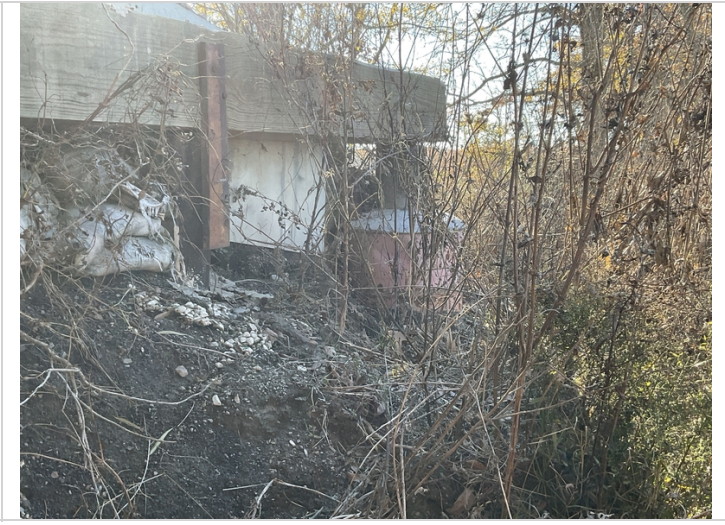
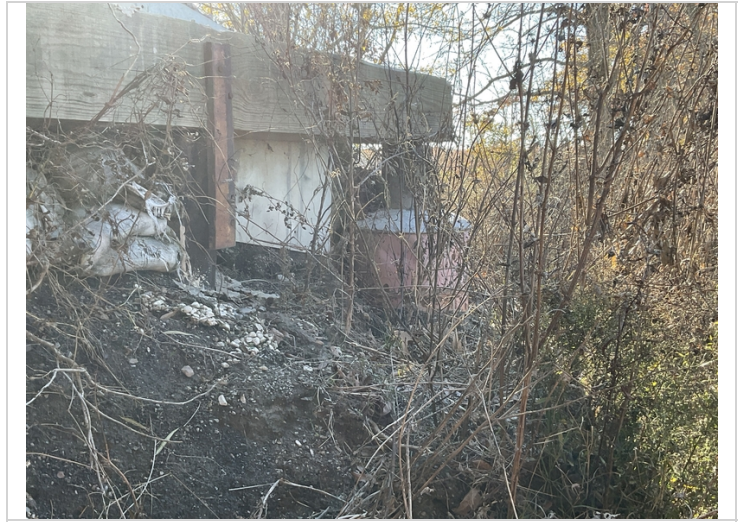
Abutment #2 pile #9 has been spliced and encased

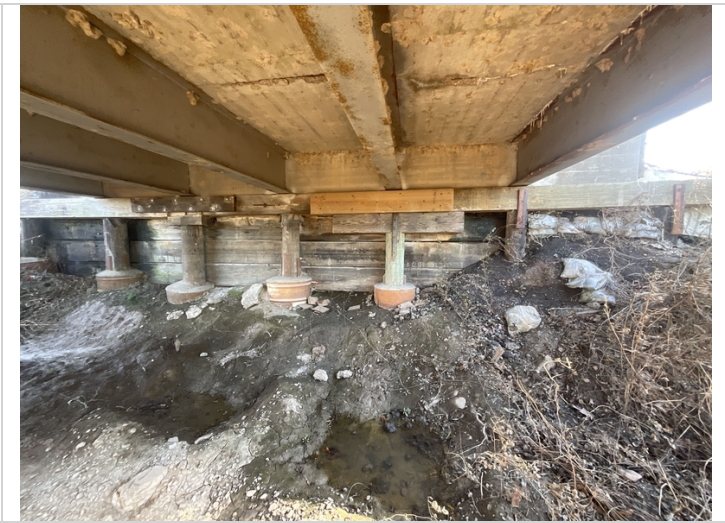
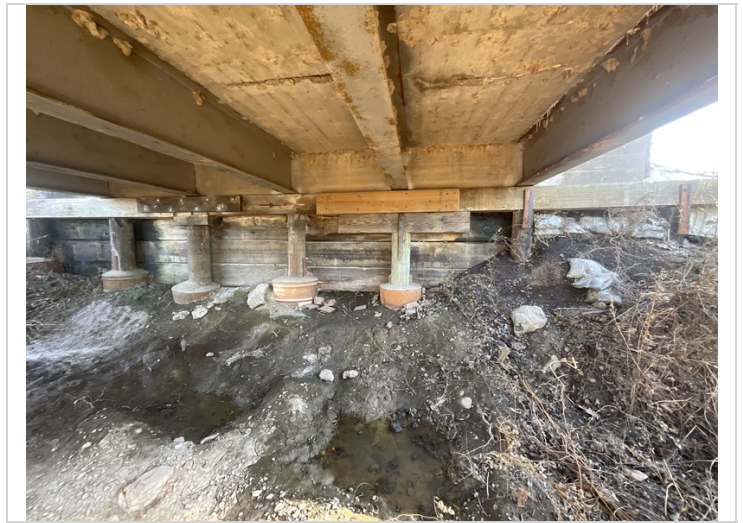
Abutment #2 cap repaired

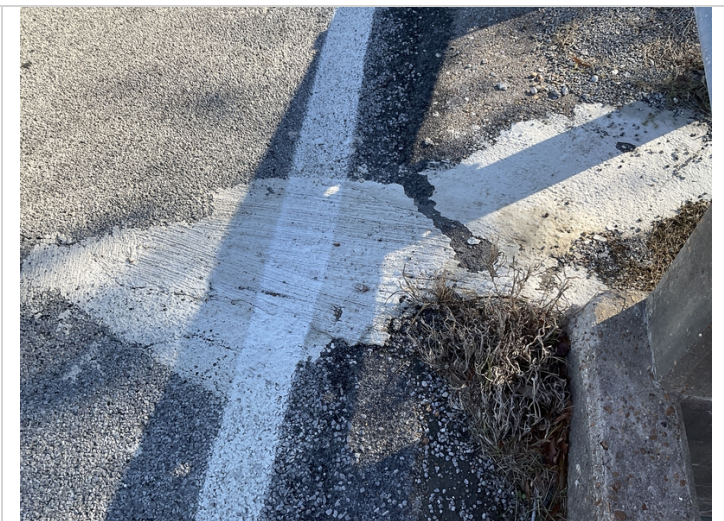
Abutment #2 hole in roadway repaired.

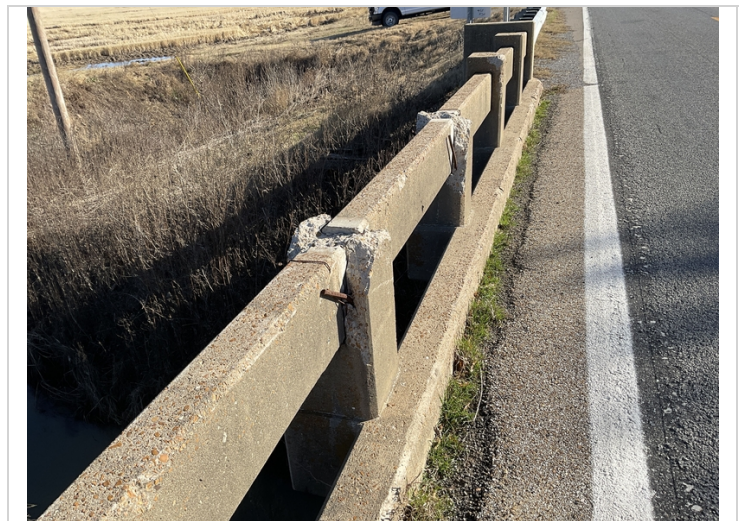
Left rail posts 1&2 are spalled with exposed rebar

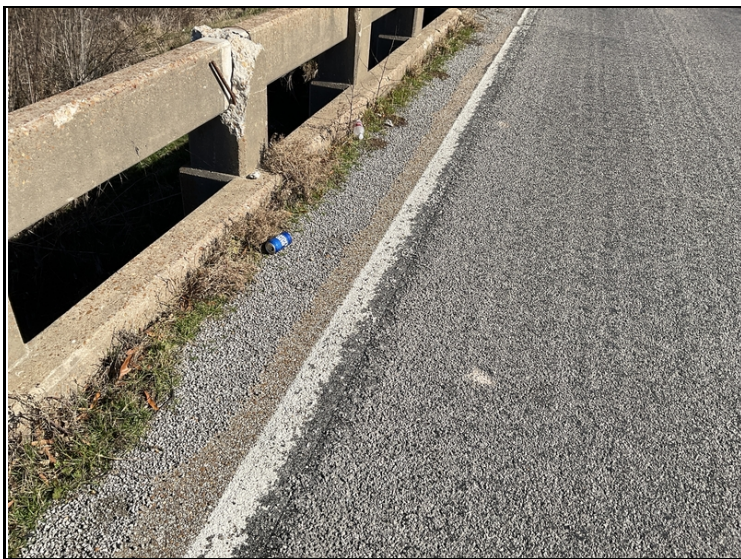
Gutters have vegetation and debris blocking drains.

Debris and vegetation in gutters

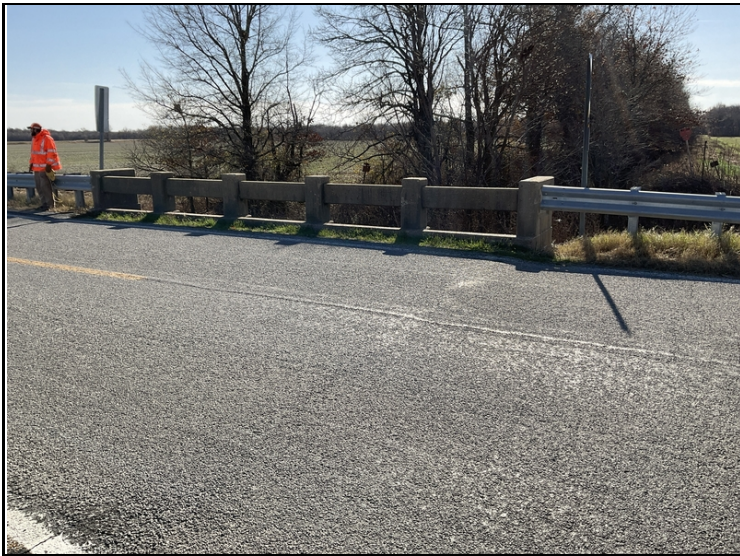
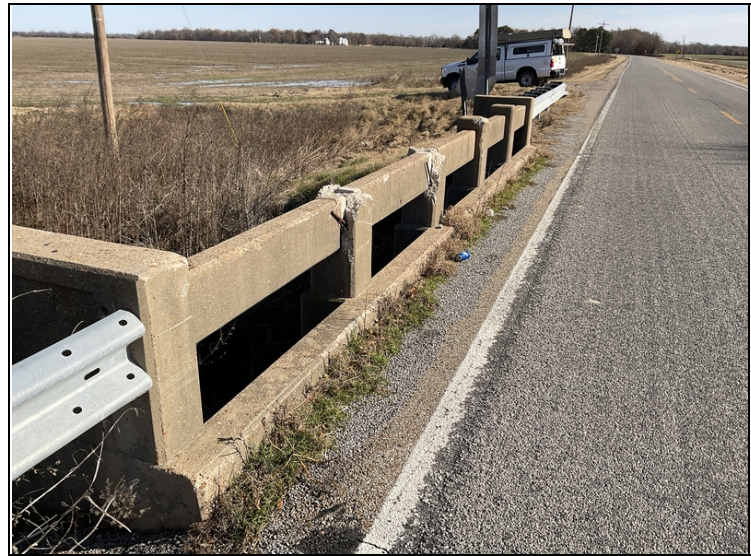
Bridge rails have a few small spalls with some rebar exposed.
Second and third rail posts on left side are broken at top with exposed rebar.

12/06/2021-added broken posts on left side.

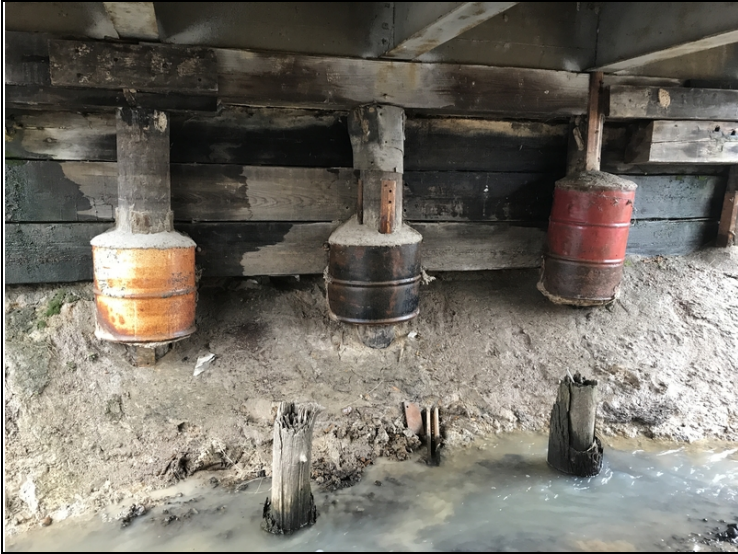
Void developing behind timber abutment at abutment #1 between piles #3 and 5 and abutment #2 between piles #6 and 7. Small void behind abutment #2 backwall right side..

12/6/2021-Erosion at abutment #1 is increasing, pile encasements are now undermined up to three feet.

Voids starting under and behind abutment #1 back wall between piles #2,4.

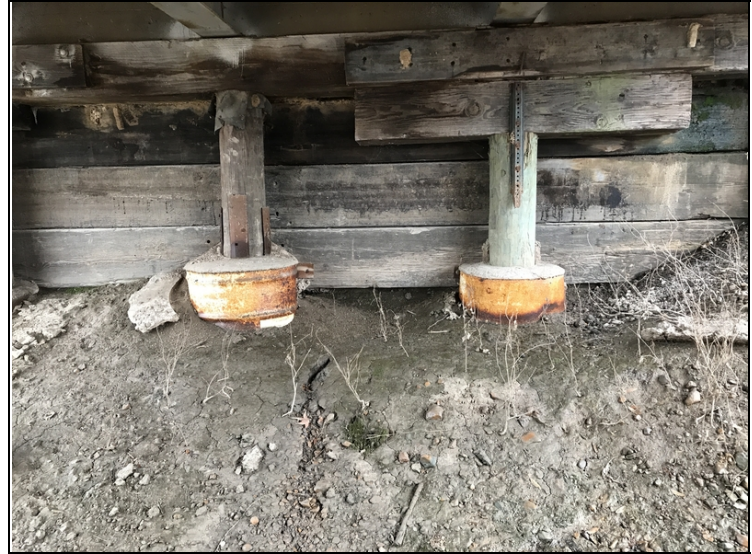
Void at abutment #2.

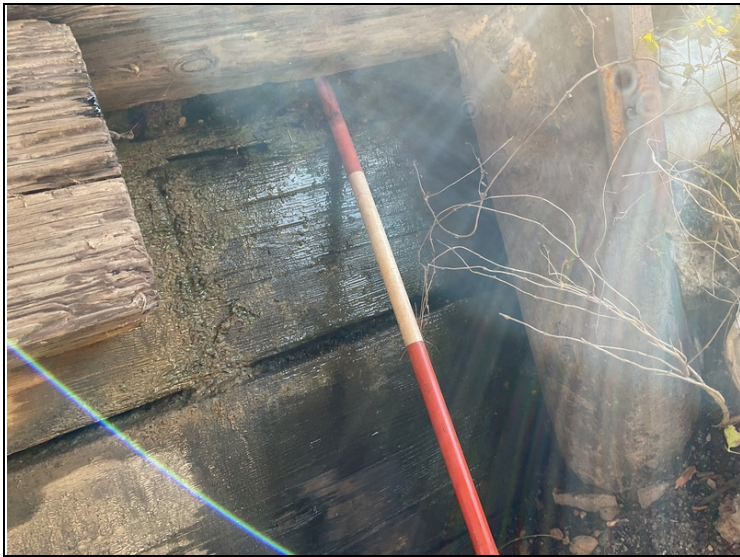
Small void behind abutment #2 back wall by pile #5 causing hole in abutment #2 approach roadway right side at bridge end.

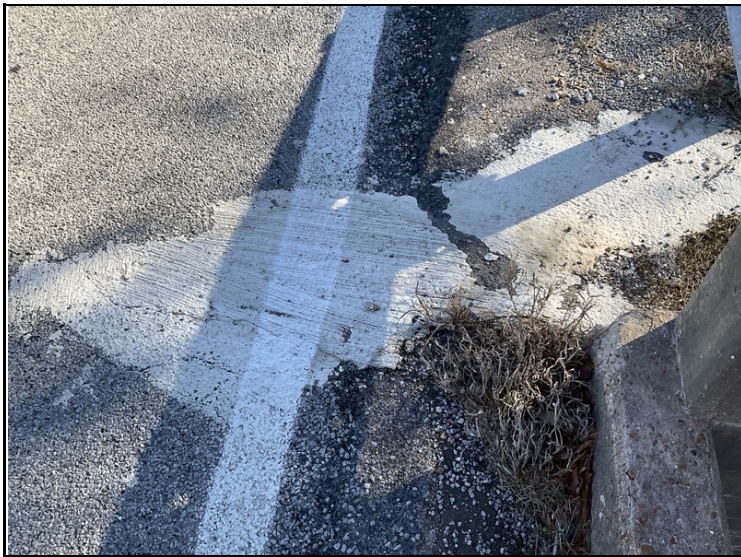
Abutment #2 hole in roadway repaired.

Small hole in abutment #2 right approach roadway at bridge end with small void underneath, behind backwall. Backwall sand bagged and void has been filled in-11/30/2022.

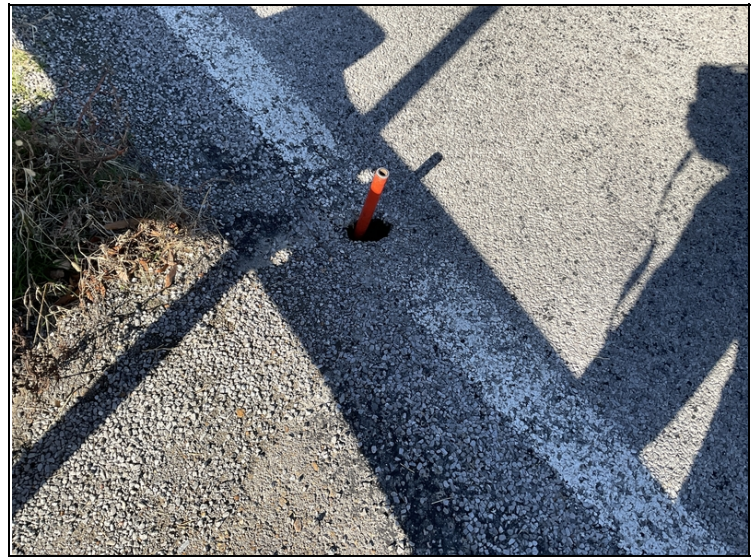
Small hole in abutment #2 right approach roadway at bridge end with small void behind backwall.

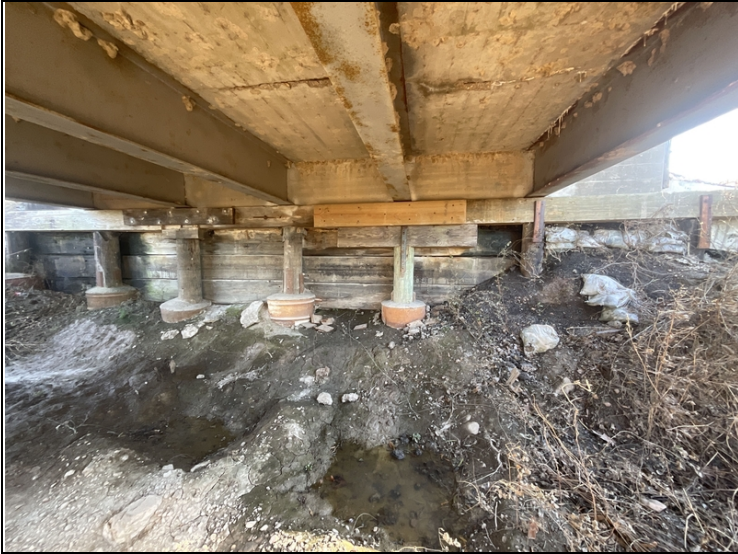
Abutment #2 cap repaired

Abutment #2 cap has been repaired-11/30/2022.

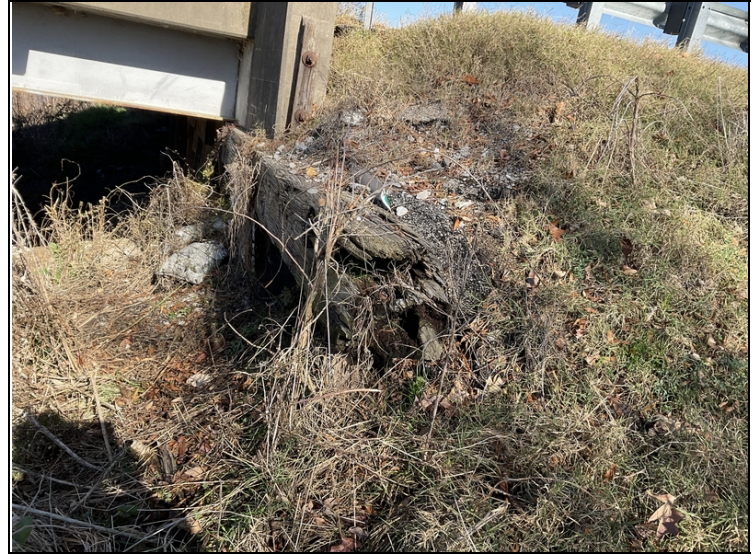
Abutment #2 cap right side above pile #7 is very hollow with up to 85% section loss, right end decayed with up to 90% section loss.

Abutment #2 cap right end

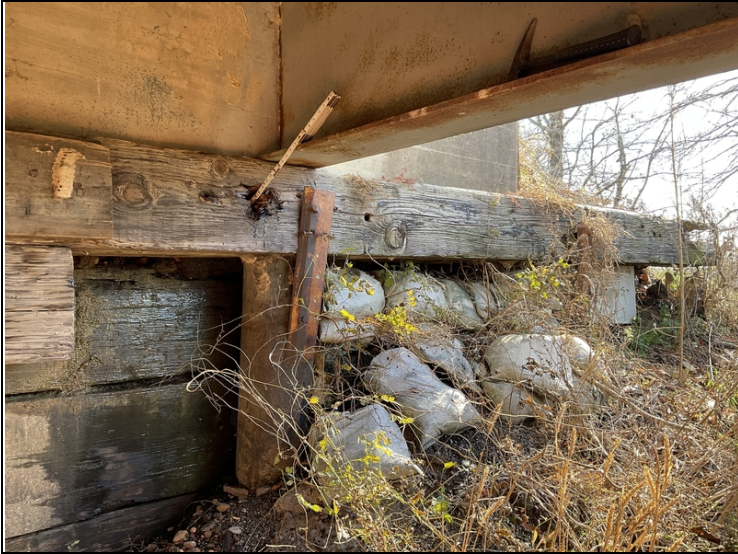
Abutment #2 cap above pile #5

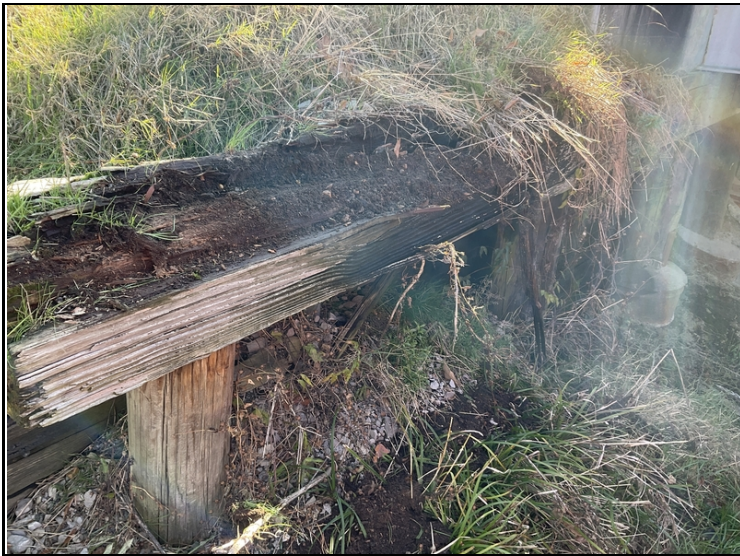
Abutment #1 caps are decayed on top cord on each side of bridge with up to 15% section loss.
Abutment #2 cap left section is decayed with up to 30% section loss, for 18'.
Abutment #2 cap above pile #5 sounds slightly hollow for four feet.

Abutment #2 cap left side

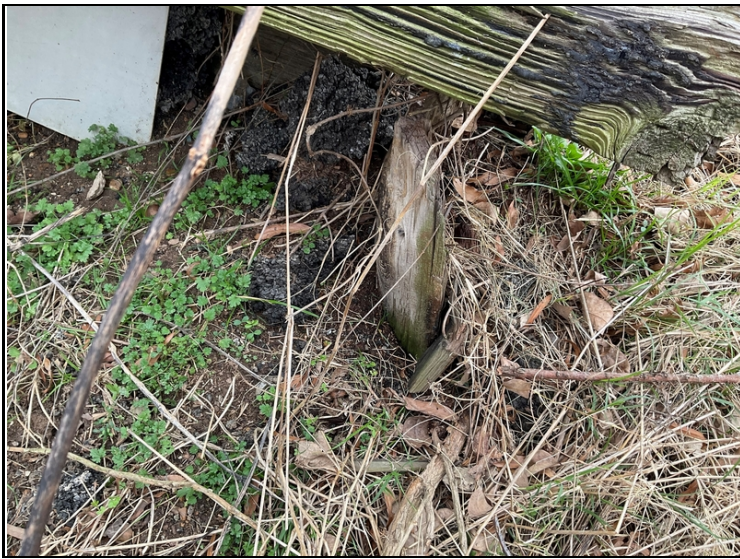
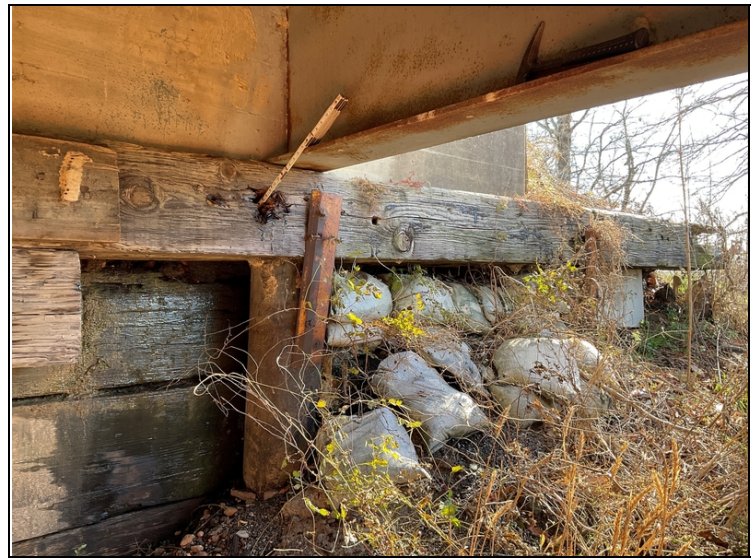
Abutment #2 pile #9 decayed with 100% section loss.

Abutment #2 pile #9 decayed non-functional
