Asset #01808(Other Special Recurring)

Sh-42/Sec-2/L-5.09 over Drainage Ditch

Team Lead: Myron Futrell, Inspection Date: 01/05/2022

Special inspection to monitor scour at abutments and substructure decay.

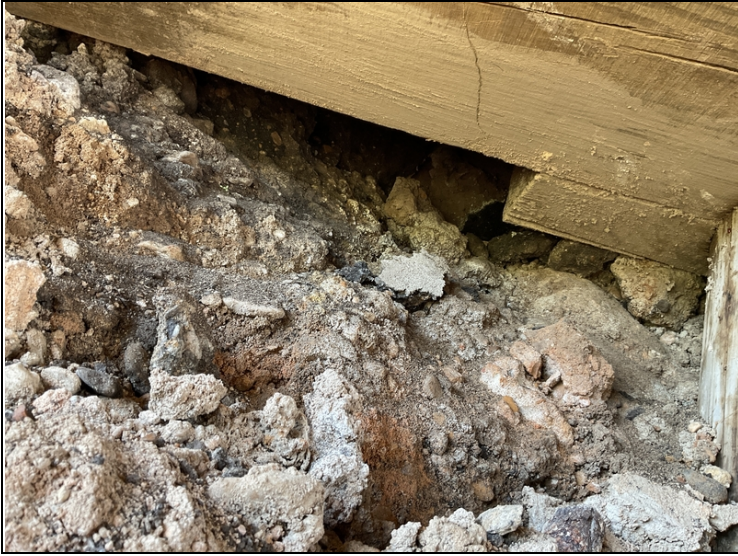
Abutment #1 and #2 bags that were placed to prevent scour of slope have deteriorated. Material is crumbling and falling apart and is beginning to allow small voids under caps.

Typical void behind cap

7/15/2021-Bags have been pulled away from abutments at time of inspection.

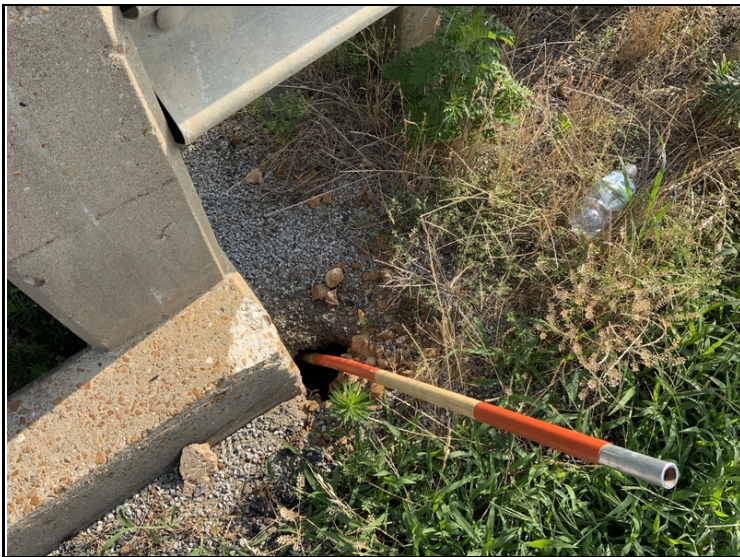
Abutment #2 left approach shoulder has a one-foot deep small hole eroded at bridge end.

Hole in abutment #2 left approach shoulder at bridge end.
