**Asset #03033**(Routine, Underwater type 2)

**Sh-42/Sec-2/L-4.53 over Overcup Creek**

**Location: 2 Miles East Of Jct Us 49**

**Team Lead: Myron Futrell, Inspection Date: 12/06/2021**

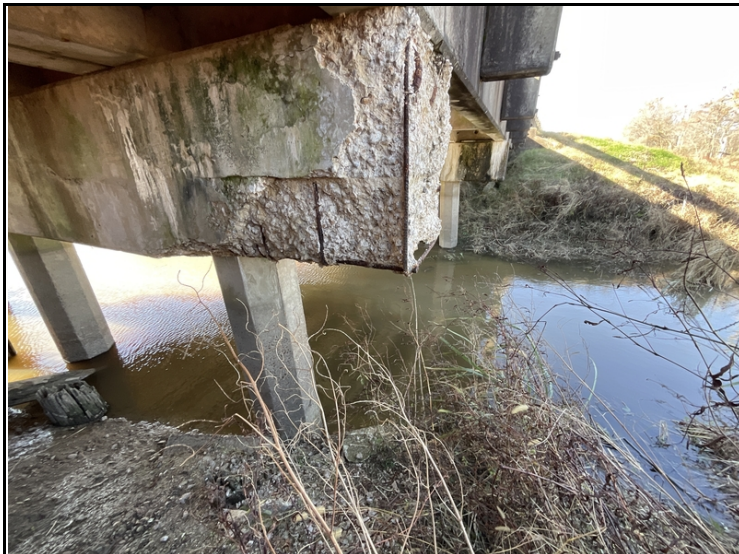
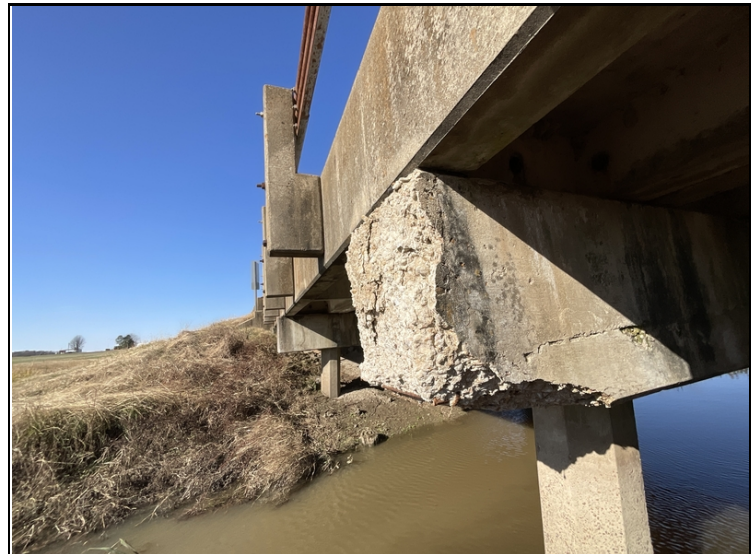
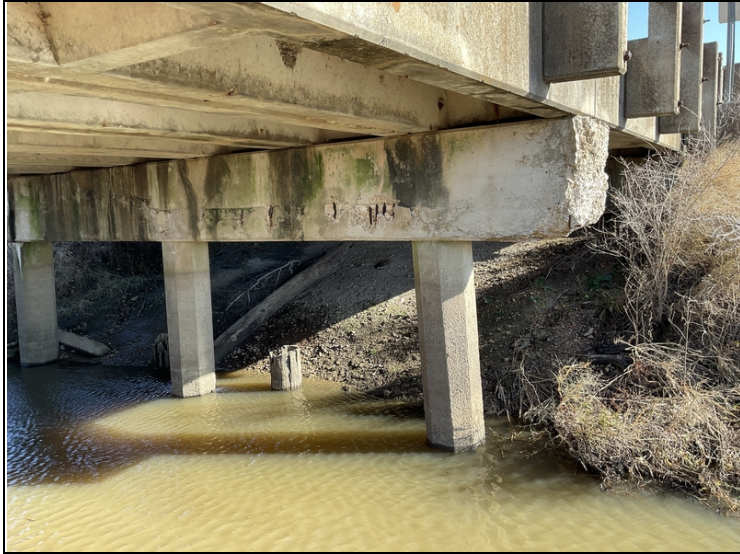
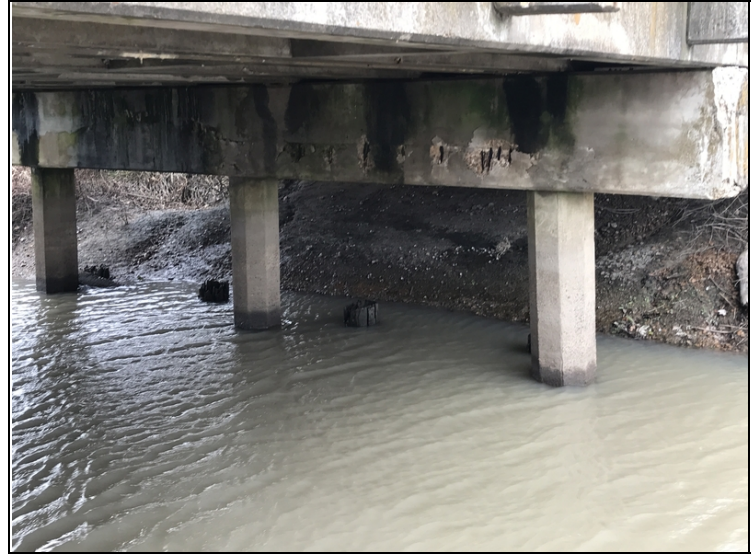
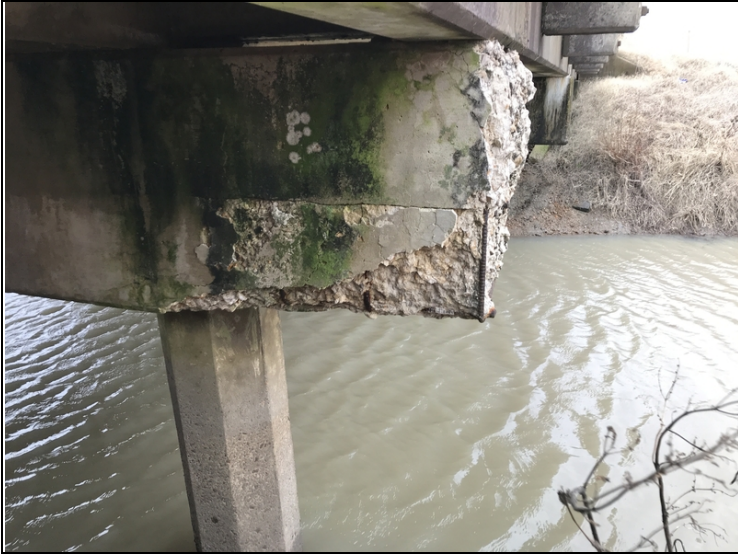
(234) Bent #2 cap has two foot crack and delamination above pile #2 on back face. Bent #3 cap back face is cracked, delaminated and spalled on left end with exposed rebar for two feet with 5% section loss. Bent #3 cap ahead face left end is heavily scaled with four feet of exposed rebar. Bent #3 cap right end has heavy scaling with exposed rebar for one foot. Bent #3 cap back face has two foot long delamination above pile #2 and five six inch spalls and a one foot spall with exposed rebar with 10% section loss and three feet of cracking with delamination.

Bent #2 cap has one foot crack and delamination above pile #2 on back face.  
Bent #3 cap is cracked, delaminated and spalled on left end with exposed rebar with 5% section loss.  
Bent #3 cap is cracked and delaminated on right end.  
Bent #3 cap back face has several small spalls with exposed rebar with 10% section loss.

Bent #3 cap left end back face

Bent #3 cap right side

Bent #3 cap back face right side

Bent #3 cap back face.

Bent #3 left end.

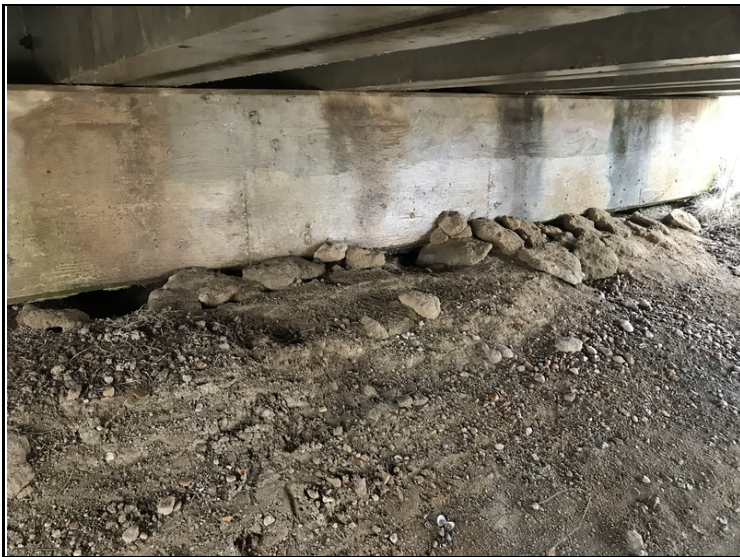
Abutment #2.

ELEMENTS	DESCRIPTION	UNITS	TOTAL	CS1	CS2	CS3	CS4
215	Reinforced Concrete Abutment	LF	71	61	10	0	0
6000	Scour	LF	10	0	10	0	0
(215) ABUTMENT #2 CAP IS UNDERMINED UP TO 6" DEEP FOR 6' LENGTH ON RIGHT SIDE & 4' LENGTH AT CENTER, exposing pile #3.							
227	Reinforced Concrete Pile	EA	7	1	6	0	0
1190	Abrasion/Wear (PSC/RC)	EA	6	0	6	0	0

Abutment #2 cap is undermined up to six inches deep for six feet in length on right side and for four feet in length at center.

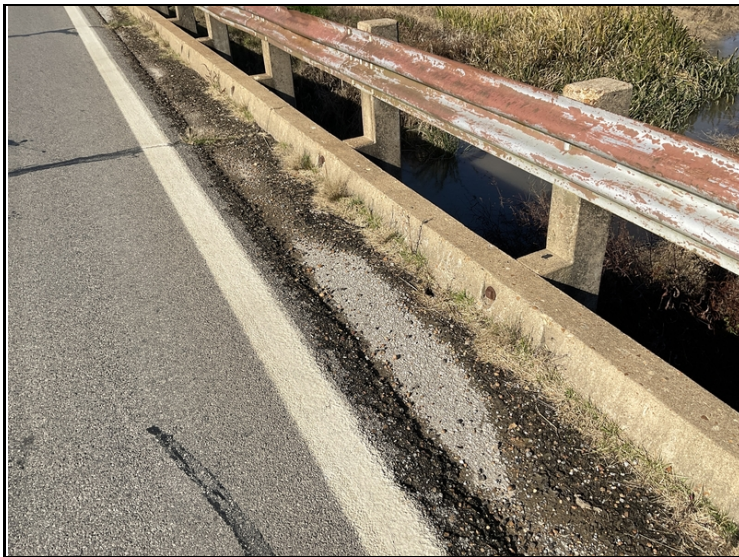
Vegetation and debris are in gutters partly blocking drains.

Vegetation in gutters

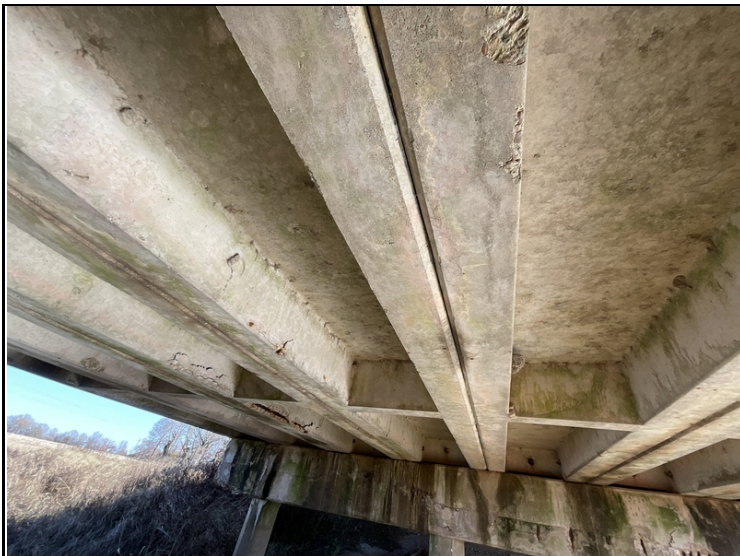
Span #1 soffit / underside of deck

Span #1 girder #1 right leg has map cracked for ten feet with heavy efflorescence.  
Span #1 girder #5 left leg has a one foot crack at bent #2.  
Span #1 girder #6 has vertical crack extending into soffit with moderate efflorescence.  
Span #1 girder #7 left leg map cracked last half of span with light efflorescence.  
Span #2 girder #1 left and right leg map cracked for three feet first part of span with light efflorescence.  
Span #2 girder #3 left leg is cracked with delamination full length.  
Span #2 girder #4 left leg has two foot crack with delamination at three quarter span, and a six foot crack with delamination at mid span.  
Span #2 girder #7 left leg has cracking first half of span with light efflorescence.  
Span #2 girder #6 left leg has cracking first half of span, with small spall at bent #2 cap, right leg first four feet has cracked with moderate efflorescence.  
Span #3 girder #2 left leg has cracks and delaminated at mid span for eight feet in length. Cs3

Span #3 girder #7 left leg has several hairline cracks for first half of span.  
Girder units have minor pop offs in various locations.  
Girder units have longitudinal and vertical cracks in stems six inches to one foot apart.

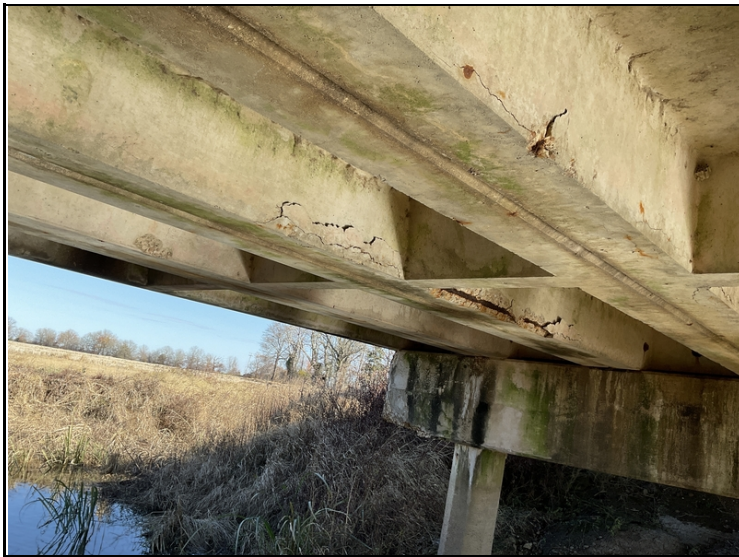
Span #2 girder #3 left leg is spalled with six feet of exposed rebar with 10% section loss.

Span #2 girder #3 left leg is cracked with delamination full length with six feet of exposed rebar with 10% section loss.

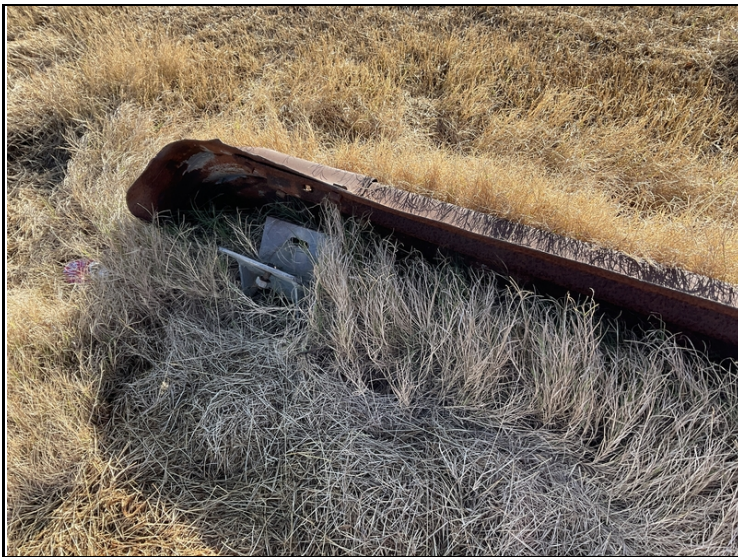
Abutment #2 left approach rail end not connected
