**Asset #M0886**(Routine, Underwater type 2)

**Sh-42/Sec-2/L-3.13 over Ditch**

**Location: 0.6 Mi E Jct Sh 39 & 42**

**Team Lead: Myron Futrell, Inspection Date: 10/13/2021**

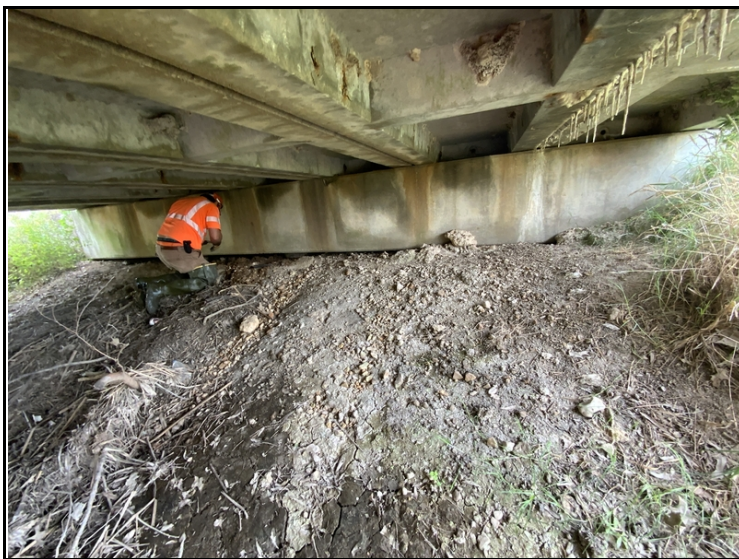
Abutment #2 cap is undermined 8" deep full length exposing pile #2 & 3.

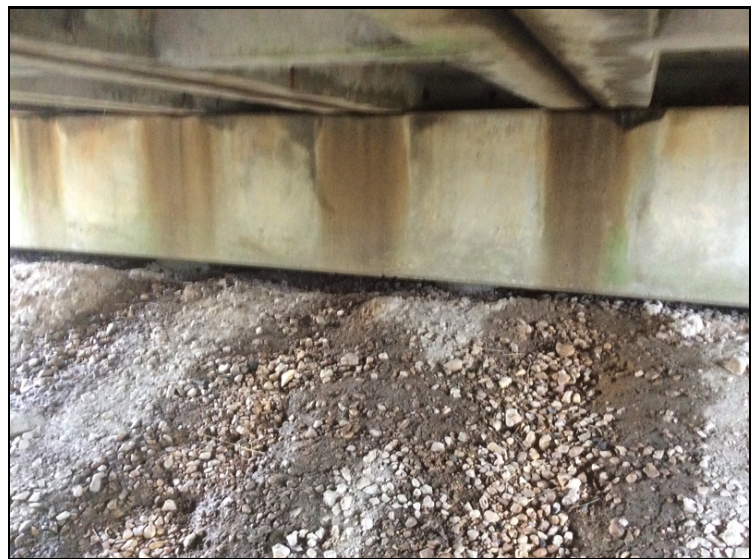
Abutment two cap is undermined.

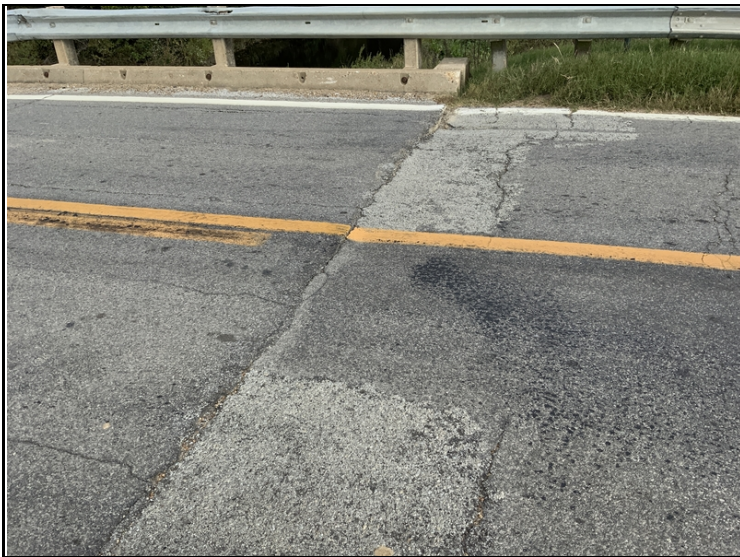
Abutment #2 approach roadway

Abutment two approach roadway has settled two inches for two feet.

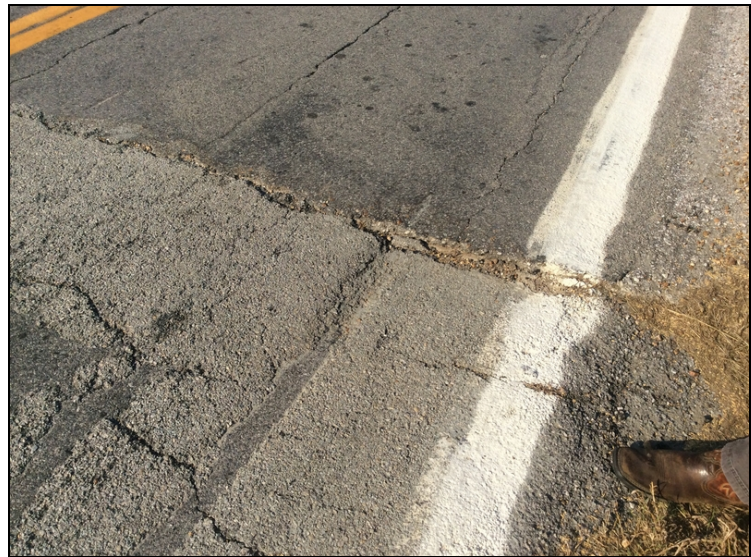
Approach roadway at abutment two.

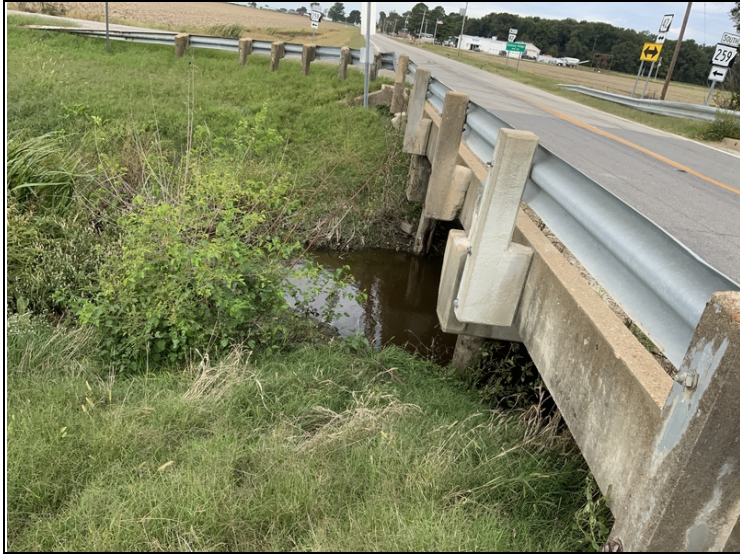
Vegetation is growing beside bridge.

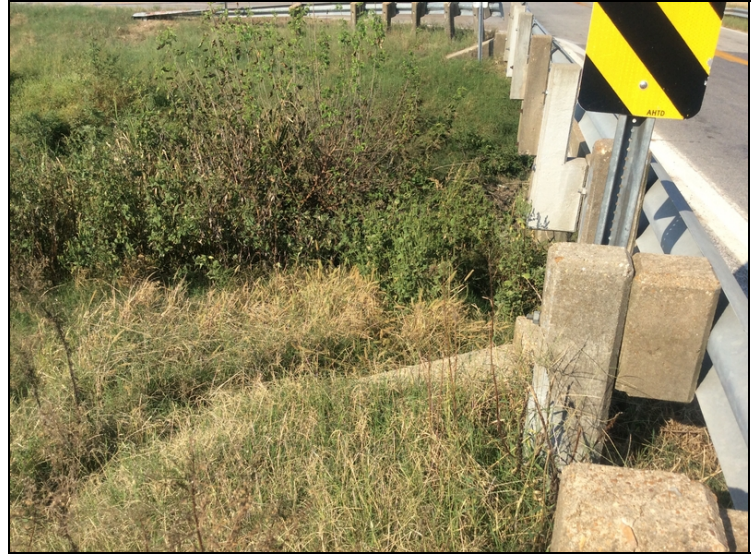
Vegetation growing beside bridge and onto roadway.

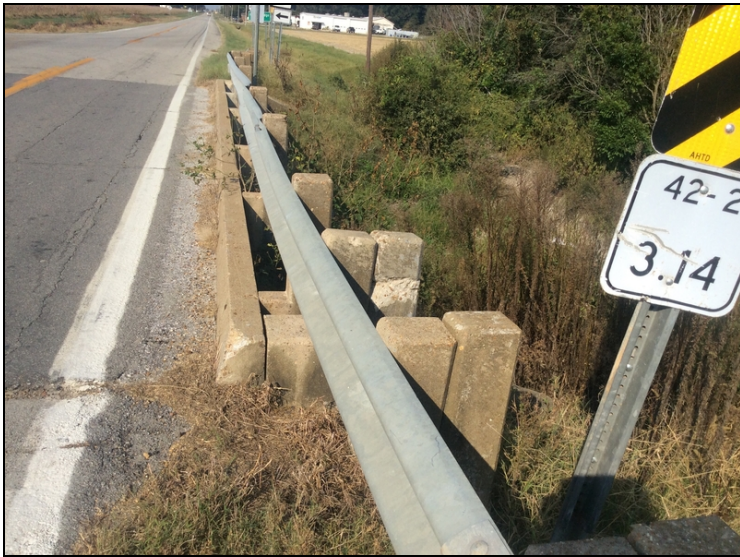
Vegetation growing beside bridge and onto roadway.

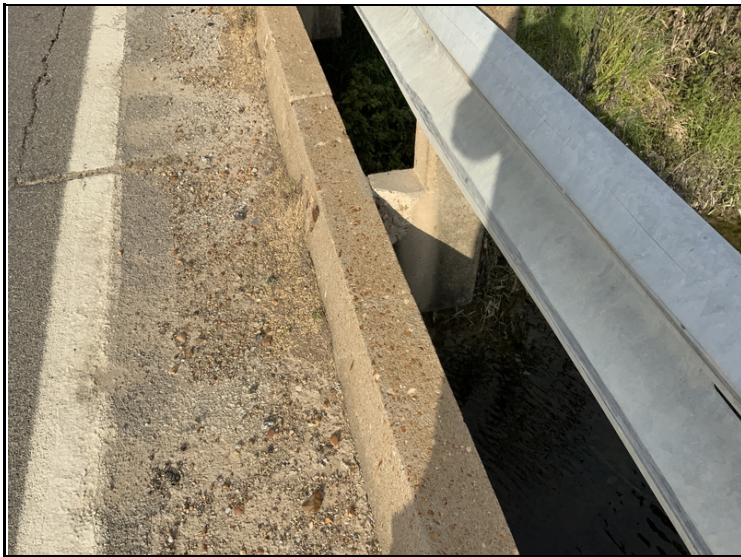
Span #2 left side first rail post spalled.

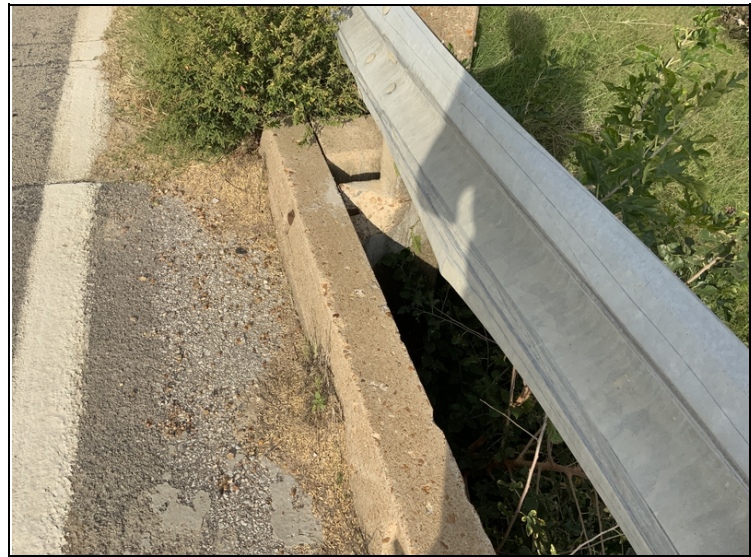
Span #1 left side first rail post spalled

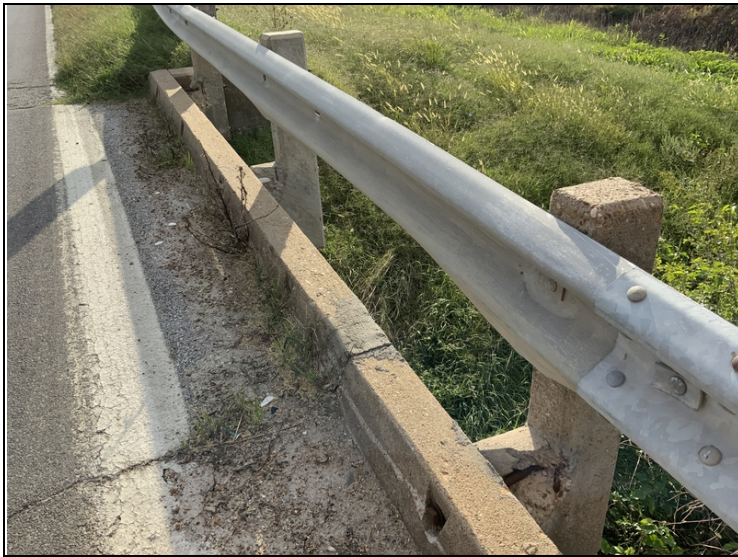
Span #2 right side second rail post spalled, span  
#3 right side, both rail posts spalled,

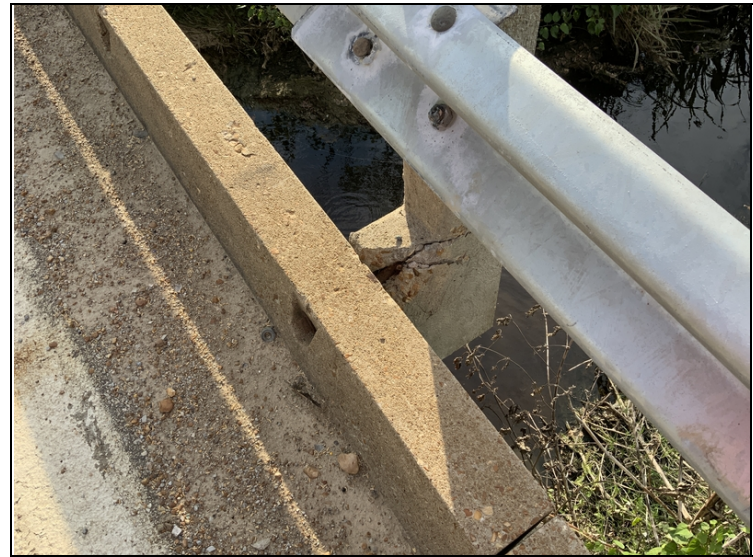
Span #2 right side first rail post spalled.

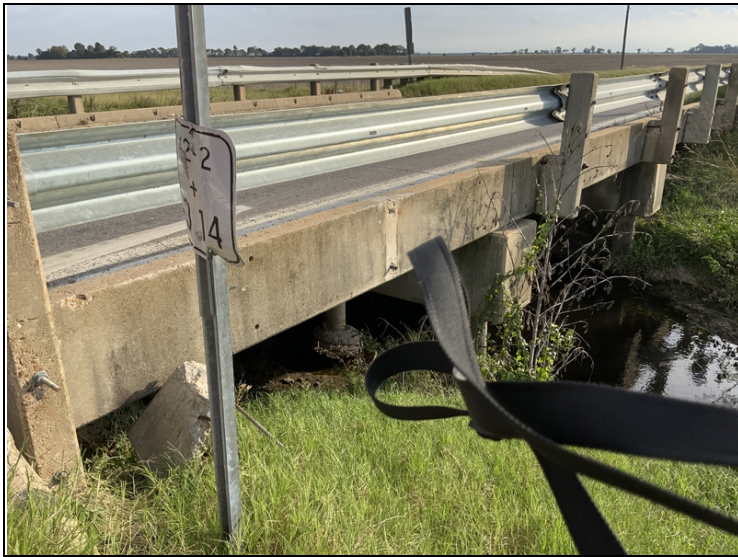
Second rail post, span #1 right side missing

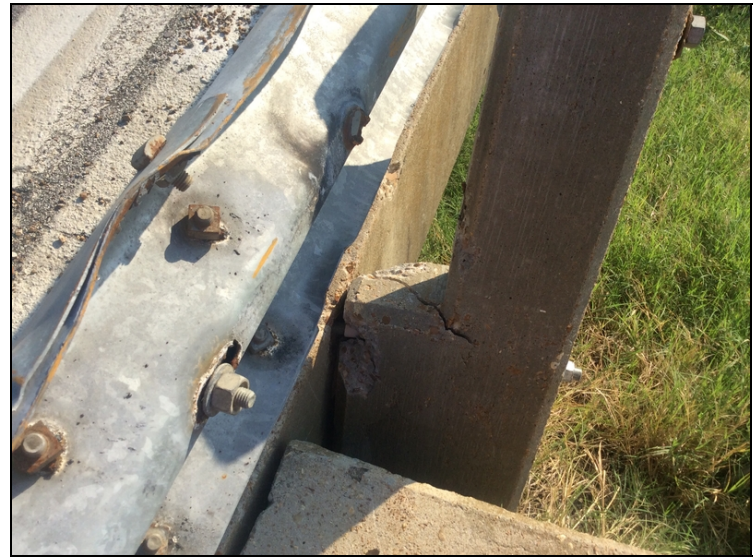
Broken rail post and rail.

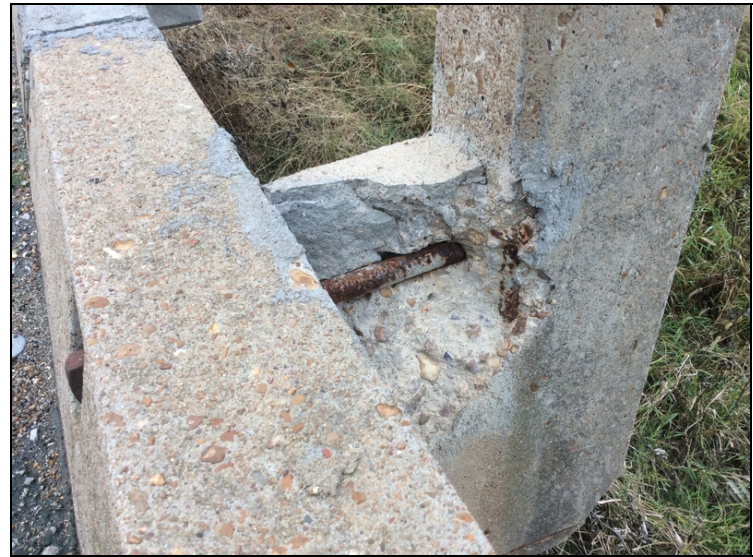
Typical spalled rail post .

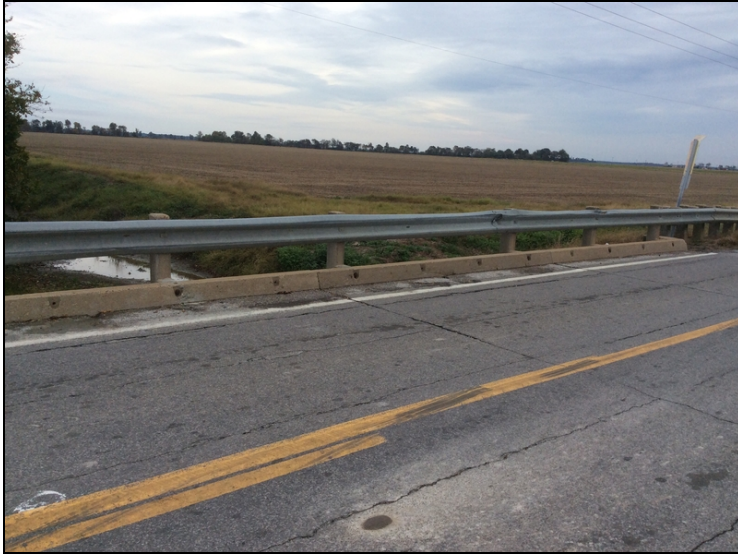
Bridge rail on left side has collision damage full length of bridge including approach rail. Right rail at abutment one has collision damage for six feet and is loosened from rail post.

Bridge rail on left side has collision damage full length of bridge.

10/13/2021-right rail spans #1 and 2 have been replaced.

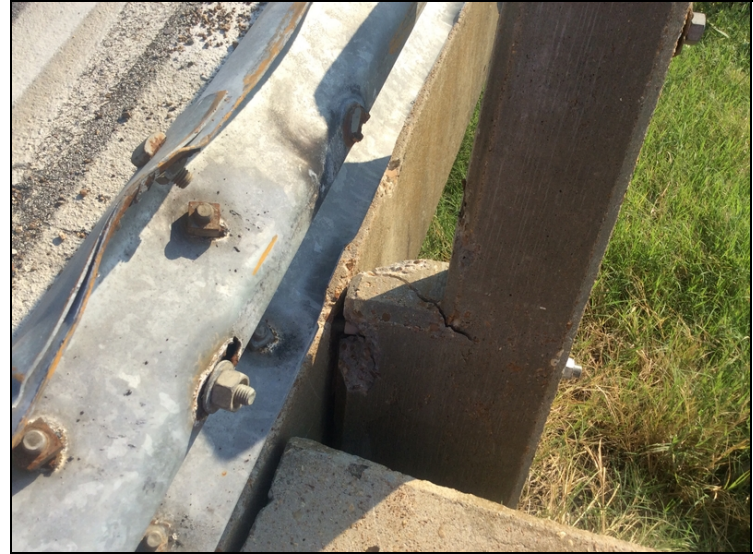
Broken rail post and rail.

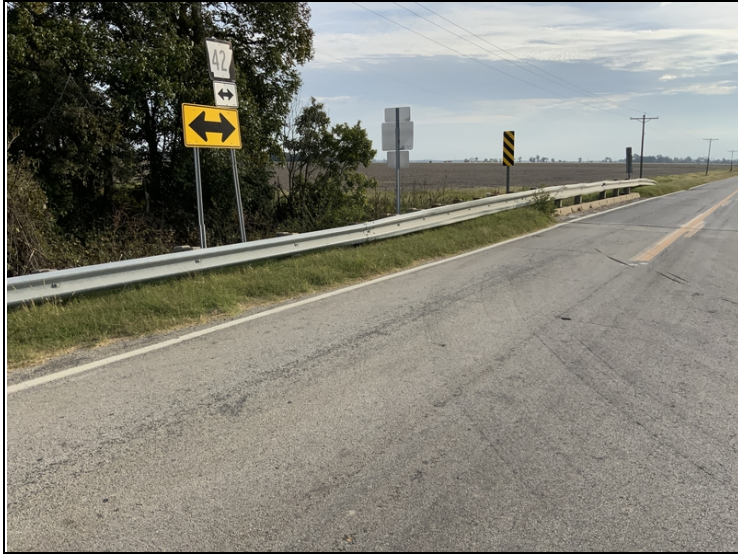
Abutment #1 left approach rail has 20' of collision damage.  
Abutment #1 right approach rail has 5' of collision damage.  
Abutment #2 left approach rail has minor collision damage for 25'.

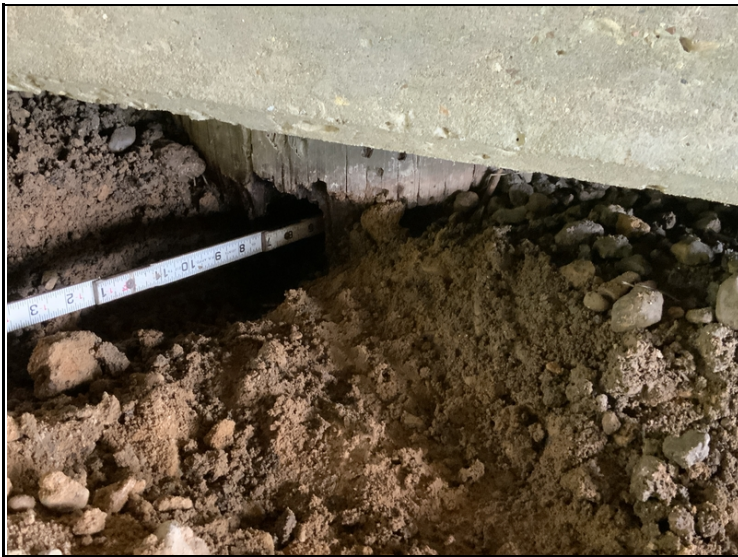
Abutment #2 pile #3.

Bent #2 pile #3 has outer shell decay with up to 15% section loss above splice.  
Abutment #2 pile #3 has outer shell decay sounds hollow, with six inch deep hole in side.

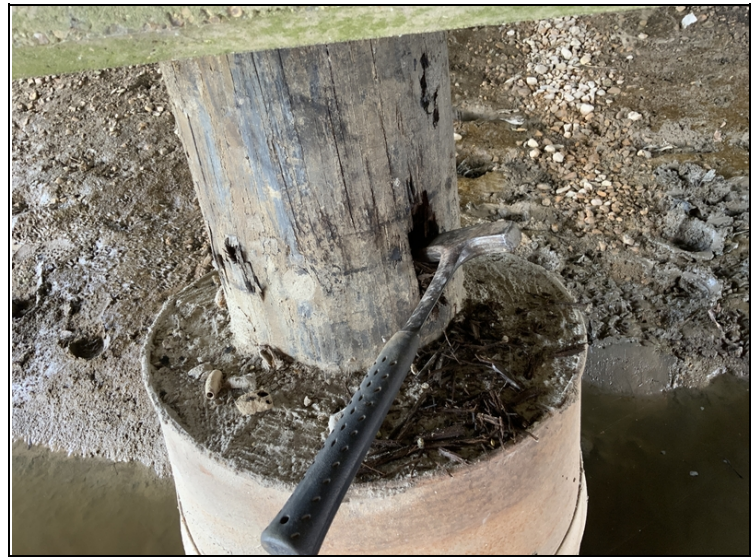
Bent #2 pile #3 has outer shell decay with up to 15% section loss above splice.

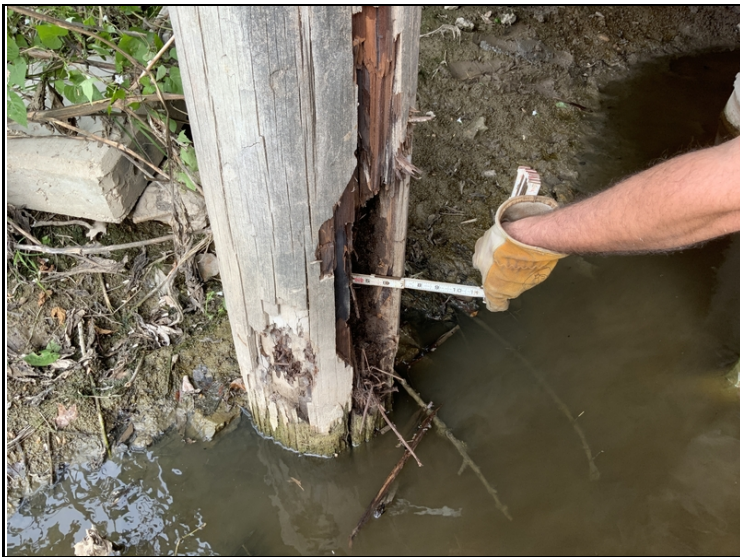
Bent 2 pile 5 has outer shell decay hole in ahead face and 40% section loss.

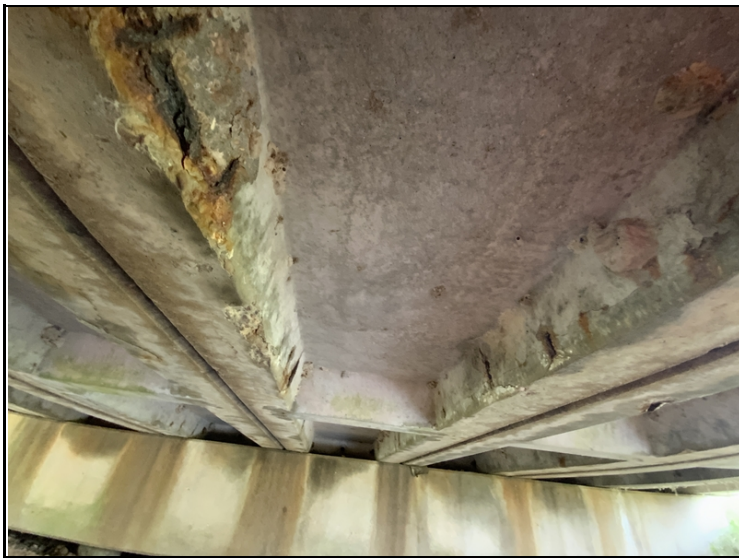
Span #1 right curb spalled at abutment #1 for one foot with exposed rebar.  
Span #1 unit #4 right leg has shallow spalls with exposed rebar with 15% section loss on sides of girder spaced at six inches.  
Span #2 unit #3 has several pop offs with exposed rebar.  
Span #2 unit #7 left leg is spalled with exposed rebar 2' near bent #3.  
Span #3 unit #4 left leg has a 1 foot spall and exposed rebar having 5 percent section loss.  
Span #3 unit #5 left leg has small spall at one quarter span with exposed rebar.  
Span #3 unit #6 both legs have pop off spalls with exposed rebar with 15% section loss.

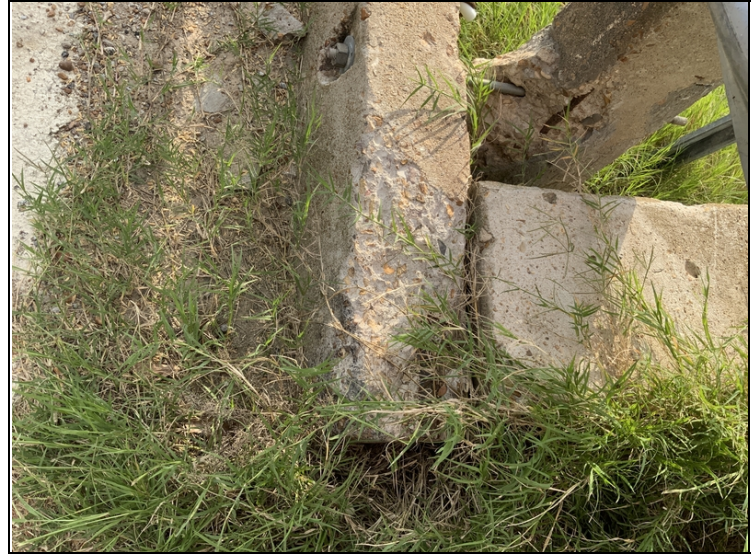
Span #1 right curb spalled at abutment #1 for one foot with exposed rebar.

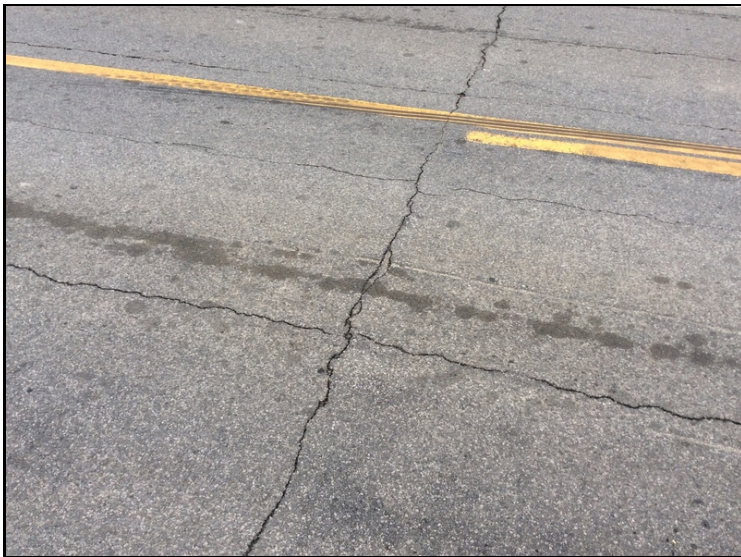
Asphalt overlay is cracked & spalled at bents & at girder unit joints in all spans.

Typical cracks in asphalt on deck.

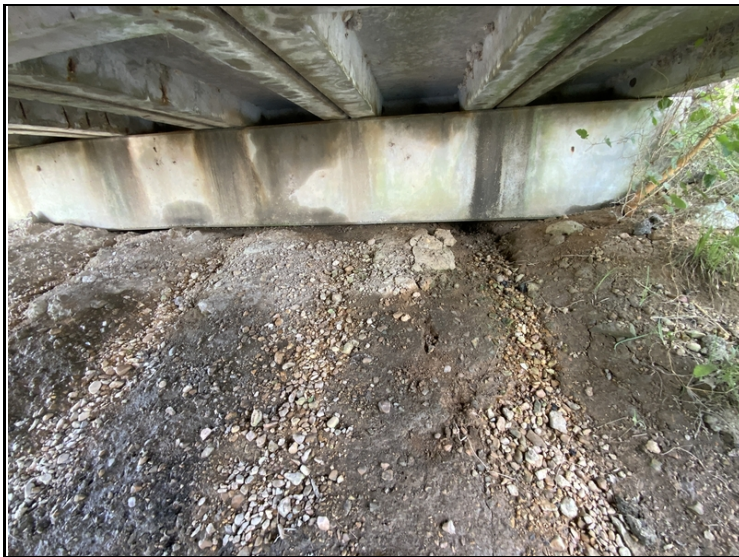
Abutment #1 cap is undermined 6" - 1' deep for the left half of the cap.

Erosion at abutment #1 cap.

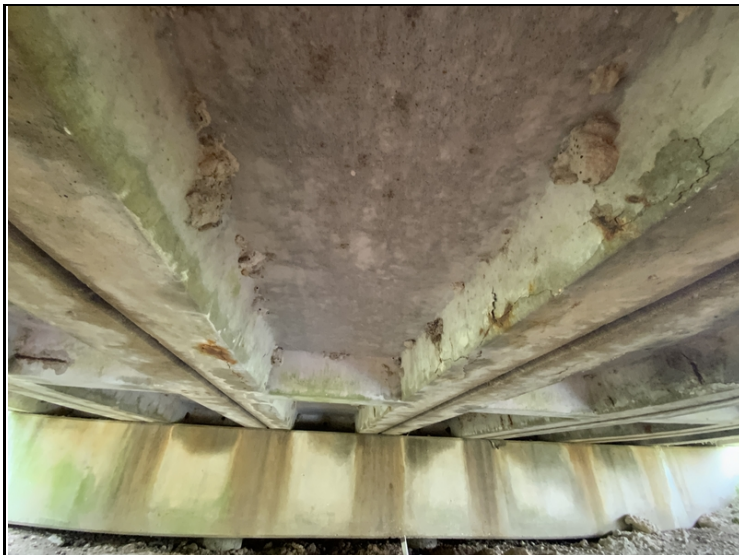
Span #1 unit #4 left leg has 3' of cracking  
Span #1 unit #4 right leg has 8' cracking  
Span #1 unit #5 left leg cracked for 8' two feet with rust staining.  
Span #1 unit #5 right leg cracked and delaminated full length with rust staining.  
Span #1 unit #6 left leg cracked and delaminated full length with rust staining.  
Span #1 unit #6 right leg cracked and delaminated with rust staining beginning of span for 7'  
Span #2 unit #2 left leg cracked 8' with rust staining, right leg cracked 6'.  
Span #3 unit #3 both legs cracked and delaminated full length with rust staining.  
Span #3 unit #4 left leg cracked and delaminated with rust staining first half of spans. Right leg cracked first half of span.  
Span #3 unit #7 right and left leg is map cracked full length with moderate to heavy efflorescence.  
Span #3 unit #7 right outside of unit has multiple longitudinal cracks with efflorescence.

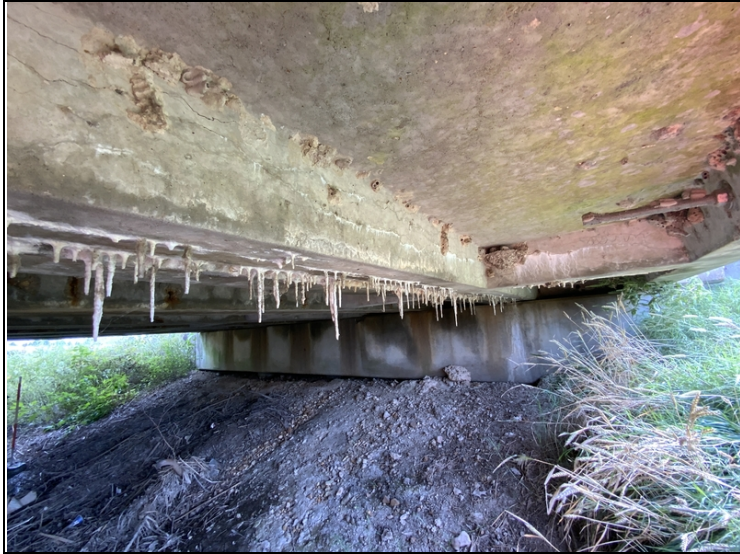
Span #3 unit #7 left leg has map cracking full length with moderate to heavy efflorescence.

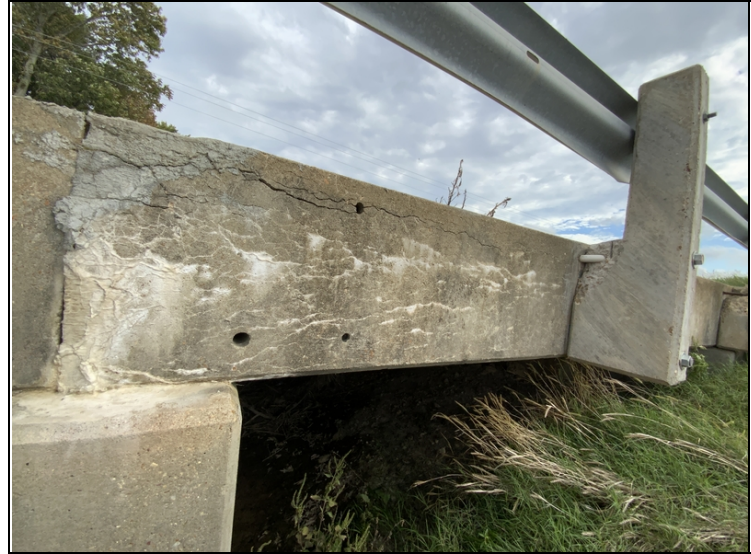
Span #3 unit #7 right leg has map cracking for 6' with moderate efflorescence.

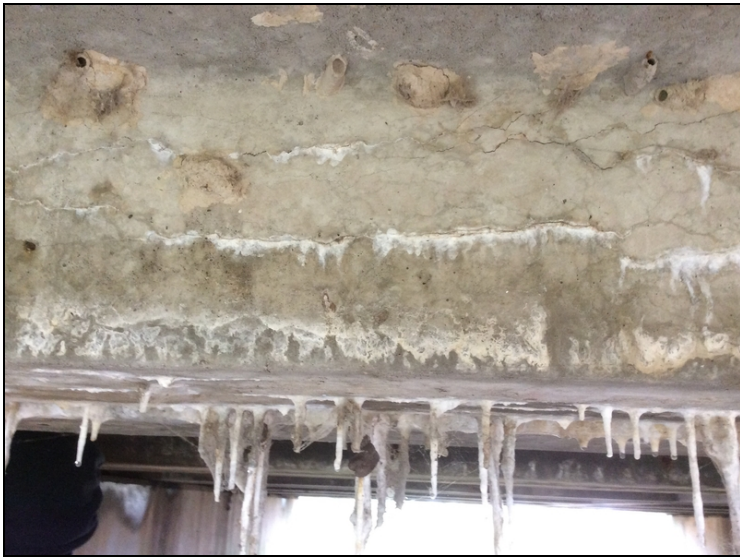
Span three girder seven right and left legs have longitudinal cracks
