## Bridge 07320 Inspection Report

Sh-1/Sec-9/L-0.089 over Big Cypress Creek

Team Lead: Drew Melton Inspection Date: 05/28/2024

05/28/2024 Routine and underwater type 2 inspection performed. Routine was performed by walking across deck and accessing under structure with rubber boots and use of binoculars. Underwater type 2 was performed by taking channel readings from both sides of bridge and viewing channel at low water conditions with no substructure in the water.

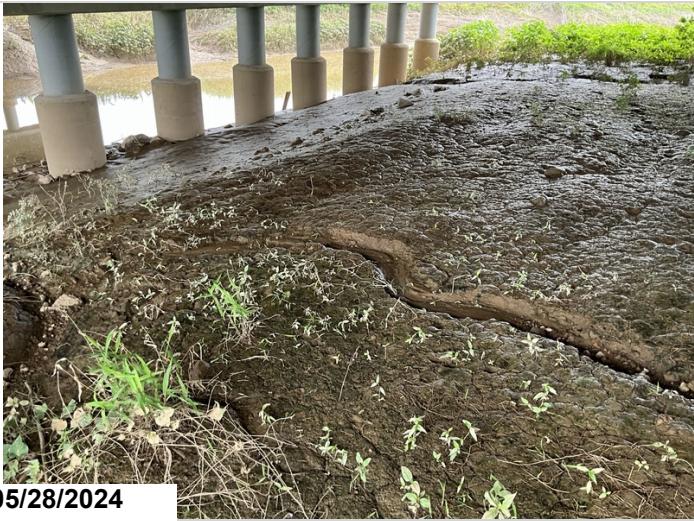
Span 1 & 3, Channel Slopes: Few minor erosion veins running down slope.

Span 1, Channel Slope: Few minor erosion veins running down slope.

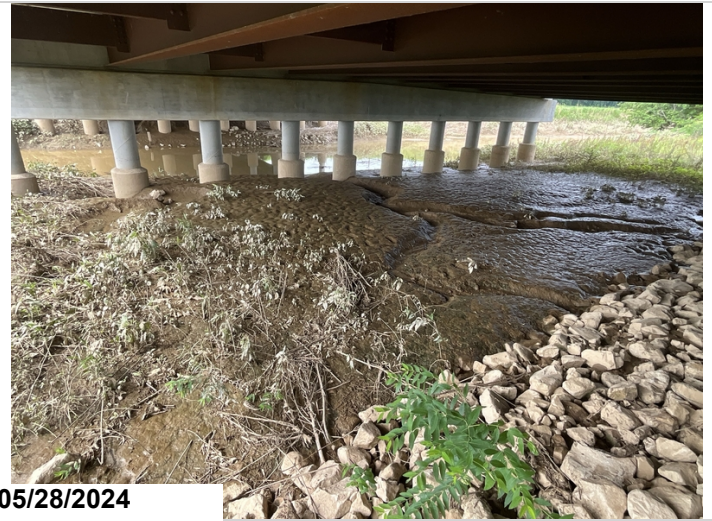
Span 3, Channel Slope: Few minor erosion veins running down slope.

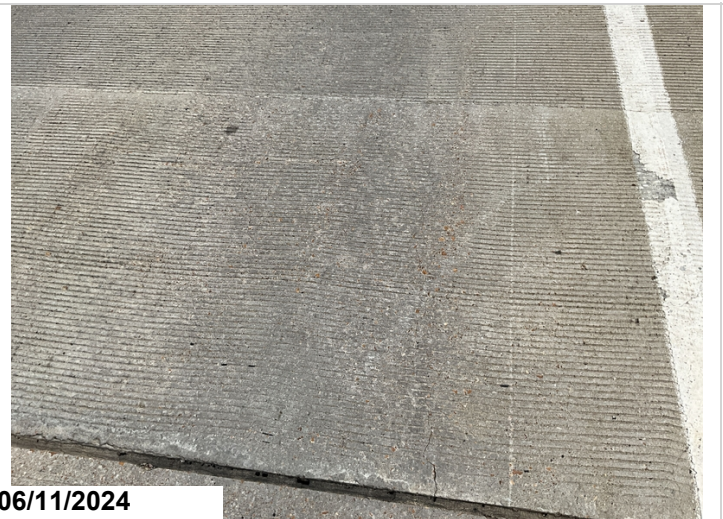
All Spans, Deck Surface, Full Length: Areas of CS2 cracks. 1510SF CS2 (Cracking)

All Spans, Deck Surface, Full Length: Areas of CS2 cracks.  
1510SF CS2 (Cracking)

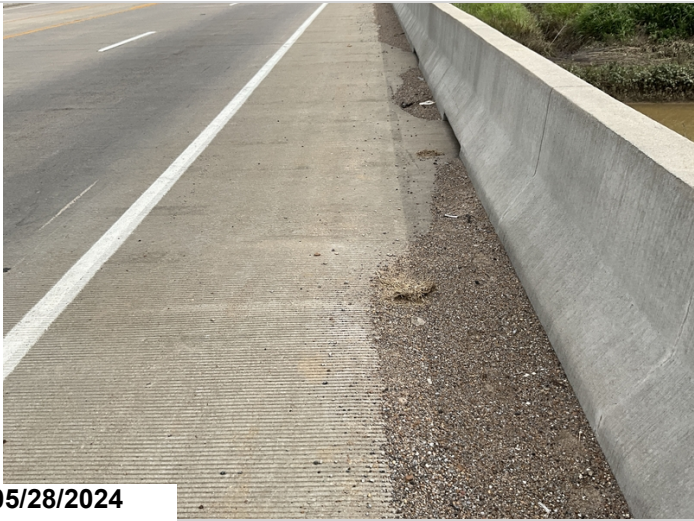
All Spans, Deck Surface Gutters: Dirt and debris.

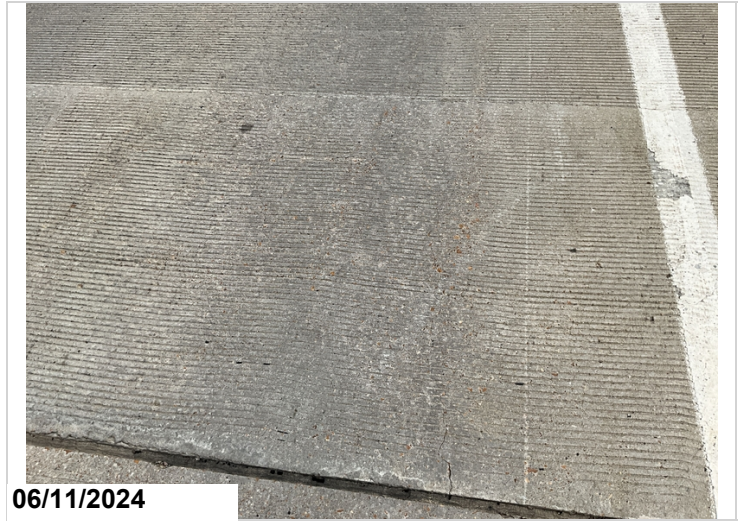
All Spans, Deck Surface, Full Length: Areas of CS2 cracks.  
1510SF CS2 (Cracking)

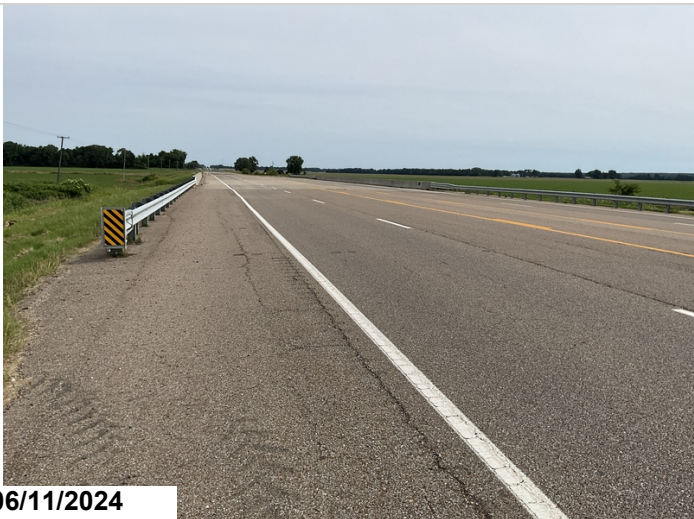
No log mile signs in place should read Sh-1, Section-9, Log Mile 0.08.

No log mile signs in place should read Sh-1, Section-9, Log  
Mile 0.08.

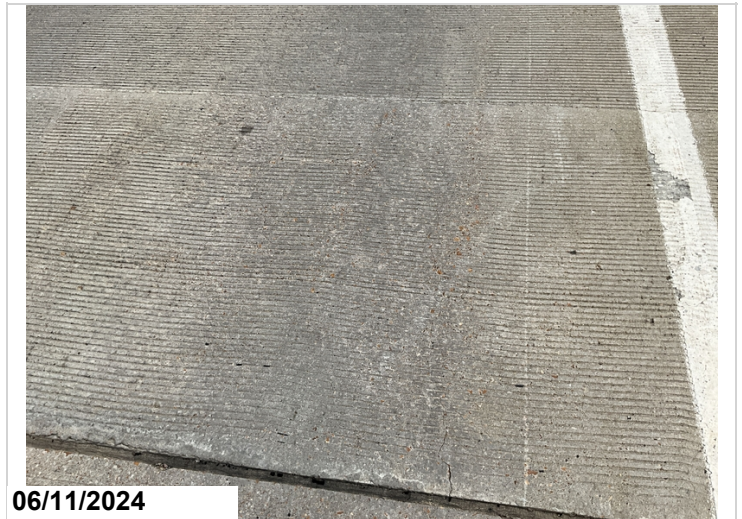
All Spans, Deck Surface, Full Length: Areas of CS2 cracks.  
1510SF CS2 (Cracking)

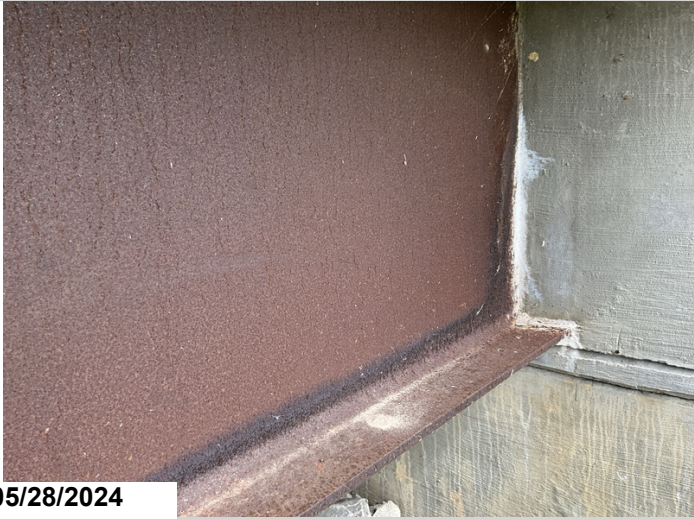
(107) Span 3, Steel Girder 9 & 10, At Bent 4, Right Side: Effectiveness of patina coating is compromised for 1'. 17SF CS3 (Effectiveness)							
Span 3, Steel Girder 9 & 10, At Bent 4, Right Side: Active corrosion with light laminations for 1'. 2LF CS2 (Corrosion)							
215	Reinforced Concrete Abutment	LF	206	183	23	0	0
1120	Efflorescence/Rust Staining	LF	23	0	23	0	0

Span 3, Steel Girder, At Bent 4, Right Side: Active corrosion with light laminations for 1'.

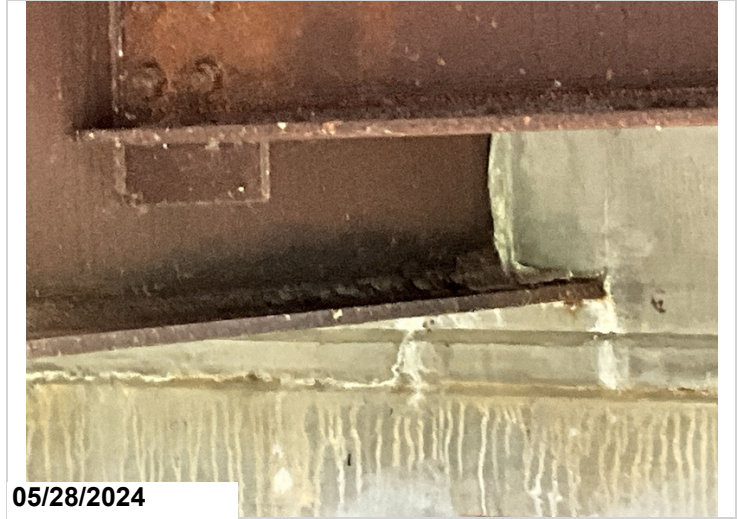
Span 3, Steel Girder 9, At Bent 4, Right Side: Active corrosion with light laminations for 1'.

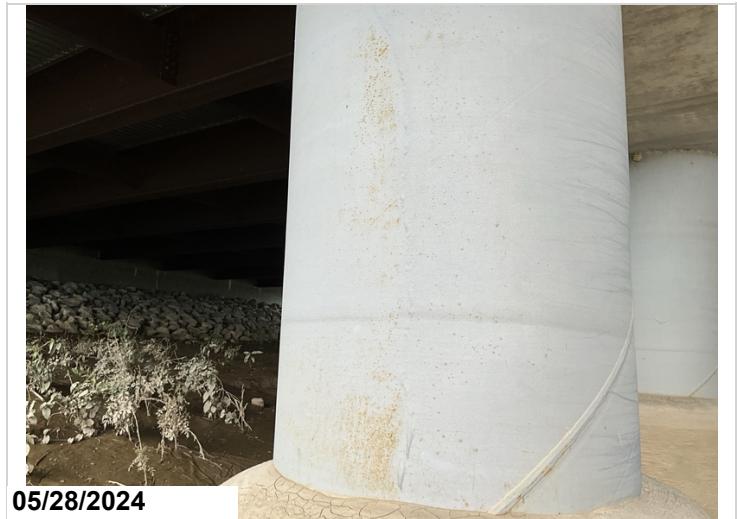
(225) Bent 2 & 3, Steel Piles, About Concrete Encasement: Areas of surface rust. 725SF CS2 (Effectiveness)							
234	Reinforced Concrete Pier Cap	LF	156	154	2	0	0
1120	Efflorescence/Rust Staining	LF	2	0	2	0	0

Bent 2 & 3, Steel Piles, About Concrete Encasement: Areas of surface rust. 725SF CS2 (Effectiveness)

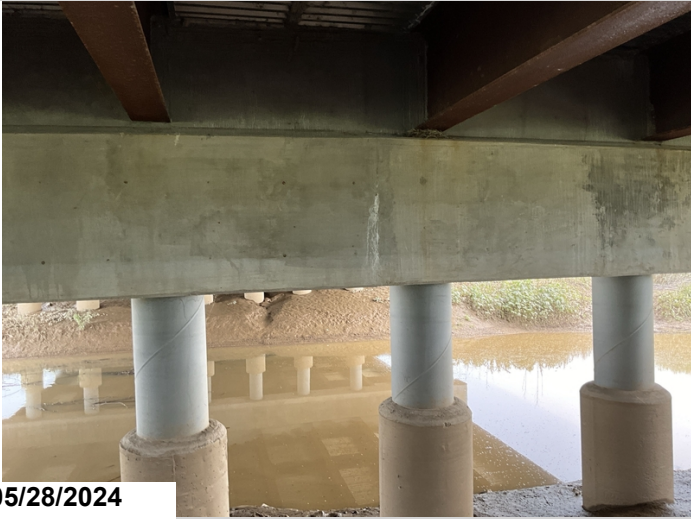
(234) Bent 2 & 3, Pile Cap, Both Sides, At Construction Joint: Hairline crack with light efflorescence. 2LF CS2 (Efflorescence/Rust Staining)							
321	Reinforced Concrete Approach Slab	SF	4307	4057	250	0	0
1130	Cracking (RC and Other)	SF	250	0	250	0	0

Bent 2 & 3, Pile Cap, Both Sides, At Construction Joint:  
Hairline crack with light efflorescence. 2LF CS2  
(Efflorescence/Rust Staining)

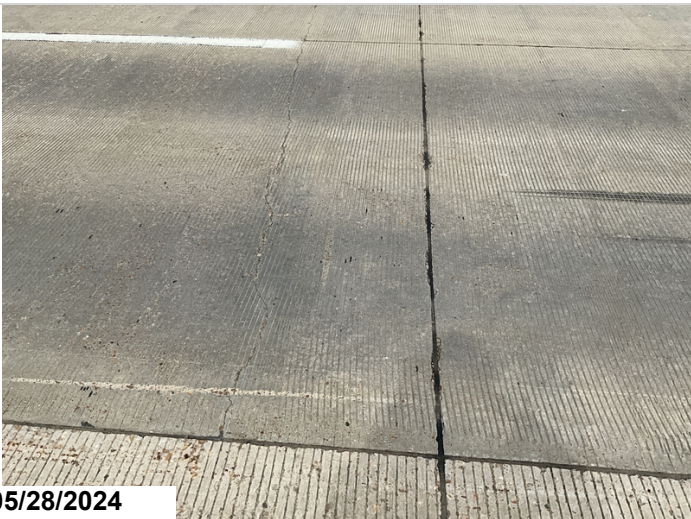
(321) Abutment 1 & 2, Approach Slab: Cracks. 250SF CS2 (Cracking)							
331	Reinforced Concrete Bridge Railing	LF	390	292	98	0	0
1130	Cracking (RC and Other)	LF	98	0	98	0	0

Abutment 1 & 2, Approach Slab: Cracks. 250SF CS2  
(Cracking)

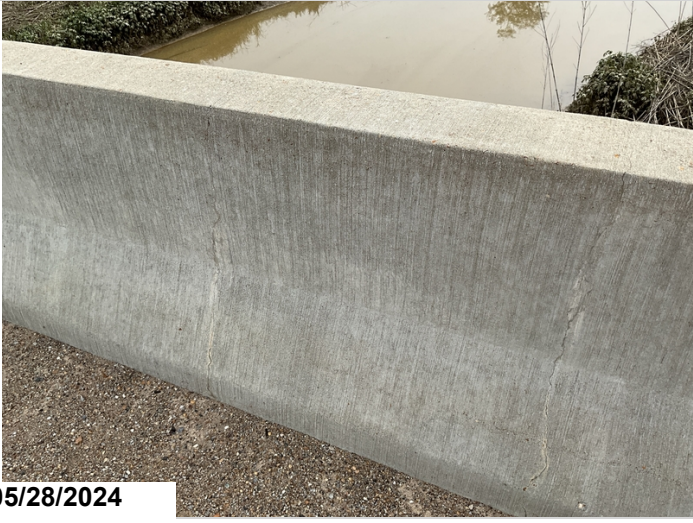
Bridge railing is in good condition with some CS2 vertical cracks.

(331) All Spans, Both Reinforced Concrete Bridge Railings: CS2 vertical cracks spaced 4' apart. 98LF CS2 (Cracking)

All Spans, Both Reinforced Concrete Bridge Railings: CS2  
vertical cracks spaced 4' apart. 98LF CS2 (Cracking)

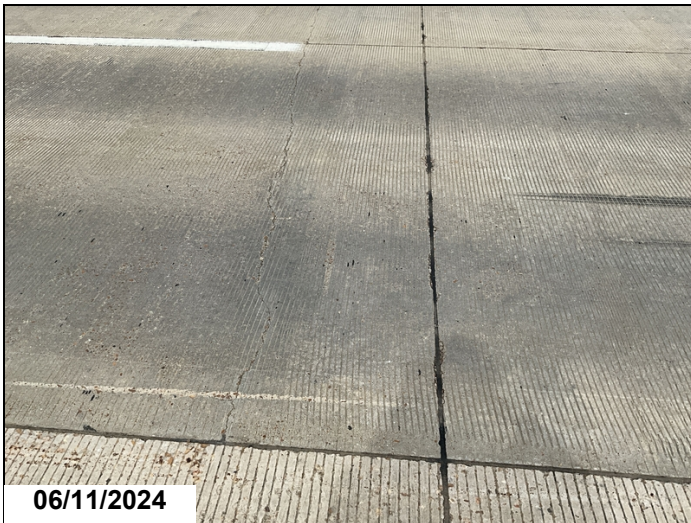
Abutment 1 & 2, Approach Slab: Cracks. 250SF CS2 (Cracking)

Abutment 1 & 2, Approach Slab: Cracks. 250SF CS2  
(Cracking)

Type of Work: Repair (General)

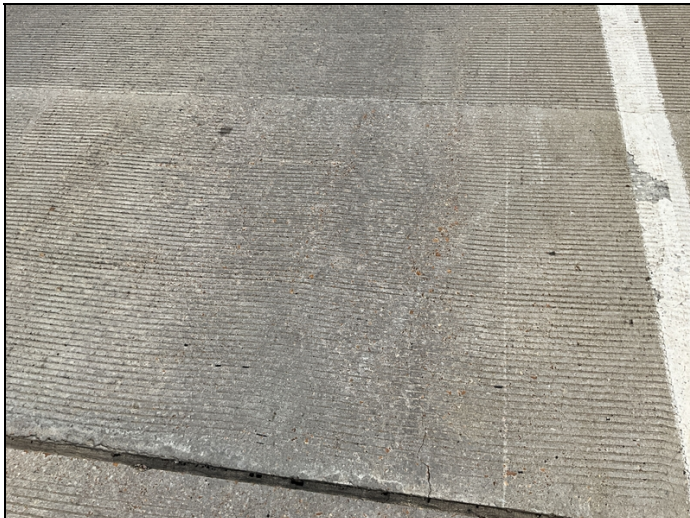
### A-54 - Sealable Deck Cracks (Yes)

All Spans, Deck Surface, Full Length: Areas of CS2 cracks. 1510SF CS2 (Cracking)

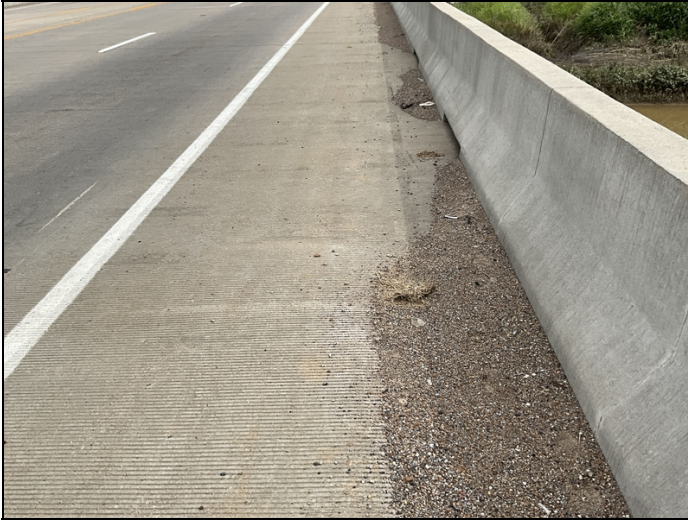
**A-55 - Deck Washing Needed (Yes)**

All Spans, Deck Surface Gutters: Dirt and debris.

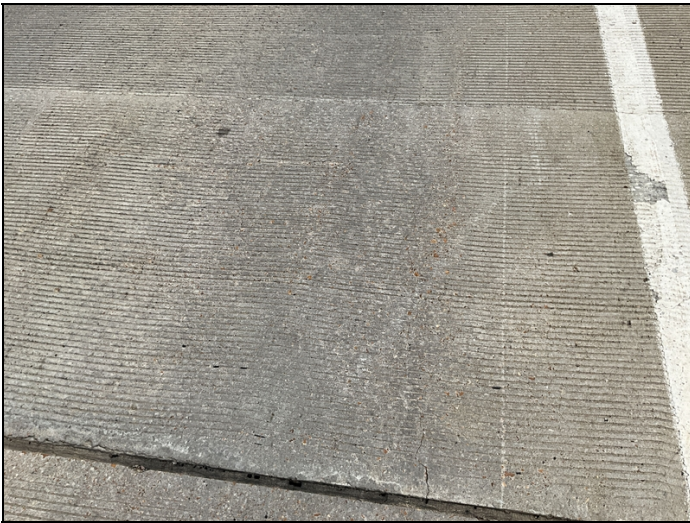
**A-61 - Polymer Overlay Advised (Yes)**

All Spans, Deck Surface, Full Length: Areas of CS2 cracks. 1510SF CS2 (Cracking)

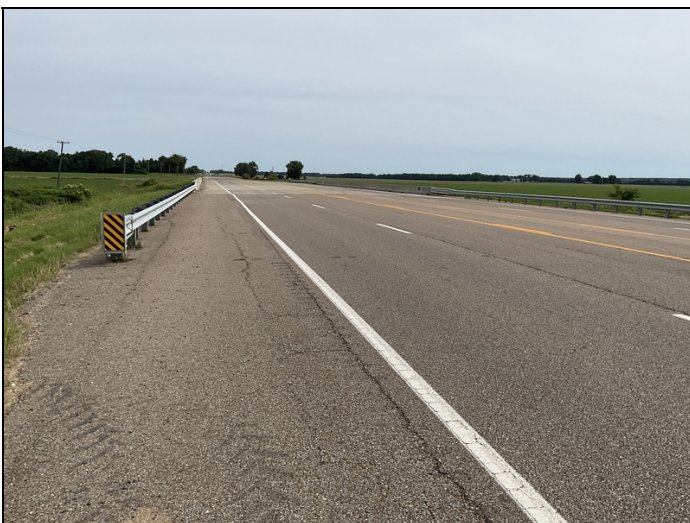
**A-63 - Missing/Incorrect Log Mile Signage (Yes)**

No log mile signs in place should read Sh-1, Section-9, Log Mile 0.08.
