Asset #02396(Routine, Underwater type 2)
Us-79/Sec-15/L6.77 over Little Hog Tusk Creek

Location: 1.0 Mi West Of Jct Sh 238

Team Lead: Myron Futrell, Inspection Date: 11/09/2022

Asset #02396(Routine, Underwater type 2)

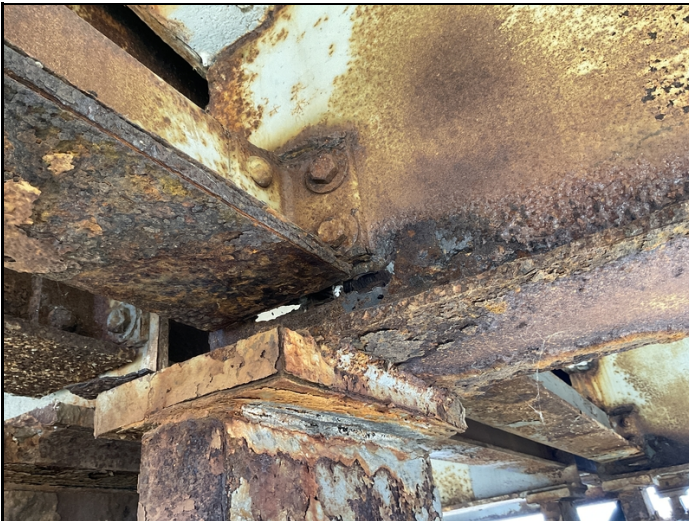
Span #3 bent #3 girder #3 has a eight inch long hole in web at diaphragm connection.

Span #3 bent #3 girder #3 web at diaphragm connection

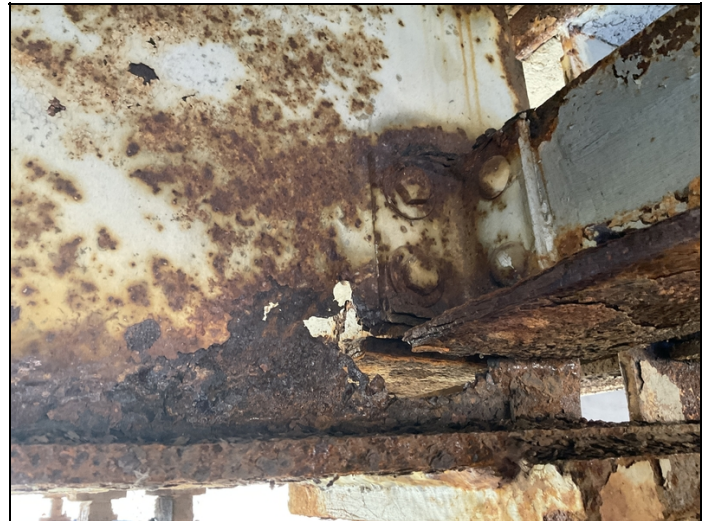
Span #3 bent #3 girder #2 has a eight inch long hole in web at diaphragm, appears to be slightly crushing, and a one and a half inch hole at expansion dam haunch.

Span #3 bent #3 girder #2 web at diaphragm connection

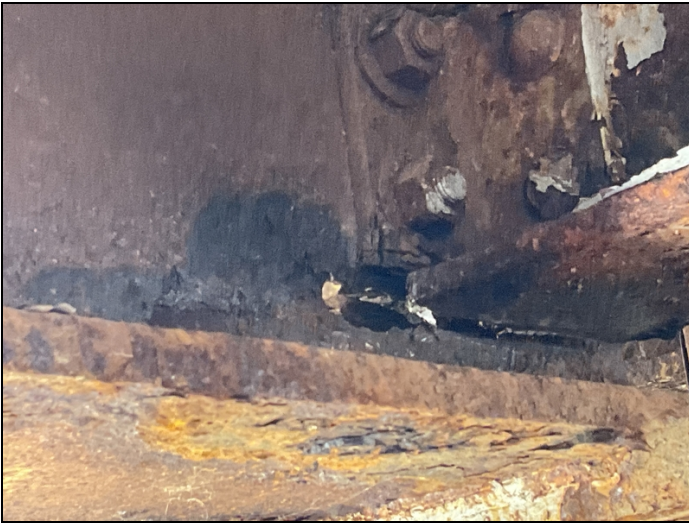
Span #3 bent #3 girder #3 has a eight inch hole in web at diaphragm connection.

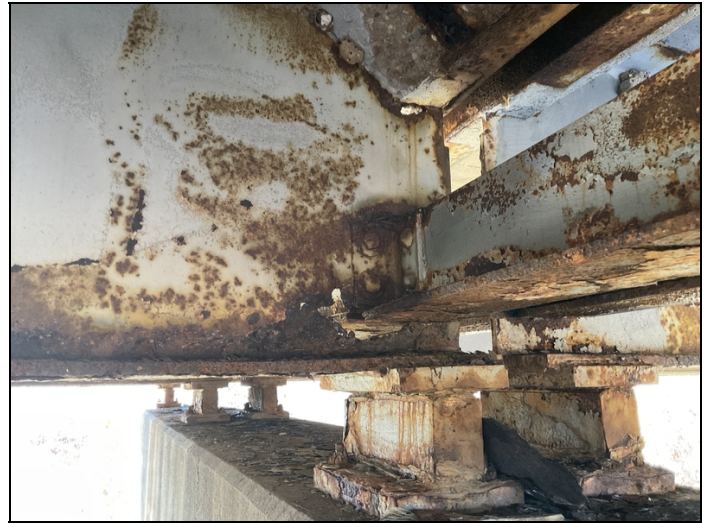
Load rating requested due to section loss in webs of girders #2 and 3 in span #3 at bent #3 and slight crushing of girder #2 span #3 at bent #3.

Span #3 bent #3 girder #2 has a eight inch hole in web at diaphragm and a one and a half inch hole at expansion dam haunch.

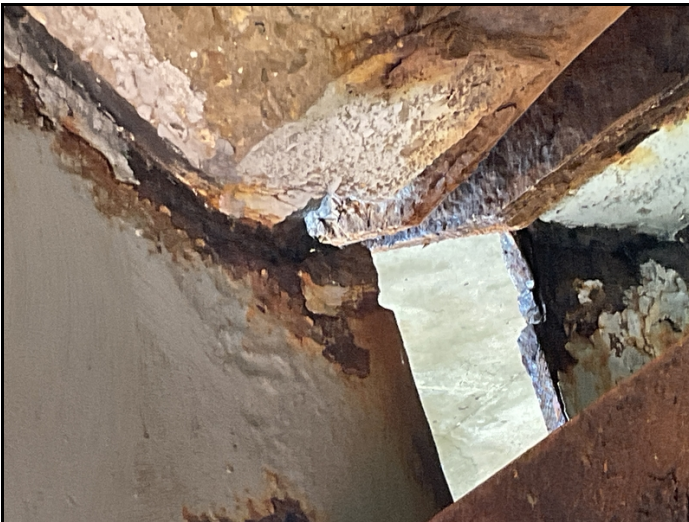
Span #3 bent #3 girder #4 has 1 1/2" hole at haunch.

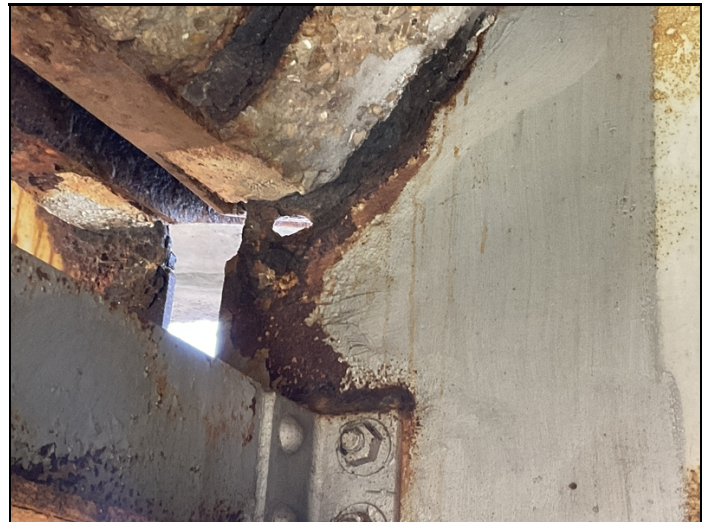
Span #3 bent #3 girder #1 has 1 1/2" hole rusted through at haunch

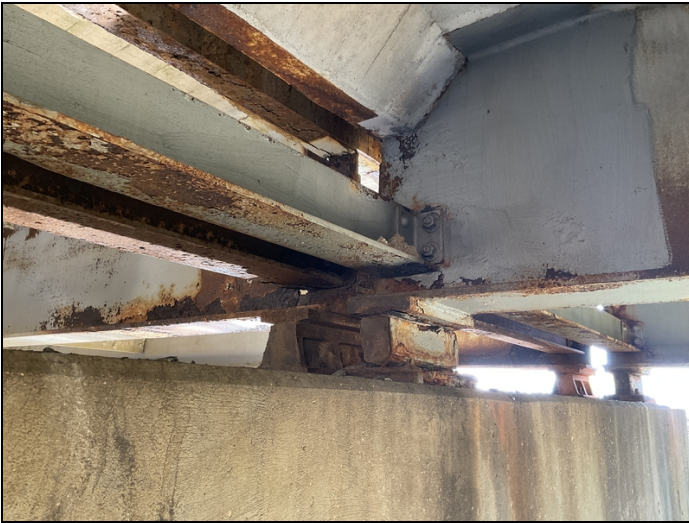
Span #2 bent #2 girder #3 has a four inch hole in web at diaphragm connection and a one inch hole in web at haunch, bottom flange and lower web corroded with laminations for first three feet.

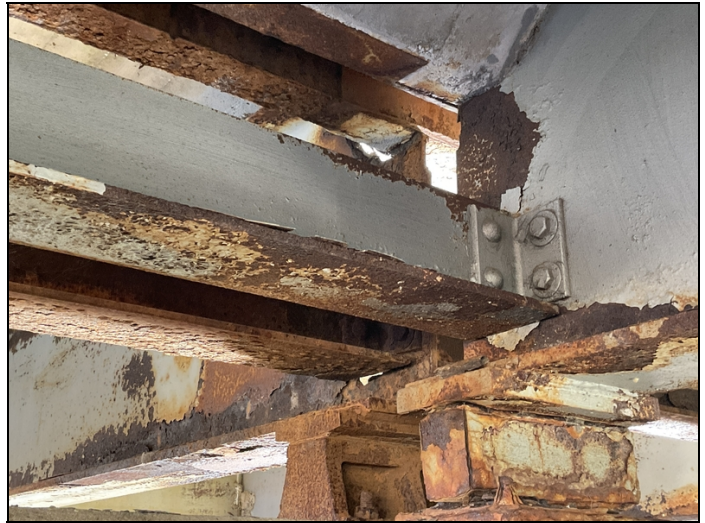
Span #2 bent #2 girder #2 has a three inch hole in web at diaphragm , and a five inch hole at haunch, bottom flange and lower web corroded with laminations for four feet.

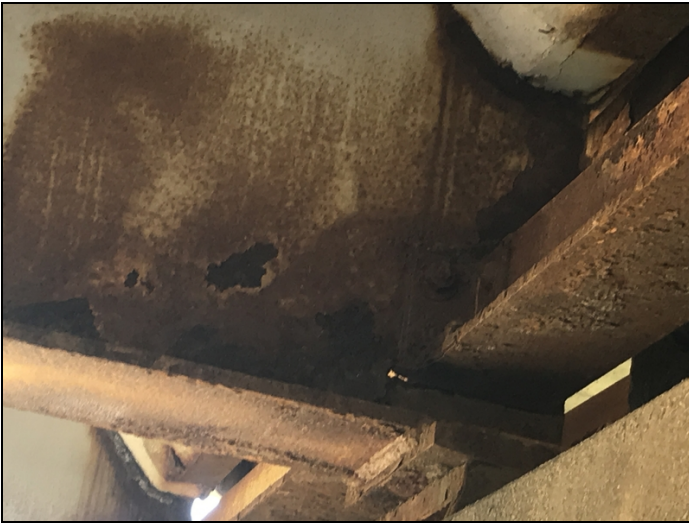
Span #2 bent #2 girder #3 has a three inch hole in web at diaphragm connection.

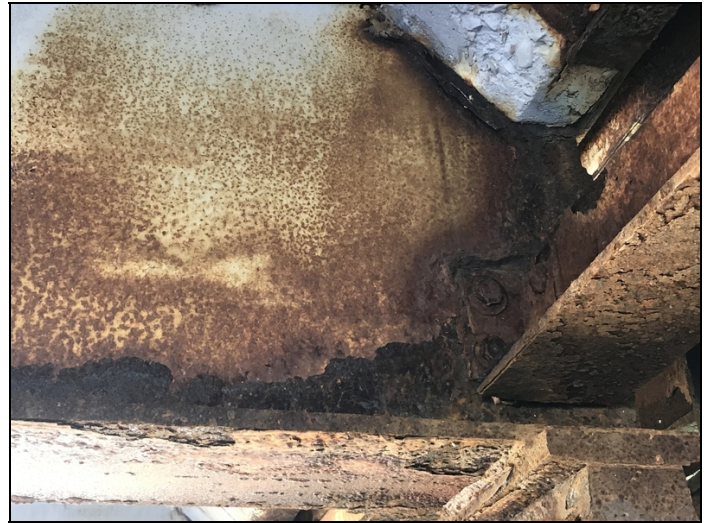
Span #2 bent #2 girder #2 has a two inch hole in web at diaphragm , and a five inch hole at haunch.

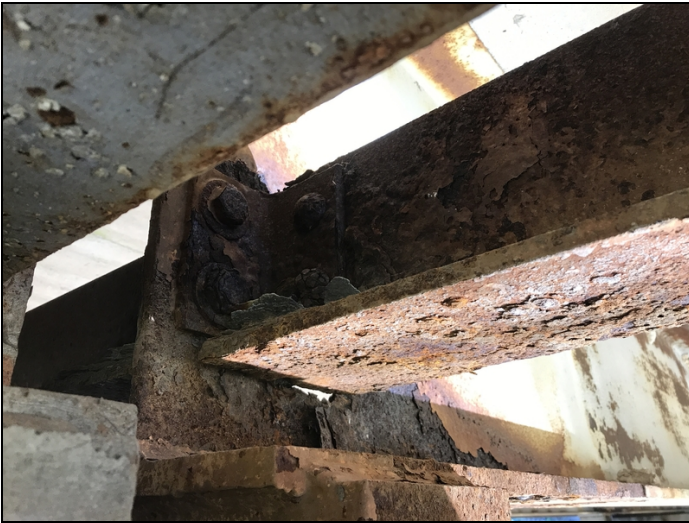
Span #2 bent #2 girder #3 has a four inch hole in web at diaphragm connection and a one inch hole in web at haunch, bottom flange and lower web corroded with laminations for first three feet.

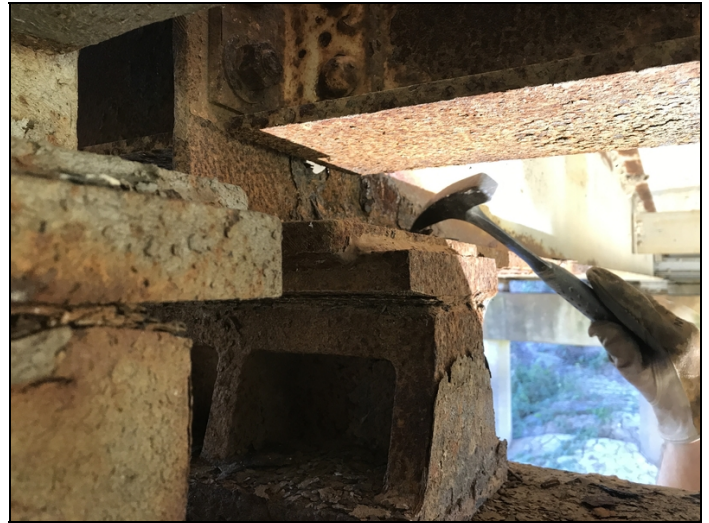
Span #2 bent #2 girder #2 hole at diaphragm connection

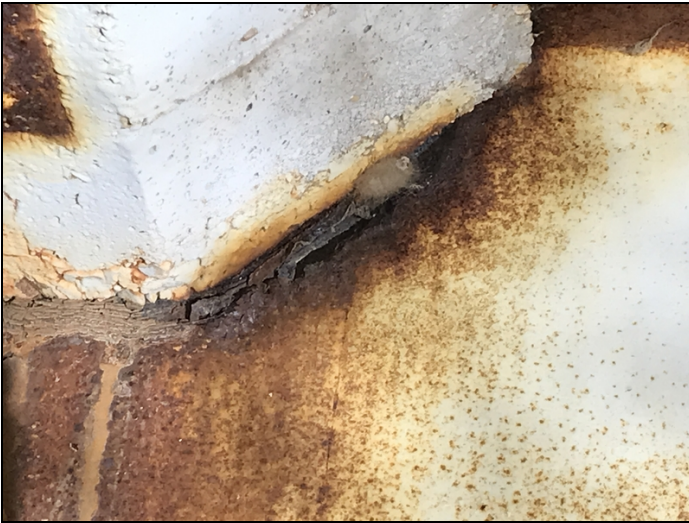
Span #2 bent #2 girder #2 hole at haunch

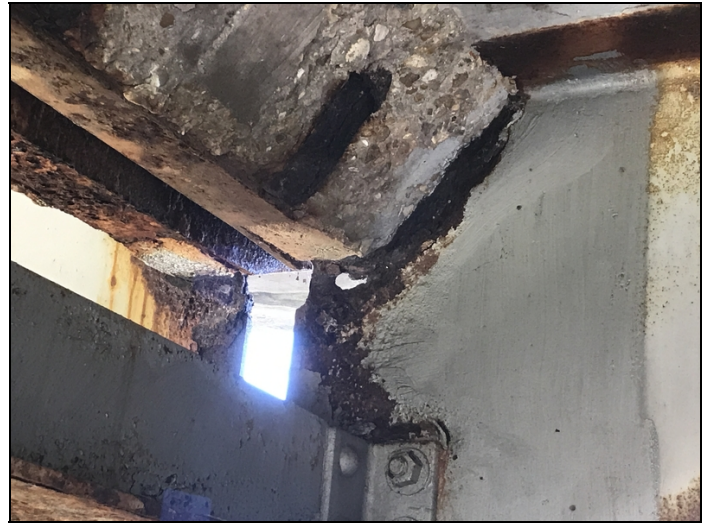
Span #3 bent #3 girder #4 has 1 1/2" hole at haunch.

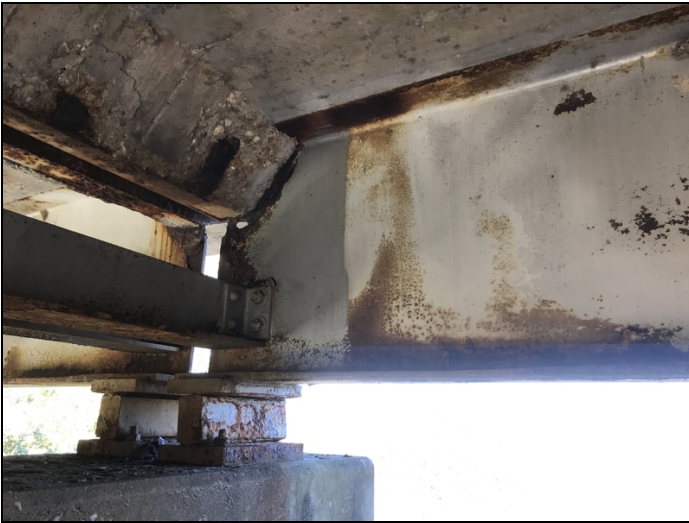
Span #3 bent #3 girder #1 has 1 1/2" hole rusted through at haunch.

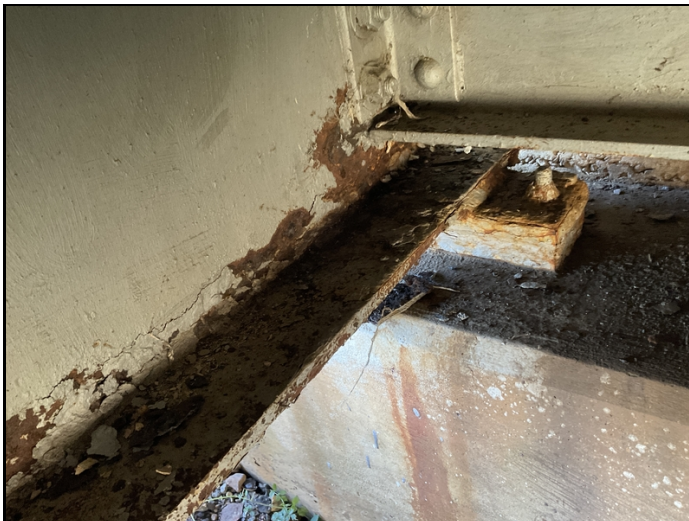
Span #3 abutment #2 girder #1

Span #3 abutment 2 girder 1,4 has section loss on lower flange and migrating into web first 1' 35% section loss.

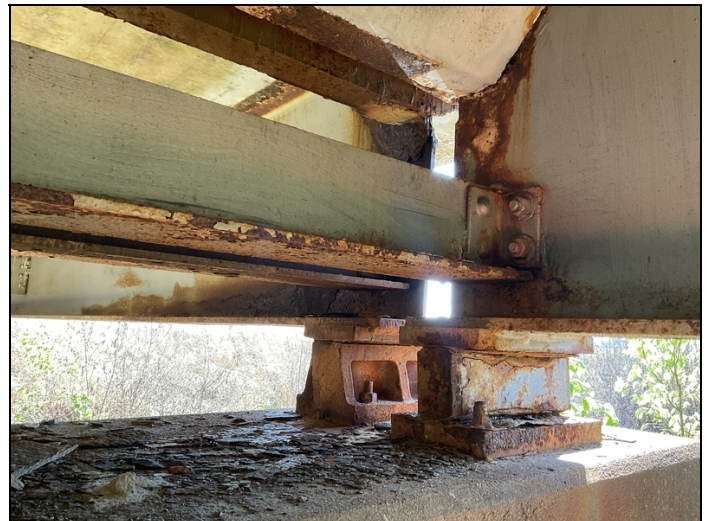
Span #2 bent #2 girder #4 corroded at haunch with up to 70% section loss, first two feet of bottom flange and lower web corroded with laminations.

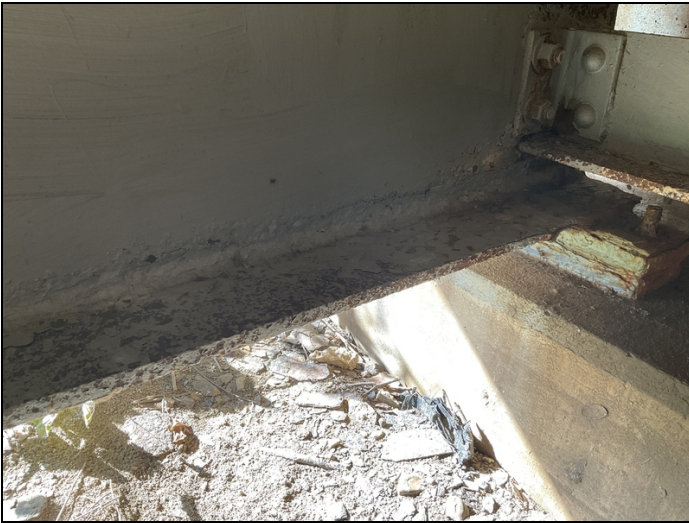
Span #1 abutment 1 girder #4 has section loss on lower flange and migrating into web first 2' 50% section loss.

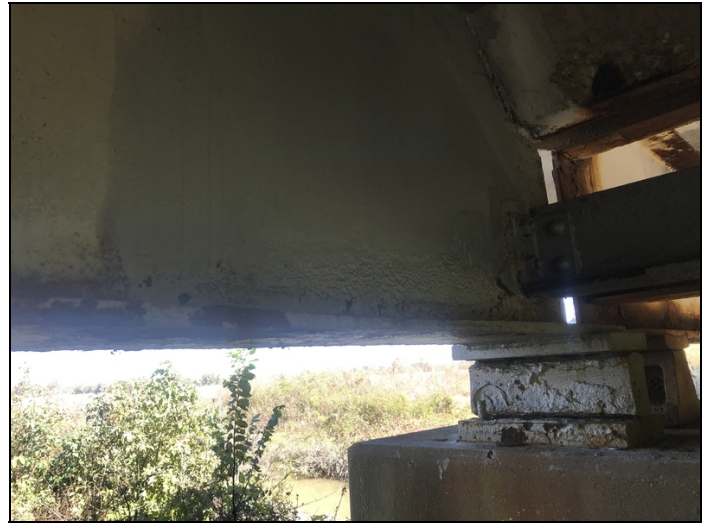
Span #1 , girder #1 at bent #2 bottom flange has 35% section loss for 2'.

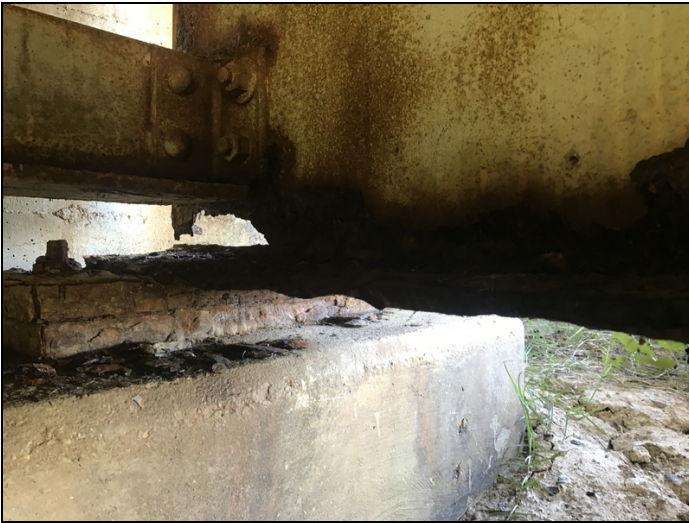
Span #1 abutment #1 girder #1 bottom flange section loss.

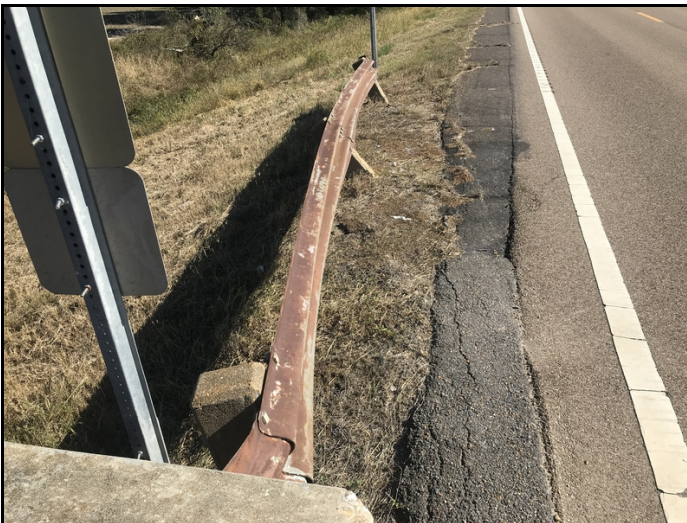
Abutment #2 left approach rail

Approach rail at abutment #1, #2 left side has collision damage.

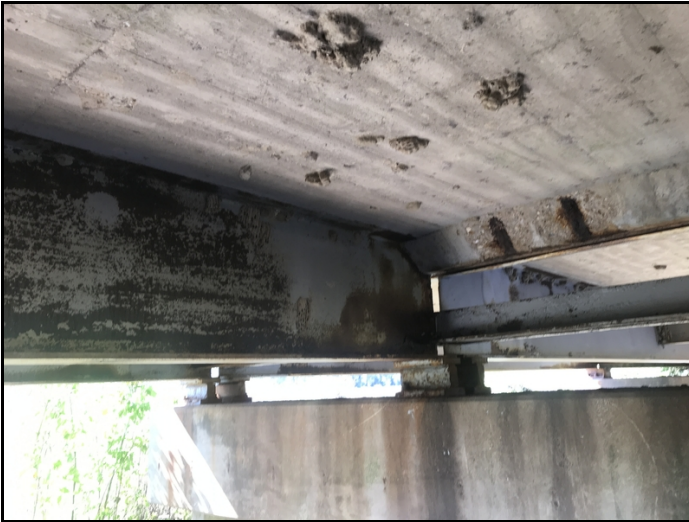
Girder ends are corroded with section loss up to 50%.

Typical girder ends.

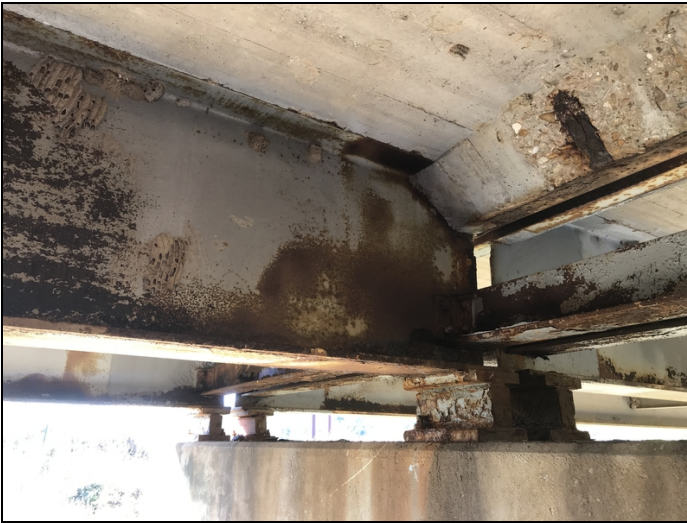
Span #3 bent #3 girder #3

Span #3, girder 1,3,4 at bent #3 first foot bottom flange has 50% section loss.

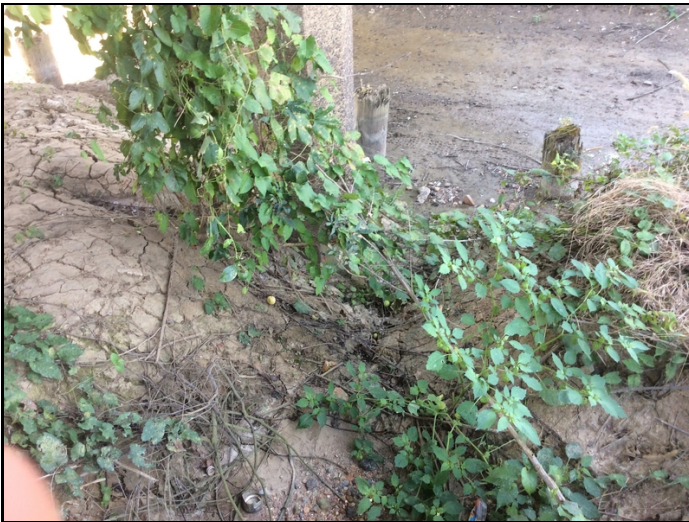
10/26/2016 lowered substructure from 8 to 7 due to local scour around bent #2,3 piles.

BENT #2, #3 LEFT AND RIGHT SIDES EROSION UP TO 2' DEEP BY PILES EXPOSING PILES 2' MORE THAN GROUND LEVEL.

Erosion bent 3.

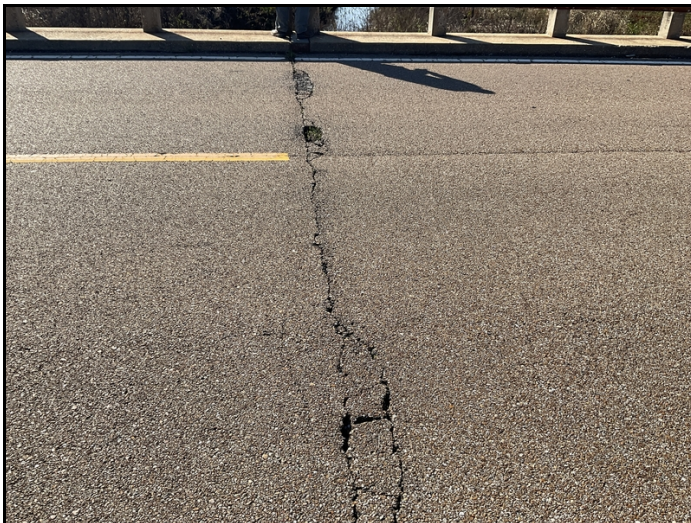
Bent #2 joint

ACHM overlay at bent #2 joint has one foot spall and six feet cracked and delaminated.

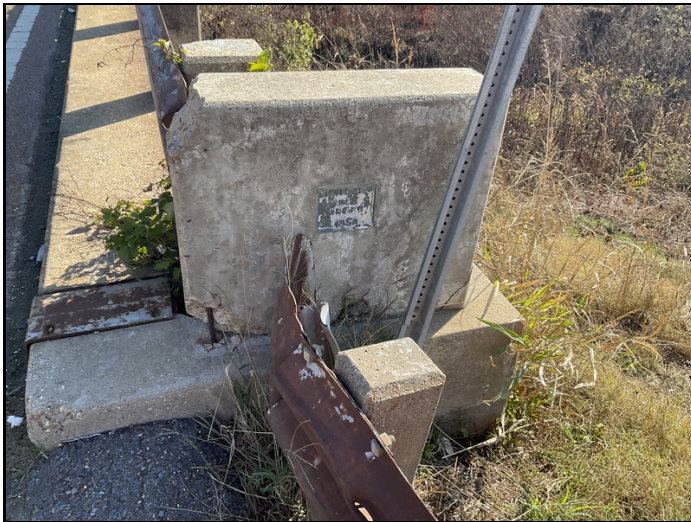
Right side abutment 1 monument post has been broken and posts 1,2,3,5 have spalls.
Abutment #2 monument wall has collision damage on left side.

Abutment #1 right monument post spalled with exposed rebar

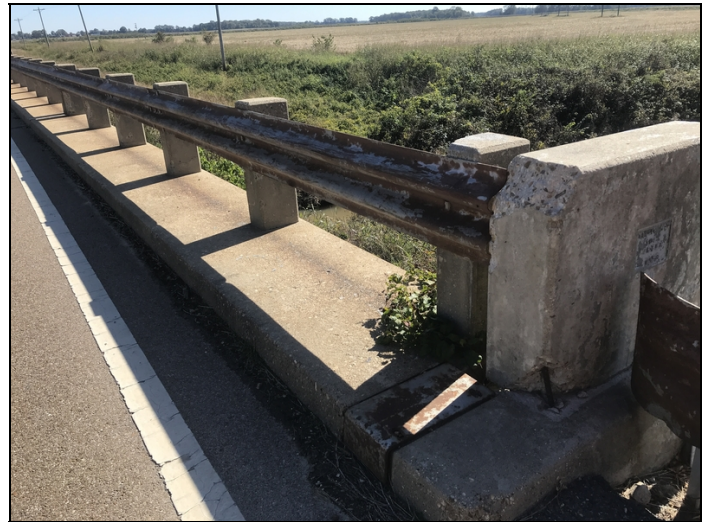
Abutment #1 right side post damage

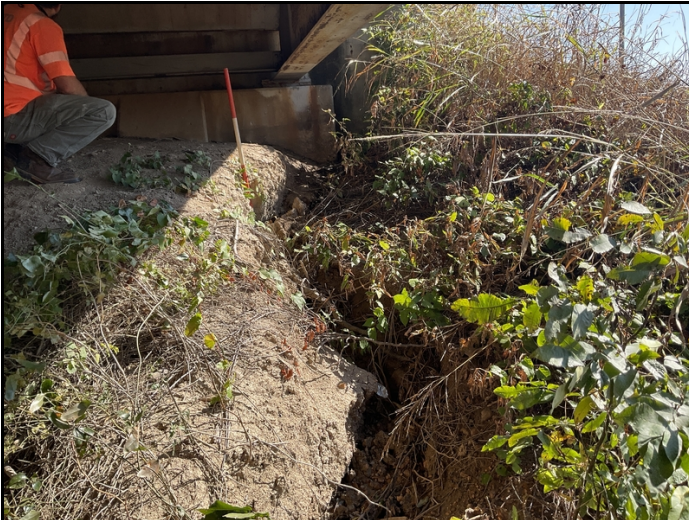
Abutment #2 slope right side has erosion vein up to two-foot deep running down slope.

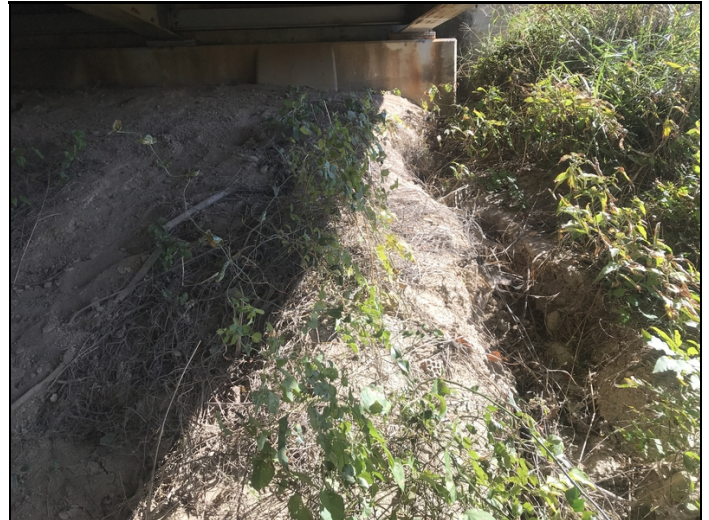
Abutment #2 slope right side has erosion vein up to one foot deep running down slope.

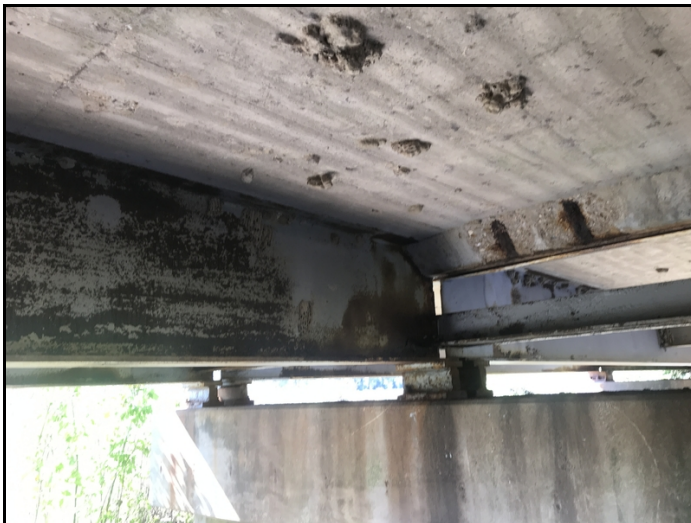
Girders have surface rust full length with 40% bare steel, 20% little effectiveness.

Typical paint on girders.

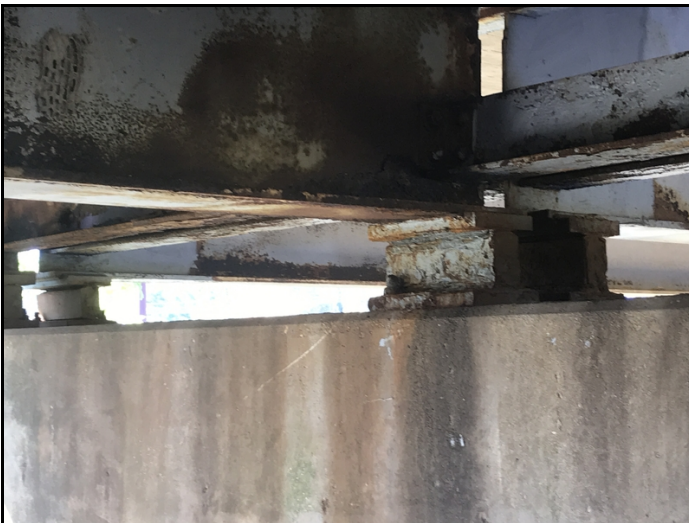
All bearings are corroded with laminations with section loss up to 15%

Typical bearings.

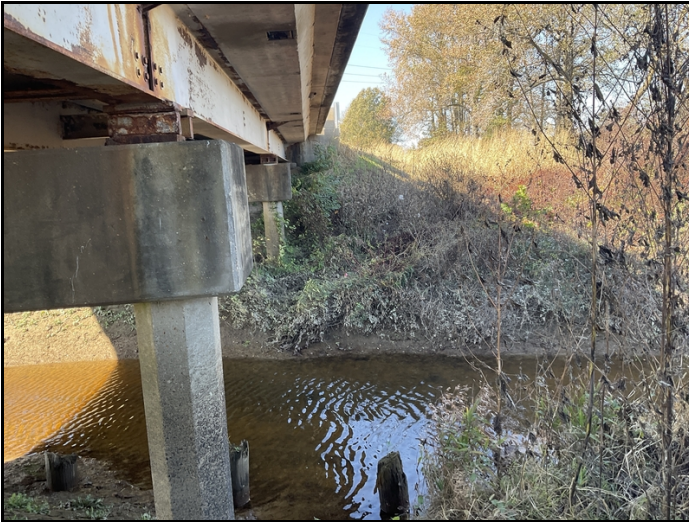
Small trees and vegetation are growing beside and under bridge.

Vegetation growing beside and under bridge

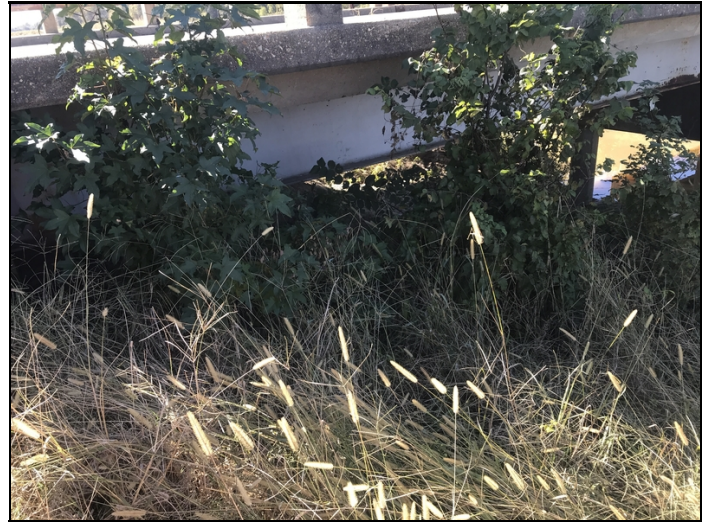
Small trees growing beside bridge
