Asset #06978(Routine, Underwater type 2)

Us-79/Sec-15/L4.29 over Walnut Lake / Big Creek

Team Lead: Myron Futrell, Inspection Date: 11/08/2021

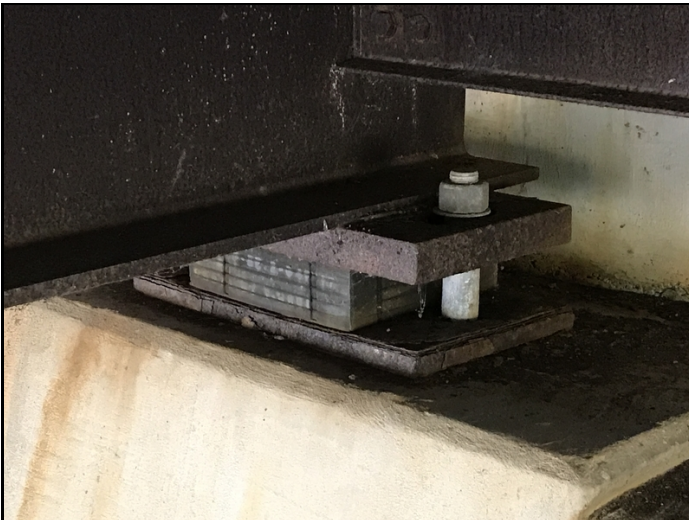
(310) Abutment #1 bearings have corrosion with laminations. Abutment #2 girders #2,3,4,5 have corrosion on sole plates and masonry plates with laminations.							
321	Reinforced Concrete Approach Slab	SF	1752	1314	438	0	0
1130	Cracking (RC and Other)	SF	438	0	438	0	0

Abutment #1 bearings have corrosion with laminations on sole plates and masonry plates.

Abutment #2 girders #2,3,4,5 have corrosion on sole plates and masonry plates with laminations.

Typical corrosion with laminations on abutment #1 bearings

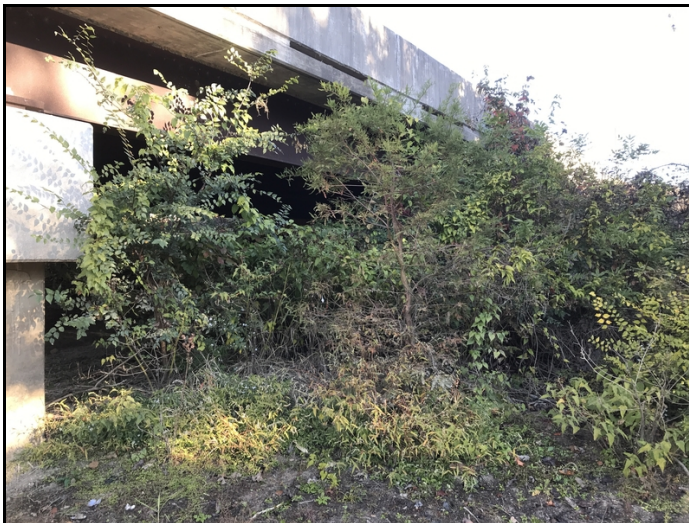
Vegetation is growing under and beside bridge.

Vegetation growing beside and under bridge

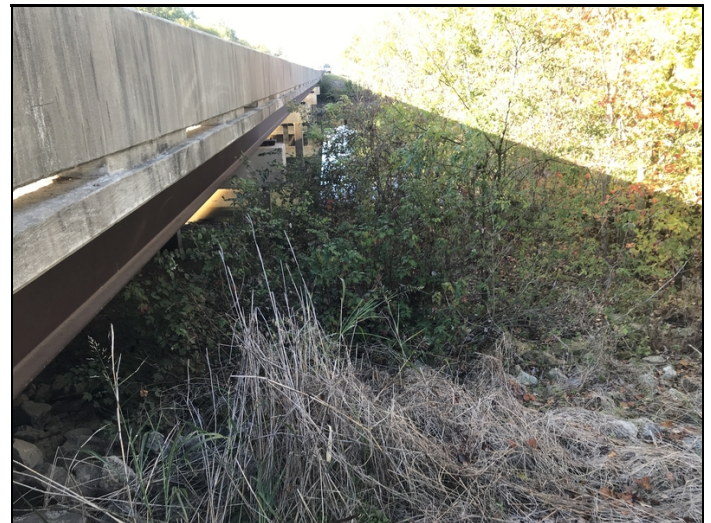
Trees and vegetation growing beside and under bridge

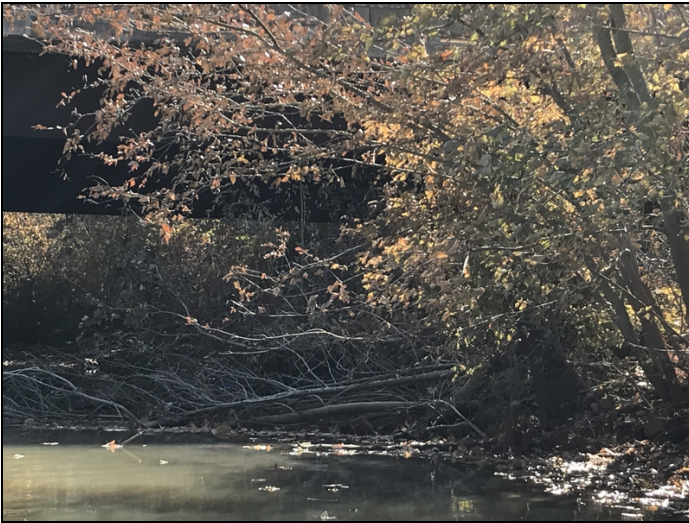
Typical vegetation

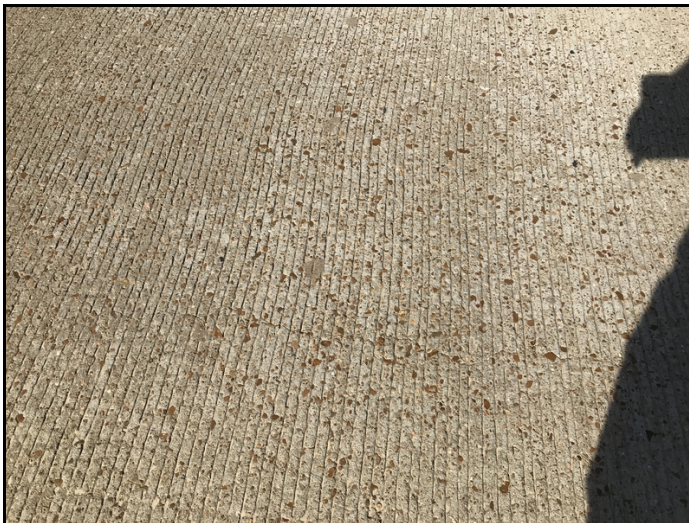
Deck has open transverse and longitudinal cracks spaced three to four feet apart.

Typical deck crack.

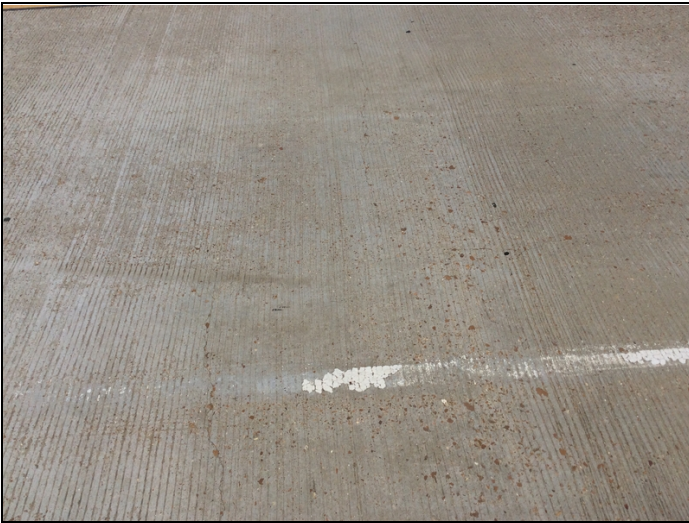
Typical deck cracks.

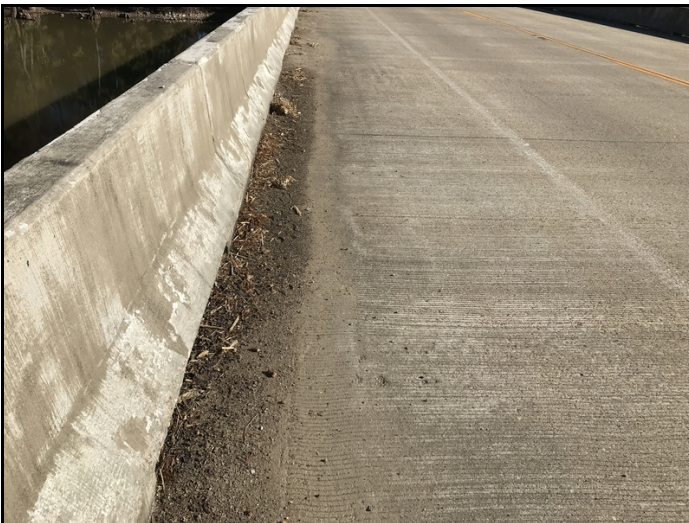
Gutters have dirt and debris.

Dirt and debris in gutters
