Asset #02398(Routine, Underwater type 2)

Us-79/Sec15/L13.33 over Cat Creek

Location: .30 Mi East Sh 121 Sec 3

Team Lead: Myron Futrell, Inspection Date: 11/09/2022

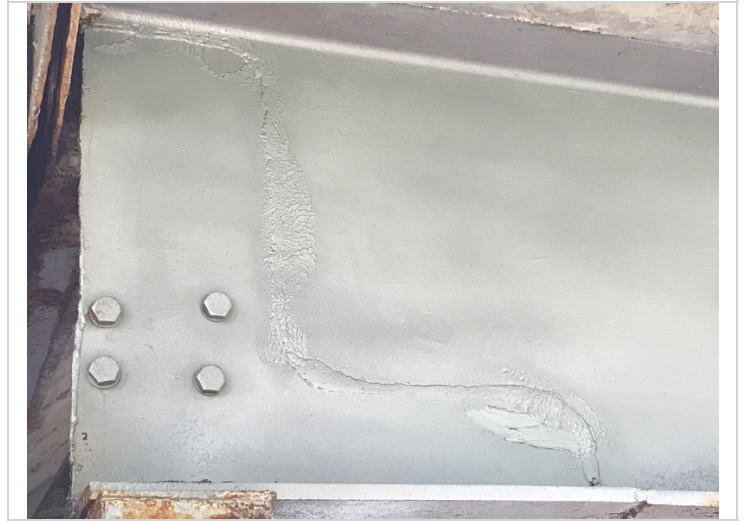
Span 1, Bent 2, Girder 1

Email from 1/28/2020-The reason for the posting change is the deterioration of the ends of the steel beams. Currently, Girder 1 in Span 1 and Bent 2 has buckled creating a need for limiting the load on the structure.

Span #1 girder #1 at bent #2 has an L shape patch that is full height at end ten inches wide the leg is two foot long by seven inches tall.

Spans #1 and 2, girder #1 at bent #2 have been Tee-spliced.

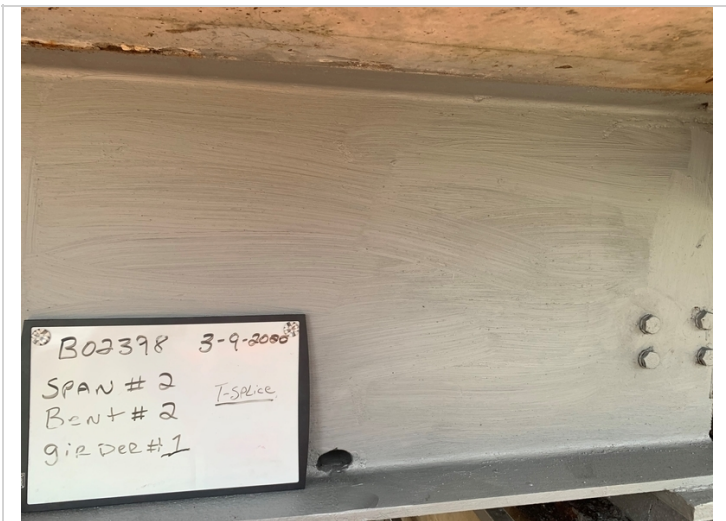
Span 2, Bent 2, Girder 1

Span #2 girder #1 at bent #2 has an L shape patch that is full height at end ten inches wide the leg is two foot long by seven inches tall.

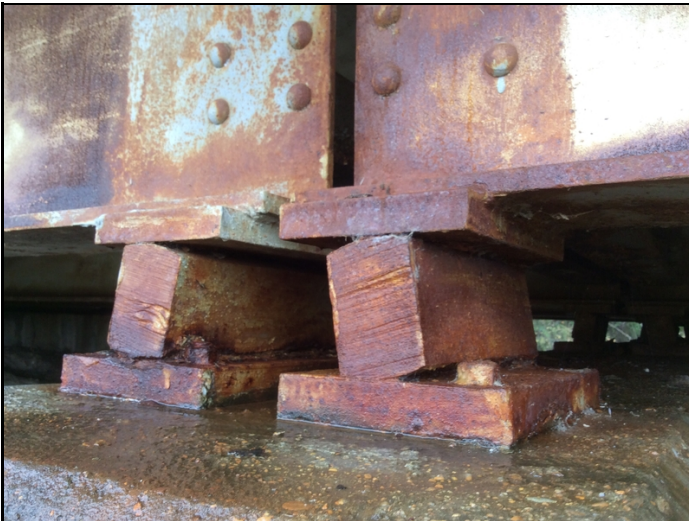
Bearings are rotated up to 15 degrees.

Movable bearings are corroded with lamination with up to 15% section loss. Several anchor bolts rusted in two and missing.

Typical movable bearing.

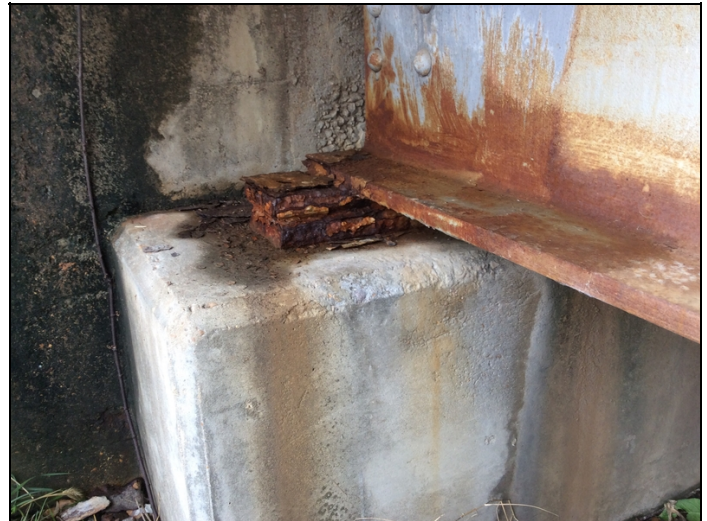
(313) Fixed bearings corroded with lamination, section loss up to 15%. Several anchor bolts are rusted in two and missing. Abutment bearings have been painted since last inspection, but have speckled rust showing through							
331	Reinforced Concrete Bridge Railing	LF	124	106	11	7	0
1080	Delamination/Spall/Patched Area	LF	6	0	0	6	0
1090	Exposed Rebar	LF	11	0	11	0	0
7000	Damage	LF	1	0	0	1	0

Typical fixed bearing.

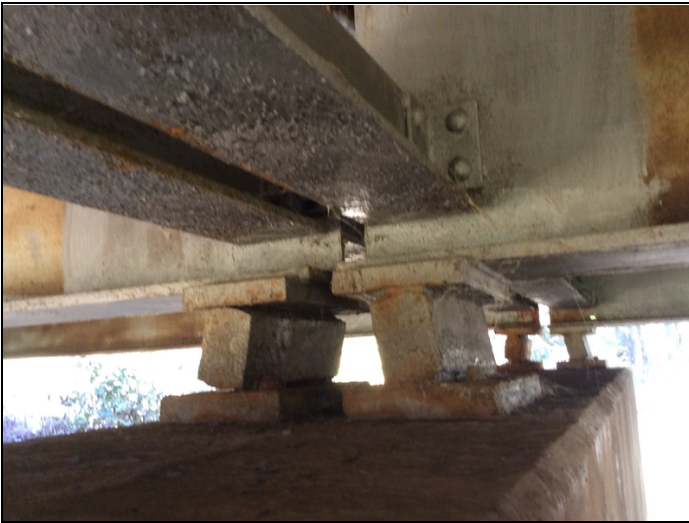
Typical movable bearings.

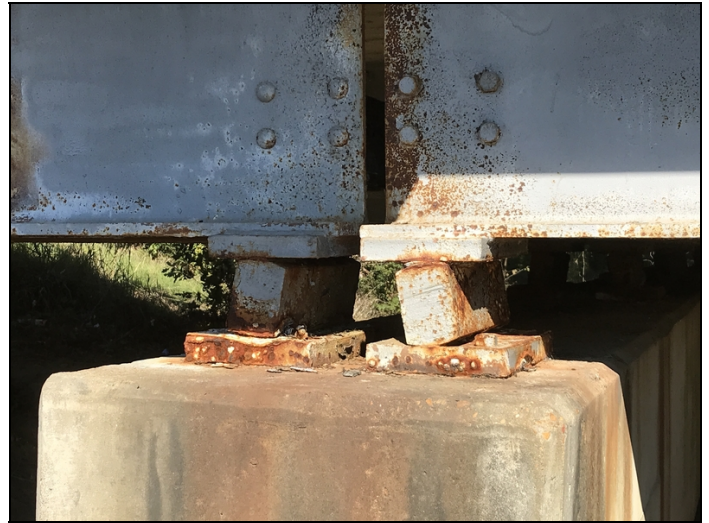
Typical movable bearing

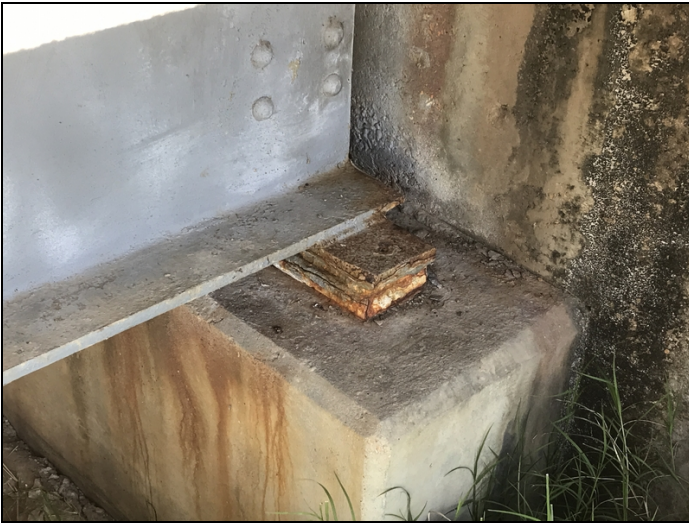
Typical fixed abutment bearing with broken anchor bolt

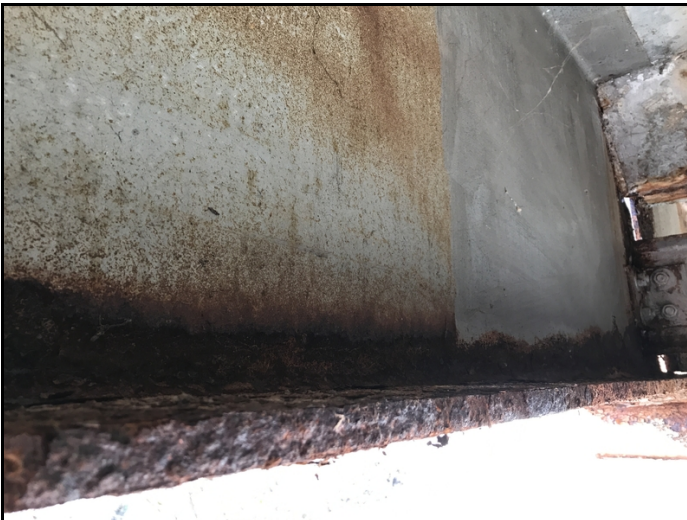
Span #2 bent #2 girder #4 has a 2" long hole at haunch, with up to 50% section loss around diaphragm area in web, and has 5' long area of corrosion with laminations and section loss up to 65% in web near bottom flange at end of girder.

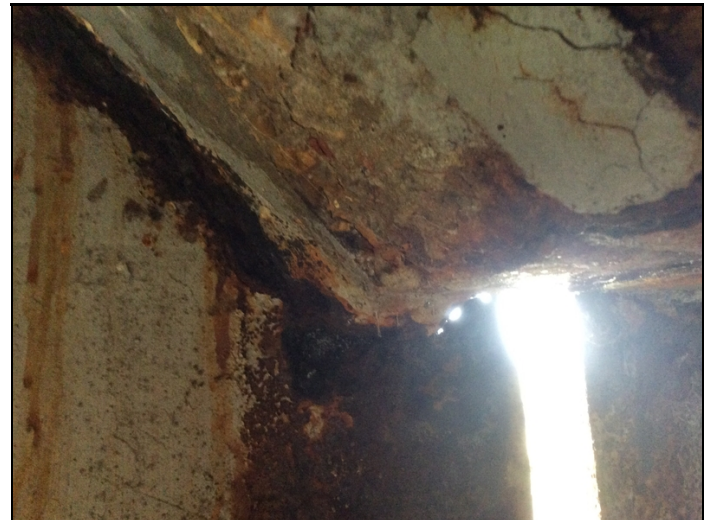
Bent 2 span 2 girder 4 has a 2" long hole at haunch.

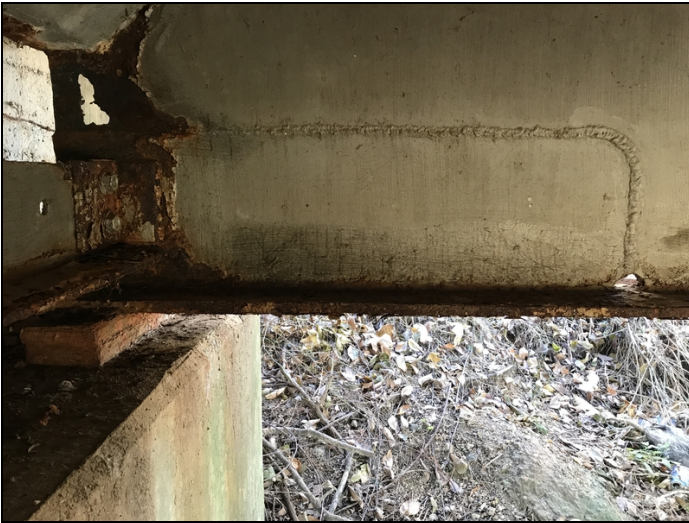
Span #1 girder #1 at bent #1 has a one and a half foot tall by three foot long t-splice at girder end. Area above T-splice has 3" hole in web.

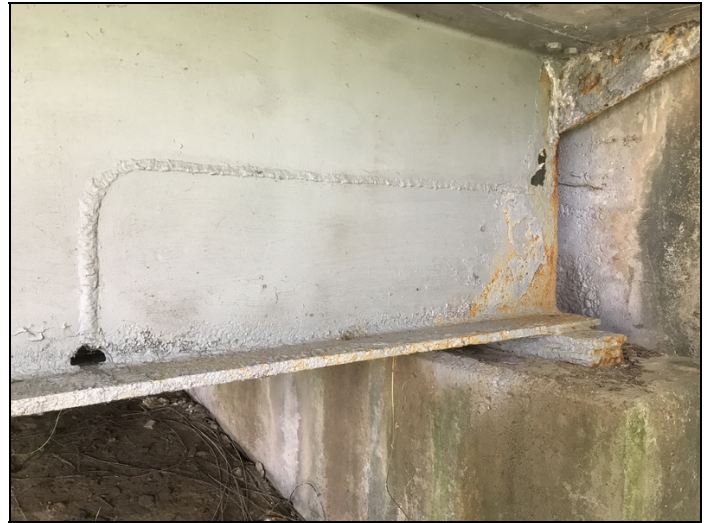
Span #1 girder #1 at bent #1 has a one and a half foot tall by three foot long t-splice at girder end. With area in web above the T-splice has a three inch hole.

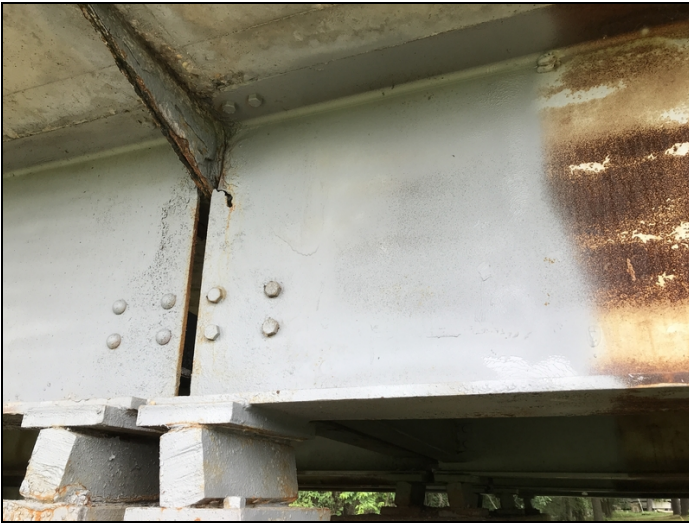
Span #2 bent #2 girder #4 has a two inch long hole at haunch, with up to 50% section loss around diaphragm area in web, and has a five foot long area of corrosion with laminations and section loss up to 65% in web near bottom flange at end of girder.

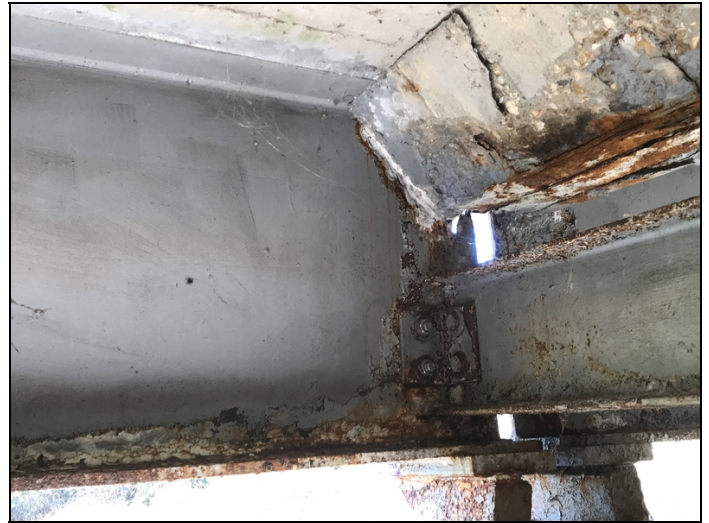
Span #2 bent #2 girder #4 hole in web at haunch

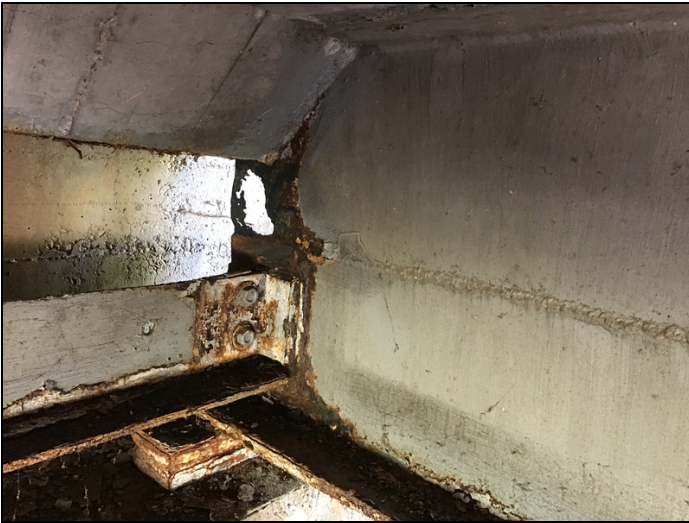
Abutment #1 girder #1, 3" x 6" hole in web at haunch

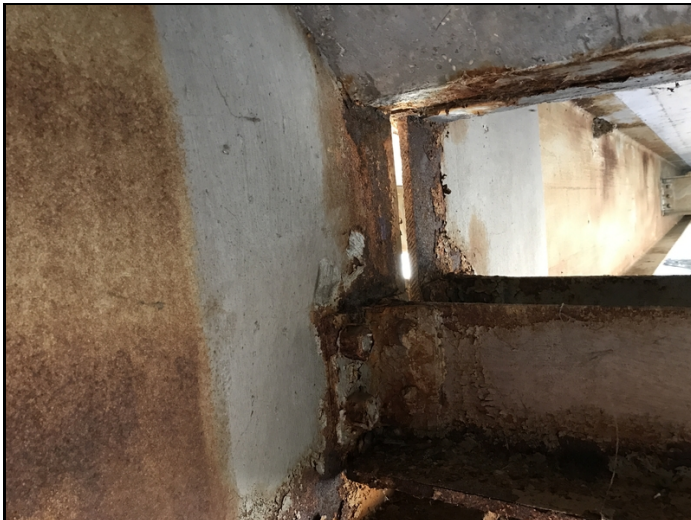
Bent #2 span #1,2 girder #2 ends.

All girders at bent #2 have areas of up to 50% section loss in the web at the haunches and diaphragm connections unless other wise noted.

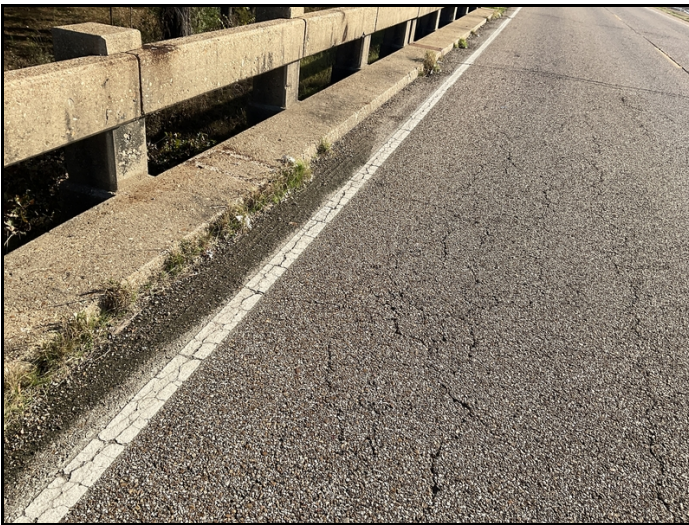
Dirt and vegetation in gutters

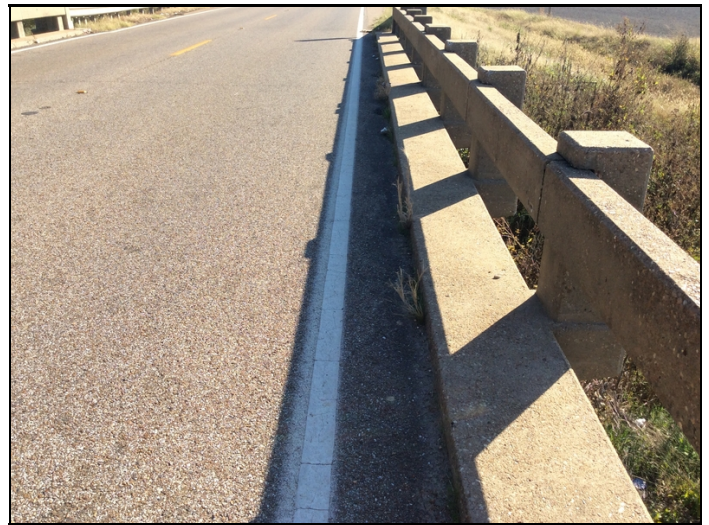
Gutters full of dirt and debris with vegetation growing in them with several drains blocked.

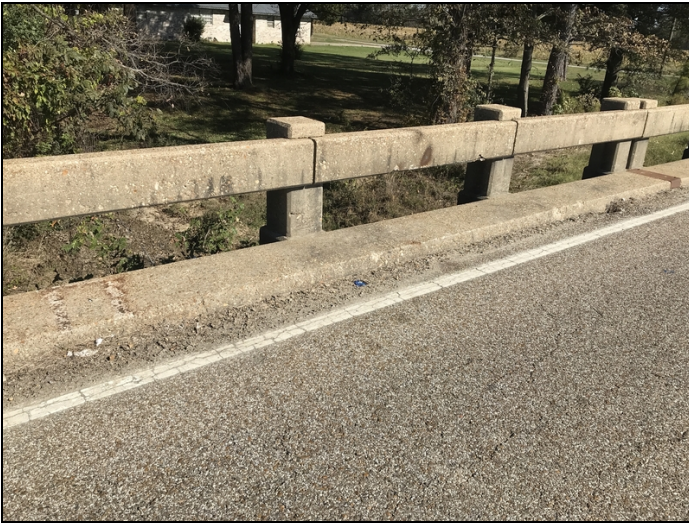
Dirt and debris in gutter

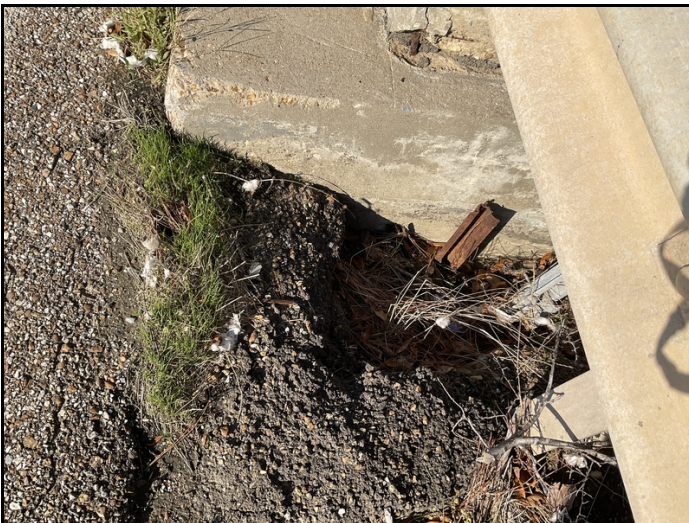
Abutment #2 left approach shoulder eroded

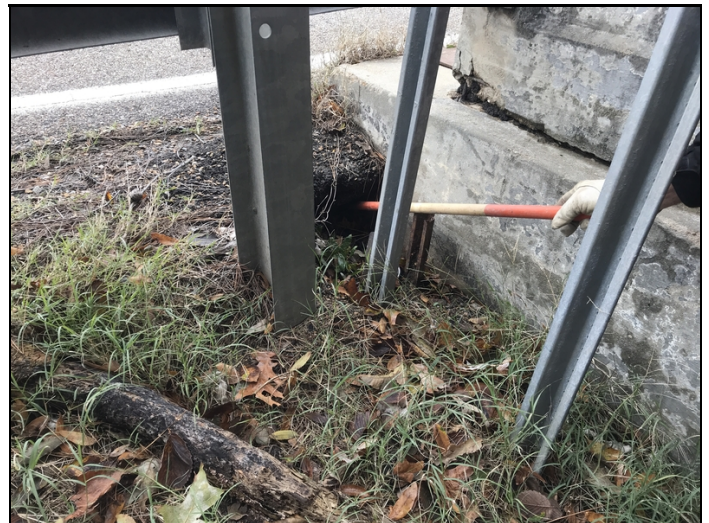
Erosion under approach roadway abutment #2 left side

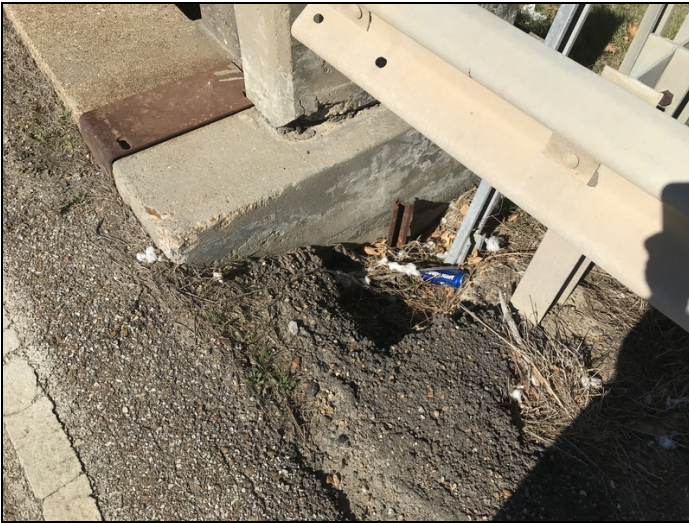
Erosion at abutment #2 left side

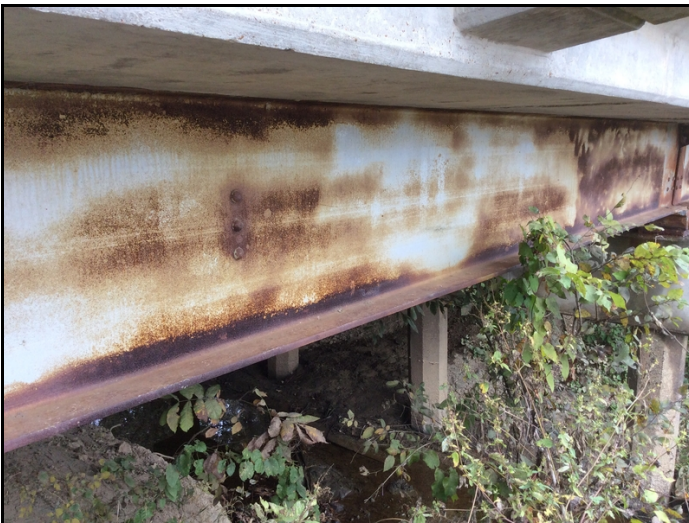
Paint is failing allowing girders to rust.

Typical paint condition

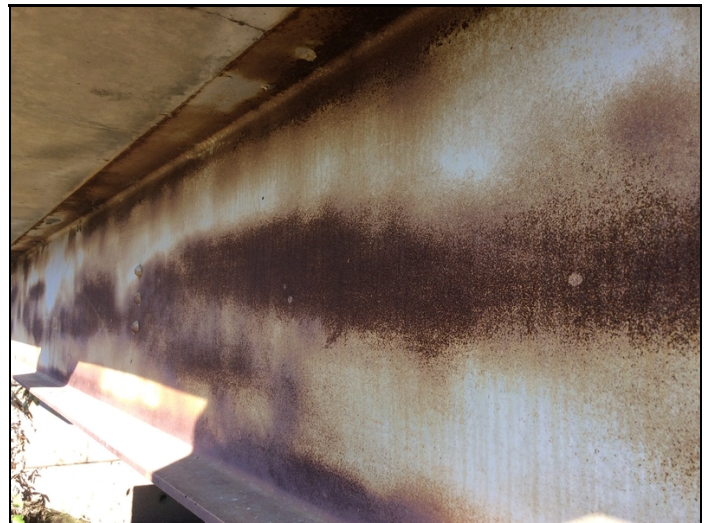
Typical paint on girders.

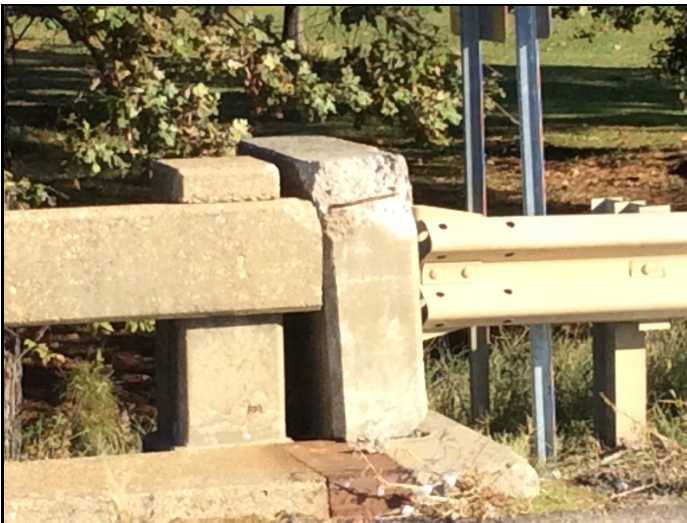
Abutment 2 left monument post.

Abutment #2 left monument post has collision damage with exposed rebar and is leaning back.

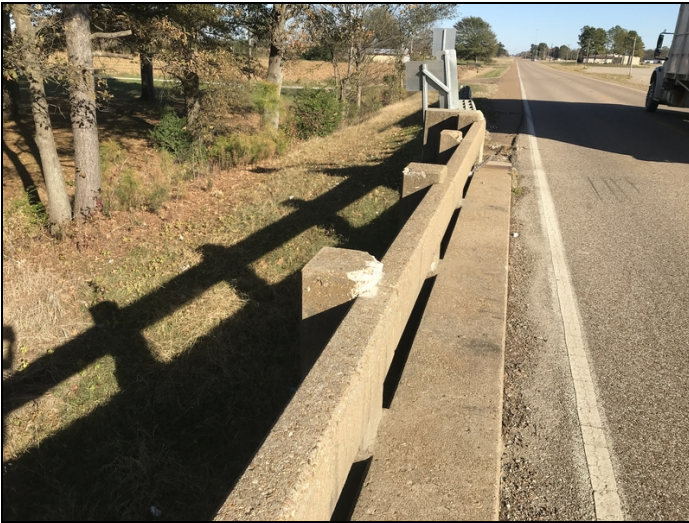
Span #3 left rail posts #2,3,4 all have collision damage on top with spalls posts #4 with rebar exposed.

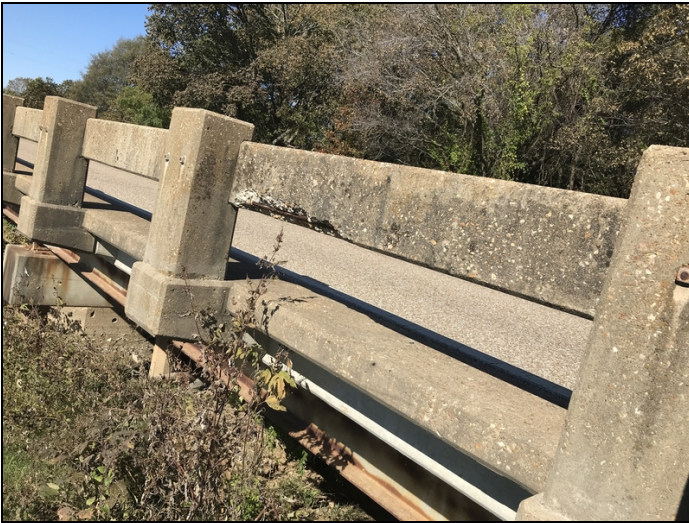
Span #2 right rail spalled

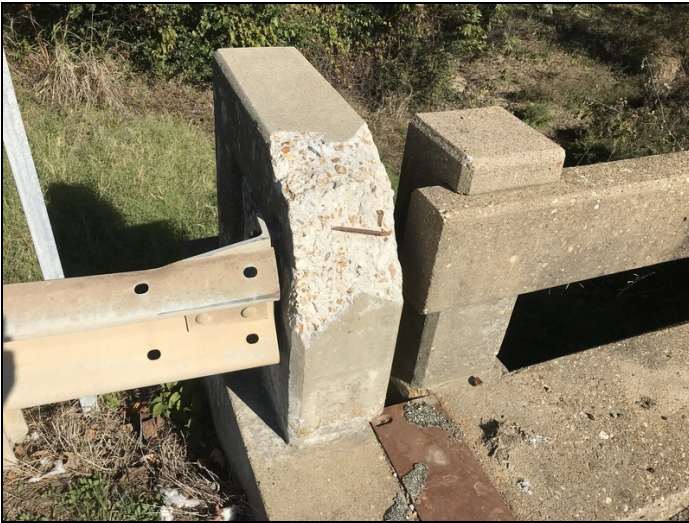
Abutment #1 left monument post spalled with exposed rebar no section loss

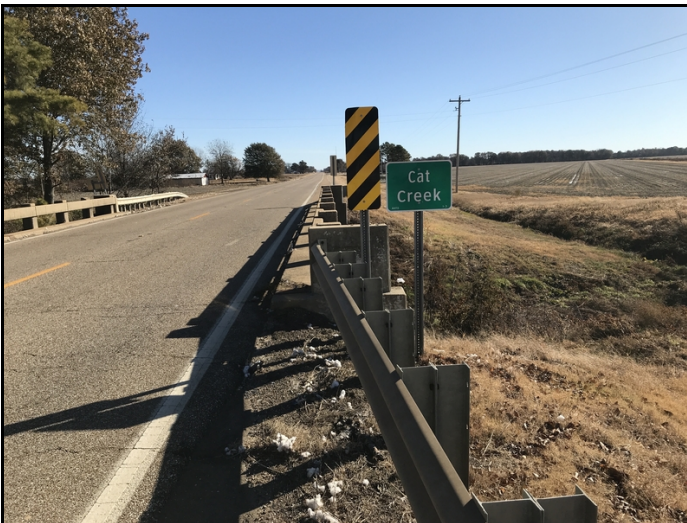
Abutment #1,2 does not have route, section, log mile sign.

Abutment #1,2 does not have route, section, log mile sign. Should read Highway 79, Section 15, Log mile 13.33.

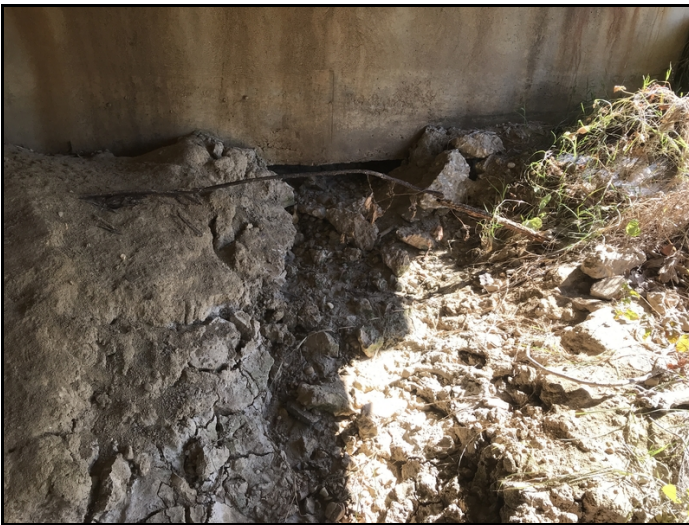
Abutment #2 cap right side has two foot long area undermined up to six inches, due to roadway runoff.

Abutment #2 erosion, right side

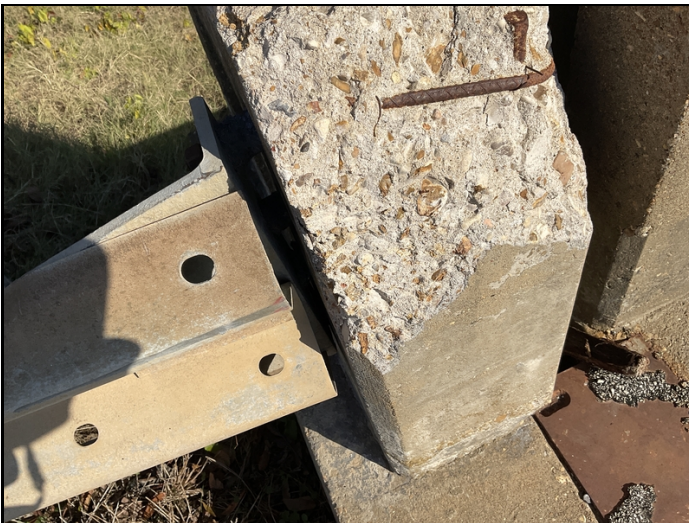
Abutment #1 left approach rail beginning to separate from monument post

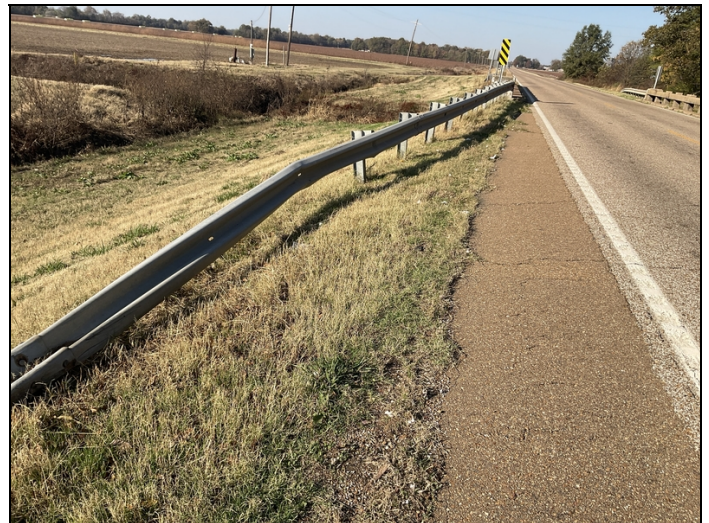
Abutment #2 right approach rail has collision damage fifteen feet from end.

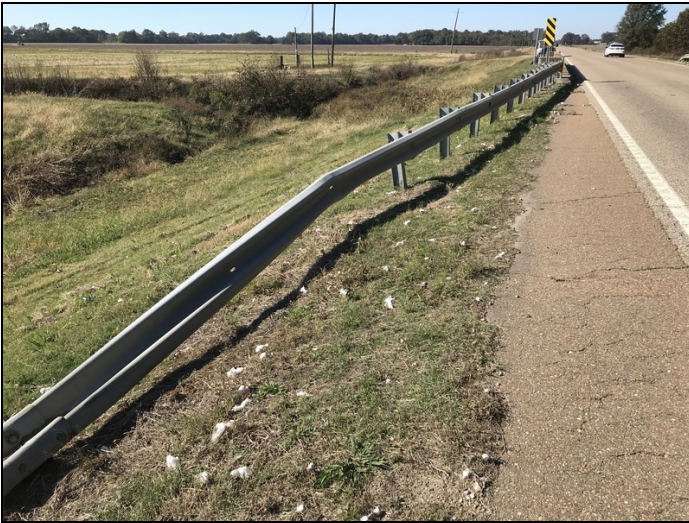
Abutment #2 right approach rail has collision damage
fifteen feet from end

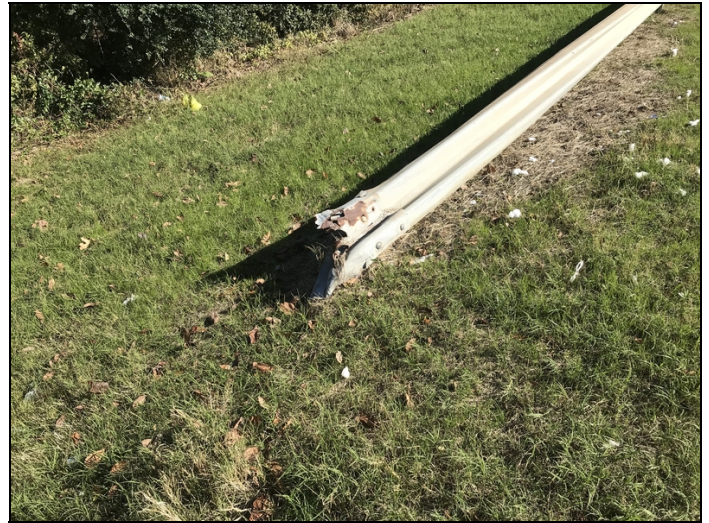
Abutment #1 left approach rail end has damage.

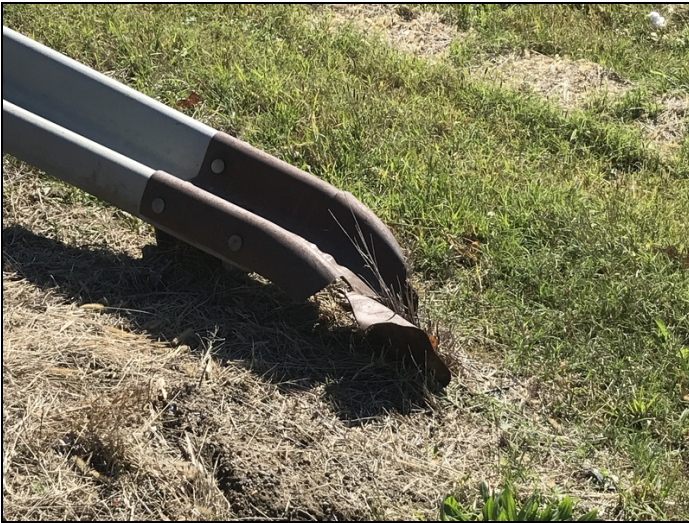
Abutment #1 right approach rail end has damage.

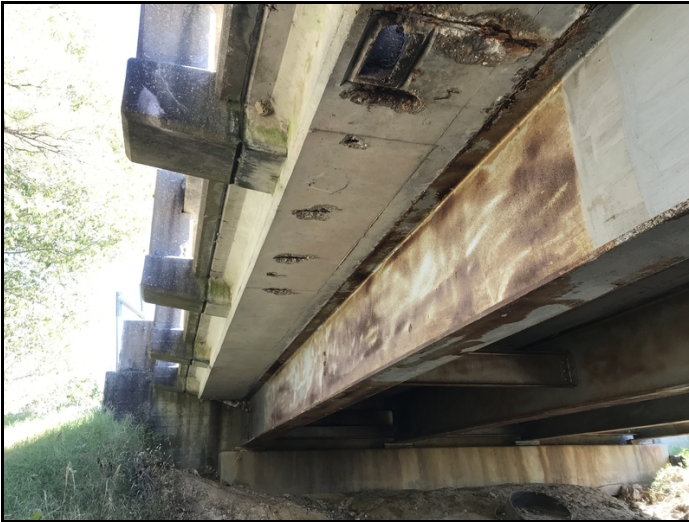
Soffit overhangs have several small spalls with exposed rebar with minor section loss.

Spalls in soffit overhang with exposed rebar
