Asset #02900(Routine, Underwater type 2)
Us79/Sec-16/L-3.35 over St.francis Div. Channel

Location: 3.4 Mi North Of Marianna

Team Lead: Myron Futrell, Inspection Date: 09/02/2021

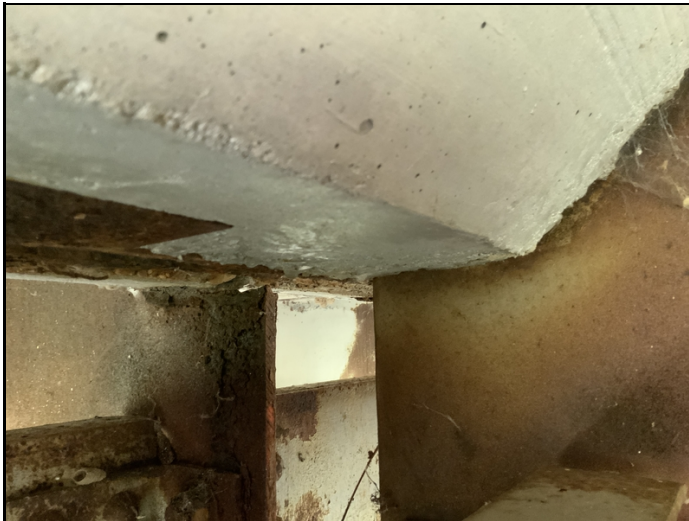
Span #16 bent #16 girder #3 has one inch hole with a one inch crack extending out of it at haunch.

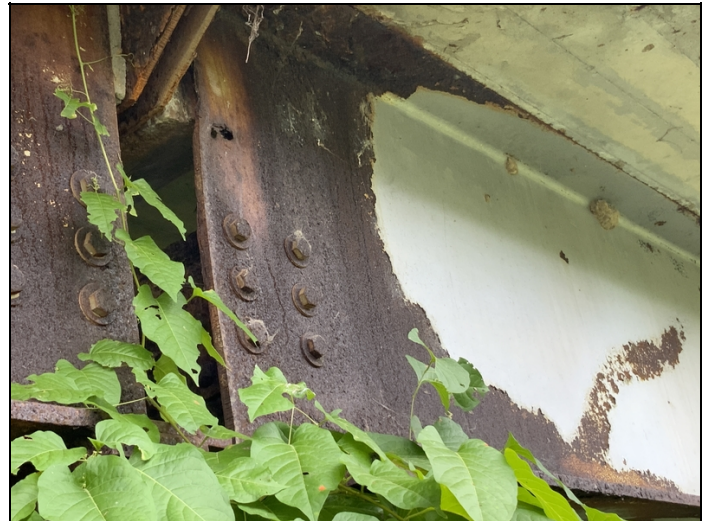
Span #16 bent #16 girder #4 has a two inch hole in web and web bowing outward at haunch.

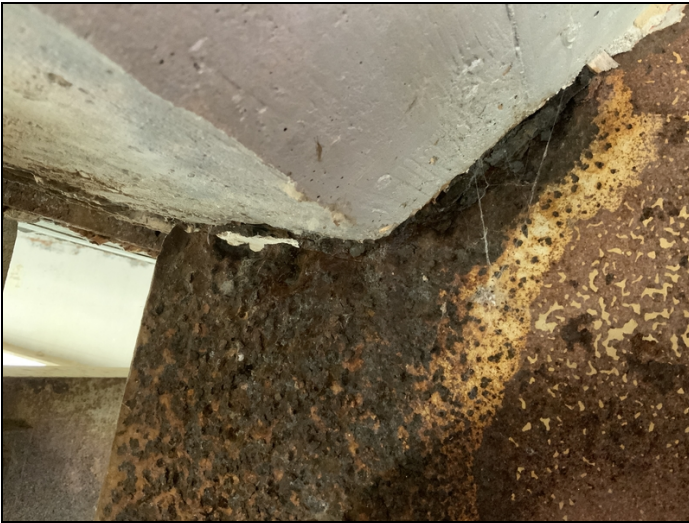
Span #15 bent #15 girder #3 has a three inch long hole with a one and a half inch crack extending out of it at haunch.

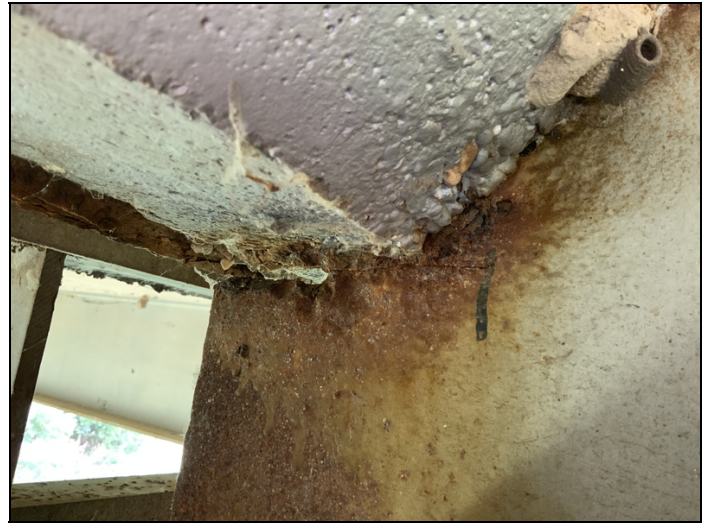
Span #13 bent #13 girder #3 at haunch has a two inch hole with a three inch crack extending out of it.

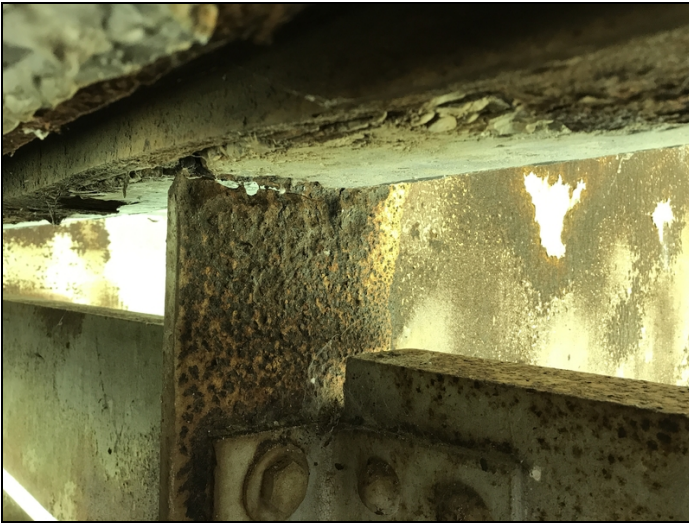
Span #15 bent #15 girder #3 has a three inch long hole with a one and a half inch crack extending out of it at haunch.

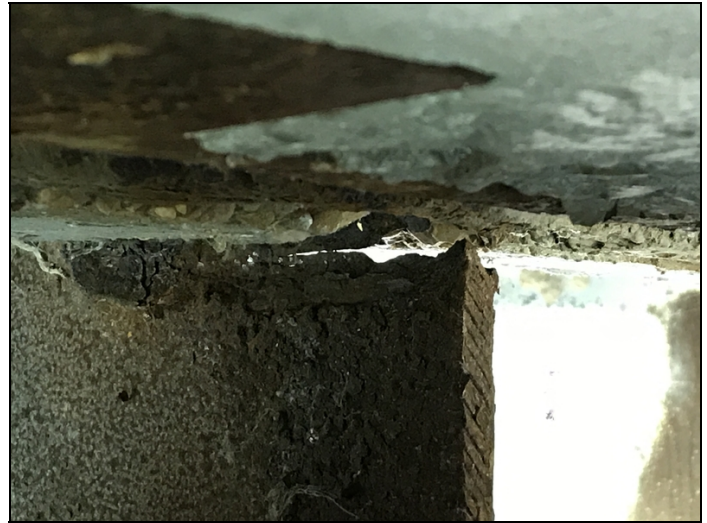
Span #16 bent #16 girder #3 has one inch hole with a one inch crack extending out of it at haunch.

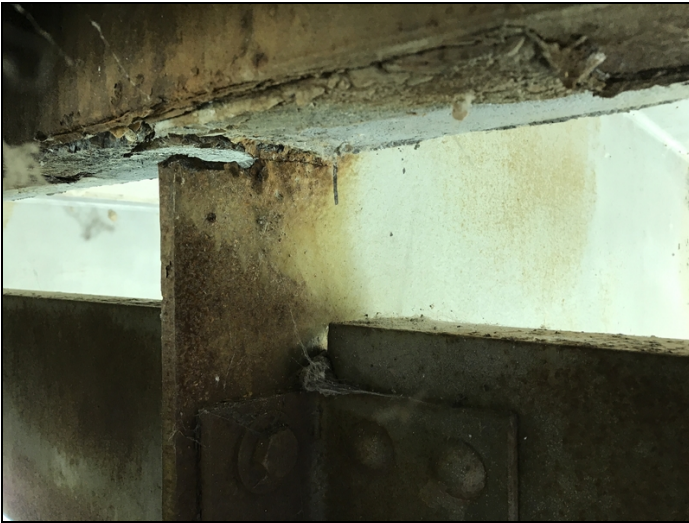
Span #13 bent #13 girder #3 at haunch has a two inch hole with a three inch crack.

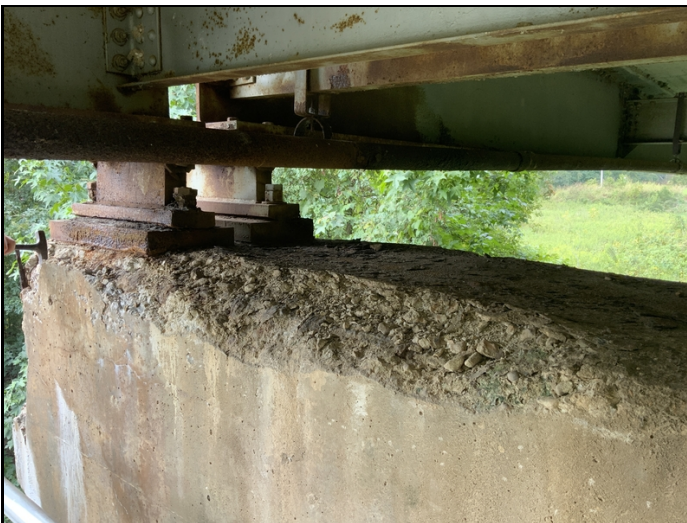
Bent #7 cap ahead face spalled at top for six feet under girder #4, with two foot delamination under girder #4.

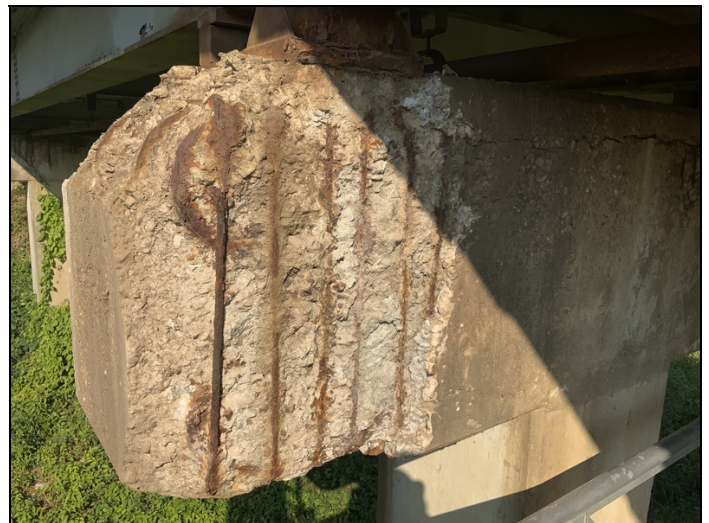
Bent #3 cap front face right corner has 2'long full height spall with exposed rebar with 20% section loss extending to the edge of span #3 girder #4 bearing.

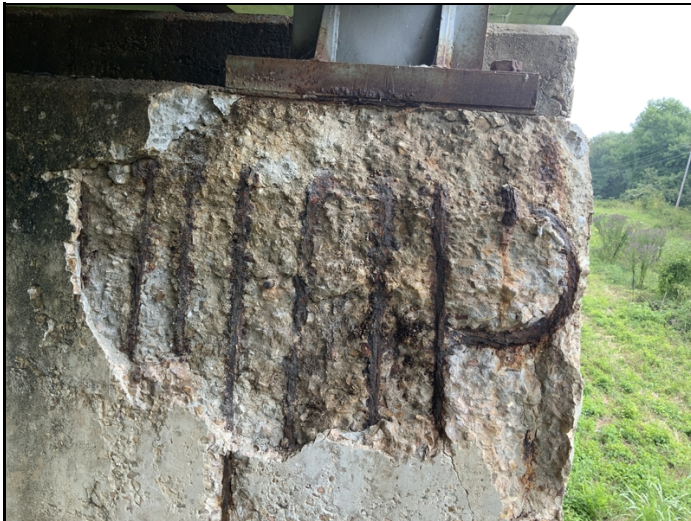
Bent #12 cap back face right side under girder #4 bearing has three foot spall with exposed rebar with 25% section loss.

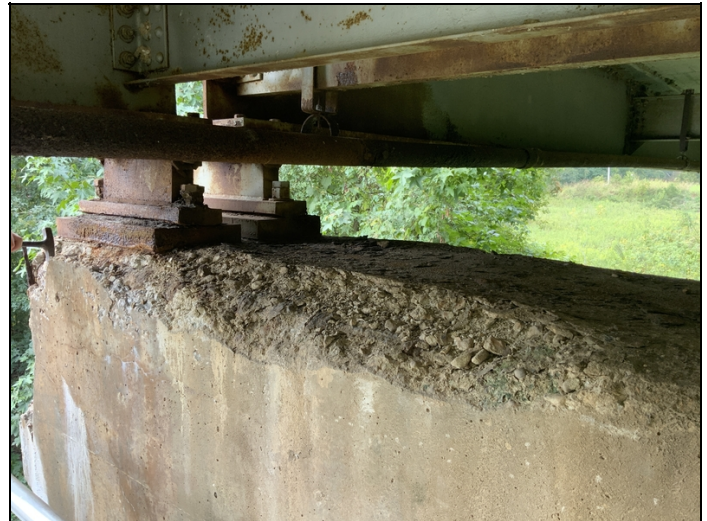
Bent #7 cap ahead face spalled at top for six feet under girder #4, with two foot delamination under girder #4.

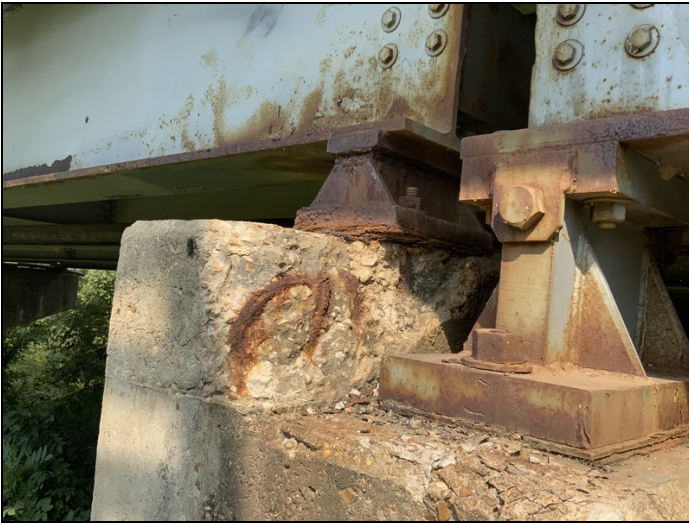
Span #5 bent #6 girder # 4 spalled under bearing with exposed rebar with 50% section loss.

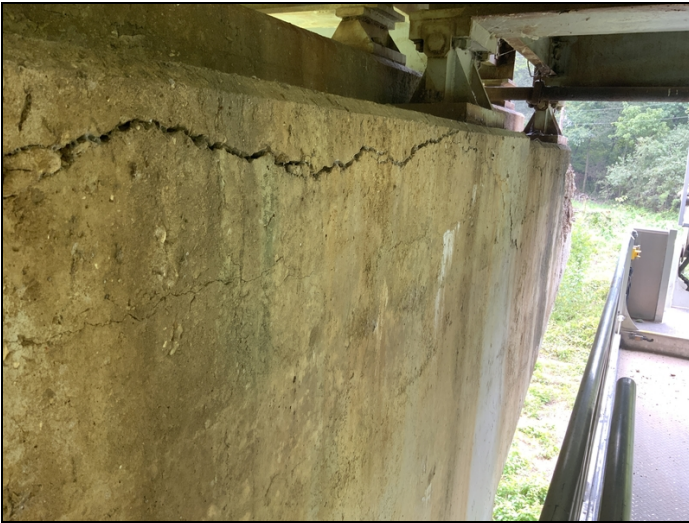
Cracking bent #12 cap back face.

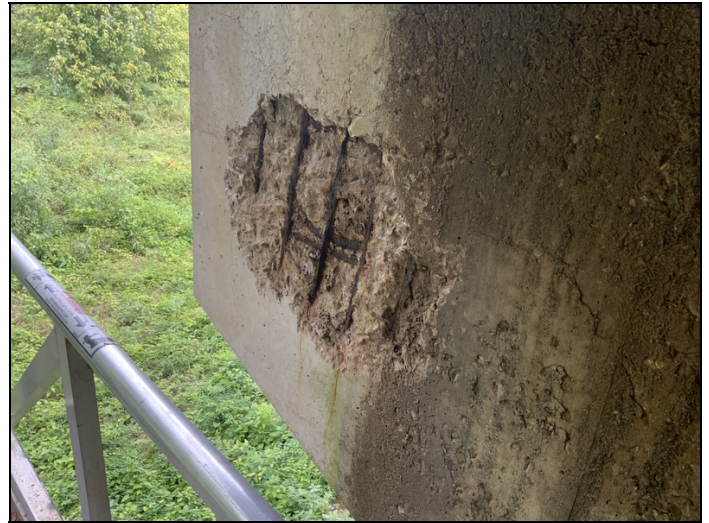
Bent #12 cap back face left side under girder #1 has two foot spall with exposed rebar with 25% section loss.

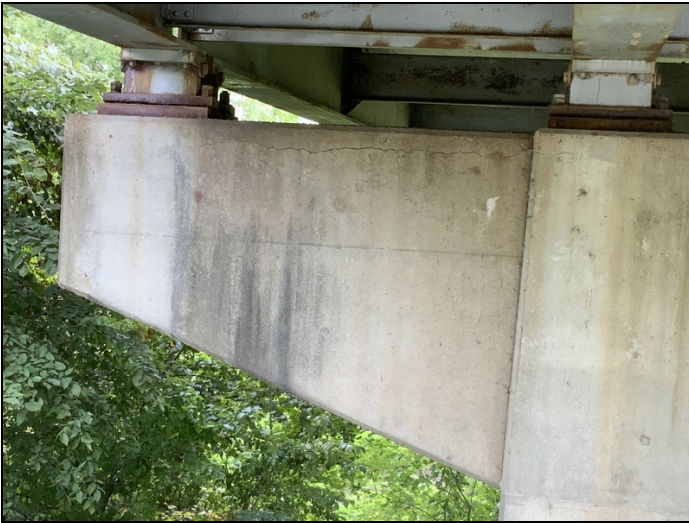
Bent #11 cap back face left side cracked horizontally.

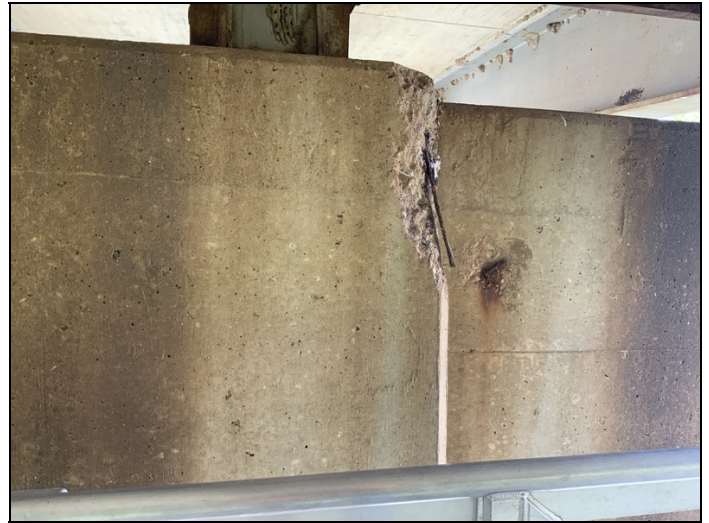
Bent #10 cap front face under girder #2 has a 1' spall with exposed rebar with 40% section loss.

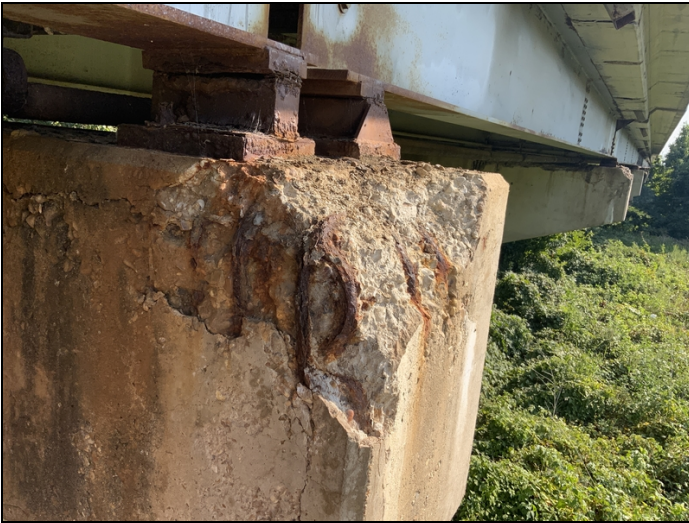
Bent #4 cap right end top right corner, back face spalled with exposed rebar with 25% section loss.

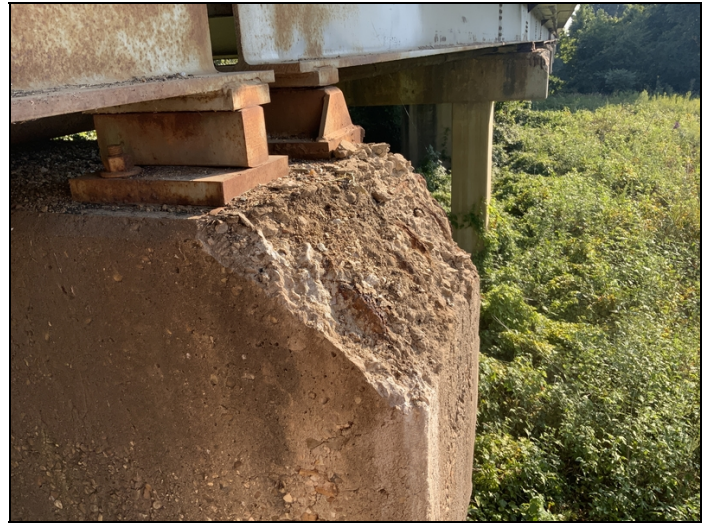
Bent #3 cap right end spalled at top with exposed rebar
with 20% section loss.

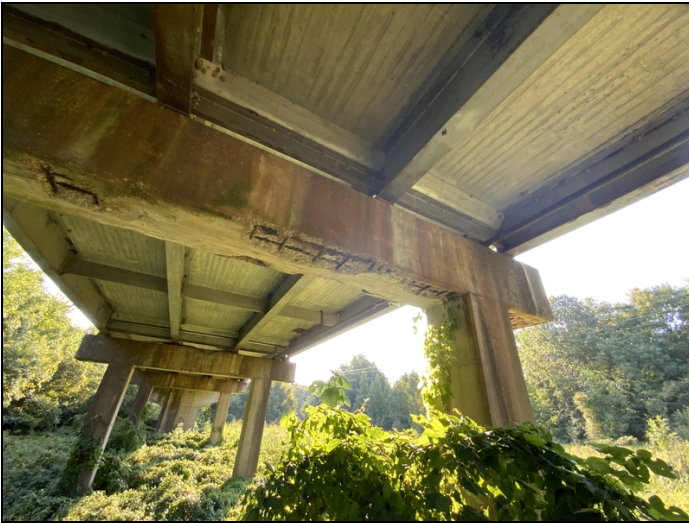
Bent #2 cap bottom face has 3' of delaminations one 2' spall, a 1' x 4' spall, a 1' x 2' spall, a 1', a 3' long spall and a 2' x 2' spall with exposed rebar with 20% section loss.

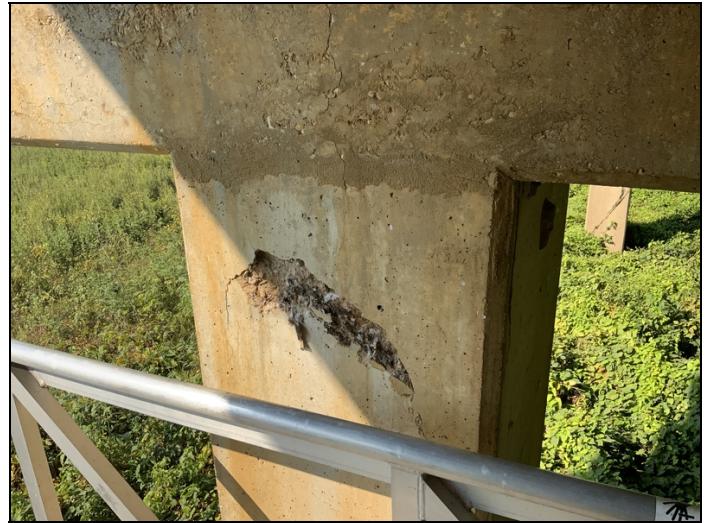
Bent #4 right column left and right sides have vertical cracks, ahead face has two foot delamination and spall with no exposed rebar.

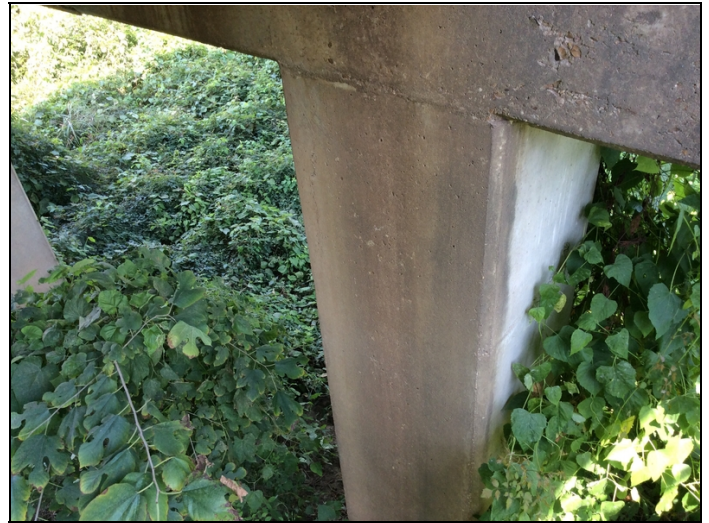
Bent 2 back face right column cracked.

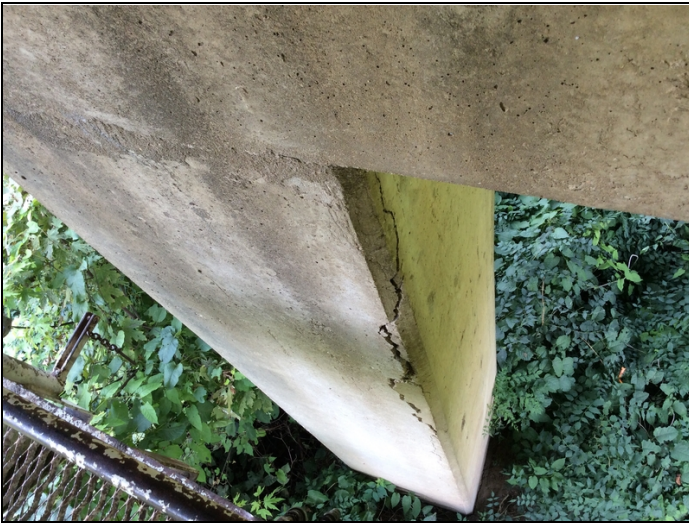
Bent 14 left column cracked.

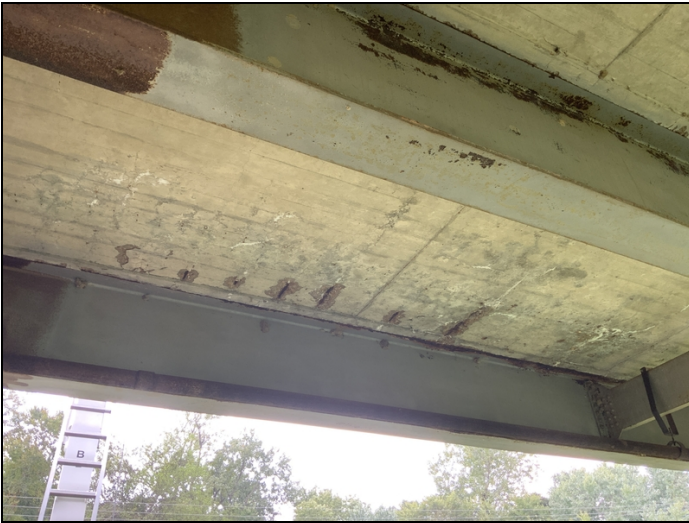
Span #13 soffit bay #3 has five 1' spalls with exposed rebar with 5% section loss.

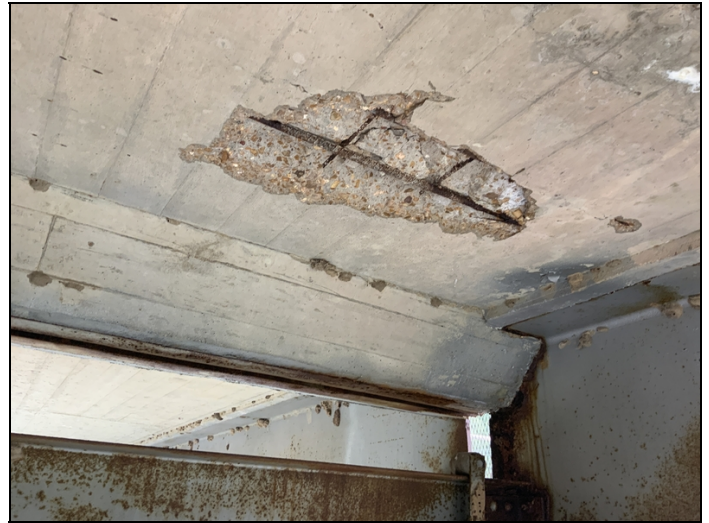
Span #8 soffit spall with exposed rebar near bent #9.

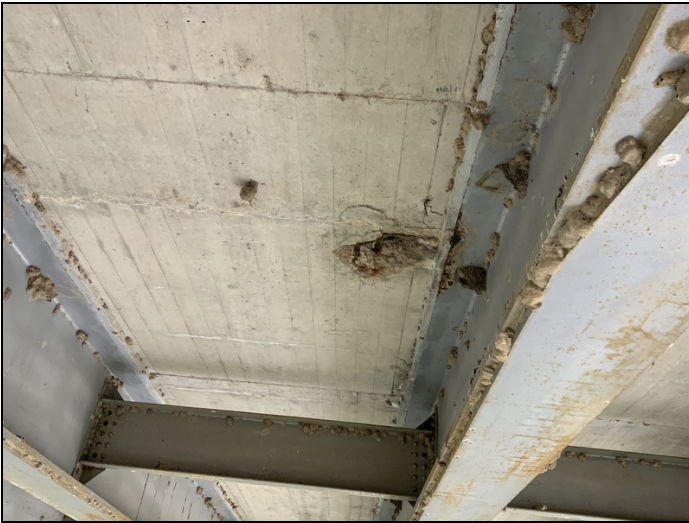
Span #8 soffit spall in bay #2.

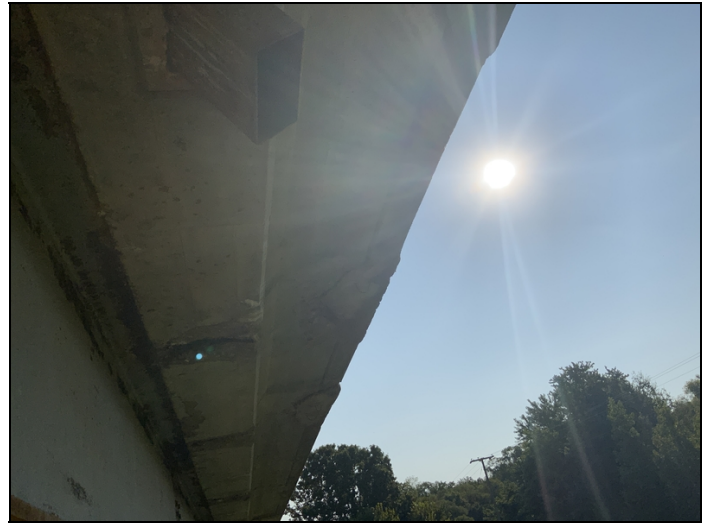
Span #1 right soffit overhang has four one foot spalls with exposed rebar with 20% section loss and four repaired areas at rail posts.

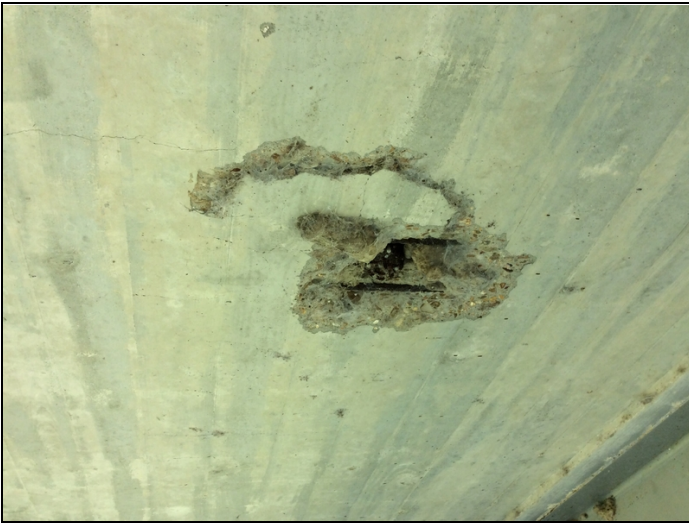
Span 3 bay 1 spall in soffit.

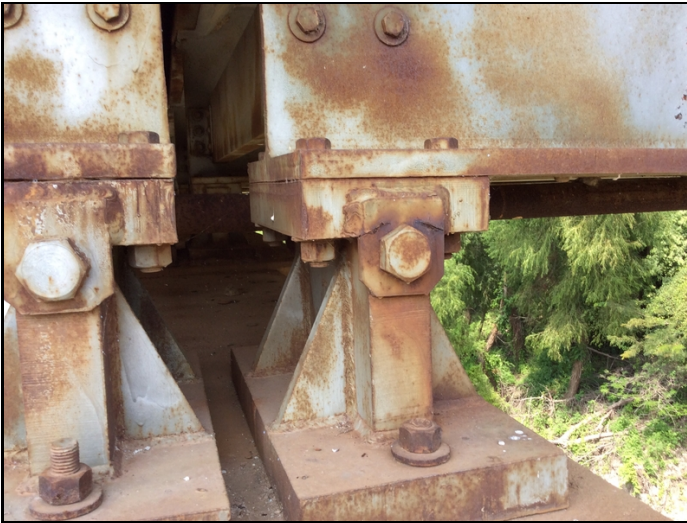
Bent 10 girder 4 right side tab for bolt from girder to bearing cracked.

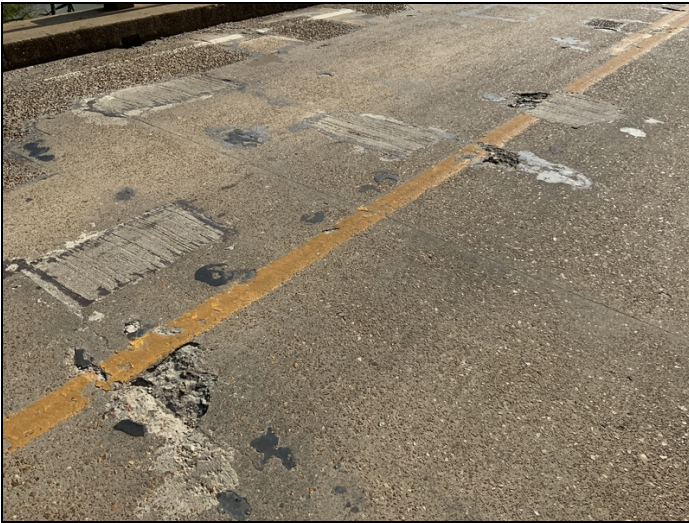
Span #10 spalls at center line.

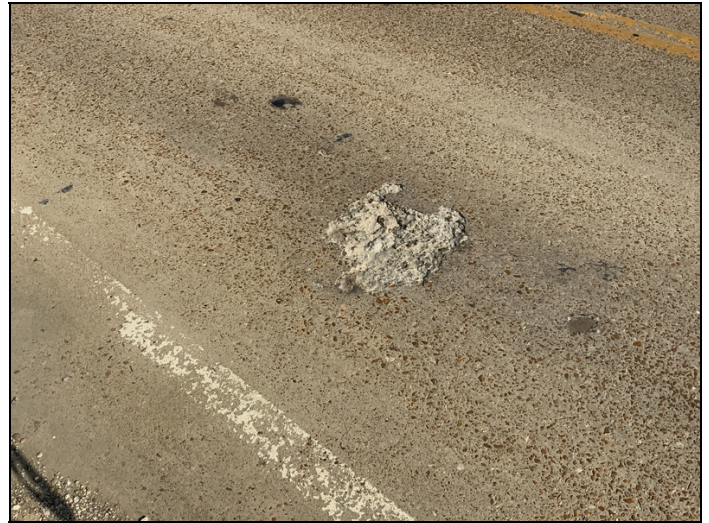
Span #10 left lane spall.

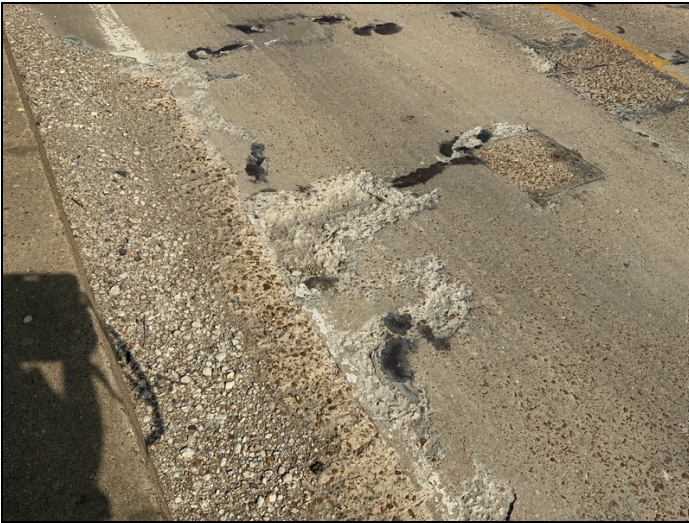
Span #9 left lane 3' x 2' spall with exposed rebar.

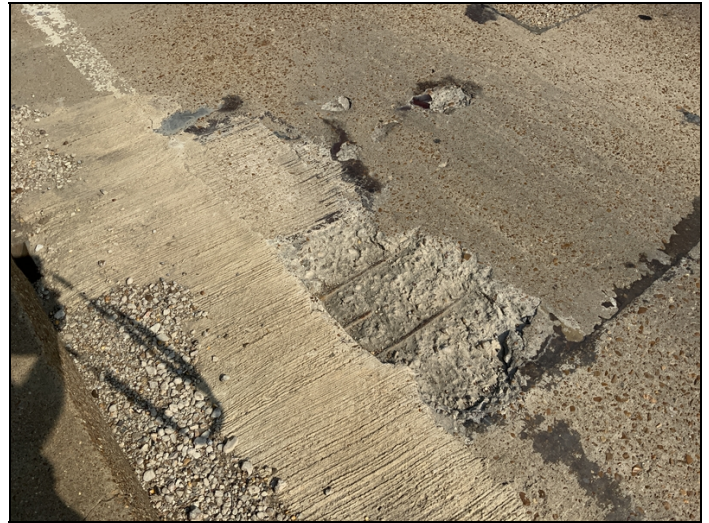
Span #9 left lane 2' x 3' spall with exposed rebar.

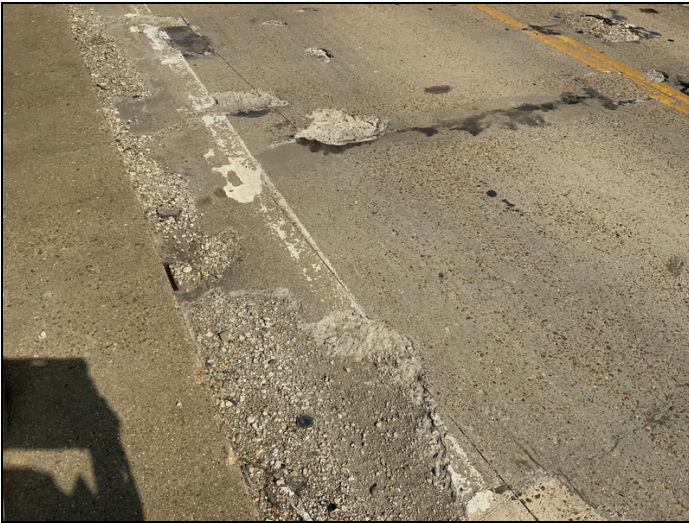
Span #6 left lane spalls with exposed rebar.

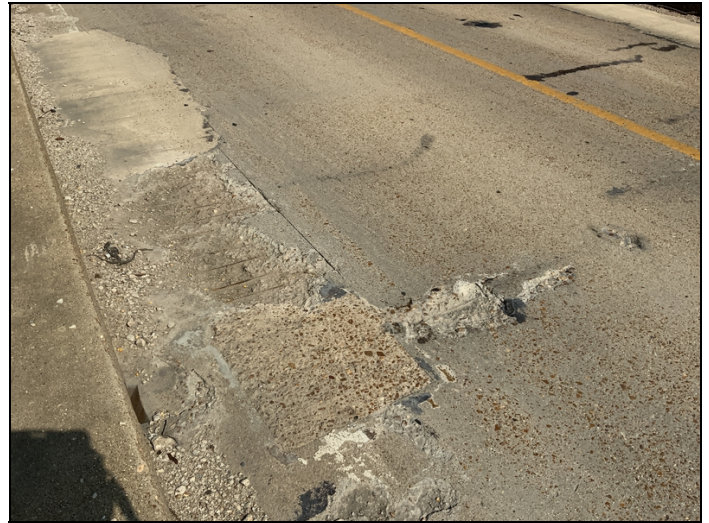
Span #6 left lane spalls with exposed rebar.

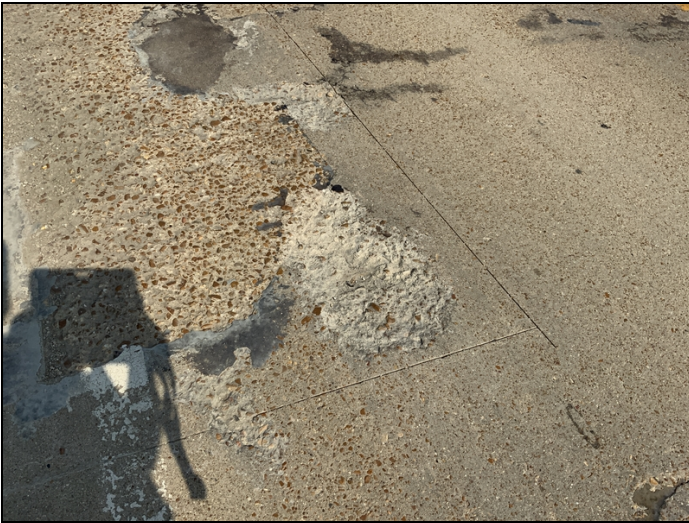
Span #6 left lane 1' x 3' spall.

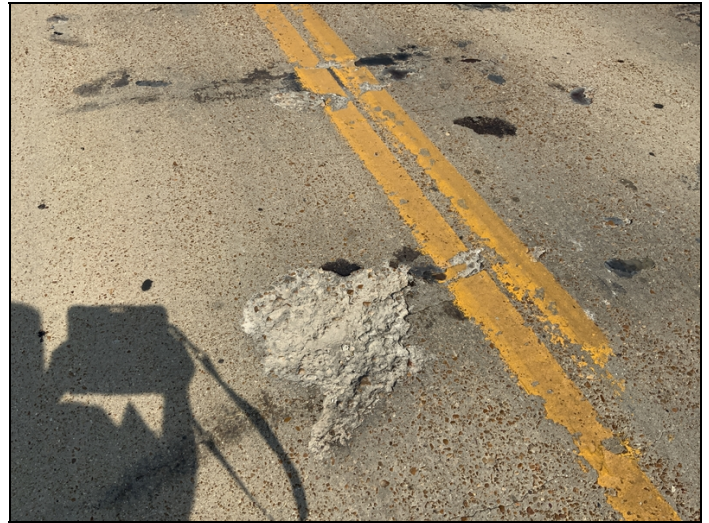
Span #6 left lane spalls at center line.

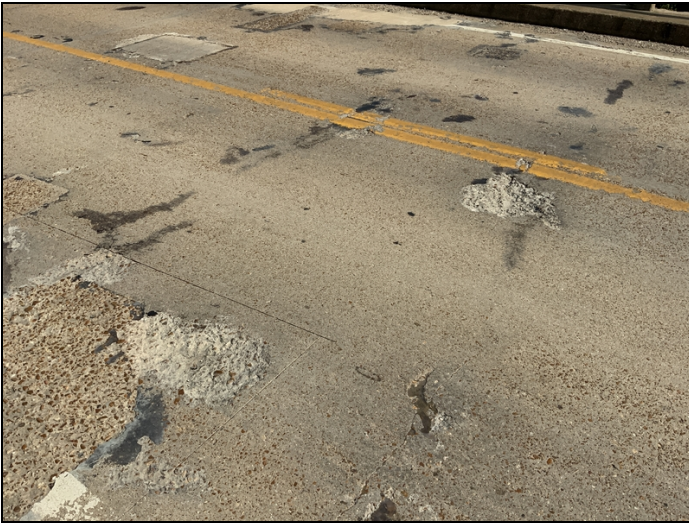
Span #6 left lane two 2 ' spalls one with exposed rebar.

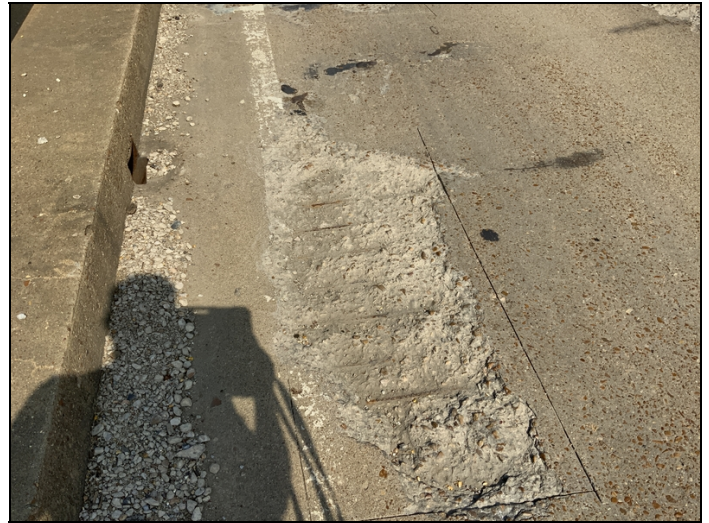
Span #6 left lane 2' x 5' spall with exposed rebar.

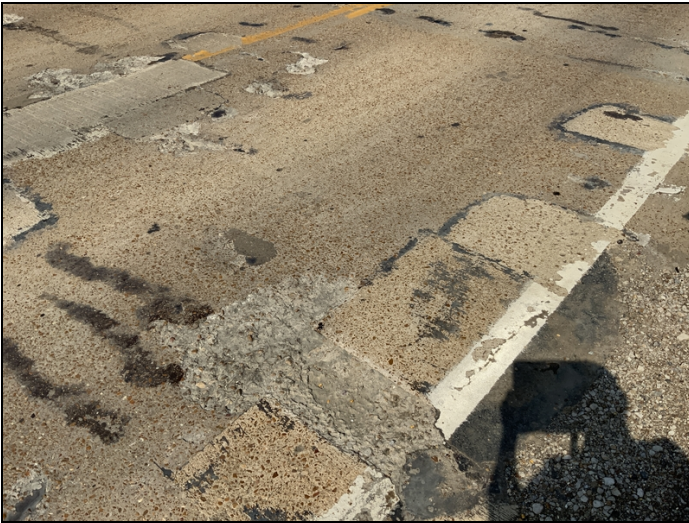
Span #5 right lane spalls

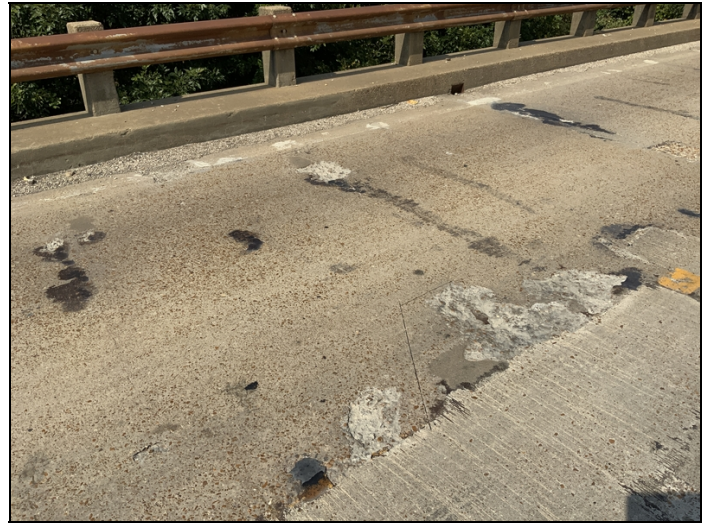
Span #5 left lane spalls.

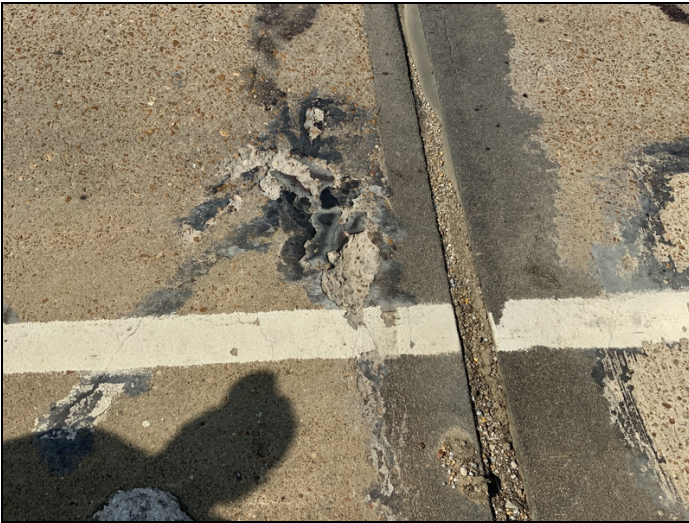
Span #4 right lane at bent #5 small spall

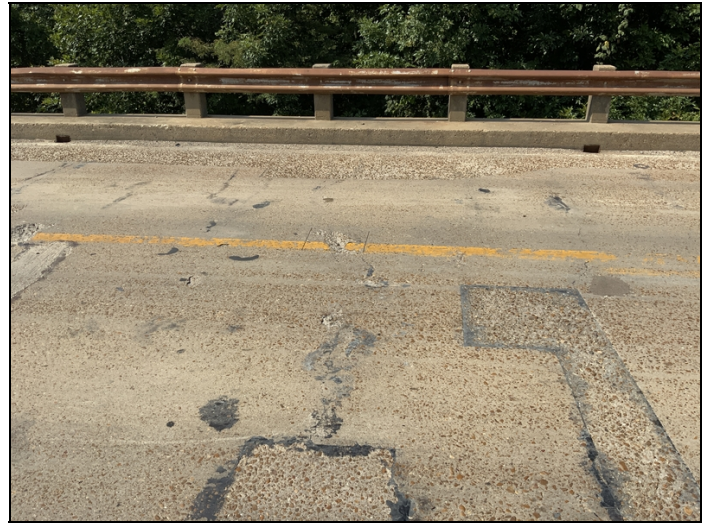
Span #3 center line 1' spall.

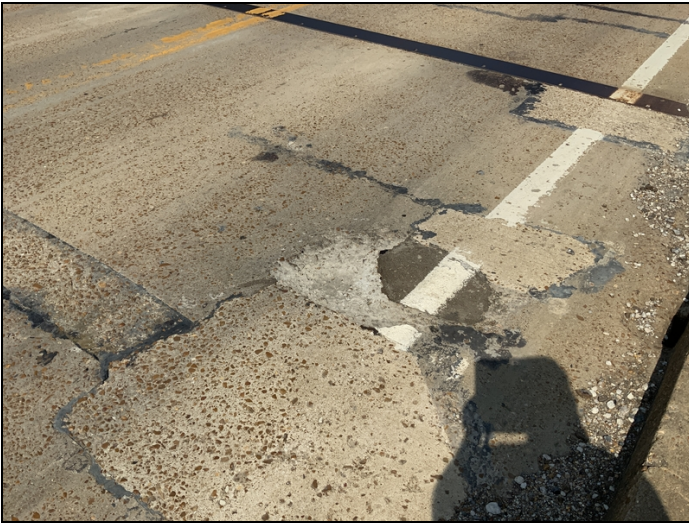
Span #3 deck 2' spall right lane.

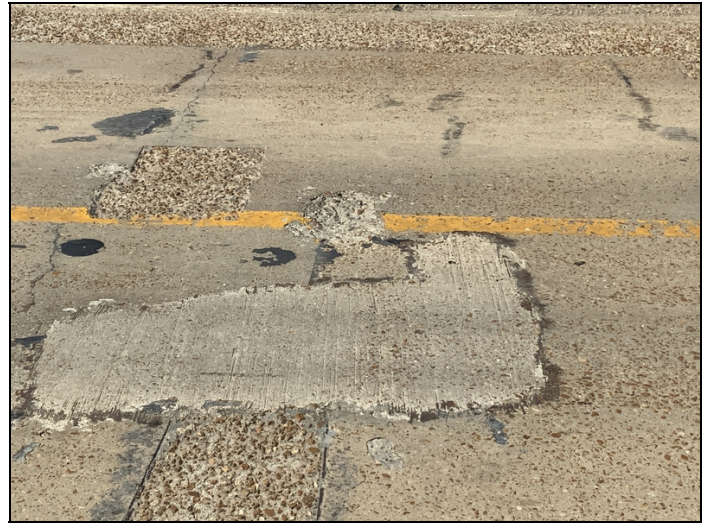
Span #3 1' x 2' spall at center line.

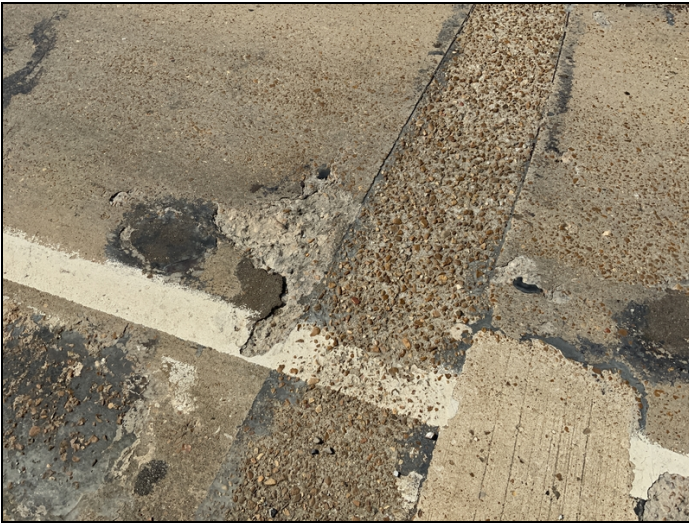
Span #3 2' spall right lane.

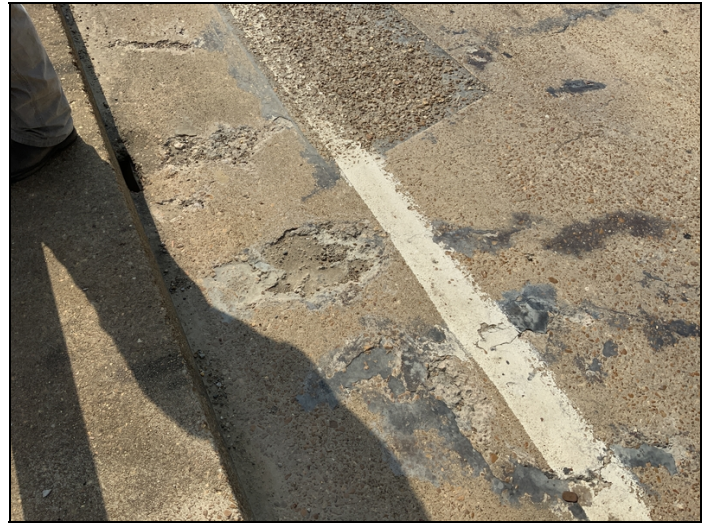
Spalls in span #2 right gutter.

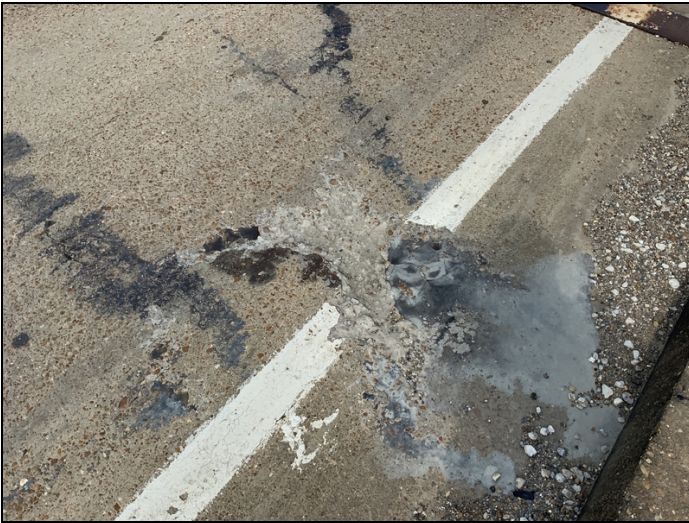
1' x 2' shallow spall right lane span #1.

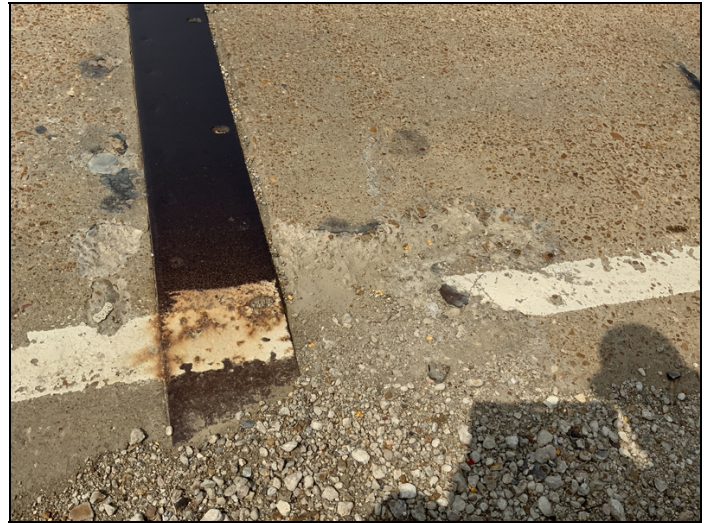
Span #13 bent #13 right lane has 2" x 2" shallow spall.

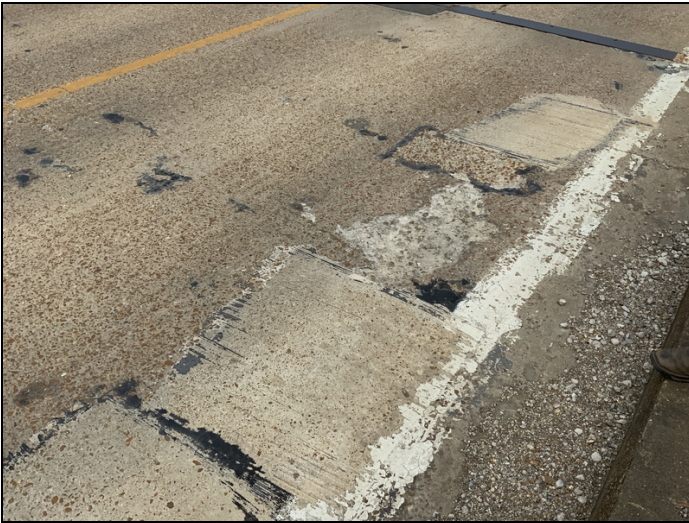
Span #13 2' x 3' shallow spall, right lane.

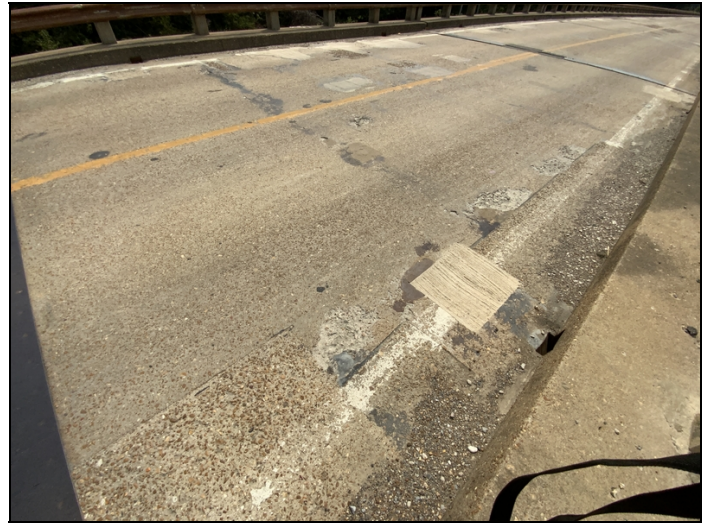
Shallow spalls in span #14 left lane.

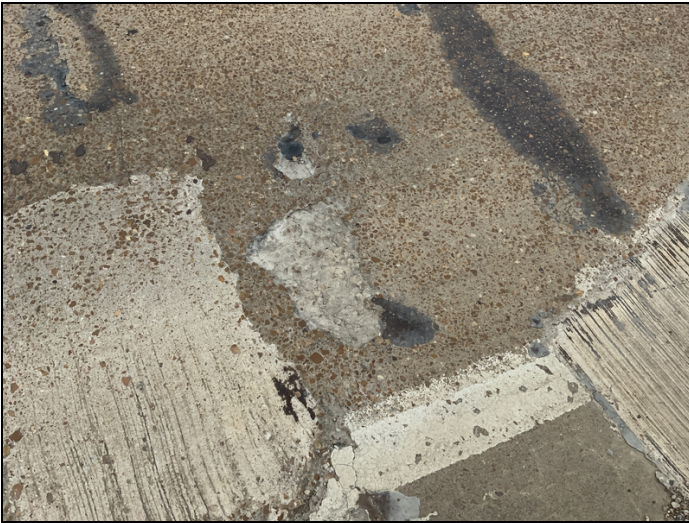
Span #16 right lane has 1' shallow spall with no exposed rebar.

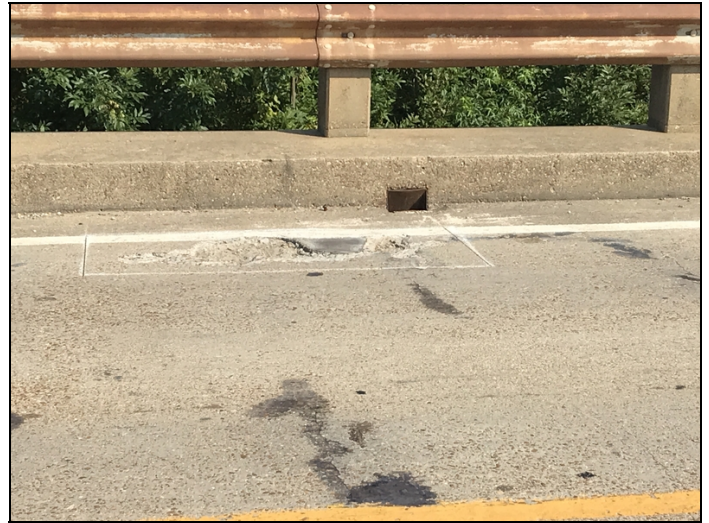
Deck span #6 left shoulder near bent #6 has a three foot spall with rebar exposed.

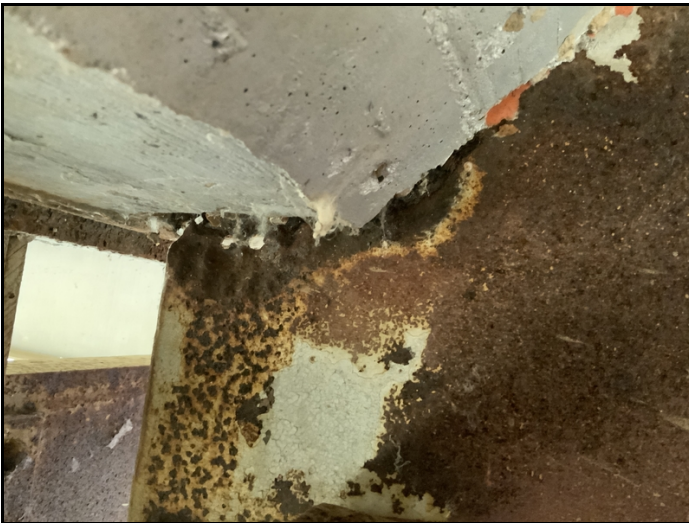
Span #15 bent #15 girder #2 has a one inch long hole at haunch.

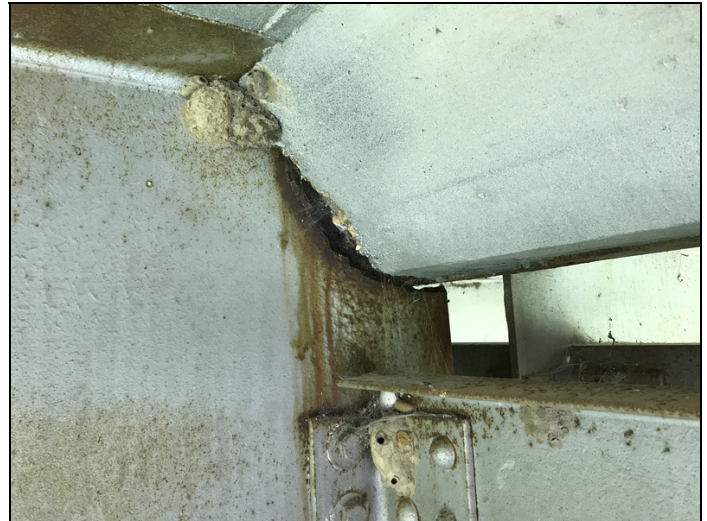
Span #2 girder #3 at bent #3 has a 2" hole corroded in web at haunch.

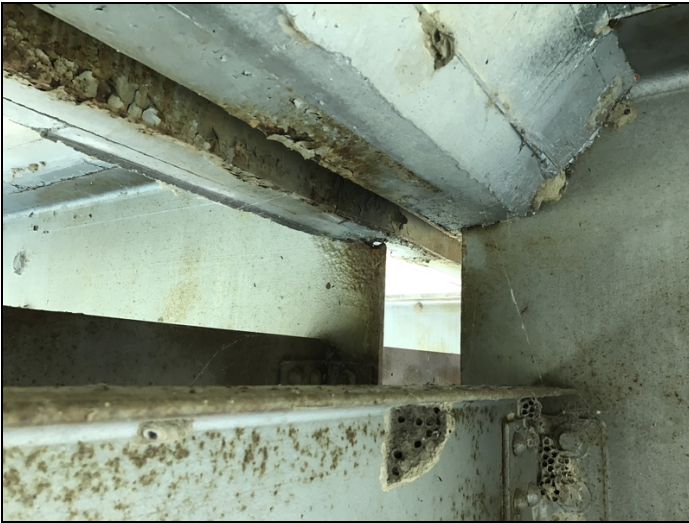
Span #12 girder #3 bent #12 one inch hole in web at haunch.

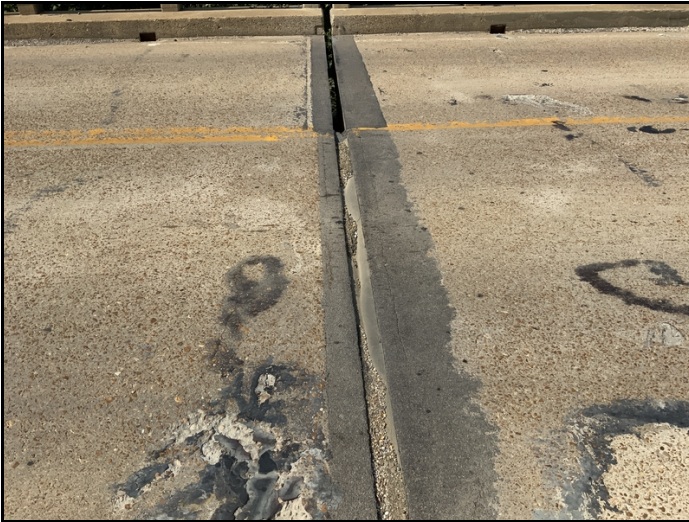
Bent #5 joint.

Bent #5 joint seal has failed.

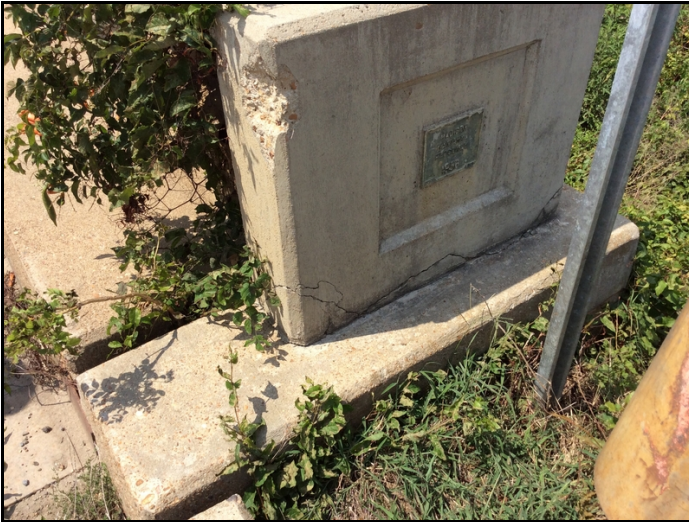
Abutment 2 left monument post.

Abutment #2 left monument post is cracked and broken at bottom.

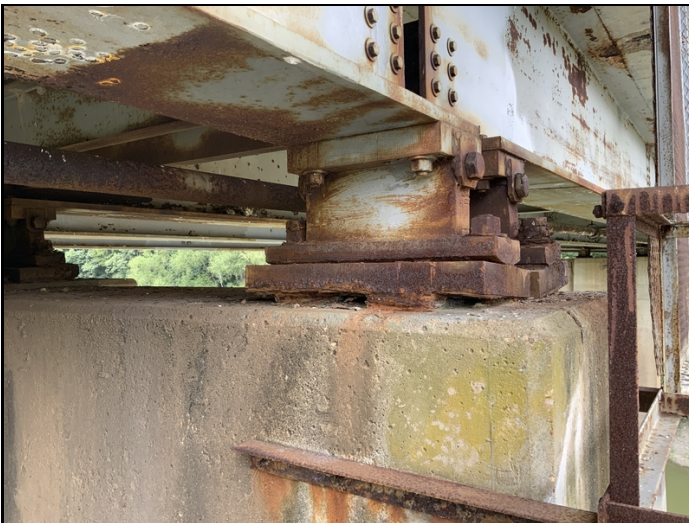
Bent #9 bearings .

Bent #9 span #9 bearing #1,2,3,4 are all shimmed with pack rust between cap and masonry plate.

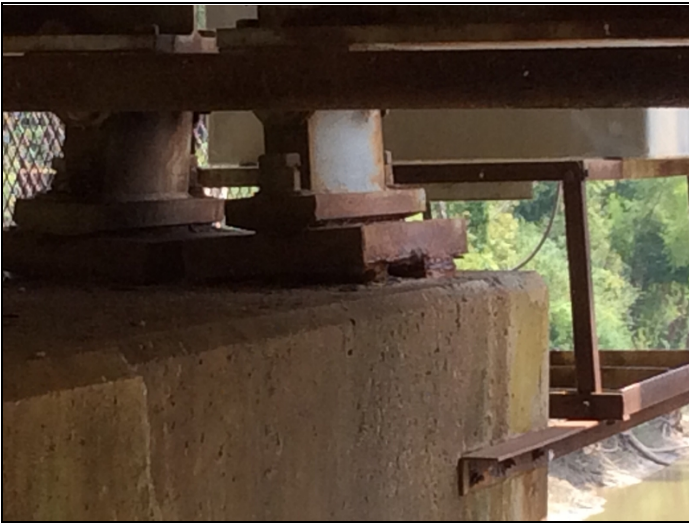
Bent 9 span 8 masonry plate shimmed by pack rust

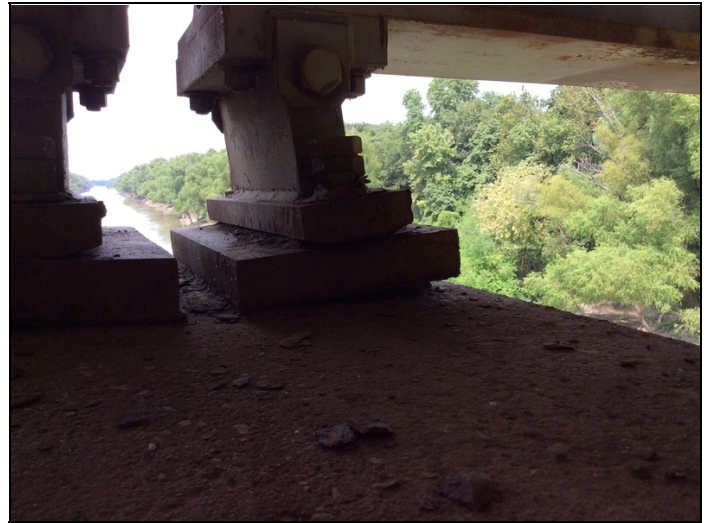
Bent 9 span 9 typical masonry plate shimmed up with pack rust.
