Asset #06829(Routine, Underwater type 2)

Us-79/Sec-13/L5.30 over Bayou Roc Roe

Team Lead: Drew Melton, Inspection Date: 09/12/2022

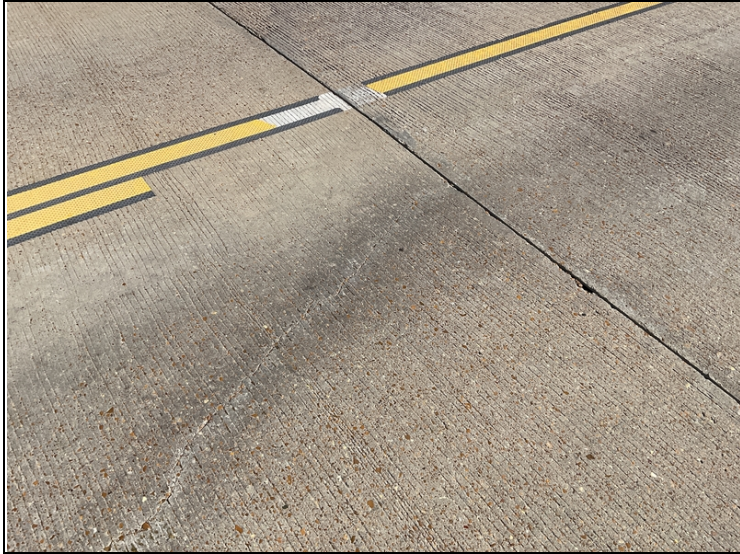
Approach slabs have sealed and mainly unsealed cracks.

Typical approach slab crack

Date Reported: 09/22/2016
Priority: D- Routine
Type of Work: Repair (General)
Status: Monitor
Component: Element

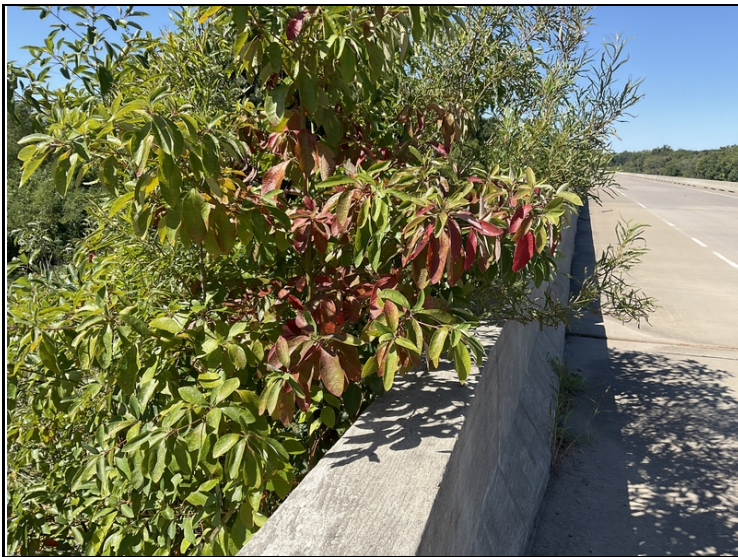
Abutment #2 right side has trees growing onto roadway.

Date Reported: 09/19/2018
Priority: C - Important
Type of Work: (Inactive) (Inactive) 1 - Clean
Status: Monitor
Component: Channel

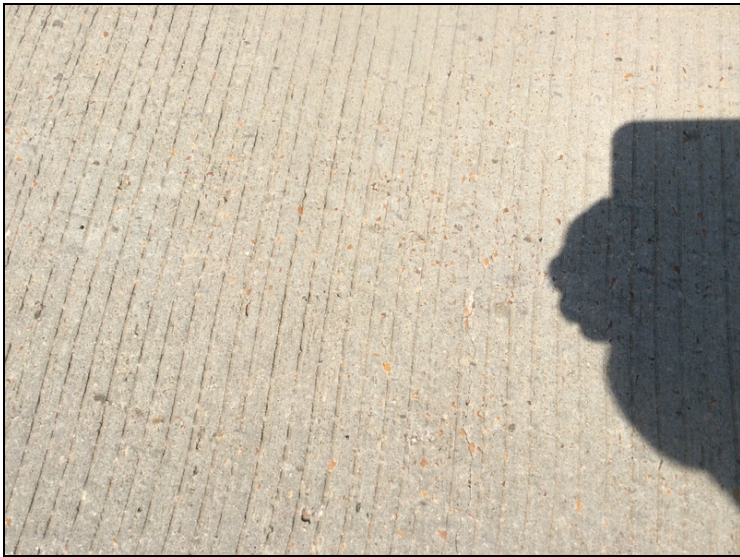
9/9/2020-Lowered deck from 7 to 6 due to spacing of deck cracks.

Each span has open transverse cracks spaced four feet.
Each span has four to five longitudinal cracks.

Typical transverse deck crack

Date Reported: 09/19/2018
Priority: C - Important
Type of Work: Repair (General)
Status: Monitor
Component: Element

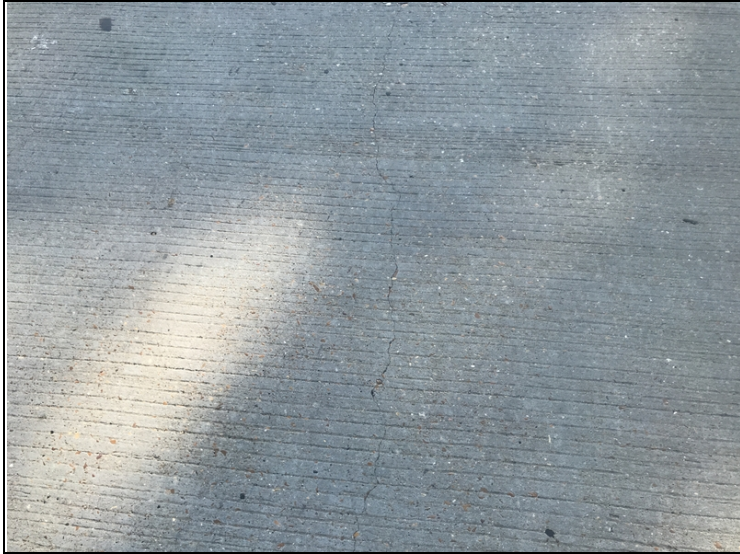
Typical longitudinal deck crack.

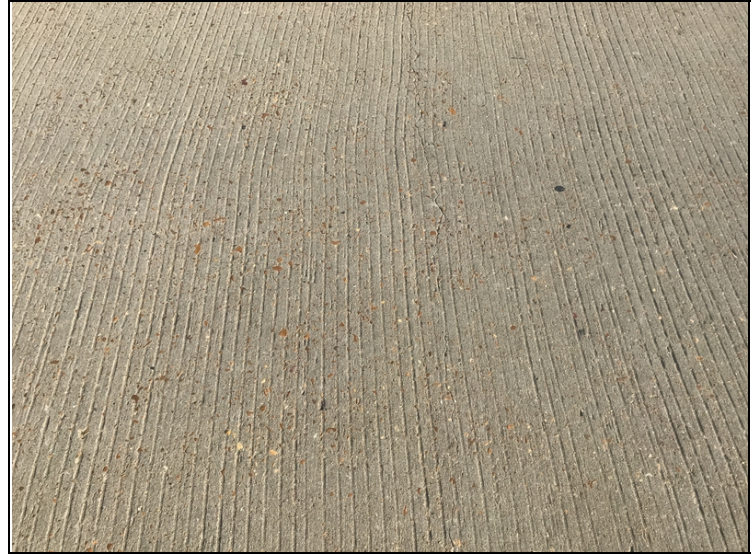
Typical transverse deck crack.

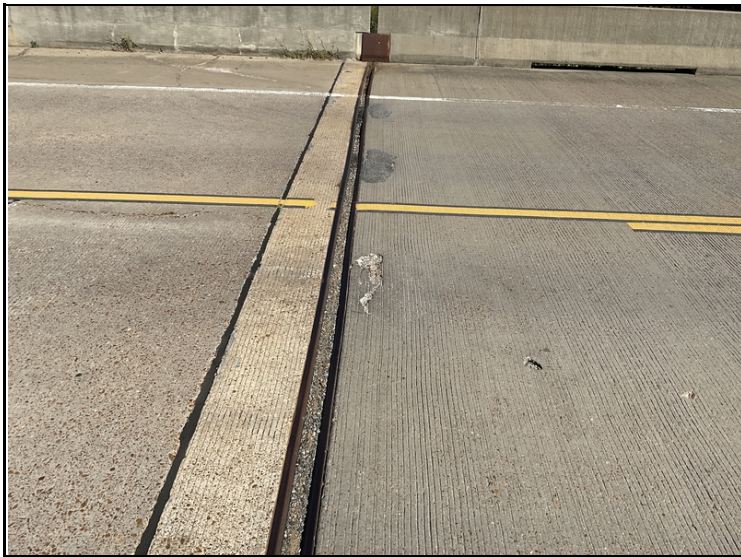
Deck Abutment #1 span #1 left lane has two 1' shallow spalls that have been filled with asphalt. Right lane has 1' shallow spall/delaminated area.

Date Reported: 09/11/2020
Priority: C - Important
Type of Work: Repair (General)
Status: Forward State
Component: Element

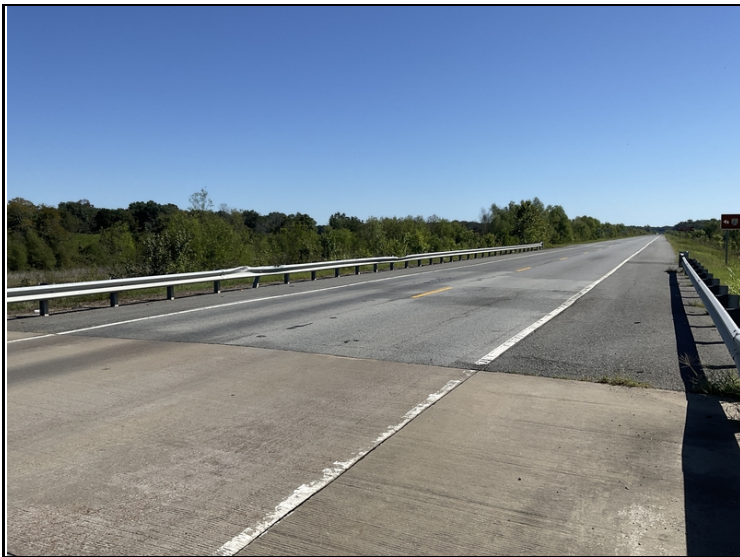
Abutment #2 left approach rail has 2 locations of collision damage.

Date Reported: 09/12/2022
Priority: D- Routine
Type of Work: Repair (General)
Status: Open
Component: Approach
