Asset #06830(Routine)

US 79 -SEC 13 over White River; RR;River Rd

Team Lead: Jacob Turner, Inspection Date: 03/29/2021

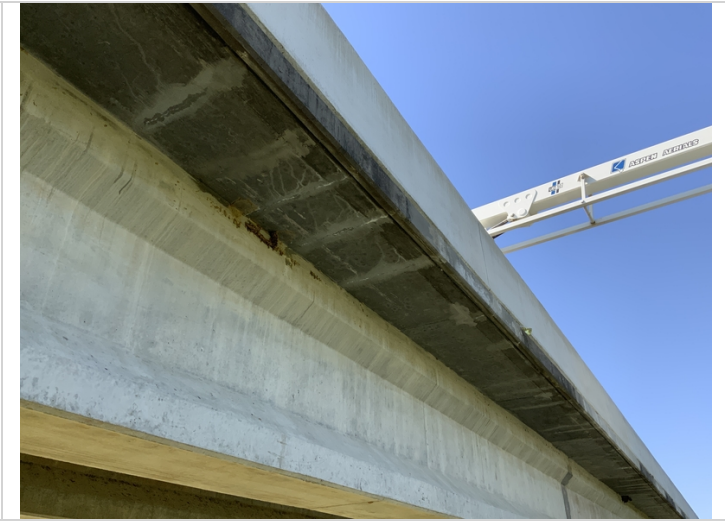
Typical transverse cracking with efflorescence along the overhangs of the North prestressed girder unit

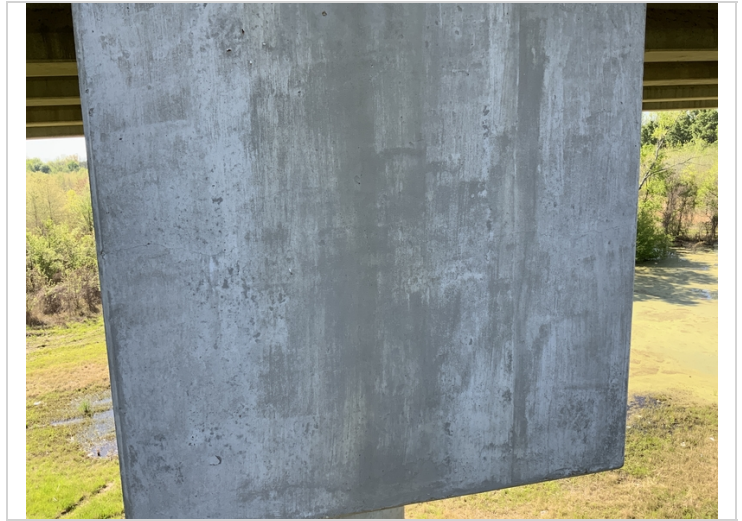
Bent 91 has horizontal cracking along the face of the cap on the upstream side and extends around on the back side of the cap in the North prestressed girder unit

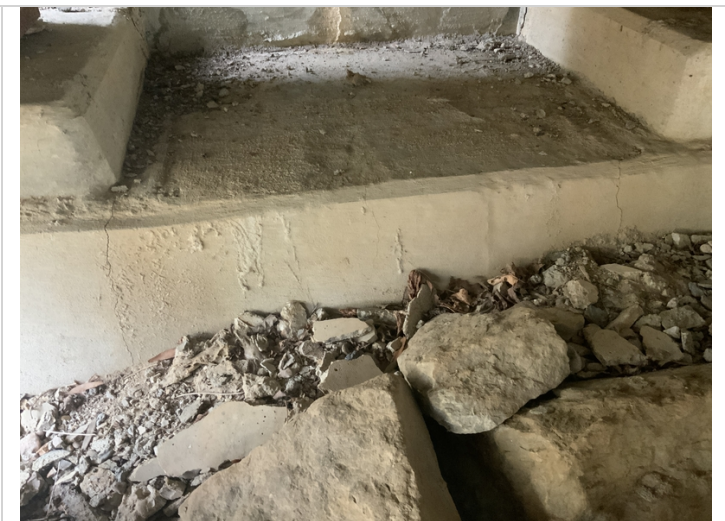
Typical cracking along the bridge seat at bent 1 South abutment

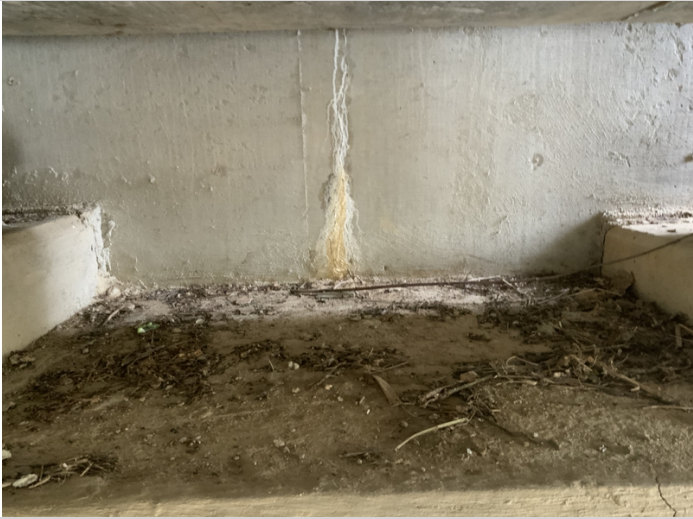
(215) 03/31/2021 - JRT & AMJ							
- Bent 1 (South Abutment) has vertical cracking with efflorescence along the back wall and bridge seat.							
04/08/2019 - RWF, APW & JRT - Minor vertialc craking with light efflorescence typical in the backwalls.							
Bent 1 has 6 feet of vertical cracks in the backwall with little build up of efflorescence.							
220	Reinforced Concrete Pile Cap/Footing	LF	180	180	0	0	0

Typical vertical cracking with efflorescence along bent 1
South abutment

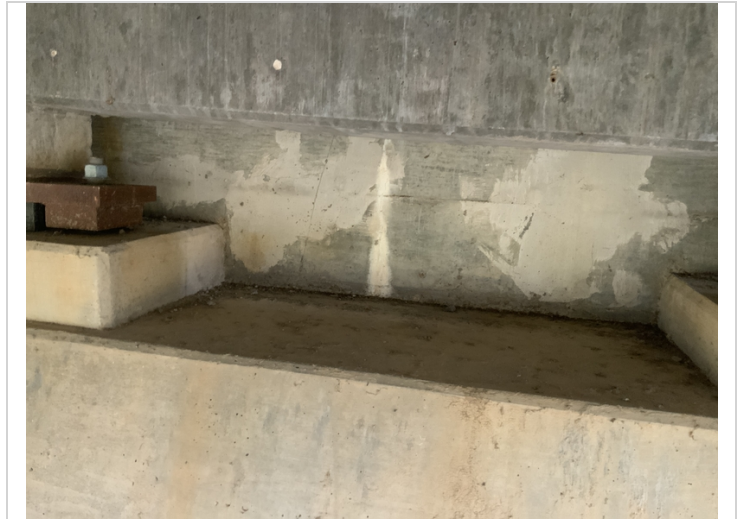
Bent 97 North Abutment typical vertical cracking with
efflorescence

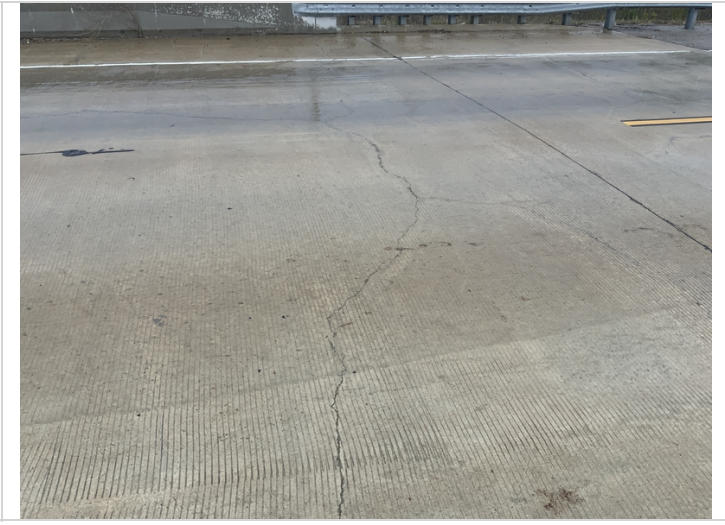
Typical cracking along bent 97 south approach

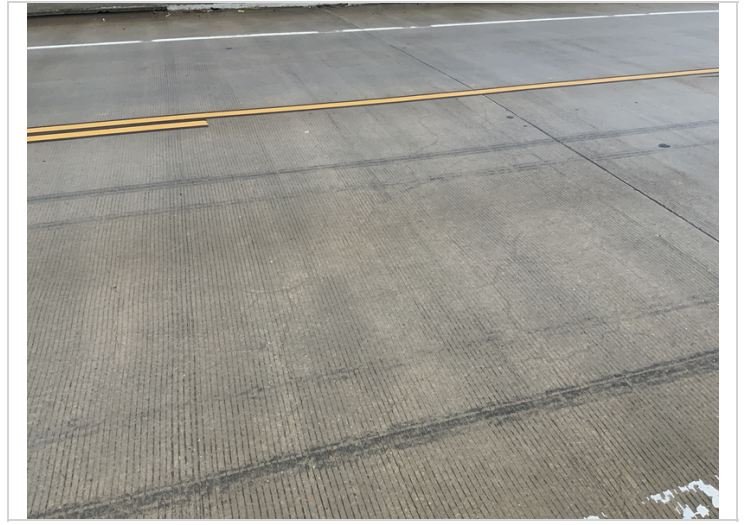
Map cracking

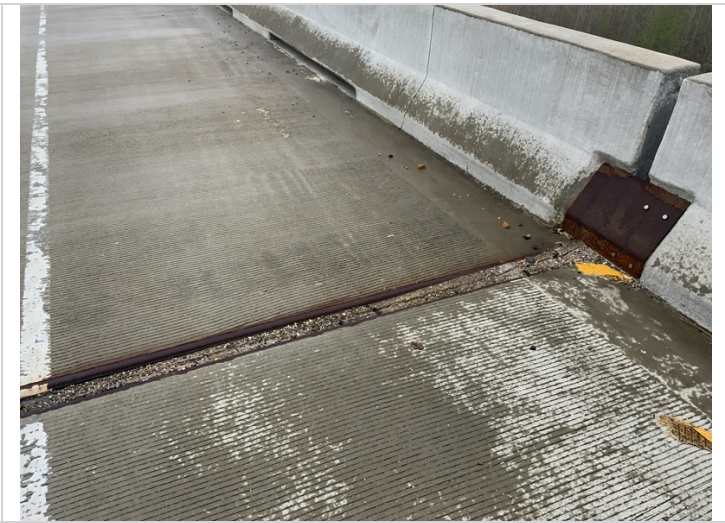
Typical debris accumulation

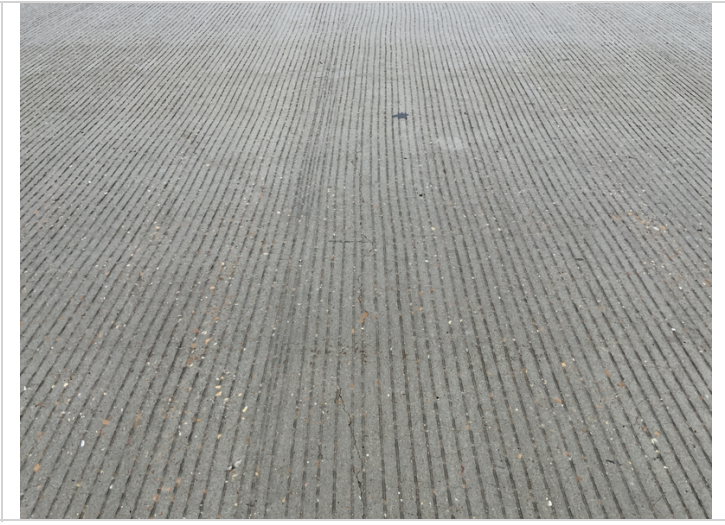
Typical transverse cracking

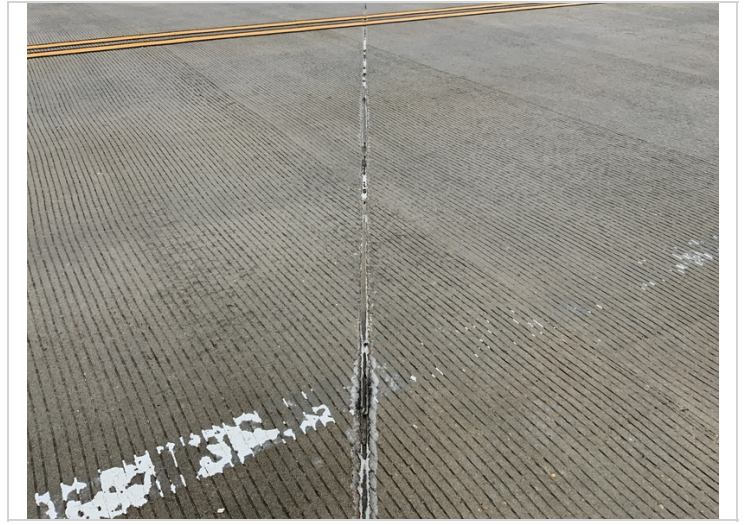
Typical deteriorated saw joints

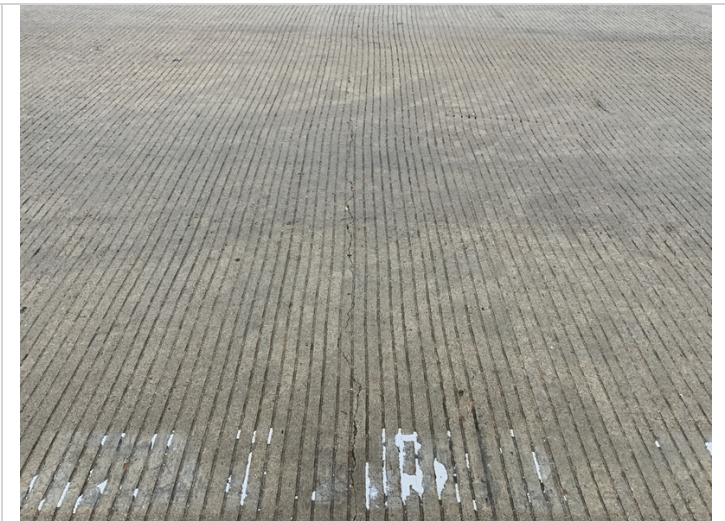
Typical transverse cracking

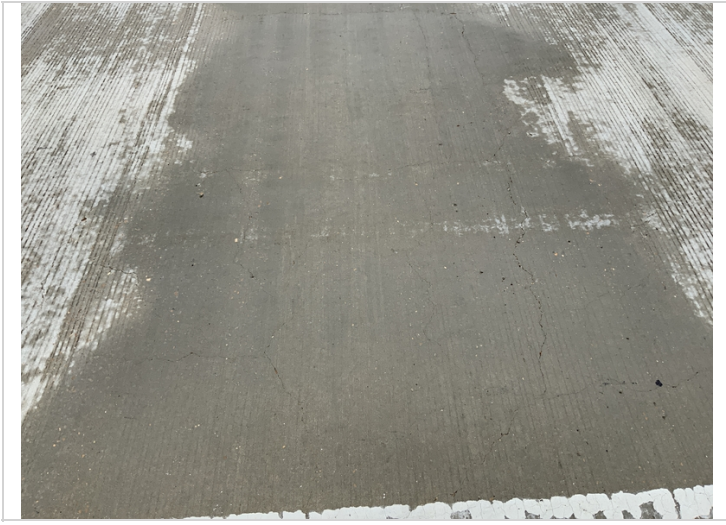
Map cracking

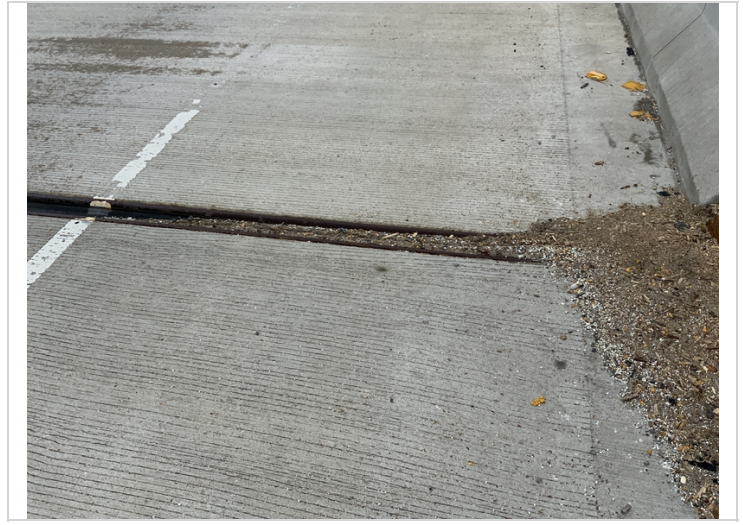
Typical debris accumulation

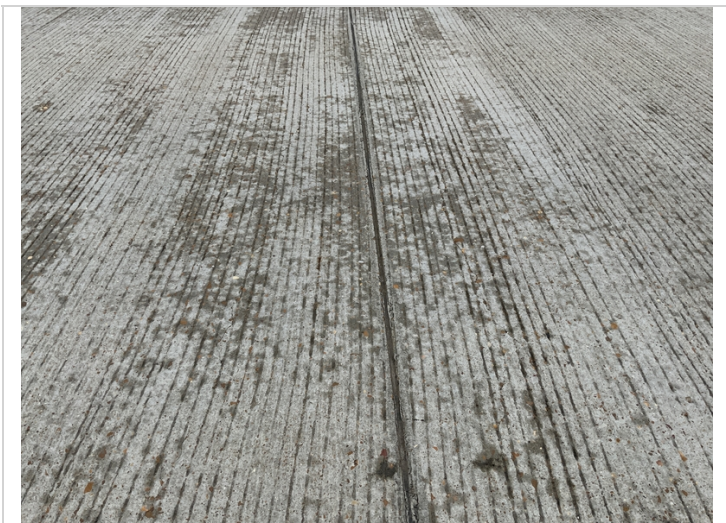
Typical transverse cracking

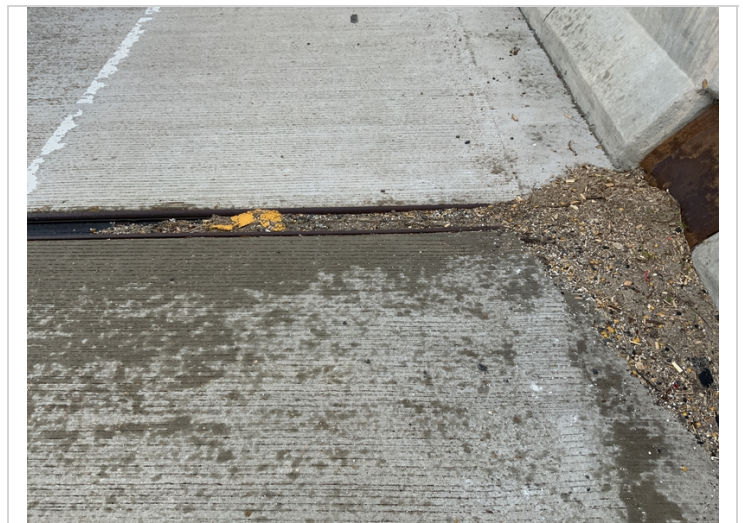
Typical debris accumulation along the gutters

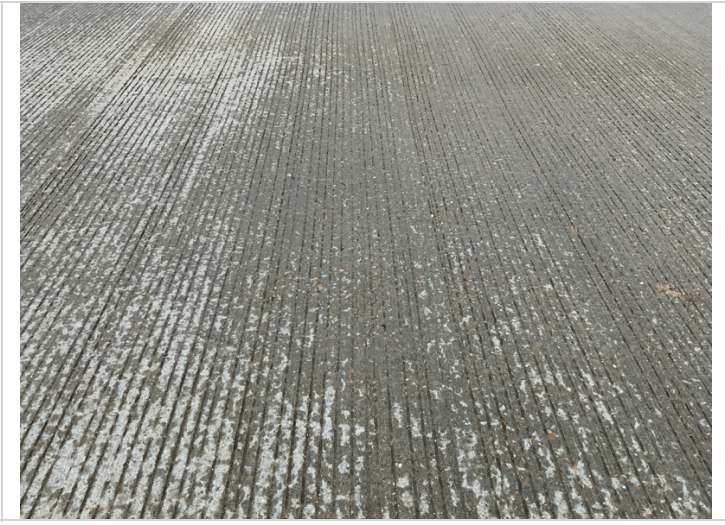
Typical transverse cracking

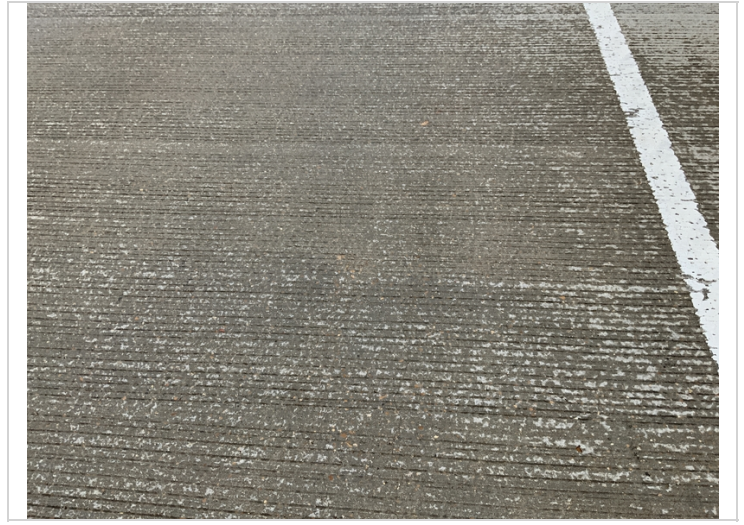
Typical map cracking

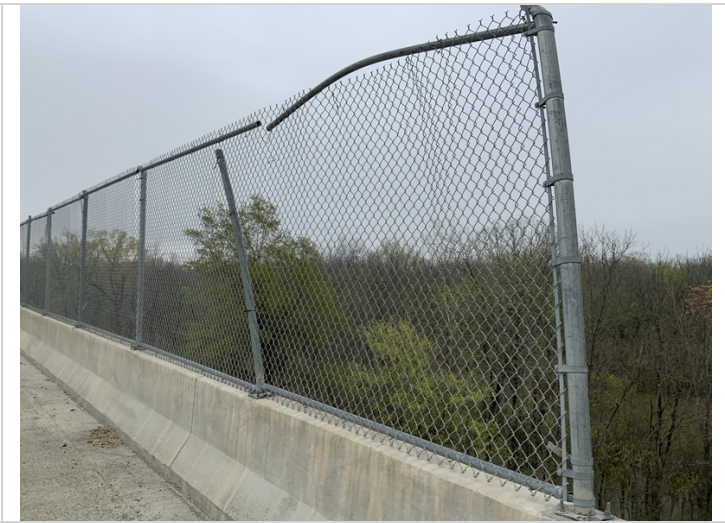
Damage chain link fence

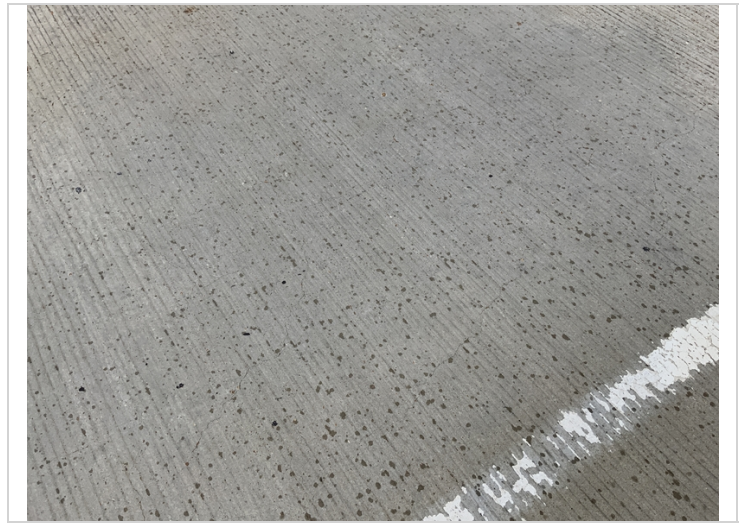
Minor map cracking

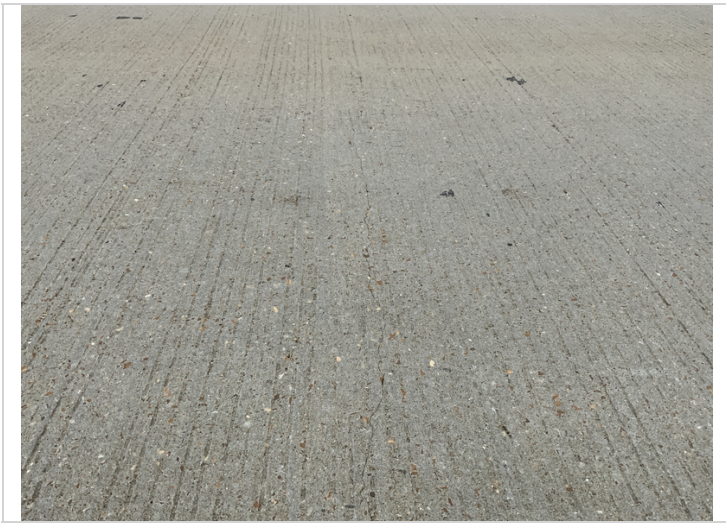
Typical transverse cracking scattered throughout the structure

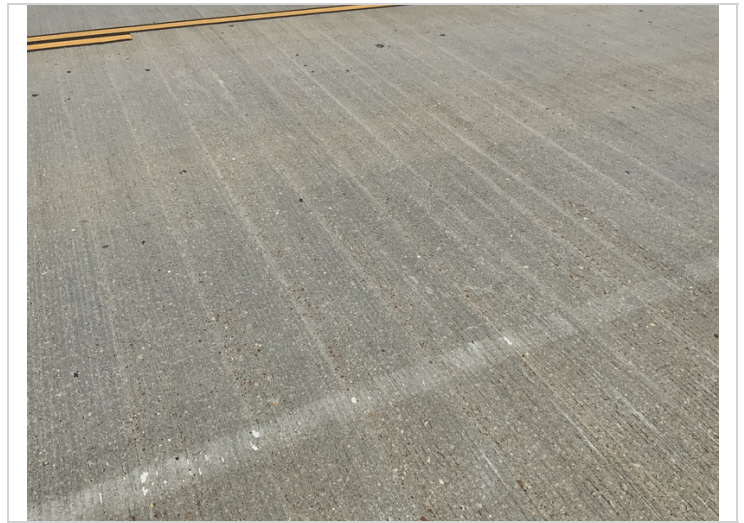
Typical abrasion in various locations throughout the structure

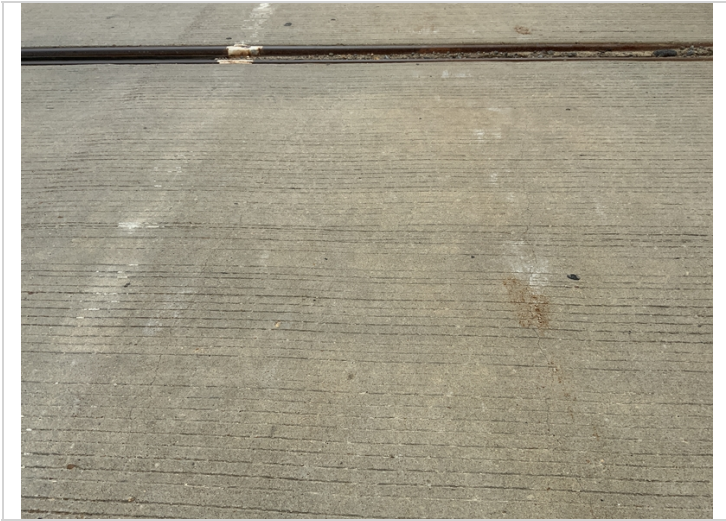
Typical longitudinal cracking adjacent to the joint seals

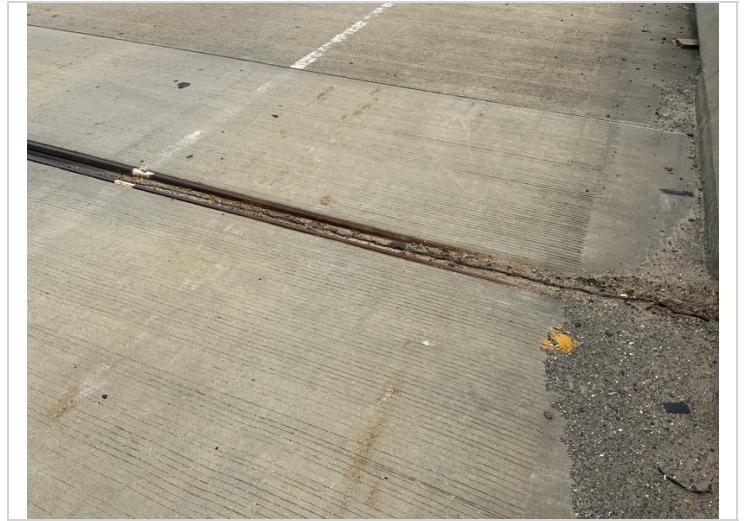
Typical debris accumulation along the gutters

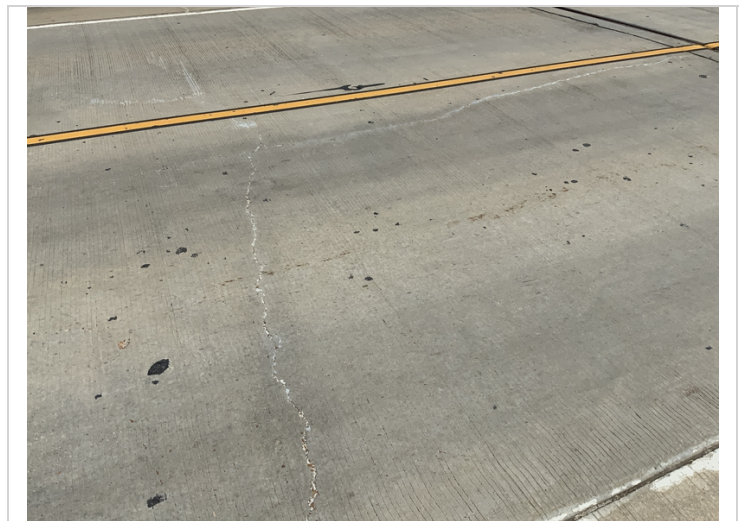
Typical transverse and longitudinal cracking along bent 1
South Approach

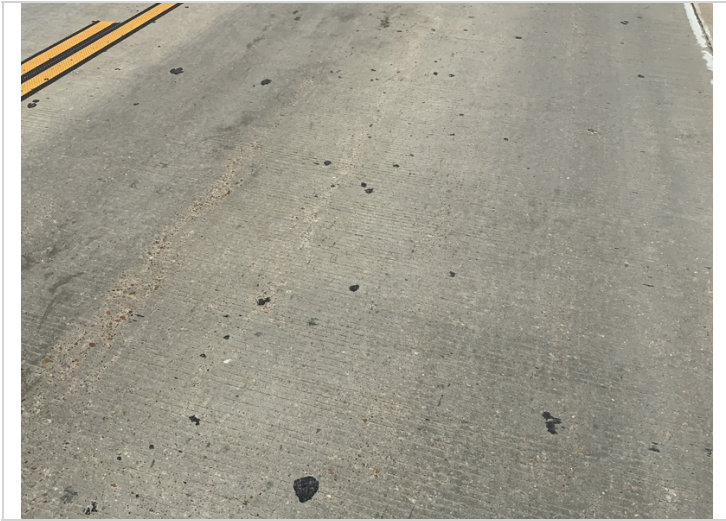
Bent 1 South approach has minor abrasion

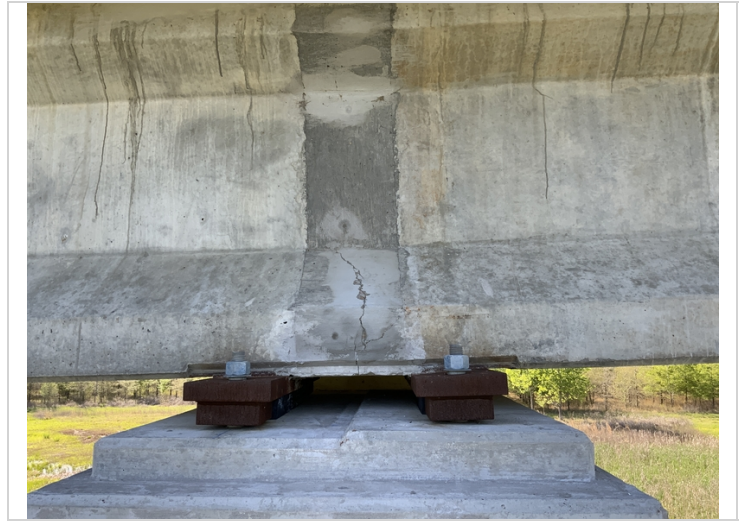
Typical cracking along the exterior girders where the girders were made continuous

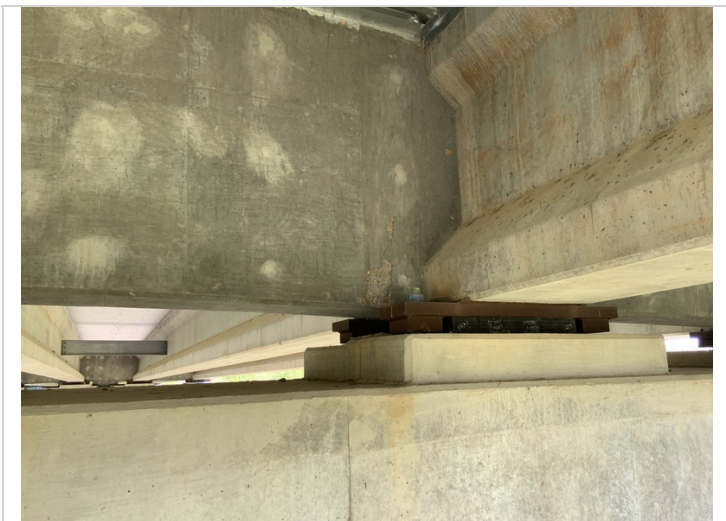
Typical spalling along the diaphragms in various locations throughout the north prestressed girder unit

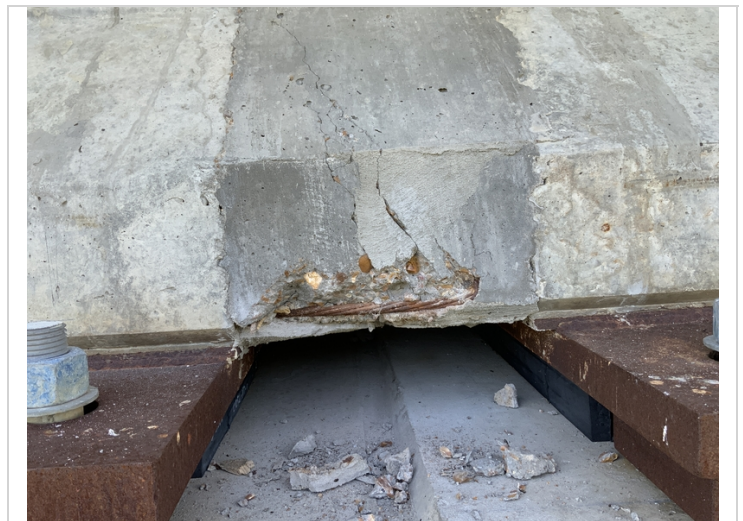
Bent 91 - Girder 1 (Upstream) has spalling with exposed prestressed strands where the girder is made continuous along the North prestressed girder unit

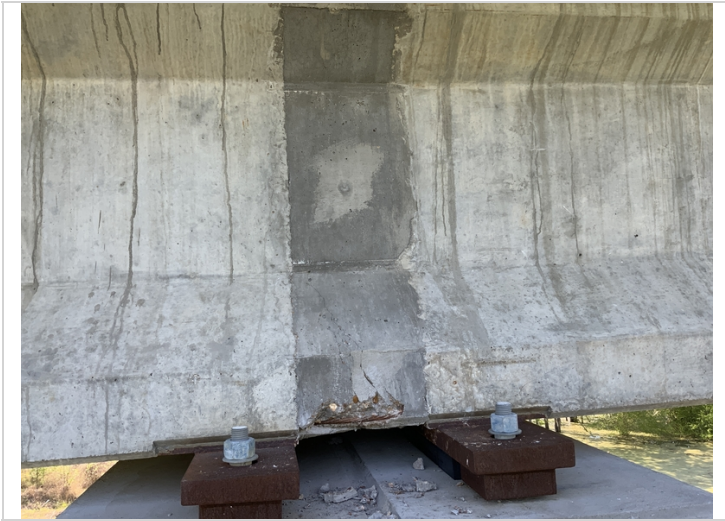
Bent 91 - Girder 1 (Upstream) has spalling with exposed prestressed strands where the girder is made continuous along the North prestressed girder unit

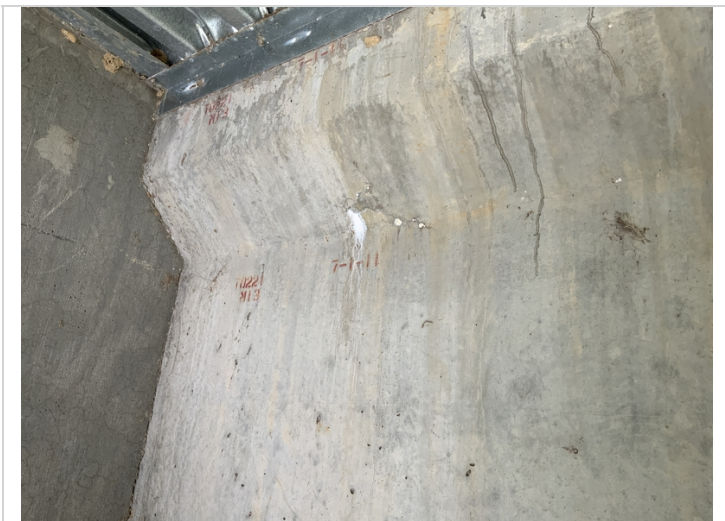
Bent 90 - Girder 1 (upstream) has minor cracking with efflorescence leaching through along the North prestressed girder unit

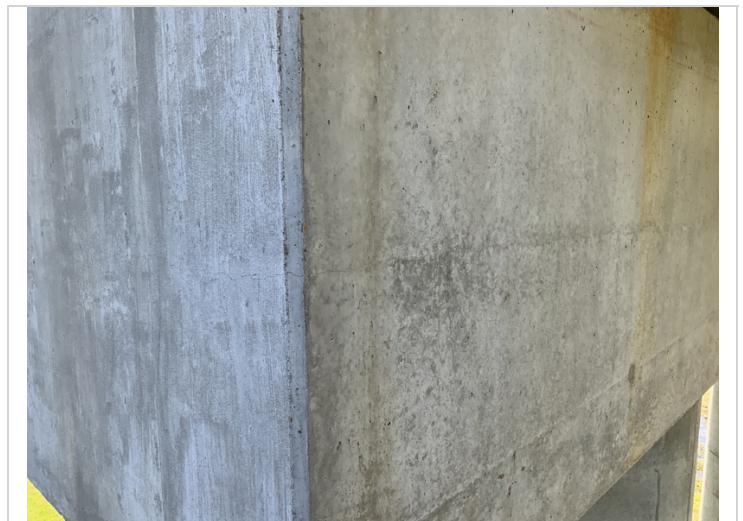
Bent 91 has horizontal cracking along the face of the cap on the upstream side and extends around on the back side of the cap in the North prestressed girder unit

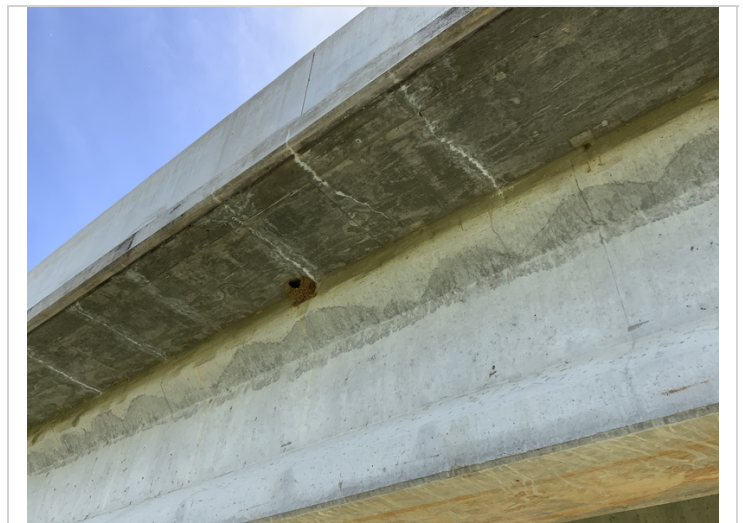
Typical cracking with efflorescence along the overhangs

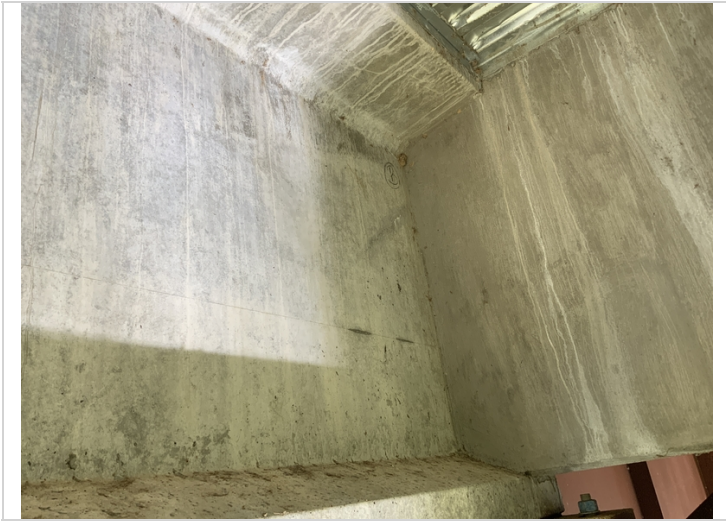
Bent 81 - span 80 - girder 3 has a diagonal crack with efflorescence

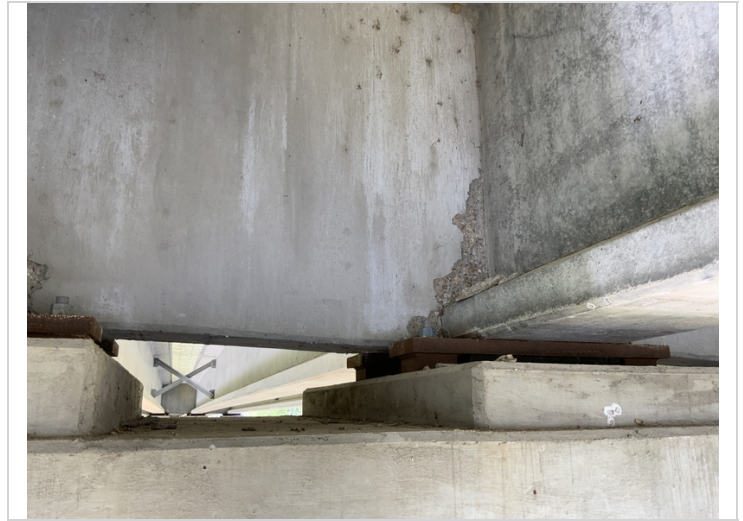
Typical spalling along the diaphragms

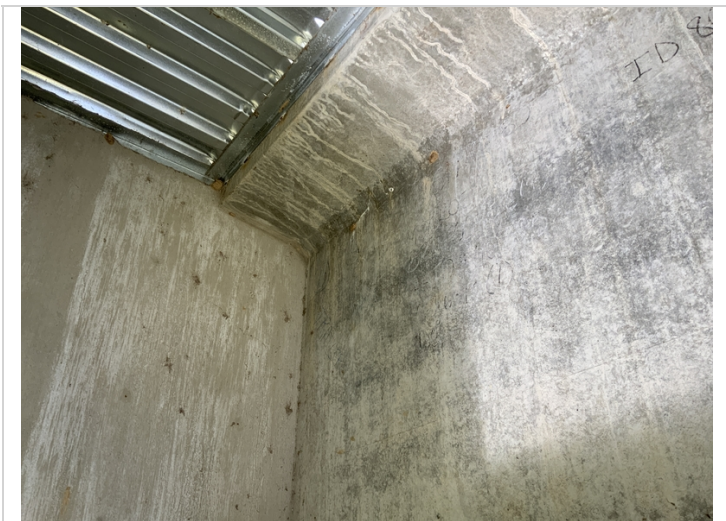
Bent 80 span 80 girder 1 has cracking with efflorescence along the top flange web juncture

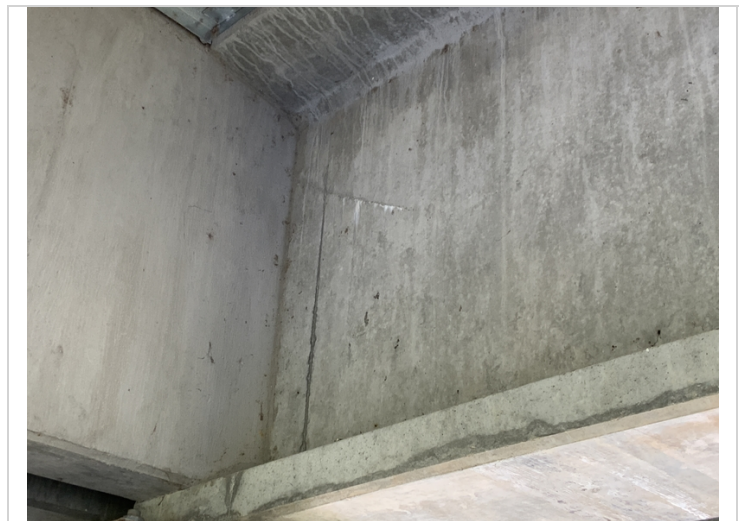
Typical diagonal cracking with efflorescence in various locations throughout the intermediate prestressed girder unit see notes for locations

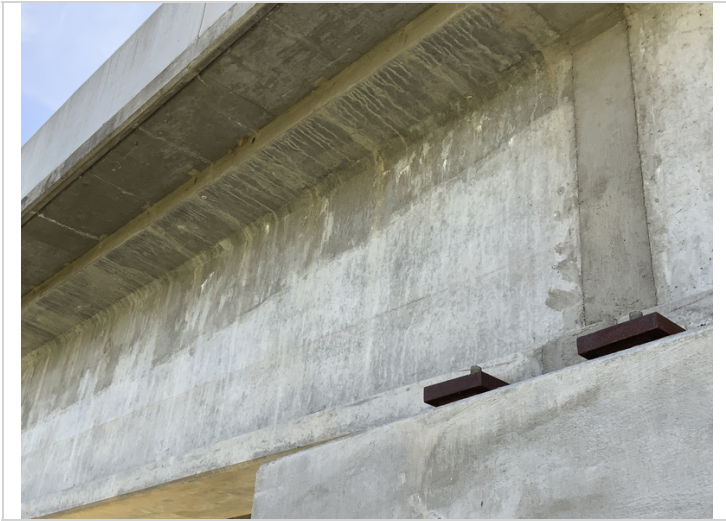
Bent 77 - Girder 1 has hairline cracking with efflorescence along the web

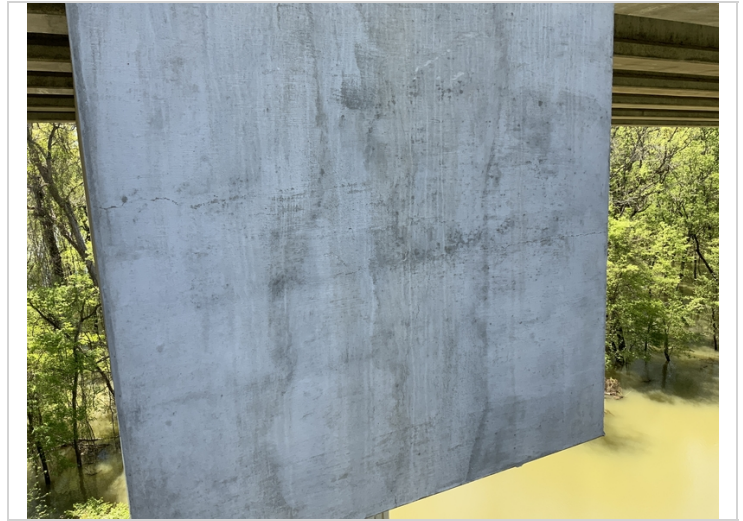
Typical cracking along the face of the caps

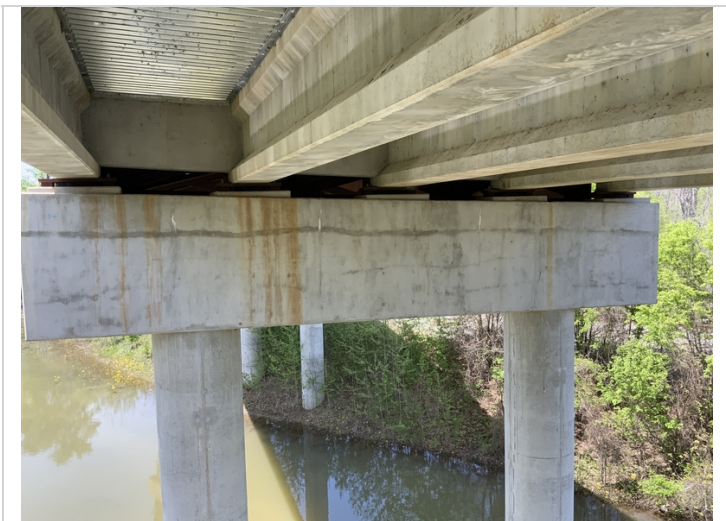
Bent 64 has 4 vertical cracks with efflorescence

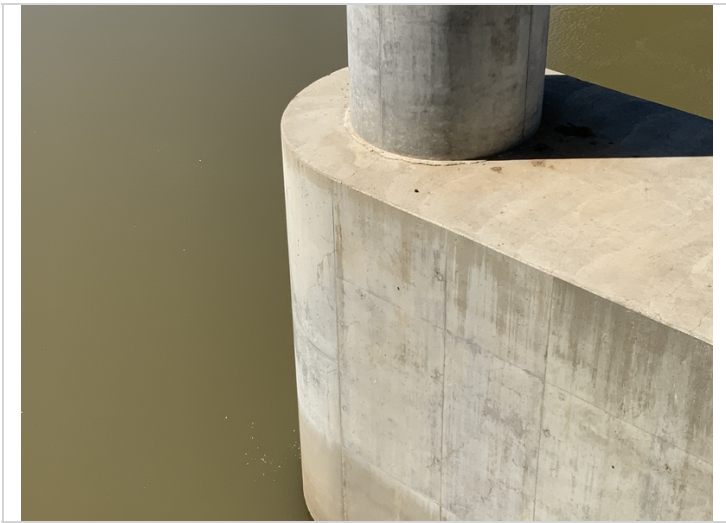
Pier 3 has map cracking along both ends of the pier wall

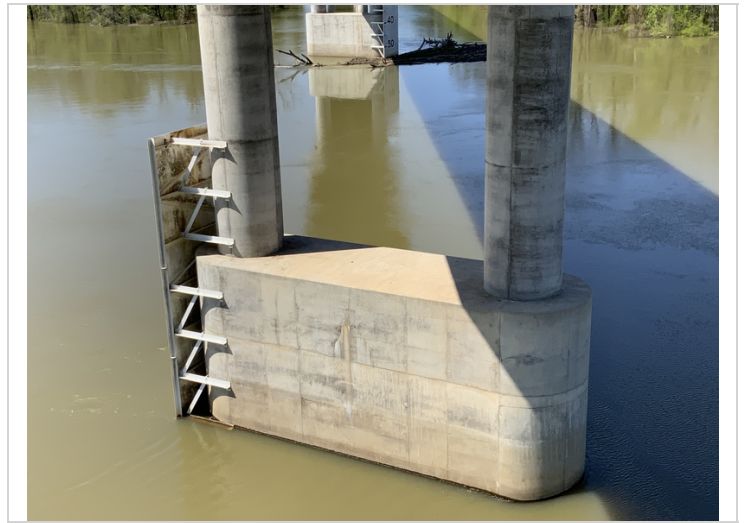
Pier walls 1 and 2 have vertical cracking with efflorescence

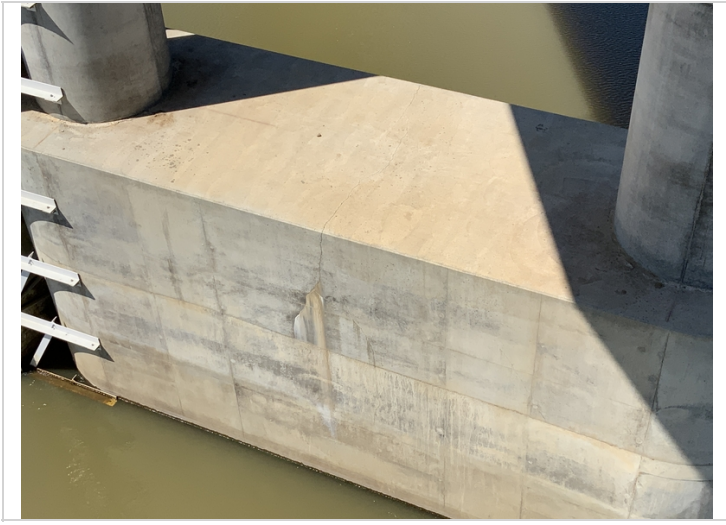
Piers 1 & 2 both have cracking along the top and vertical cracking with efflorescence

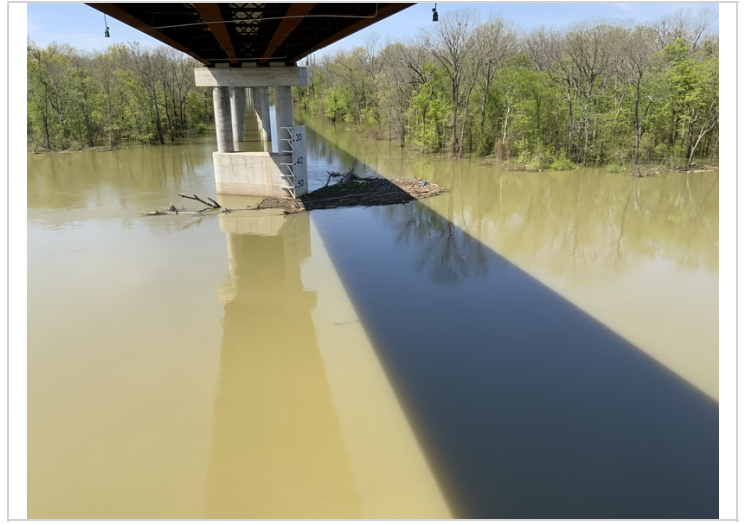
Pier 1 drift accumulation

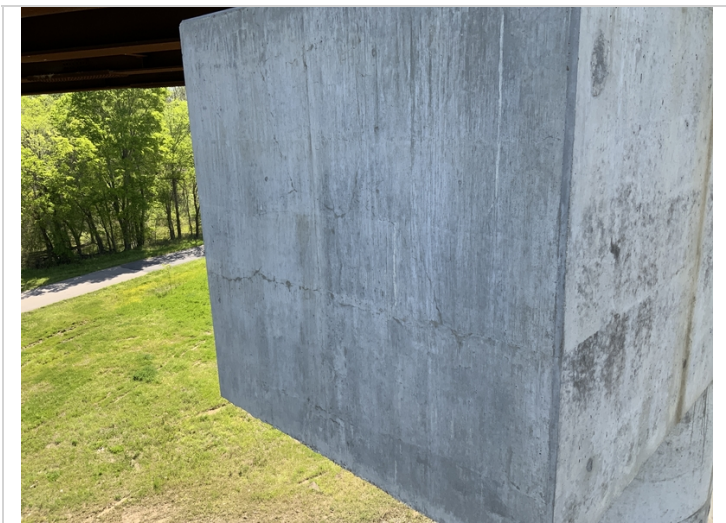
Typical cracking along the face of the pier caps

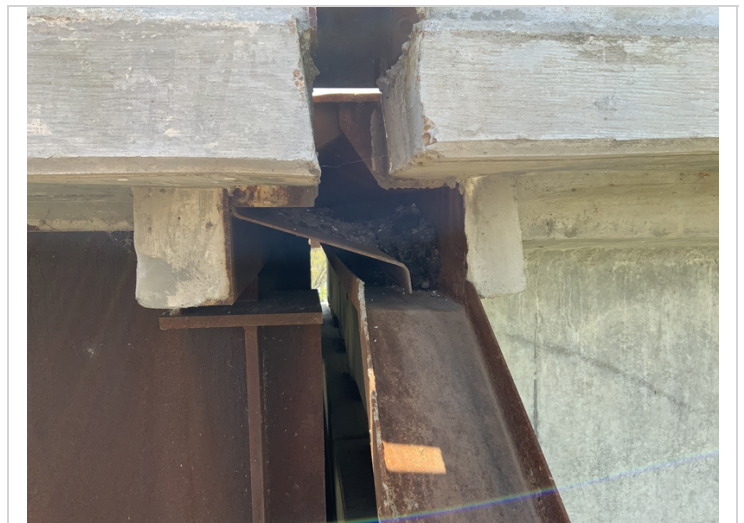
Joints have a accumulation of debris

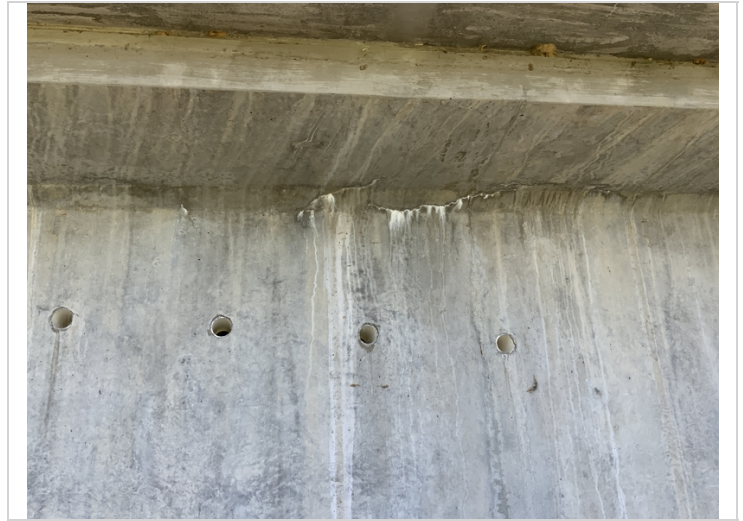
Bent 88 - Girder 1 (upstream) has diagonal cracking with efflorescence along the top flange web juncture

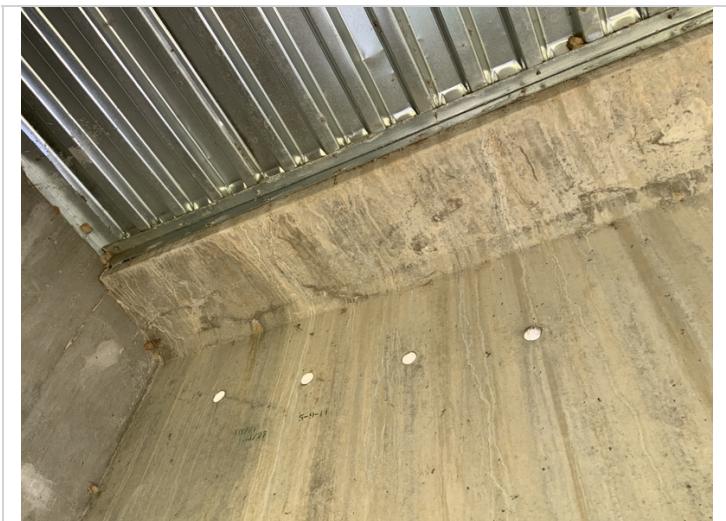
Span 87 - Girder 1 (upstream) has map cracking along the to flange and the top web juncture

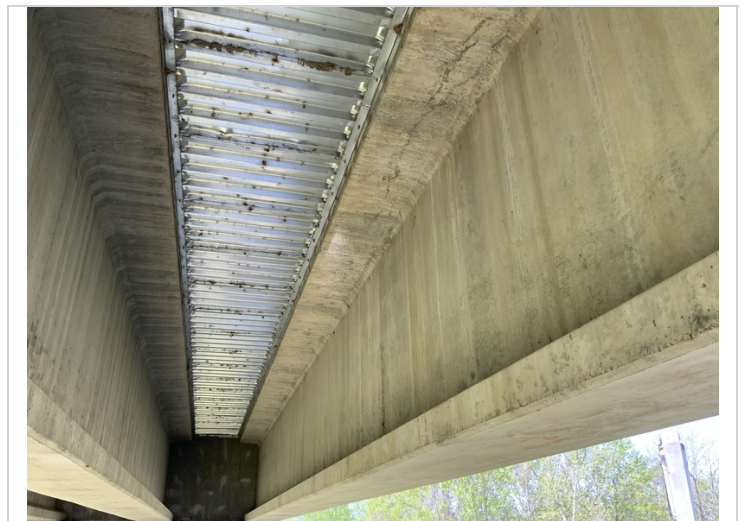
Span 87 - Girder 1 (upstream) has map cracking along the to flange and the top web juncture

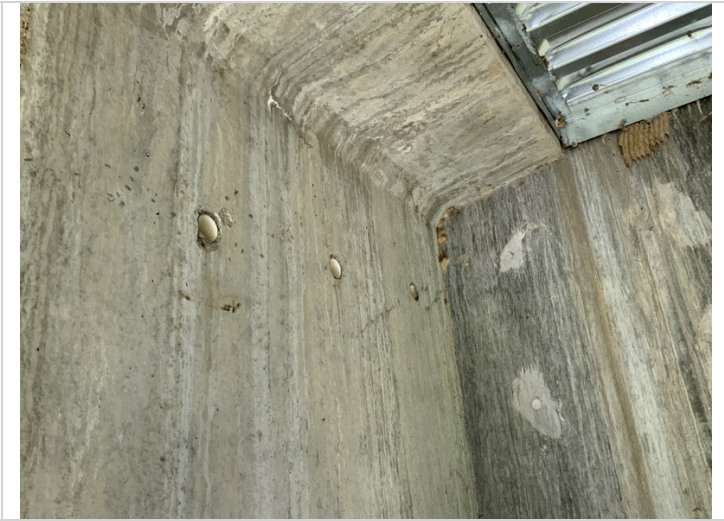
Span 85 - Girders 4 & 5 has cracking along the top flange web juncture with efflorescence and diagonal cracking center of the web adjacent to bent 86

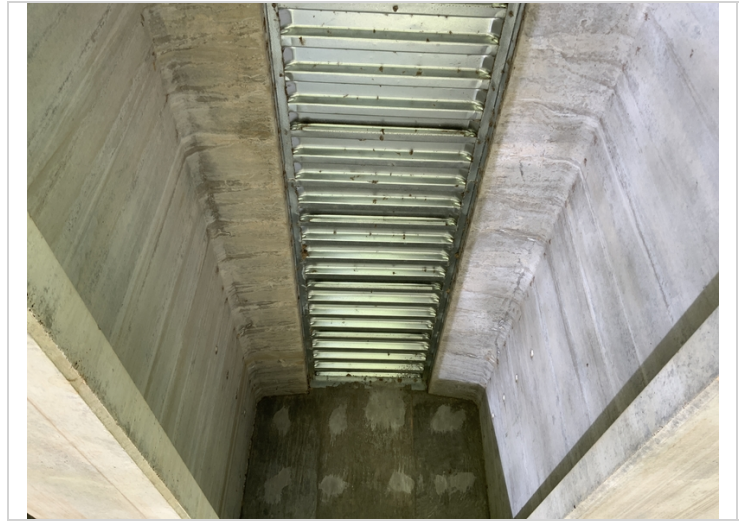
Span 85 - Girders 1 thru 6 (adjacent to bent 85) has cracking with efflorescence along the top flange and web juncture

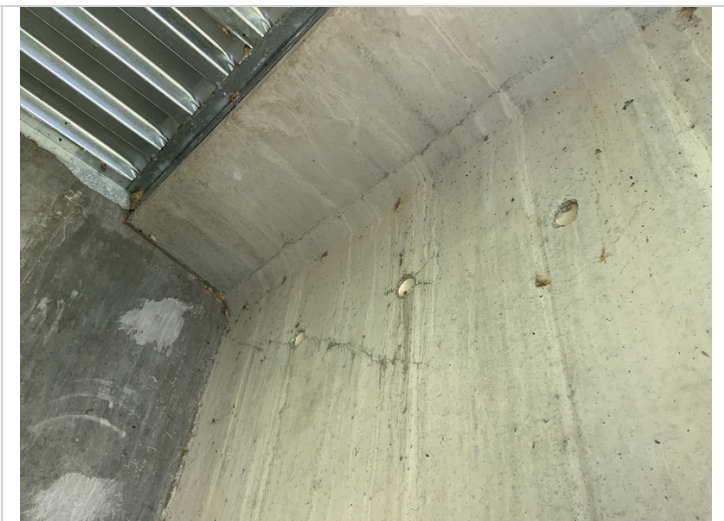
Bent 85 - Girder 2 (span 84) in bay 1 and 2 has a 45 degree crack that starts at the top web juncture and extends down approximately 3' and a longitudinal crack that follows along the top flange web juncture

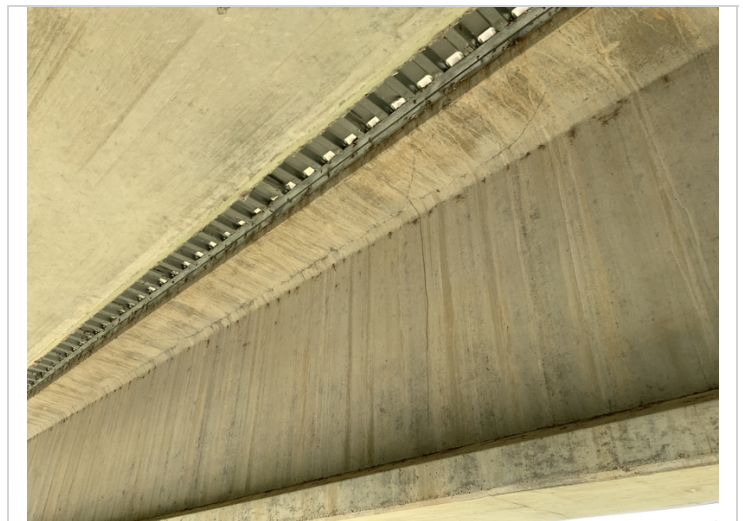
Span 84 - Girder 1 has 2 diagonal cracks along the top flange and a longitudinal crack along the top flange web juncture that starts approximately 20' from bent 85 and extends 30' towards bent 84

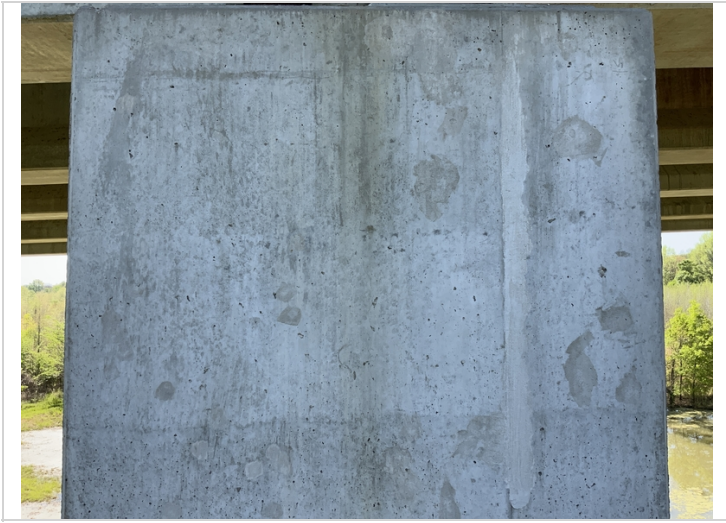
Bent 90 (upstream) has vertical and horizontal cracking along the face of the cap in the North prestressed girder unit

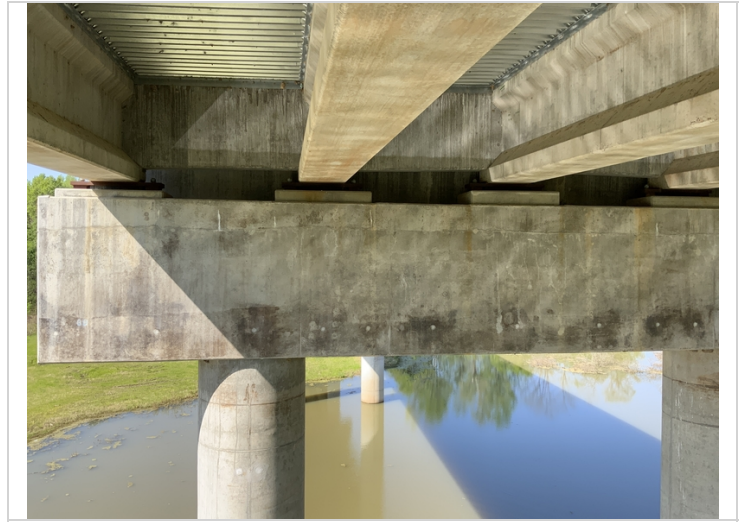
Bent 89 (AHD) has 6 vertical cracks with efflorescence along the North prestressed girder unit

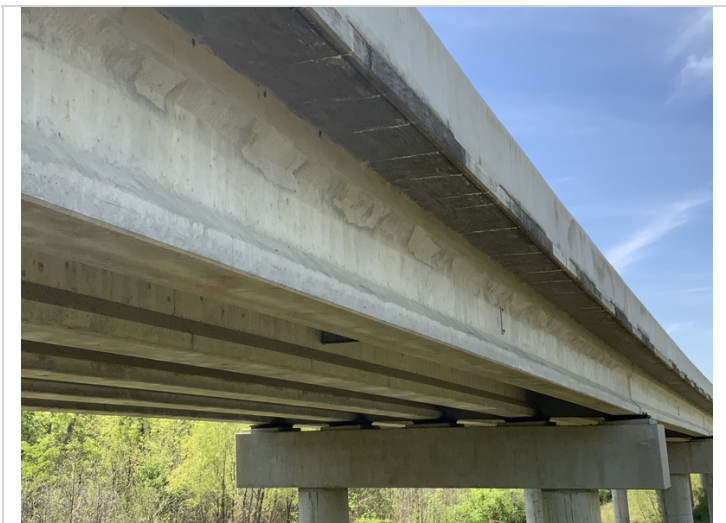
Typical cracking with efflorescence along the overhangs

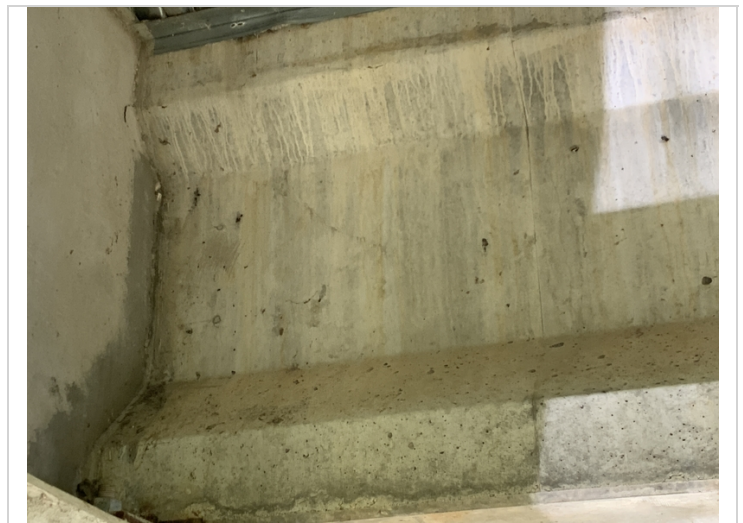
Typical diagonal cracking

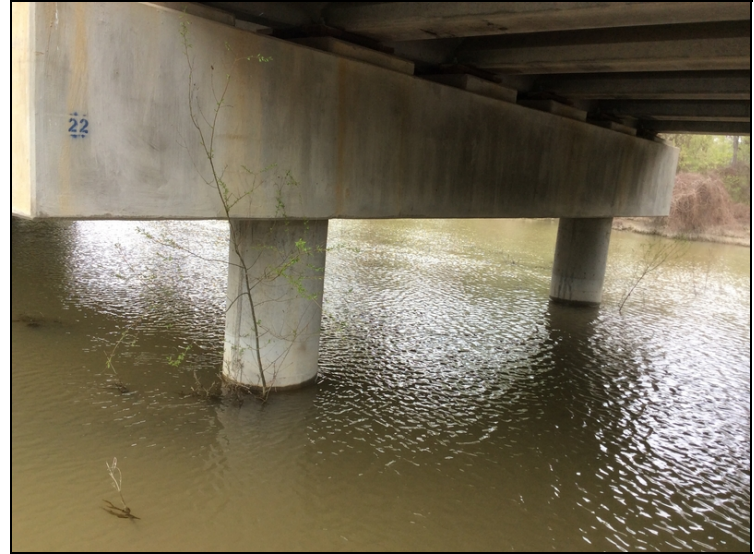
- The South Prestressed Units have trees interfering with the inspection platform approximately 35% of the spans on the upstream and downstream side
Looking back at bent 22, trees growing against columns.

Looking back at bent 22, trees growing against columns.
