Asset #06830(Routine)

US 79 -SEC 13 over White River; RR;River Rd

Team Lead: Jacob Turner, Inspection Date: 03/29/2021

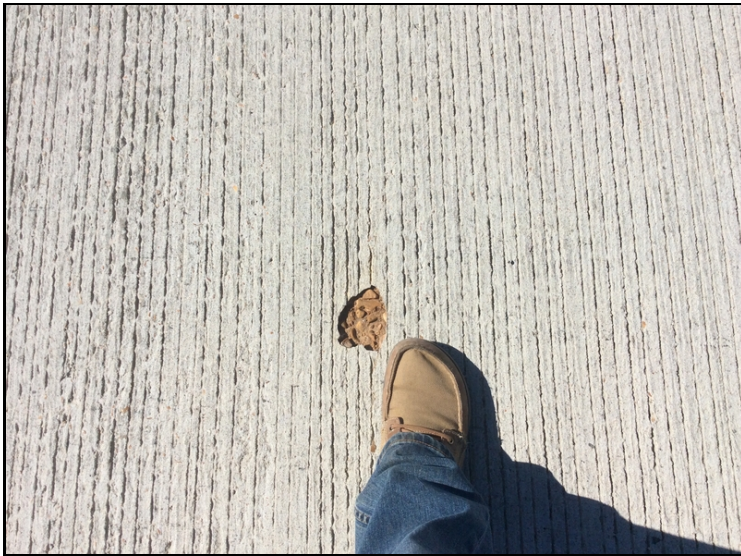
MFF & ADN - 04/04/2017 - sealable transverse crack was visible throughout the deck at 6' spacing. One Spall ahead of pier 1 north bound right lane over the river.

Spall in Deck located at Pier 1 north bound right lane.

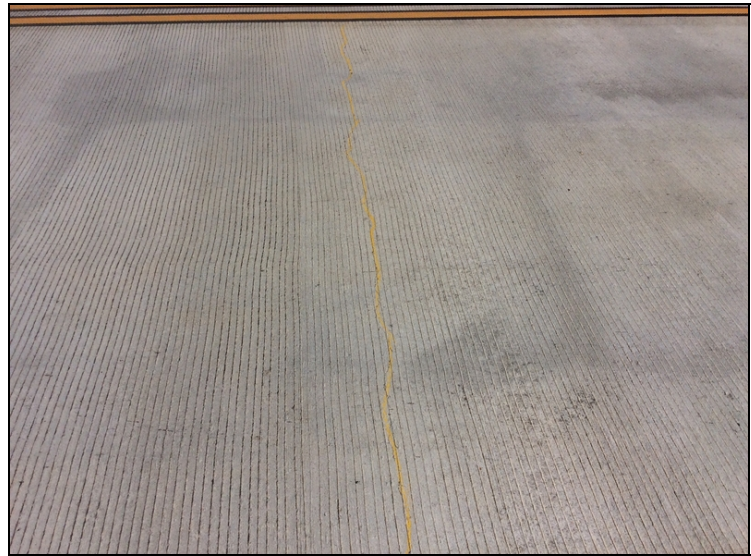
Sealable Transverse cracks.

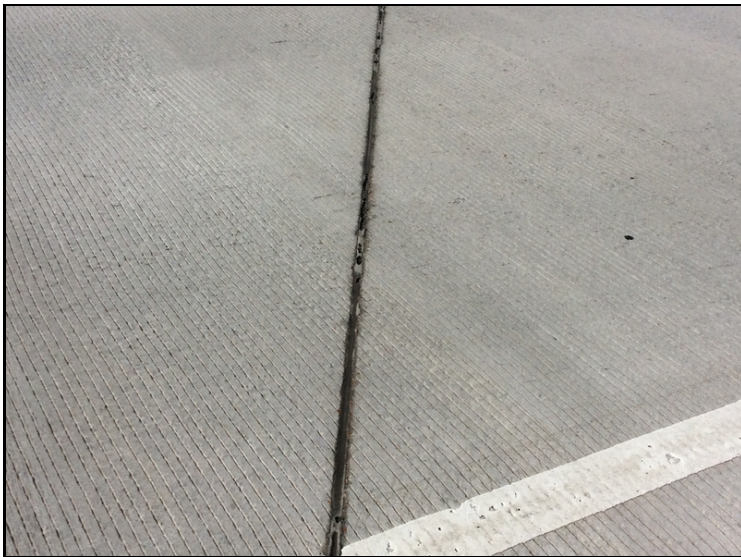
MFF & ADN - 04/04/2017 - Sawed Pourable joint adhesion failure. Pier 2 typical with all joint over the river span.

Pourable joint adhesion failure. Pier 2 typical with all joint over the river span.

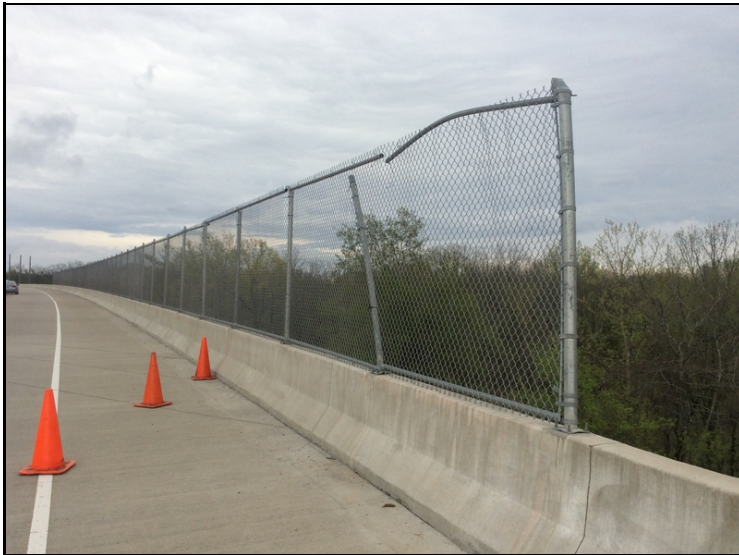
Minor collision damage to the fence posts and top railing.

Steel Girder Spans, Chain Link Fence:
Approximately 30' of damaged fencing.

Notified District 1 DME of condition and asked to repair.
