**Asset #07027** (Routine, Underwater type 2)

**Us-79/Sec-13/L6.58 over White River Relief**

**Location: 6.58Mi Ne Prairie Co Line**

**Team Lead: Drew Melton, Inspection Date: 09/12/2022**

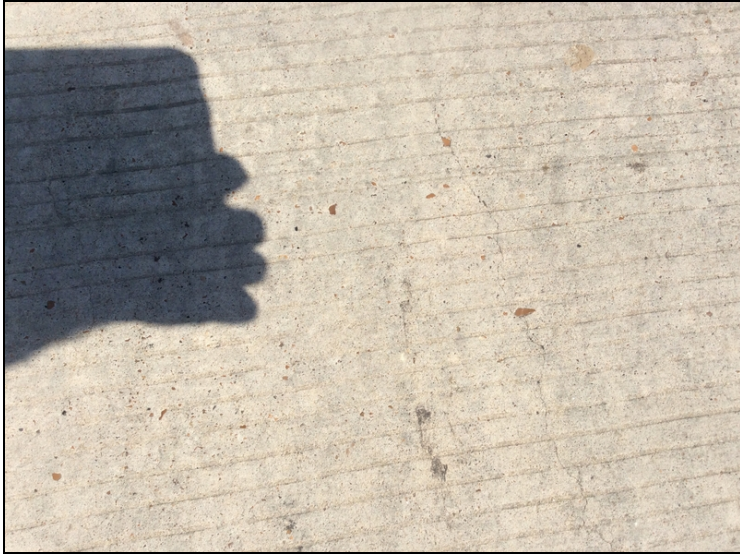
Typical longitudinal deck crack

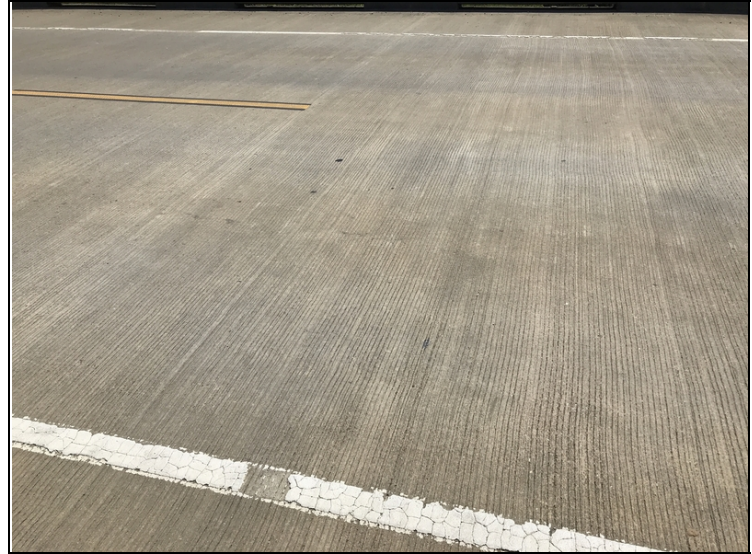
Spans have hairline and a few wider transverse cracks spaced two to three feet apart.

Typical deck

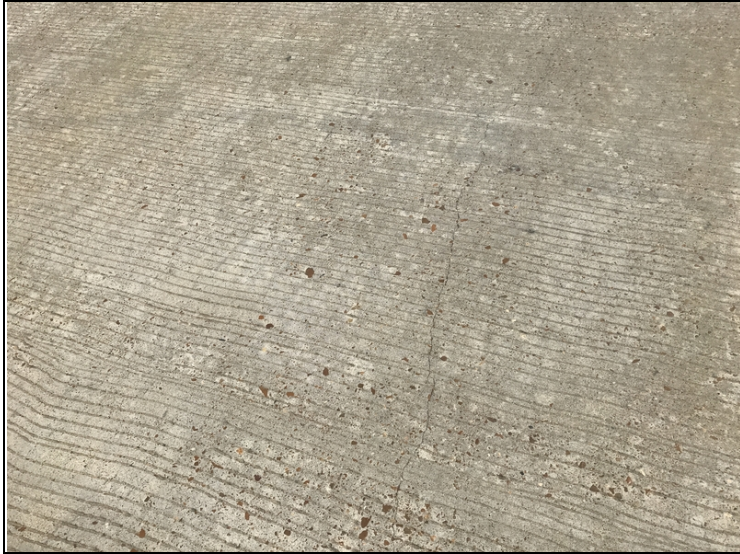
Typical longitudinal deck crack.

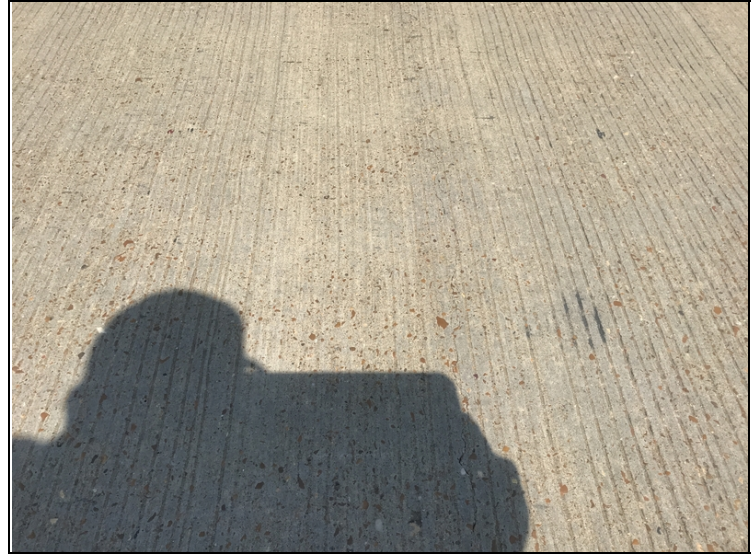
Typical transverse deck crack.

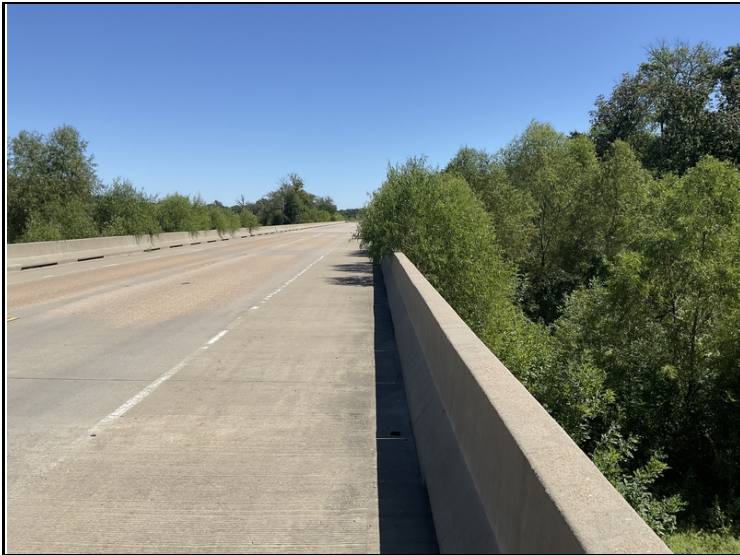
09-12-2022 lowered channel from 8 to 5 due to debris restrictions

Channel has vegetation on banks with restrictions from vegetation and trees in channel.

Trees and vegetation are growing under and beside bridge and onto roadway.

Typical vegetation

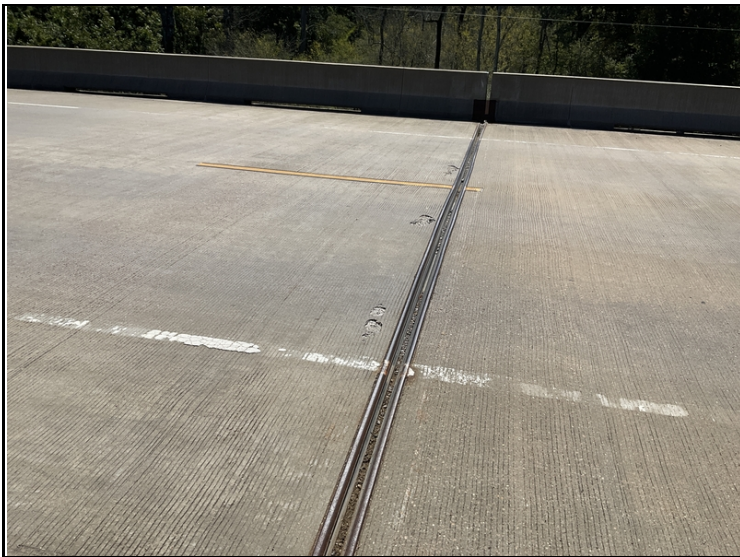
Span #13 deck at bent #13 has three 1' shallow spalls.

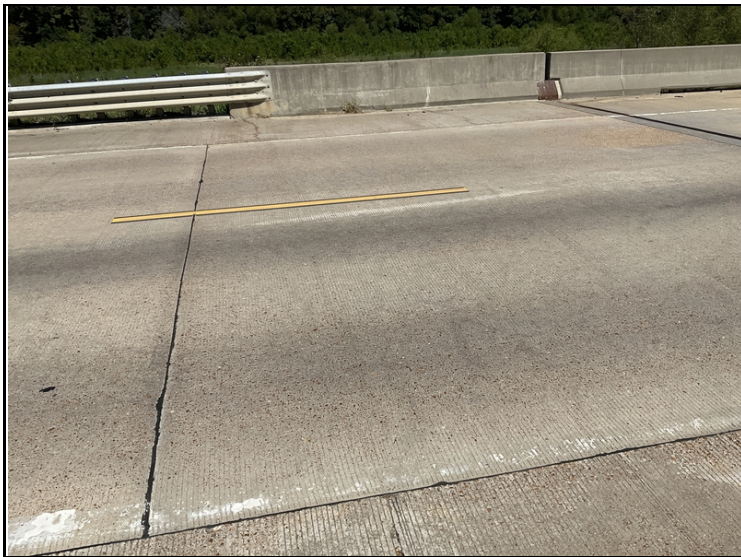
Abutment #1 approach slab

Approach slabs have cracks mainly sealed a few open.
