Asset #03069(Routine)

Sh-1/Sec-7/L-0.79 over Little Cypress

Team Lead: Drew Melton, Inspection Date: 05/18/2022

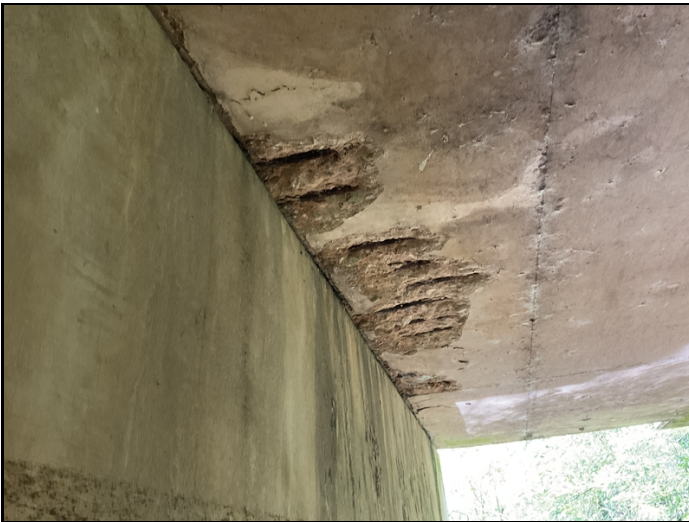
Span #1 soffit-under surface at bent #2 above piles #3,4 has a few small delaminated areas and 6, of spalls with exposed rebar with moderate section loss.

Type of Work: Repair (General)

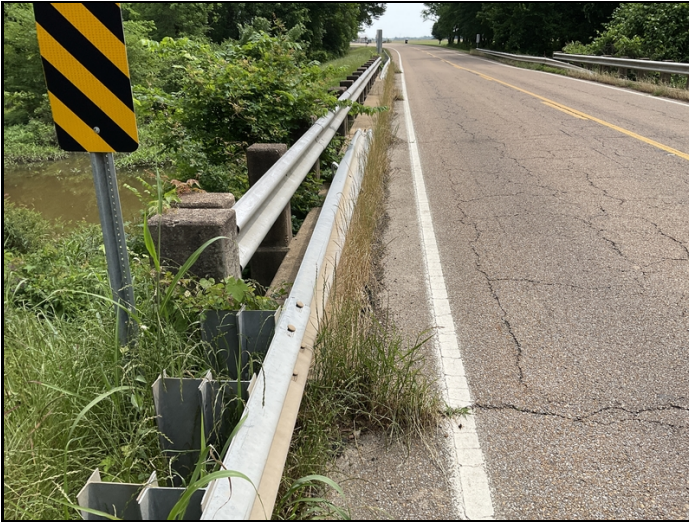
Grass growing in gutters both sides.

Typical gutters

Type of Work: (Inactive) (Inactive) 1 - Clean

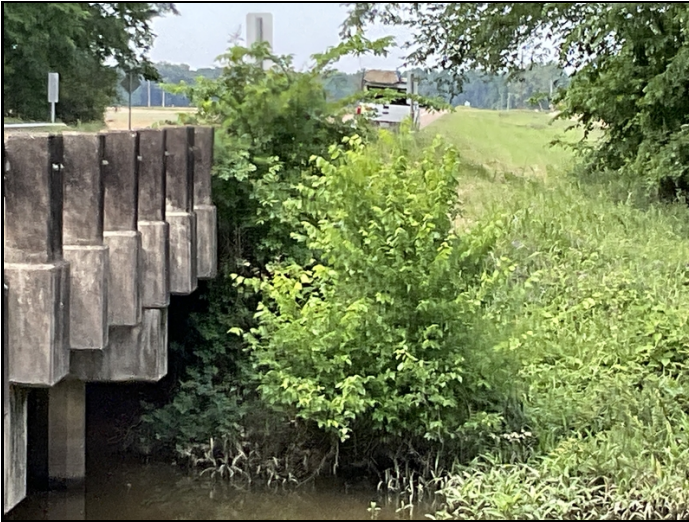
05/18/2022 lowered channel from 8 to 6 due to restriction in channel from vegetation growing.

Small trees and vegetation are growing under and beside bridge.

Typical trees and vegetation

Type of Work: (Inactive) (Inactive) 1 - Clean

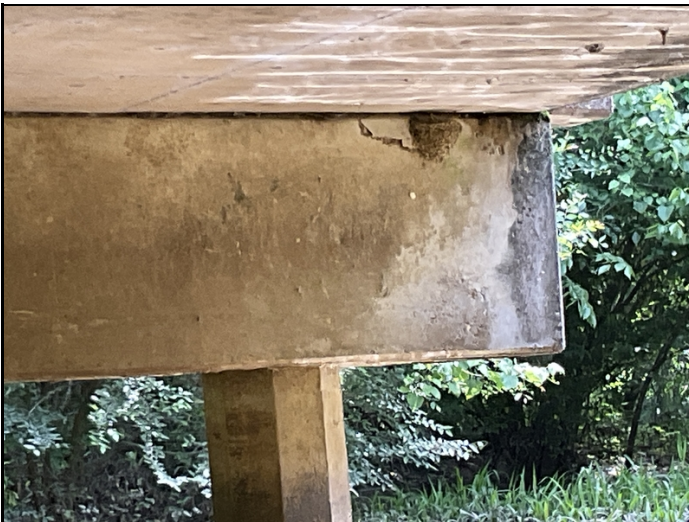
Bent #2 cap back face 1' from right side has a 1' delaminated area at top.

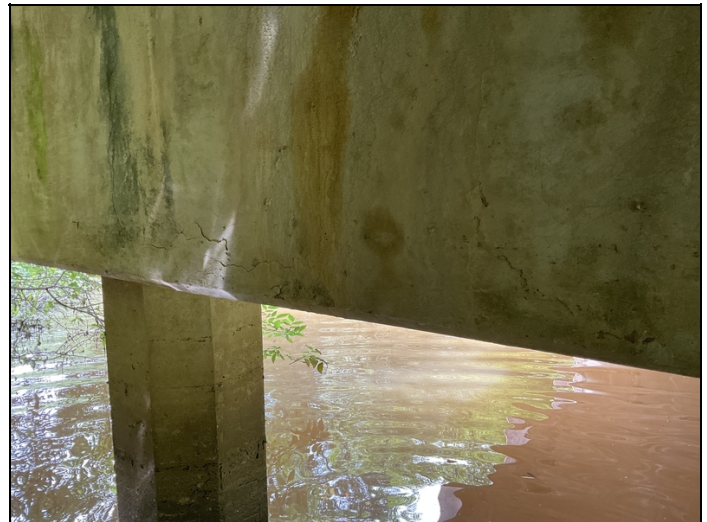
Bent #4 cap right side ahead face 3' from end has a 1' delaminated area and a 6" delaminated area.

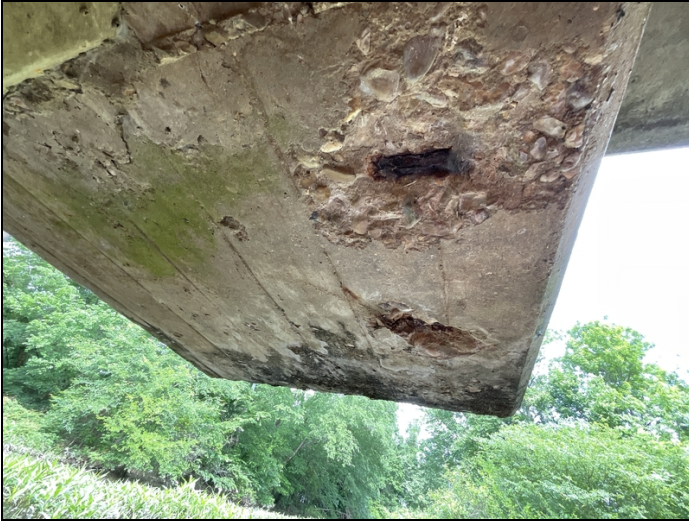
Bent #4 cap on bottom left end has 1' spall exposed
rebar moderate section loss.

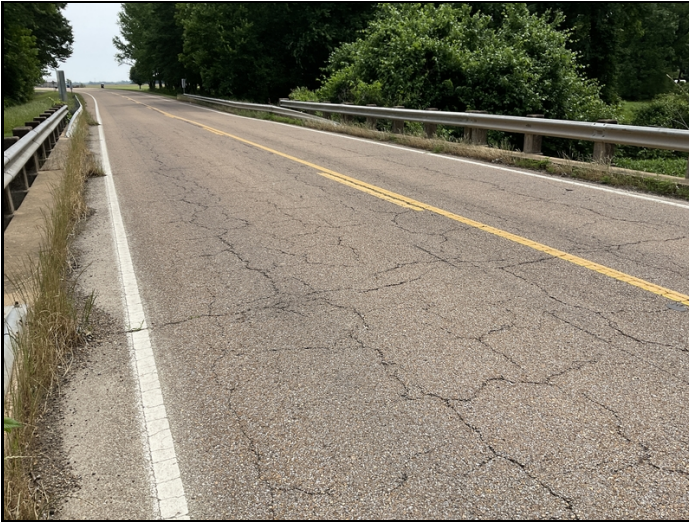
Wearing surface has multiple cracks different directions.

Typical deck

Type of Work: Repair (General)
