Asset #03070(Routine)

Sh-1/Sec-7/L-4.01 over Coffee Creek

Team Lead: Drew Melton, Inspection Date: 07/27/2022

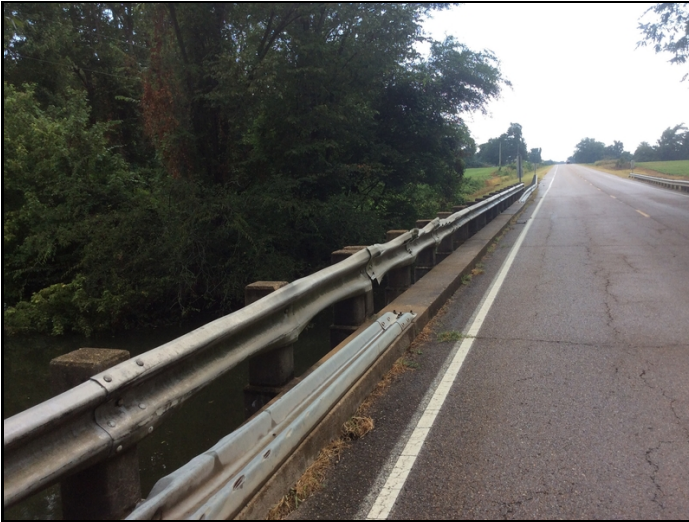
Span #1,2 bridge rail has collision damage full length.

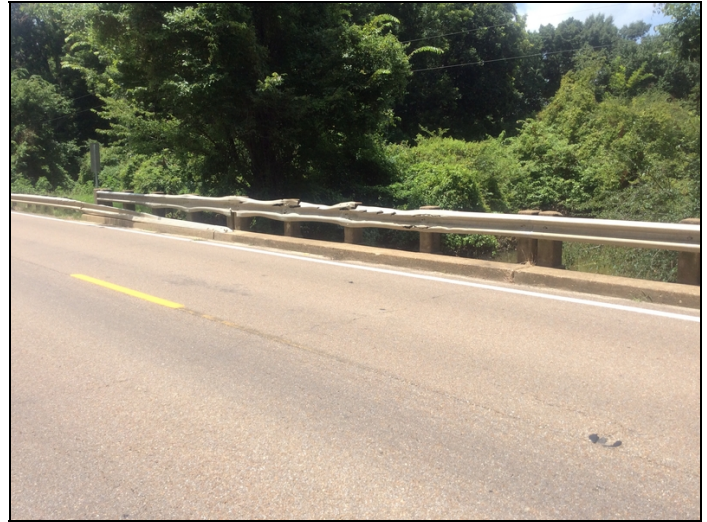
Left rail span #1

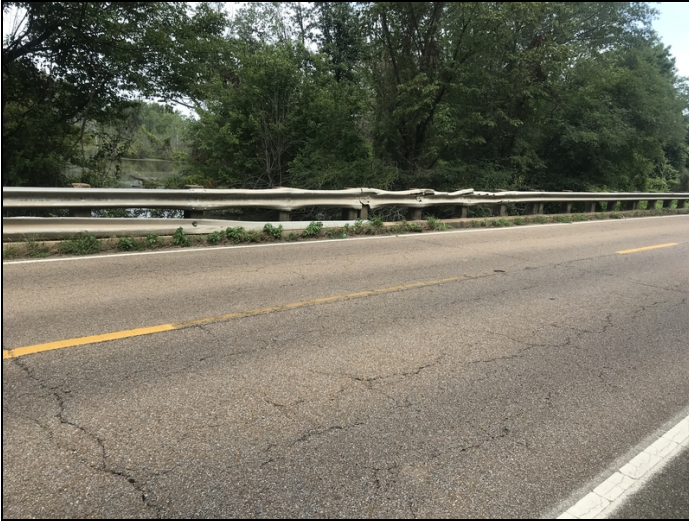
Left rail damage spans #1 and 2.

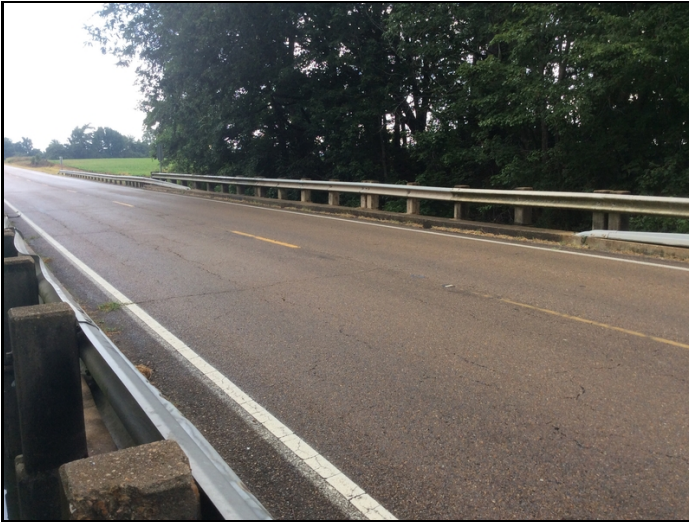
Gutters are full of dirt and debris with vegetation growing in them.

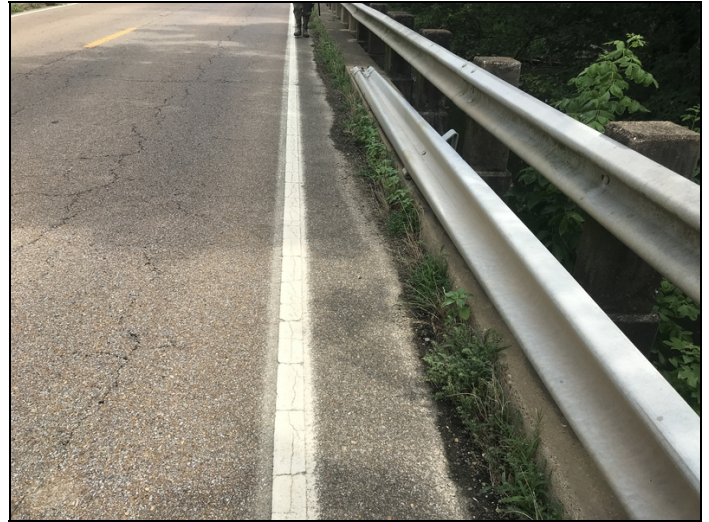
Dirt and vegetation in gutters.

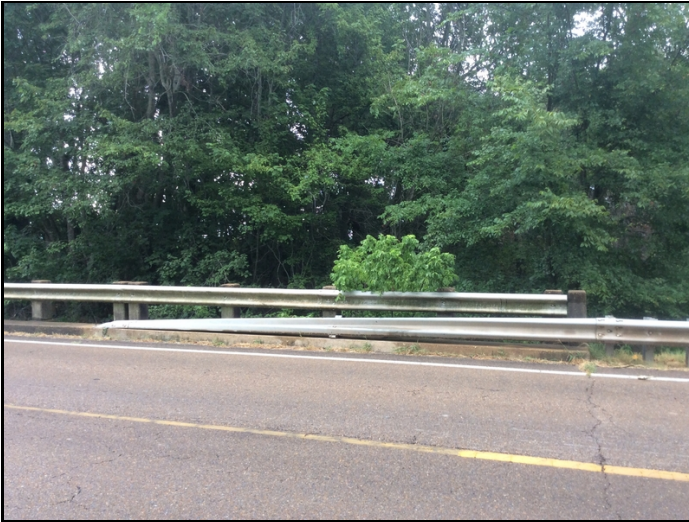
Trees and vegetation are growing beside and under bridge bridge and onto roadway.

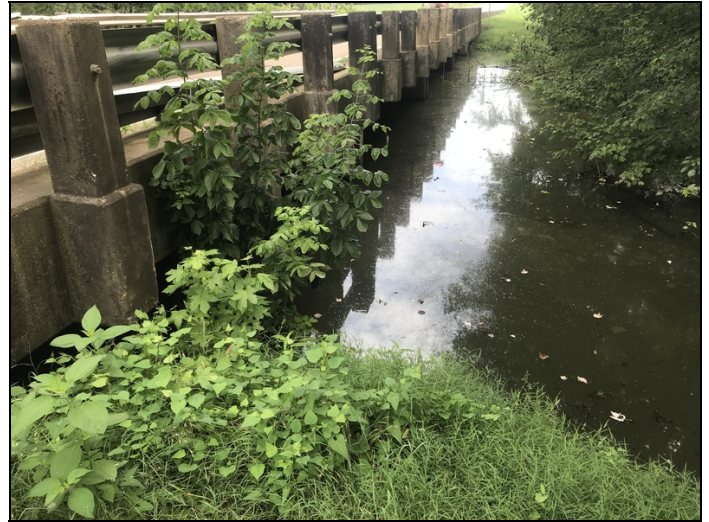
Vegetation growing bridge at abutment #1 right side

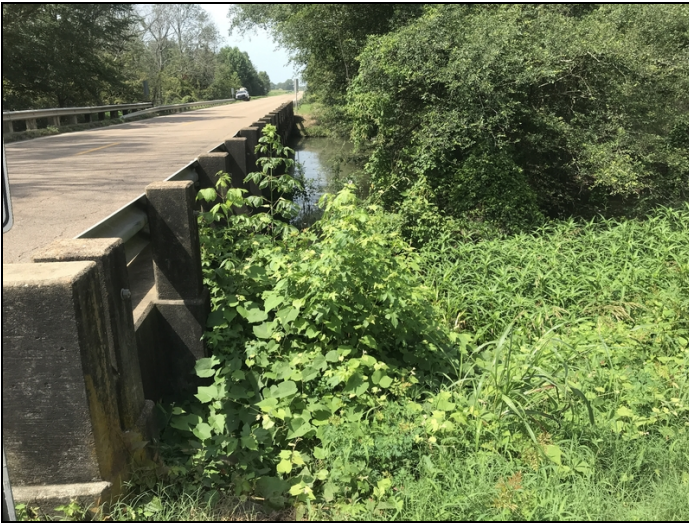
Trees and vegetation growing beside and under bridge
left side.

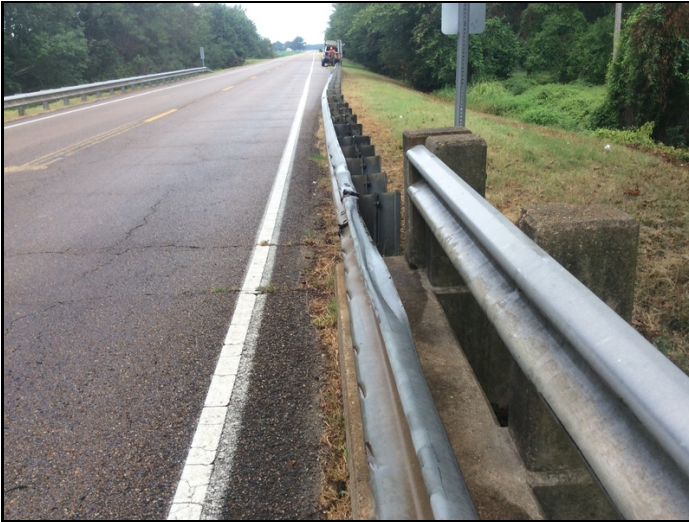
Abutment #1 left approach rail has multiple areas of collision damage.

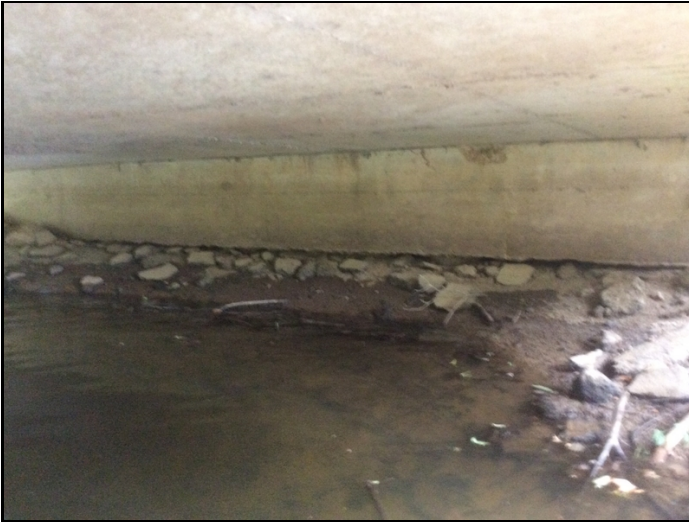
Abutment #1 cap is undermined six inches to eight inches deep for twenty five feet.

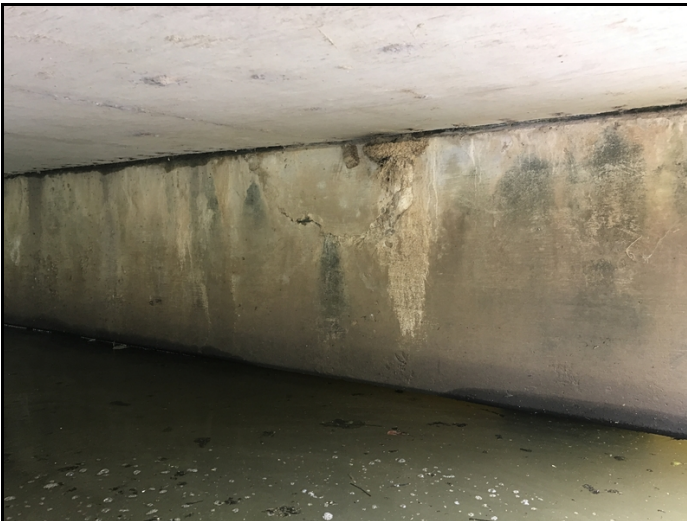
Bent #3 cap ahead face has 2' delamination on left side.

Delamination on bent #3 ahead face left side.

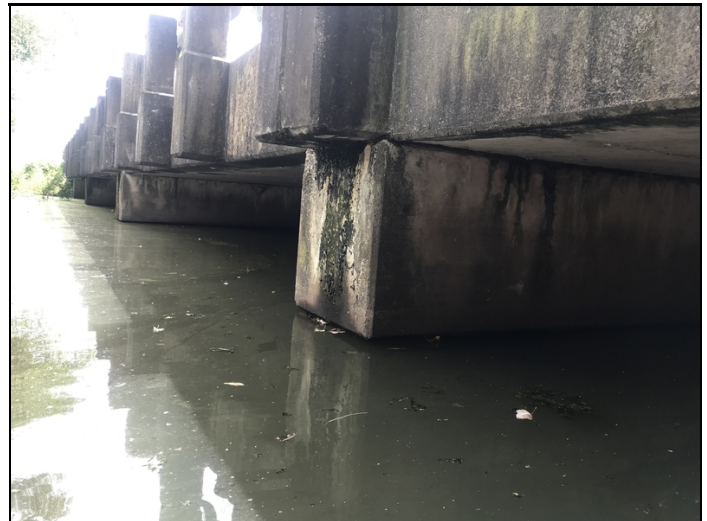
Bent #2 cap left side has two six inch spalls with no rebar exposed.

Bent #2 cap left end spalled with no exposed rebar.

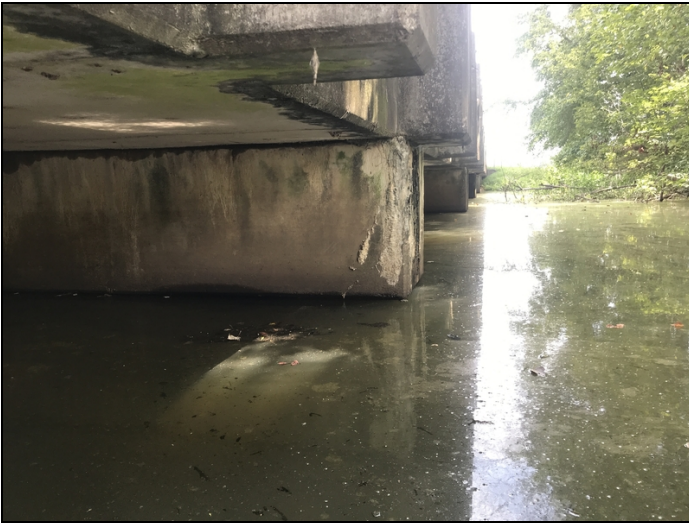
Bent #2 cap right end cracked with efflorescence last 1'.

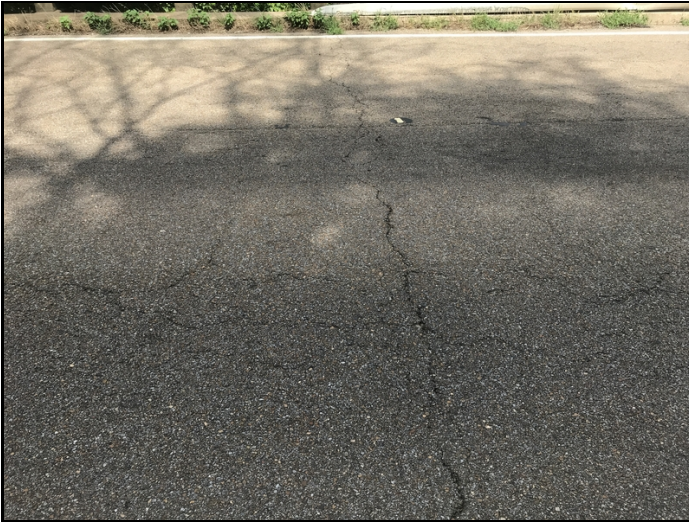
Bent #5 deck.

Wearing surface has open cracks throughout.
