Asset #03071 (Routine, Underwater type 2)

Sh-1/Sec-7/L-4.89 over Branch Of Coffee Creek

Location: 3.20 Mi S Jct Of Us 49

Team Lead: Drew Melton, Inspection Date: 08/10/2022

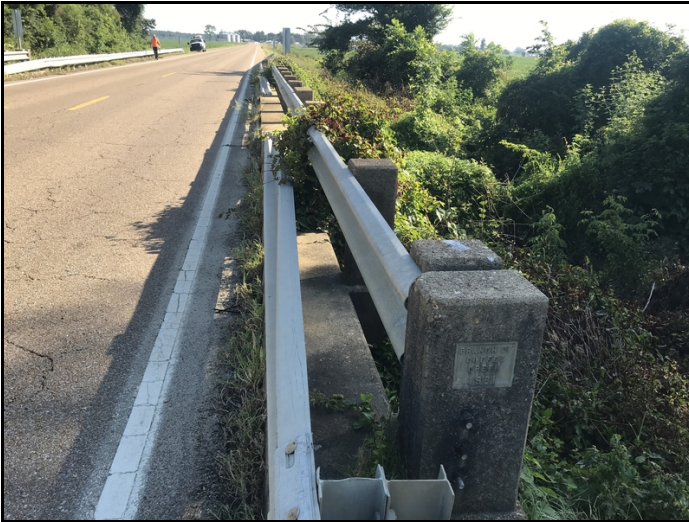
Gutters have vegetation growing in them.

Vegetation growing in gutters and beside, under and onto bridge.

Type of Work: (Inactive) (Inactive) 1 - Clean

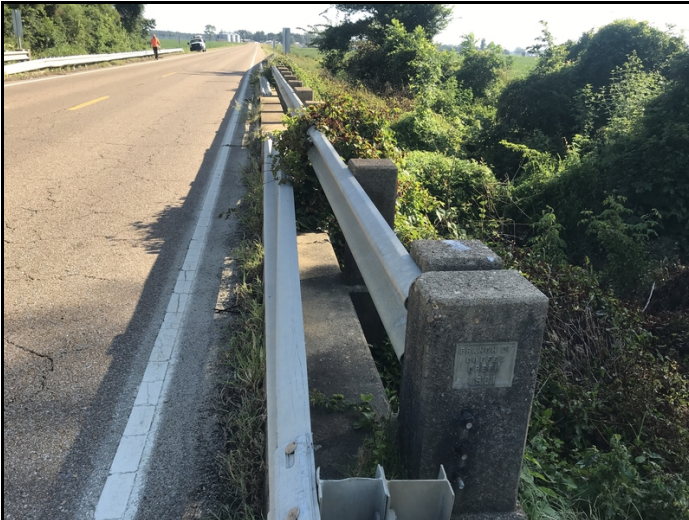
Vegetation growing beside and under bridge.

Vegetation growing in gutters and beside, under and onto bridge.

Type of Work: (Inactive) (Inactive) 1 - Clean

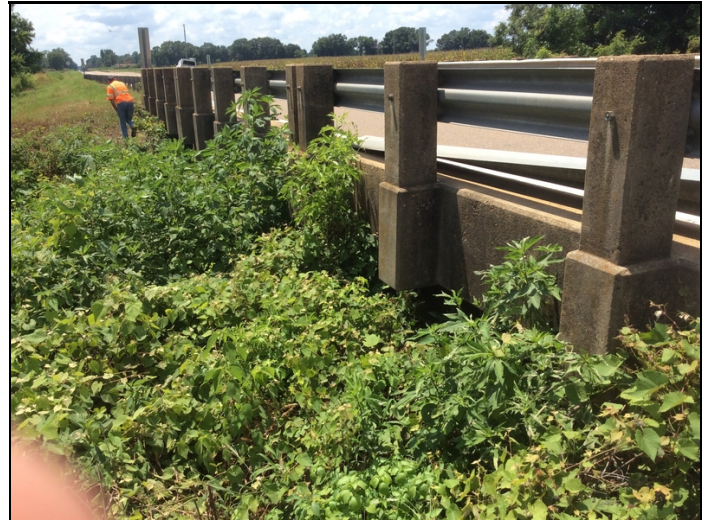
Vegetation growing beside and under bridge both side of both abutments

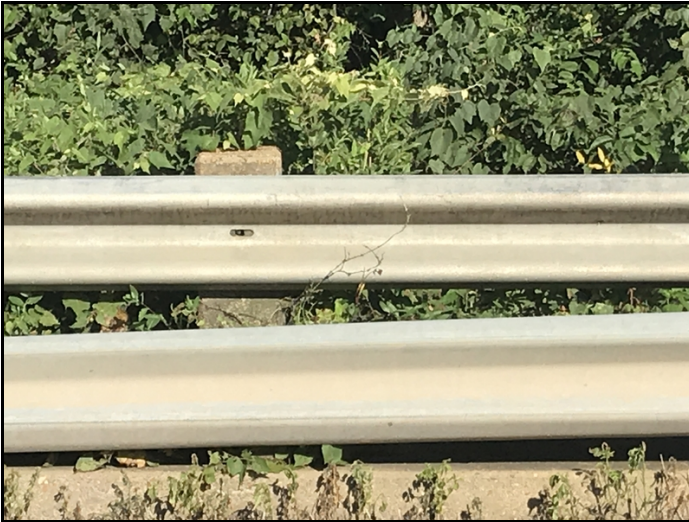
Span #3 left side fourth rail post missing bolt.

Type of Work: Replace (General)
