**Asset #M2516**(Routine, Underwater type 2)

**Sh-242/Sec-1/L9.30 over Creek**

**Location: 0.7 Miles East Of Sh 1**

**Team Lead: Myron Futrell, Inspection Date: 11/29/2022**

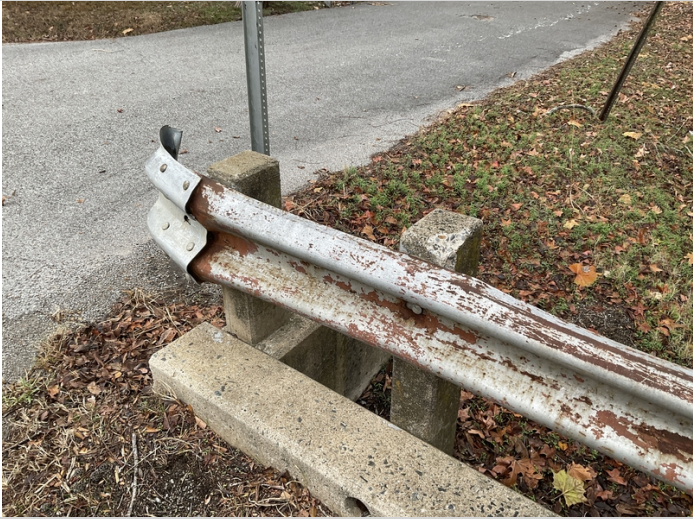
Sixth rail post right side has small spall on top with no exposed rebar end of rail has minor collision damage

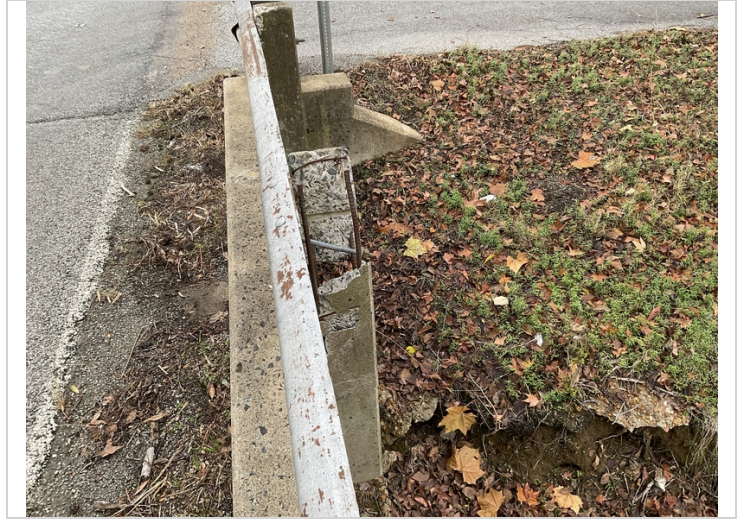
Fifth rail post right side broken, spalled with exposed rebar not connected to rail

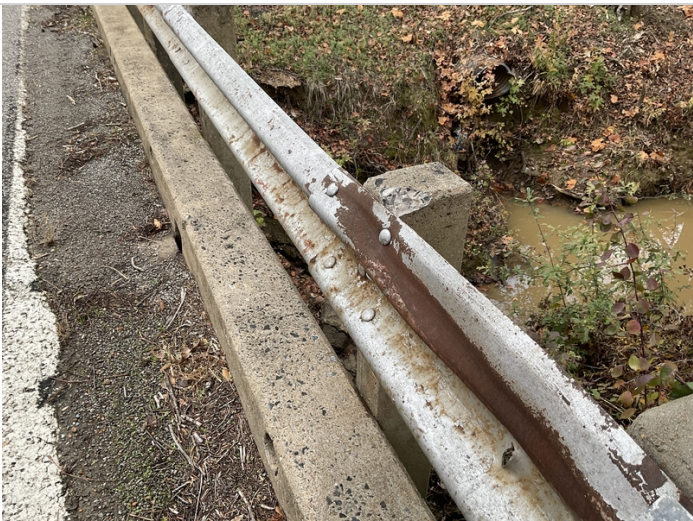
Second rail post right side has small spall with no exposed on top

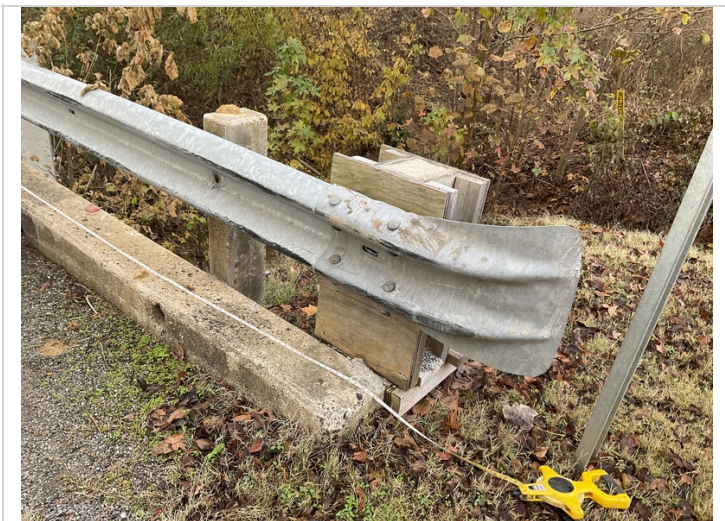
Left side rail posts #6 and 7 not connected, form left in place on rail post #7.

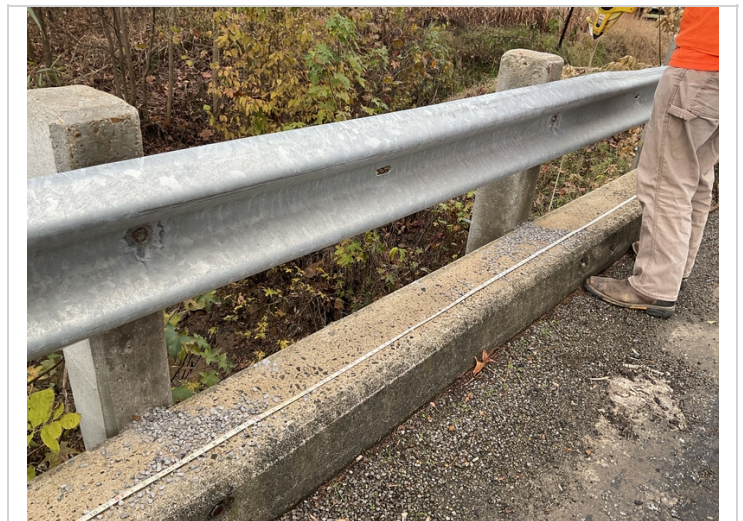
Left side, third and fourth rail posts not connected

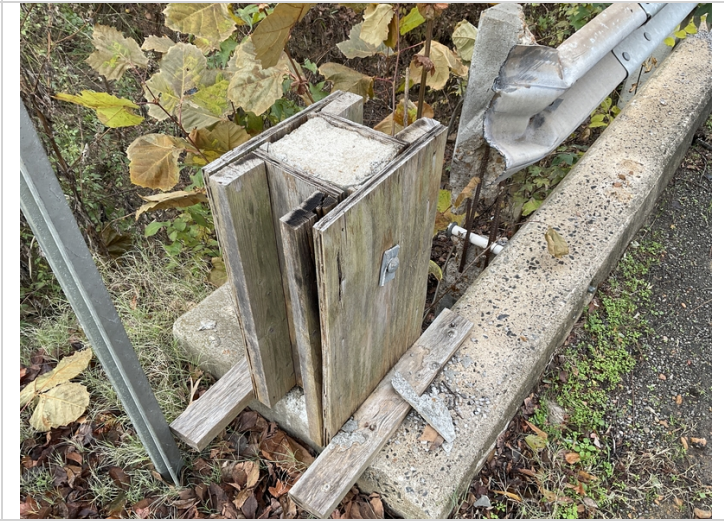
Abutment #1 left rail post has been repaired with form left in place. Second rail post broken, spalled with exposed rebar, first four feet of rail missing.

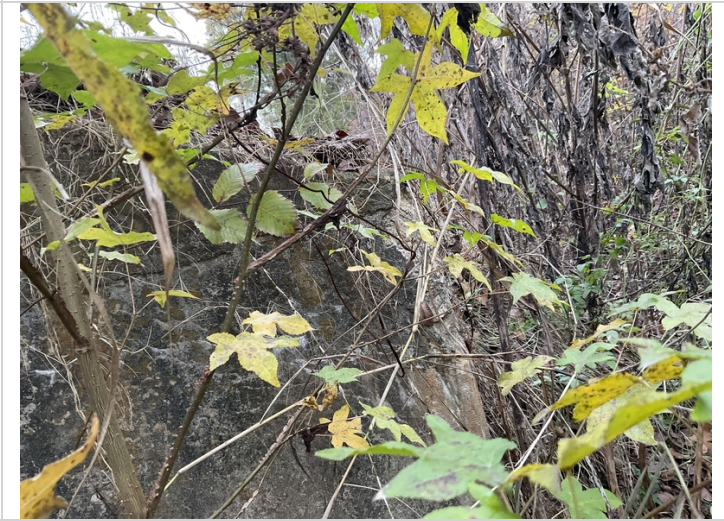
(215) Abutment #1 left wing has one foot of scaling with light efflorescence.							
216	Timber Abutment	LF	35	21	14	0	0
1140	Decay/Section Loss	LF	14	0	14	0	0

Abutment #1 left concrete wing has scaling with efflorescence first one foot.

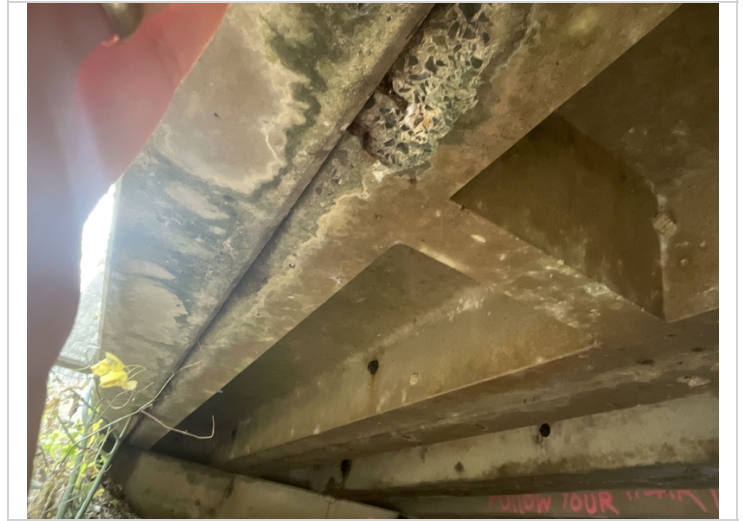
(110) Several units have pop outs with exposed rebar. Connection bolts are corroded with laminations no section loss. Unit #1 left leg center span has a one foot spall with no exposed rebar. Unit #1 left leg three quarter span has a six inch spall with no rebar exposed. Second transverse bolt between girders #2 and 3 has nut rusted off. Unit #6 at first transverse bolt has small spall and delamination.							
215	Reinforced Concrete Abutment	LF	20	19	1	0	0
1080	Delamination/Spall/Patched Area	LF	1	0	1	0	0

Unit #1 left leg spalled at half and three quarter span with no exposed rebar.

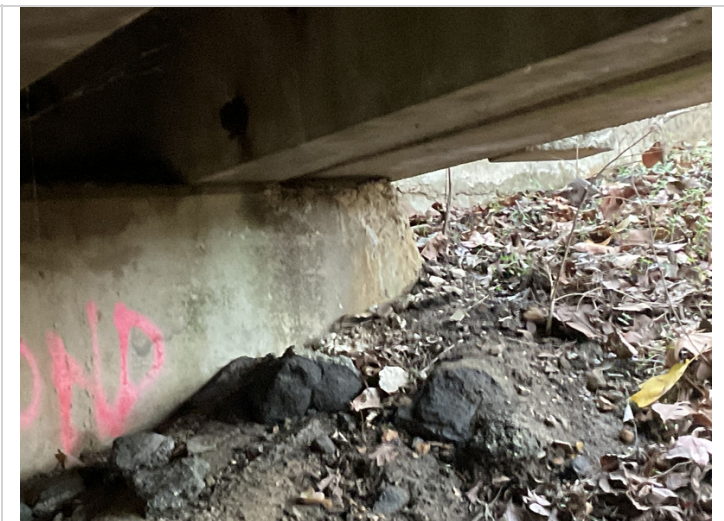
(234) Several small areas of steel exposed on faces of cap where snap ties were broken off. Abutment #1 cap has a few cracks with light efflorescence. Abutment #2 cap back face right side has six inch shallow spall with no exposed rebar.							
330	Metal Bridge Railing	LF	62	14	37	5	6
1000	Corrosion	LF	31	0	31	0	0
1020	Connection	LF	5	0	0	5	0
7000	Damage	LF	12	0	6	0	6
515	Steel Protective Coating	SF	186	70	111	0	5

Abutment #2 cap back face right side has six inch shallow spall with no exposed rebar.

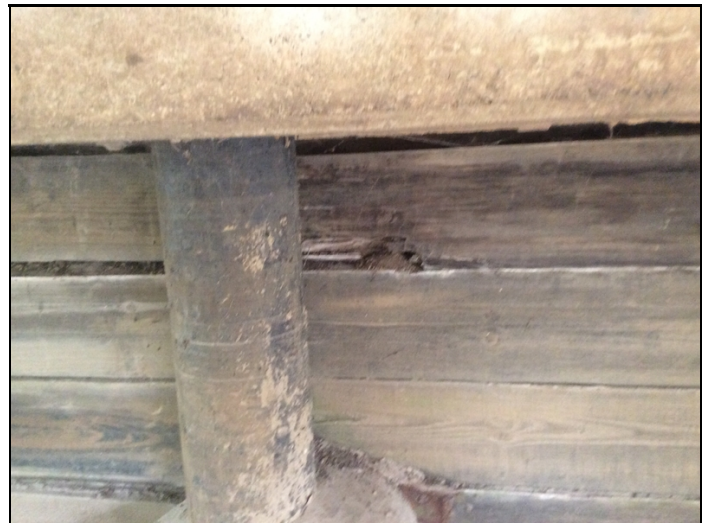
Abutment #1 timber back wall behind pile #3

(216) Abutment #1 timber abutment is decayed behind piles #3,5 for eight feet in length.							
228	Timber Pile	EA	5	1	0	4	0
1140	Decay/Section Loss	EA	4	0	0	4	0

Abutment #1 timber abutment is decayed behind piles #3,5 for eight feet in length.

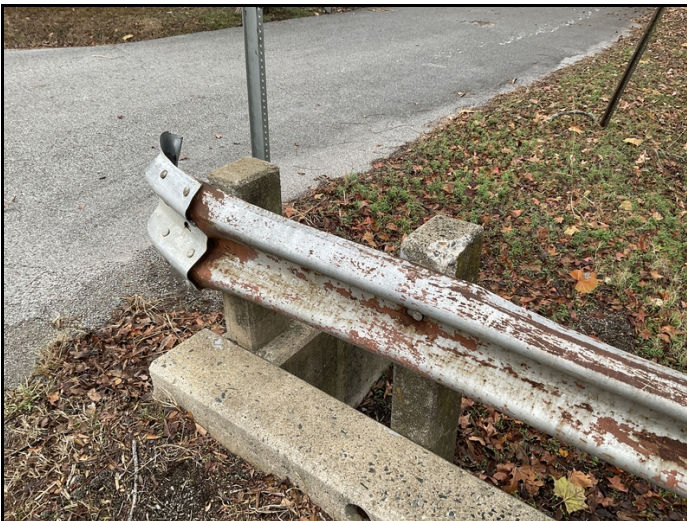
Sixth rail post right side has small spall on top with no exposed rebar end of rail has minor collision damage

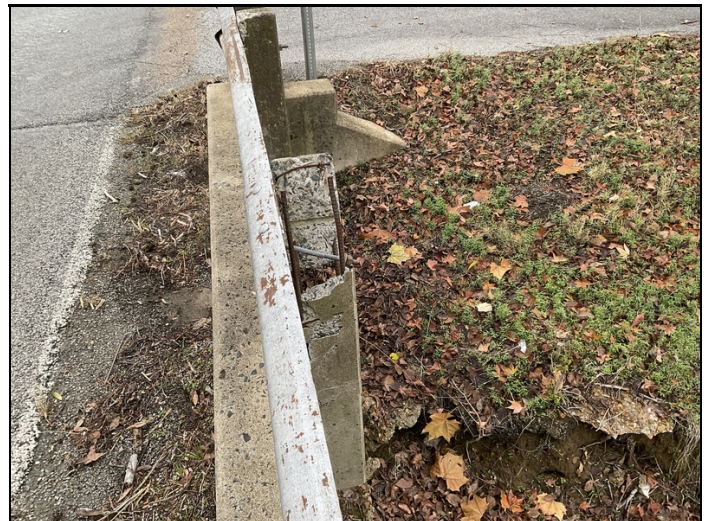
Fifth rail post right side broken, spalled with exposed rebar not connected to rail

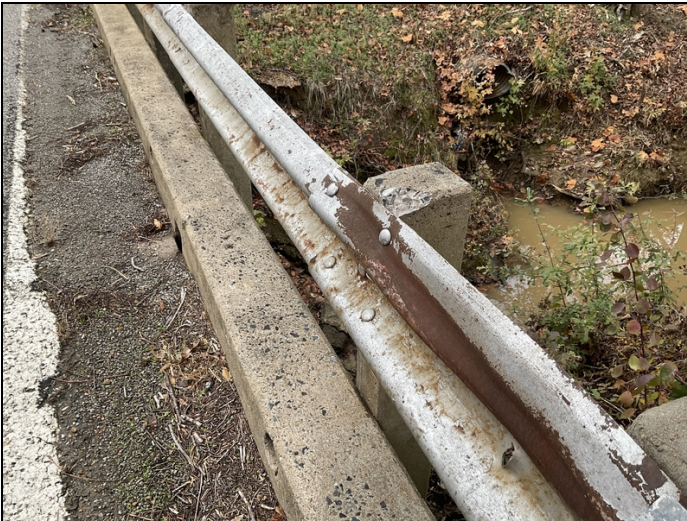
Second rail post right side has small spall with no exposed on top

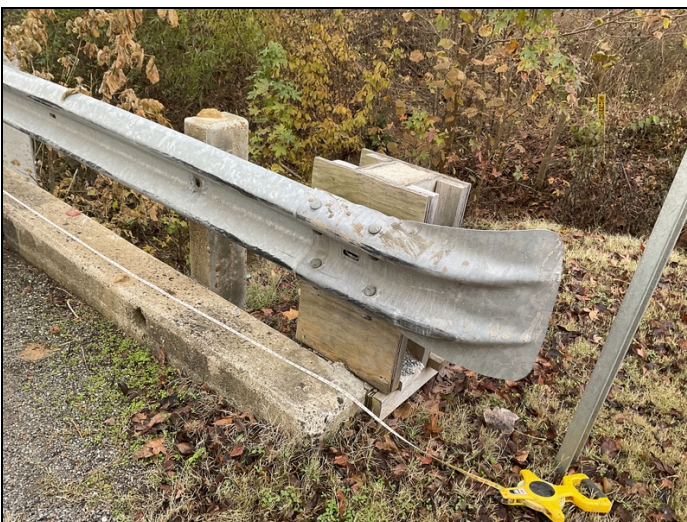
Left side rail posts #6 and 7 not connected, form left in place on rail post #7.

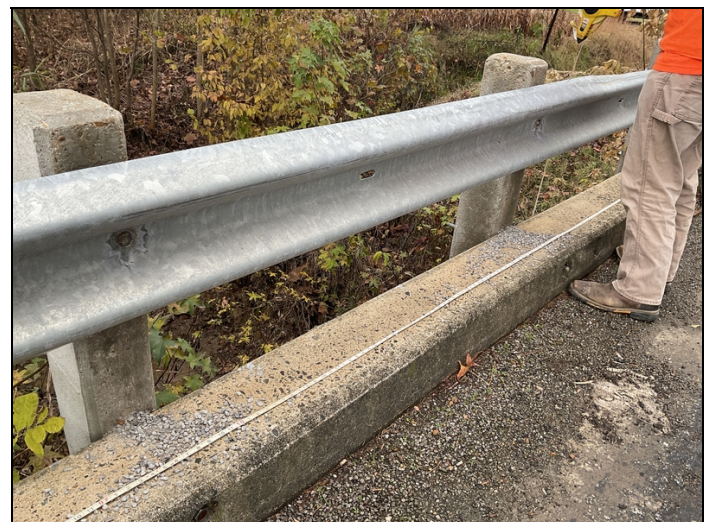
Left side, third and fourth rail posts not connected

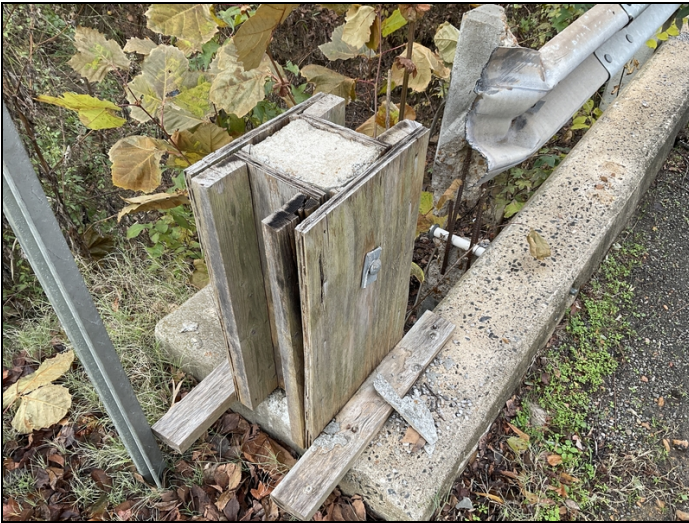
Abutment #1 left rail post has been repaired with form left in place. Second rail post broken, spalled with exposed rebar, first four feet of rail missing.

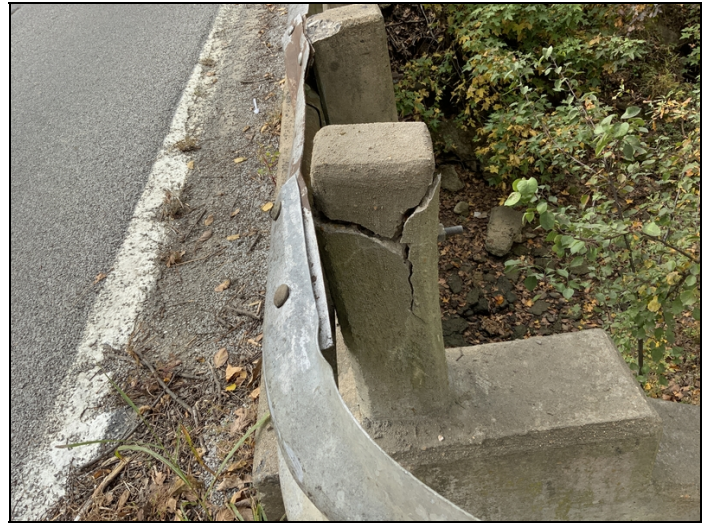
Abutment #1 right side first rail post broken.

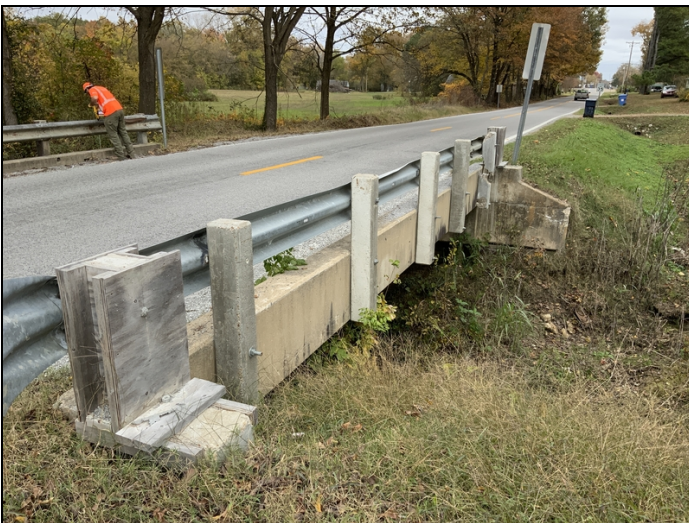
Second rail post on left side broken with exposed rebar.  
Fifth rail post on right side broken with exposed rebar.  
Abutment #1 and 2 left side first and last posts have been repaired, forms left in place.

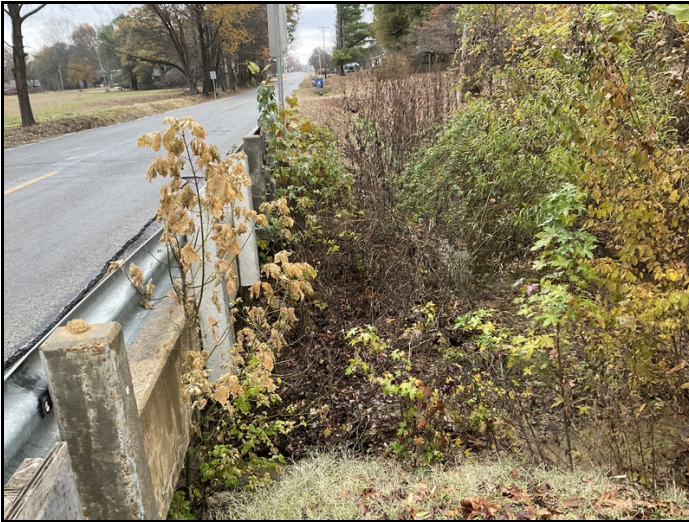
Trees and vegetation growing beside and under bridge

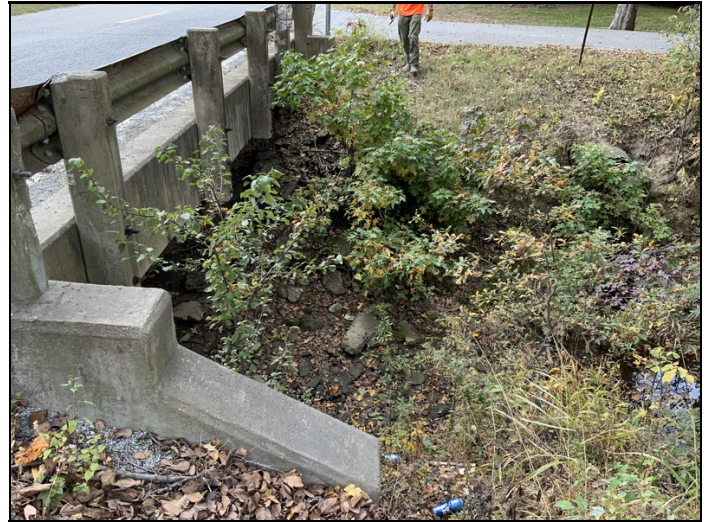
Small trees and vegetation growing beside bridge.
