Asset #M4049(Routine, Underwater type 2)

Sh-242/Sec-1/L8.71 over Cura Creek

Location: 1.3 Mi East Jct 1 & 242

Team Lead: Drew Melton, Inspection Date: 08/09/2022

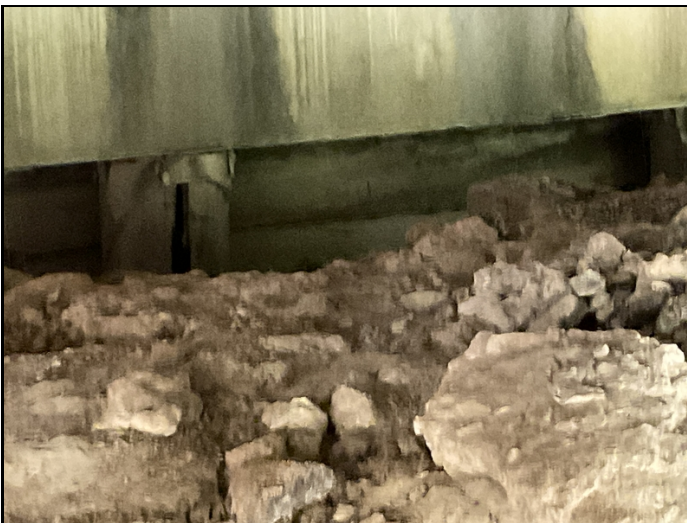
Bent #1 pile #3 is split 2" wide and core decayed with moderate section loss.

Type of Work: Replace (General)

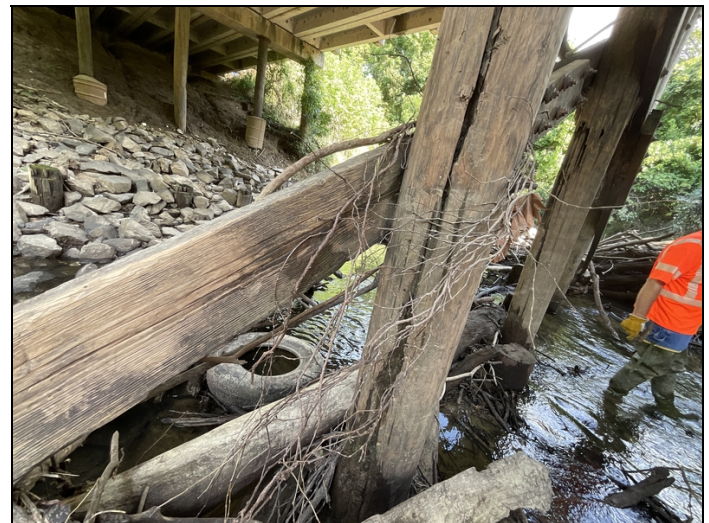
Bent #3 pile #2 has a split and outer shell decay with moderate section loss.

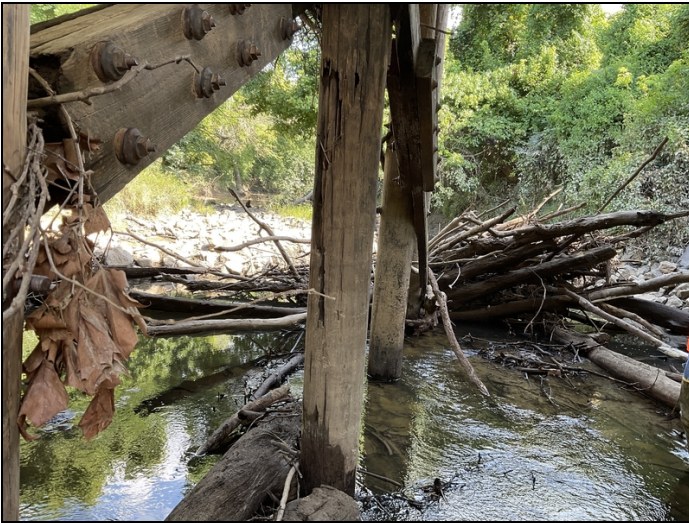
Bent #3 pile #3 has outer shell decay with moderate section loss.

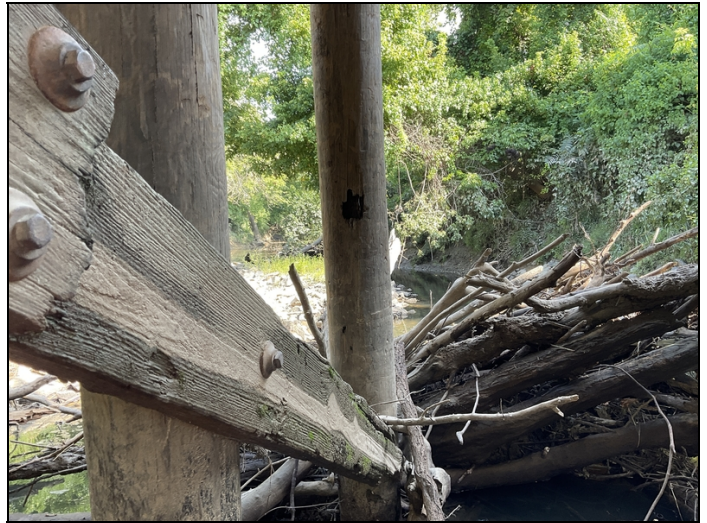
Bent #3 pile #5 each has outer shell decay with moderate section loss.

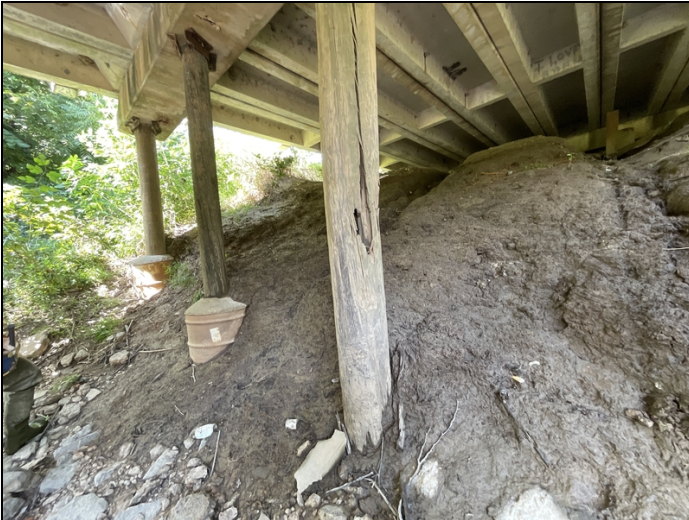
Bent #4 pile #3 has outer shell decay with moderate section loss and is split.

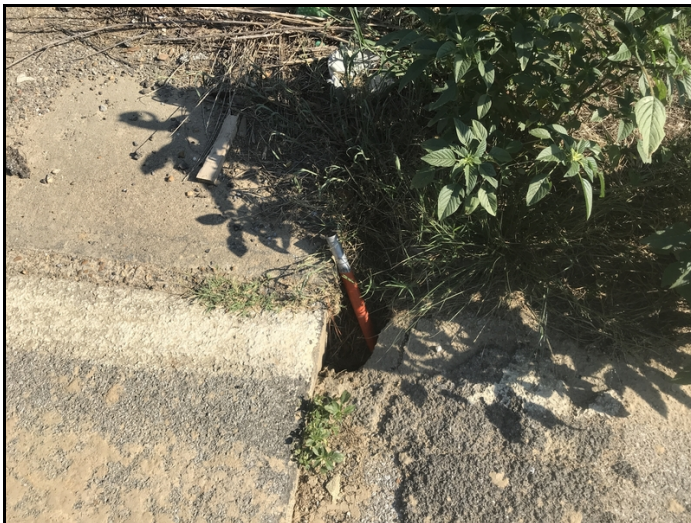
Abutment #1 right approach roadway has 2' tall x 3' wide x 2' long void behind cap at bridge end.

Hole in abutment #1 approach roadway, right side.

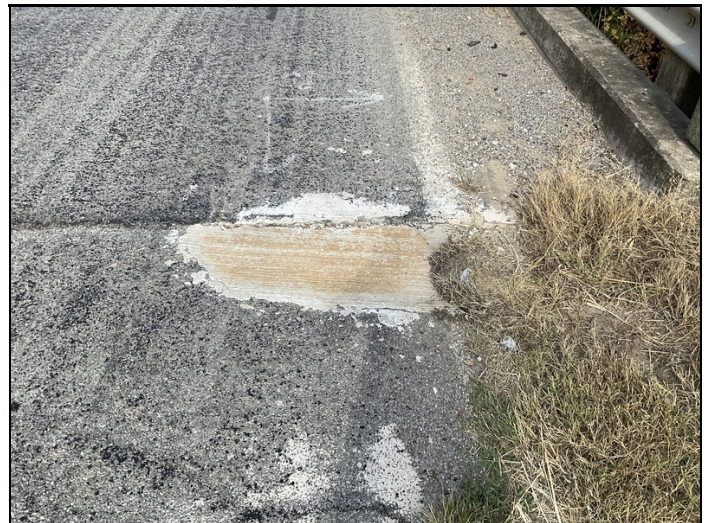
Abutment #1 hole in approach roadway repaired.

Hole at bridge end has been repaired at time of inspection

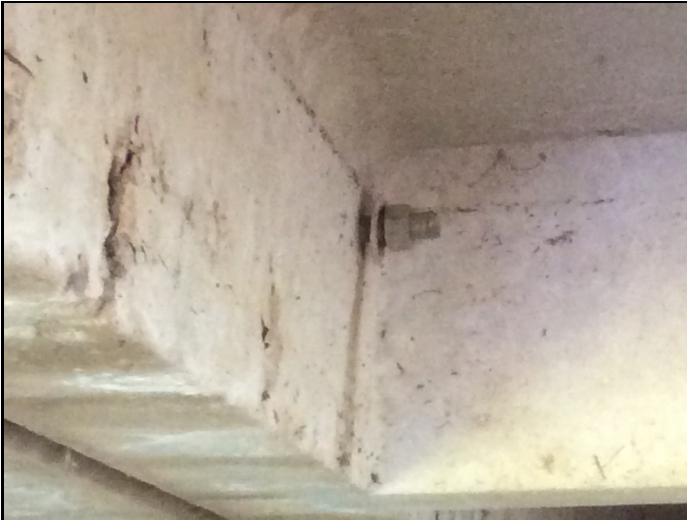
Span #1 between units #4,5 center span bolt is loose.

Loose bolt between units #4&5 span #1 typical other locations.

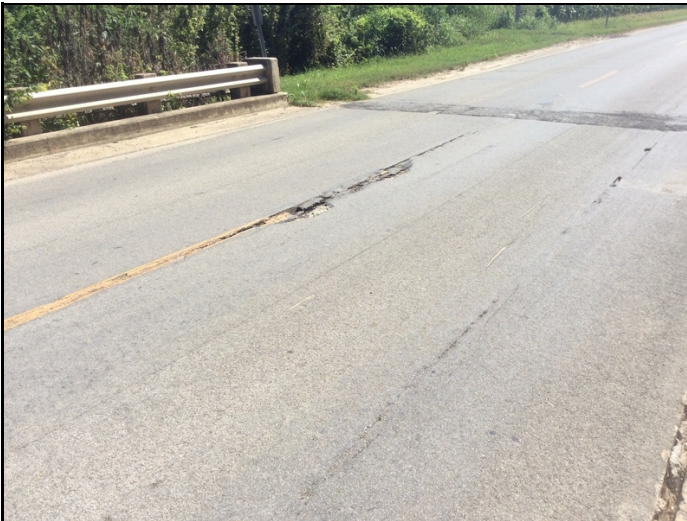
Span #1 deck.

Span #1 joint between units #1,2 and 2,3 is spalled two inches deep.

Span #1 between units #4,5 is spalled three to four inches deep and also spalling unit #4.

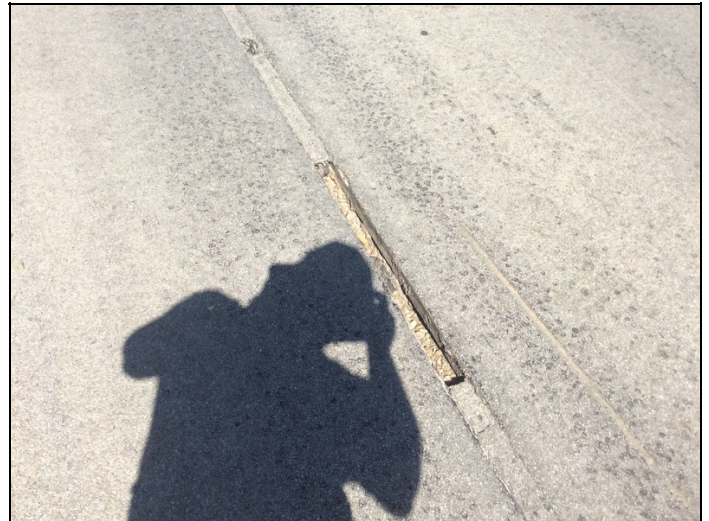
Span #3 deck joint between units #2,3 spalled three inches deep.

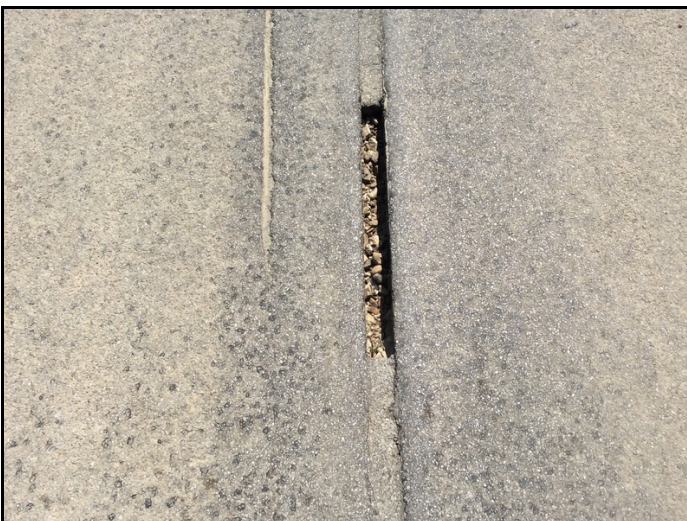
Span #3 joint between units 2&3

Span #3 deck joint between units #2,3 has repaired spalled area with asphalt.

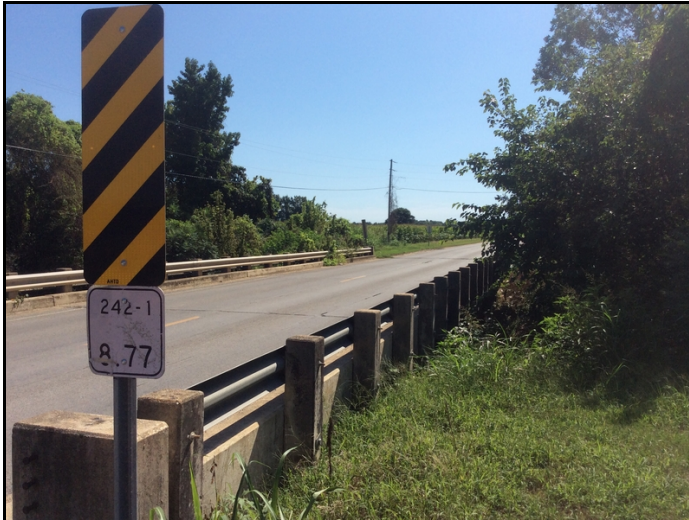
Trees and vegetation are growing beside and under bridge and onto roadway.

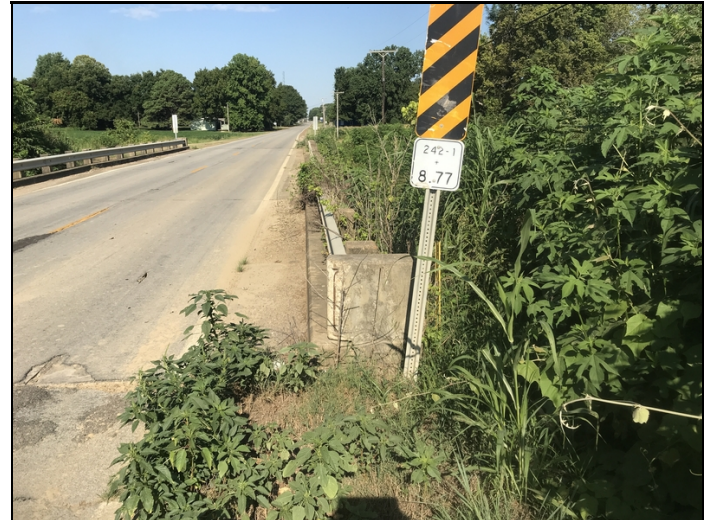
Vegetation growing beside, under and onto bridge.

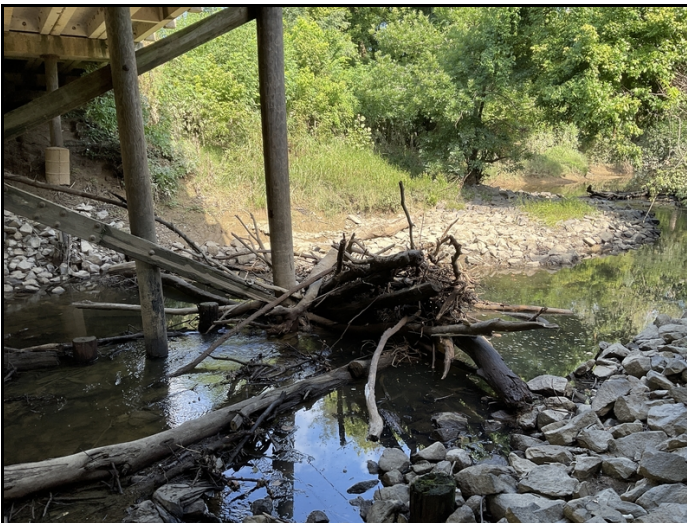
Bent #3 right side has a moderate drift

Drift in channel right side at bent #3

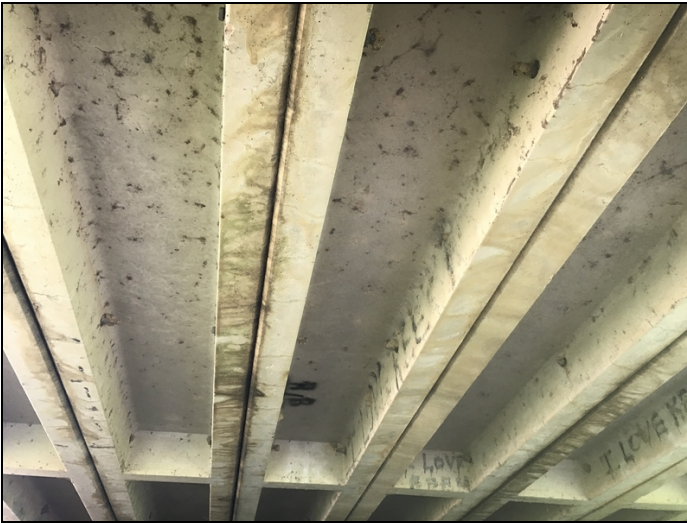
Span #4 soffit / underside of deck.

Span #4 unit #2 left leg has cs2, cs3 cracks in side and bottom for 18' starting at 1/4 span.
Span #4 unit #5 right leg has cs2 cracks in side of steam for 3' at 1/4 span.
Span #4 unit #7 right leg has cs2, cs3 cracks in side of stem for 15' center span.

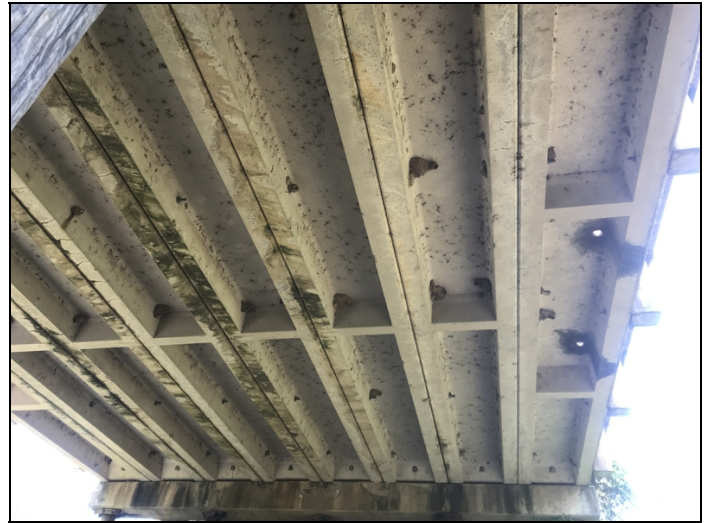
Span #3 soffit/ underside of deck.

Span #3 unit #1 left leg has cs3 cracks for 2' on bottom chord 1/4 span.
Span #3 unit #2 left leg has cs3 cracks for 3' on bottom chord 1/4 span.
Span #3 unit #2 right leg has cs3 cracks for 2' on bottom chord center span.
Span #3 unit #4 left leg has cs2 cracks on side and bottom at 1/4 span for 4'.
Span #3 unit #5 right leg has cs2 cracks for 12' on side of stem starting at 1/4 span.
Span #3 unit #6 left leg has cs2 cracks on bottom for 15' starting at 1/4 span.

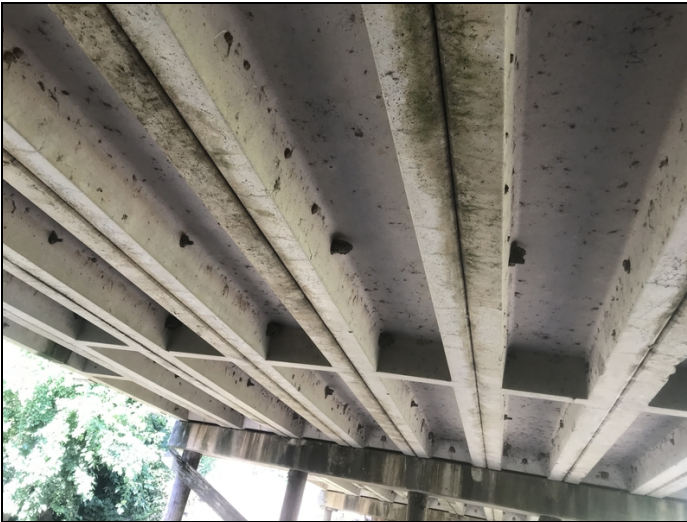
Span #2 soffit / underside of deck.

Span #2 unit #1 right leg has cs3 cracks for 8' on bottom chord starting at bent #2.

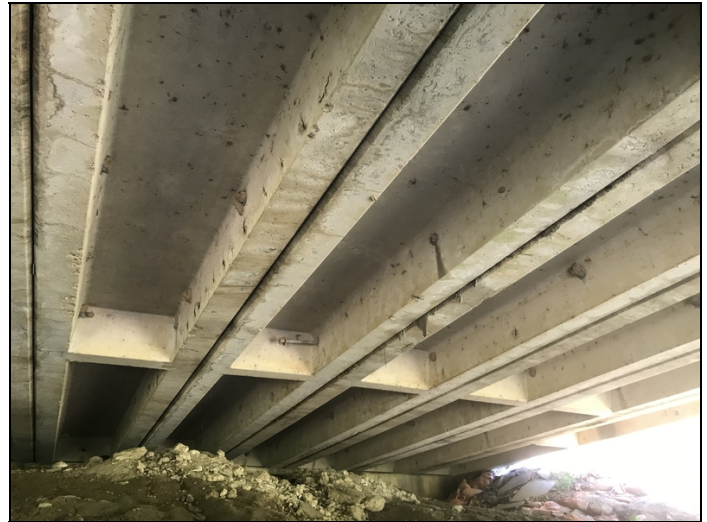
Span #1 soffit / underside of deck.

Span #1 at bent #2 and span #4 at bent #5 curb unit left and right sides have areas of spalling with no rebar exposed.
Span #1 unit #1 right leg has cs3 cracks for 3' on side of girder just ahead on center span, has a 1' delamination on side of leg at 1/4 span, and a 1' spall with no exposed rebar on bottom just ahead on center span.
Span #1 unit #2 both legs have cs3 cracks in side of stem full length.
Span #1 unit #3 both legs have cs3 cracks in side of stem first half of span.
Span #1 unit #4 right leg has cs3 cracks in side of stem full length, and a 1' spall exposed rebar just ahead of center span in side/bottom moderate section loss.
Span #1 unit #4 left leg has cs3 cracks first half of span on side of steam.
Span #1 unit #6 left leg has cs2,cs3 cracks in side of stem in center for fifteen feet and several pieces of exposed rebar due to poor coverage with moderate section loss.
Span #1 unit #6 right leg has cs2 cracks for 6' on side of stem first part of span.

Span #1 unit #7 left leg has cs2,cs3 cracks in side of stem first half of span.
Span #1 unit #7 right leg has cs2 cracks for 8' on side of stem near center.

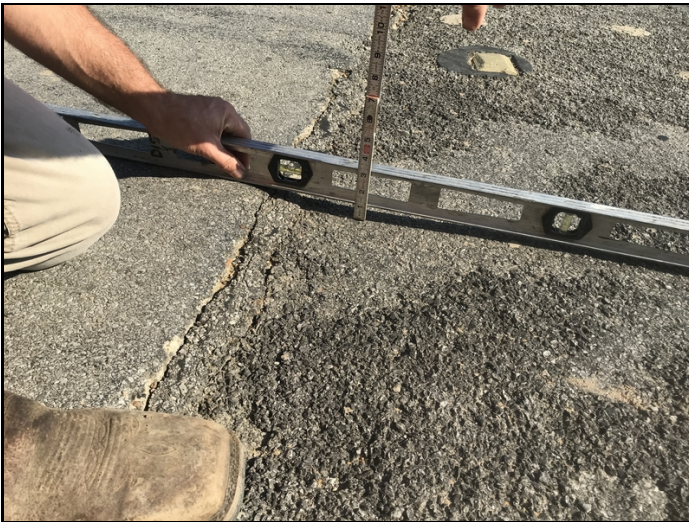
Abutment #1 approach roadway has settled up to 1 1/4".
Abutment #2 approach roadway has settled up to 1 1/4".

Abutment #1 approach roadway settlement.

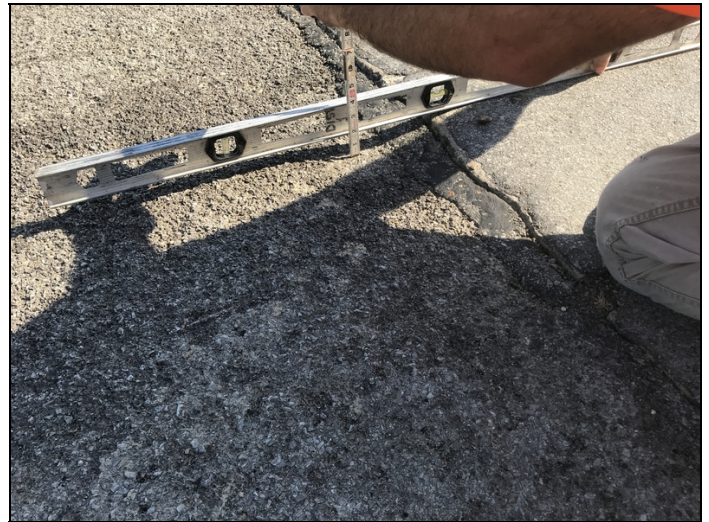
Abutment #2 approach roadway settlement.

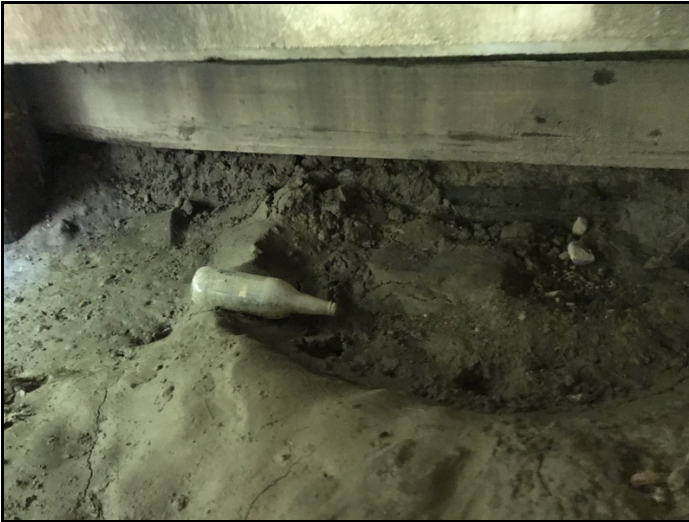
Abutment #1 timber back wall between piles #4 and 5.

Abutment #1 timber back wall decayed between piles #4 and 5 allowing erosion behind cap.

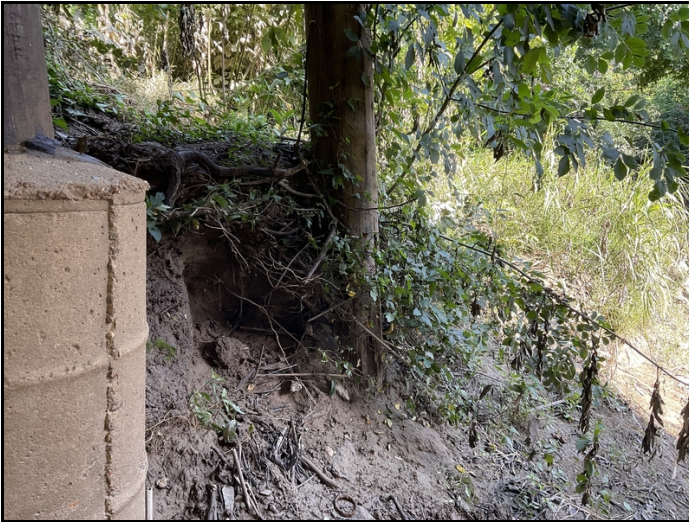
Bent #4 pile #5 has minor outer shell decay.

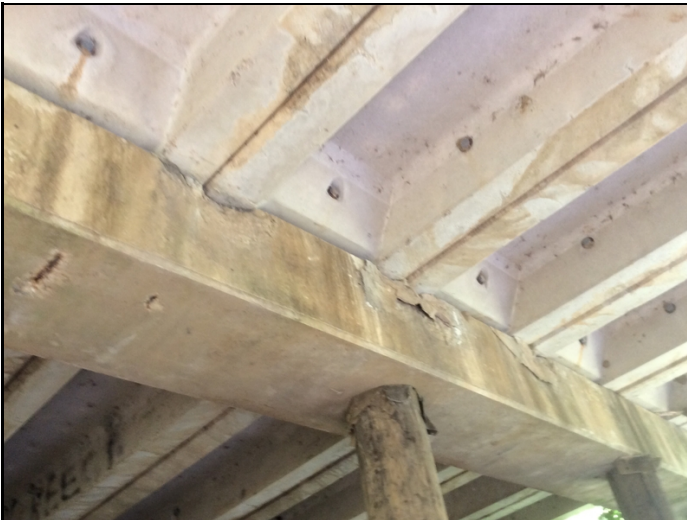
Bent #4 cap back face has five one foot spalls at top with no rebar exposed.

Bent #4 cap back face 6 sq ft spalls no rebar.

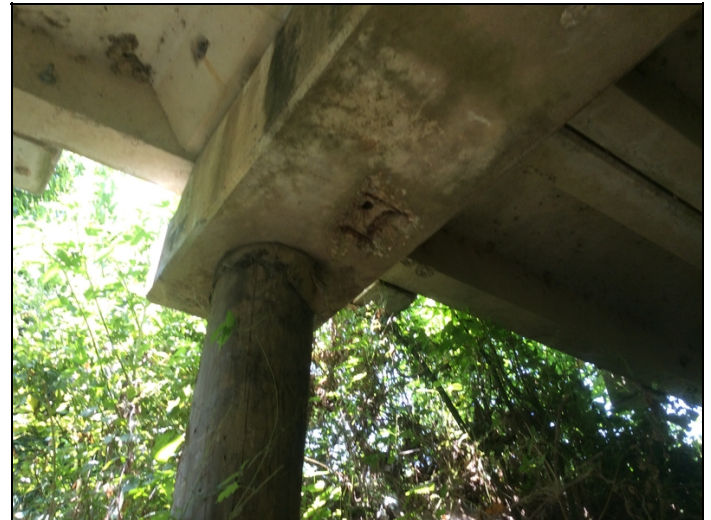
Bent #4 cap bottom at pile #1

Bent #4 cap bottom has a one foot spall with exposed rebar with moderate section loss near pile #1 and a few random pieces of rebar exposed due to poor coverage.

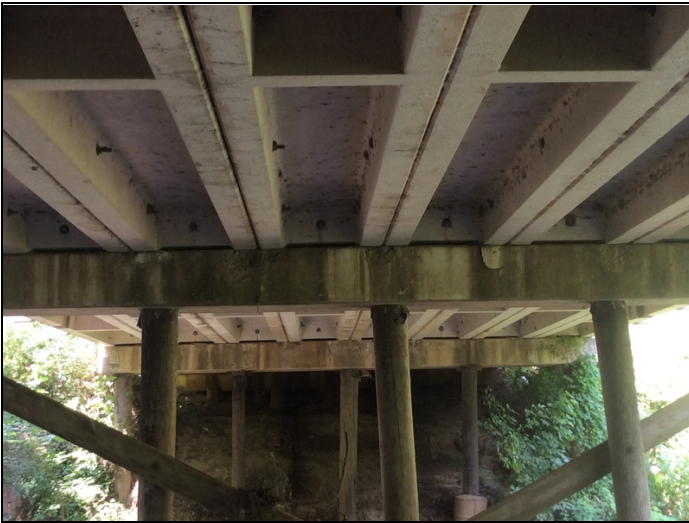
Bent #3 cap back face has three one foot and one two foot spalls at top with no exposed rebar and two 1' delaminations.

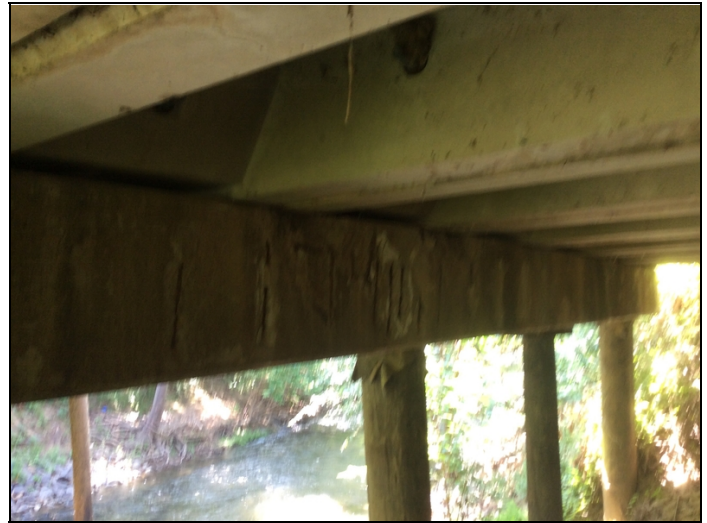
Bent #4 cap ahead face has six feet of spalls between piles #3,#4 with exposed rebar with minor section loss.

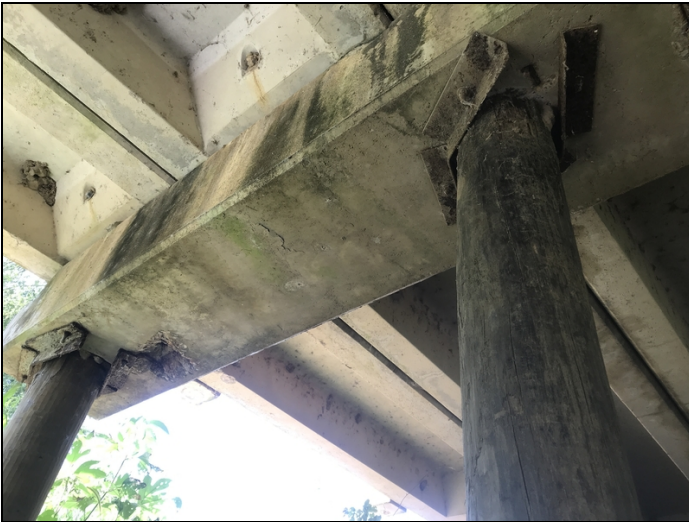
Bent #3 cap bottom face has 1' spall with exposed rebar with 5% section loss above pile #1.

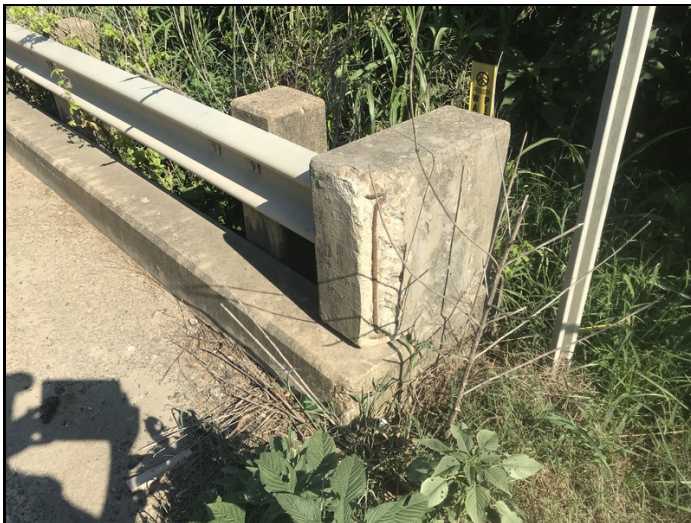
Abutment #1 right headwall is spalled with exposed rebar with no section loss.

Abutment #1 right monument post spalled with exposed rebar.

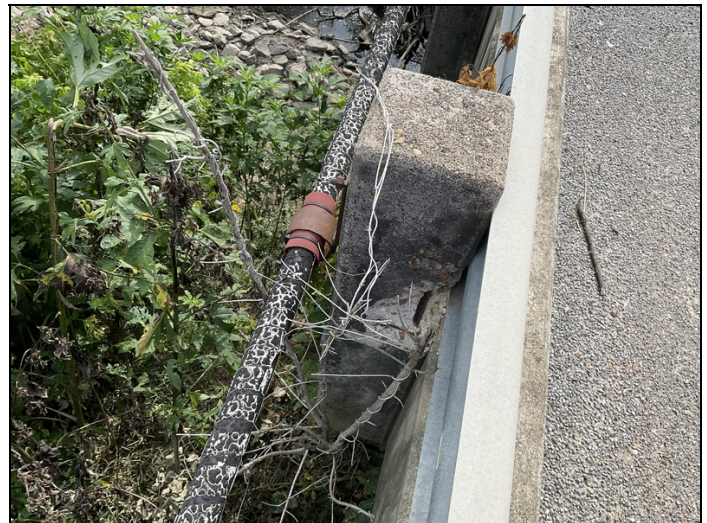
Span #4 right bridge rail span #4 post #2 is spalled with exposed rebar minor section loss.

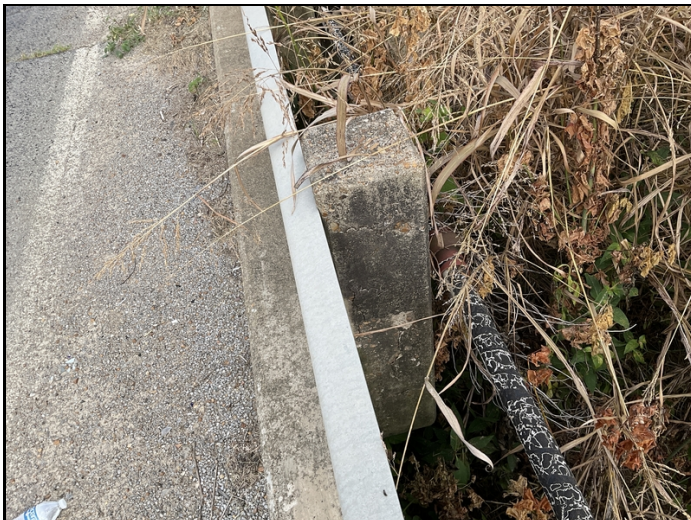
Span #4 right bridge rail span #4 post #4 has cs3 cracks and delaminated areas.

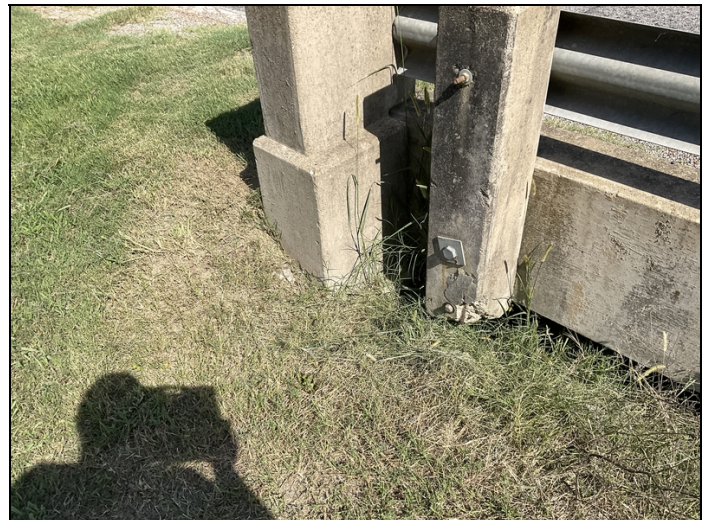
Span #4 left bridge rail last post is spalled at bottom with exposed rebar no section loss.

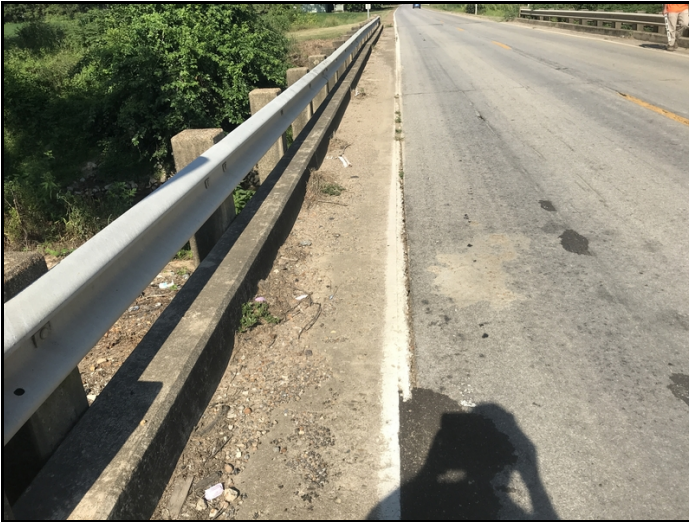
Gutters have dirt and debris in them.

Dirt and debris in gutters.
