Asset #06293(Routine, Underwater type 2)

Sh-38/Sec-2/L-1.55 over Cache River

Location: 1.55 Miles East Jct Sh 33

Team Lead: Drew Melton, Inspection Date: 12/20/2022

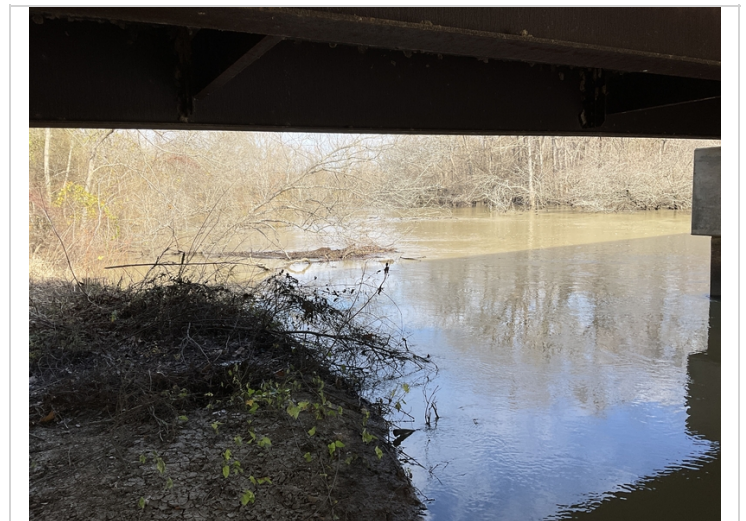
Channel banks has some slumping, and channel has trees and vegetation hanging into and some in channel.
Abutment #1 left side channel is eroded within 30' of bridge.

Channel left side

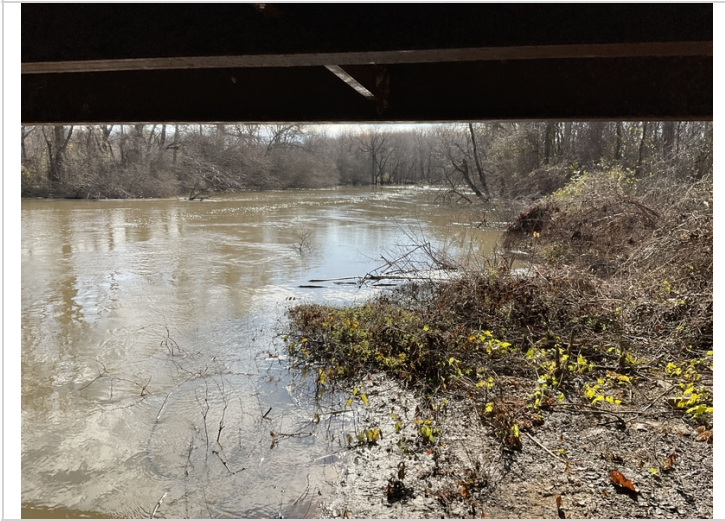
Channel right side

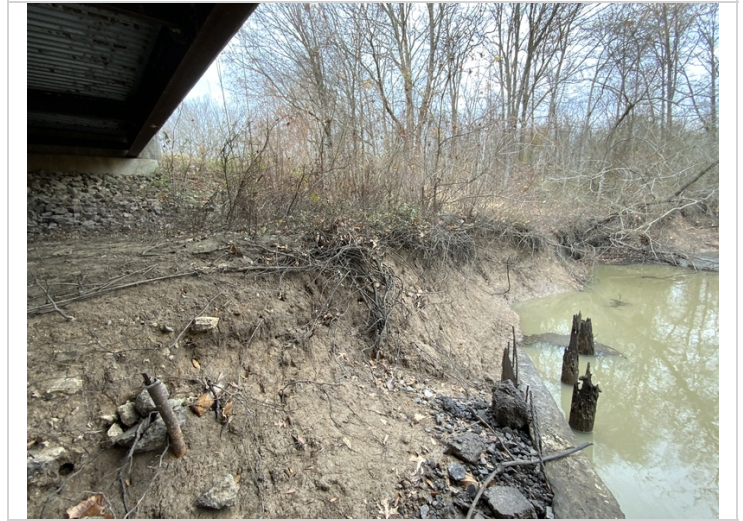
Comment: Channel banks has some slumping, and channel has trees and vegetation hanging into and some in channel. Abutment #1 left side channel is eroded within 30' of bridge.

Abutment #1 left side channel eroded within 30' of bridge.

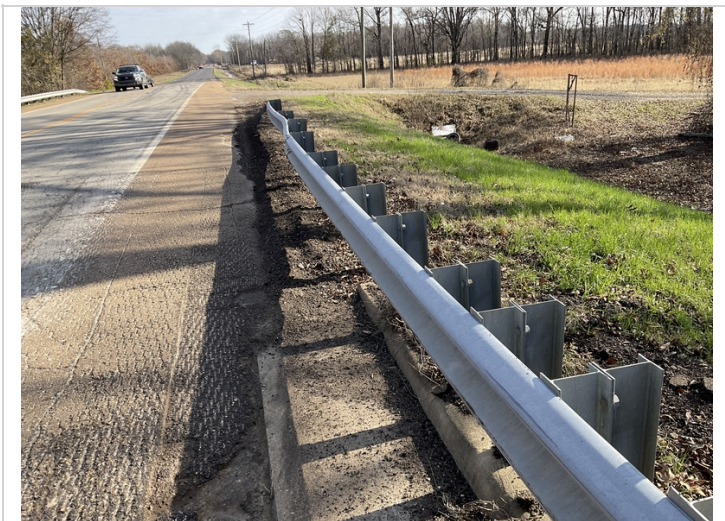
Abutment #2 right approach rail has 10' of minor collision damage.
Abutment #2 approach gutter right side has animal hole underneath.
Abutment #1 left side channel eroded within 30' of bridge.

Abutment #2 right approach rail has minor collision damage.

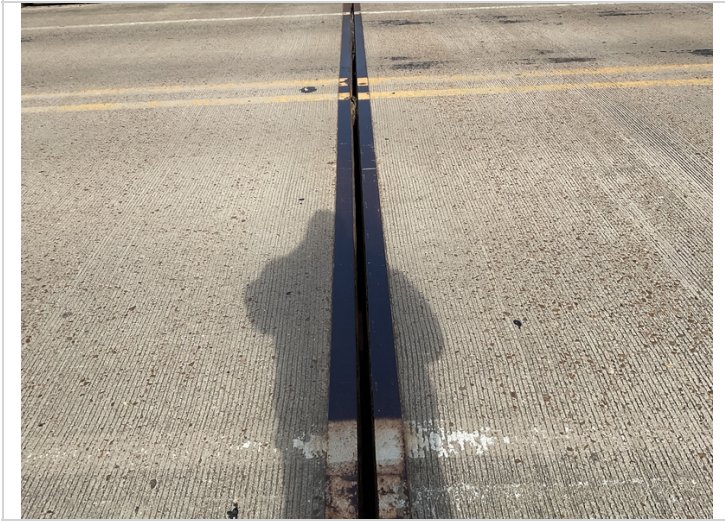
(302) Bent #3 joint seal has fallen out.							
311	Movable Bearing	EA	35	0	35	0	0
1000	Corrosion	EA	35	0	35	0	0
515	Steel Protective Coating	SF	70	0	0	70	0
3430	Oxide Film Degradation Color/Texture Adherence(Steel Protective Coatings)	EA	70	0	0	70	0

Bent #3 joint seal has failed.

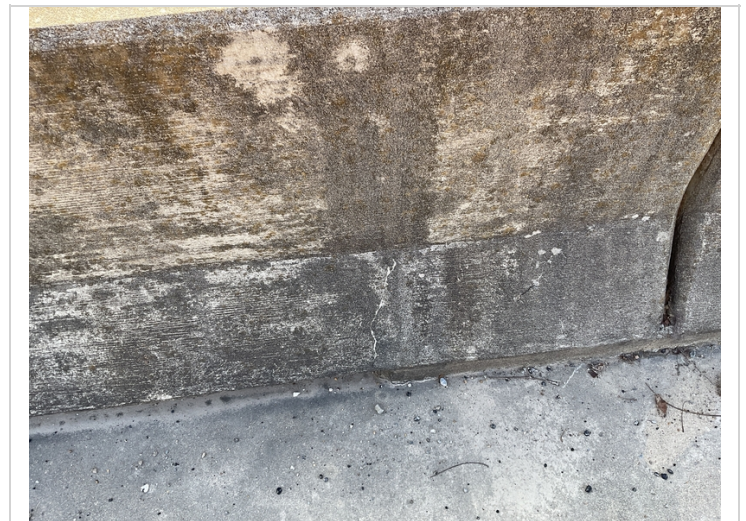
ELEMENTS	DESCRIPTION	UNITS	TOTAL	CS1	CS2	CS3	CS4
	(331) Rails have vertical hair line cracks spaced four feet apart.

Typical bridge rail crack

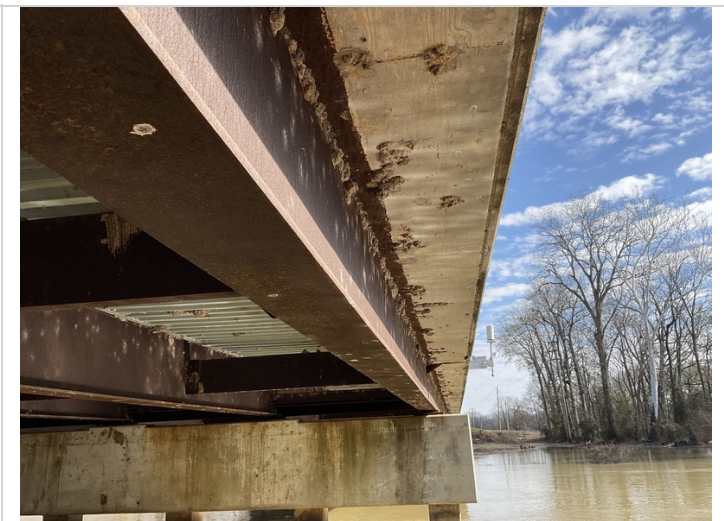
(12) All spans have transverse and longitudinal cracks. Soffit-under surface overhangs have transverse cracks some with light efflorescence.							
107	Steel Open Girder/Beam	LF	2250	2166	84	0	0
1000	Corrosion	LF	84	0	84	0	0
515	Steel Protective Coating	SF	16532	16462	70	0	0
3430	Oxide Film Degradation Color/Texture Adherence(Steel Protective Coatings)	LF	70	0	70	0	0

Typical soffit-under surface over hang

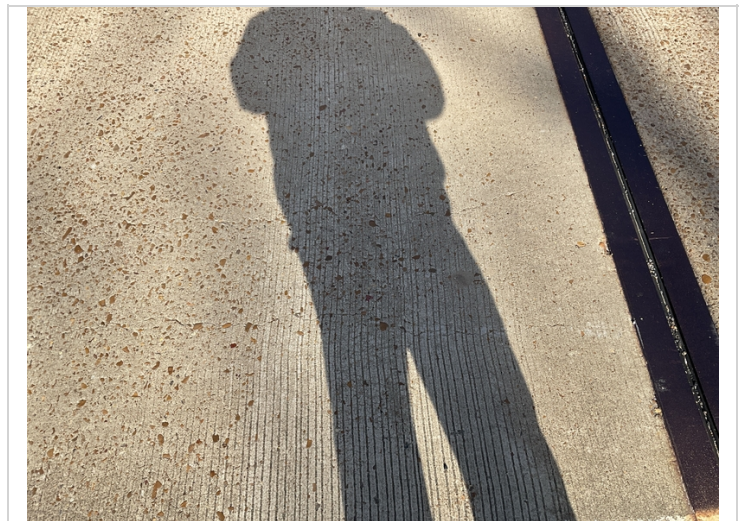
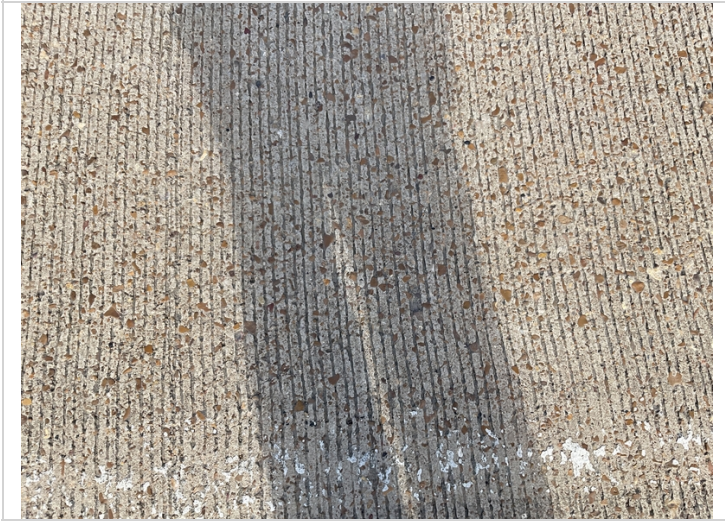
Deck is cast in place concrete. Deck has some open cracks.

Typical deck crack

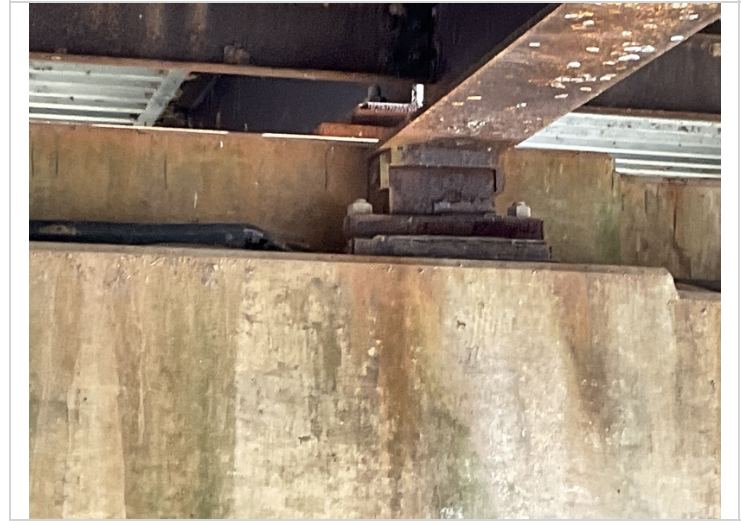
(311) Movable bearings have some scaling rust.							
313	Fixed Bearing	EA	35	0	35	0	0
1000	Corrosion	EA	35	0	35	0	0
515	Steel Protective Coating	SF	70	0	0	70	0
3430	Oxide Film Degradation Color/Texture Adherence(Steel Protective Coatings)	EA	70	0	0	70	0

Typical movable bearing

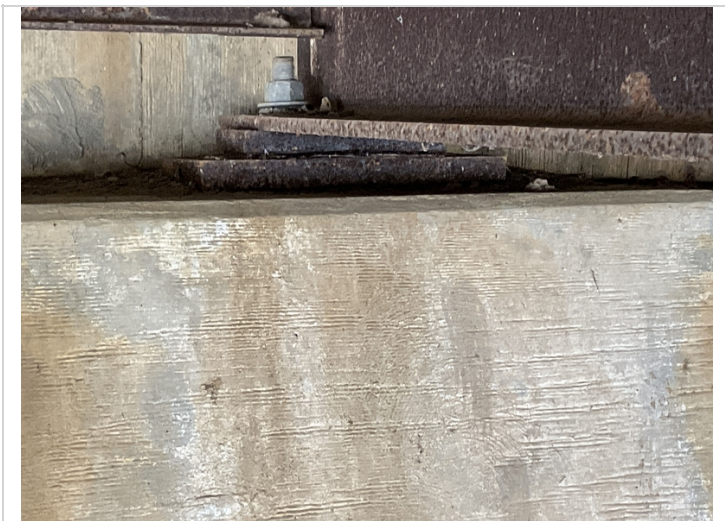
(313) Fixed bearings have some scaling rust.							
331	Reinforced Concrete Bridge Railing	LF	754	565	189	0	0
1130	Cracking (RC and Other)	LF	189	0	189	0	0

Typical abutment bearing

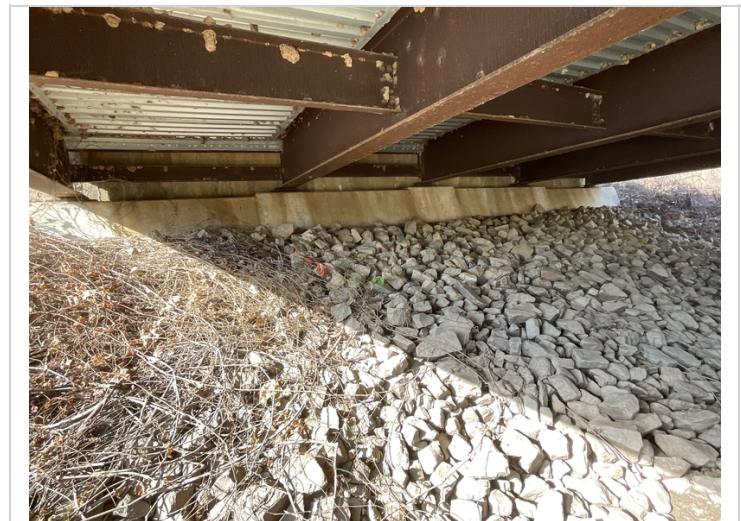
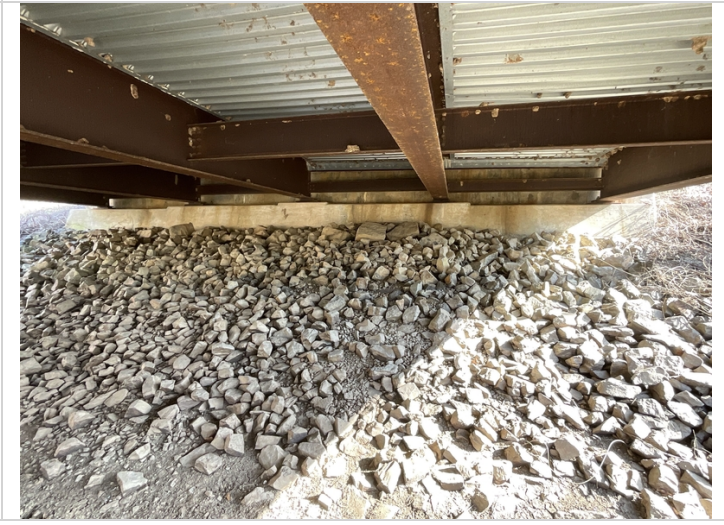
(215) Abutment back walls have hair line vertical cracks some with light efflorescence.							
227	Reinforced Concrete Pile	EA	32	32	0	0	0
234	Reinforced Concrete Pier Cap	LF	224	224	0	0	0
302	Compression Joint Seal	LF	312	273	0	0	39
2310	Leakage	LF	39	0	0	0	39

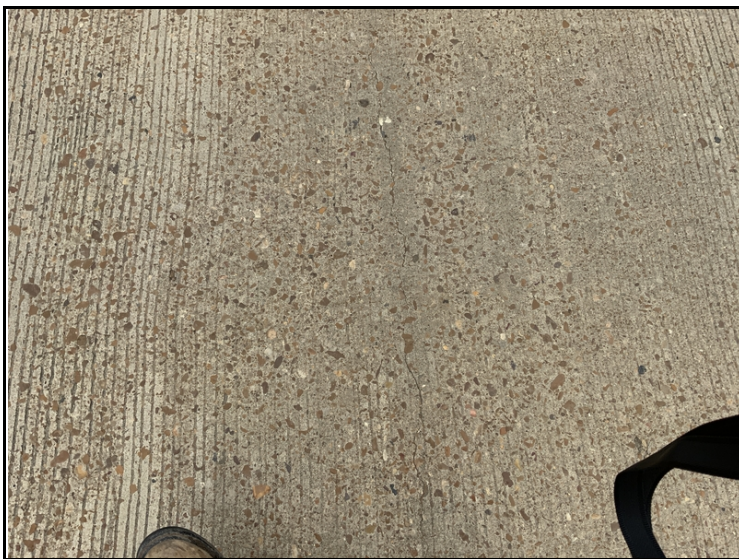
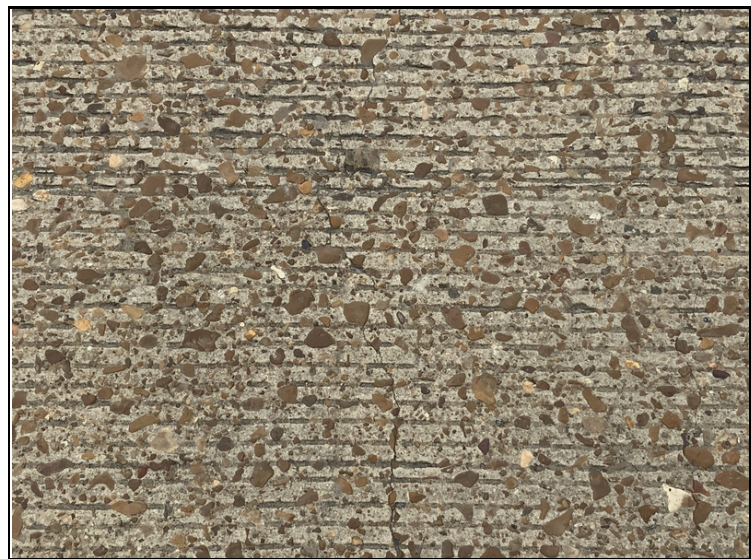
All spans have transverse and longitudinal cracks.

Typical transverse deck crack.

Typical longitudinal deck crack.

Date Reported: 12/11/2018
Priority: C - Important
Type of Work: Deck Repair
Status: Monitor
Component: Deck

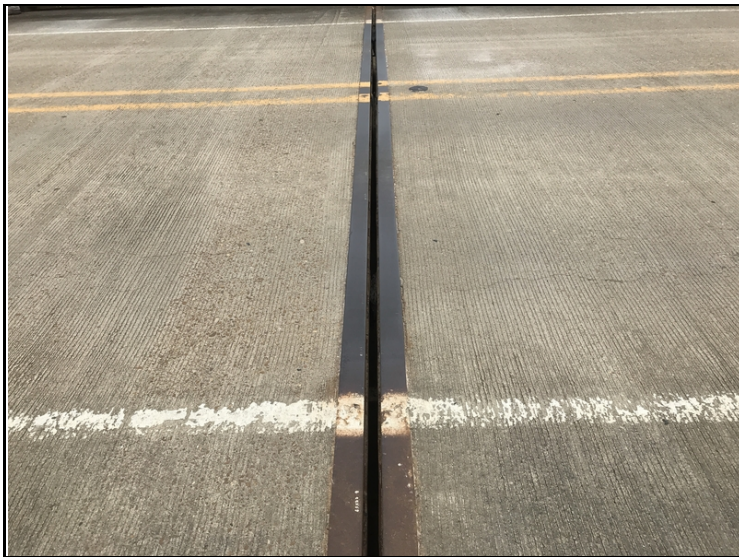
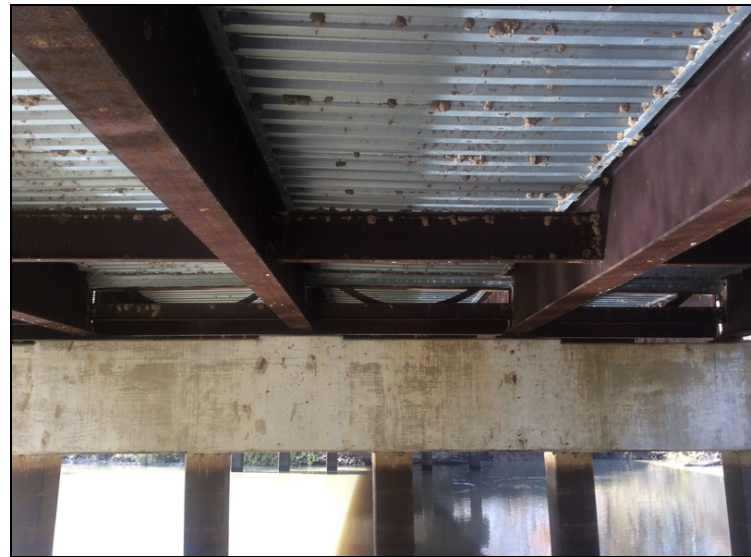
Bent #3 joint seal has fallen out.

Bent #3 joint seal sagging onto cap

Date Reported: 12/20/2012
Priority: C - Important
Type of Work: Joint Repair
Status: Monitor
Component: Element

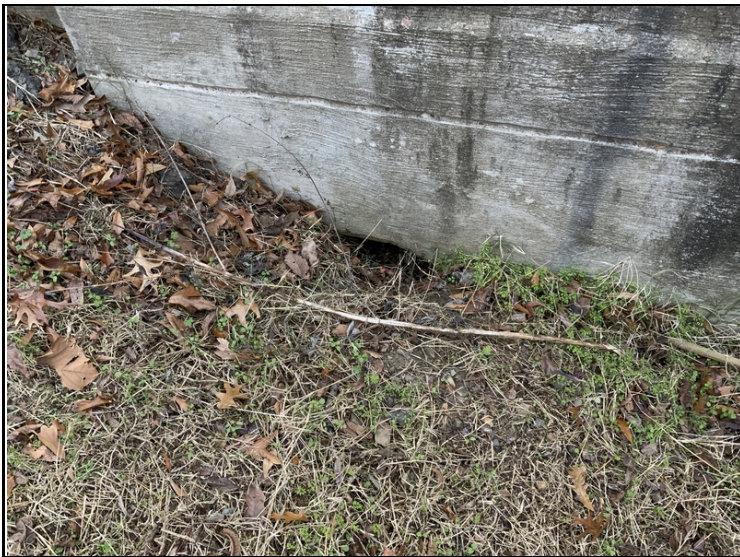
Abutment #2 left and right approach gutters have small void underneath due to animal activity.

Abutment #2 left approach gutter has small void underneath.

Date Reported: 12/17/2020
Priority: D- Routine
Type of Work: Repair (General)
Status: Forward State
Component: Approach

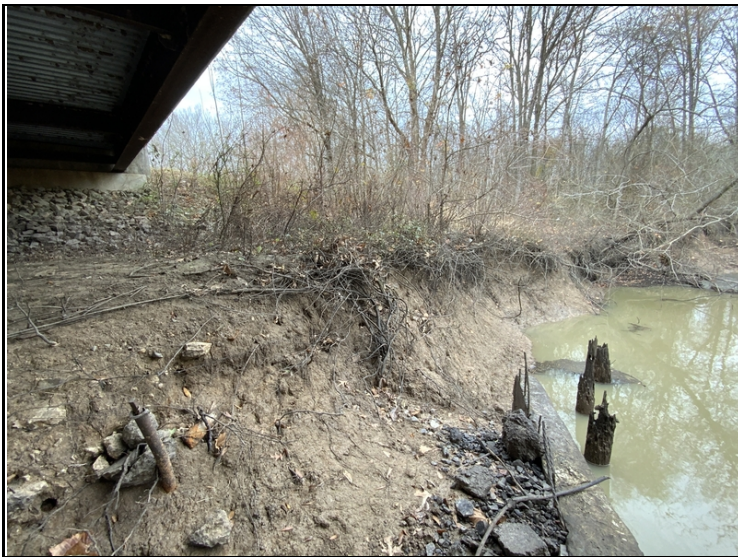
Abutment #1 left side channel eroded within 30' of bridge.

Date Reported: 12/17/2020
Priority: C - Important
Type of Work: Repair (General)
Status: Forward State
Component: Channel

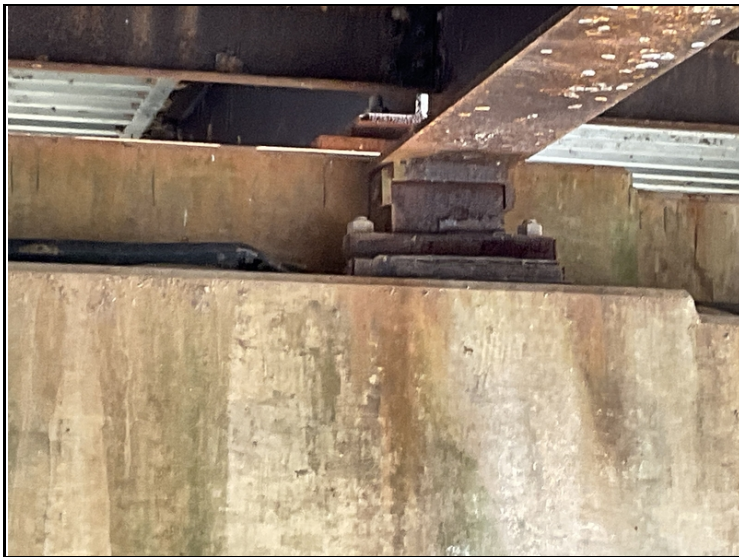
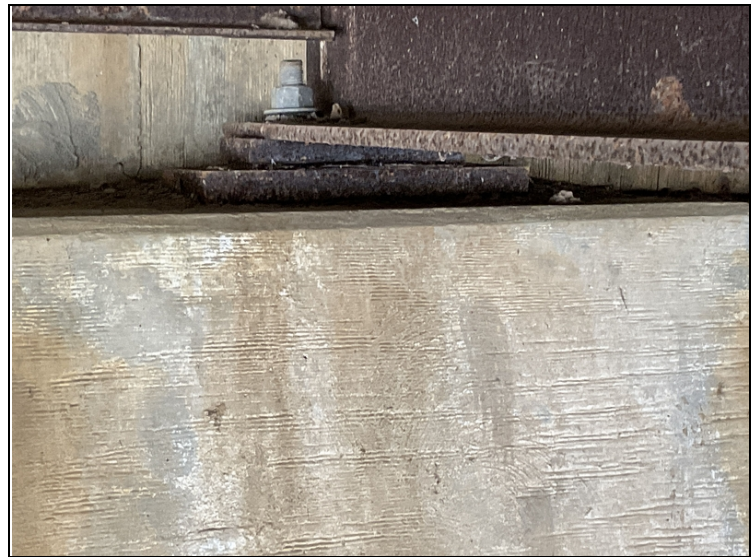
Bearings have some scaily rust on them.

Typical movable bearing

Typical abutment bearing

Date Reported: 12/20/2022
Priority: D- Routine
Type of Work: Repair (General)
Status: Open
Component: Element

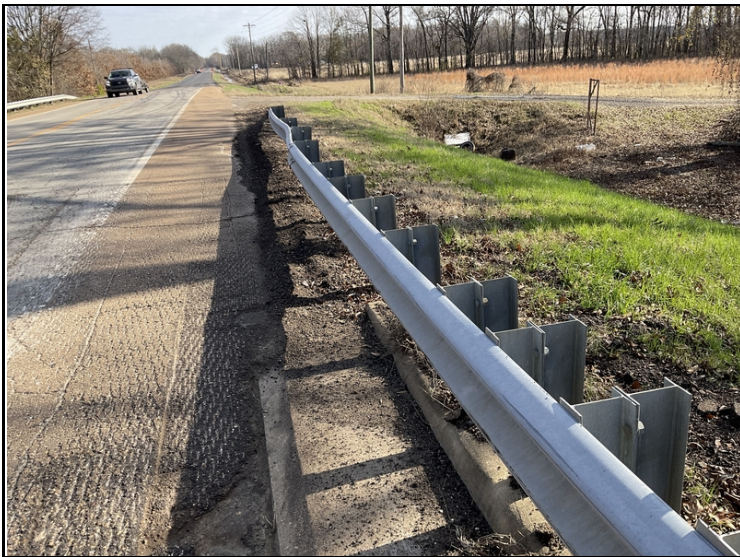
Abutment #2 right approach rail has minor collision damage.

Date Reported: 12/20/2022
Priority: D- Routine
Type of Work: Repair (General)
Status: Open
Component: Miscellaneous
