**Asset #M3140**(Routine, Underwater type 2)

**Sh-38/Sec-2/L-5.09 over Slough**

**Location: 5.09 Mi E Of SH 33 & 38**

**Team Lead: Drew Melton, Inspection Date: 08/11/2022**

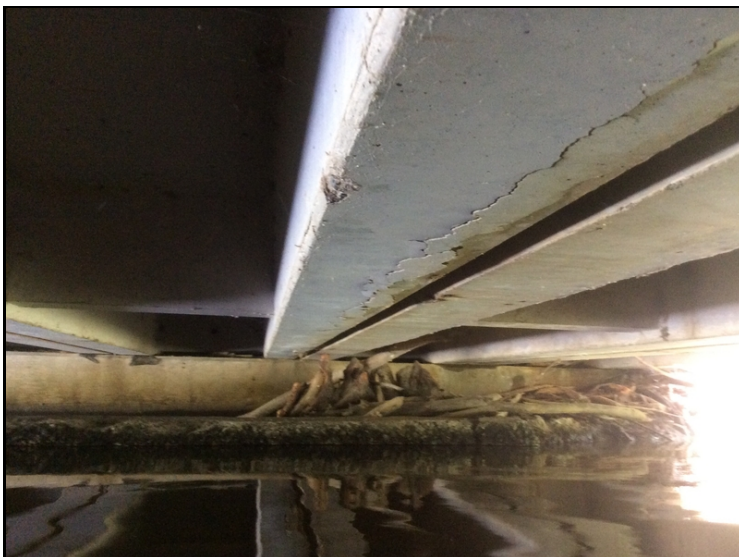
Span #4 unit #6 right leg.

Span #4 unit #4 left leg has longitudinal crack on side for fifteen feet.  
Span #4 unit #4 right leg cracked for 10'.  
Span #4 unit #6 left leg has longitudinal crack on side for fifteen feet.  
Span #4 unit #6 right leg is cracked and delaminated on bottom full length.  
Span #4 unit #8 left leg cracked for 2'.

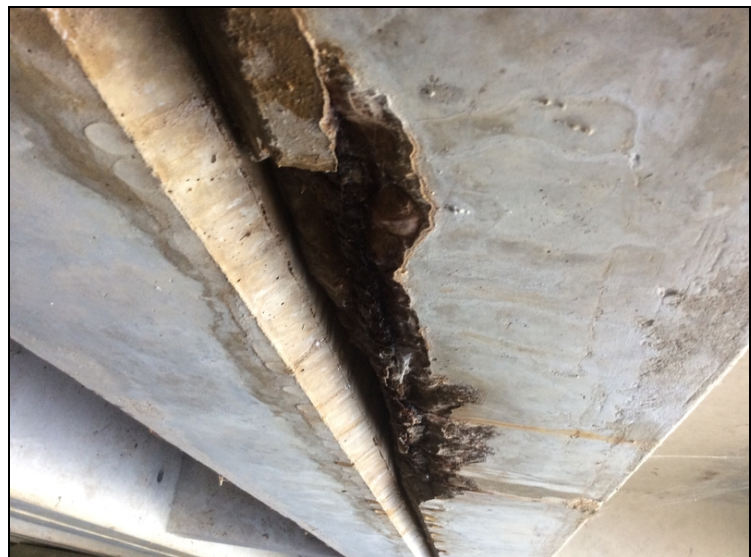
Span #1 unit #1 right leg.

Span #1 unit #1 right leg is cracked and delaminated for ten feet with a one foot spall with exposed rebar with moderate section loss.

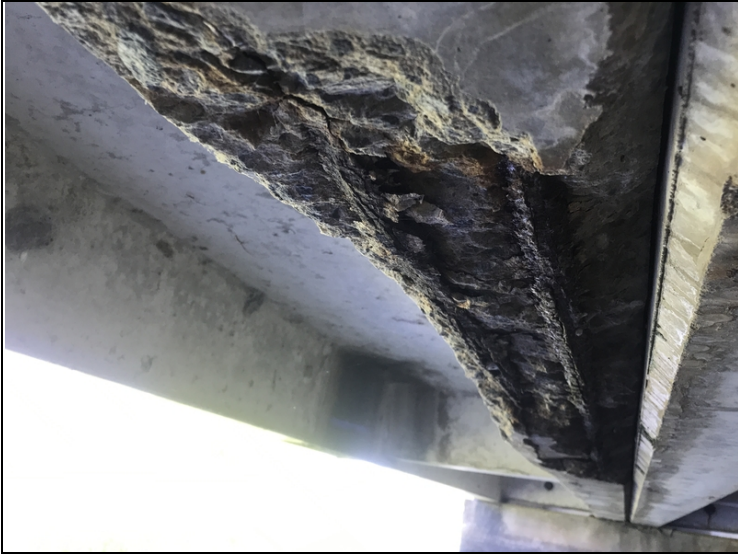
Span #3 unit #1 right leg.

Span #3 unit #1 right leg has an eight foot spall with exposed rebar with large section loss ahead of bent with ten foot crack with delamination.  
Span #3 unit #8 left leg cracked for 10' with rust staining.

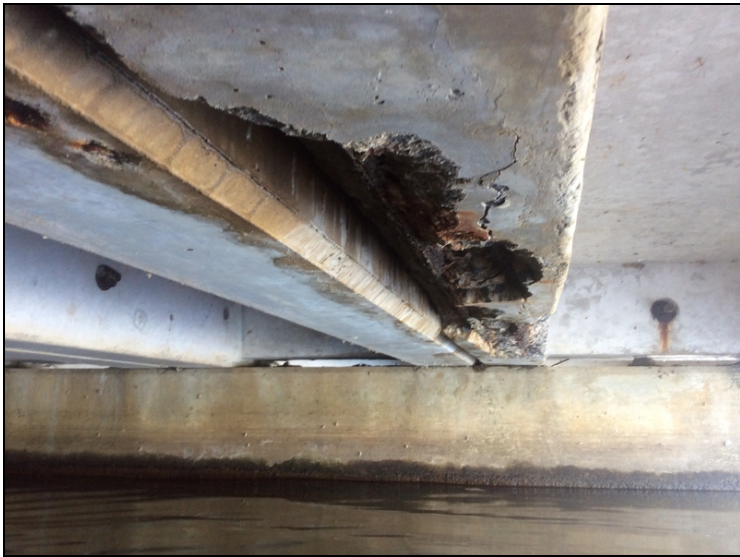
Span #3 unit #1 right leg spalled.

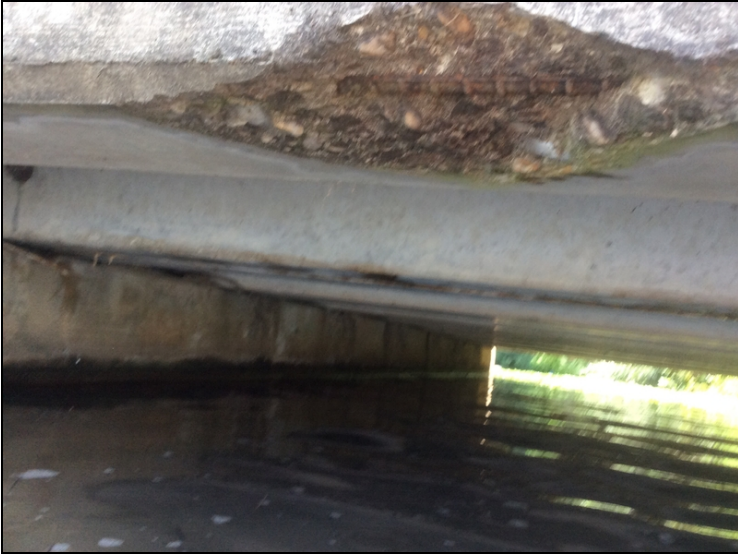
Span #2 unit #1 left leg.

Span #2 unit #1 left leg has a one foot spall at 3/4 span with exposed rebar with moderate section loss.  
Span #2 unit #1 right leg has 1' delamination at 3/4 span.

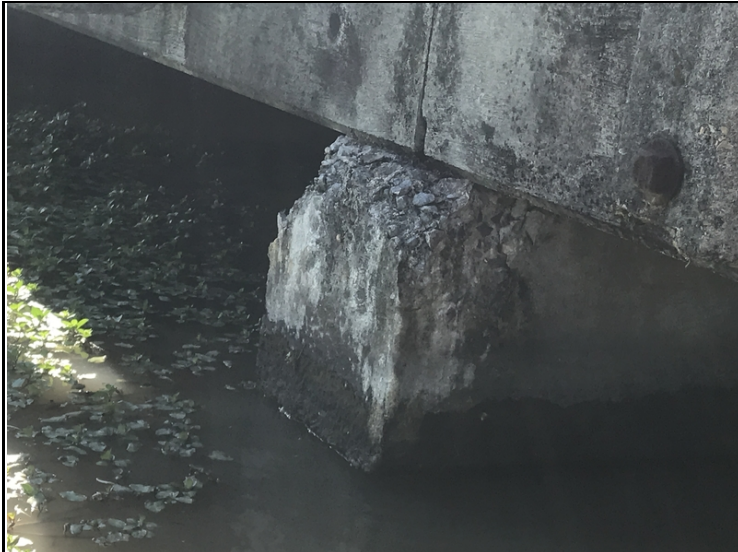
Bent #2 cap left end.

Bent #2 cap left end is spalled off.  
Bent #2 cap back face has four one foot spall no rebar and two one foot delaminations all at top.  
Bent #2 cap ahead face has one spall one foot with no rebar exposed.  
Bent #3 cap back face has nine feet of one foot spalls at top no rebar exposed.  
Bent #3 cap ahead face has two one foot spalls no rebar and one delamination one foot at top.  
Bent #4 ahead face has two one foot spalls at top no rebar exposed.

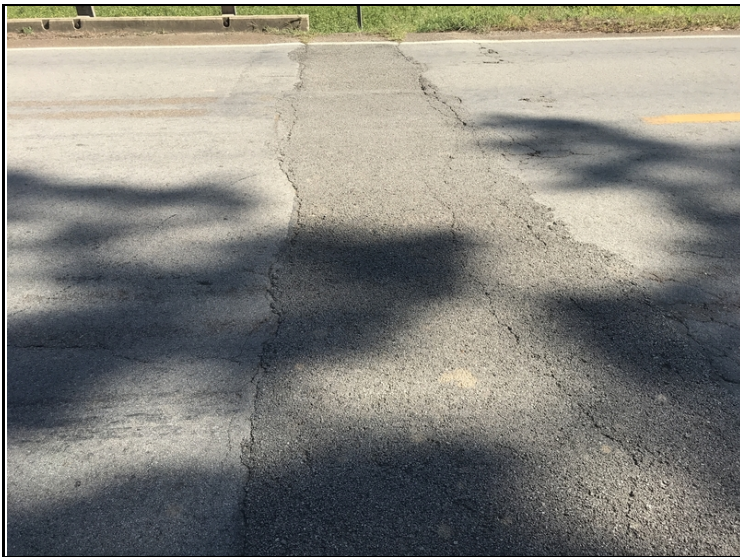
Abutment #2 approach roadway.

Abutment #2 approach roadway has settled up to 3/4"

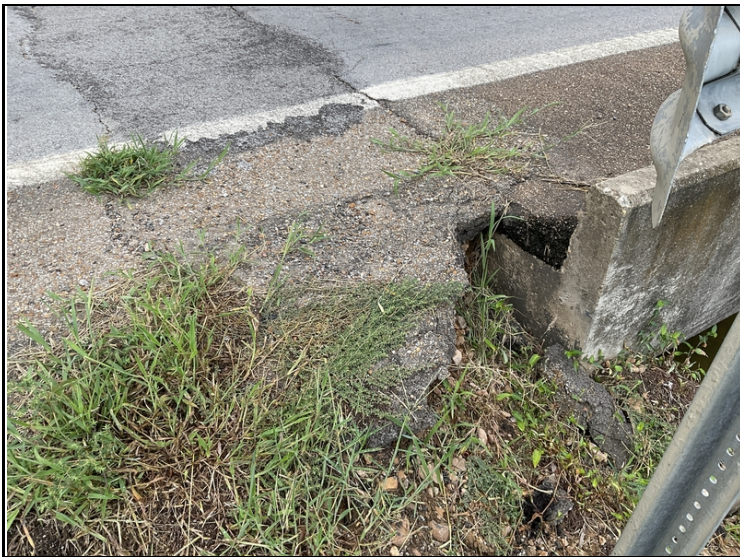
Abutment #2 left approach shoulder is eroded at bridge end.

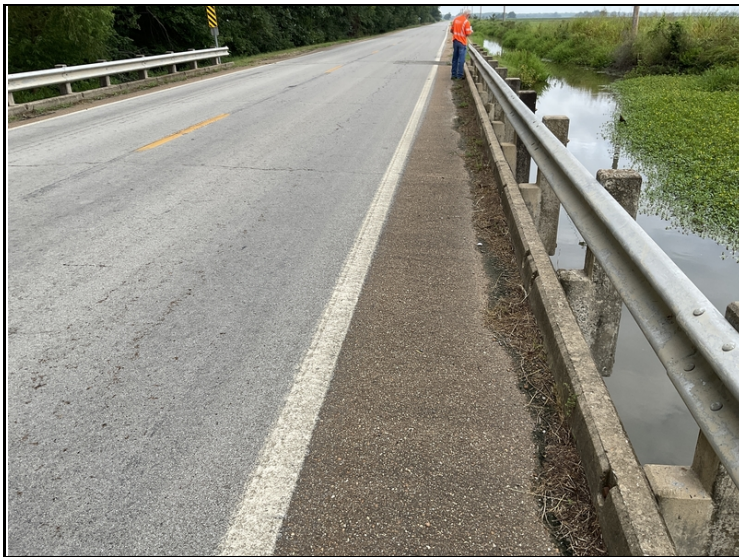
Typical gutter

Dirt and vegetation in gutters with vegetation growing.
