Asset #07233(Routine)

Sh-38/Sec-5/L-0.21 over I-40/Sec-51/L-247.05

Location: 0.3 Mi North Of Jct Us 70

Team Lead: Drew Melton Inspection Date: 07/26/2022

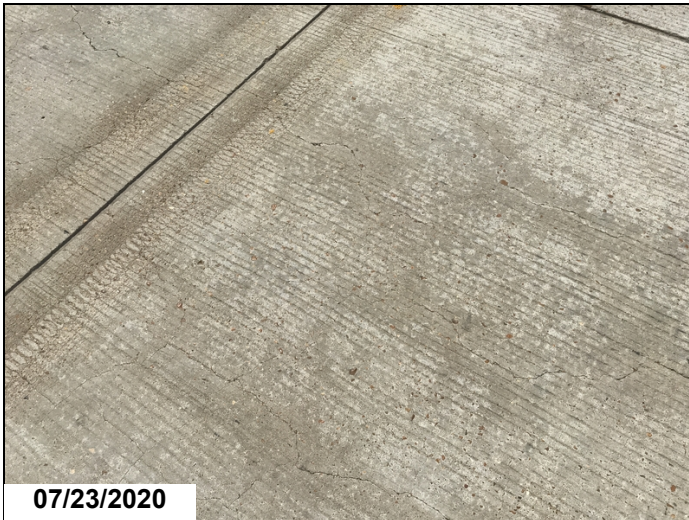
(321) Approach slabs have a few open cracks. Abutment #1 has a 10' x 15' area of map cracking.							
331	Reinforced Concrete Bridge Railing	LF	725	705	20	0	0
1120	Efflorescence/Rust Staining	LF	20	0	20	0	0

Approach slabs have a few open cracks.
Abutment #1 has a 10' x 15' area of map cracking.

Abutment #1 approach slab map cracking.

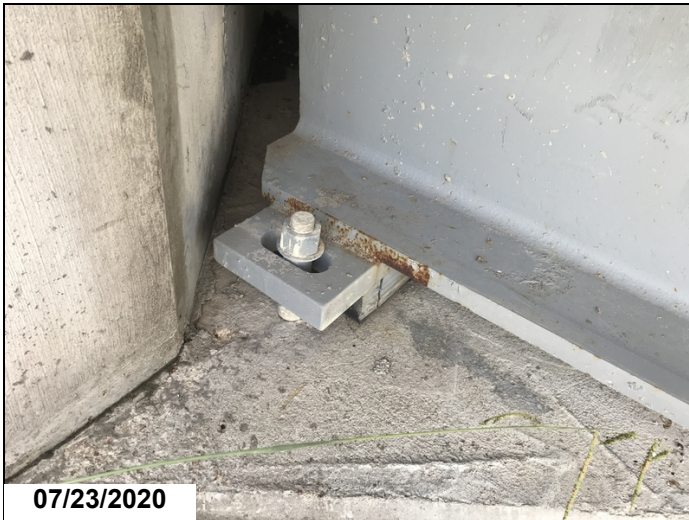
Light rust beginning to form on girders at abutments and over intermediate bents.
Paint beginning to peel on bottom flange of several girders in spans #1 and 2.

Corrosion beginning at abutment #1 girder #4.

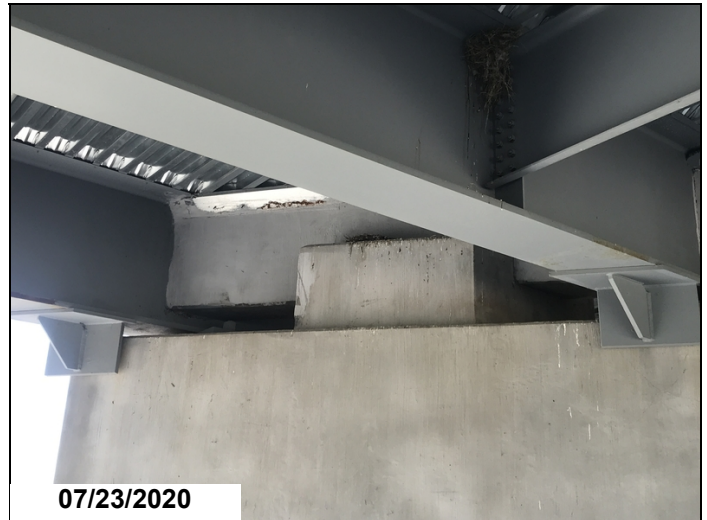
08/14/2018 lowered superstructure from 9 to 7 due to some surface rust on girders at bents

Typical light rust on girders at bents.

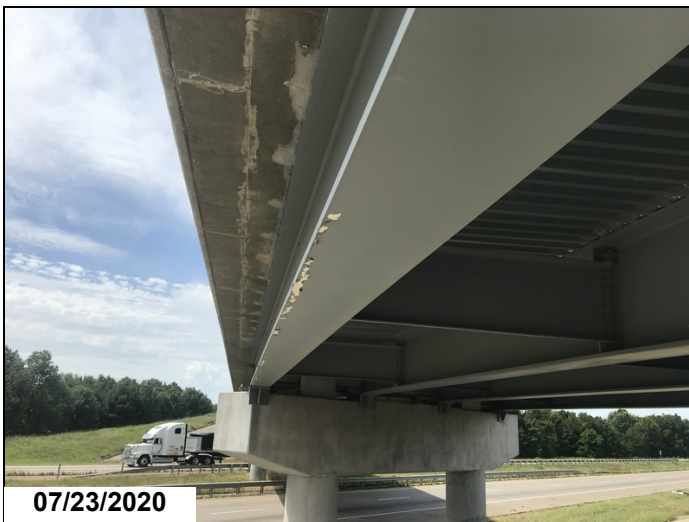
(107) Span #1 girder #1,2, 4 span #2 girder #1 bottom flange has areas of paint peeling. Bottom flanges all girders all spans have areas of surface rust at bents							
205	Reinforced Concrete Column	EA	6	6	0	0	0
215	Reinforced Concrete Abutment	LF	131	130	0	1	0
1080	Delamination/Spall/Patched Area	LF	1	0	0	1	0

Typical peeling paint, typical of span #1 girders #1 and 4.

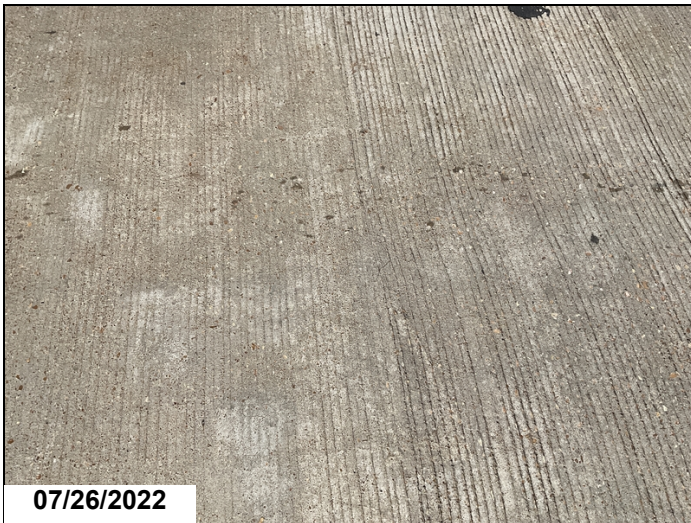
(12) Each span has approximately 20 transverse cracks on overhangs each side some with light efflorescence. Each deck span has 2 to 3 transverse and 2 to 3 longitudinal cracks.							
107	Steel Open Girder/Beam	LF	1440	1340	100	0	0
1000	Corrosion	LF	100	0	100	0	0
515	Steel Protective Coating	SF	14688	14498	90	100	0
3420	Peeling/Bubbling/Cracking	LF	90	0	90	0	0
3440	Effectiveness (Steel Protective Coatings)	LF	100	0	0	100	0

Each deck span has 2 to 3 transverse and 2 to 3 longitudinal cracks.

Typical deck crack

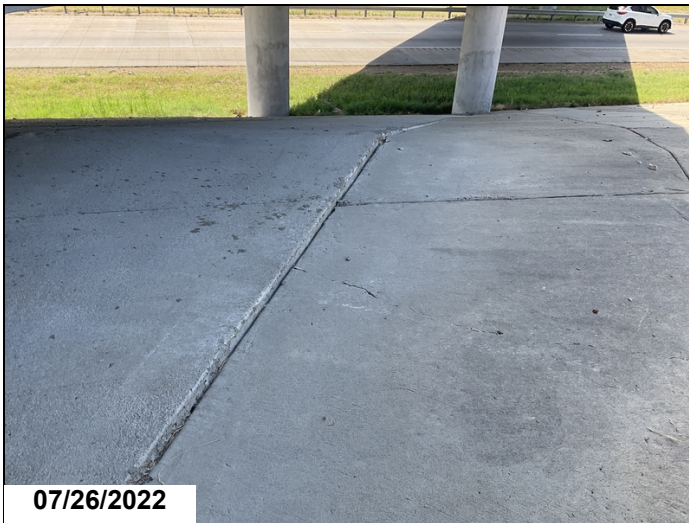
Abutment #1 right slope pavement near top is cracking and has settled 1".

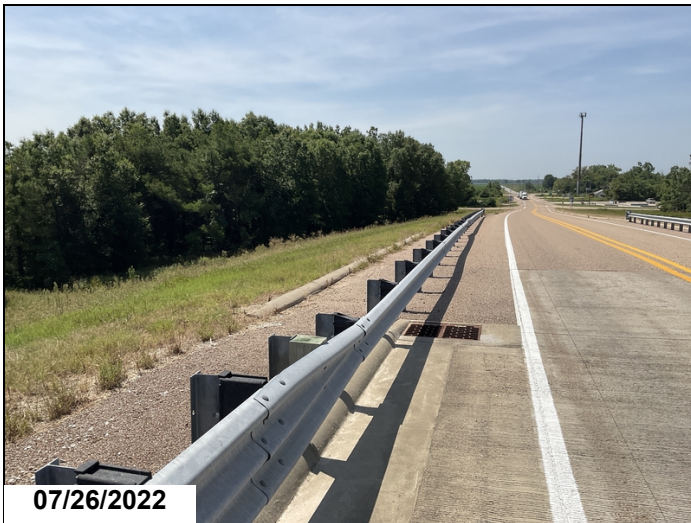
Abutment #2 left approach rail has minor collision damage.
