Asset #07467(Routine)

Sh-50/Sec-1/L20.80 over cutoff bayou

Location: 0.8 Mi W Jct Us 79 & 50

Team Lead: Myron Futrell Inspection Date: 04/12/2023

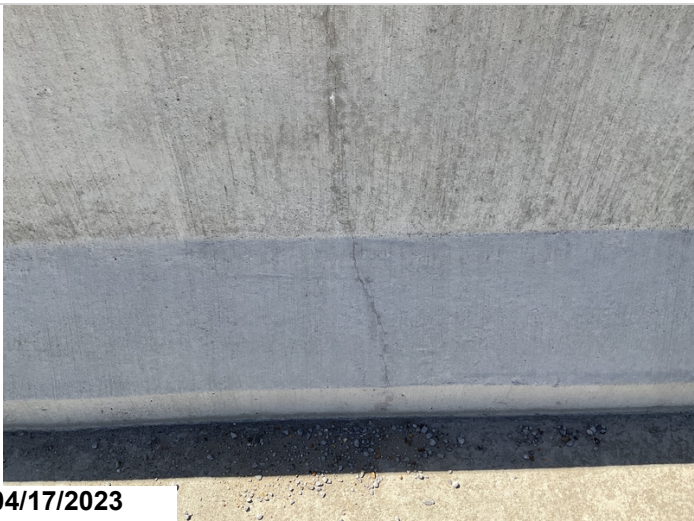
(331) Right rail has vertical hairline cracks spaced 4' to 6' a few have light efflorescence. Span #4 right rail has three feet of longitudinal hairline cracking with light efflorescence near top at mid span.

Typical hairline vertical crack in concrete bridge rail

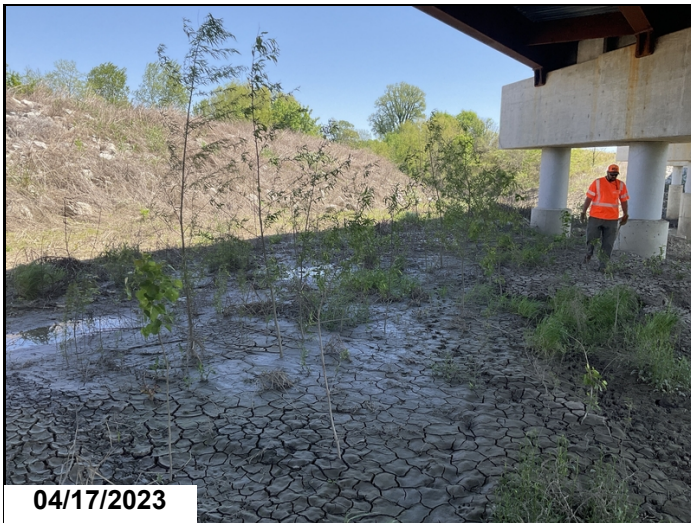
04/17/2023

Spans #2 and 3 have small trees growing underneath bridge.

Small trees and vegetation growing under spans #2 and 3.

Type of Work: Channel Work/Drift Removal

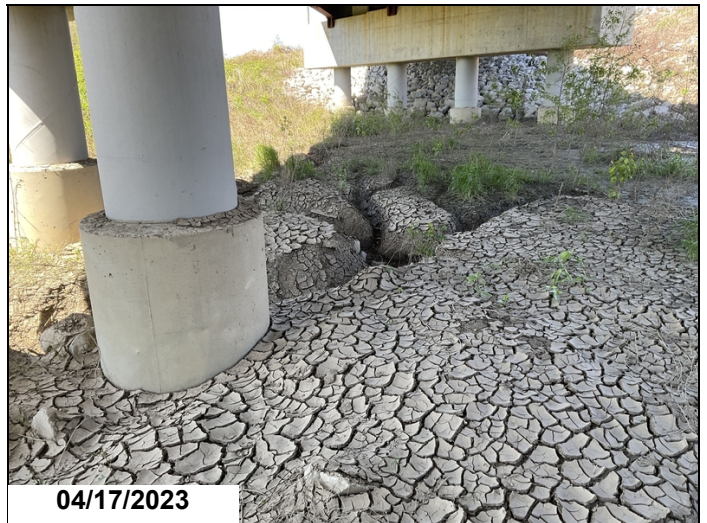
04/17/2023

Channel is in overall good condition rip rap is in place, channel is fairly open with only small amounts of debris at bents #4 and 5. There is minor erosion under spans #2 and 3 with several erosion veins up to two feet deep.

4/17/2023-Lowered channel from 8 to 7 due to minor slope erosion under spans #2 and 3.

Spans #2 and 3 slope has several erosion veins running down slope up to two feet deep, spans #2 and 3.

Erosion veins up to three feet deep under spans #2 and 3 in slope.
