Asset #M3330(Routine, Underwater type 2)

Sh-50/Sec-1/L11.08 over Ten Mile Bayou

Location: about 4 Mi East Sh 38 S

Team Lead: Austin Janes Inspection Date: 10/02/2024

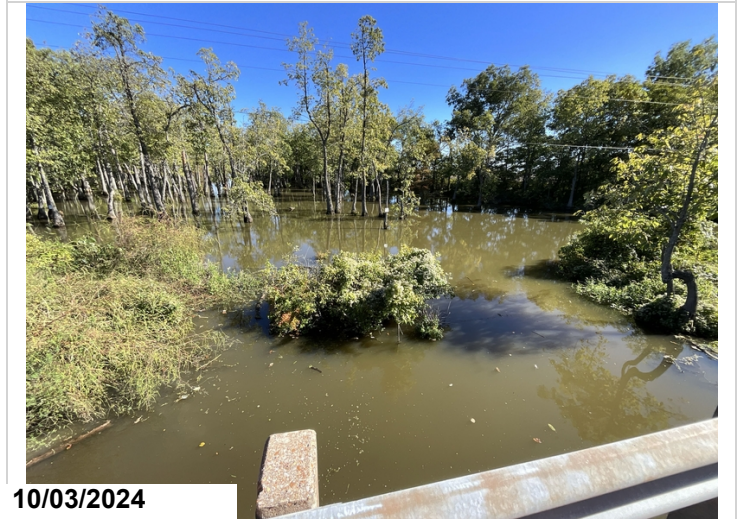
Overall the Channel is in fair condition with fair alignment and trees, brush and debris restricting the flow of the channel.

Right side of bridge: channel view.

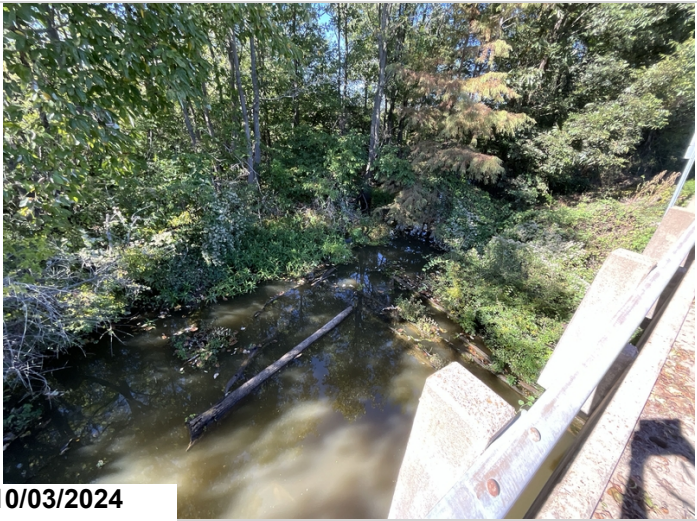
Left side of bridge: channel view

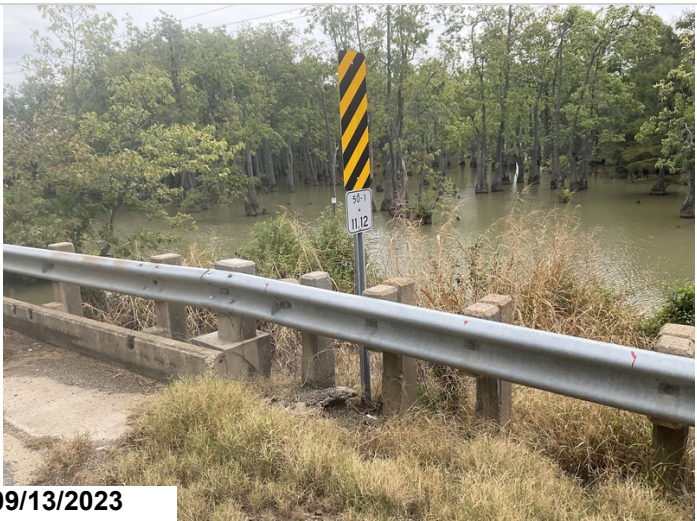
Abutment #1 log mile sign

Log mile should be 11.08

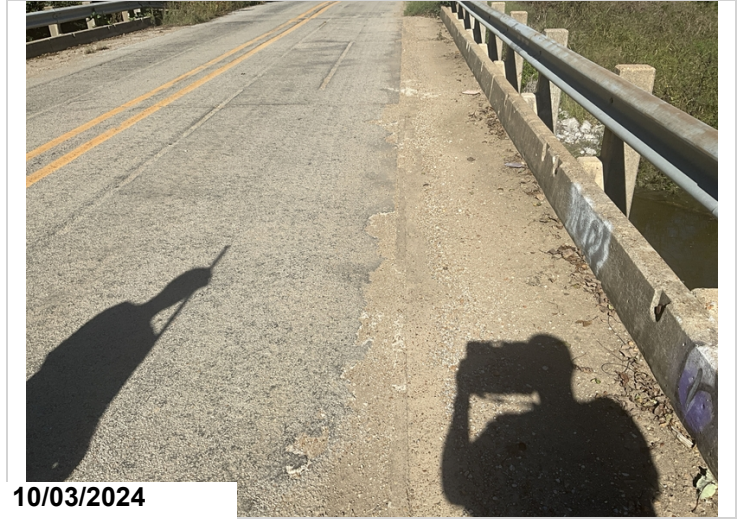
Span 4, Channel unit 7: 13" of spalling. CS3.

Span #4 bent #4 unit #7 has 1' x 2' shallow spall.
Span 4, Channel unit 7: 13' of spalling. CS3.

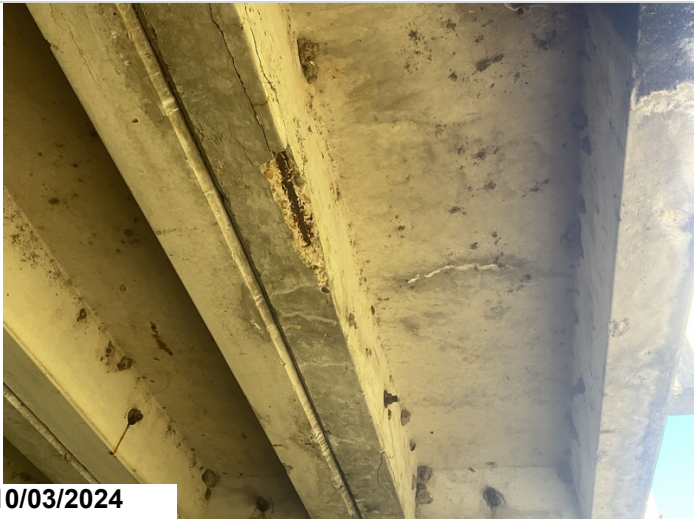
Span 4, unit 7: Rust staining & unit 8 efflorescence. CS2 & cs3.

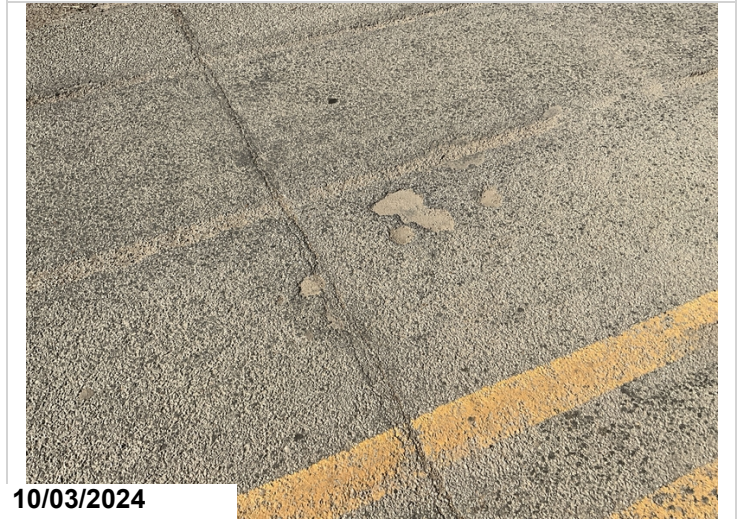
Span 5, Unit 4, wearing surface: 2' cs3 spalling.

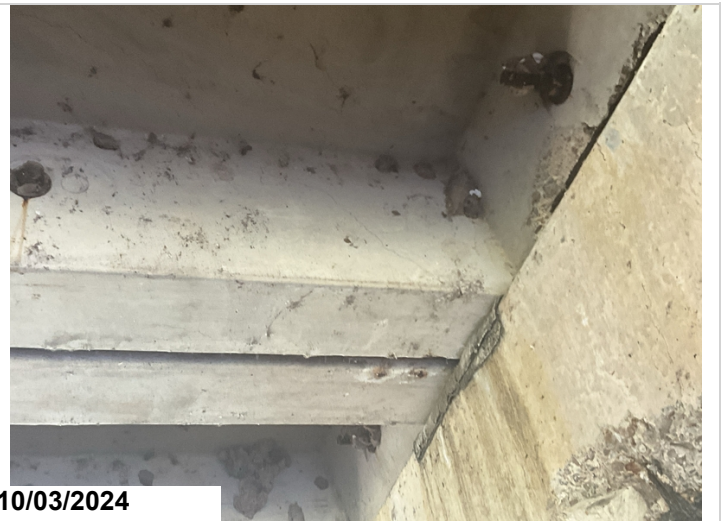
Span 2, Channel Unit 4: Minor shear type cracking.

Channel Unit 4: 2' shear type crack CS2, 8' CS3 crack.

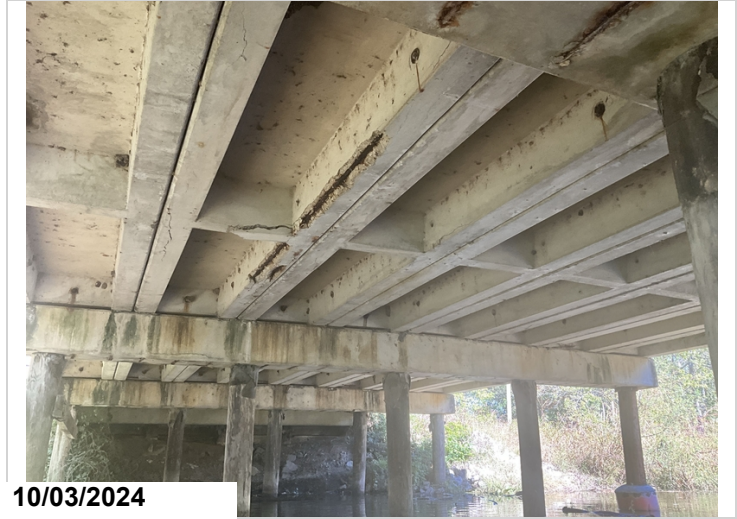
Span 4, Unit 2: Spalling with exposed reinforcing steel. CS3.

Channel Unit 2: 9' CS3 exposed steel & 7' CS3 cracking.

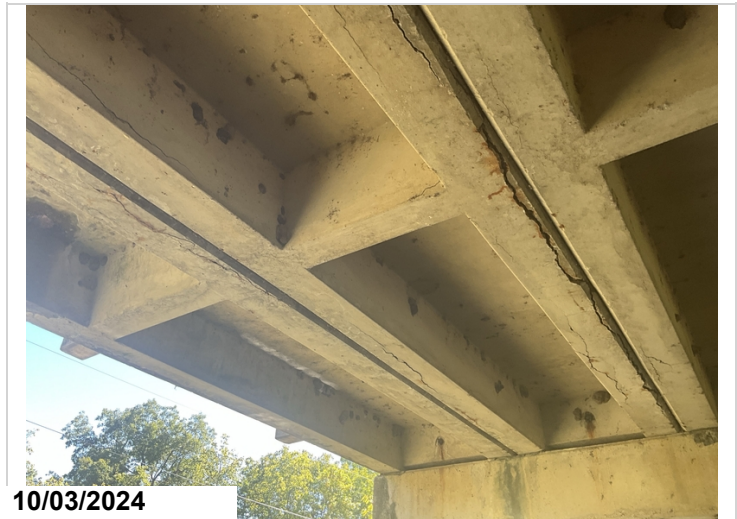
Span 5, Channel Unit7: large cracking.

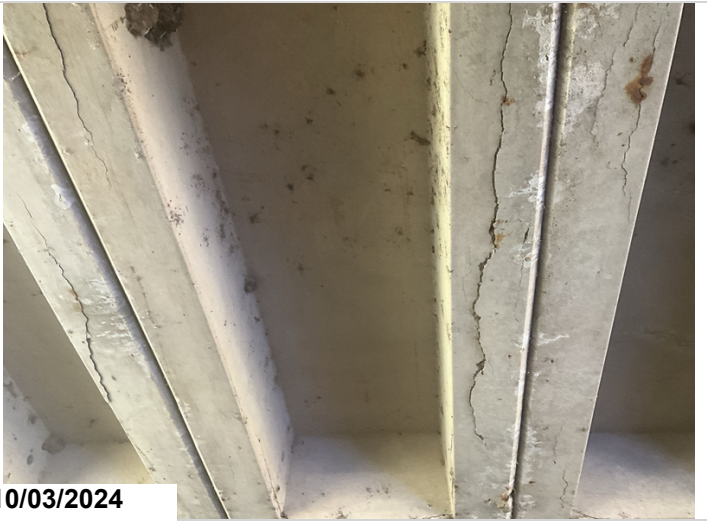
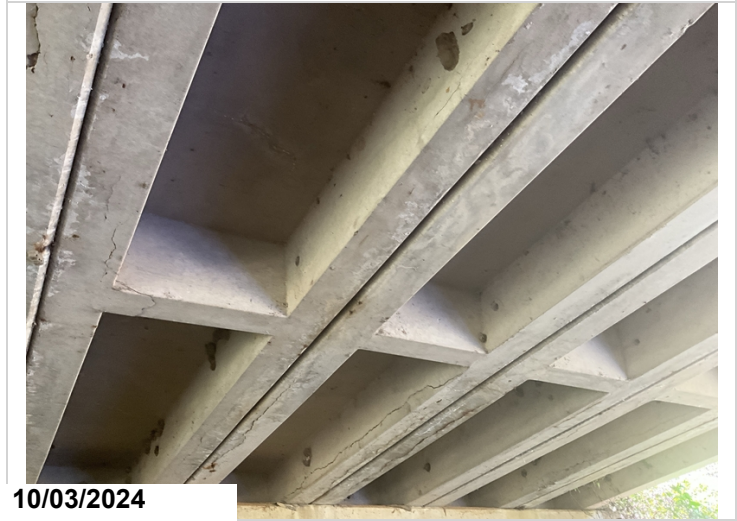
Span 6, Channel units: Longitudinal cracking.

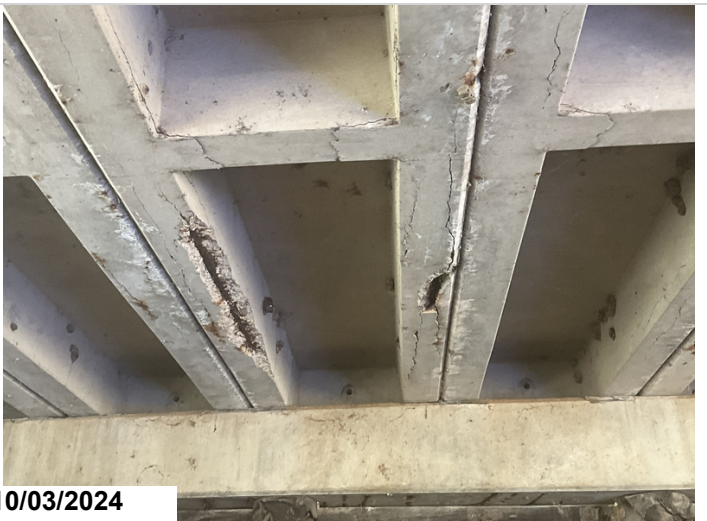
Span 6, Channel Unit 3: Spalling with 5' of exposed reinforcing steel. CS3.

Channel Unit 3: 12' CS3 cracking & 5' CS3 rebar.
Channel Unit 4: 8' CS3 cracking & 1' staining CS3.
Channel Unit 5: 8' CS3 cracking & 1' staining CS3
Channel Unit 6: 8' CS3 staining & 2' CS3 cracking.
Channel Unit 7: 10' CS3 cracking & 2' CS2 cracking & 1' CS3 spall.
Channel Unit 8: 4' CS3 cracking & 1' CS2 spalling.

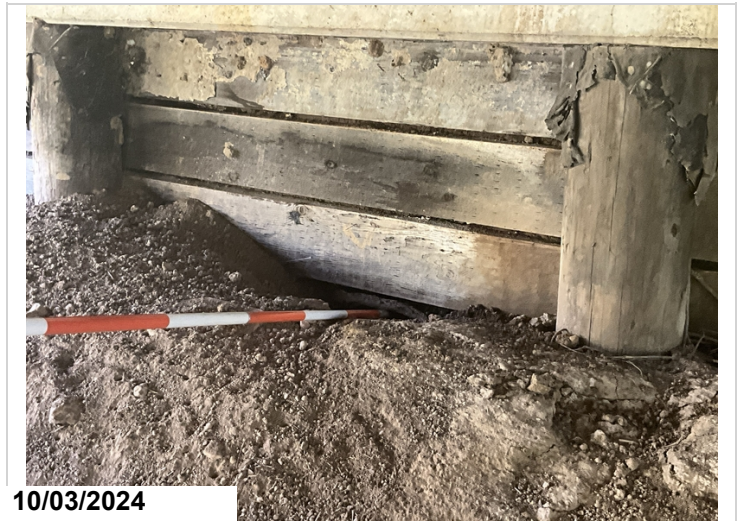
Bent 1, Between Piles 3 & 4: 2' erosion/void.

Bent 1, Between Piles 3 & 4: 3' erosion/void.

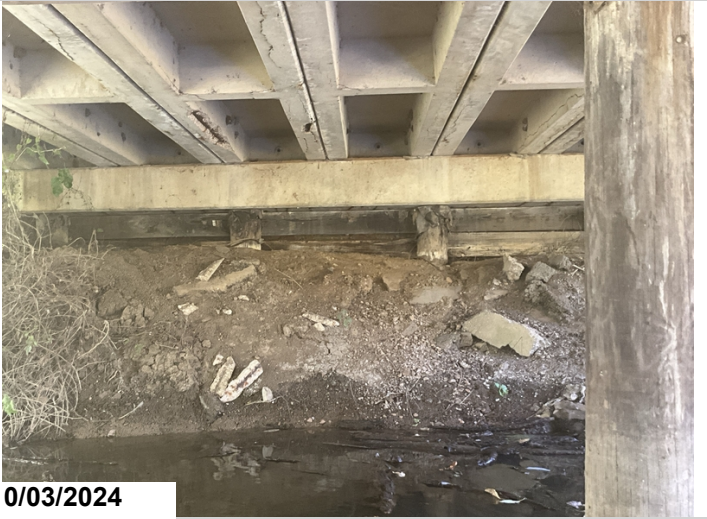
Bent 7: Decay in timber back wall full length.

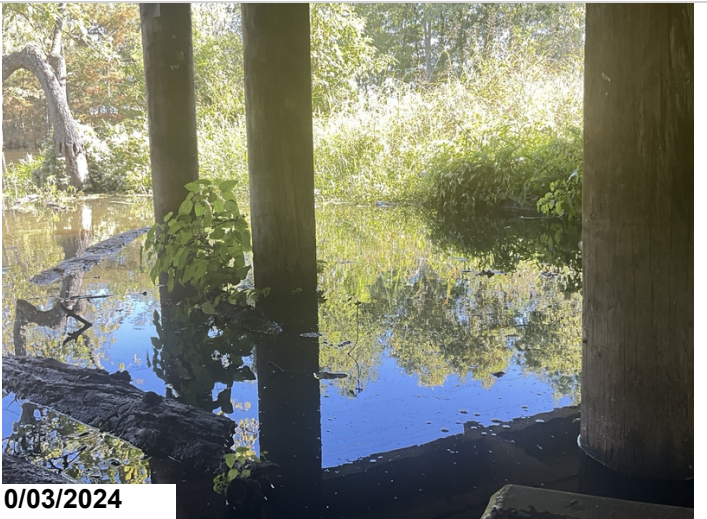
Bent 3, pile 4: Decay along the water line.

Bent #3 pile #4 has minor outer shell decay.

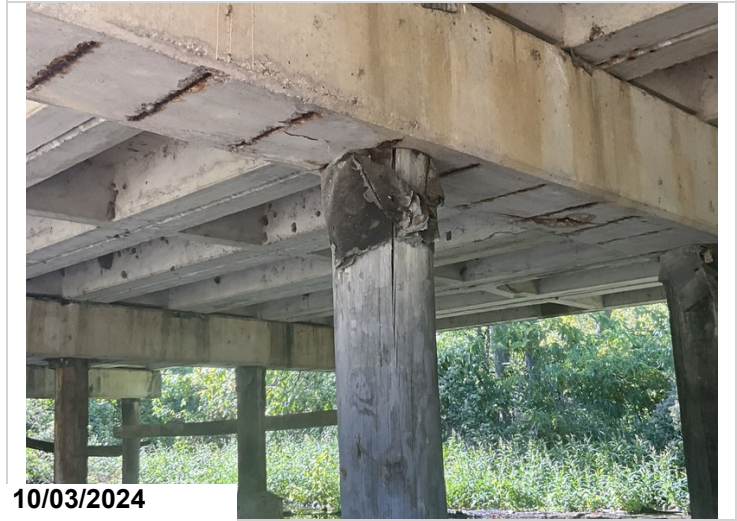
Bent 5, pile 4: Split.

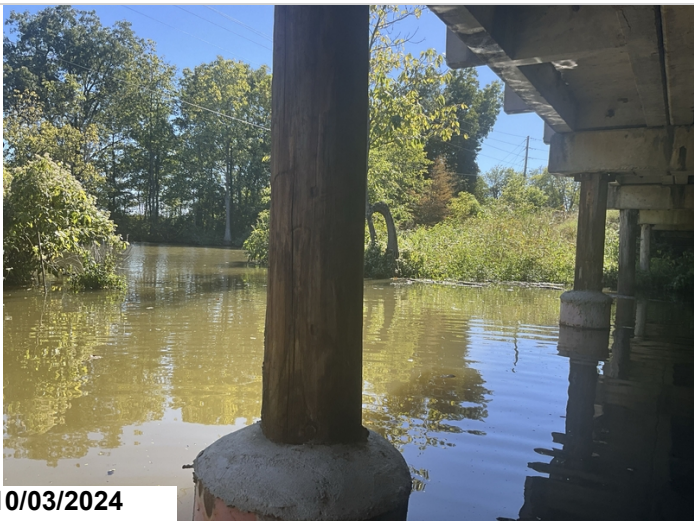
Bent 5, Pile 5: Minor cracking. CS2.

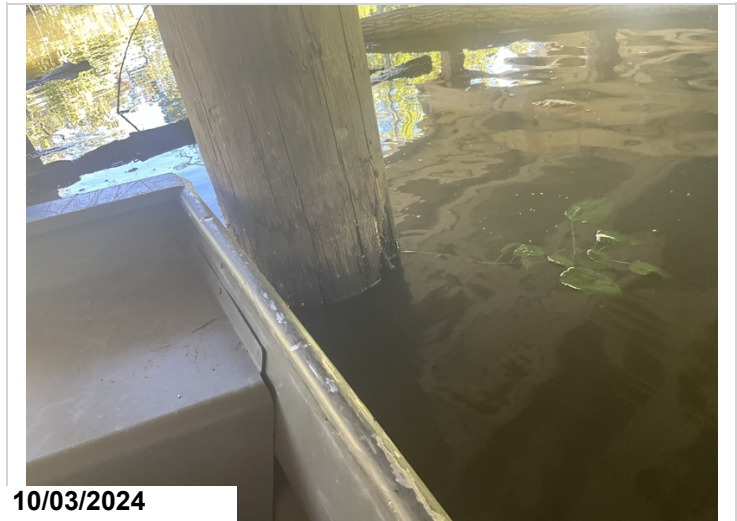
Bent 5, Piles 1 & 2: Minor to moderate decay to outer shell.

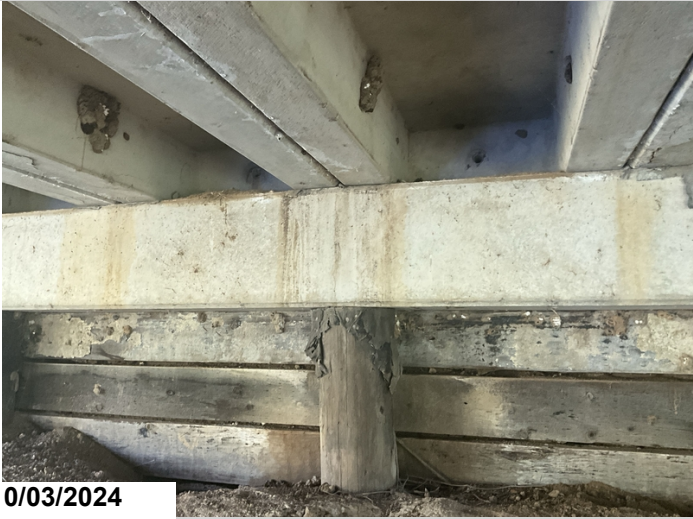
Bent 1: minor vertical crack above pile 3.

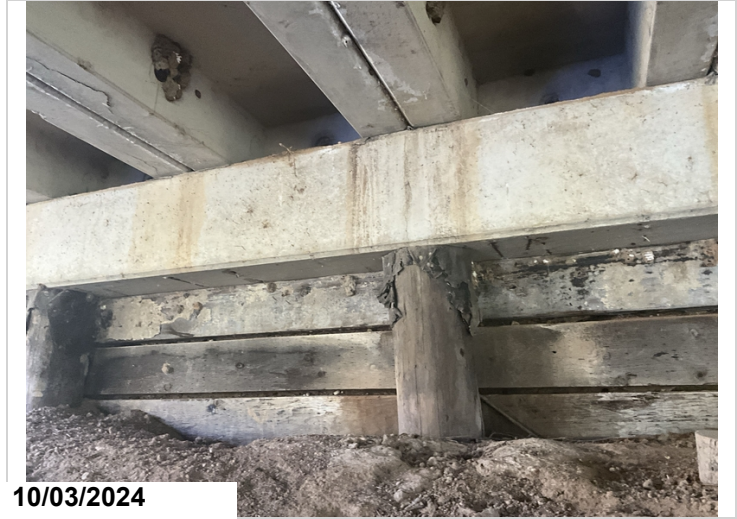
Bent 1, bottom 10' rebar. Cs3.

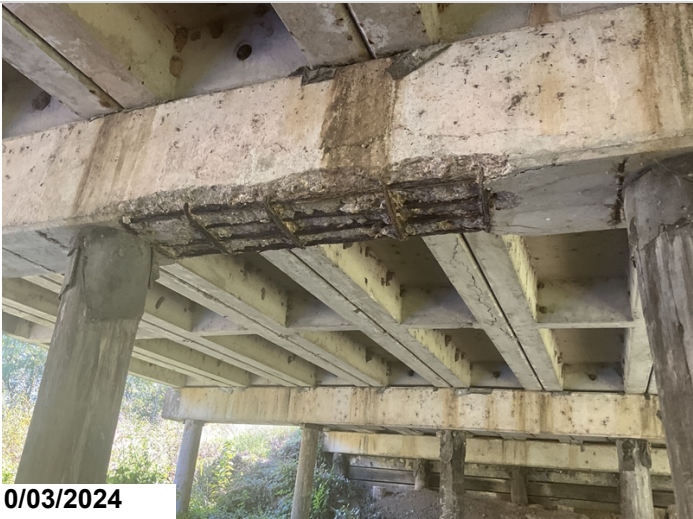
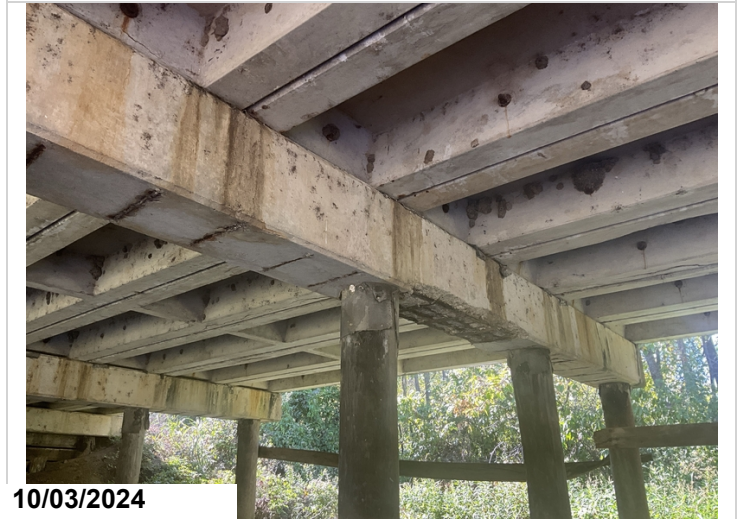
Bent 3, bottom: spalling with 19' exposed reinforcing steel.
Cs3.

Bent 3, bottom: spalling with 19' exposed reinforcing steel. Cs3.

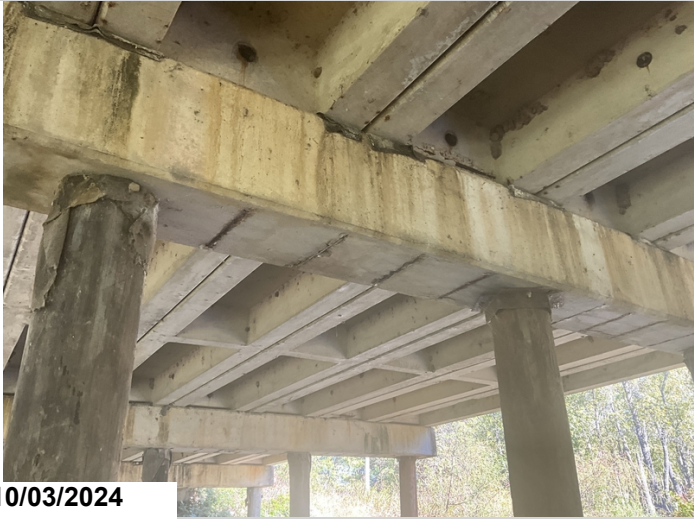
Bent 4, Bottom: Spalling with 20' of exposed reinforcing steel. CS3.

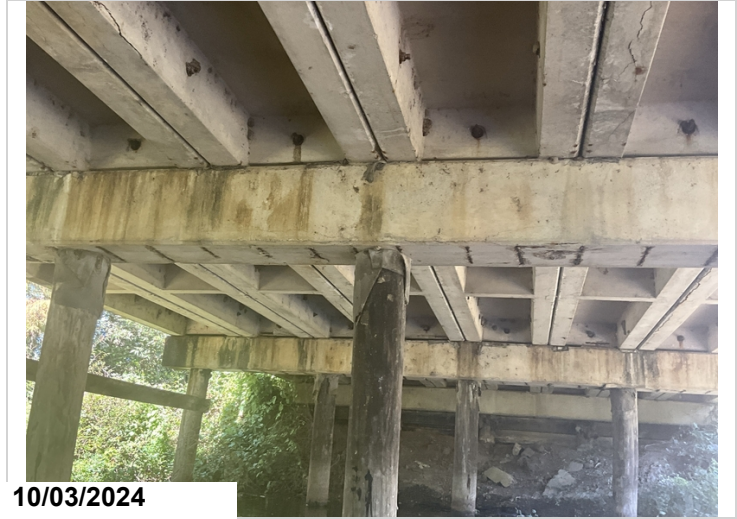
Bent 5, Bottom: Spalling with 20' cs3 rebar.

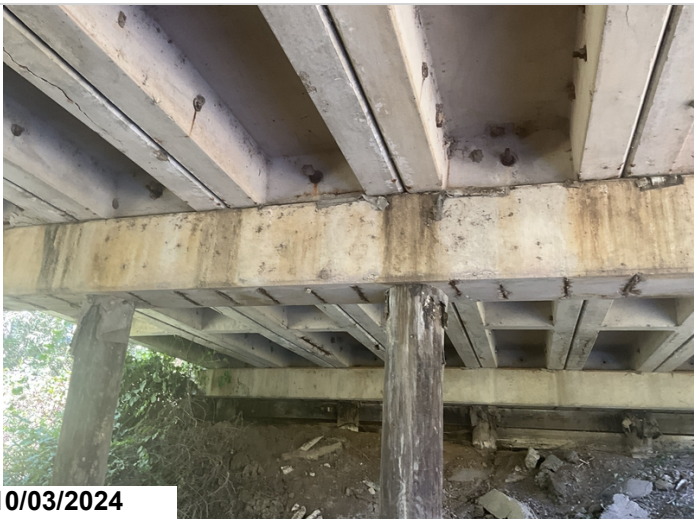
Bent 6: Spalling with 21' of exposed reinforcing steel. CS3.

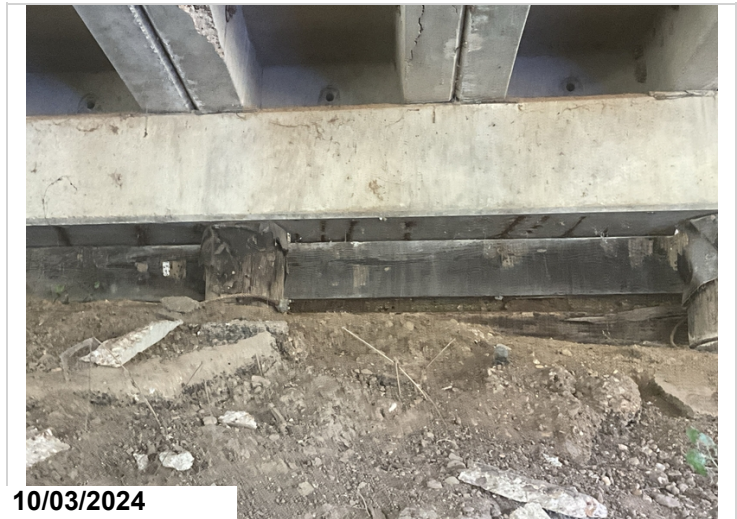
Bent 7, Bottom of cap: Spalling with 20' of exposed reinforcing steel. CS3.

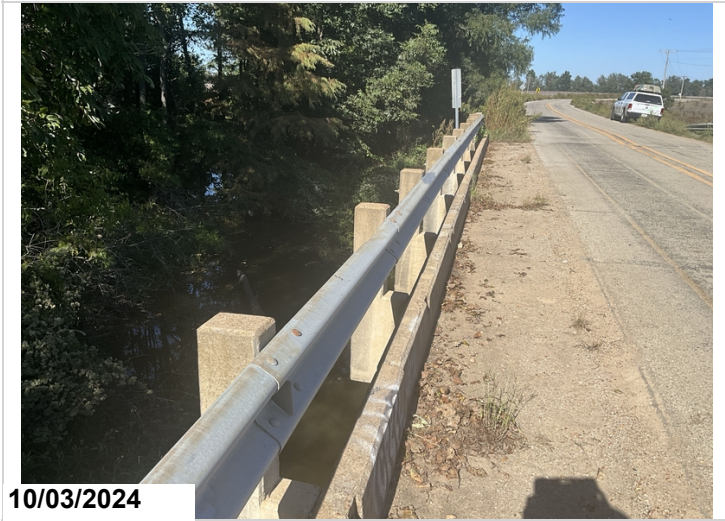
(330) Spans 4 and 5 the left side have 1 missing rail bolt in each span. Span 4, Left: minor damage. 2' CS2.

Span 4, Left: minor damage. 2' CS2.

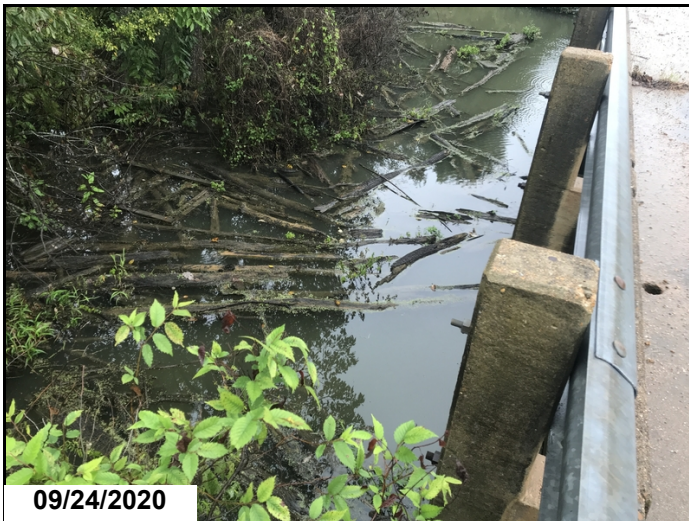
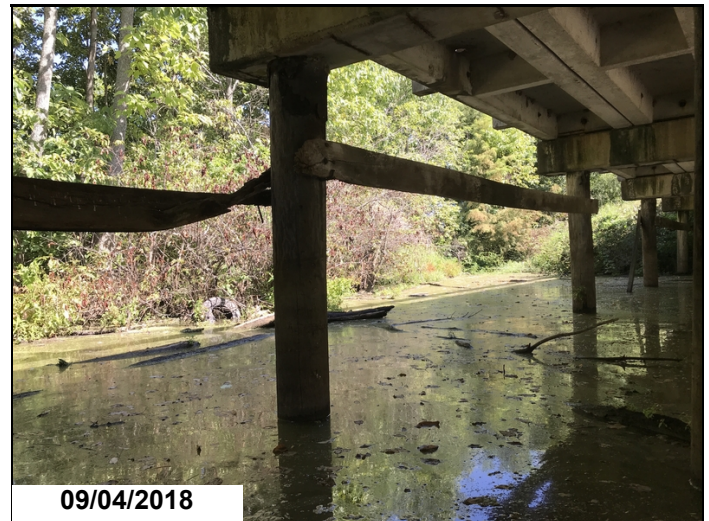
Left side of the Bridge: Channel has debris and vegetation growth.

Debris in channel left side.

Channel left side of bridge is full of debris.

Type of Work: Channel Work/Drift Removal

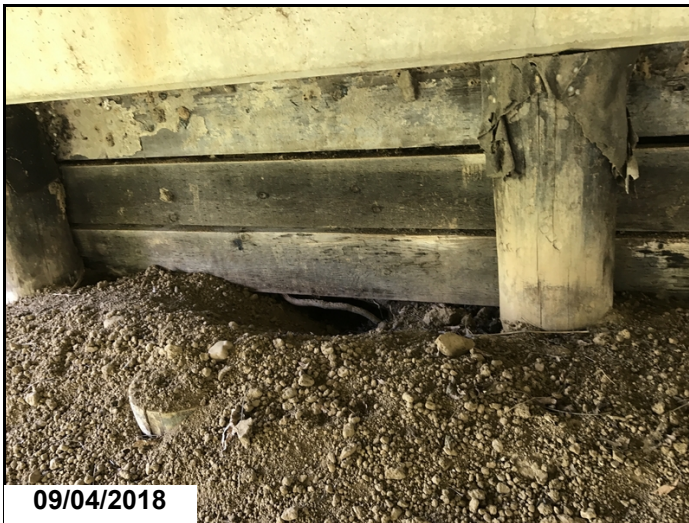
Abutment #1 has two deep animal holes.

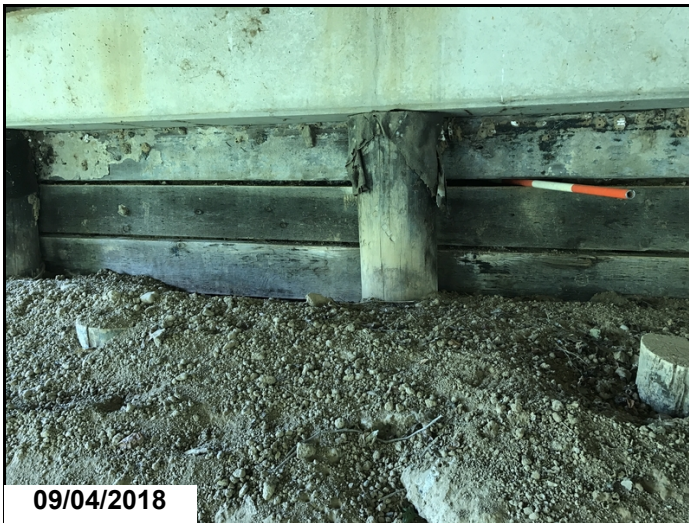
Abutment #1 back wall has a three foot by three foot void behind pile #3.

Abutment #1 void

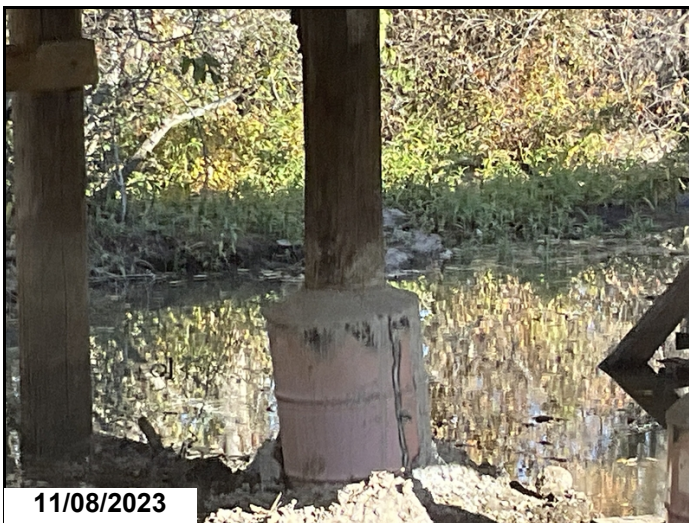
11/7/2023-Damage to bent 4 pile 2 has been encased in concrete at time of inspection.

Bent #4 pile #2 has outer shell decay with moderate section loss, damage now encased concrete, structural integrity unknown.

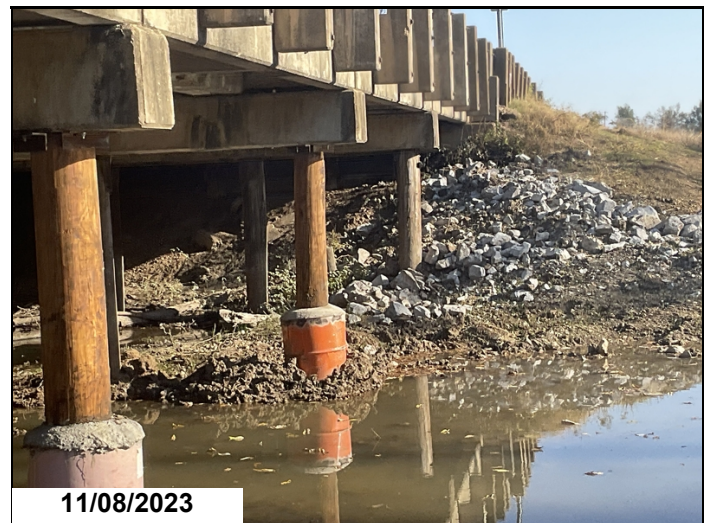
11/7/2023-Bent 5 pile 5 has been spliced and encased in concrete at time of inspection.

Bent #5 pile #5 has been spliced and encased in concrete, structural integrity unknown.

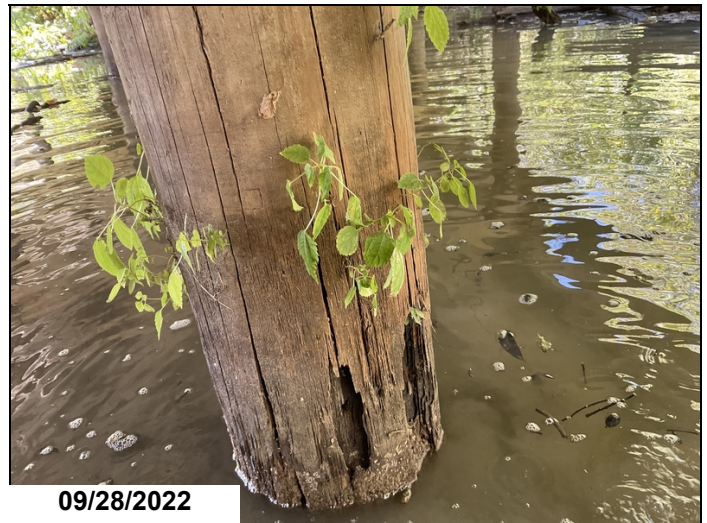
Bent #4 pile #2 has outer shell decay with moderate section loss.

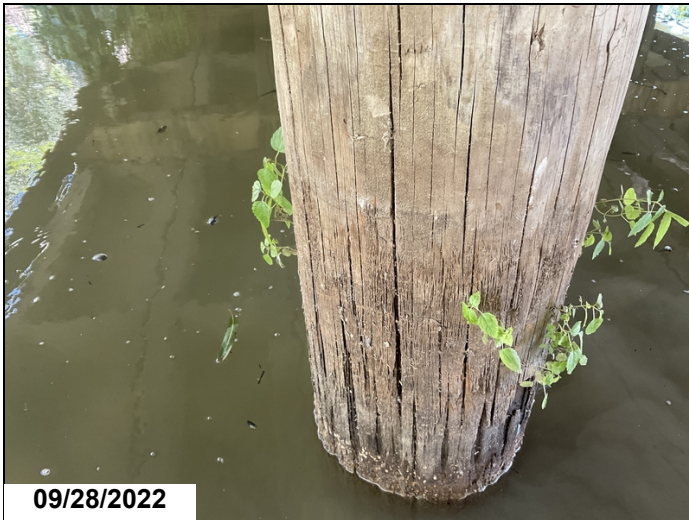
Bent #5 pile #2 has outer shell decay with minor section loss.

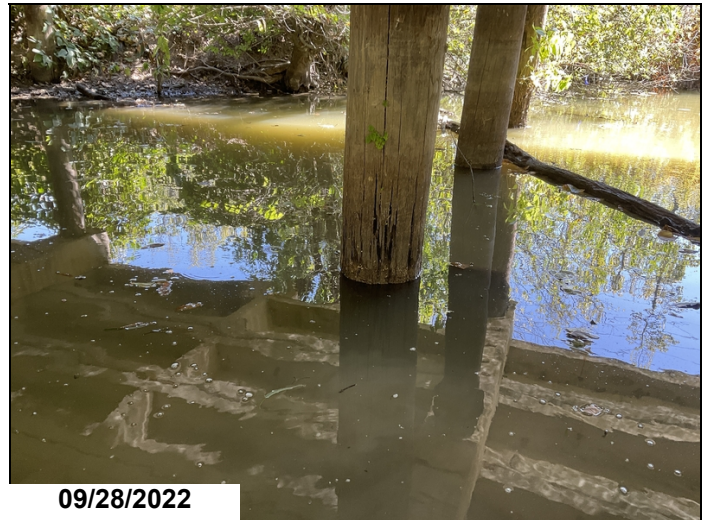
Bent #5 pile #3 has outer shell decay with minor section loss.

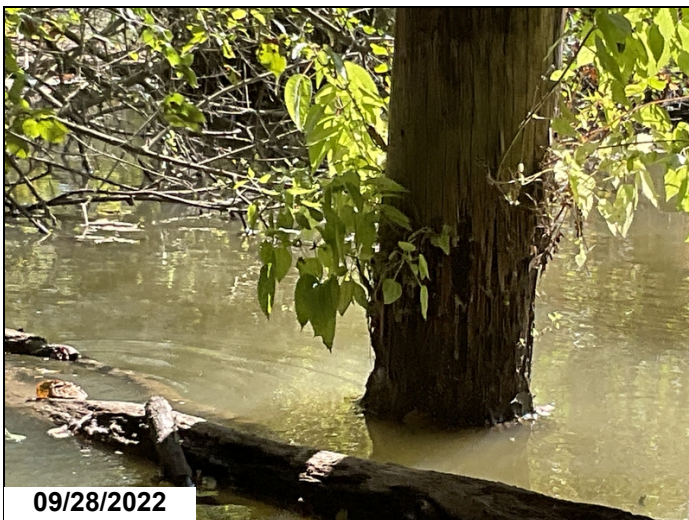
Bent #5 pile #5 has outer shell decay with moderate section loss.

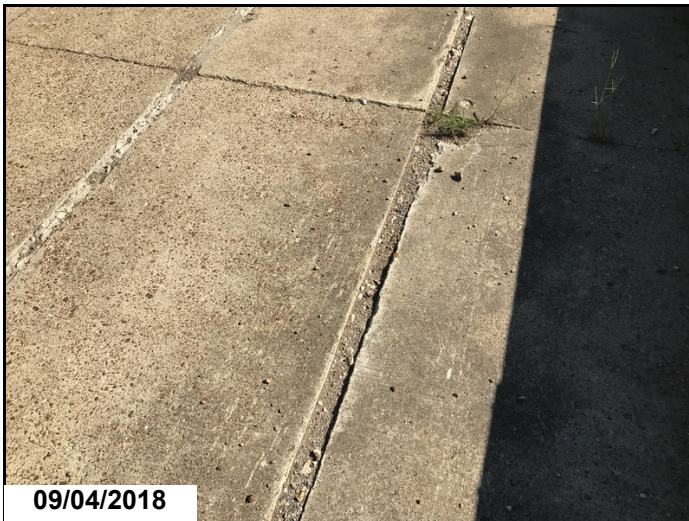
Grout Joints have areas of spalling up to 1" deep.

Typical spalled deck joint.

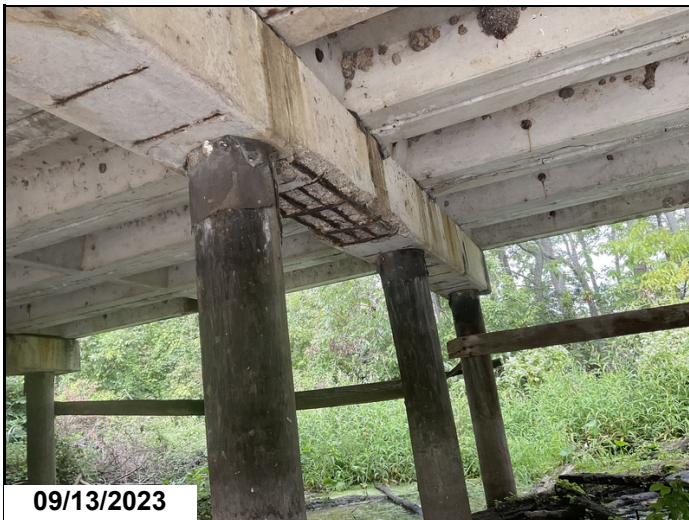
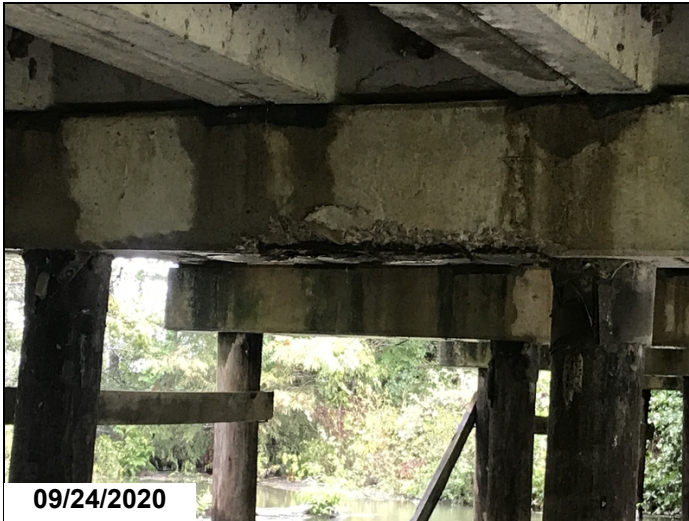
Bottom of all interior caps have spalls with exposed rebar with moderate section loss.

Bent #3 cap bottom face between piles #2 and 3

Bent #3 cap between piles #2 and 3.

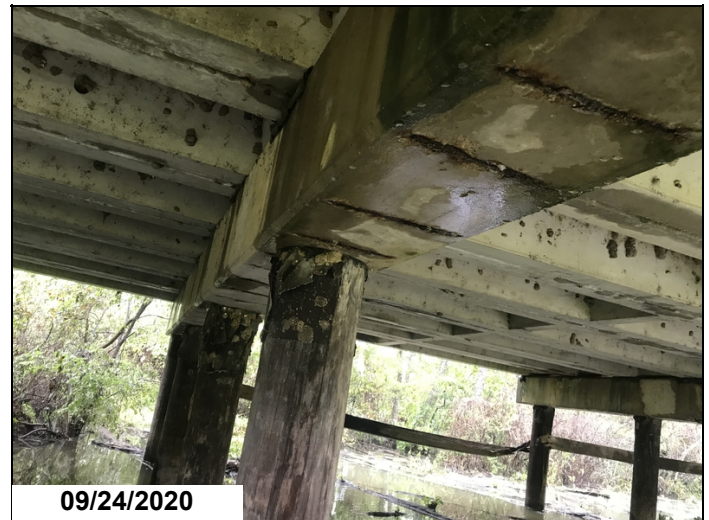
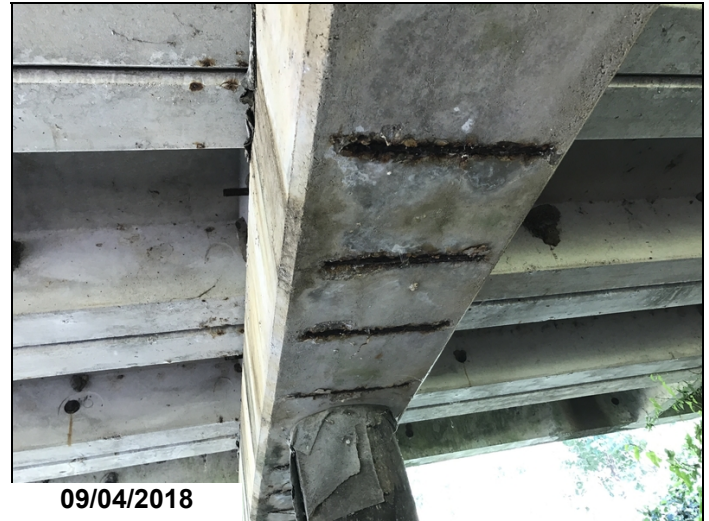
Typical bottom face of cap

Typical spalls on bottom of caps.

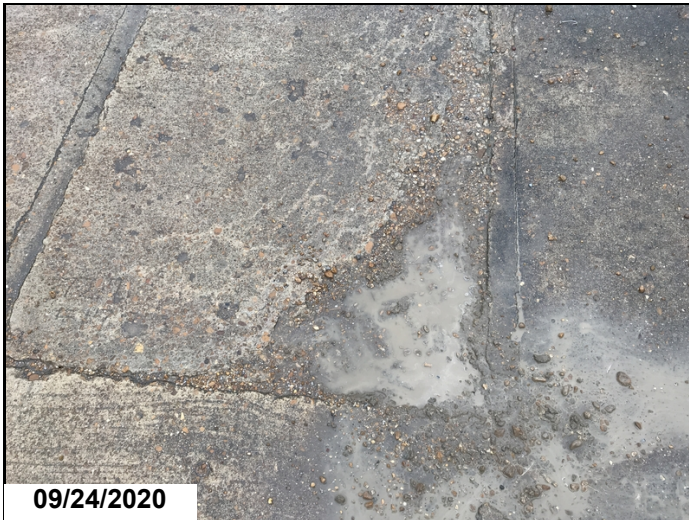
Span #4 bent #4 unit #7 has 1' x 2' shallow spall.

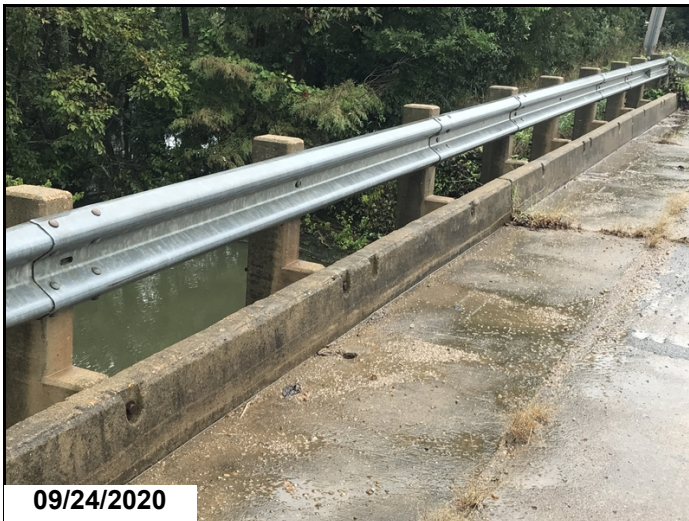
Spans #4 and #5 left side have 1 missing rail bolt each span.

Spans #4 and 5 left side have 1 missing rail bolt each span.

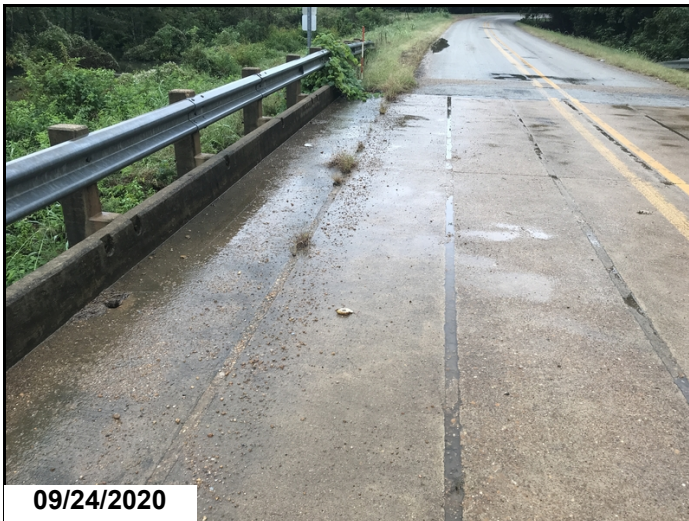
Vegetation is growing along the longitudinal shear key connections between channel units 1 & 2 and channel units 7 & 8.

Vegetation growing in grout joint.

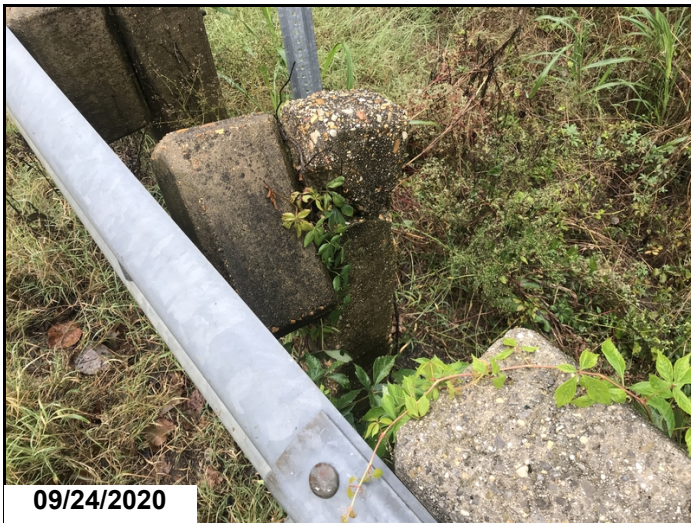
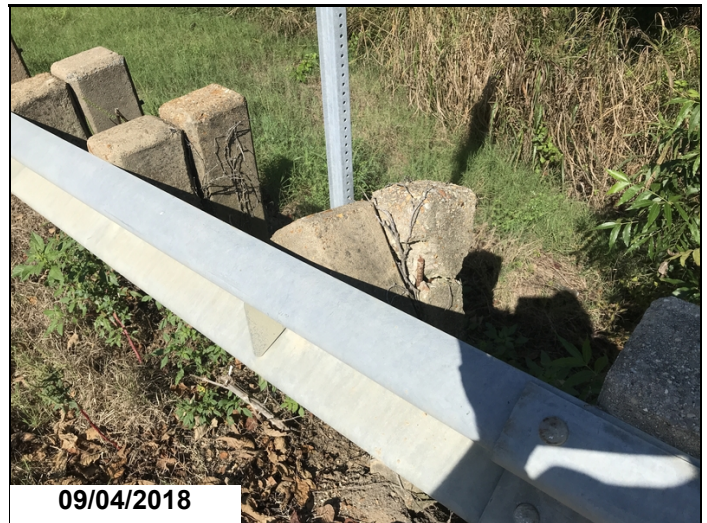
Abutment #1 left approach rail last post at bridge is broken.

Abutment #1 left side last approach rail post.

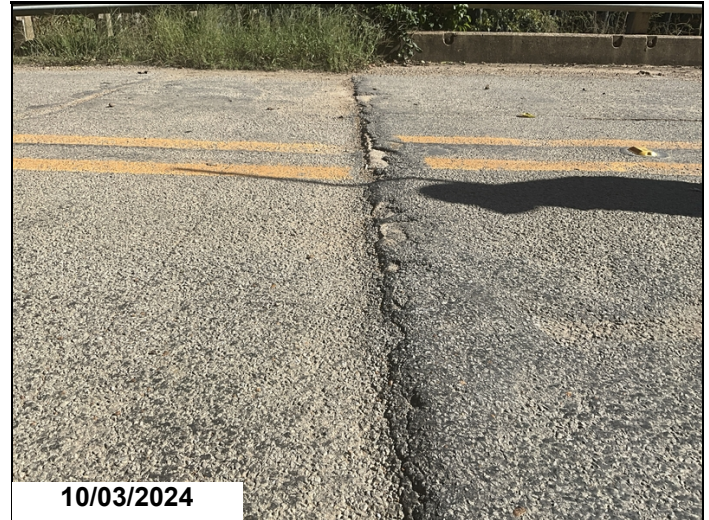
Approach Roadways at Bents 1 & 7: Settlement in the approach roadways along both ends of the bridge.

Bent 7: Approach roadway settlement.

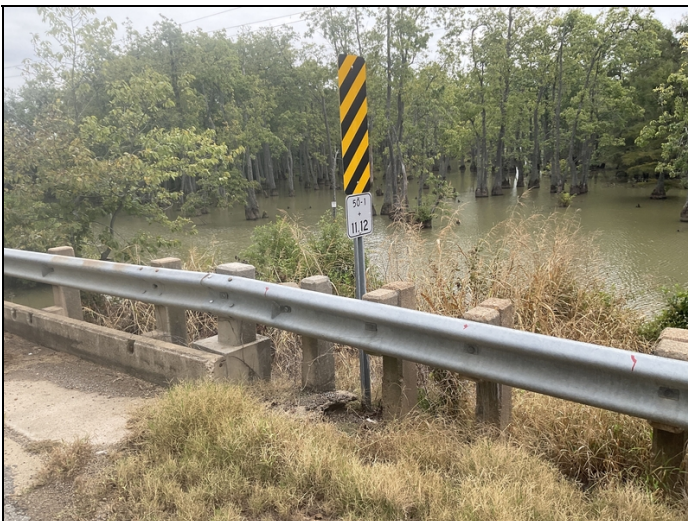
Abutment #1 log mile sign

Log mile should be 11.08
