Asset #M3331(Routine, Underwater type 2)

Sh-50/Sec-1/L13.54 over Blackfish Bayou

Location: 1.4 Mi W Jct Sh 149 & 50

Team Lead: Myron Futrell Inspection Date: 03/25/2024

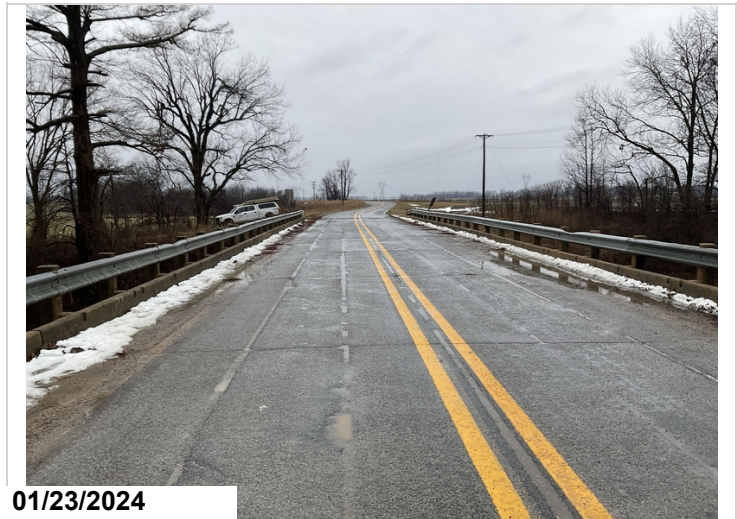
Minor damage to bridge rails

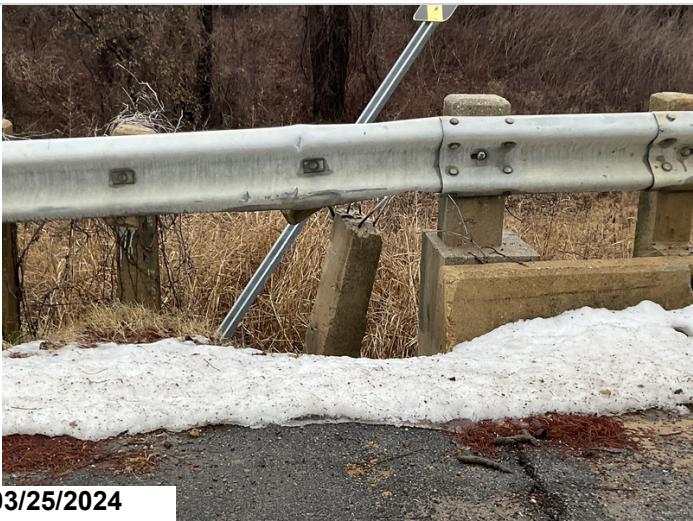
Abutment #1 left side last approach rail post spalled with exposed rebar

Abutment #1, left side, last approach rail post is broken.
Approach rail abutment #2 left side has collision damage.

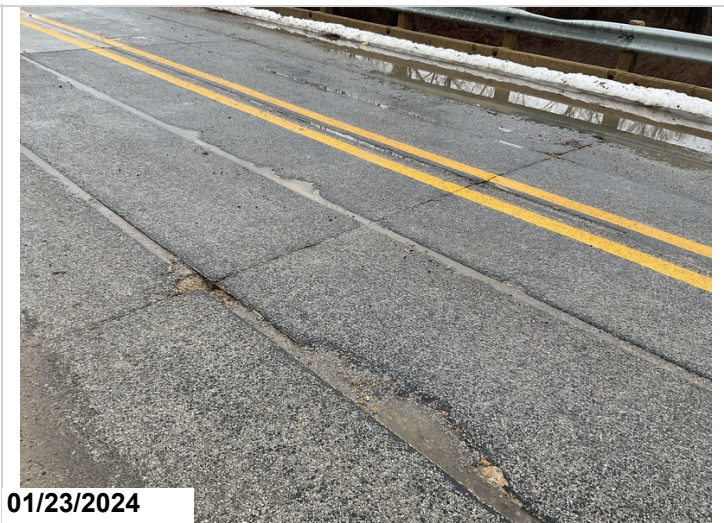
Typical deck spalling

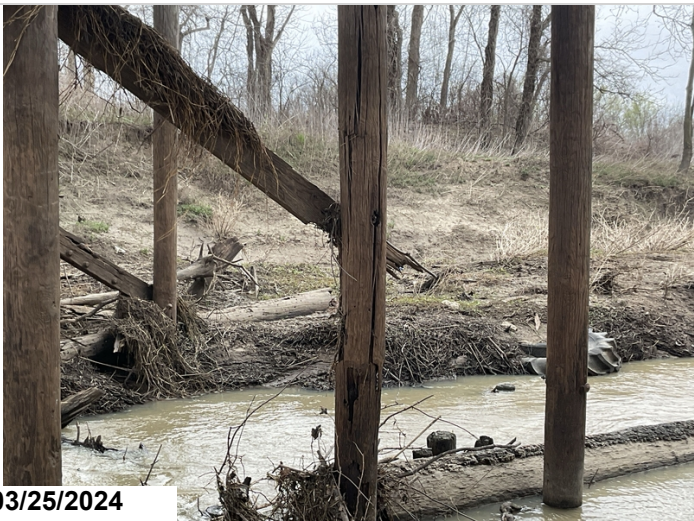
Bent #5 pile #4 is core decayed with large section loss and mushrooming.

Bent #5 pile #4 is core decayed with large section loss and mushrooming.

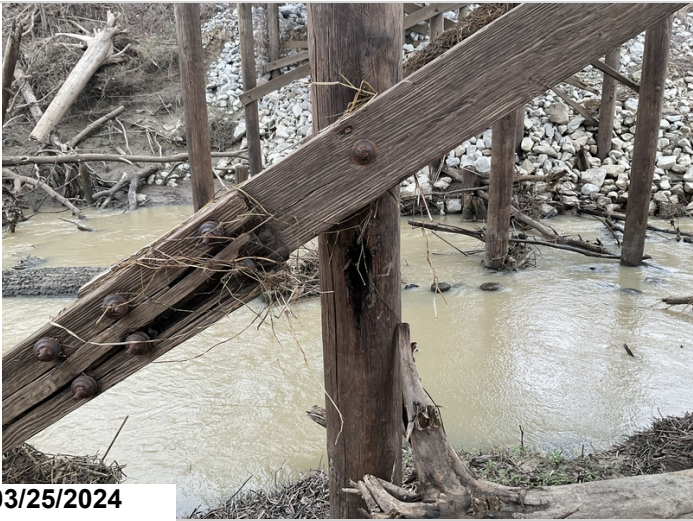
Bent #6 pile #4 has outer shell decay with moderate section loss.

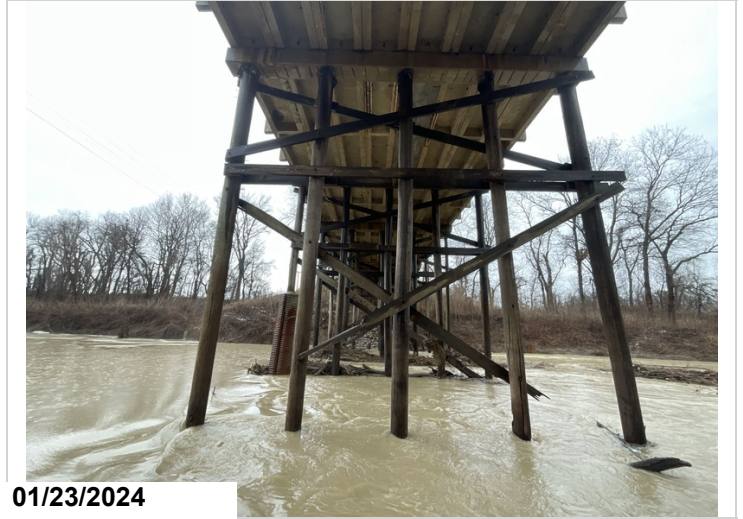
234	Reinforced Concrete Pier Cap	LF	329	219	0	110	0
1080	Delamination/Spall/Patched Area	LF	1	0	0	1	0
1090	Exposed Rebar	LF	109	0	0	109	0
(234) Caps are spalled on bottom chord with exposed rebar with moderate section loss. 109SF CS3							
<p>Abutment #1 cap has been put back in place and fastened to girders with metal brackets.</p> <p>Bent #2 cap has been repositioned and is held in place laterally with metal brackets attached to both sides of the cap.</p>							
Bent #11 left side has a 1' spall with no exposed rebar. 1SF CS3							
301	Pourable Joint Seal	LF	259	0	0	259	0
2350	Debris Impaction	LF	259	0	0	259	0

Typical exposed rebar on bottom of cap

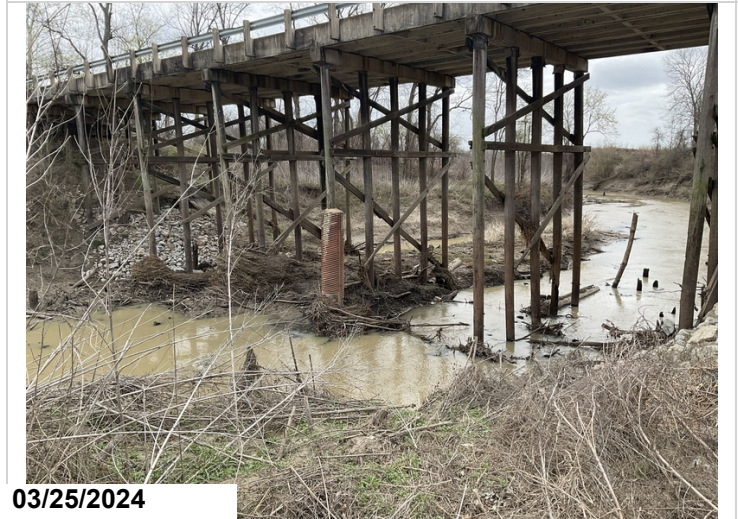
Channel is in fair condition with a large accumulation of debris and silt in channel at bents 6, 7, 8 and silt build up in channel on downstream side of bridge. Channel alignment is fair, downstream slopes are steep and eroded on east bank. Rip rap has been placed under spans #2 and 3. Rip rap has been displaced at bent 9 exposing filter fabric.

Silt and debris in channel

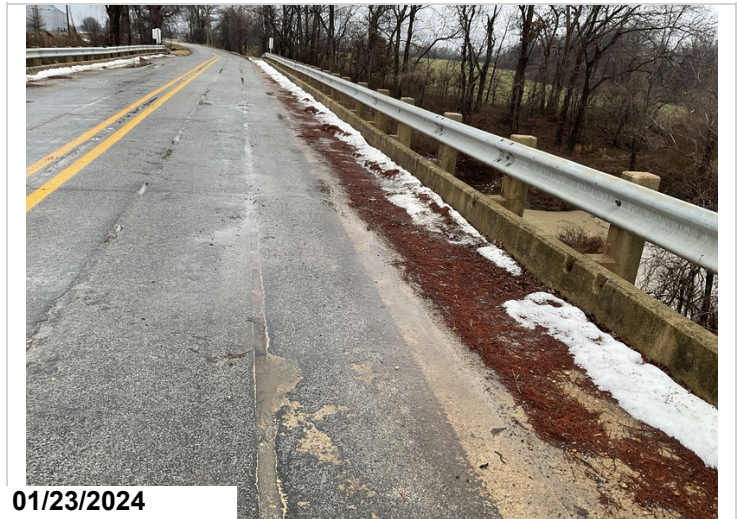
Dirt and debris in gutters

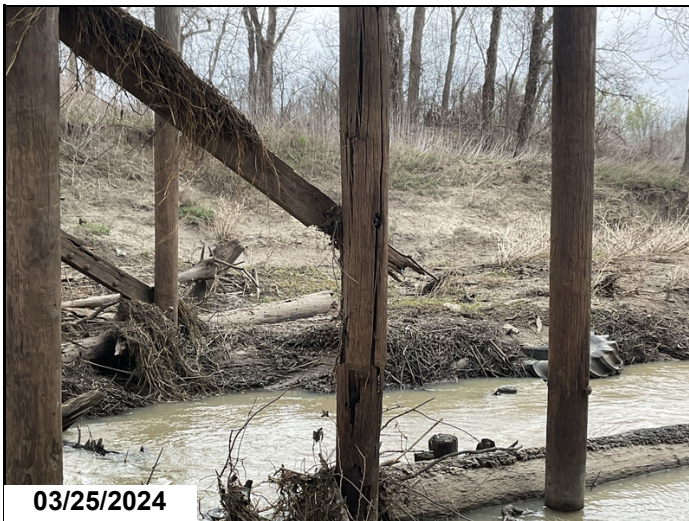
03/25/2024

01/24/2023 this should not be in repaired documented Bent #5 pile #4 is in bad condition.

Bent #5 pile #4 is core decayed with large section loss and mushrooming.

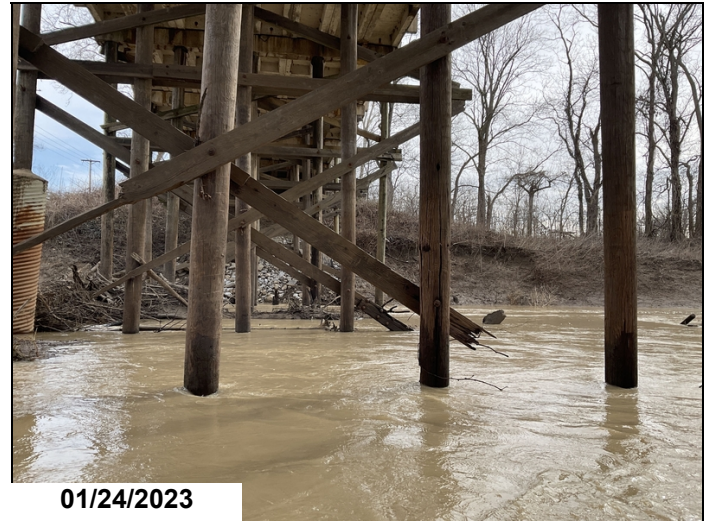
01/24/2023

Bent #5 pile #4 is core decayed with large section loss and mushrooming.

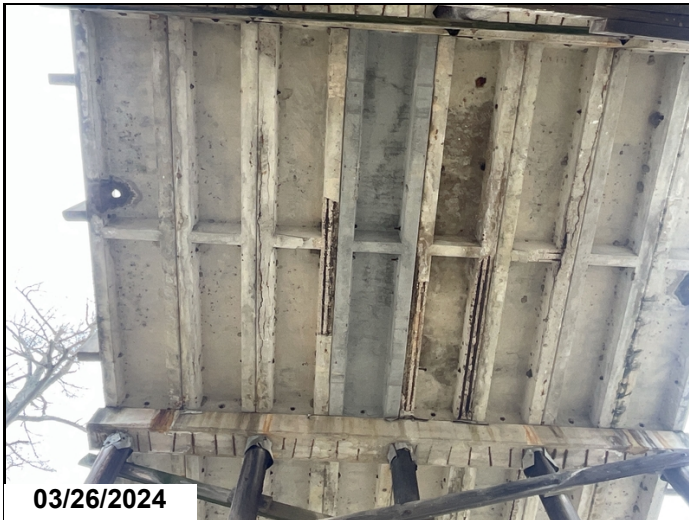
Span 5 soffit / under surface of deck.

Span 5, Unit 4, Left Leg, First ½ of Span: Spalled with exposed, unbonded reinforcing steel with moderate section loss. 9LF CS4

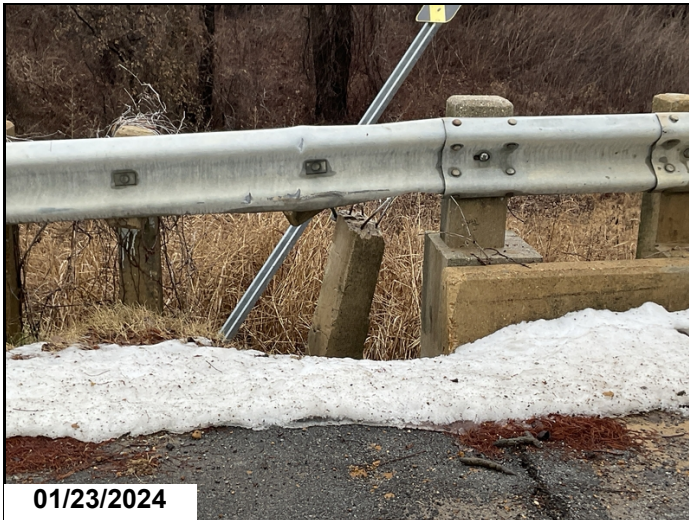
01/23/2024

Abutment #1 left side last approach rail post spalled with exposed rebar

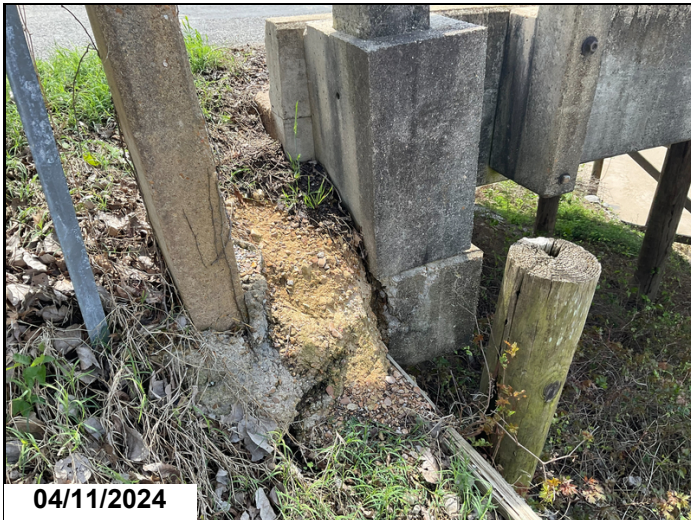
04/11/2024

Void at abutment 2 left approach shoulder has been repaired at time of inspection.

4/11/2024-Void at abutment 2 left approach shoulder has been repaired at time of inspection.

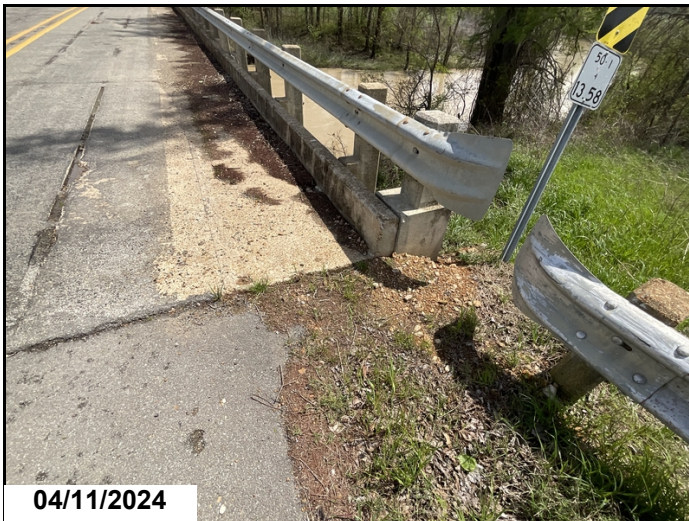
Erosion at abutment #1 right approach shoulder has been repaired at time of inspection.

4/11/2024-Erosion at abutment #1 right approach shoulder has been repaired at time of inspection.

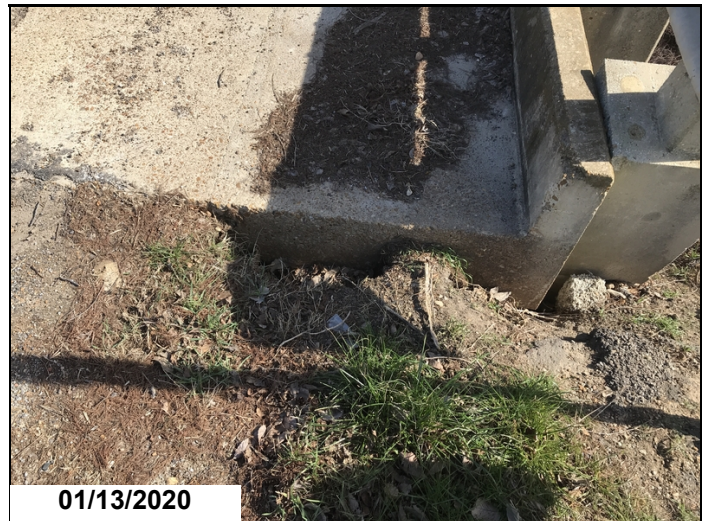
Abutment #1 right approach shoulder is eroded with two holes at bridge end.

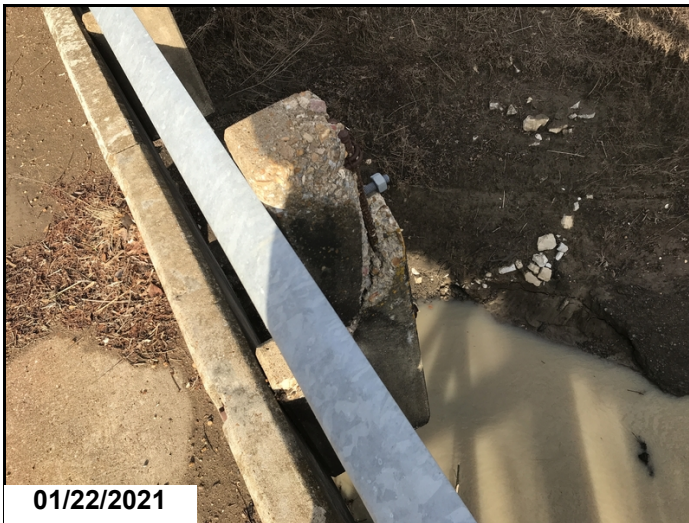
Span #5 left first post spalled with exposed rebar.

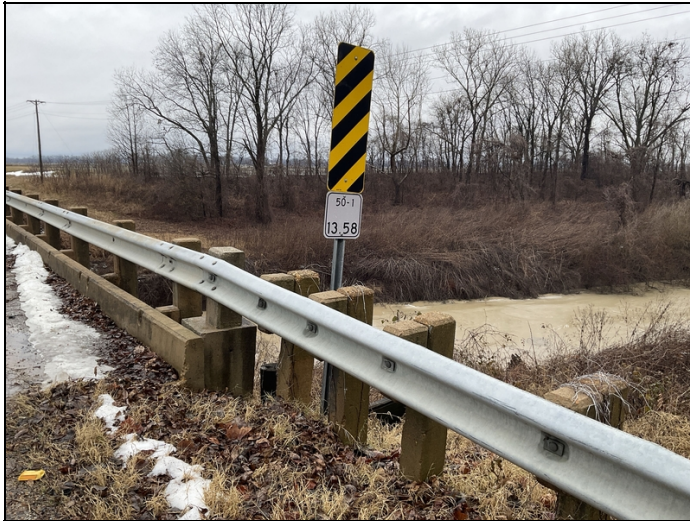
Abutment #2 log mile sign

Log mile signs say 13.58 they should read 13.54
