Route:50 Section:01 Log:15.35

Arnold Road ID:68x50x1xA, Arnold Log mile:15.345

District 01, 123 - St. Francis County

(4) Place Code	0
(6) Features Intersected	Big Rabbit Bayou
(7) Facility Carried	Sh-50/Sec-1/L15.35
(9) Location	.03 Mi W Jct Sh 149 & 50
(11) Mile Point	15.35 mi

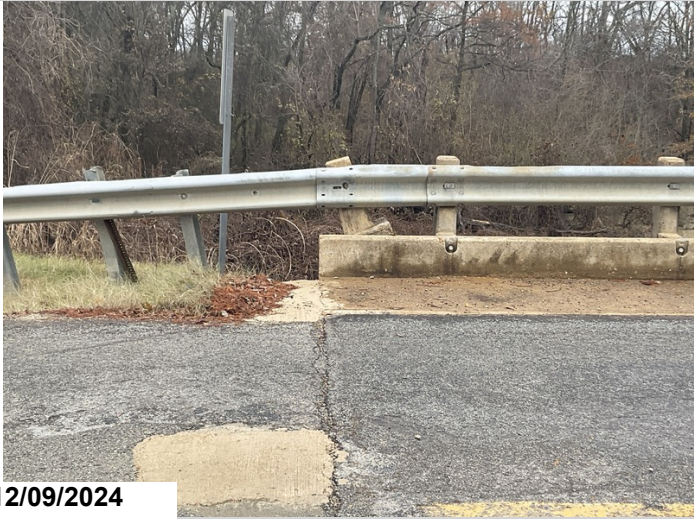
Abutment 1, left side, first rail post: leaning back.

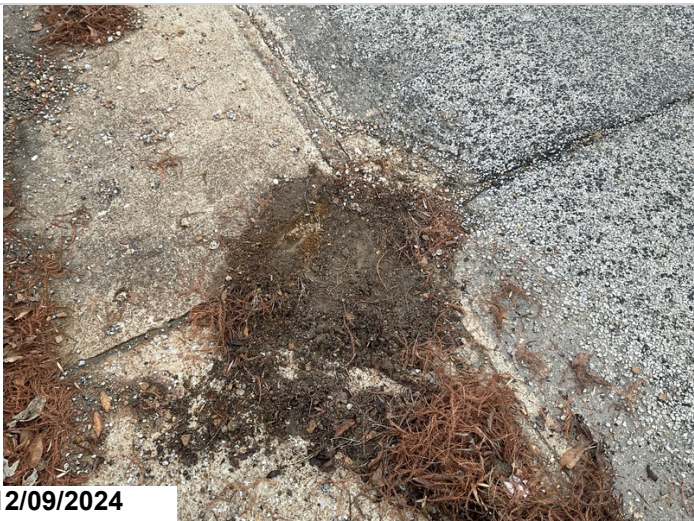
Span 1, unit 1, at bent 2: 1' heavy scaling 1" deep with loose aggregate.  
Span 2, unit 1, at bent 2: 1' heavy scaling 1", deep with loose aggregate

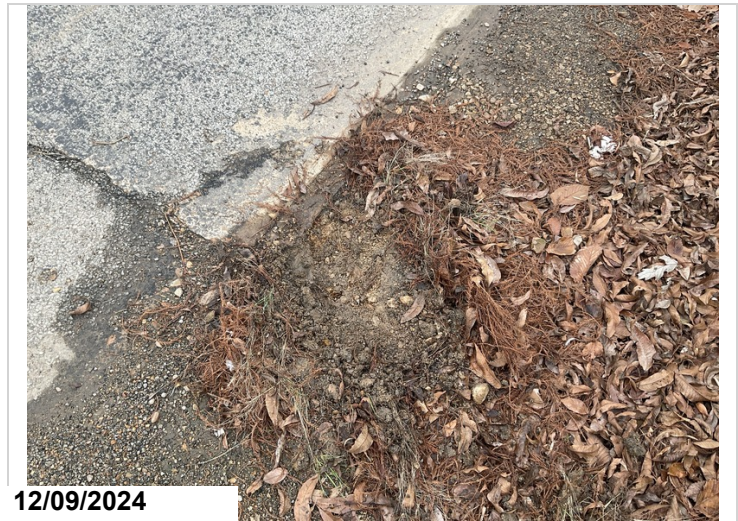
Span 1, unit 8, at bent 2, right side white line: 1' spall no reinforcing steel exposed. Spall

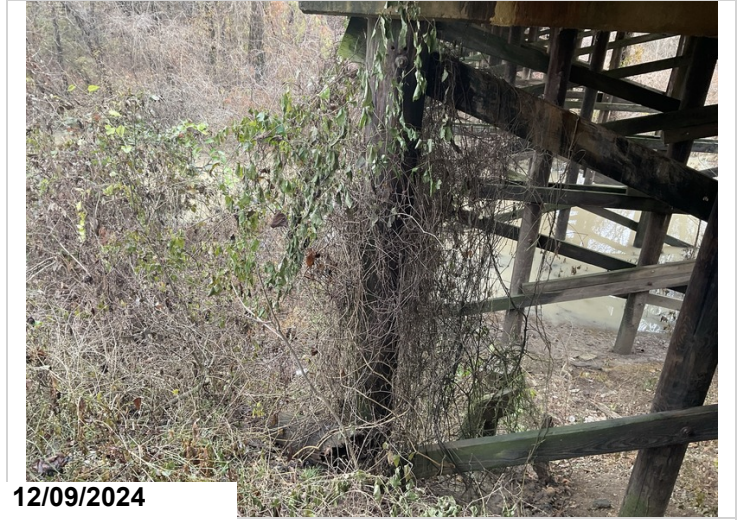
Typical vegetation growing beside, under and onto bridge.

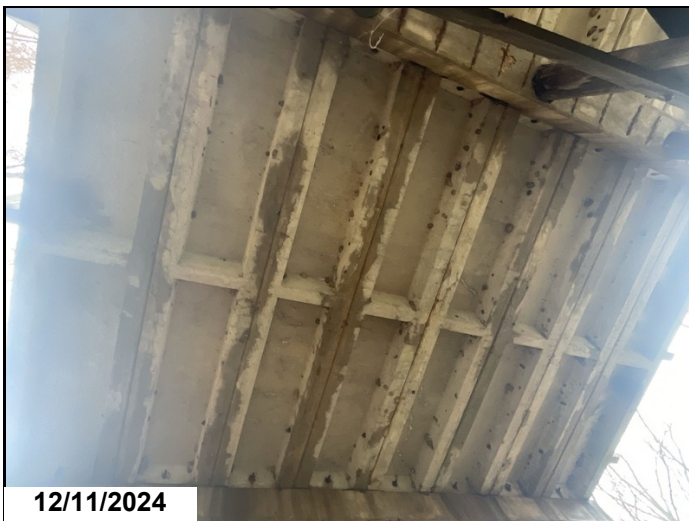
Span 6, unit 6, left leg: cracked and delaminated for 14' with 1' spall with exposed reinforcing steel with moderate section loss.

Span 6, unit 6, right leg, full length: cracked and delaminated.

Type of Work: Superstructure Repair

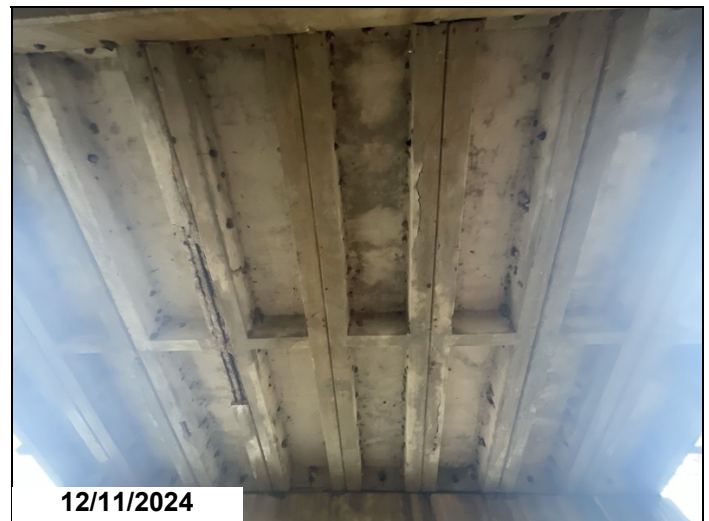
Span 2, unit 3, right leg, full length cracked and delaminated, with 6' spall with exposed reinforcing steel with moderate section loss mid span.

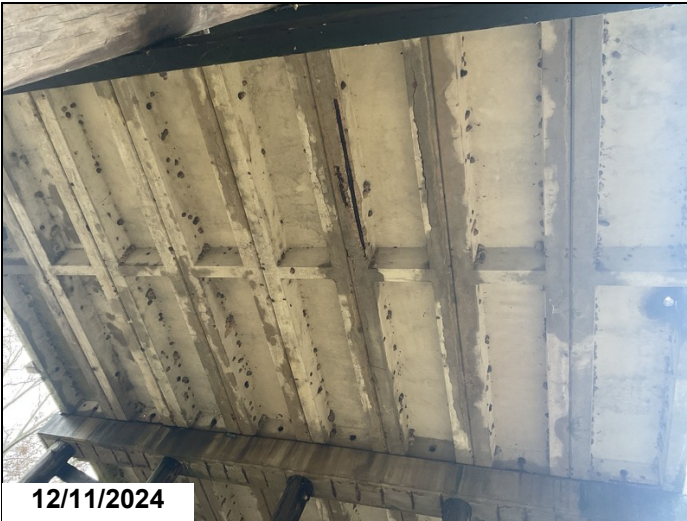
Span 4, unit 3, right leg: spalled 5' with exposed reinforcing steel with moderate section loss rest of leg is cracked.

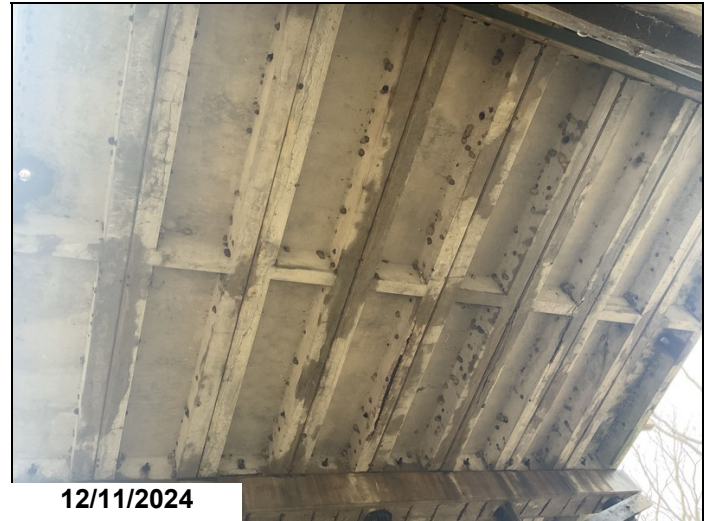
Span 5, unit 4, right leg: 5' spall with exposed rebar at 3/4 span with moderate section loss and 5' of cracking with rust staining.

Span 5, unit 6, right leg, full length: cracked and delaminated with 1' spall with exposed reinforcing steel with moderate section loss near mid span.

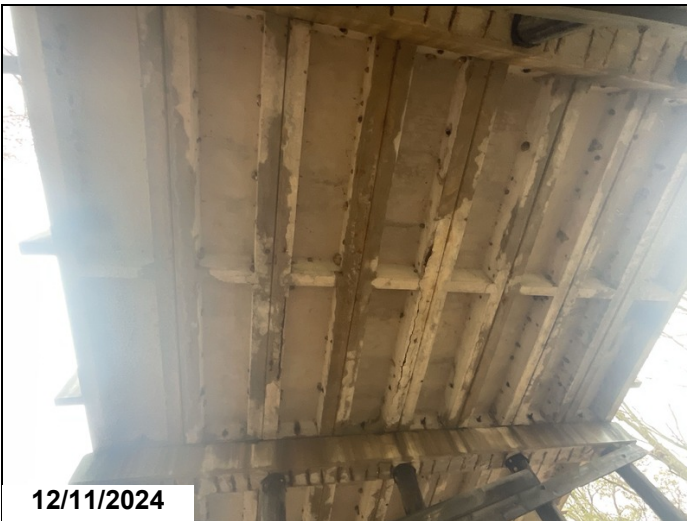
Span 7, unit 3, left leg, starting at 1/4 span: cracked with rust stains for 6' with 4' spall with exposed reinforcing steel with moderate section loss.

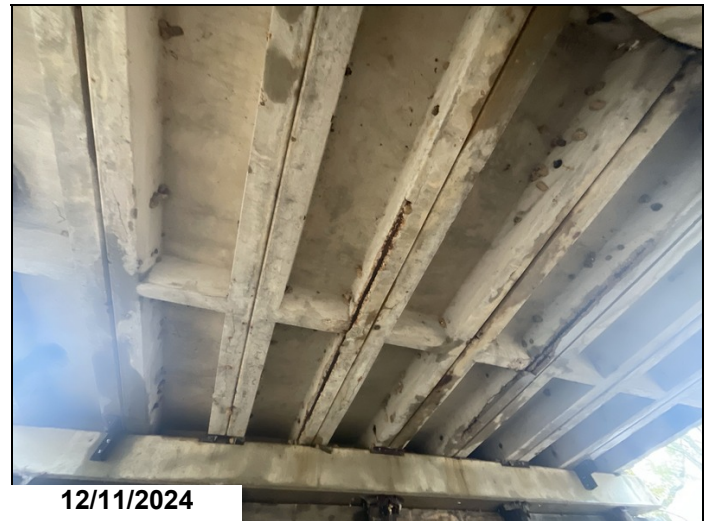
Span 9, unit 3, right leg: cracked and delaminated 2' with 14' spall with exposed reinforcing steel with moderate section loss.

Span 9, unit 5 right leg: cracked and delaminated full length, with 6' spall with exposed reinforcing steel with moderate section loss.

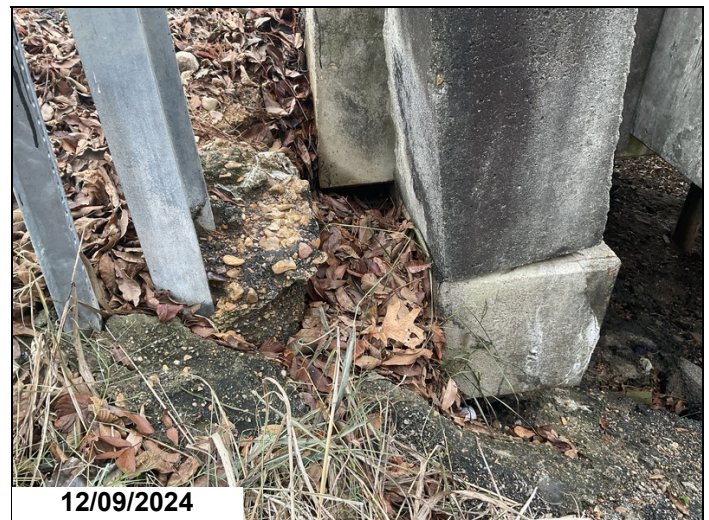
Abutment 2, left side: void behind cap

Type of Work: Repair (General)

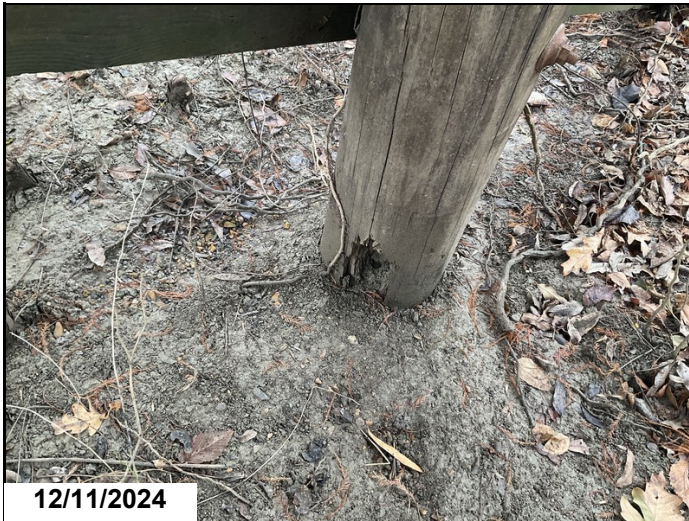
Bent 7 pile 2: 4" wide by 3" deep hole in outer shell at ground line. Decay 1EA CS3

**Type of Work:** Piling Repair/Replace

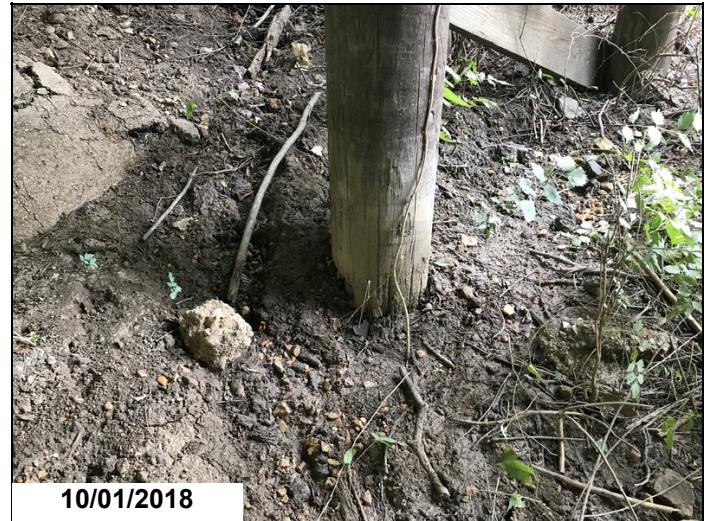
Bent #9 pile #4

Bent 9, pile 4: outer shell decay with 10% section loss at ground.

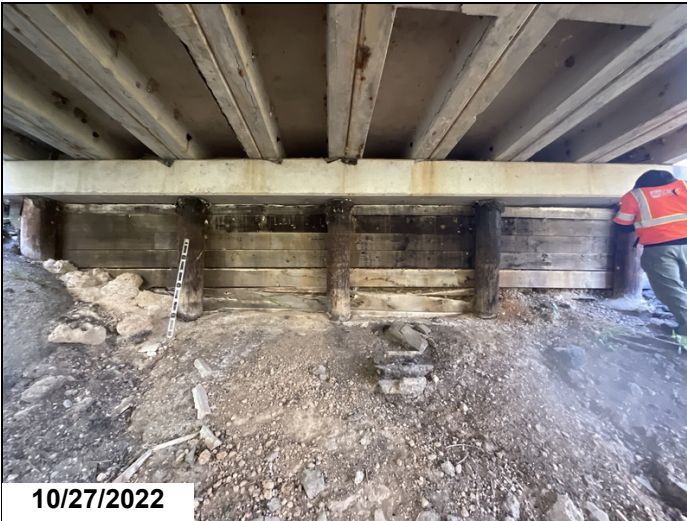
(216) Abutment #2 back wall is rotated 1 1/4" per foot measured at pile #2,3 and 2" per foot at pile #4. Abutment #2 timber back wall is decayed full width with areas of 100% section loss allowing for erosion. Abutment #2 has void behind abutment #2 cap left side. 1' x 2' at outer edge, tapering towards center of bridge. Abutment #1 is decayed, weathered and cracked with a one foot void behind back wall. Abutment #1 has small void behind cap extending under bridge.							
228	Timber Pile	EA	50	35	2	13	0
1140	Decay/Section Loss	EA	13	0	0	13	0
1150	Check/Shake	EA	2	0	2	0	0

Abutment #2 timber back wall is decayed full width with areas of 100% section loss allowing for erosion.

**Type of Work:** Substructure Repair

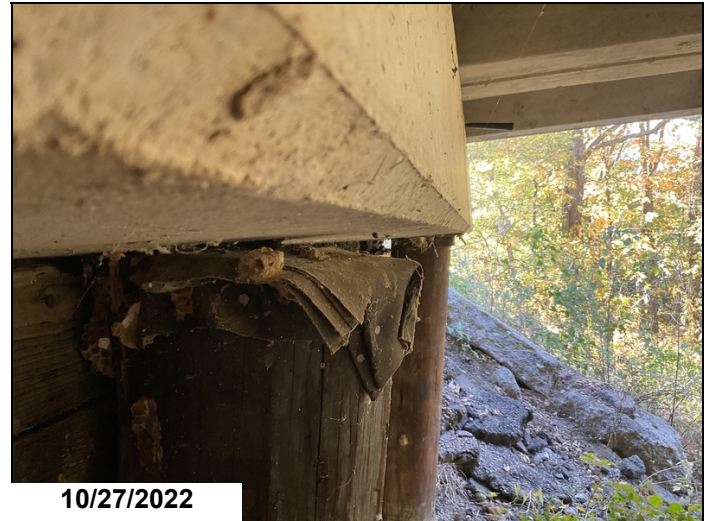
Typical bearing of piles at abutment #2 cap due to rotation

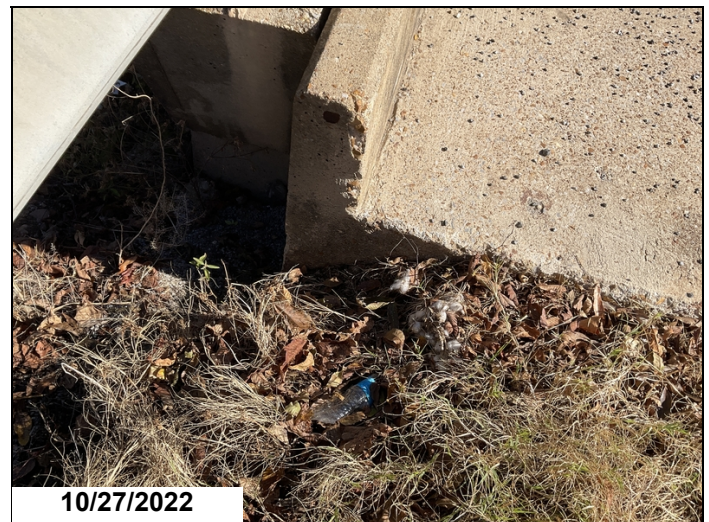
Erosion at abutment #1 right shoulder

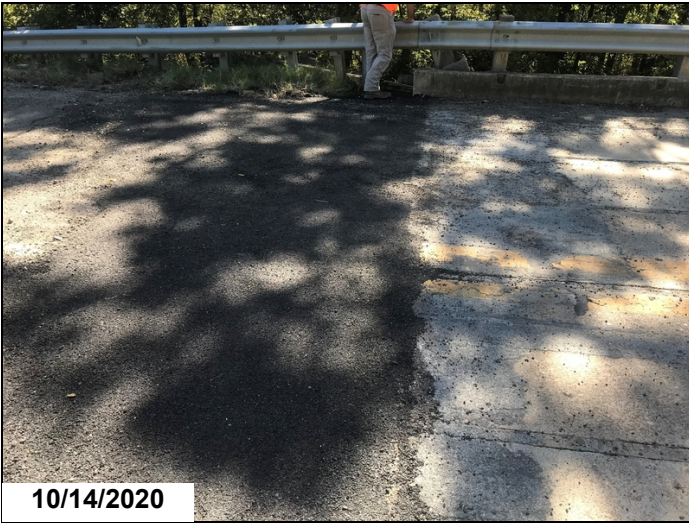
Abutment #2 approach roadway has been repaired with achm.

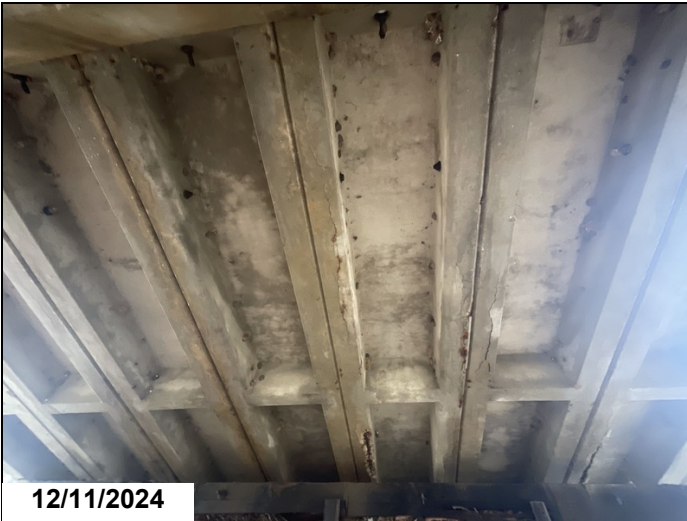
Span 1, unit 2, right leg: cracked and delaminated for 4' with 3' spall with exposed reinforcing steel with moderate section loss first 1/2 span.

Span 1, unit ,3 right leg, mid span: cracked and delaminated 7' with rust staining, and 1' spall with exposed reinforcing steel with moderate section loss.

Span 1, unit 7, right leg: cracked for 9' mid span.

**Type of Work:** Superstructure Repair

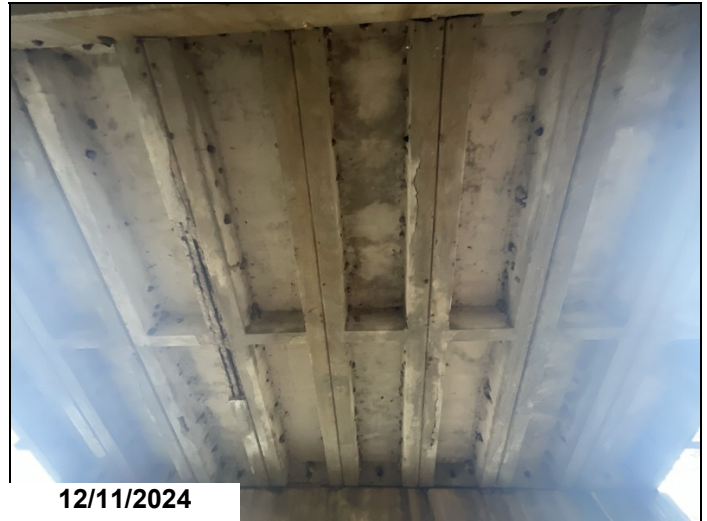
Span 2, unit 6, left leg, last 1/2 span: cracked for 8' with rust staining.

Span 2, unit 6, right leg: cracked for 6' first 1/2 span and 1' at 3/4 span.

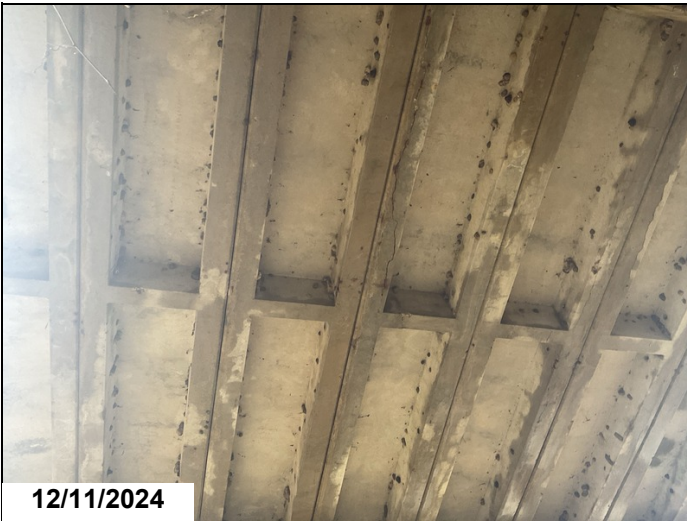
Span 3, unit 4, left leg: cracked 9' first half of span with rust stains, with 2' of cracking at 3/4 span.

Span 3, unit 5, right leg, mid span: cracked for 10'.

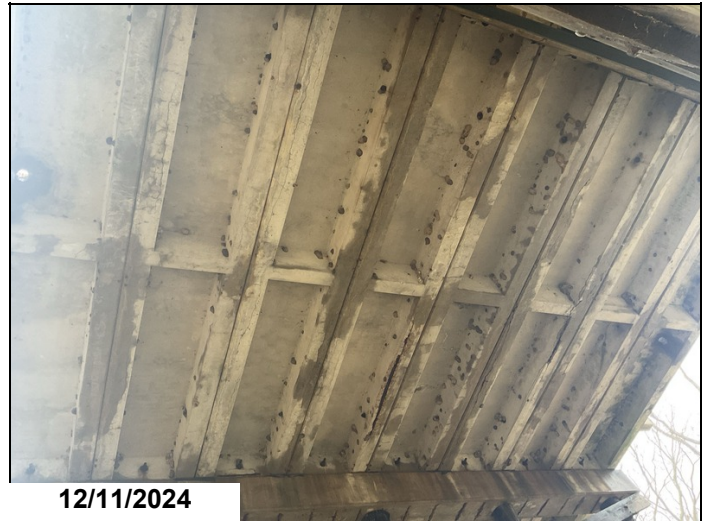
Span 5, unit 7, left leg: cracked for 10'.

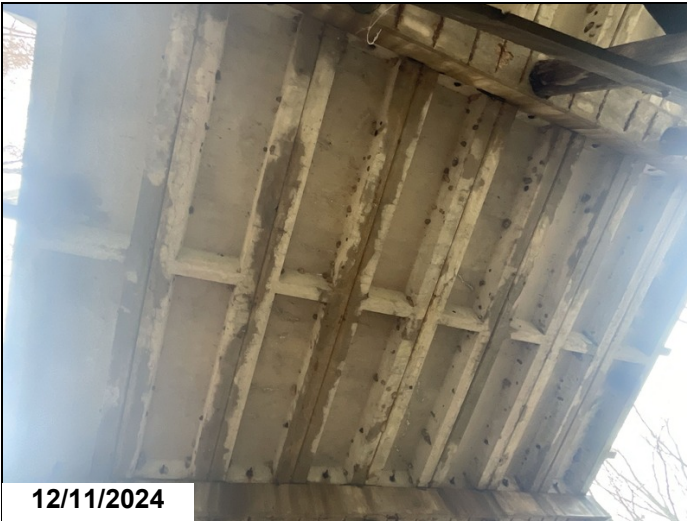
Span 6, unit 2, left leg: is cracked for 16' with rust staining.

Span 6, unit 5, left leg, mid span: cracked for 8' with rust staining.

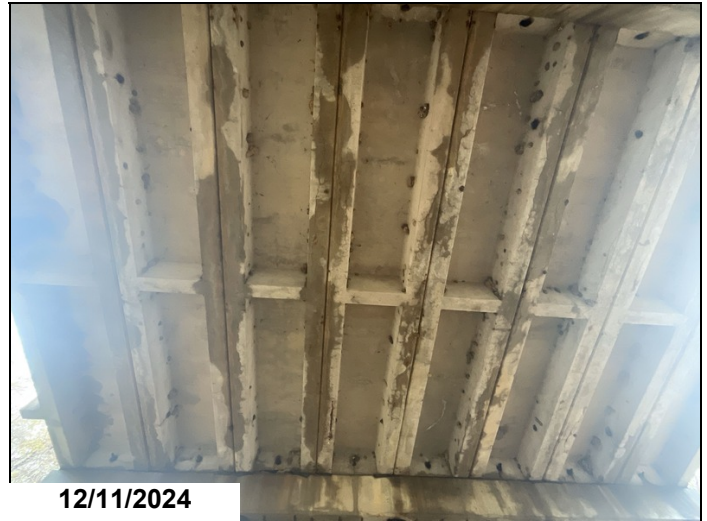
Span 8, unit 3, right leg: is cracked and delaminated for 8' mid span.

Span 8, unit 4, left leg: 4' of cracking and delamination first 1/2 span and 2' spall with exposed reinforcing steel with moderate section loss at 3/4 span.

Span 8, unit 4, right leg: 12' of cracking with rust staining.

Span 8, unit 5, right leg, scattered throughout: cracked and delaminated for 10'.

Span 8, unit 6, left leg: cracked for 7' first 3/4 span.

Span 8, unit 6, right leg: cracked and delaminated for 8' starting at 1/4 sp

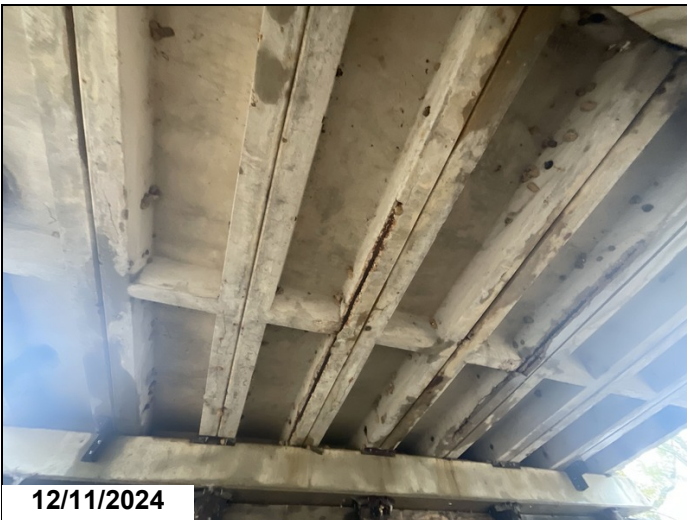
Span 9, unit 4, left leg, starting at 1/4 span: cracked and delaminated for 10'.

Span 9, unit 4, right leg, scattered throughout: cracked for 10',

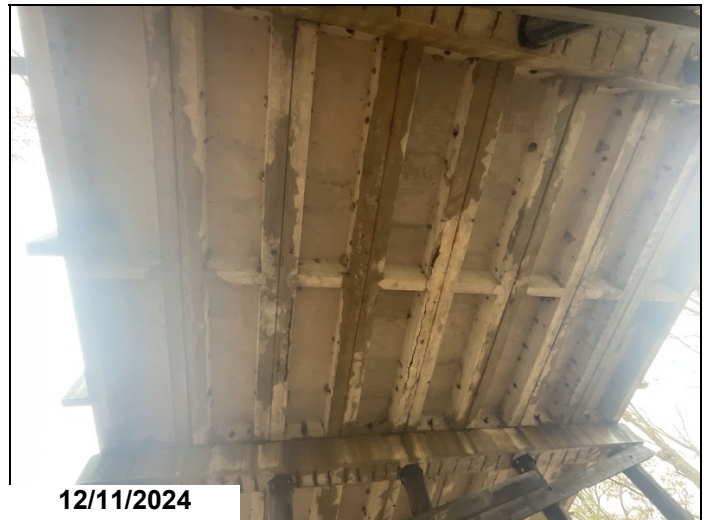
Span 7, unit 5, right leg, starting at 1/4 span: cracked for 12'.

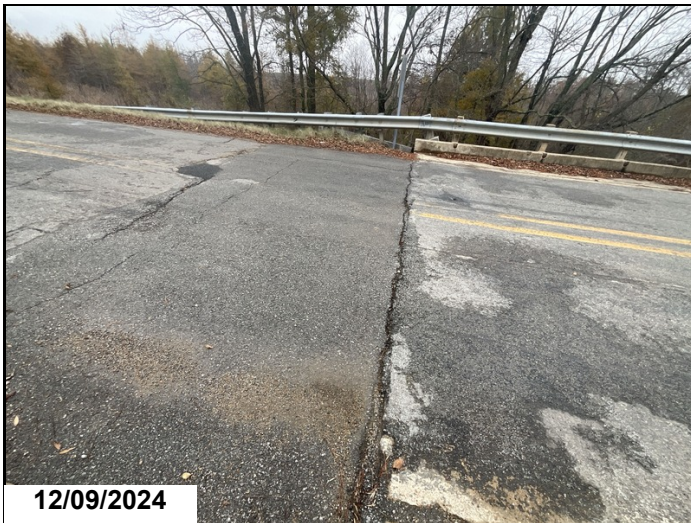
Abutment 2, approach roadway settlement

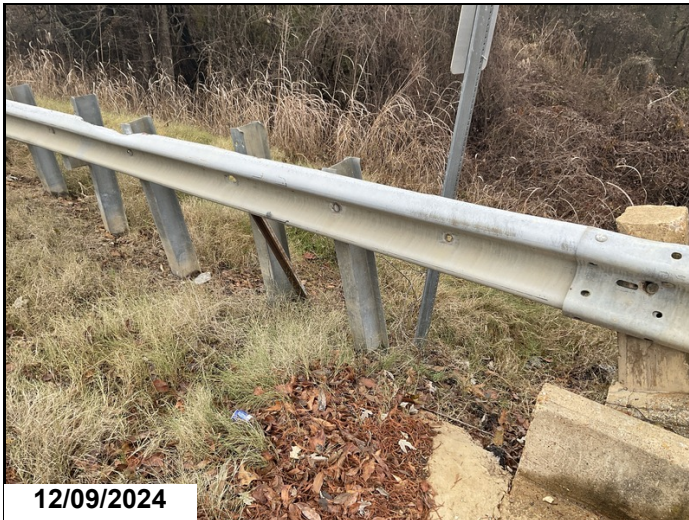
Abutment 1, left side, approach rail transition: last post missing, third post from bridge not connected.

**Type of Work:** Repair (General)

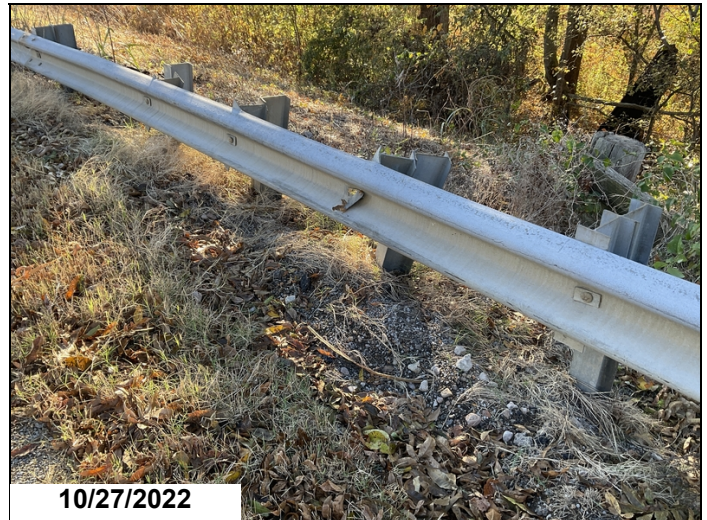
Abutment #2 right approach rail has several damaged posts with the fourth rail post not connected

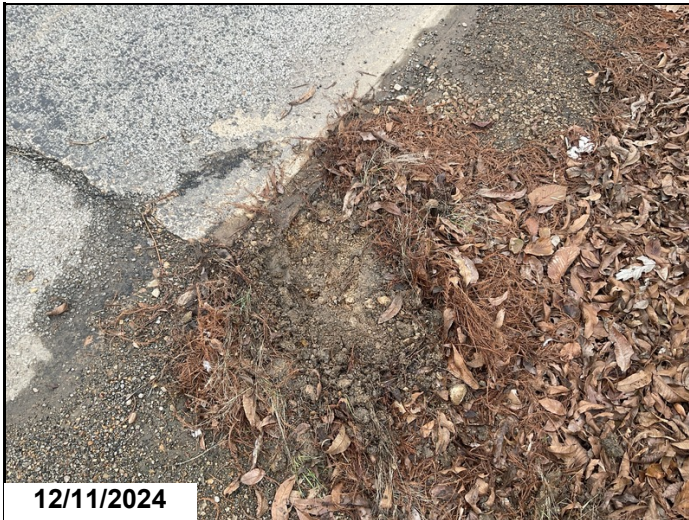
Span 1, unit 8, at bent 2, right side white line: 1' spall no rebar exposed. Spall

**Type of Work:** Deck Repair

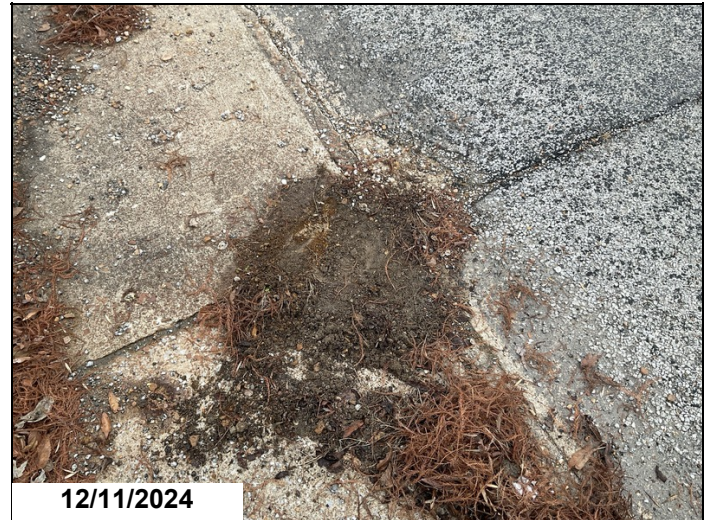
Span 1, unit 1, at bent 2: 1' heavy scaling 1" deep with loose aggregate.  
Span 2, unit 1, at bent 2: 1' heavy scaling 1", deep with loose aggregate

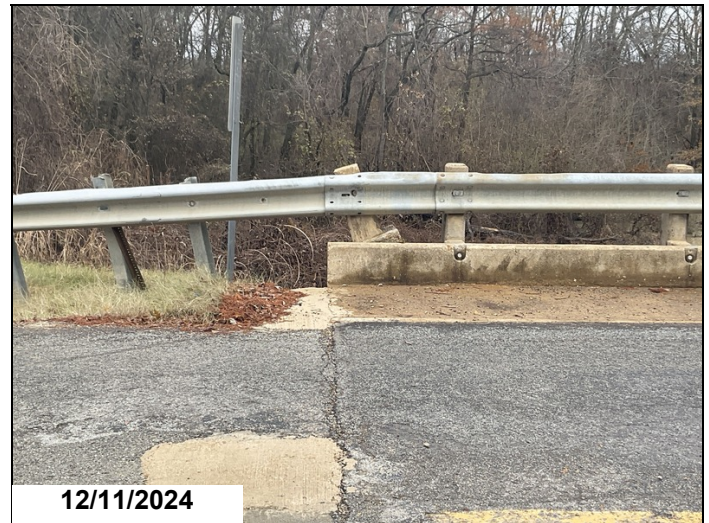
Abutment 1, left side, first rail post: leaning back. Typical of others.

**Type of Work:** Repair (General)
