Asset #M3333(Routine, Underwater type 2)

Sh-50/Sec-1/L16.22 over Little Rabbit Bayou

Location: 0.9 Mi E Jct Sh 50 & 149

Team Lead: Drew Melton Inspection Date: 01/25/2023

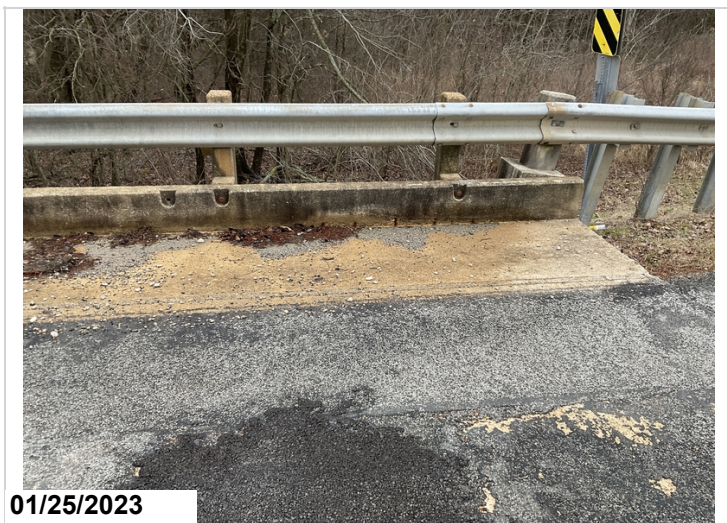
Curbs have areas of exposed rebar due to poor coverage.

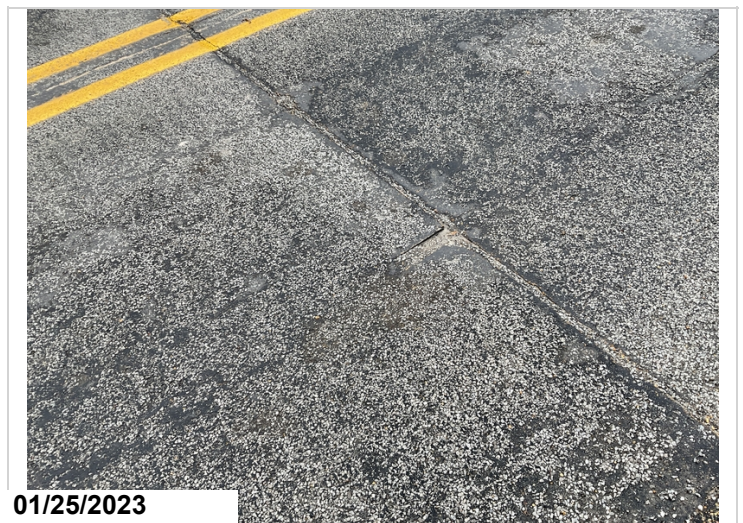
Grout joints in all spans between units are spalling up to one inch deep. Some have been filled with asphalt.

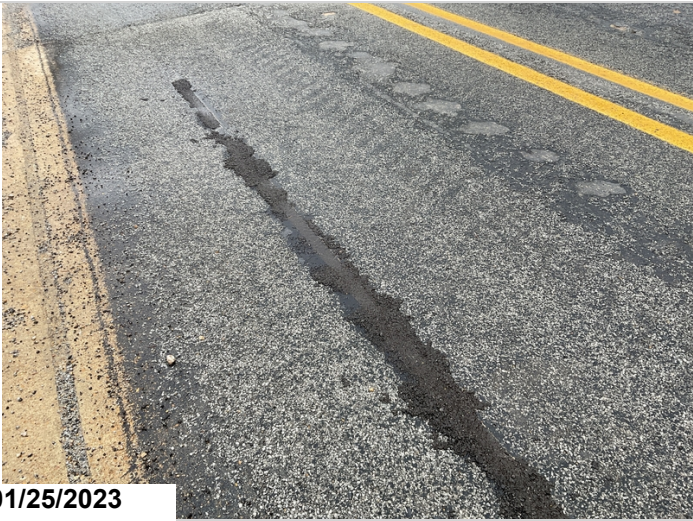
Grout joints in all spans between units are spalling up to one inch deep. Some have been filled with asphalt.

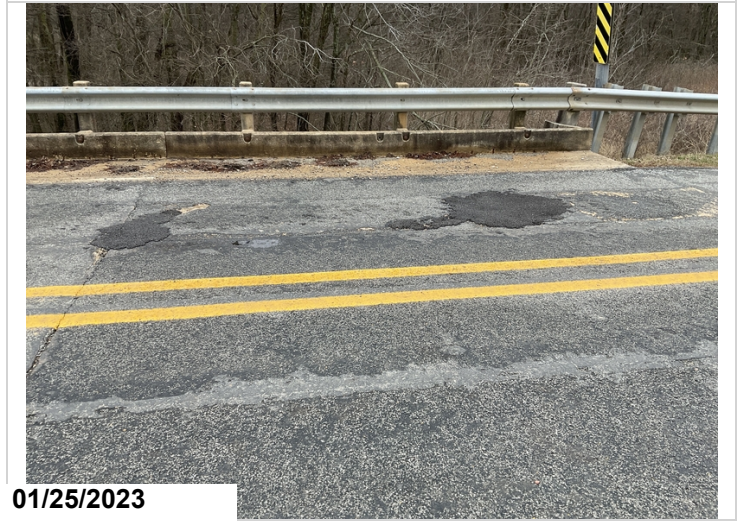
Deck span #1 unit #6 has several spalls no rebar exposed with asphalt patch with a four foot by two foot sound repaired area at beginning of bridge.

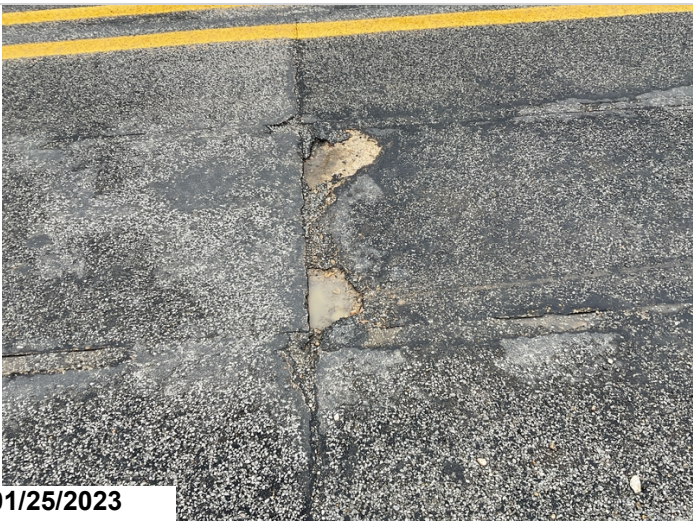
Span #2 unit #3 at bent #3 has two 1' shallow spalls no exposed rebar.

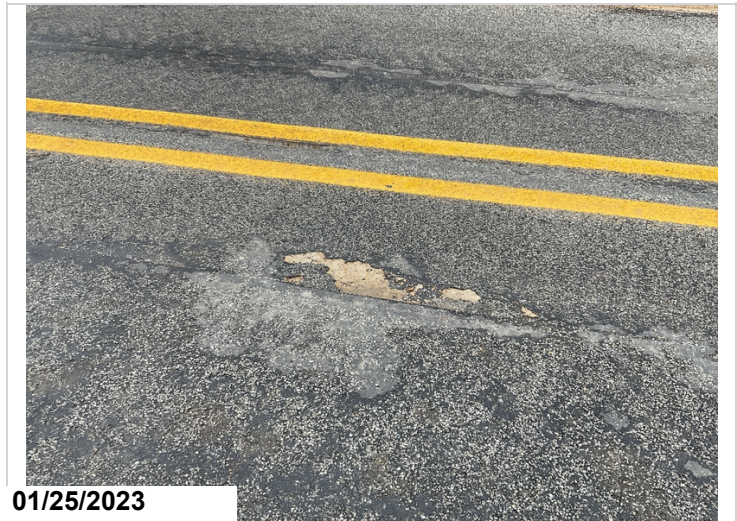
Span #3 unit #4 has 1' shallow spall center span no rebar exposed.

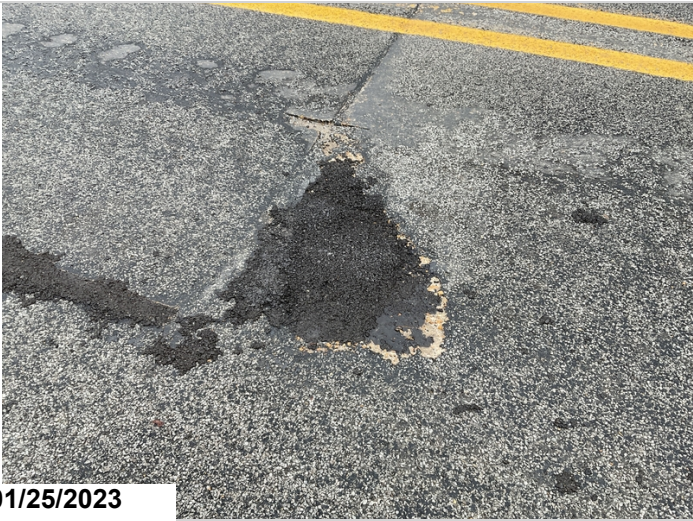
Deck span #8 unit #6 has a two foot spall at bent #8 no rebar exposed with asphalt patch.

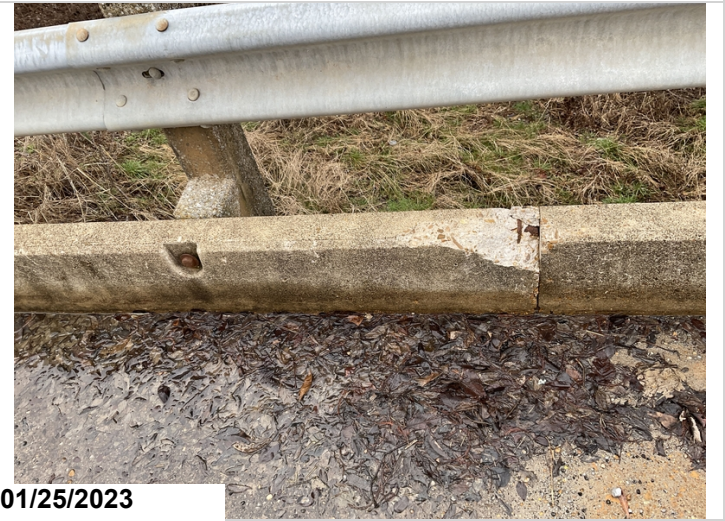
Deck span #9 right curb at bent #9 has one foot spall with exposed rebar no section loss.

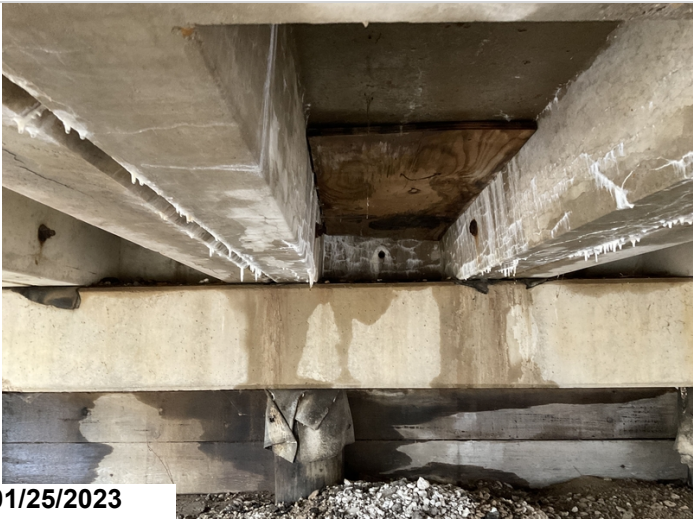
Soffit-Under surface span #1 unit #6 has a repair with form left in place.

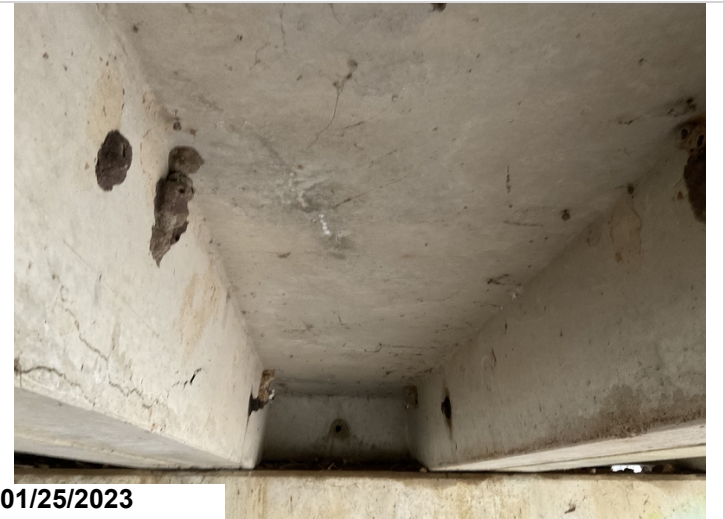
Soffit-Under surface span #1 unit #2 has cracks with light efflorescence.

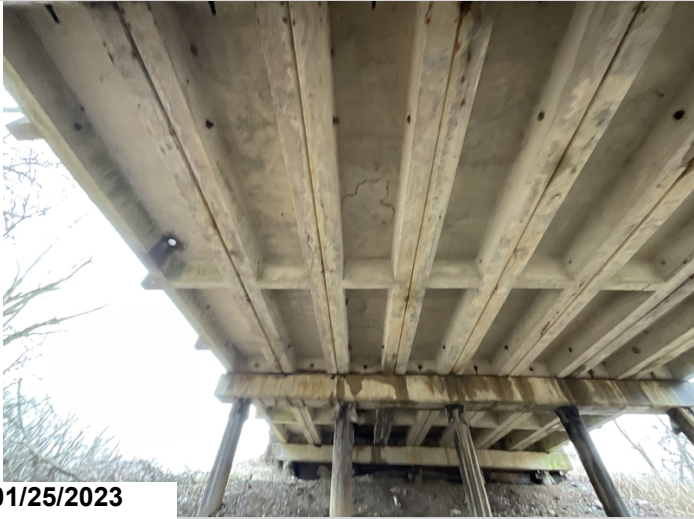
Soffit-Under surface span #2 unit #6 has six feet of cracks with light efflorescence, and 3 2' delaminated areas.

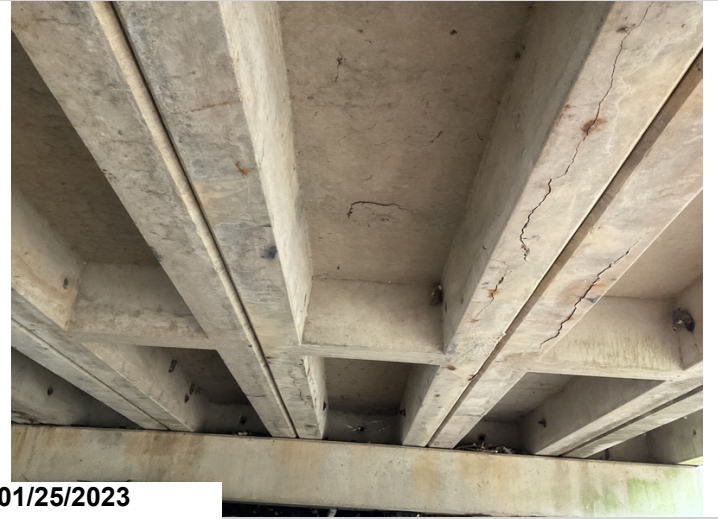
Soffit-under surface span #9 unit #6 has a 1' delaminated area at 1/4 span.

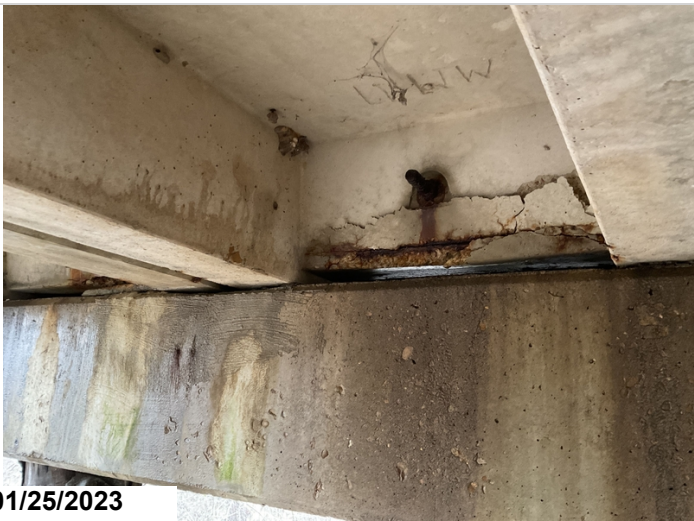
Typical spalling of diaphragms at bents.

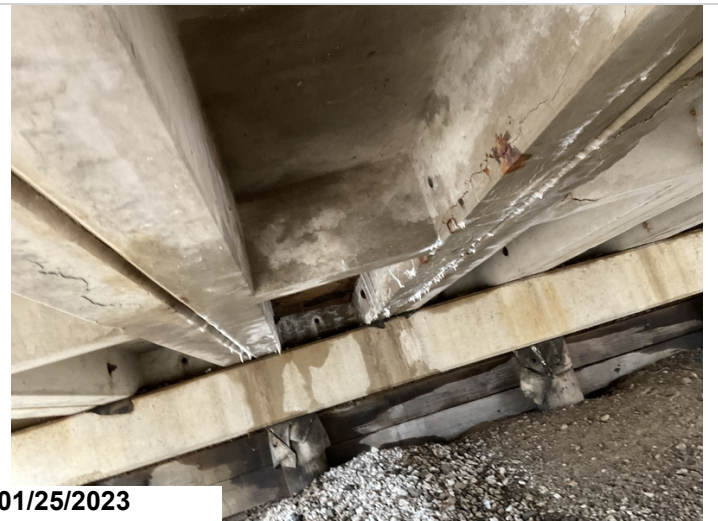
Span #1 unit #6 both legs have map cracking with moderate efflorescence first half of span.

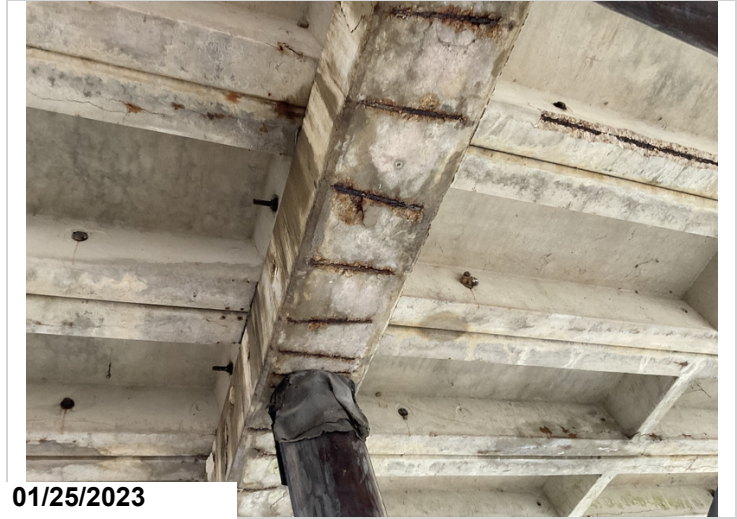
Typical rebar exposed on bottom of caps

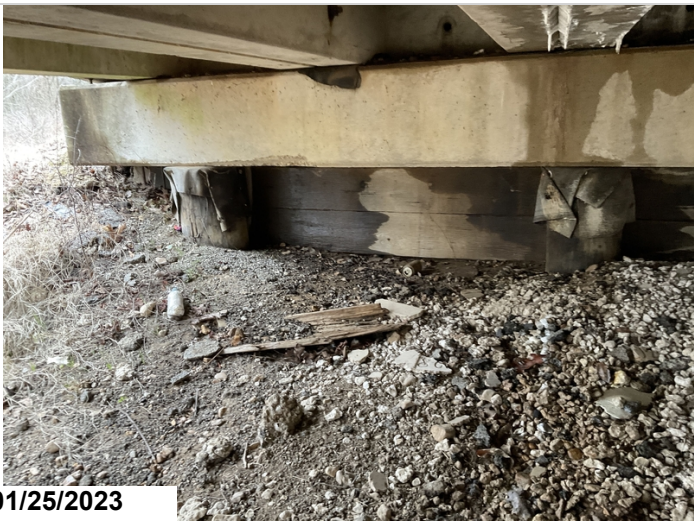
Abutment #1 cap has 1' long corner spalled off near pile #5.

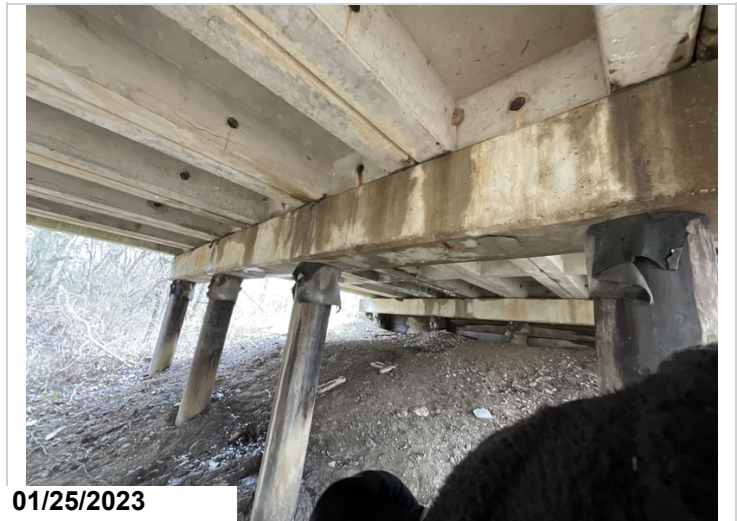
Bent #2 cap ahead face has three 1' delaminated areas.

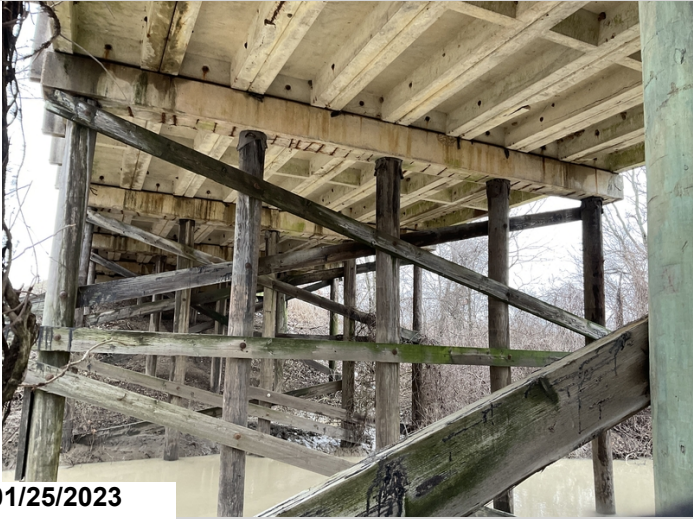
Bent #5 cap ahead face at top between piles #2,3 has a 1' spall with no rebar exposed.

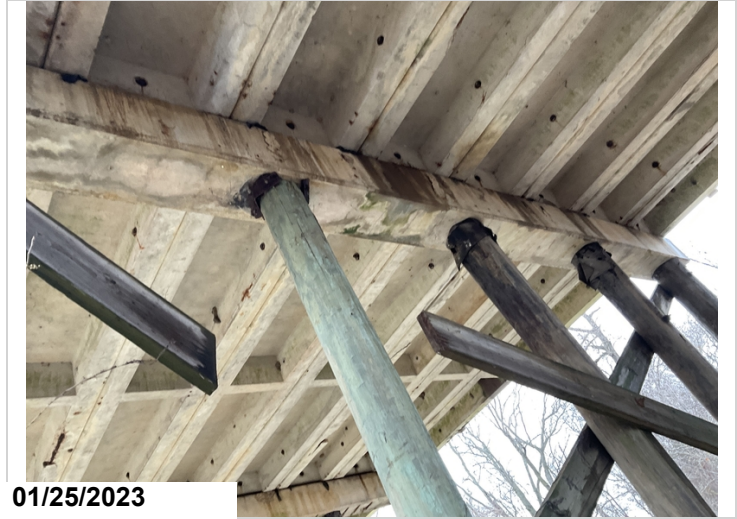
Bent#6 cap ahead face has several delaminations and two 6" spalls with rebar exposed with moderate section loss.

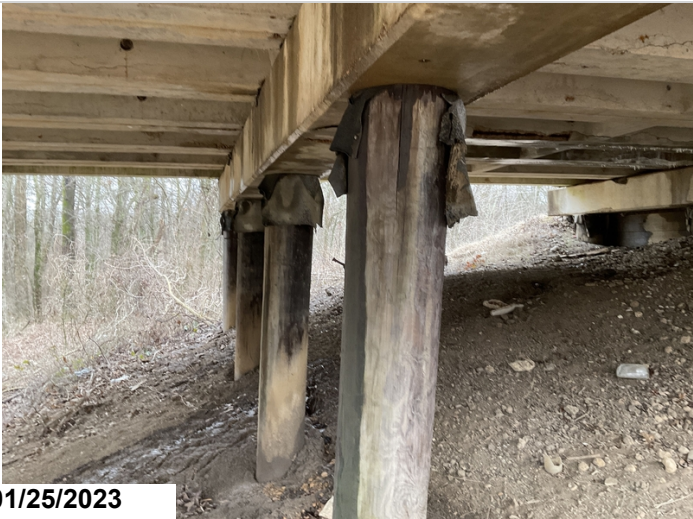
Typical cracks in piles

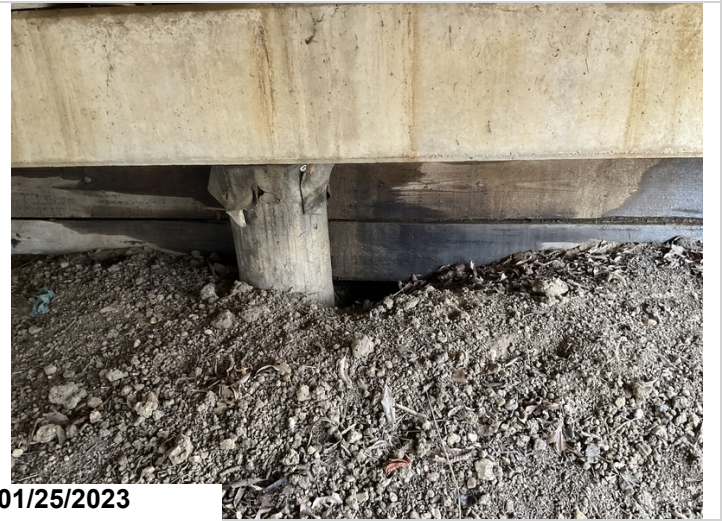
Abutment #1 beside pile #2 has a four foot void behind timber back wall.

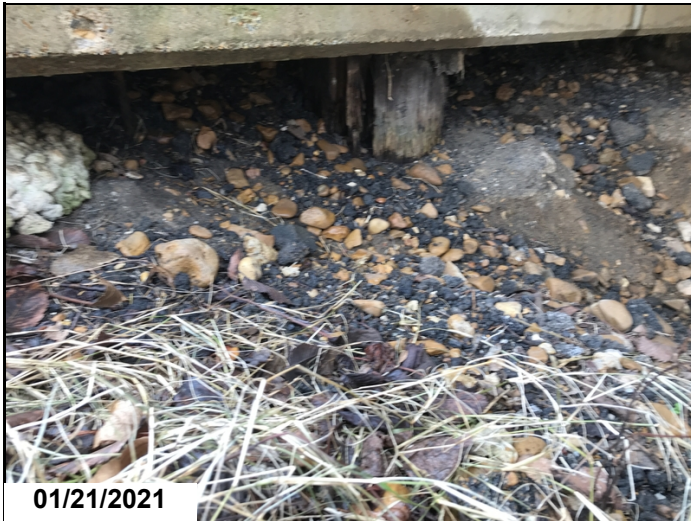
Bent #2 pile #1 is core decayed with 30% section loss.
Bent #10 pile #1 is core decayed with 40% section loss.
Bent #10 pile #2 sounds slightly hollow.

Bent #10 pile #1 is core decayed with 40% section loss.

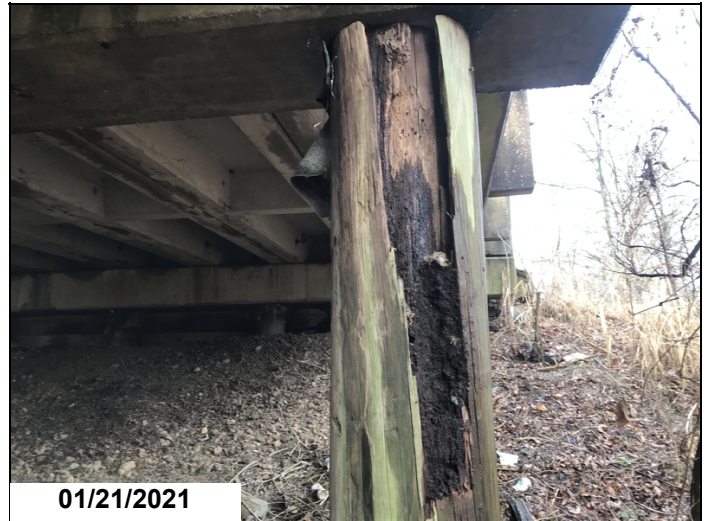
Bent #2 pile #1 is core decayed with 30% section loss.

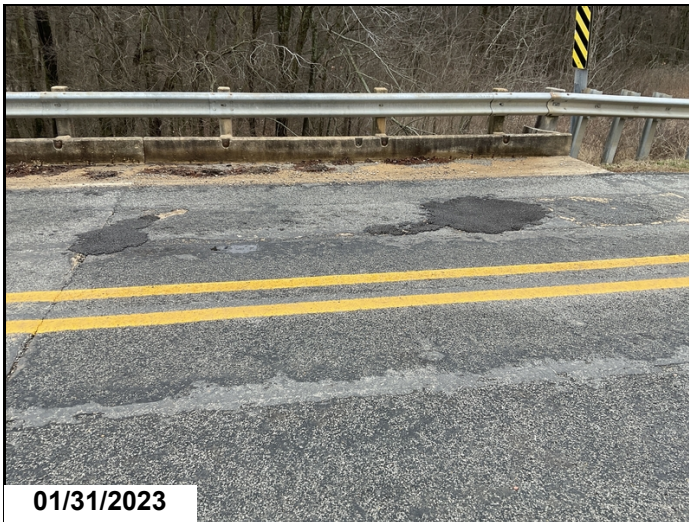
Deck span #1 unit #6 has several spalls no rebar exposed with asphalt patch with a four foot by two foot sound repaired area at beginning of bridge.

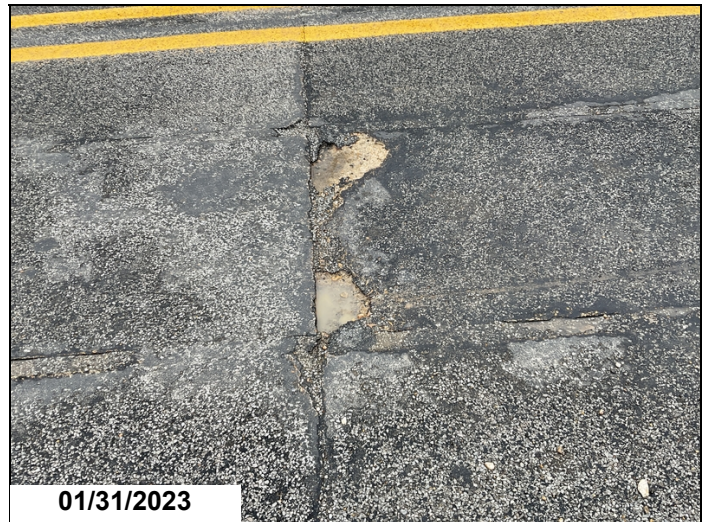
Deck span #2 unit #3 at bent #3 has two 1' shallow spalls no exposed rebar.

Span #2 unit #3 at bent #3 has two 1' shallow spalls no exposed rebar.

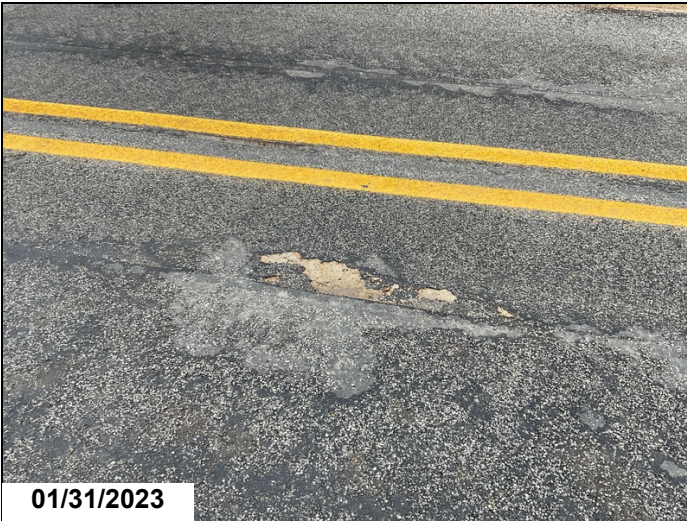
Deck span #3 unit #4 has 1' shallow spall center span no rebar exposed.

Span #3 unit #4 has 1' shallow spall center span no rebar exposed.

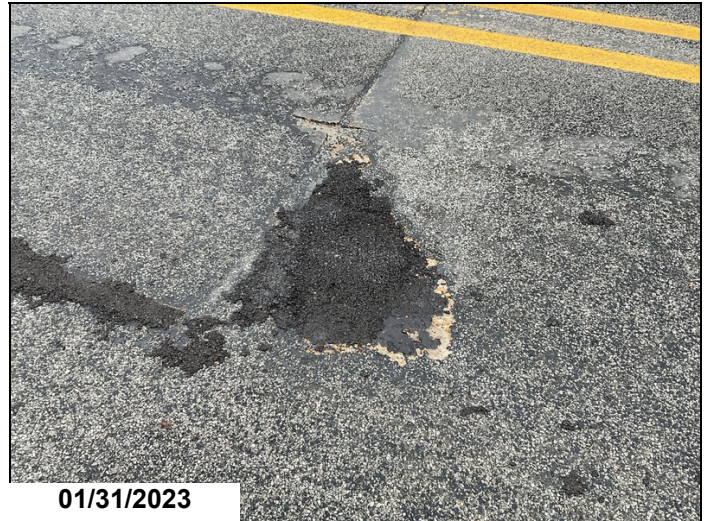
Deck span #8 unit #6 has a two foot spall at bent #8 no rebar exposed with asphalt patch.

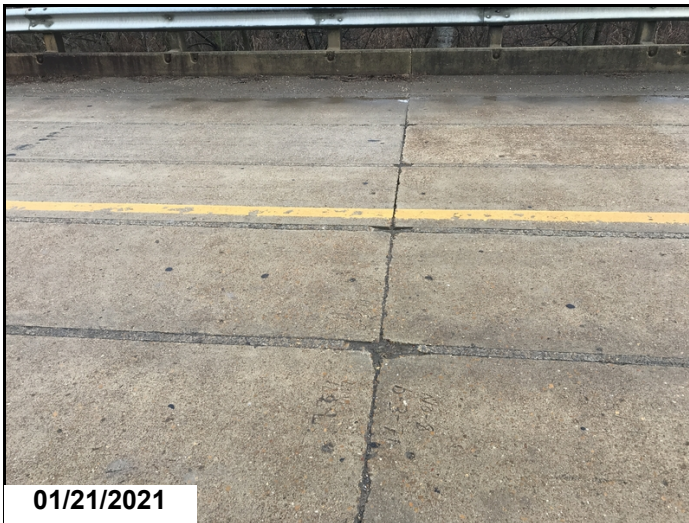
Typical joint

Joints are missing material allowing joints to fill with non compressible material.

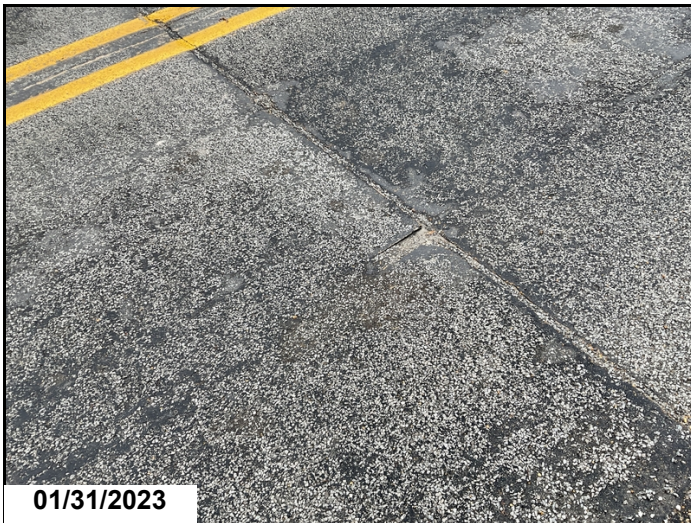
Grout joints in all spans between units are spalling up to one inch deep.

Grout joints in all spans between units are spalling up to one inch deep. Some have been filled with asphalt.

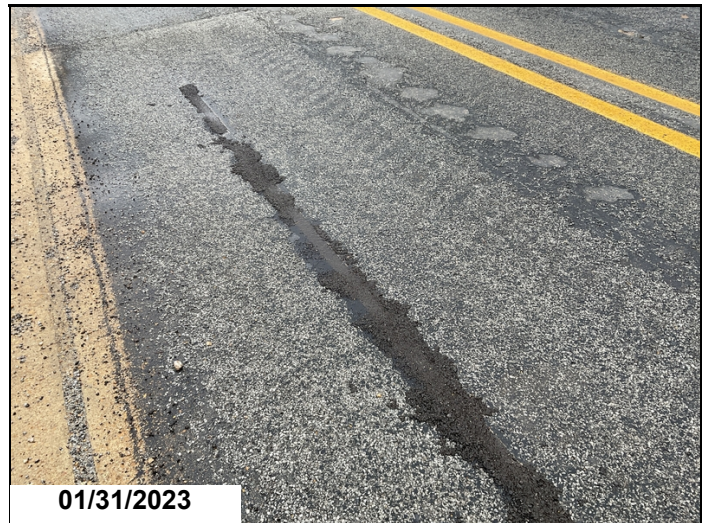
Grout joints in all spans between units are spalling up to one inch deep. Some have been filled with asphalt.

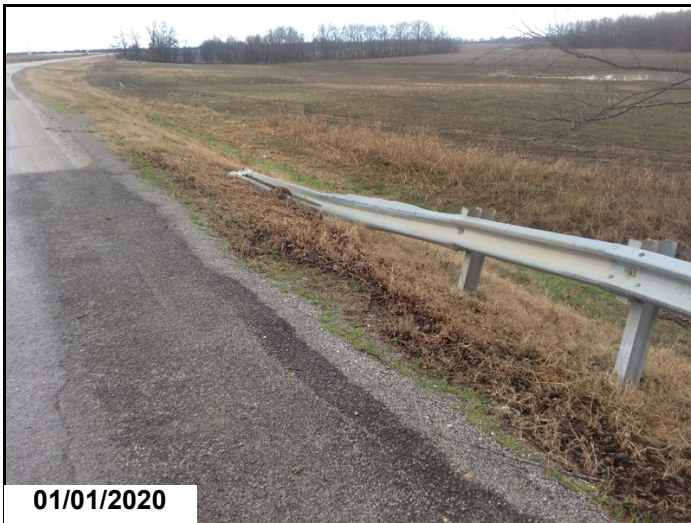
Abutment #2 right approach rail at terminal end

Abutment #2 approach rail right side has collision damage at terminal end.

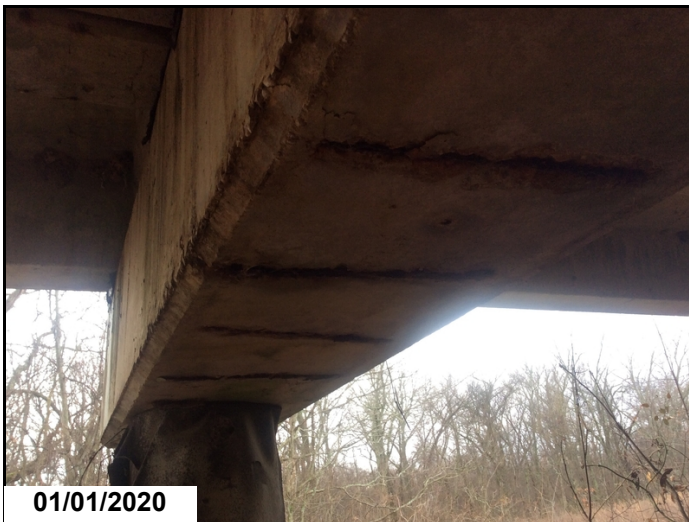
All caps on bottoms have spalls with exposed rebar with moderate section loss.

Typical spalls on bottom of caps

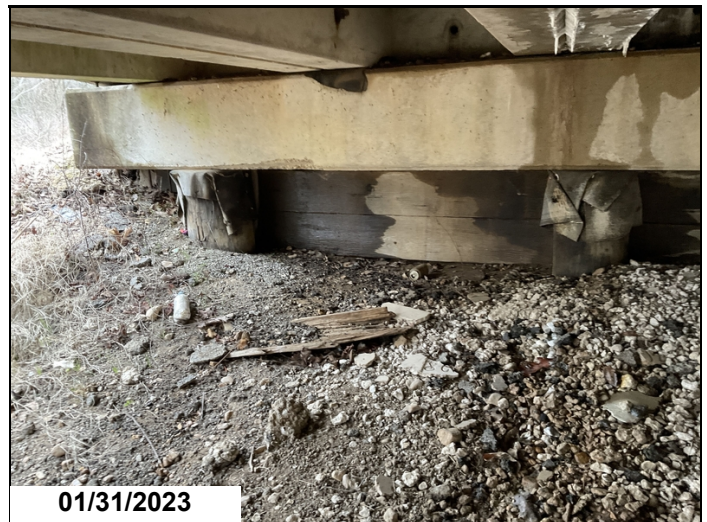
Abutment #1 cap has 1' long corner spalled off near pile #5.

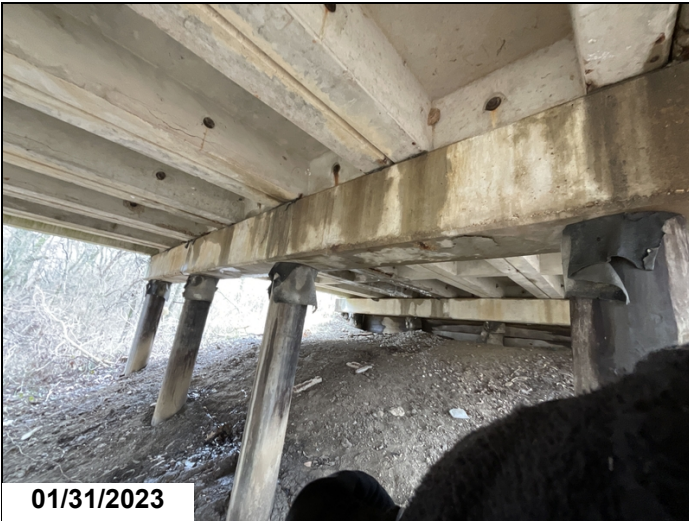
Bent #2 cap ahead face has three 1' delaminated areas.

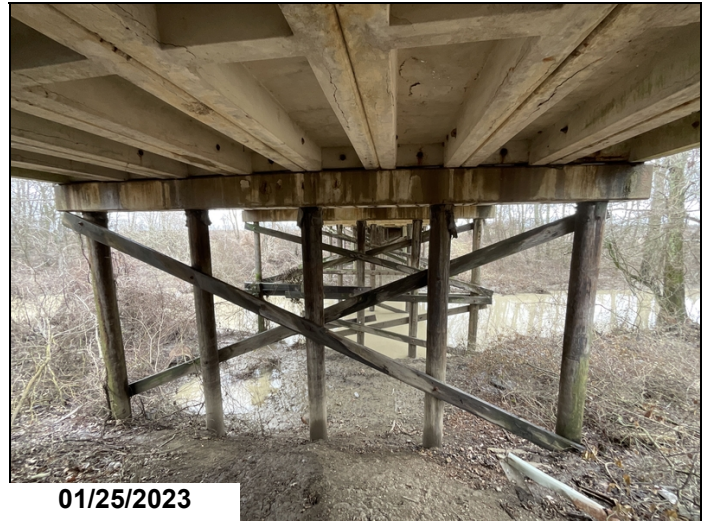
Bent #3 cap back face has three 6" spalls with exposed rebar with moderate section loss and several delaminations.

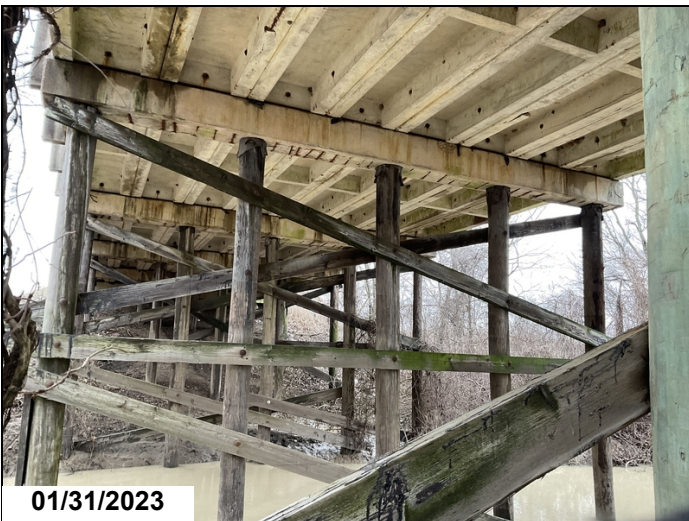
Bent #5 cap ahead face at top between piles #2,3 has a 1' spall with no rebar exposed.

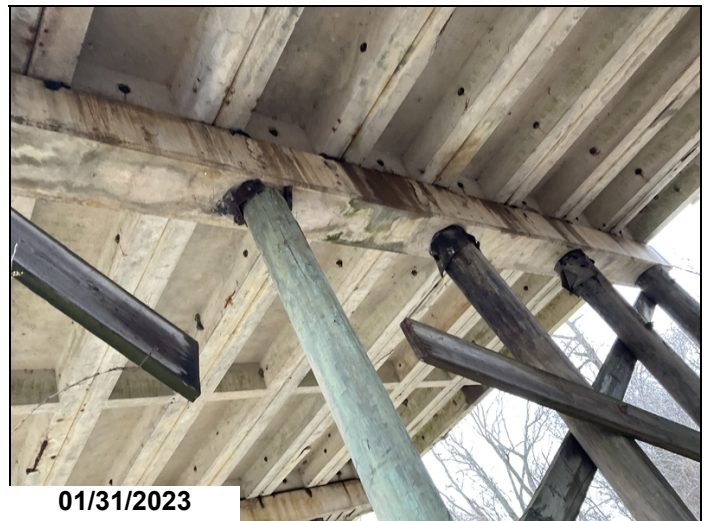
Bent#6 cap ahead face has several delaminations and two 6" spalls with rebar exposed with moderate section loss.

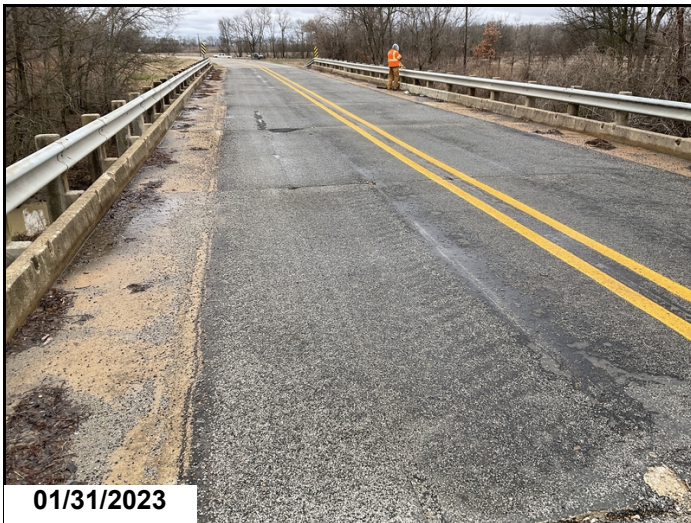
Typical wearing surface

Wearing surface has numourous areas of patches and bad coverage.
