Asset #05951(Routine)

Us-79/Sec-16/L9.30 over Cow Bayou

Location: 9.0 Miles Ne Of Jct Sh 1

Team Lead: Drew Melton Inspection Date: 09/09/2024

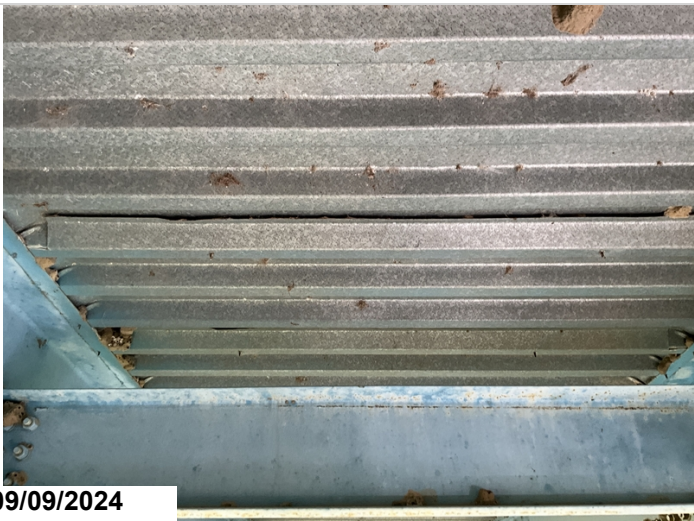
Typical deck undersurface

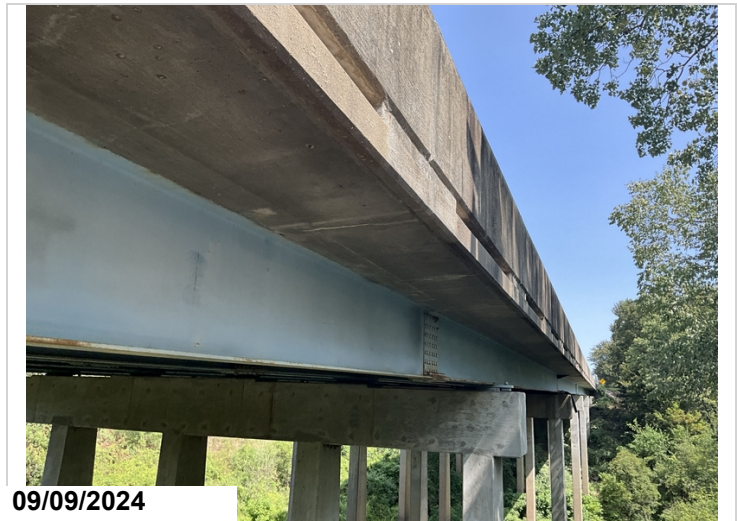
Deck is in good condition with an epoxy overlay. Deck undersurface overhangs have cracks some with light efflorescence.

Typical deck undersurface overhang

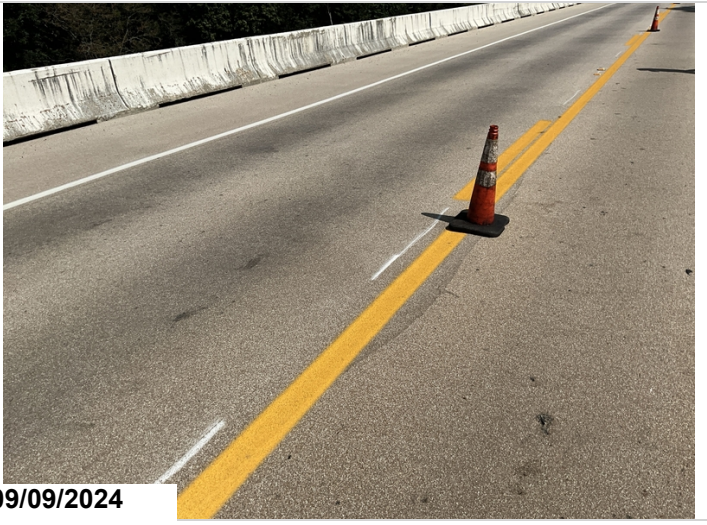
Typical deck surface

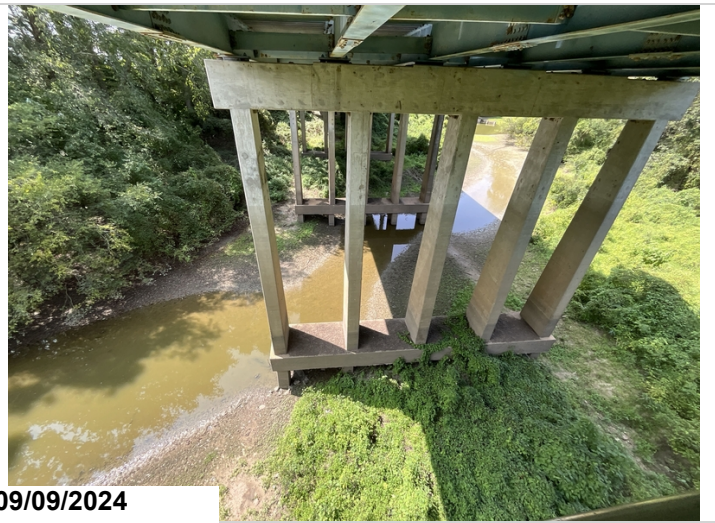
**61 - Channel/Channel Protection** (6 - Bank is beginning to slump. River control devices and embankment protection have widespread minor damage. There is minor stream bed movement evident. Debris is restricting the channel slightly.) Channel has good alignment with structure. Channel banks have areas of erosion with channel having minor amounts of debris.

Channel under bridge

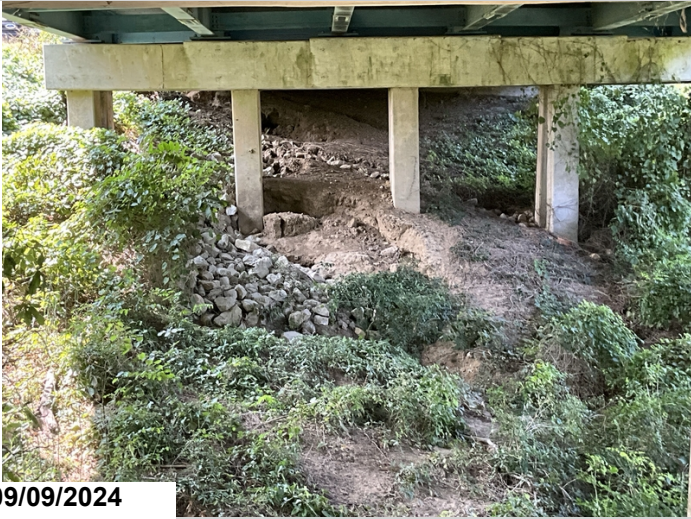
Slopes, Span 1, 2 & 8: Eroded with depths up to 4' extending down slopes.

Span 1 & 2 slope erosion

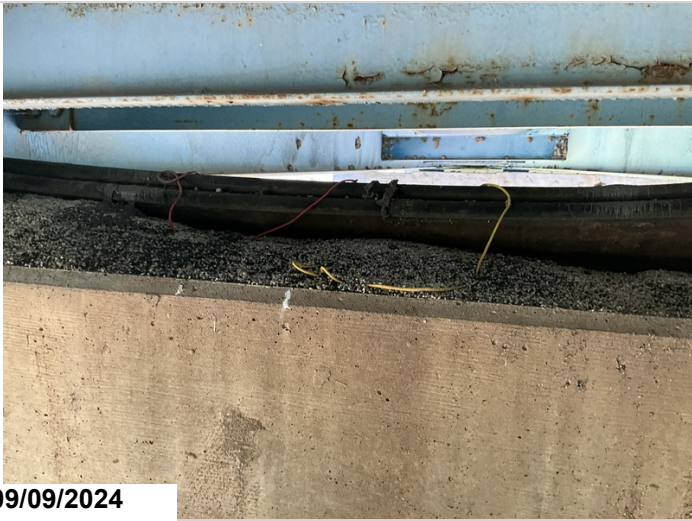
Bent caps have some debris.

Bent 5 cap has fertilizer, dirt and debris on it.

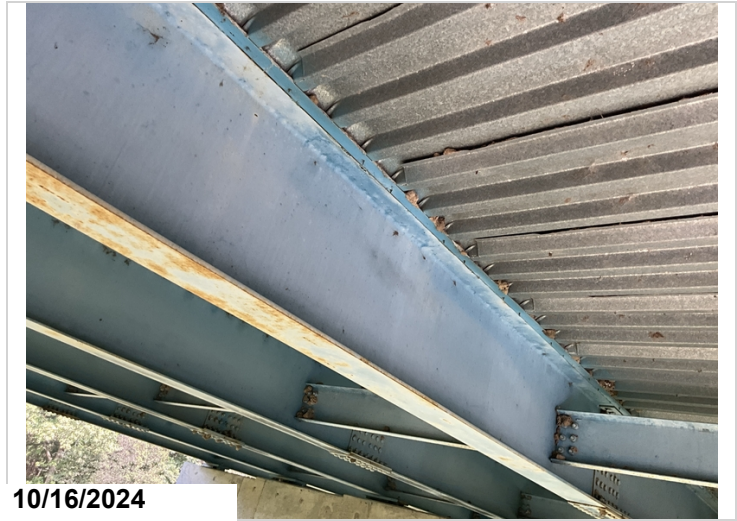
All Spans, All Girders, Full Length: Surface rust.

Typical girder condition

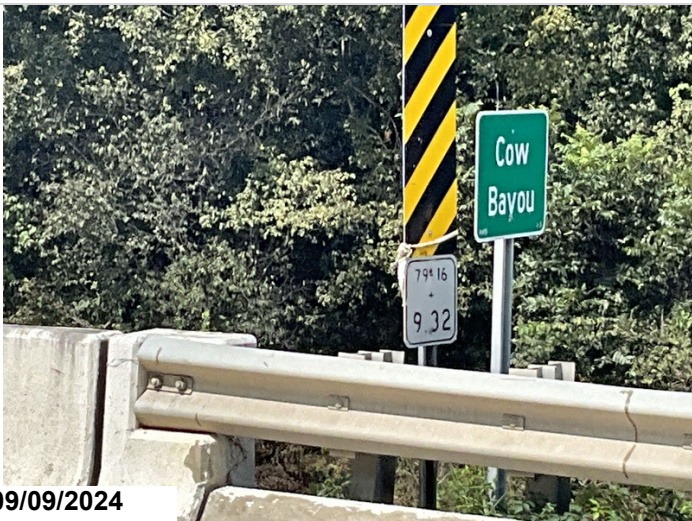
Log mile signs are incorrect should be US-79, Section-16, Log Mile 9.3.

Log mile sign abutment 2.

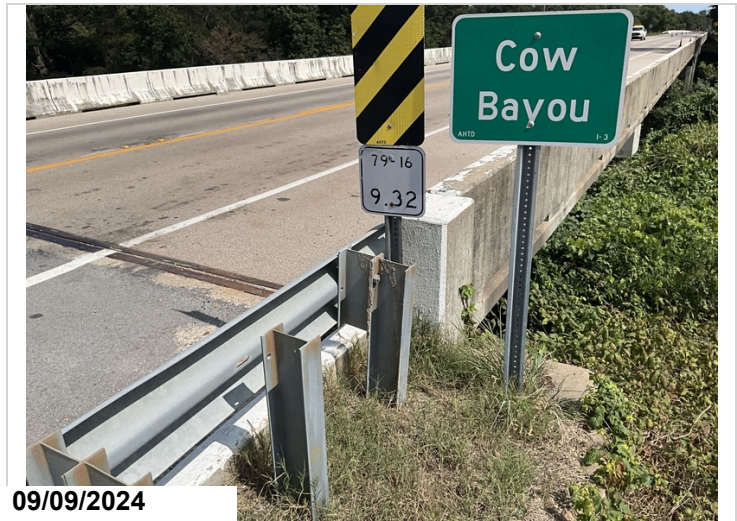
Log mile sign abutment 1.

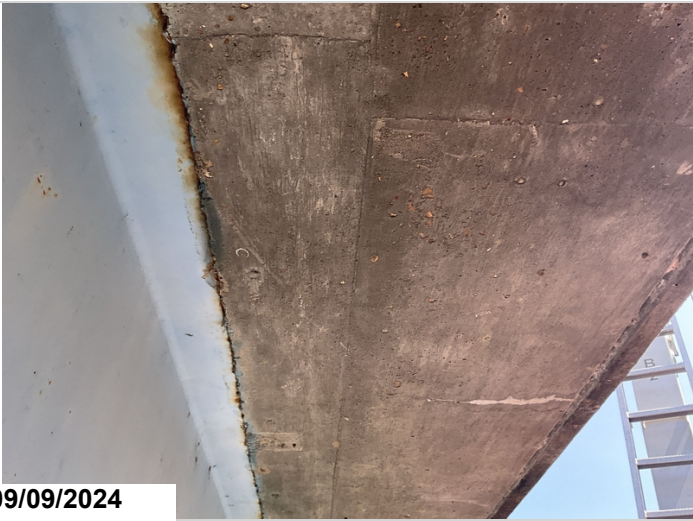
All Spans, Deck Undersurface Overhangs: Hairline transverse cracks some with light efflorescence spaced 6' apart.

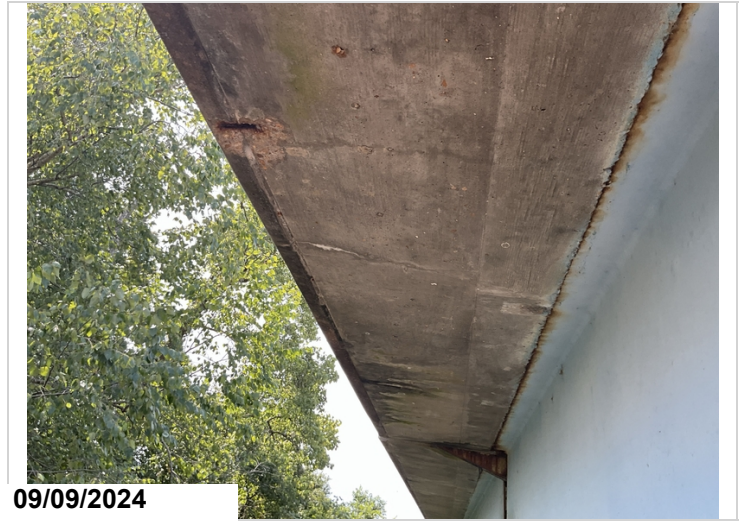
Span 5, Deck Undersurface Overhang, Right Side, 20' Ahead Of Bent 5: 6" spall exposed reinforcing steel. Reinforcing steel has minor section loss.

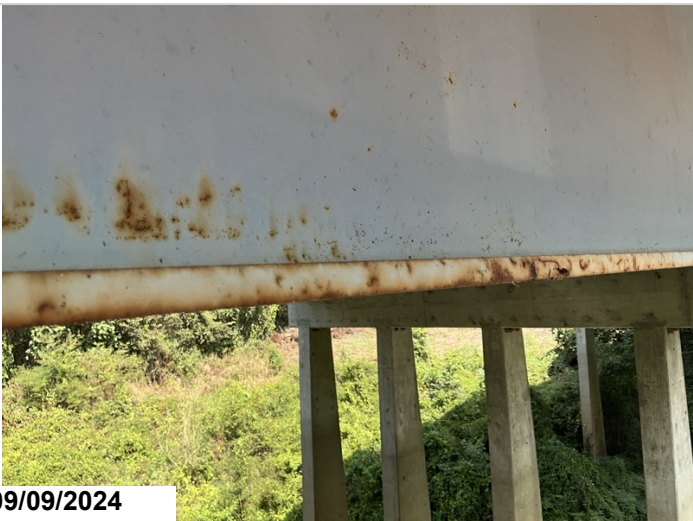
Span 5, Girder 5, 20' Ahead Of Bent 5, Right Side: Lower flange has 1" delamination.

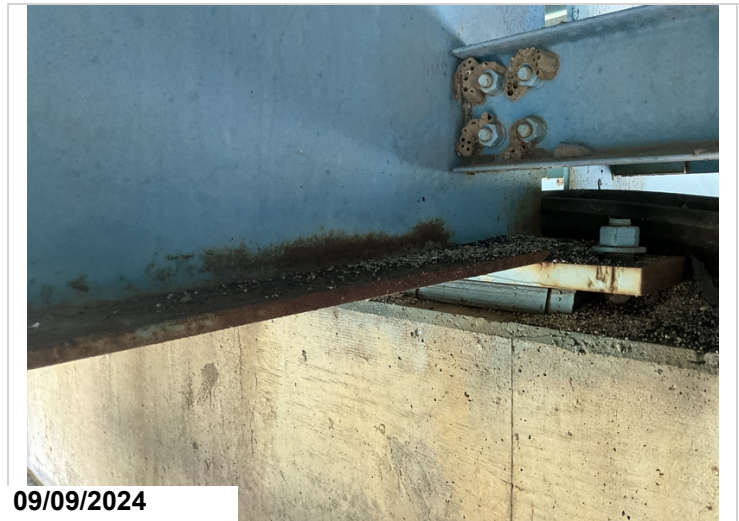
Span 4, Girders 1, 3 & 5, Bent 5: Active corrosion on bottom flange at bearing connection with minor section loss.

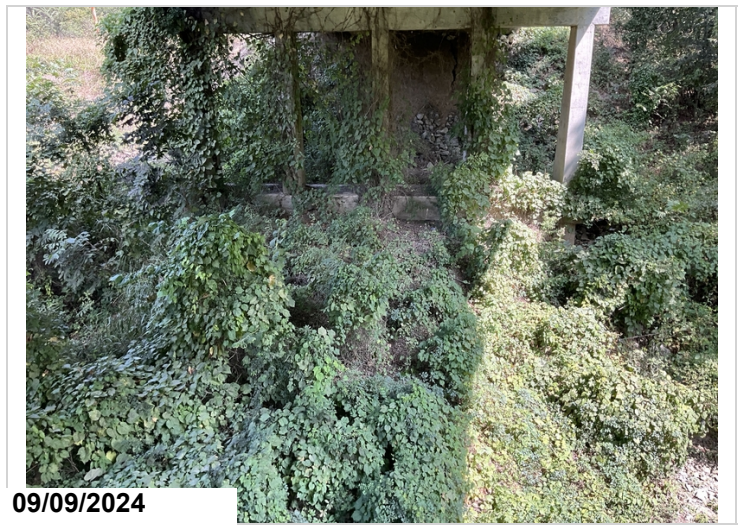
Bent 8 pile cap footing

Bent 8, Footing is exposed full length.

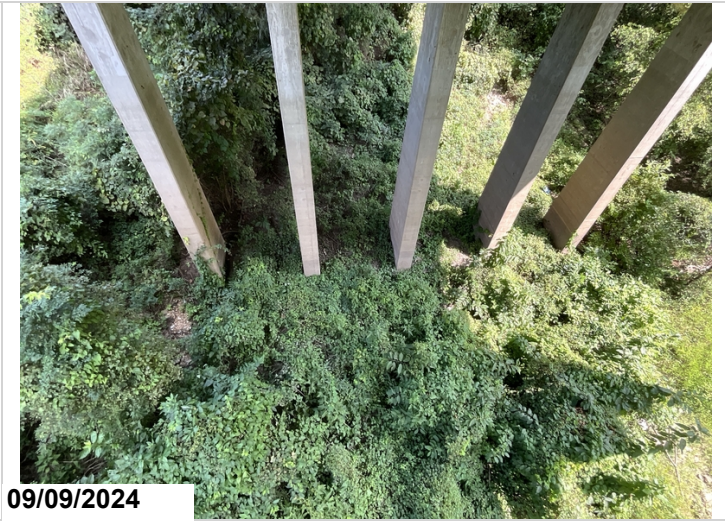
Bent 7 pile cap footing

Bent 7, Footing: Exposed on right end.

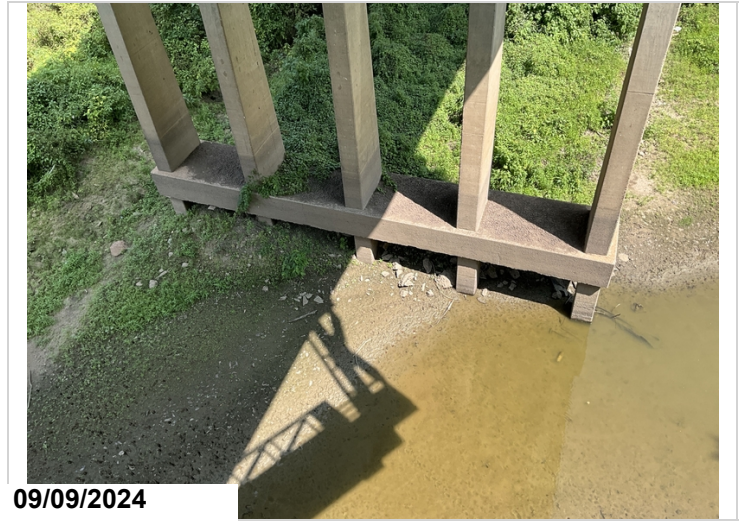
Bent 6 pile cap footing

Bent 6, Footing: Exposed and undermined 3' on left end to 4' on right end.

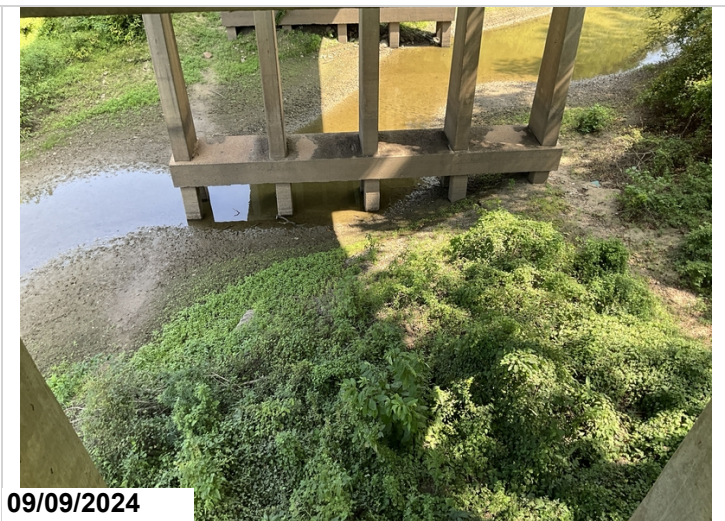
Bent 5 pile footing

Bent 5, Footing: Exposed and undermined 2' on right end to 4' on left end.

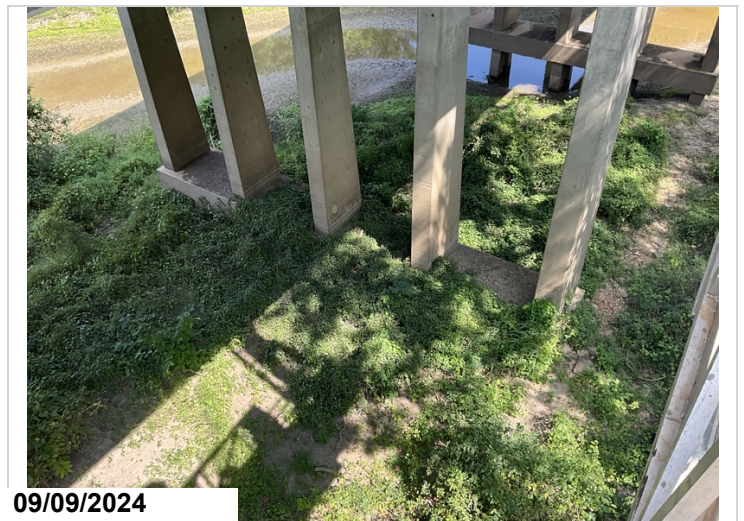
Bent 4 pile footing

Bent 4, Footing: Exposed full length with undermining at left end up to 2'.

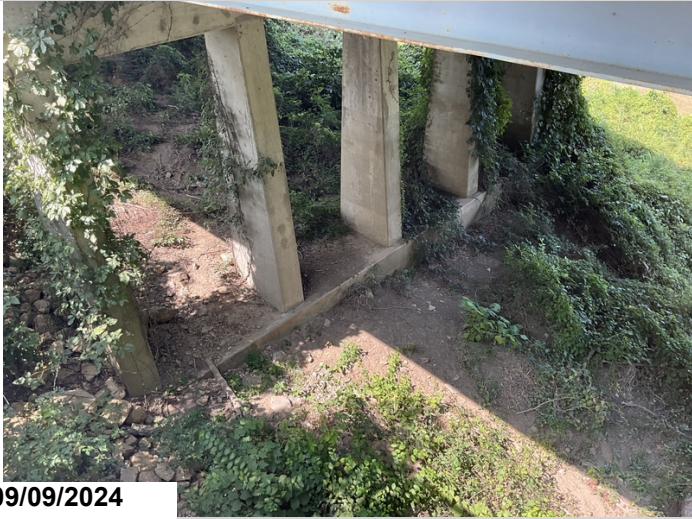
Bent 3 pile footing

Bent 3, Footing: Exposed full length.

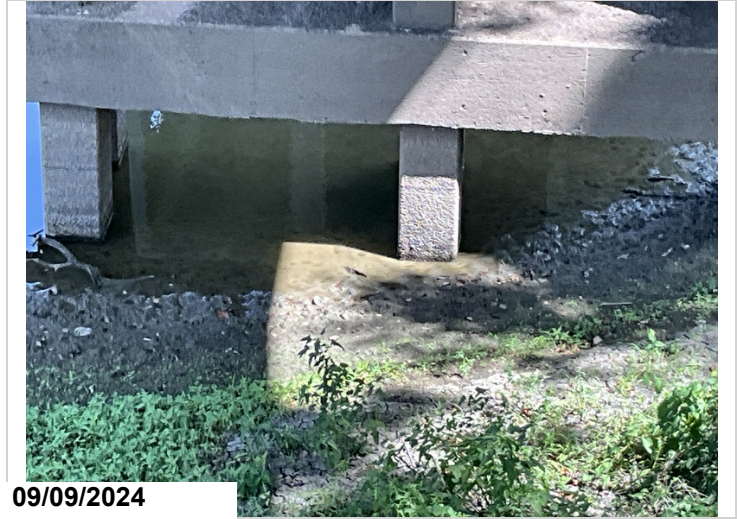
Bent 4 & 5, Piles: Light abrasion with no loose aggregate

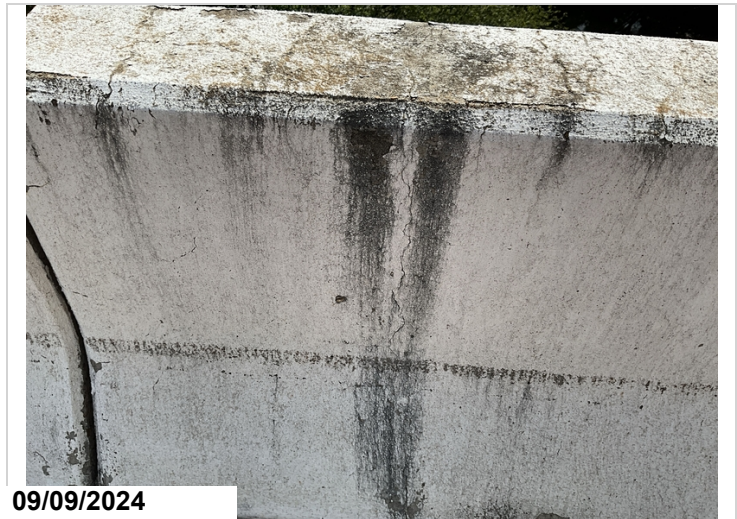
(331) Bridge Rails, Both Sides, Full Length: Vertical cracks spaced 6' apart. 140LF CS2 (Cracking) Bridge Rails, Both Sides: 10 pieces total of reinforcing steel exposed due to poor concrete coverage. Reinforcing steel has minor section loss. 10LF CS3 (Exposed Rebar)

Bridge Rails, Both Sides, Full Length: Vertical cracks spaced 6' apart.

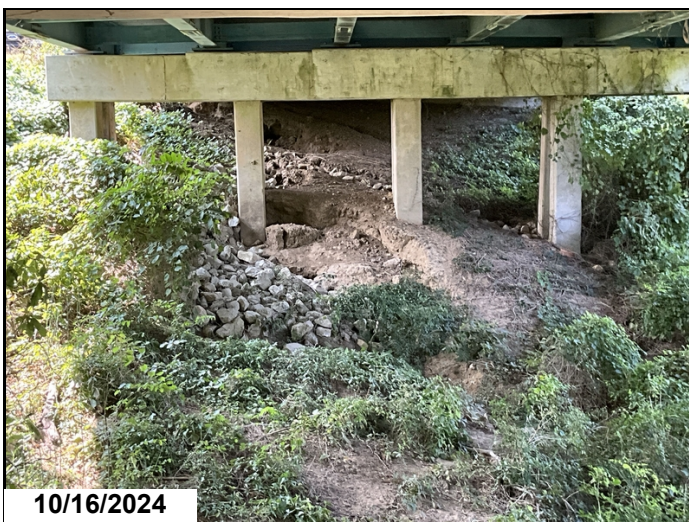
Slopes, Span 1, 2 & 8: Eroded with depths up to 4' extending down slopes.

Span 1 & 2 slope erosion

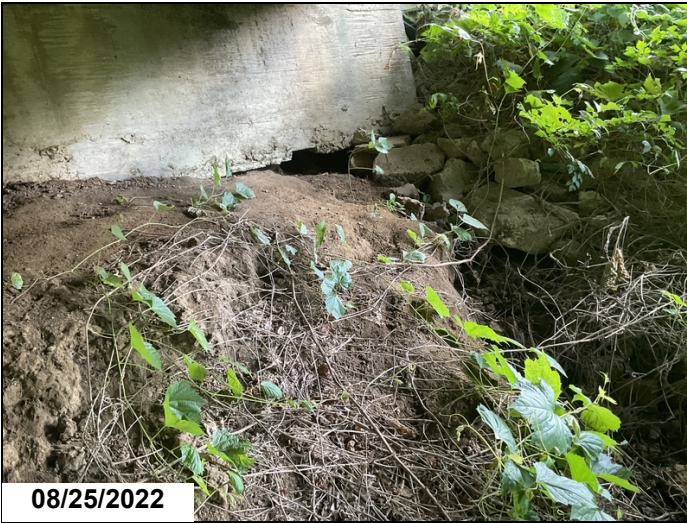
Abutment 1 cap left side undermined for 2' up to 6"

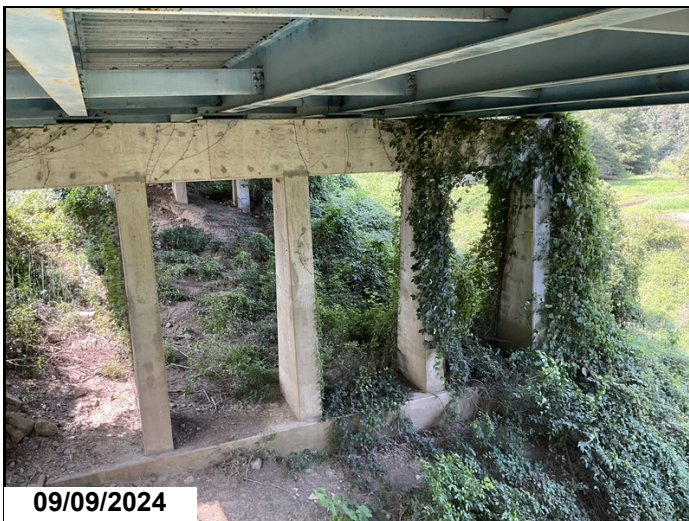
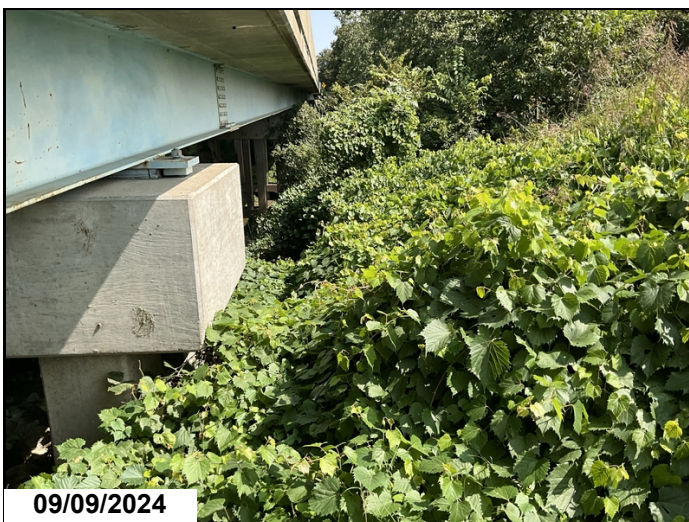
Vines and vegetation are growing under and beside bridge with vines growing up columns and onto caps. Vegetation is impeding the use of snooper in several locations.

Typical vegetation growing on bents

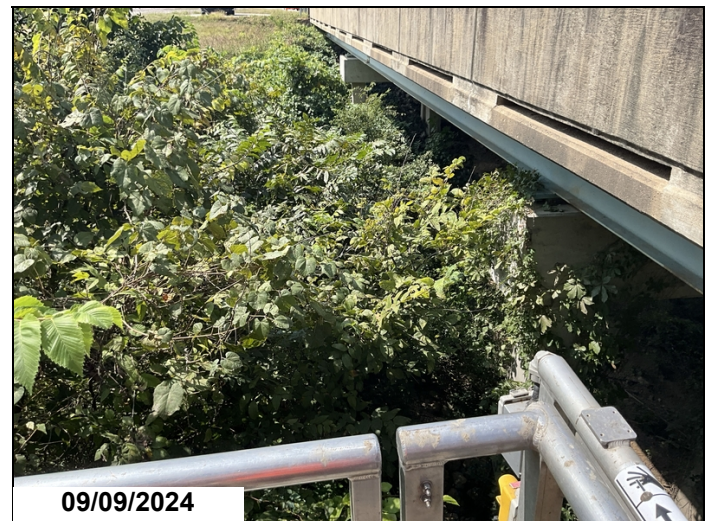
Span 1 and vegetation will not let snooper access

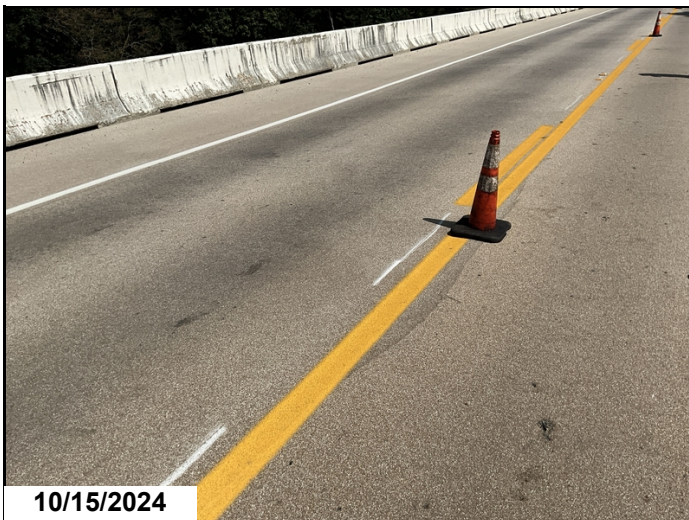
Typical deck repair

Deck has been repaired and epoxy overlaid since last inspection.

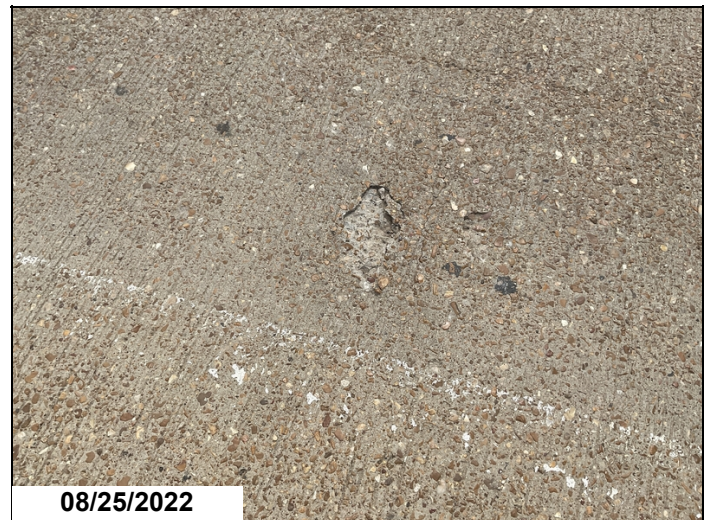
Span #8 left lane has one foot shallow spall with no exposed rebar.

Span 8 left lane has 1' shallow spall with no exposed rebar

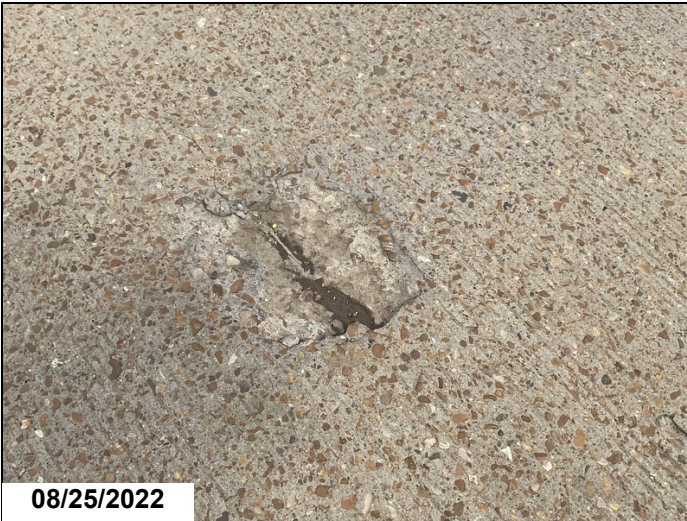
Span #4 deck right lane has one foot spall with exposed rebar with 10% section loss

Span 4 deck right lane has 1' spall with exposed rebar with 10% section loss

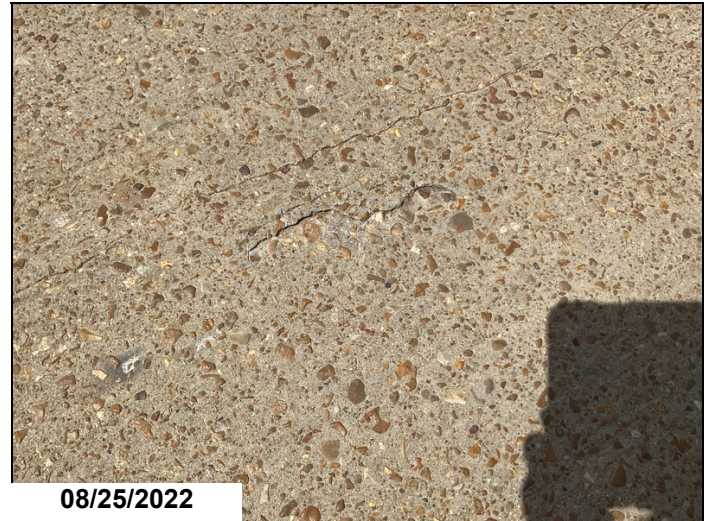
Span #2 deck right lane has one foot long by two inch wide shallow spall with no exposed rebar

Span 2 deck right lane has 1' long by 2" wide shallow spall with no exposed rebar

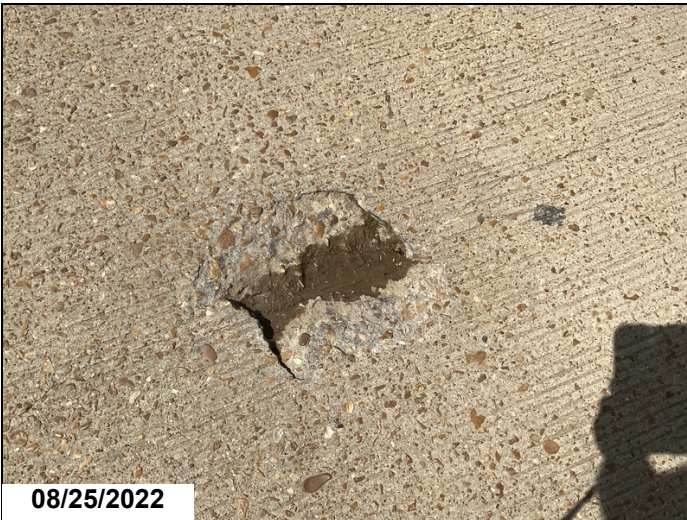
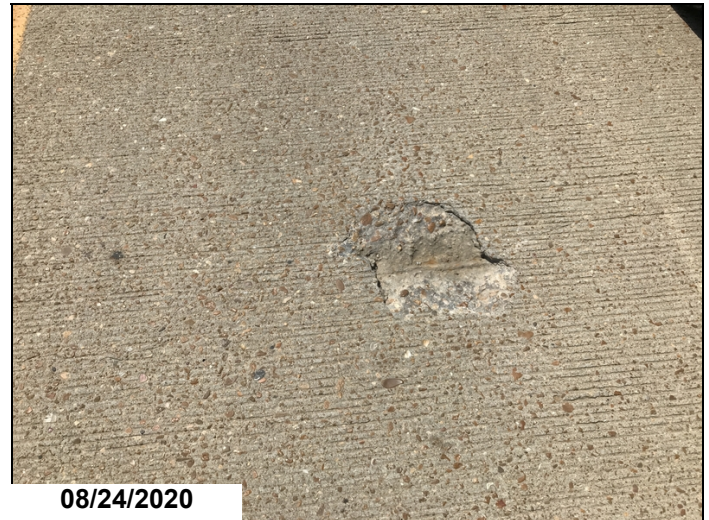
Span #2 left lane has one foot spall with exposed rebar with 10% section loss.

Span 2 deck left lane has 1' spall with exposed rebar

Span 2 left lane has a 1' spall with exposed rebar.

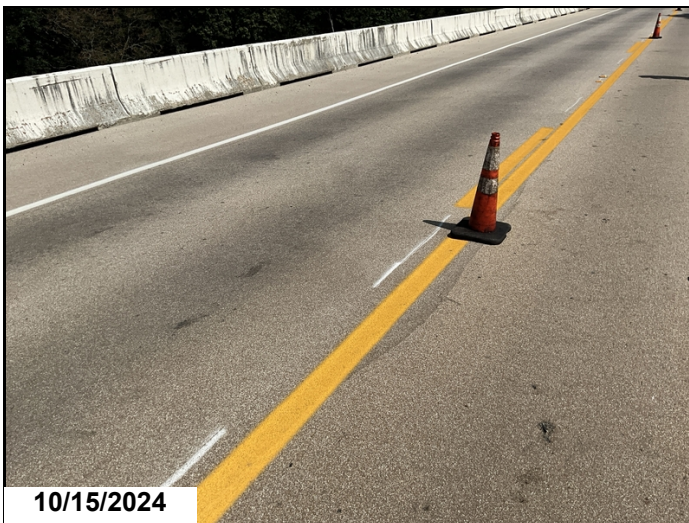
Typical deck surface repair

Deck as had an epoxy overlay since last inspection.

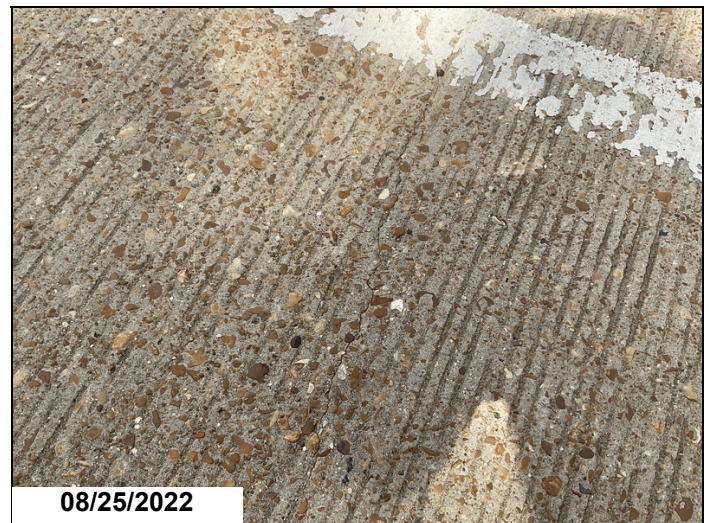
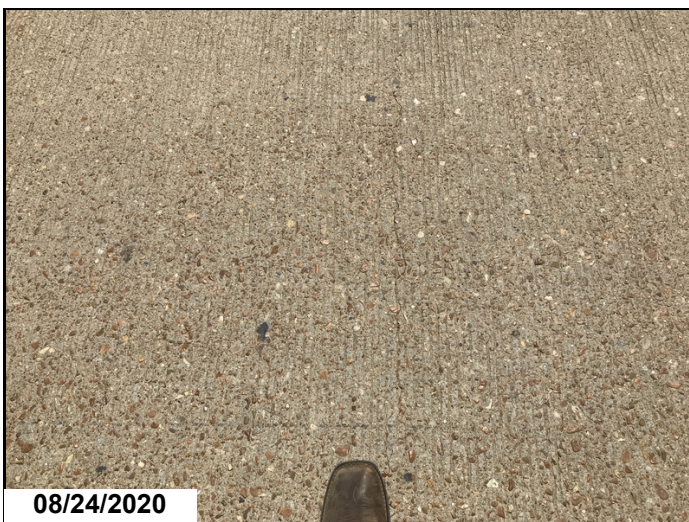
Deck has open transverse cracks spaced three feet apart.

Typical transverse deck crack

Typical deck crack

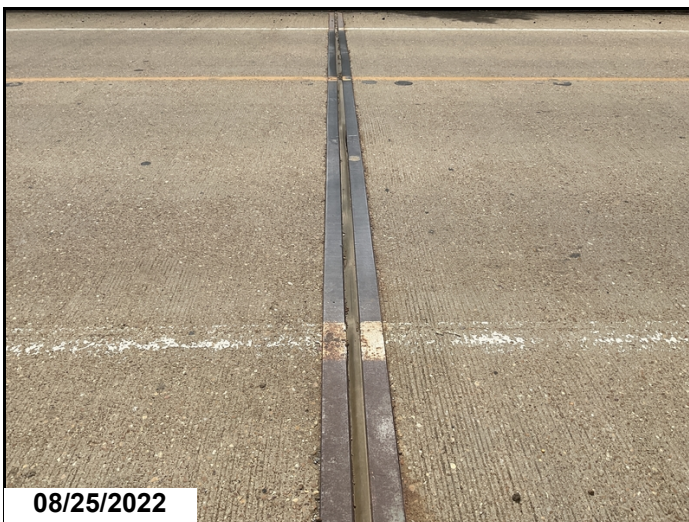
Bent 5 joint

Bent #5 seal has lost adhesion for twenty two feet.

Joints have been rehabbed since last inspection.

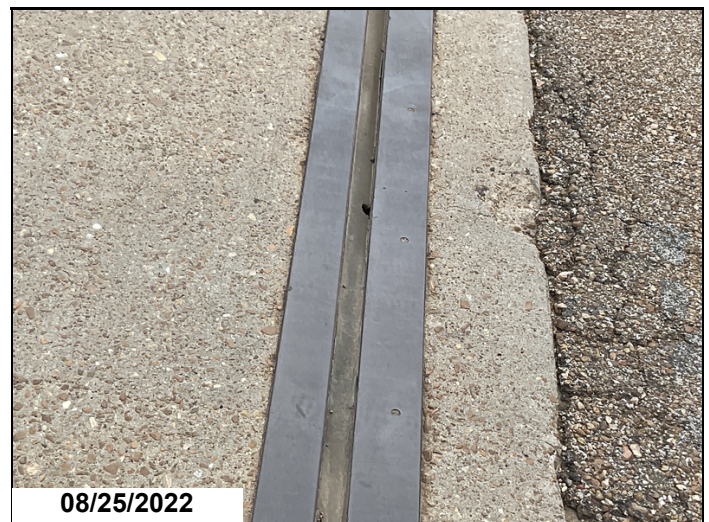
Typical hole in joint seal

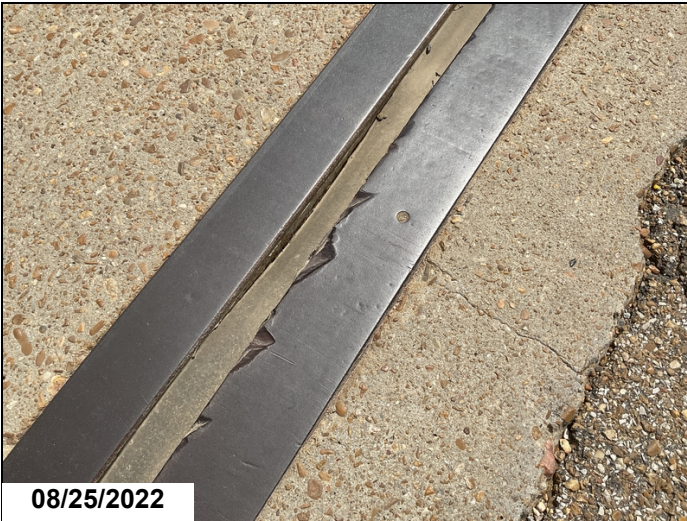
Typical joint seal lost adhesion

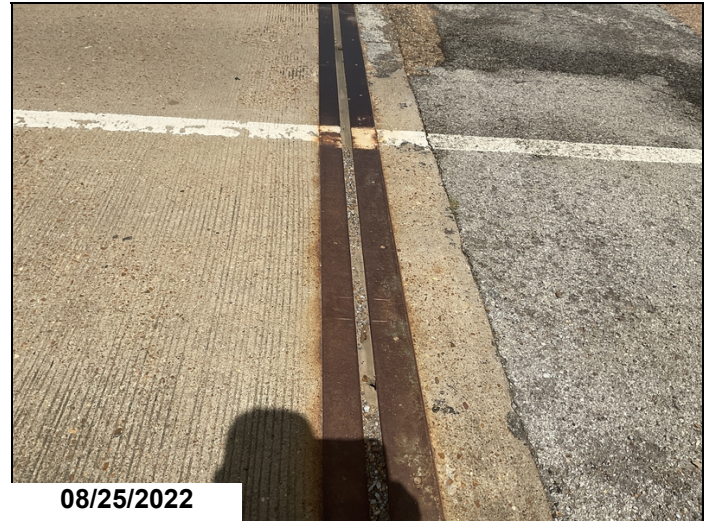
Abutment #2 seal has two one inch holes in the right lane and shoulder.

Abutment 2 seal has two 1" holes in the right lane and shoulder.

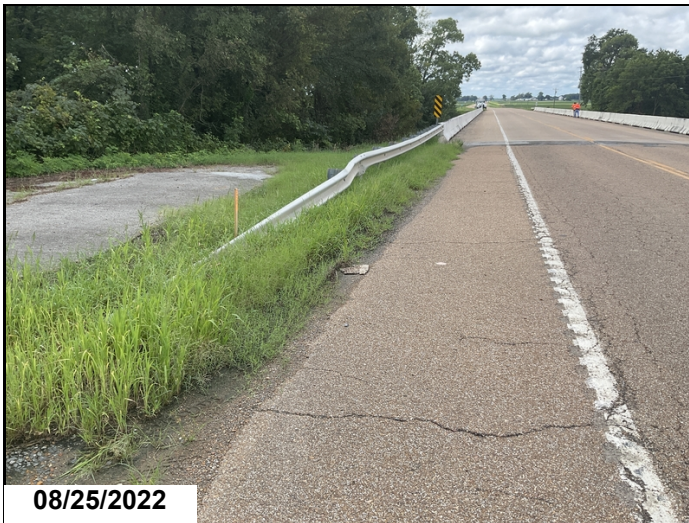
Abutment 2, Approach Rail, Right: minor collision damage.

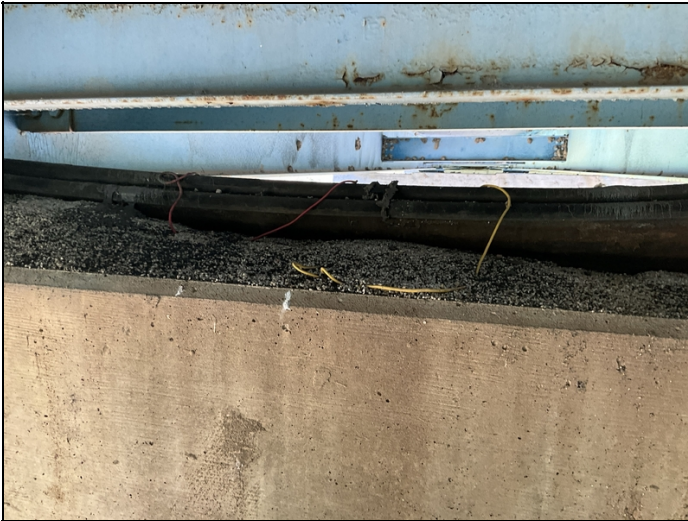
Bent caps have some debris.

Bent 5 cap has fertilizer, dirt and debris on it.

**A-58 - Cap Cleaning/Flushing Needed (Yes)**

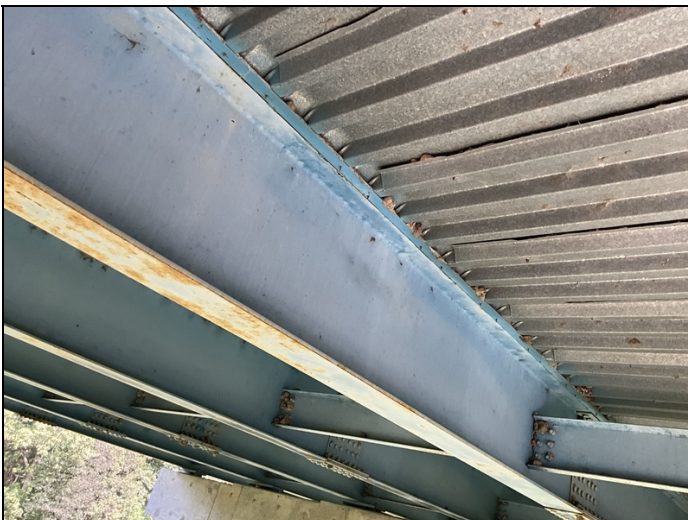
All Spans, All Girders, Full Length: Surface rust.

Typical girder condition

**A-60 - Full Girder Painting Needed (Yes)**

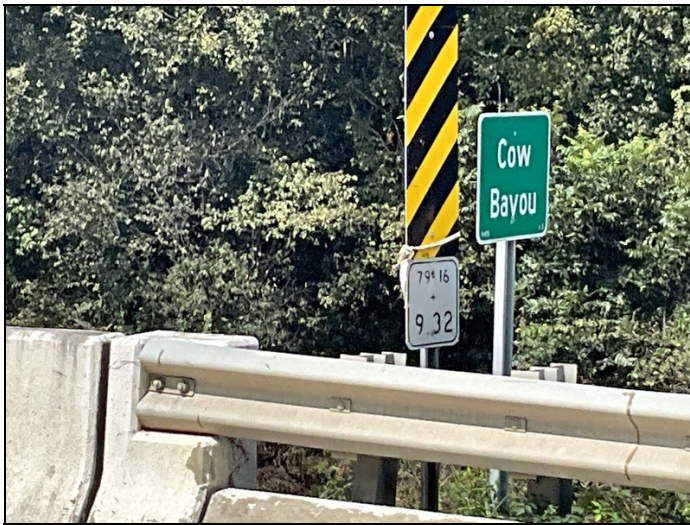
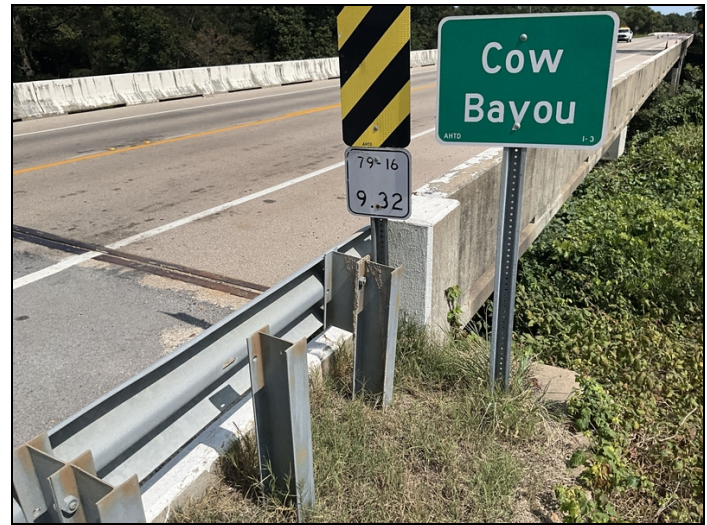
Log mile signs are incorrect should be US-79, Section-16, Log Mile 9.3.

Log mile sign abutment 2.

Log mile sign abutment 1.

**A-63 - Missing/Incorrect Log Mile Signage (Yes)**
