Asset #06023(Routine, Underwater type 2)

Sh-131/Sec-2/L6.10 over Zanone Bayou

Location: 6 Mi No Jct Sh 147 & 131

Team Lead: Drew Melton Inspection Date: 02/13/2024

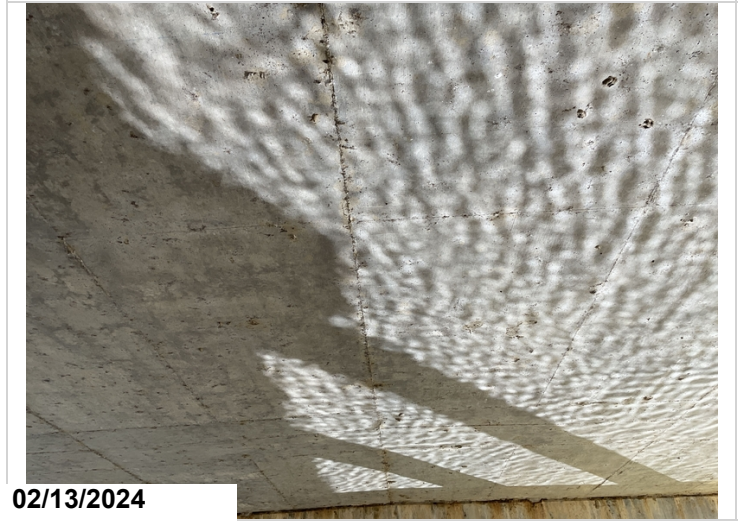
Deck is a slab so deck and superstructure are rated the same. Deck surface has a thin overly with areas that are failing. Soffit/under surface has one delaminated area.

(38) Span #2 soffit/under surface has a 2' delaminated area left side near mid span. Span #3 wearing surface has two tire marks to bare deck. Span #4 center has 6" spot with no overlay. Wearing surface has 2' wide full length of bridge not overlaid.							
215	Reinforced Concrete Abutment	LF	75	75	0	0	0
227	Reinforced Concrete Pile	EA	15	5	10	0	0
1190	Abrasion/Wear (PSC/RC)	EA	10	0	10	0	0

Typical soffit/under surface

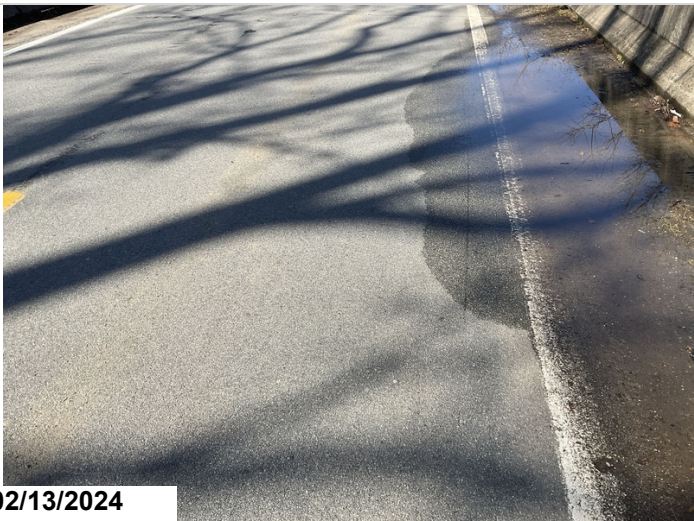
Typical deck

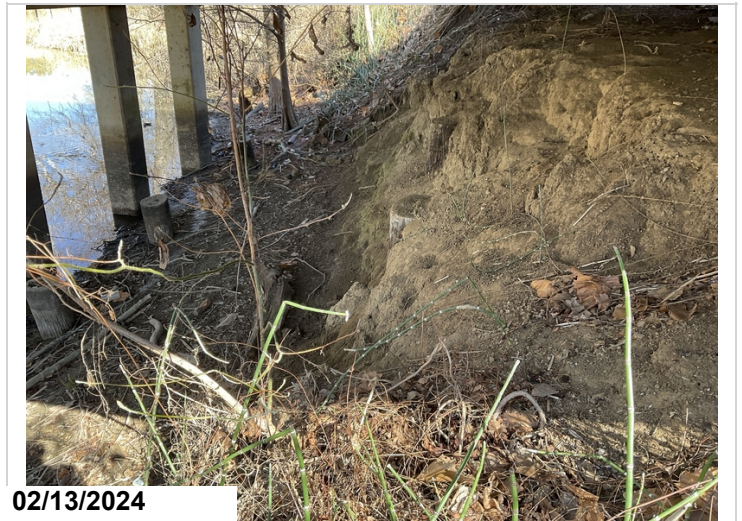
Abutment banks are scoured where water used to hit shoreline.

Abutment #1 slope

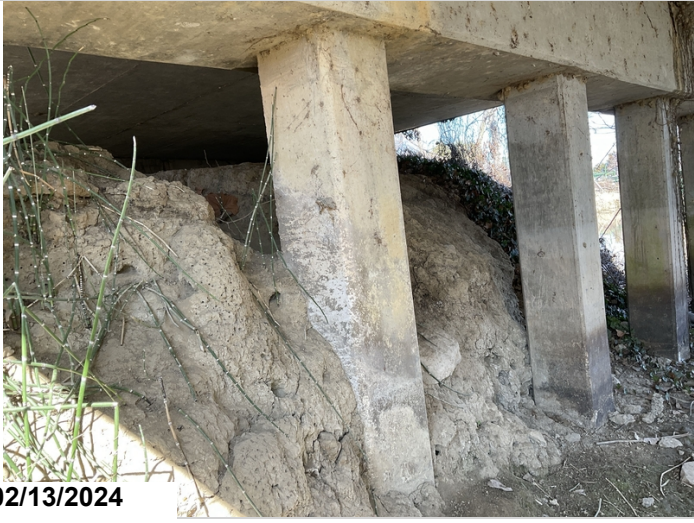
Abutment #2 slope

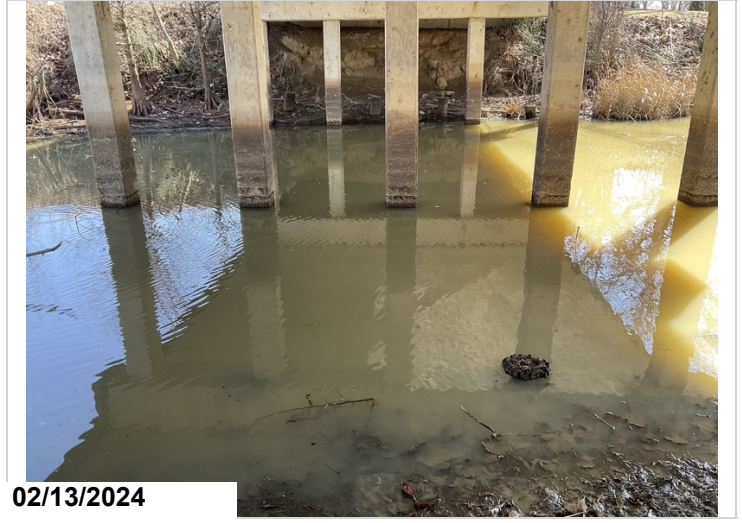
61 - Channel/Channel Protection (6 - Bank is beginning to slump. River control devices and embankment protection have widespread minor damage. There is minor stream bed movement evident. Debris is restricting the channel slightly.) Channel has good alignment with structure. Banks are slumping were water hits the banks. Channel has some vegetation and debris restricting water flow rate.

Channel under bridge

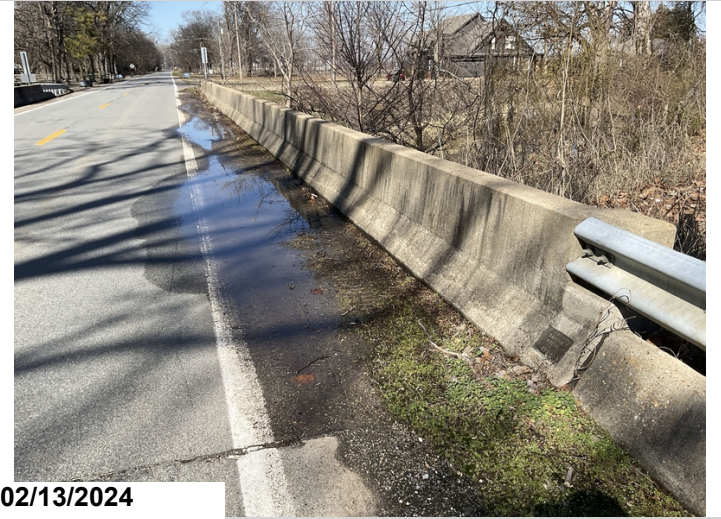
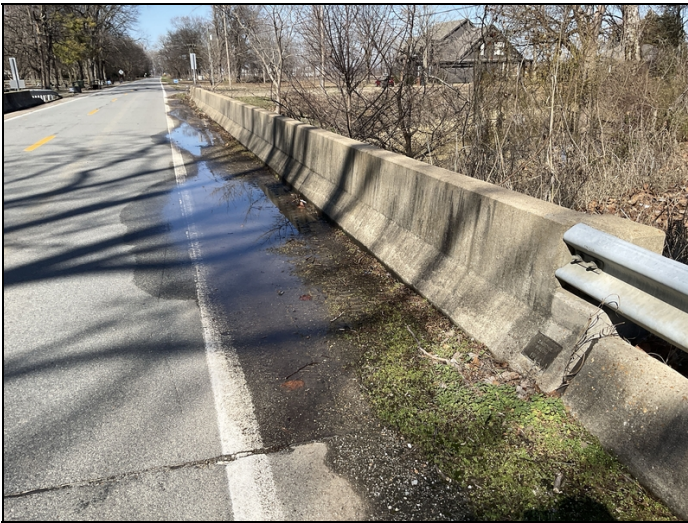
Gutters are full of dirt and debris partly clogging scuppers.

Typical debris in gutters

A-55 - Deck Washing Needed (Yes)

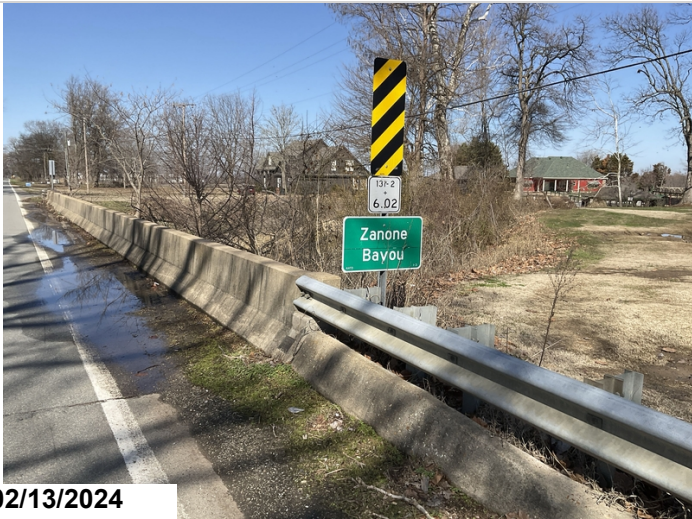
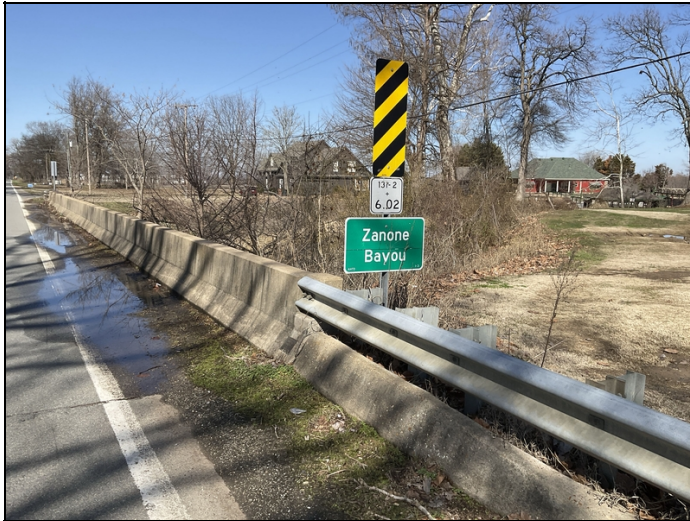
Incorrect log mile sign, should now read 6.1.

Typical log mile sign

A-63 - Missing/Incorrect Log Mile Signage (Yes)

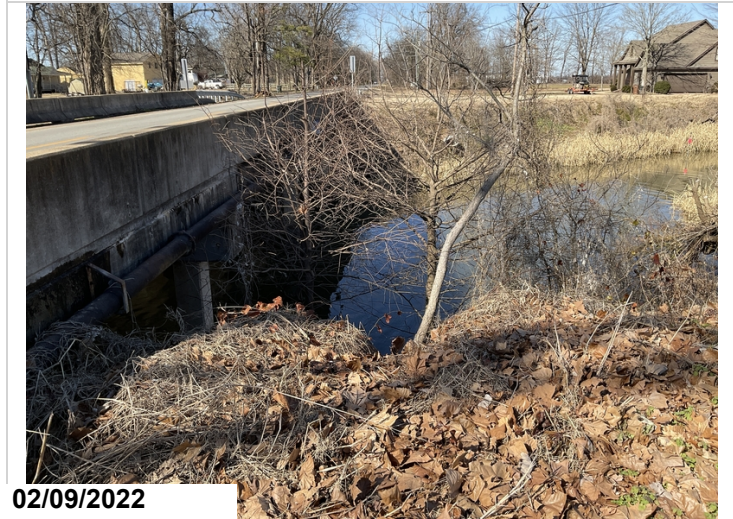
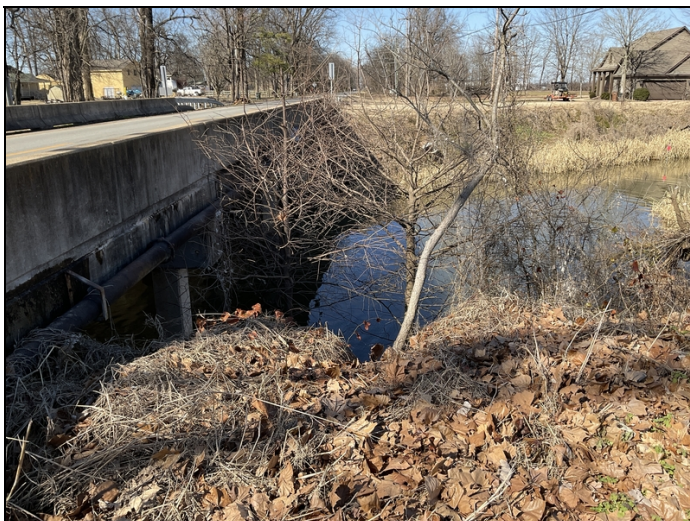
Abutment #1 both sides have vegetation growing beside and under bridge.

Trees and vegetation growing beside and under bridge

A-64 - Vegetation Removal Requested (Yes)

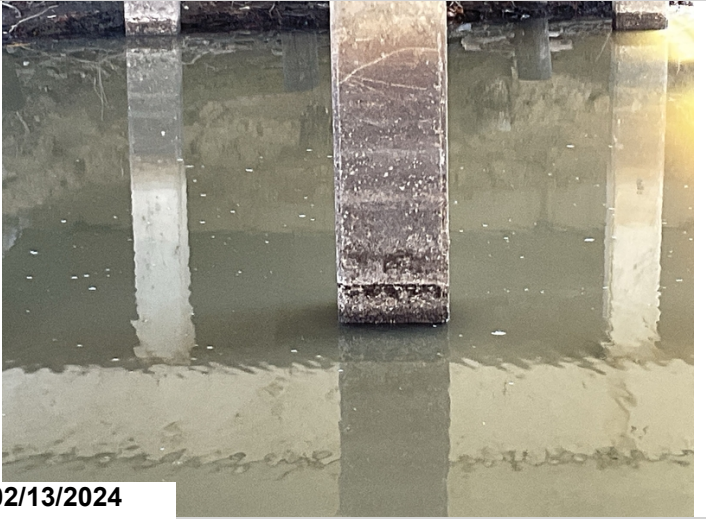
(227) Bents #2,3 piles have light abrasion with no loose aggregate							
234	Reinforced Concrete Pier Cap	LF	93	93	0	0	0
301	Pourable Joint Seal	LF	155	0	0	155	0
2350	Debris Impaction	LF	155	0	0	155	0

Typical abrasion on piles

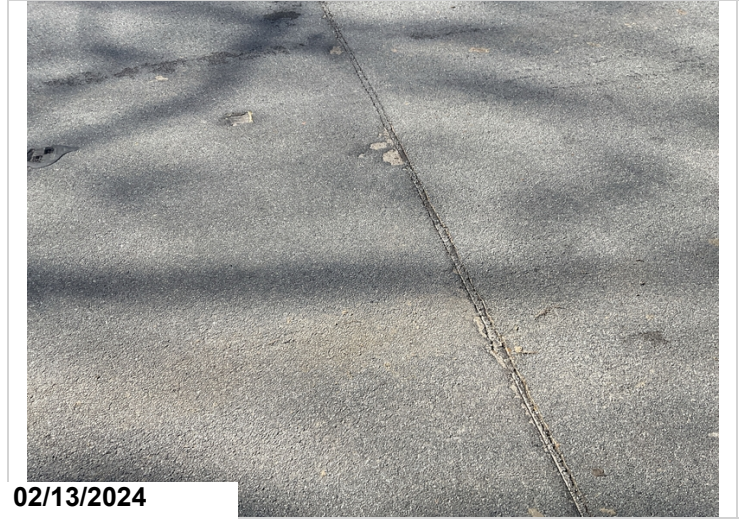
Joints are in good condition with joint material having weathering and cracking with partial covering with overlay.

(301) Joints are weathered and cracked with partial covering with overlay.							
321	Reinforced Concrete Approach Slab	SF	762	762	0	0	0
510	Wearing Surfaces	SF	690	690	0	0	0

Typical joint
