Bridge M3610 Inspection Report

Route:49 Section:06 Log:11.96

Us-49/Sec-6/L11.96 over Canal

Team Lead: Drew Melton Inspection Date: 02/06/2024

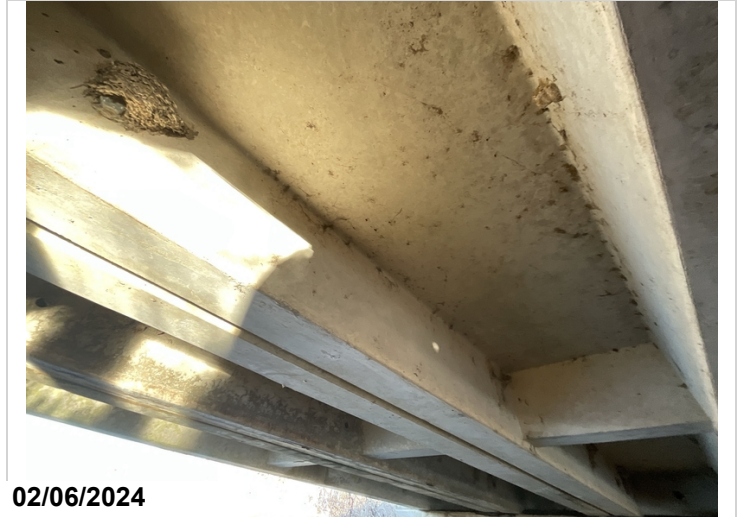
Typical soffit/under surface

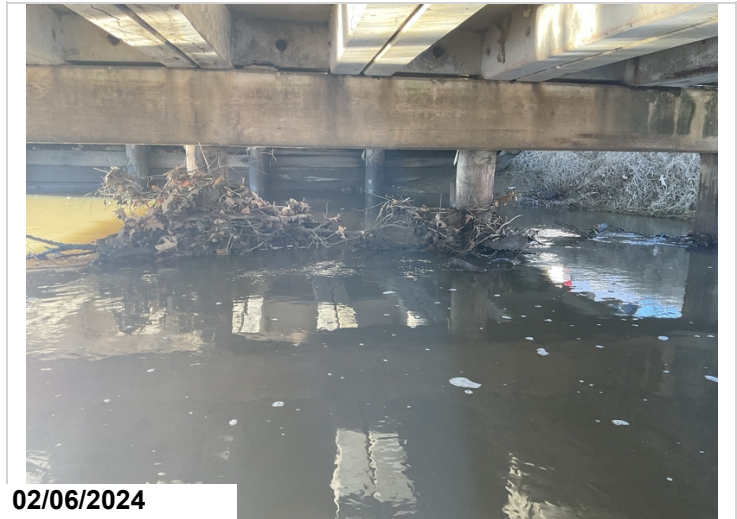
Channel has poor alignment with structure. Banks have areas of erosion and slumping with scour under bridge due to channel alignment. Channel has moderate drift with water flow rate affected.

Typical drift in channel

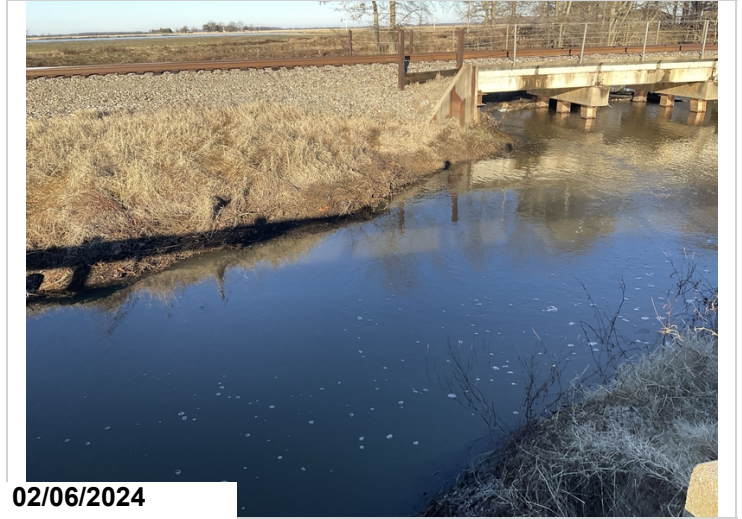
Channel right side and bent #2,3 all have moderate drift.

Channel right side

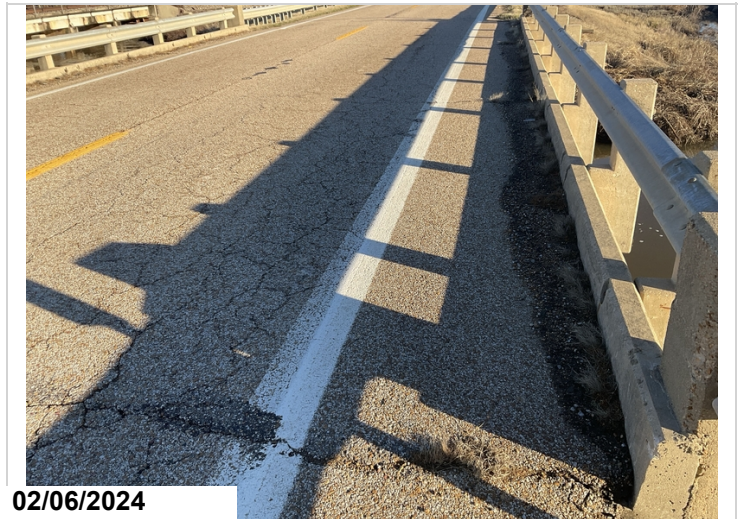
Gutters have dirt and debris in them.

Typical debris in gutters

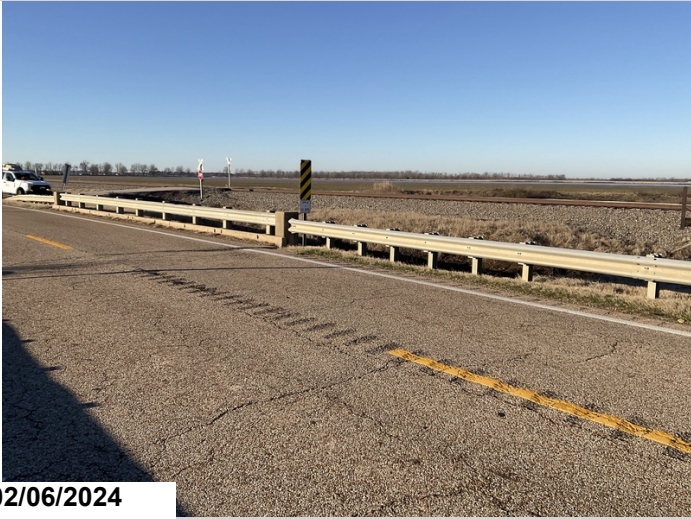
Log mile signs are incorrect. They should read Us-49, Section-6, Log mile-11.96.

Typical log mile sign

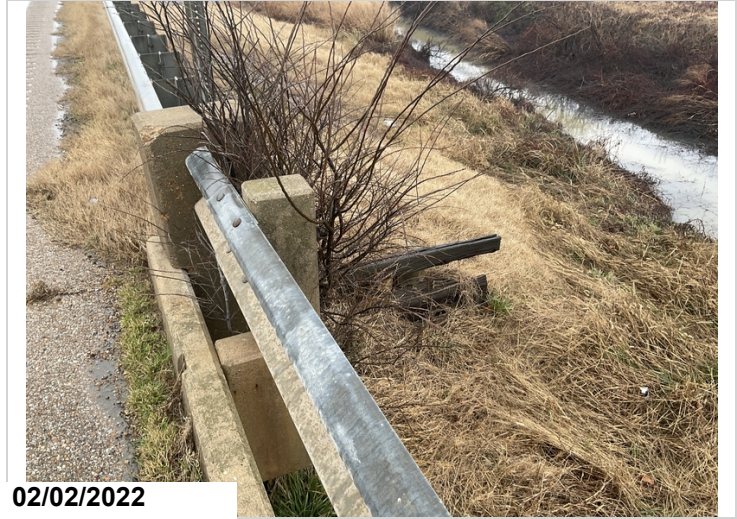
Brush is growing at abutment #1 left side.

Brush growing at abutment #1 left side

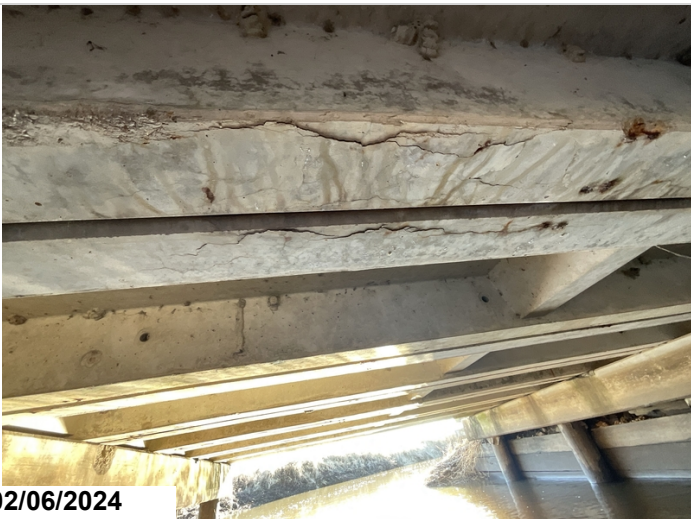
Span #3 channel beam units

Superstructure is in fair condition with unit legs having Cracks, delaminated areas, and spalls some with exposed rebar.

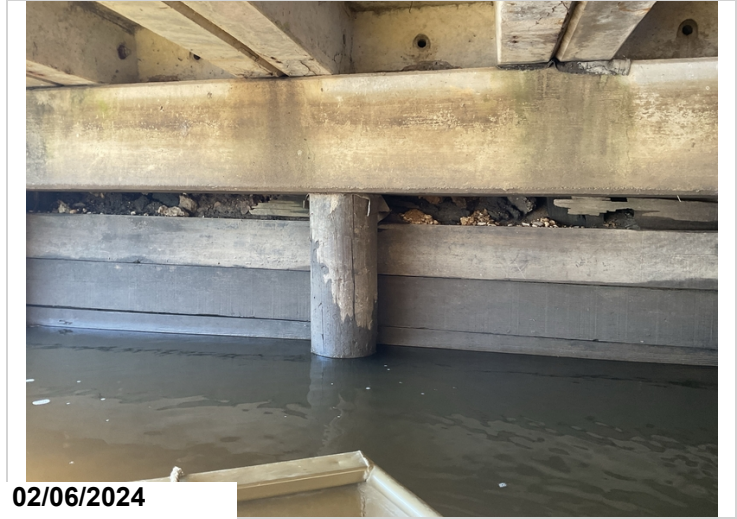
Abutment #2 timber back wall just below cap is decayed with areas of moderate to heavy section loss full length with voids to material behind cap and under roadway.

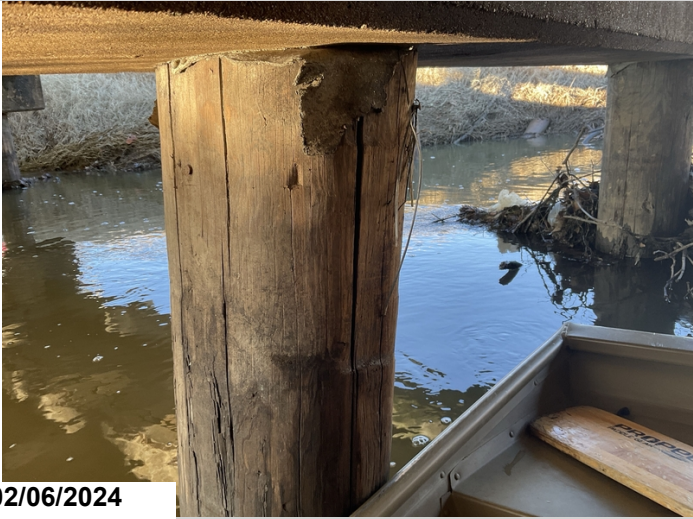
Substructure is in satisfactory condition with caps having cracks, and spalls some with exposed rebar. Piles have cracks, splits, and shakes.

Typical pile condition

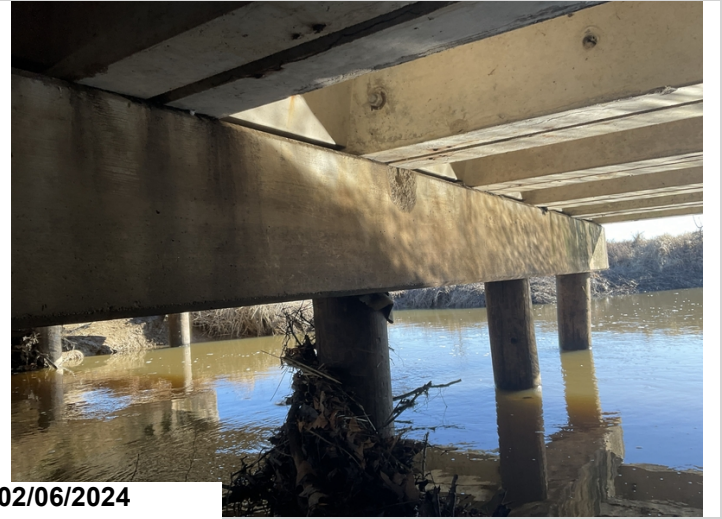
Bent #3 cap ahead face spall 8" over pile #3 no rebar exposed.

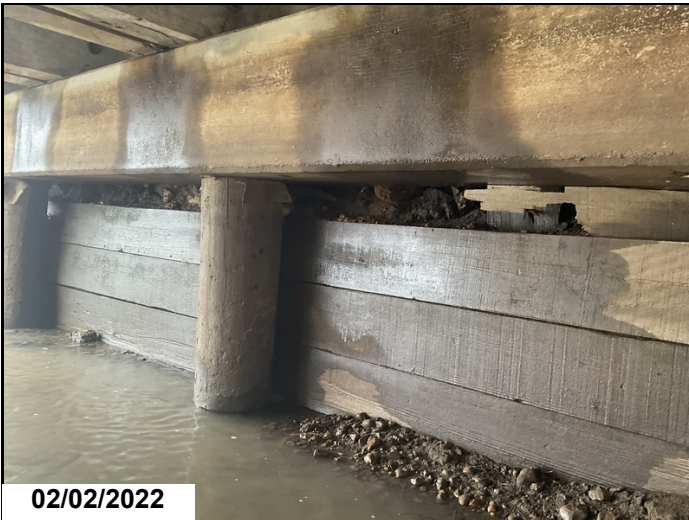
Abutment #2 timber back wall just below cap is decayed with areas of moderate to heavy section loss full length with voids to material behind cap and under roadway.

Type of Work: Repair (General)

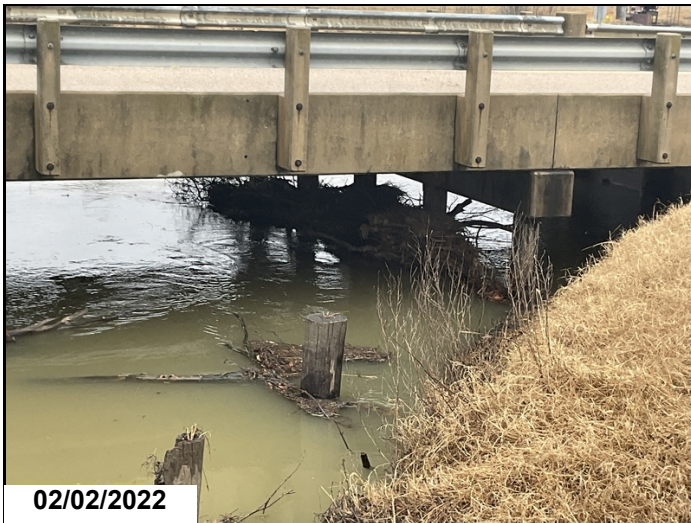
Channel right side and bent #2,3 all have moderate drift.

Moderate amount of drift at bent #3

Type of Work: Channel Work/Drift Removal

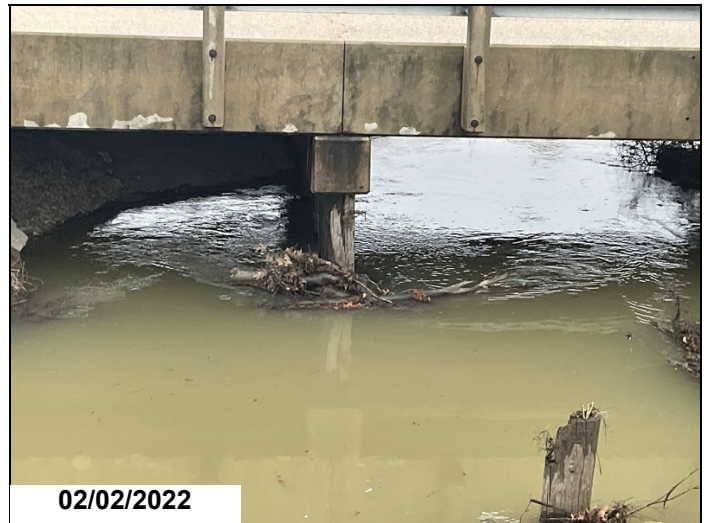
Small amount of drift at bent #2

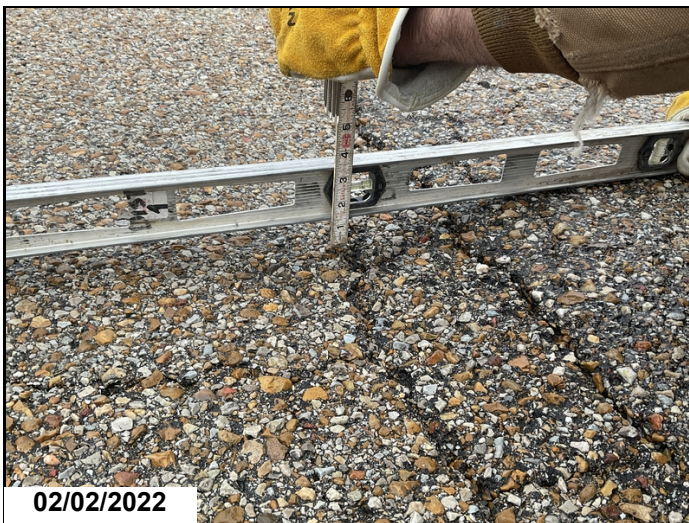
Abutment #1 right lane approach roadway has settled 1".
Abutment #2 approach roadway has settled up to 1 1/2".

Abutment #1 right lane approach roadway has settled one inch

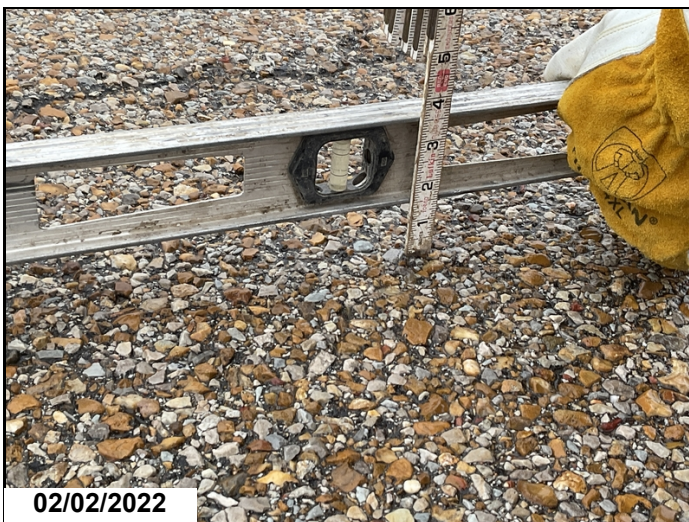
Abutment #2 approach roadway has settled up to one and a half inches

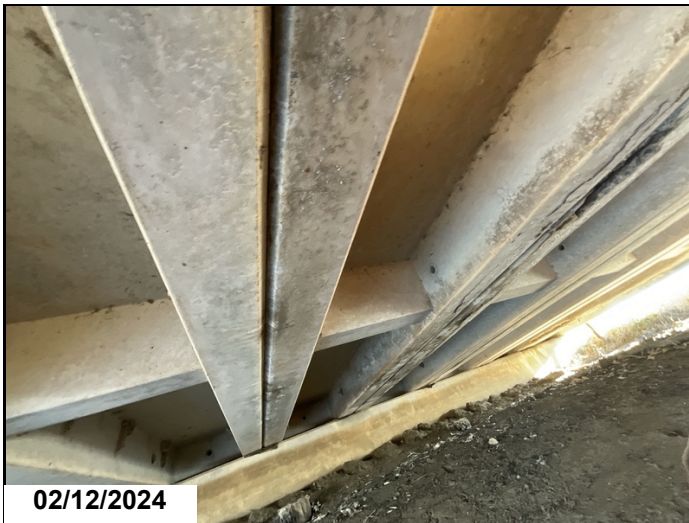
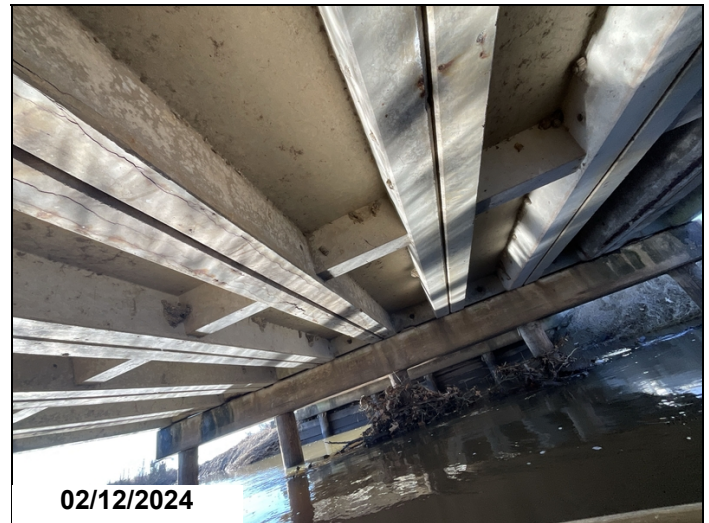
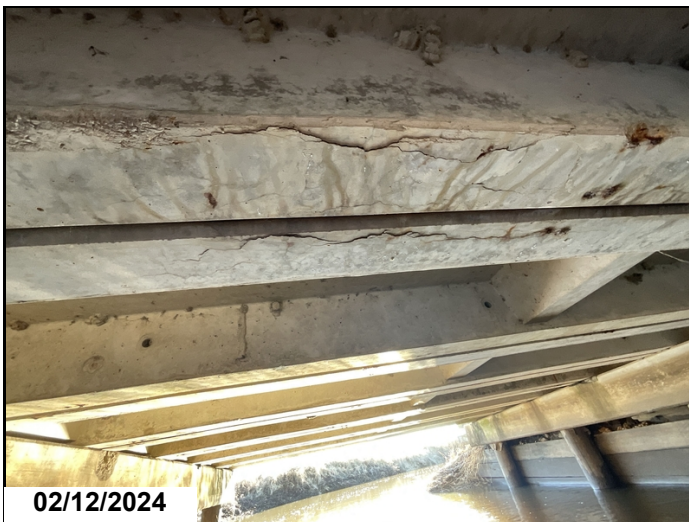
Units have wide cracks, delaminated areas and spalls with exposed rebar to unit legs.

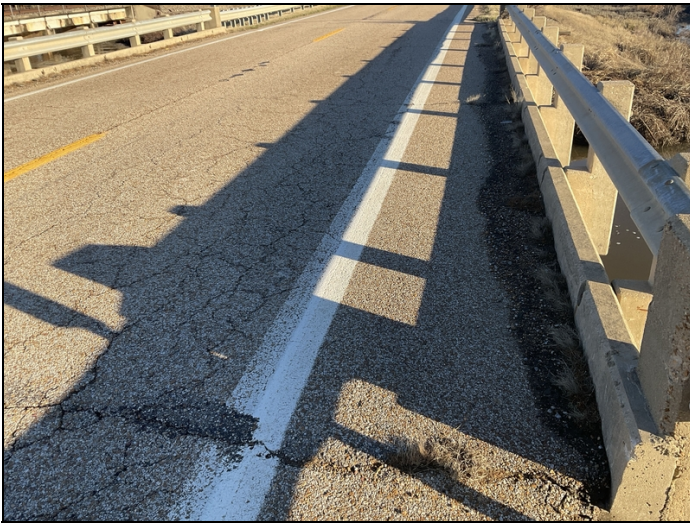
Gutters have dirt and debris in them.

Typical debris in gutters

A-55 - Deck Washing Needed (Yes)

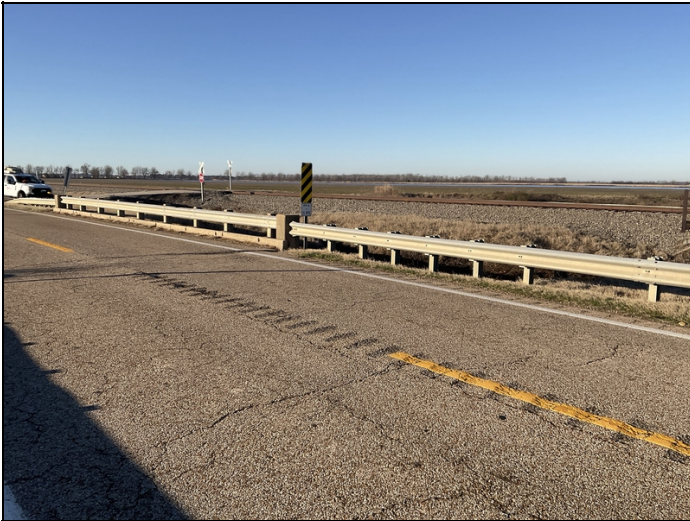
Log mile signs are incorrect. They should read Us-49, Section-6, Log mile-11.96.

Typical log mile sign

A-63 - Missing/Incorrect Log Mile Signage (Yes)

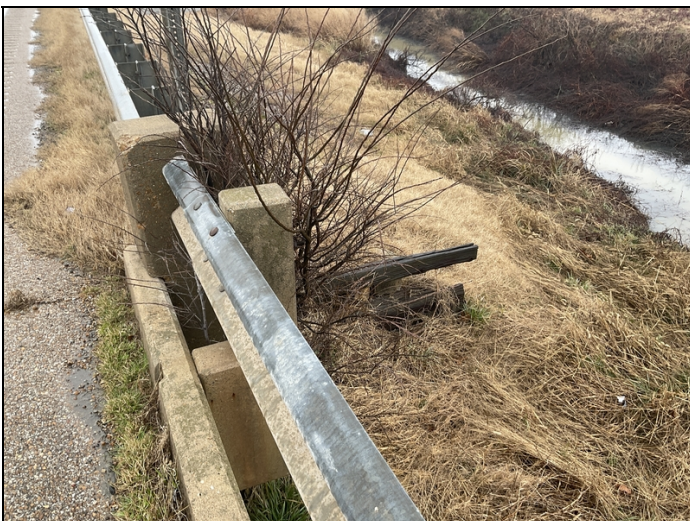
Brush is growing at abutment #1 left side.

Brush growing at abutment #1 left side

A-64 - Vegetation Removal Requested (Yes)
