Bridge M3986 Inspection Report

Asset #M3986(Routine, Underwater type 2)

Us-49/Sec-7/L-1.10 over Creek

Team Lead: Myron Futrell Inspection Date: 06/12/2024

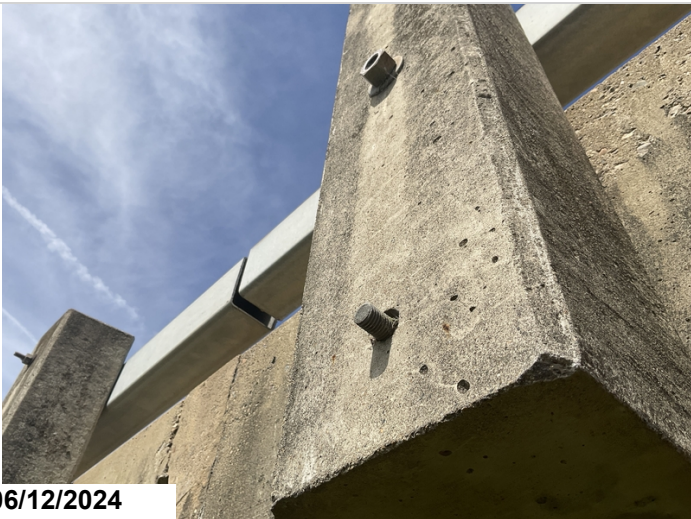
Span 2, rail post, left side, last post, bottom rail bolt: missing nut.

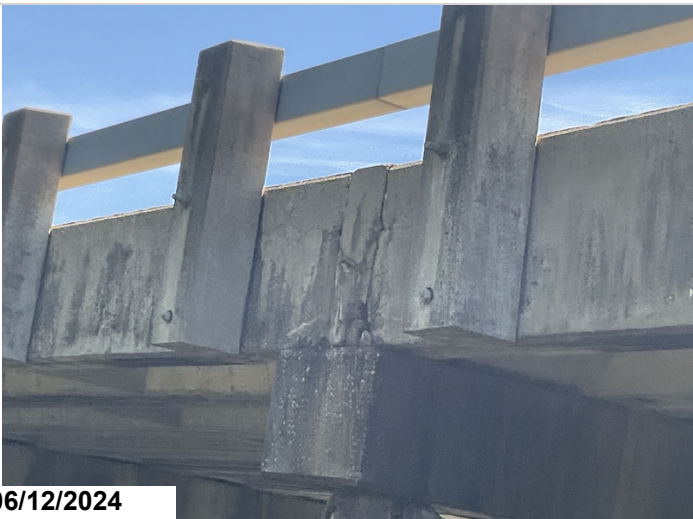
Bent 3, joint between spans 2 and 3, right side: cracked and spalled.

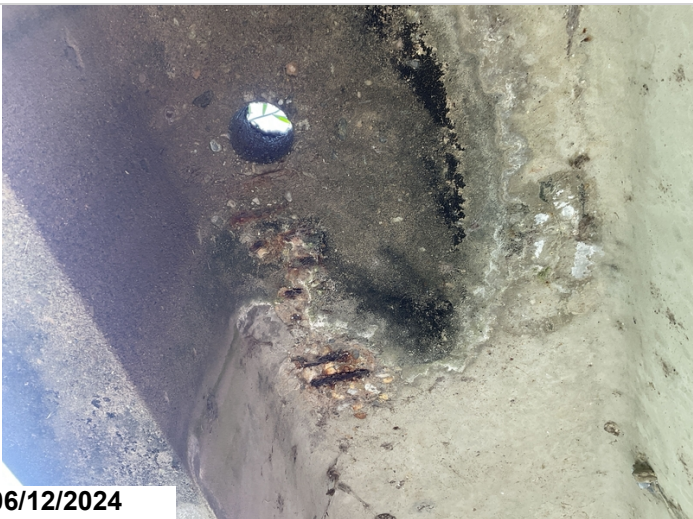
Span 1, unit 1, undersurface of deck near bent 2, at drain: 2 square feet of reinforcing steel exposed with moderate section loss near drain. 2SF CS3

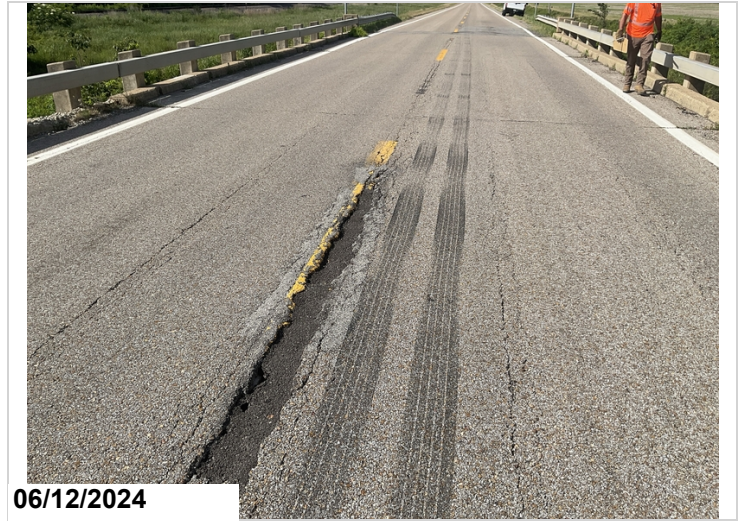
Cracking and spalling in overlay along centerline.

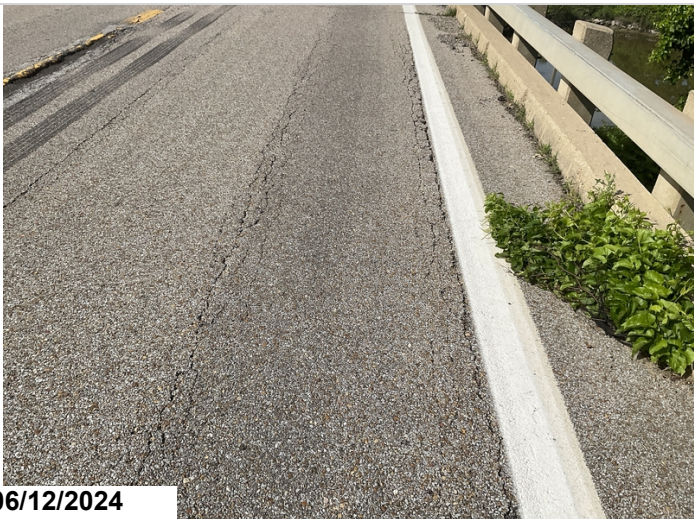
Typical longitudinal cracking in overlay along grout joints.

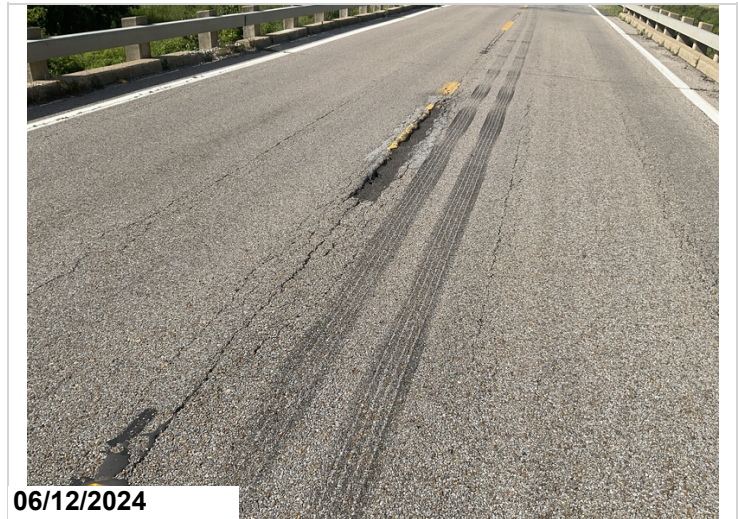
Span 1, deck, at centerline: 6" wide by 12' long patched area that is failing.

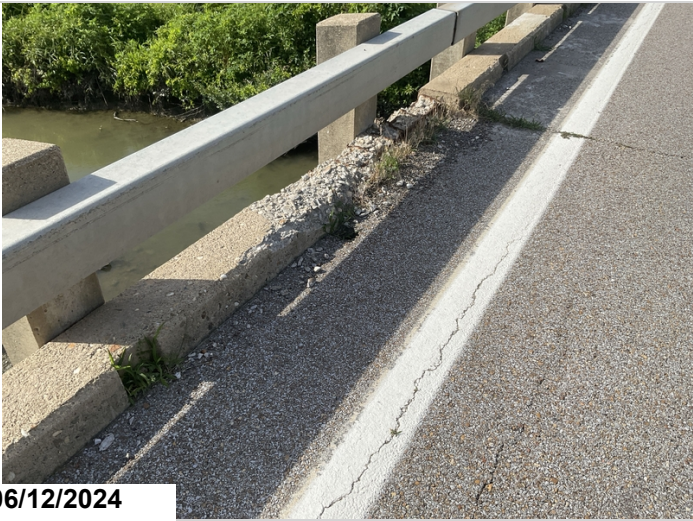
Span 1, left curb, at bent 2: spalled for 5' with 3' exposed reinforcing steel with minor section loss.

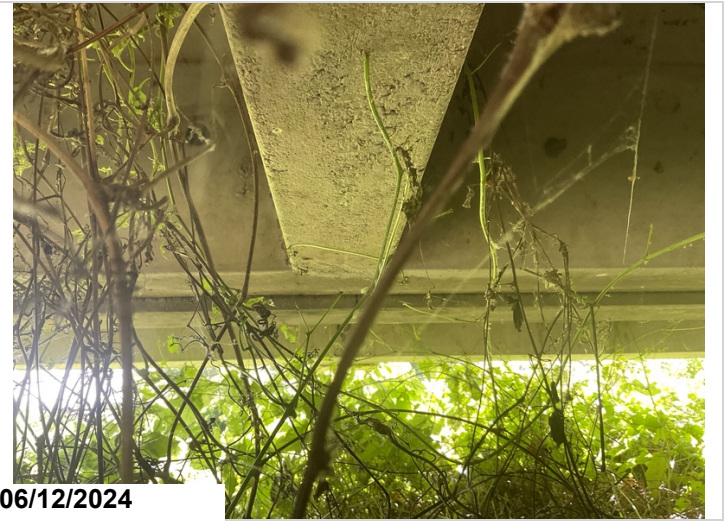
Span 3, connection bolts, between units 1 and 2: all bolts are missing.

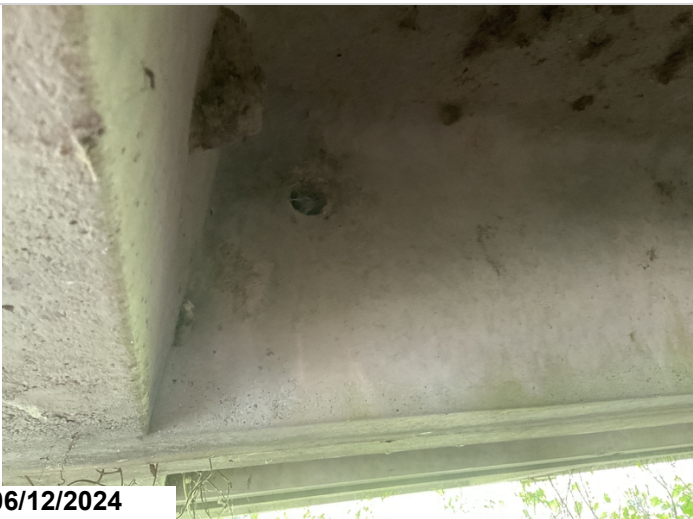
Span 3, connection bolt, between unit 2 and 3: missing bolt.

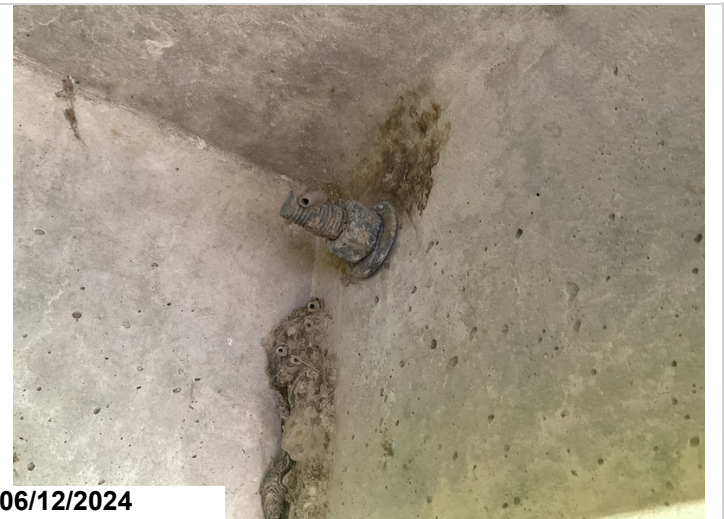
Typical loose bolt between units

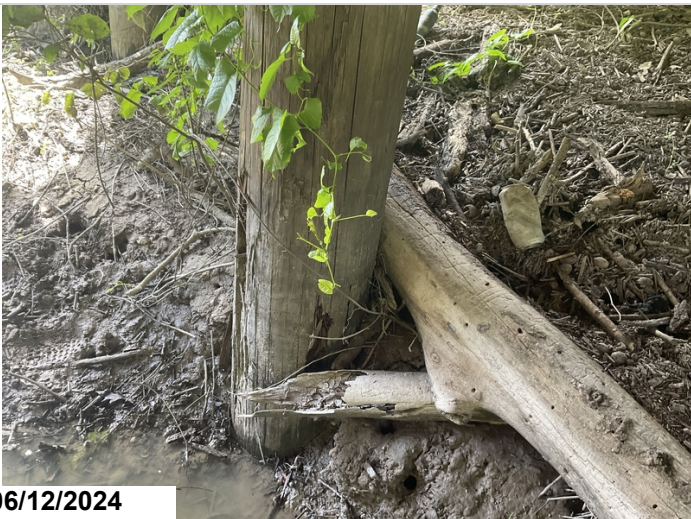
Bent 3, pile 2: outer shell decay with a small amount of section loss. 1EA CS2

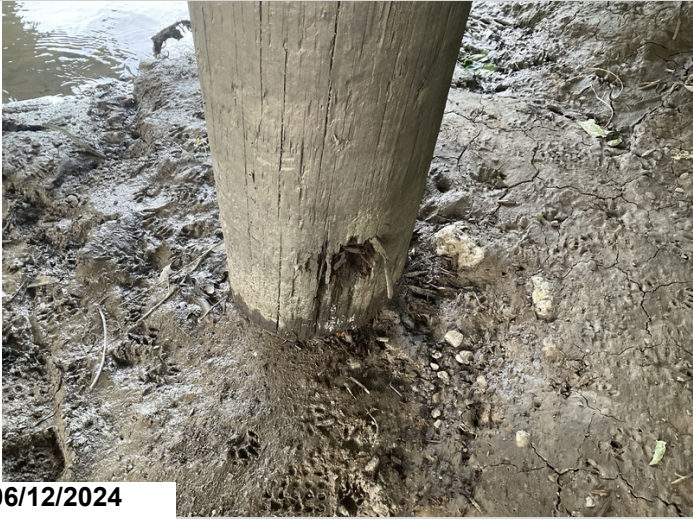
Bent 2, pile 4: minor outer shell decay at ground line. 1EA
CS2

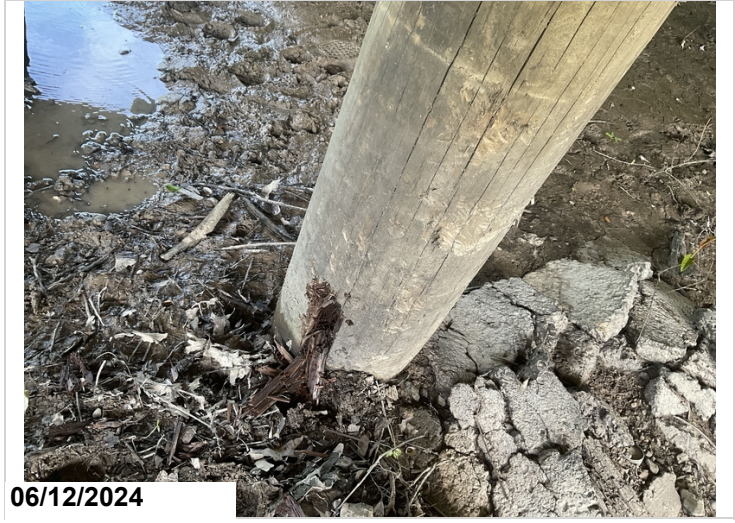
Bent 2, pile 3: minor outer shell decay at ground line. 1EA
CS2

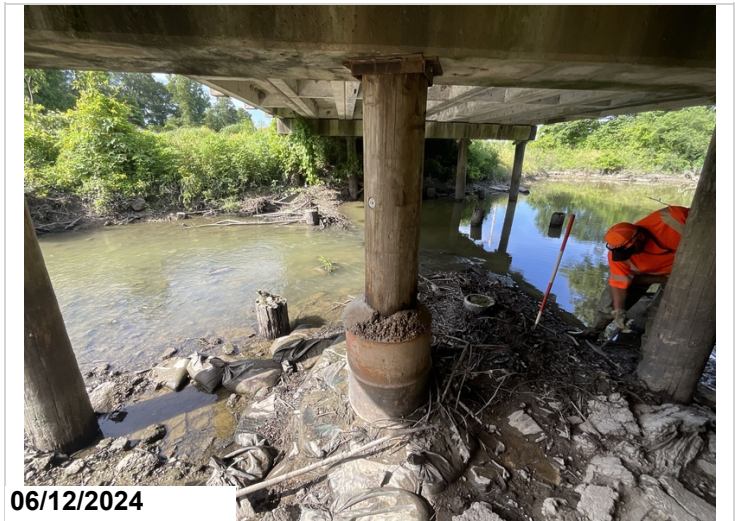
Bent 2, pile 2: spliced and encased in concrete. Structural
integrity of concrete encasement unknown.

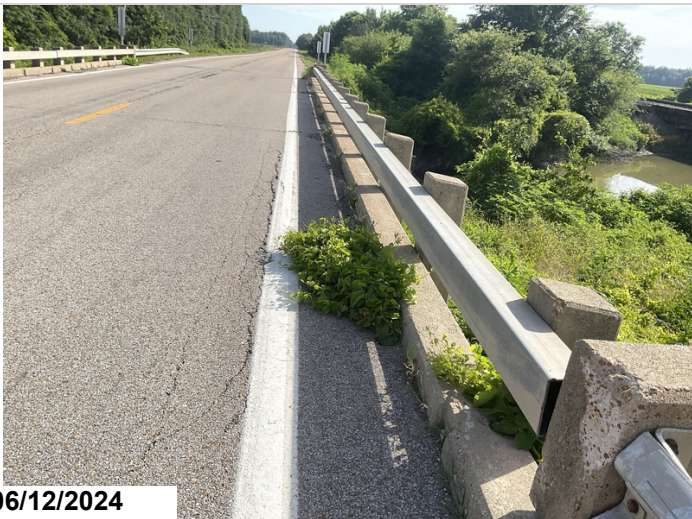
Dirt and vegetation growing in gutters.

Vegetation growing in gutters

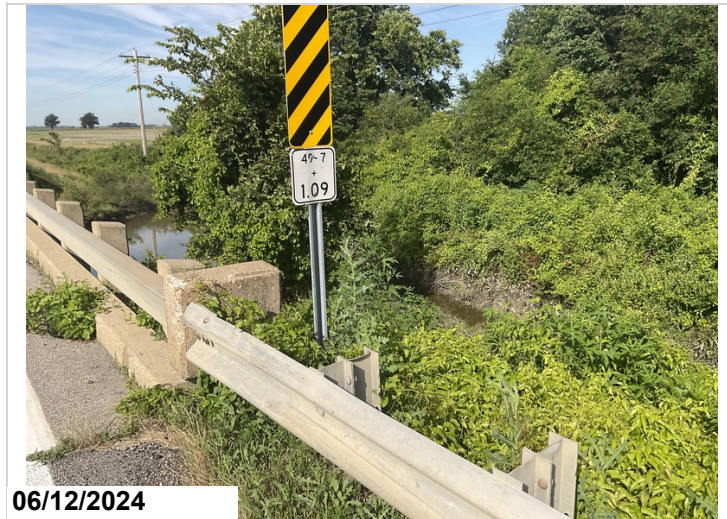
Abutment 1, log mile sign

Log mile should be 1.10

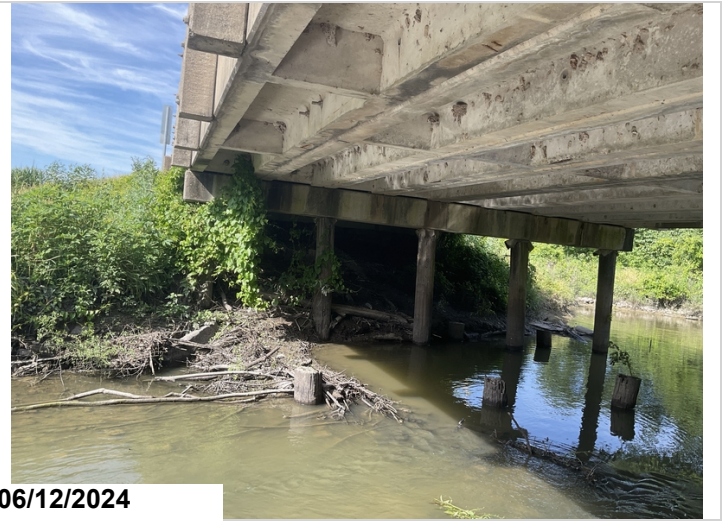
Vegetation growing under, beside and onto bridge.

Vines and vegetation growing beside, under and onto bridge.

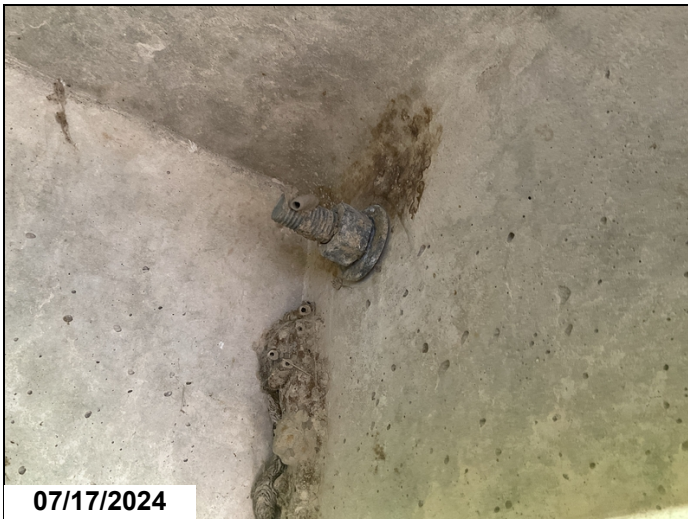
Span 1, mid span, connecting bolts between units 1 and 2: both bolts loose.

Span 1, mid span, connecting bolts between units 3 and 4: both bolts loose.

Typical loose bolt between units

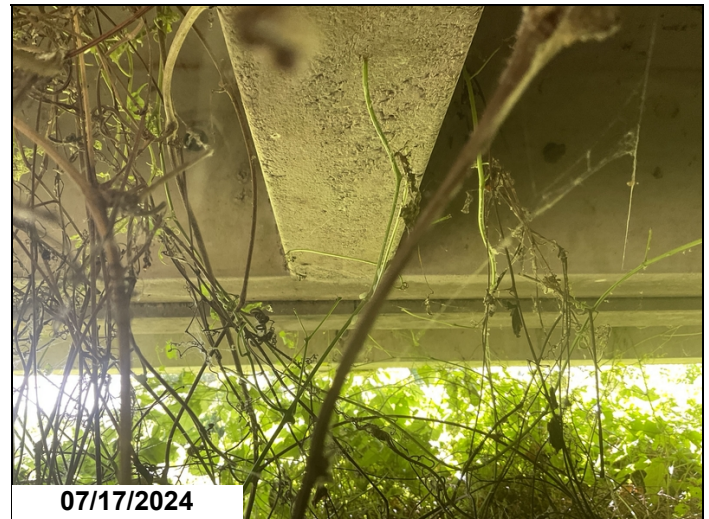
Span 3, connection bolts, between units 1 and 2: all bolts are missing.

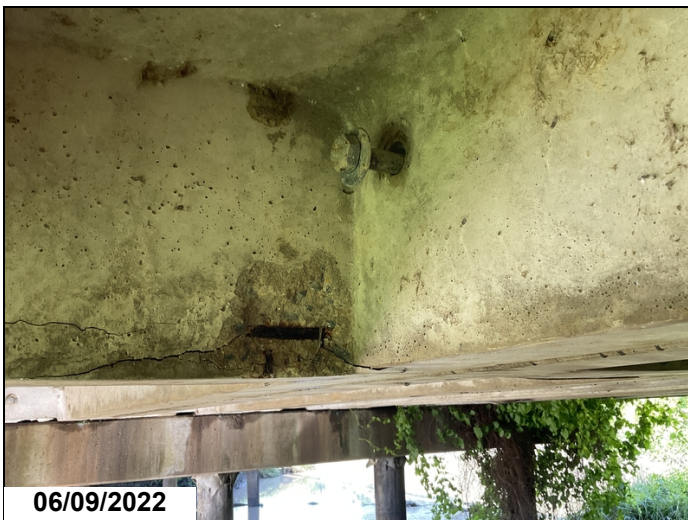
Span #1 has a loose connection bolt between unit #3,4 at mid span.

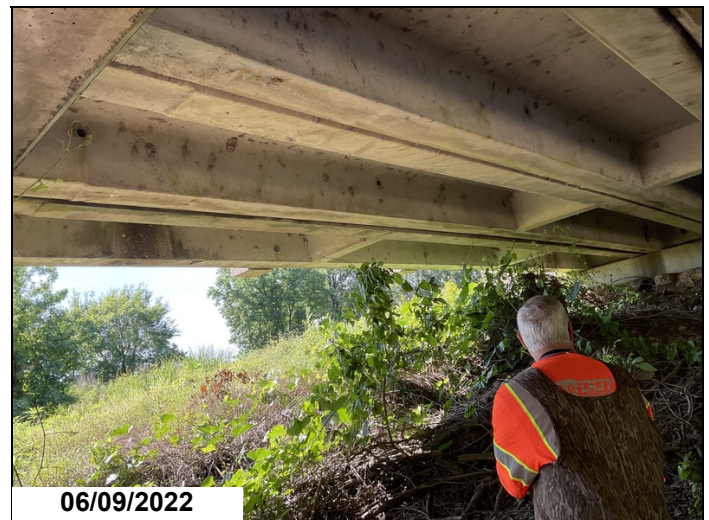
Span #3 all bolts are missing between units #1,2.

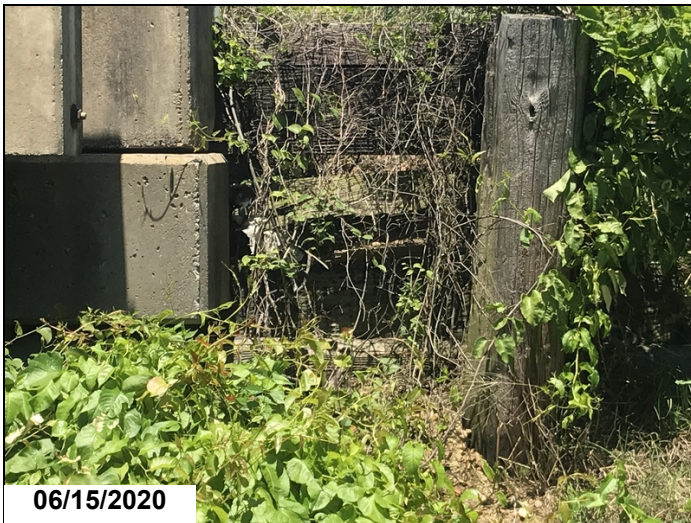
Abutment #1 left side timber back wall has areas of 100% decay.

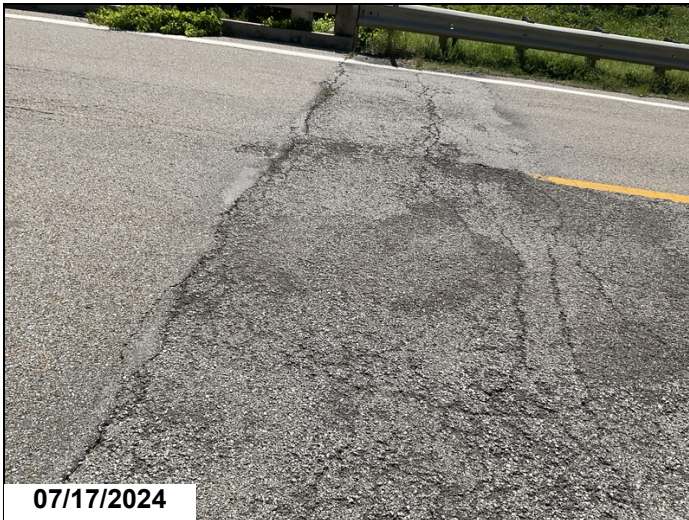
Abutment 2, approach roadway

Abutment 2, approach roadway: settled up to 2 3/4"causing impact loading on bridge.

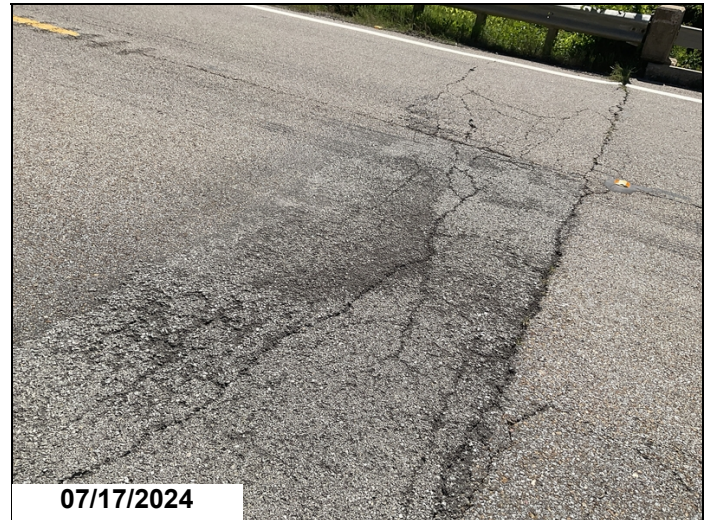
Abutment 1, approach roadway

Abutment 1, approach roadway: settled up to 1 1/2"causing impact loading on bridge.

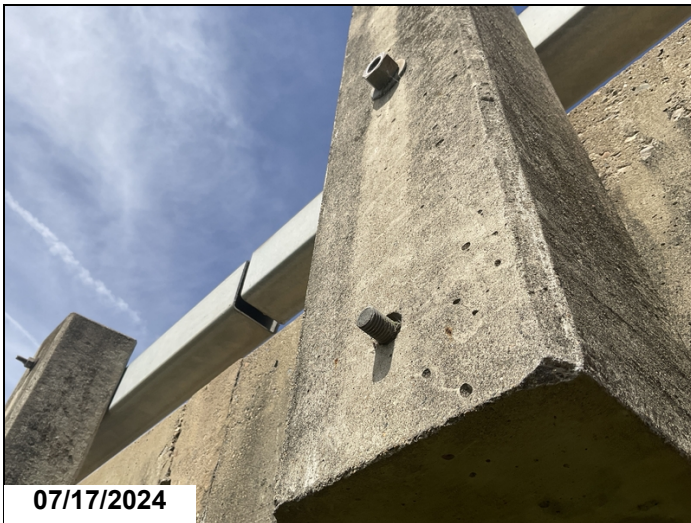
Span 2, rail post, left side, last post, bottom rail bolt:
missing nut.

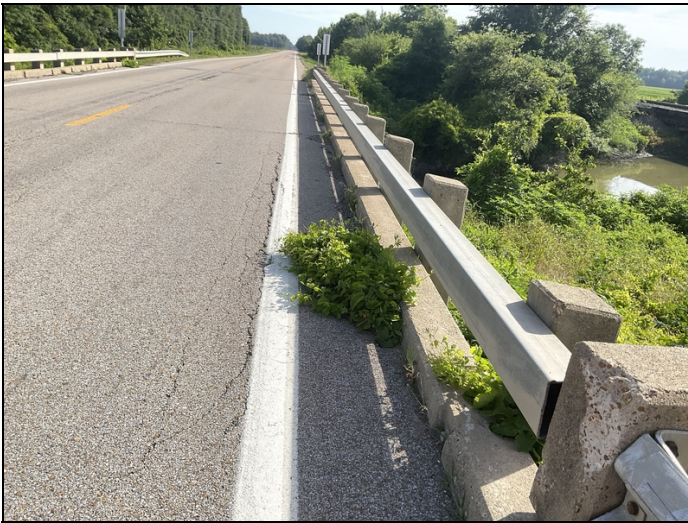
Dirt and vegetation growing in gutters.

Vegetation growing in gutters

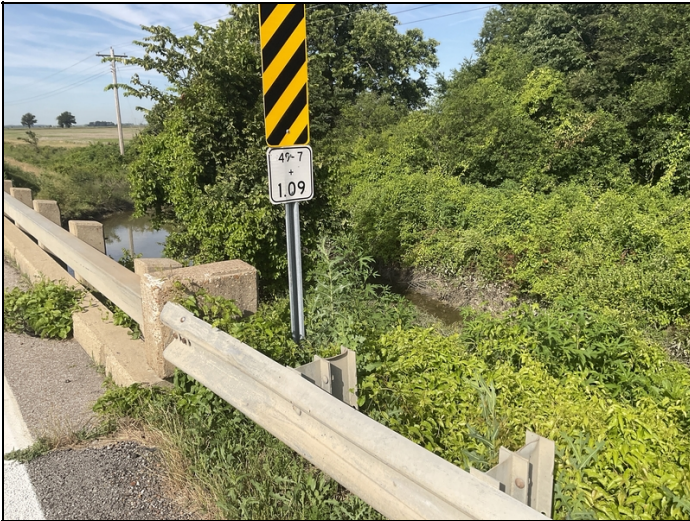
Abutment 1, log mile sign

Log mile should be 1.10

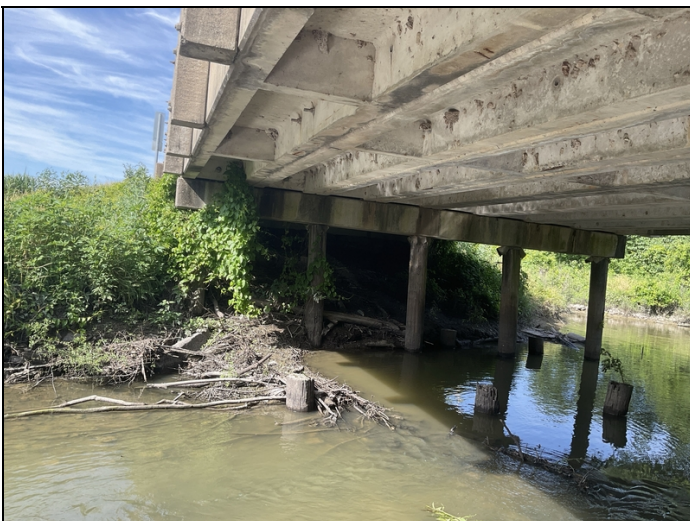
Vegetation growing under, beside and onto bridge.

Vines and vegetation growing beside, under and onto bridge.
