Bridge 03137 Inspection Report

National Bridge Inventory Data Sheet

Team Lead: Drew Melton, Inspection Date: 02/28/2024

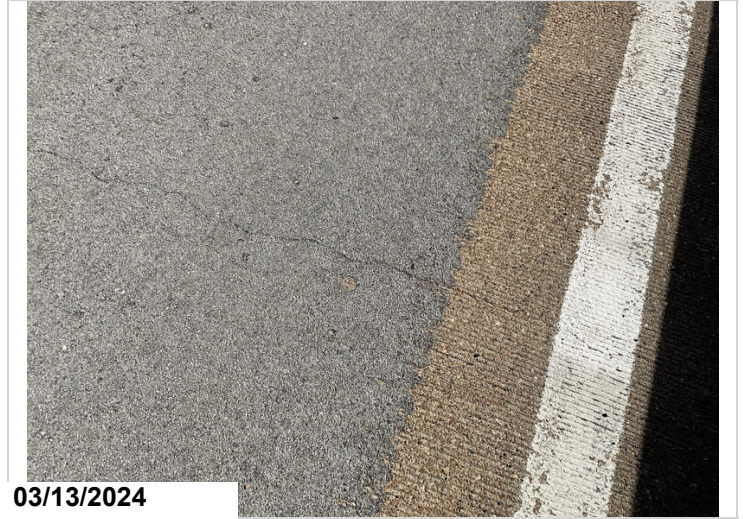
Typical deck crack

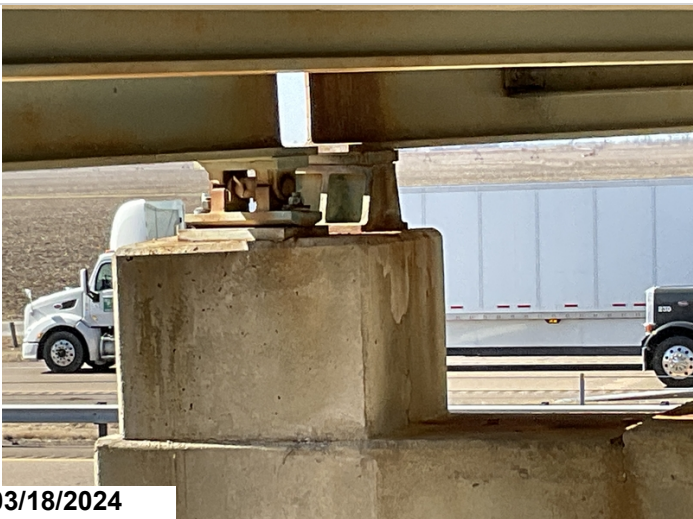
Typical bearings

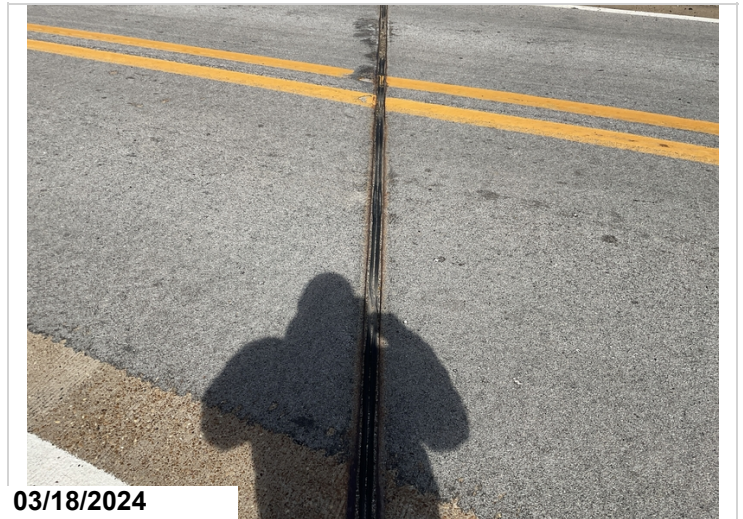
Bent 2, Compression Joint Seal: 7' of lost adhesion seal is sagging. 7LF CS3

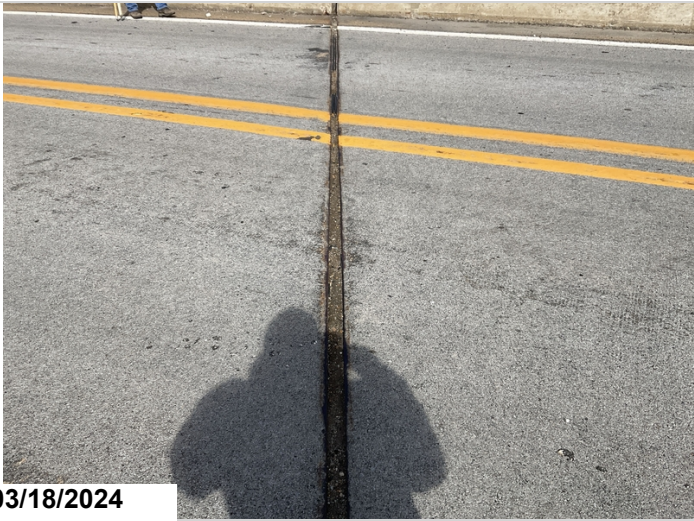
Bent 3, Compression Joint Seal: 14' of lost adhesion seal is sagging. 14LF CS3

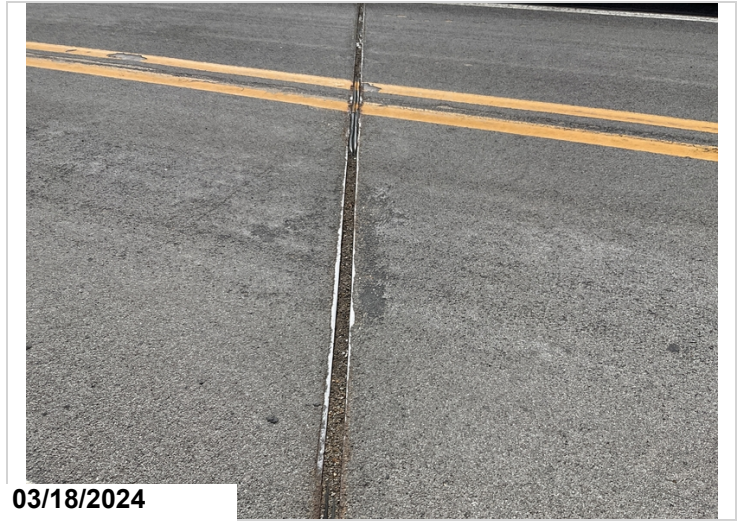
Bent 4, Compression Joint Seal: 18' of lost adhesion seal is sagging. 18LF CS3

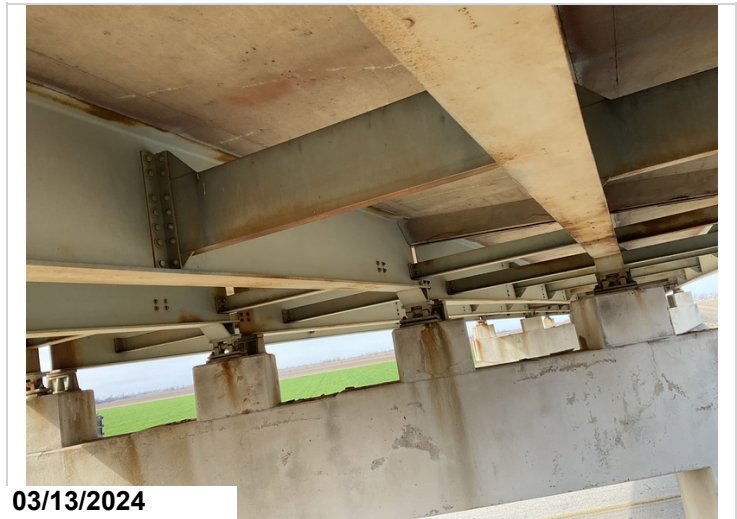
All Spans, All Girders, Full Length: Paint is discolored and oxidized with minor areas of bare steel full length. 6,445SF CS2, 6,446SF CS3, 678SF CS4

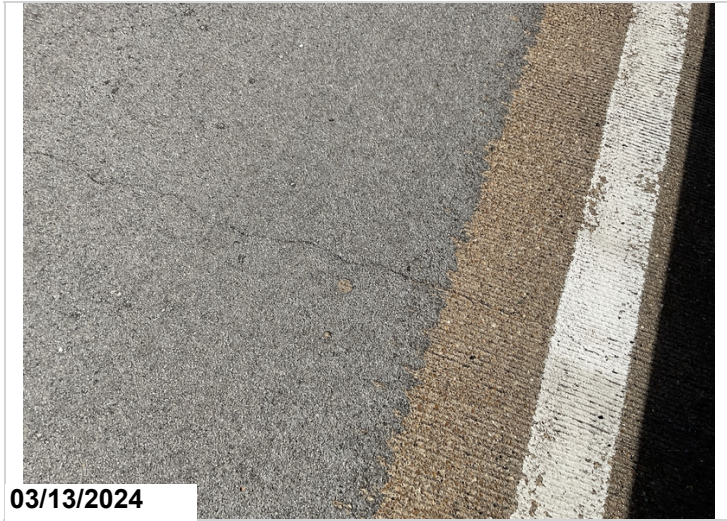
Typical deck crack

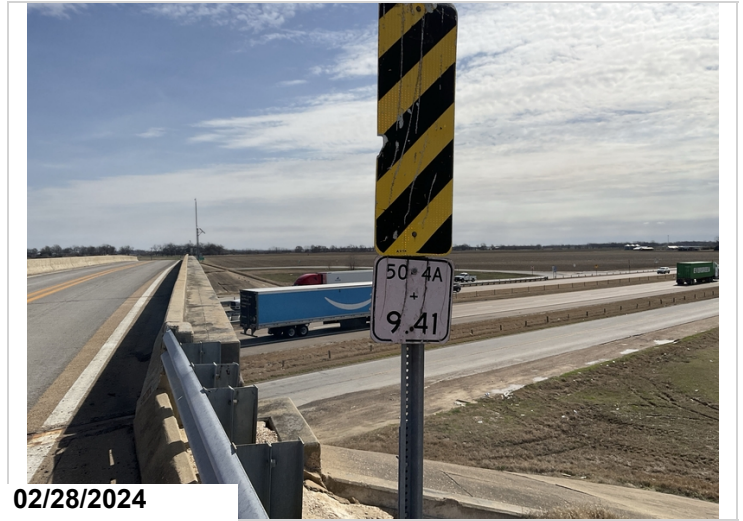
Abutment 1 log mile sign right side

Log mile signs are incorrect should read Sh-50, Section-4, Log Mile-9.20.

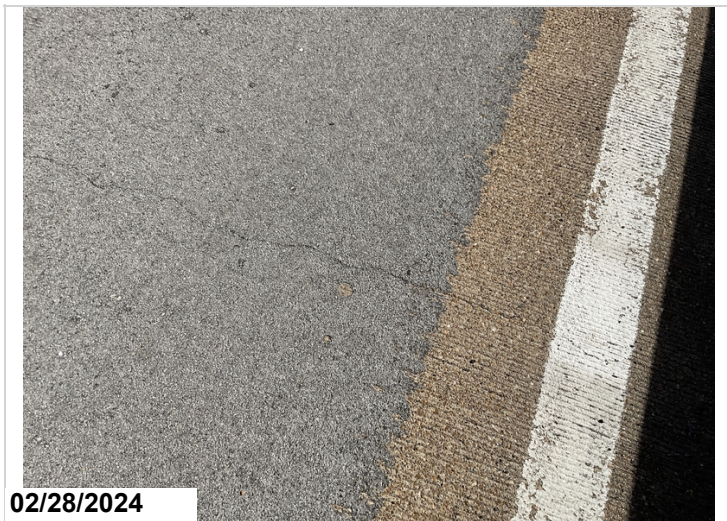
Typical deck crack

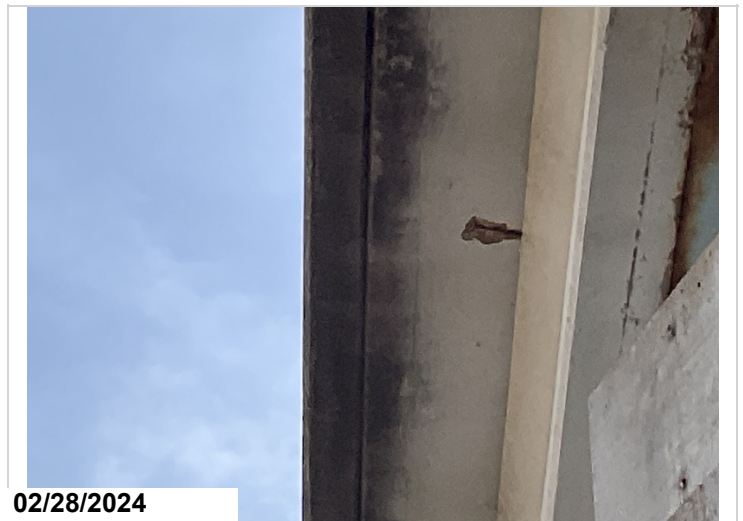
Deck Undersurface Overhang, Left, 4' From Bent 4: 8" spall with exposed reinforcing steel. Reinforcing steel has minor section loss. 1SF CS3

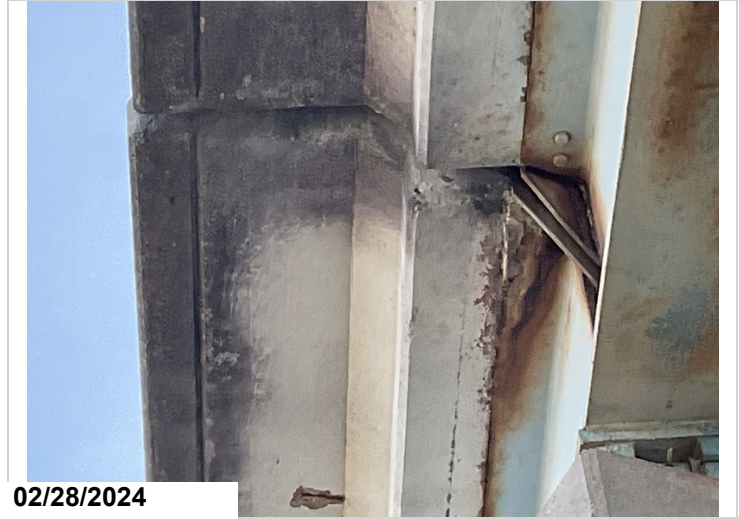
Superstructure is in satisfactory condition with some surface rust due to paint failing. Outside girders have some out of plane bending at haunch due to pack rust between girder and haunch.

All Spans, Girders 1 & 5, All Bents, Haunch: Slight out of plane bending due to pact rust between girder and haunch.

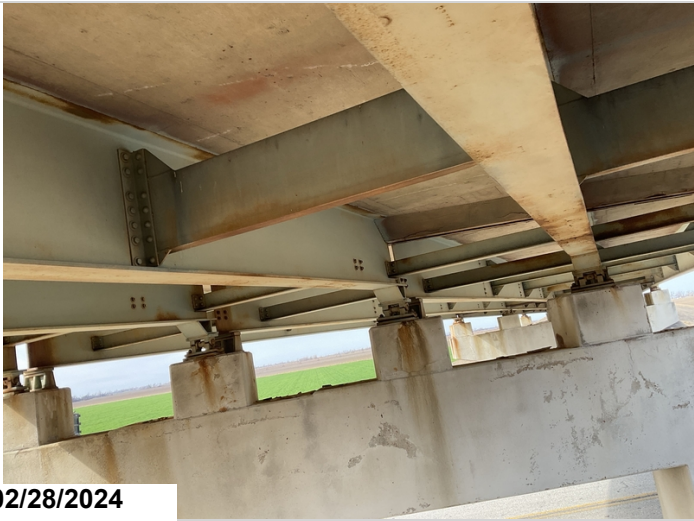
All Spans, All Girders, Full Length: Paint is discolored and oxidized with minor areas of bare steel full length. 6,445SF CS2, 6,446SF CS3, 678SF CS4

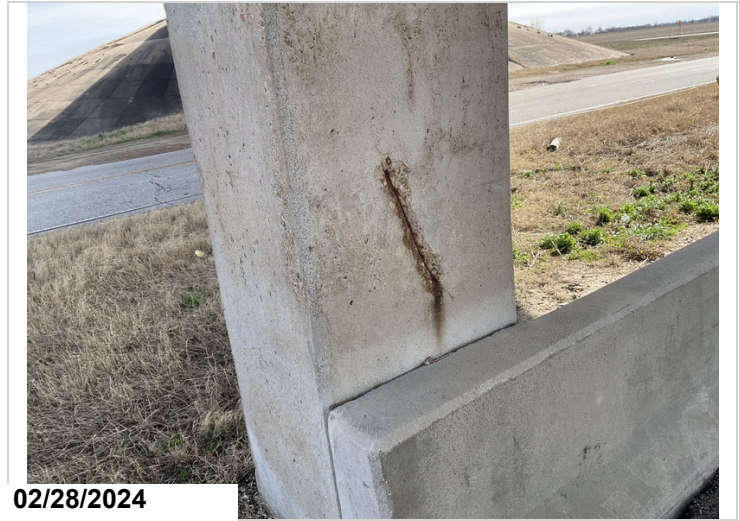
Bent 5, Column 1, Back: 3' piece of cage steel exposed due to poor concrete coverage. 1Each CS3

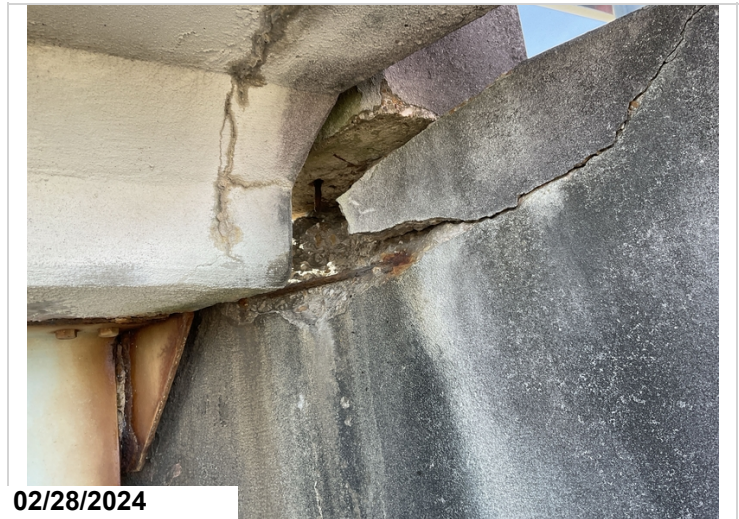
Abutment 1, Left, Top: Spalled exposed reinforcing steel. Reinforcing steel has minor section loss. 2LF CS3

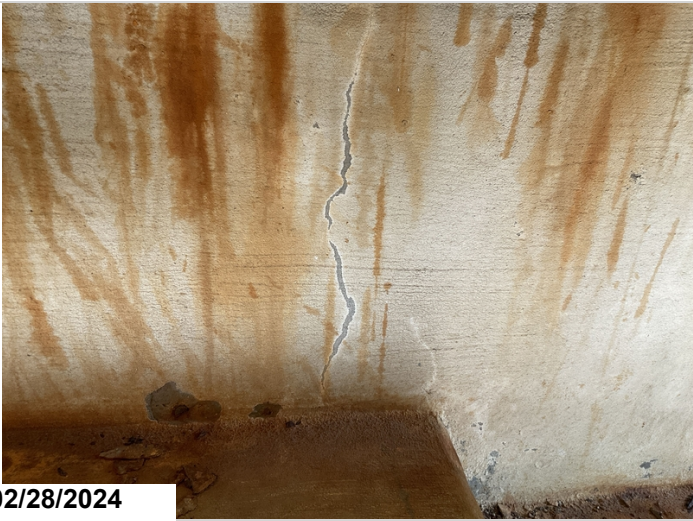
Both Abutments, Backwalls: Vertical cracks. 8LF CS2

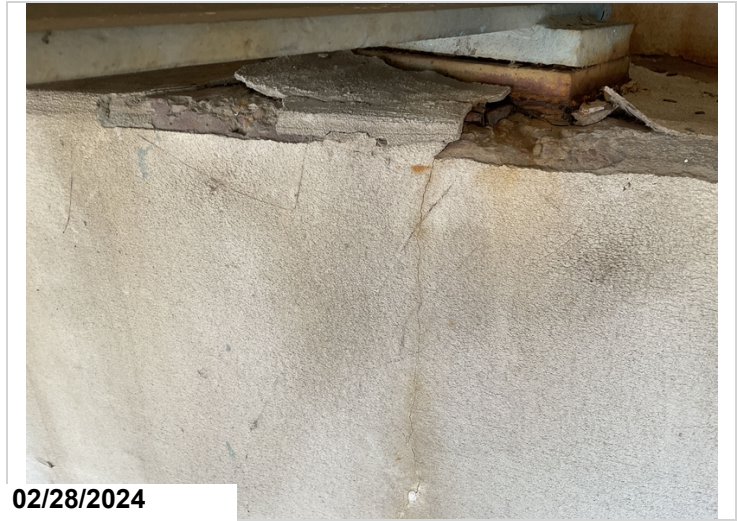
Both Abutments, Pile Caps, Top, Under Bearings: Spalled no exposed reinforcing steel. 6LF CS3

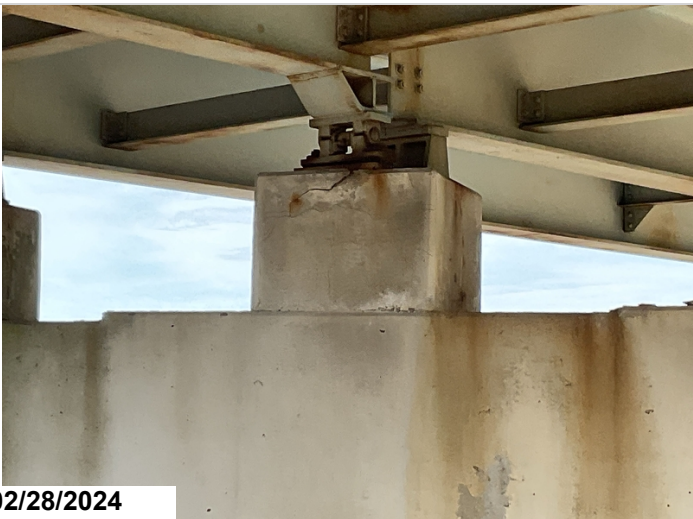
Bent 2, Pier Cap, Back, Under girder 2: 1' spall with exposed reinforcing steel. Reinforcing steel has no section loss. 1LF CS2

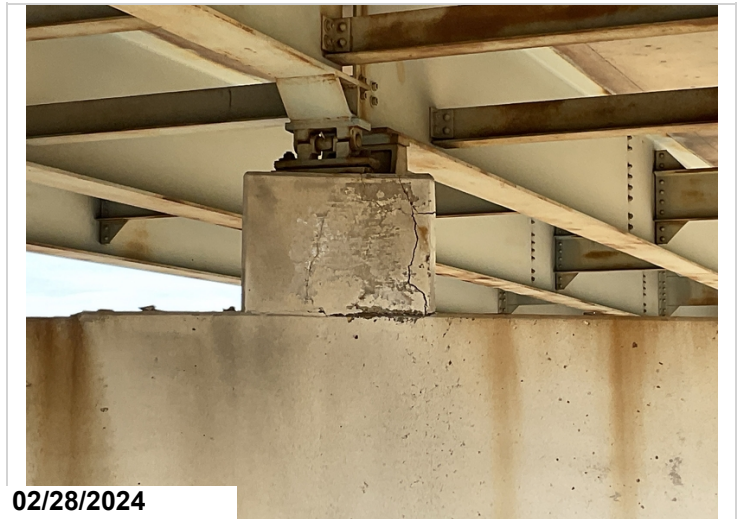
Bent 2, Pier Cap, Back, Under girder 3: 1' spall with exposed reinforcing steel. Reinforcing steel has no section loss. 1LF CS2

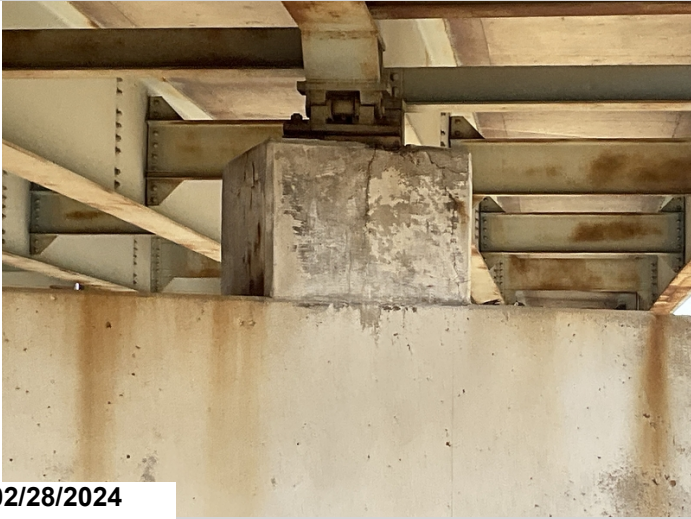
Bent 2, Pier Cap, Back, Under girder 4: 1' spall no exposed reinforcing steel, and CS3 cracks. 1LF CS3

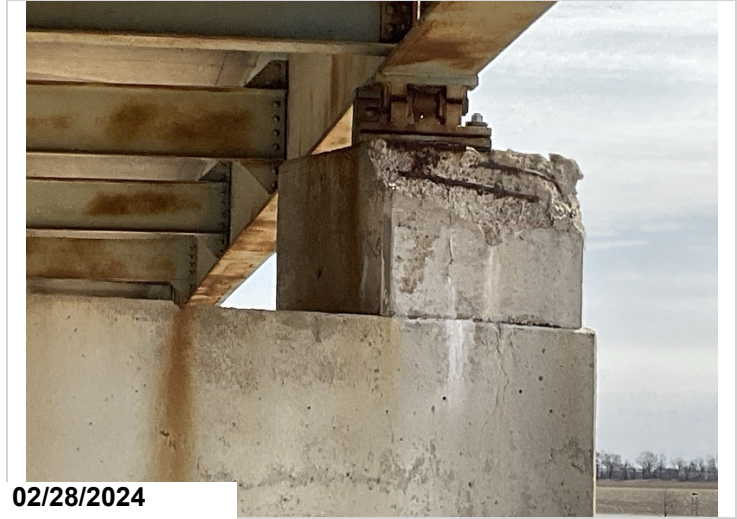
Bent 2, Pier Cap, Back, Under girder 5: 1' spall with exposed reinforcing steel. Reinforcing steel has no section loss. 1LF CS2

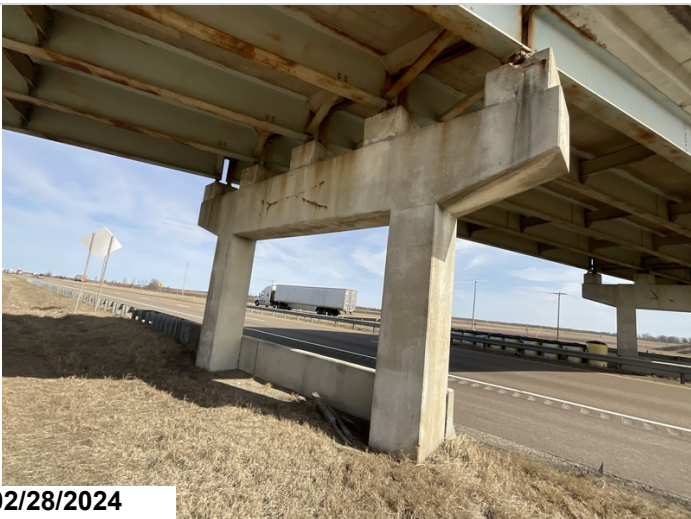
Bent 3, Pier Cap, Back, Under girder 5: Riser spalled at top no exposed reinforcing steel. 1LF CS3

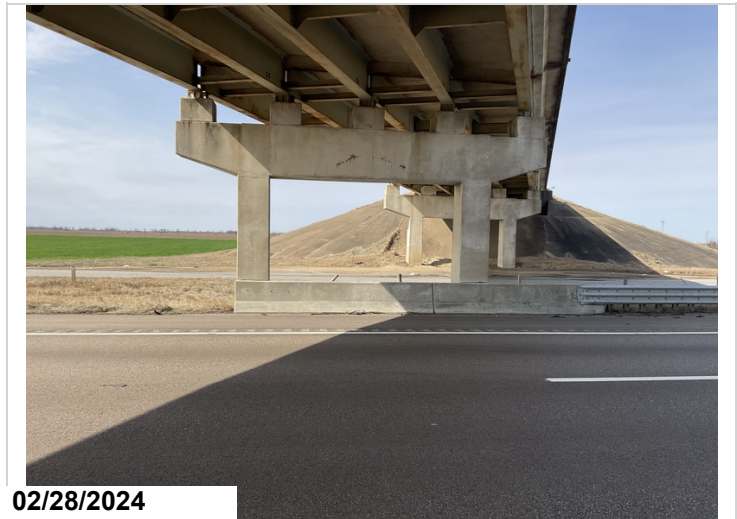
Bent 3, Pier Cap, Both Sides: 6' of reinforcing steel exposed due to poor concrete coverage at center. Reinforcing steel has no section loss. 6LF CS2

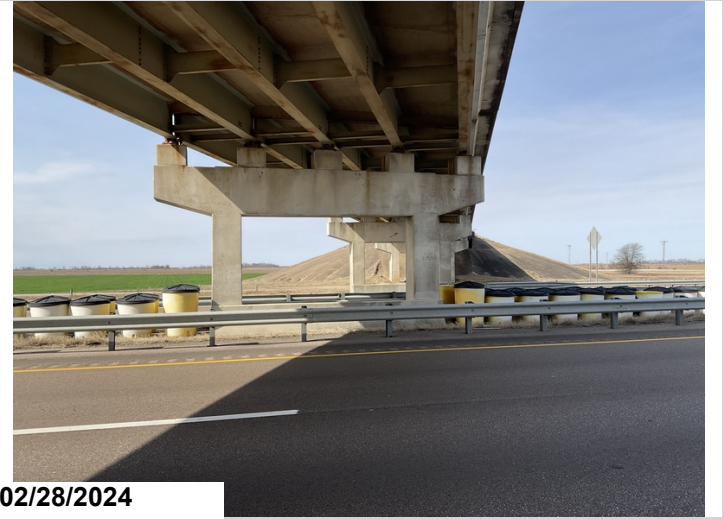
Bent 4, Pier Cap, Ahead: Cracking at top of riser under girder #3 . 1LF CS3

Bent #4 ahead face has cracking at top of riser under girder #3. Cs3

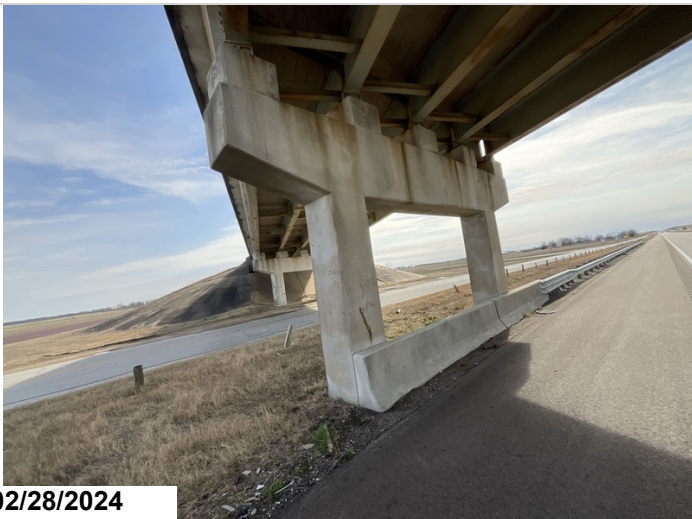
Bent 5, Pier Cap, Back, Under Girder 1 & 2: Risers have cracking. 2LF CS2

Bent #5 cap back face risers under girders #1 and 2 have cracking. Cs2

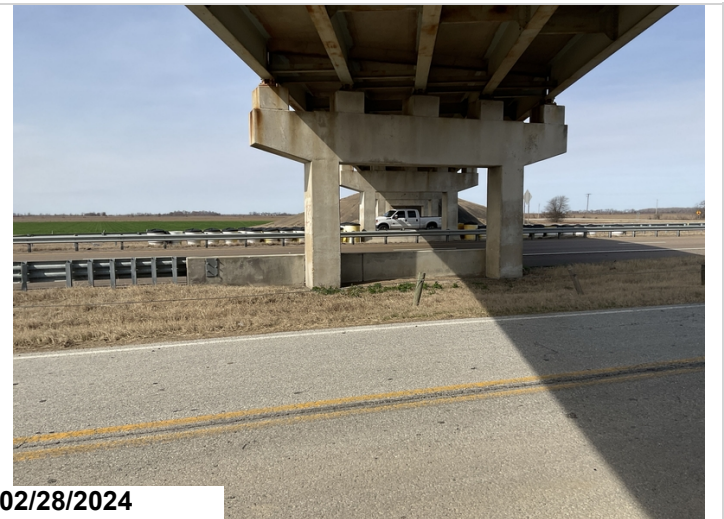
Bent 5, Pier Cap, Ahead, Under Girder 2: Riser has 1' of cracking. 1LF CS3

Bent #5 cap ahead face riser under girder #2 has one foot of cracking. Cs3

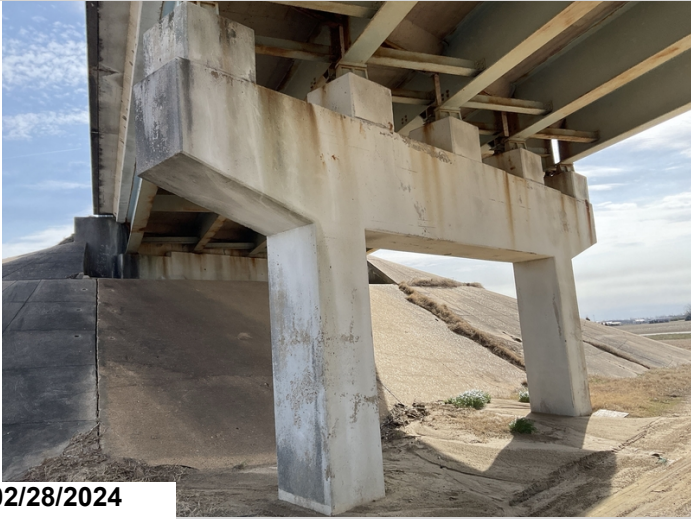
Bent 6, Pier Cap, Back, Under Girder 2: Riser has cracking at top. 1LF CS3

Bent #6 cap back face riser under girder #2 has cracking at top. Cs3

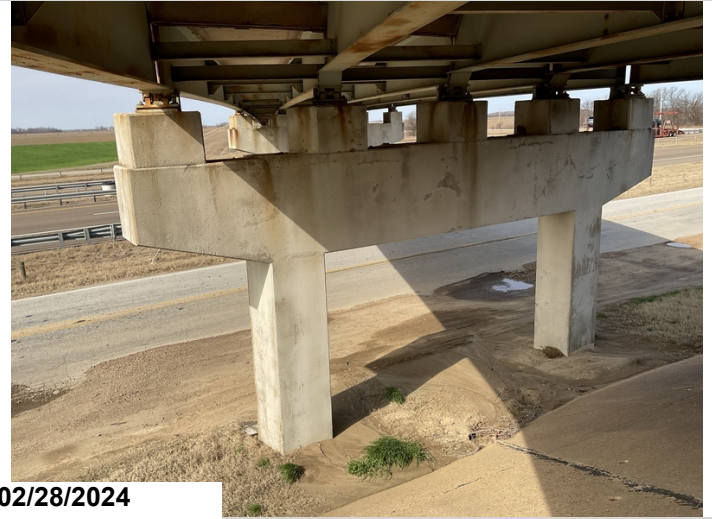
Bent 6, Pier Cap, Ahead: Vertical cracks under girders 1, 2, 5, risers, riser under girder 3 is spalled at top, and riser under girder 4 has cracking with rust staining. 3LF CS2, 1LF CS3, 1LF CS3

Bent #6 cap ahead face has vertical cracks under girders #1, 2, 5, riser under girder #3 is spalled at top riser under girder

#4 has cracking with rust staining. Cs3

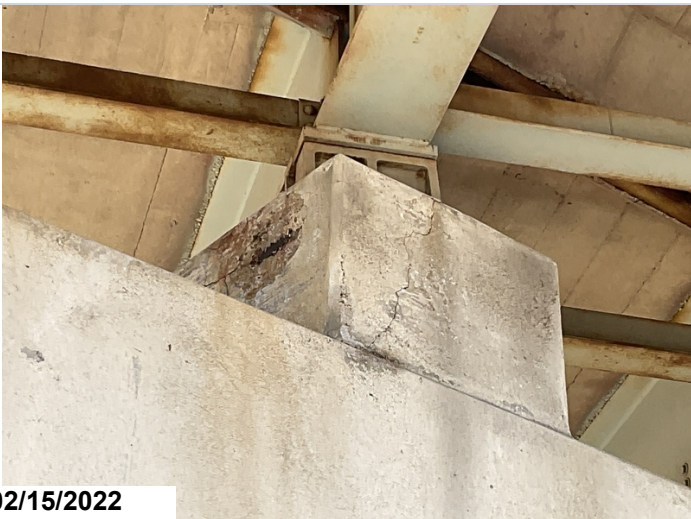
Bent 3, Pier Cap, Back, Under girder 3: Riser spalled with exposed reinforcing steel. Reinforcing steel has moderate section loss.

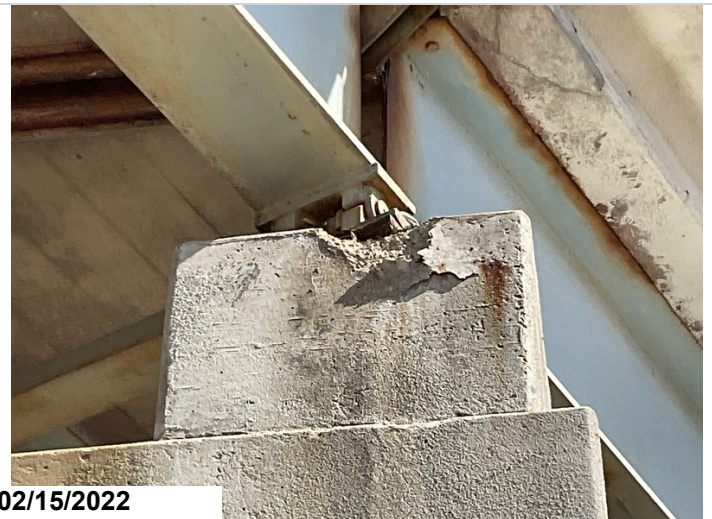
Bent 3, Pier Cap, Back, Under girder 5: Riser spalled at top no exposed reinforcing steel. 1LF CS3

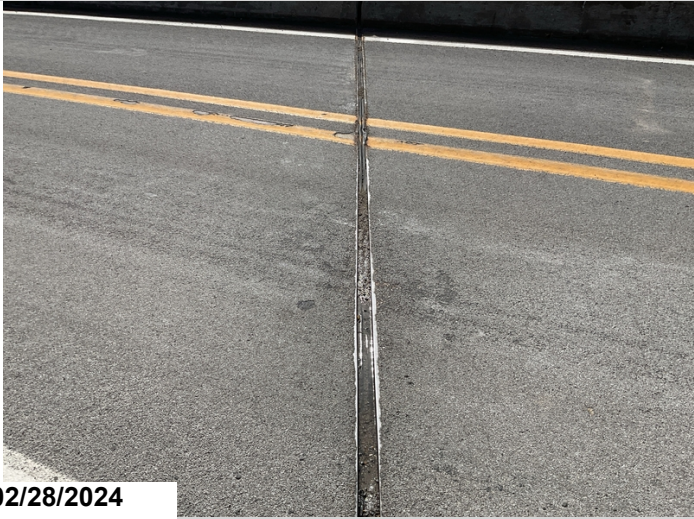
Bent 6, Compression Joint Seal: 10' of lost adhesion seal is sagging. 10LF CS3

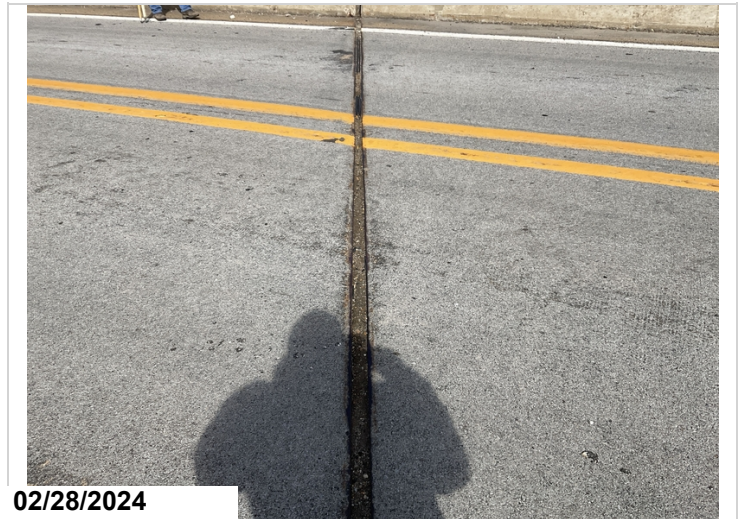
Bent 3, Compression Joint Seal: 14' of lost adhesion seal is sagging. 14LF CS3

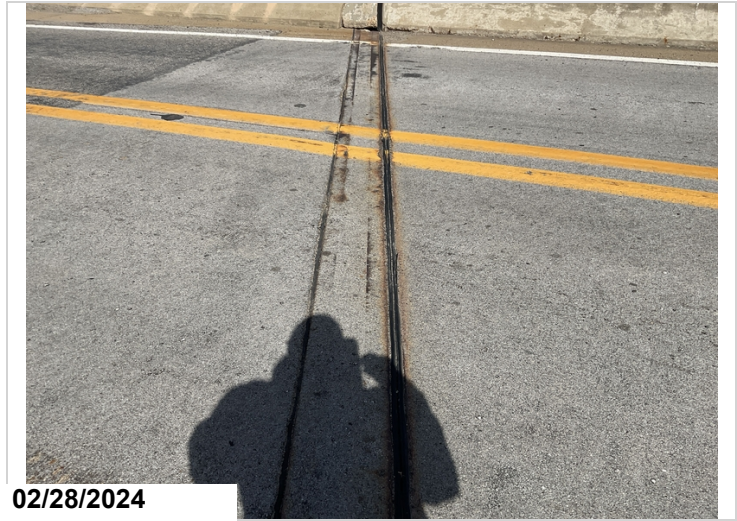
All Joints, Compression Joint Seals: Weathered and cracked. 144LF CS2

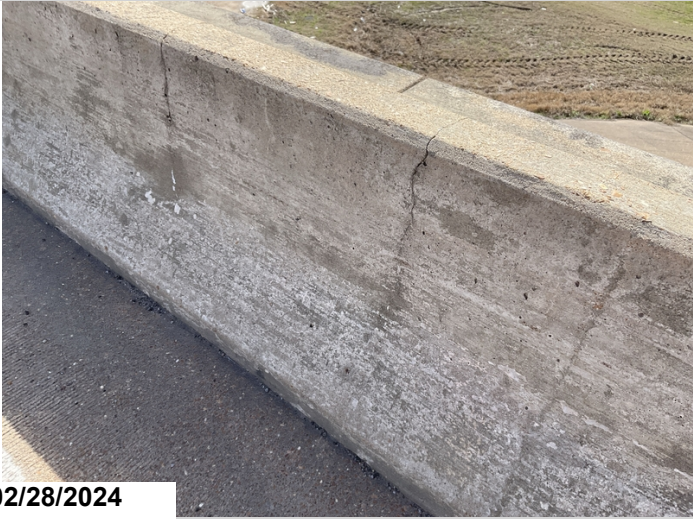
Typical bridge rail crack

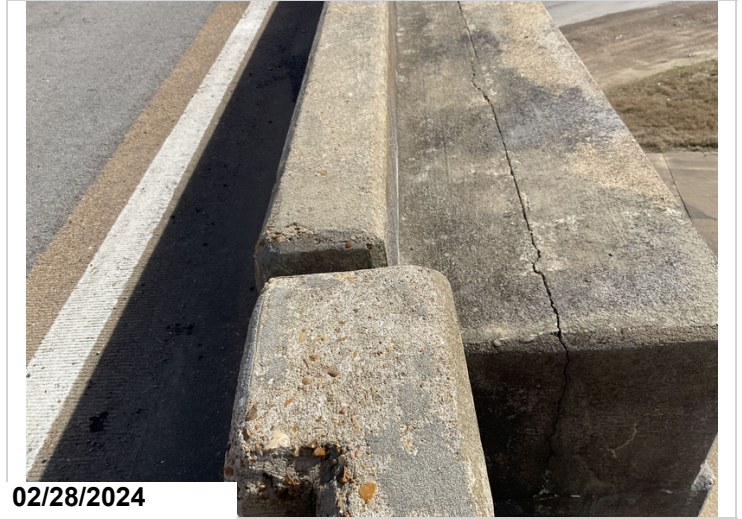
Bring rail extension crack full length of structure

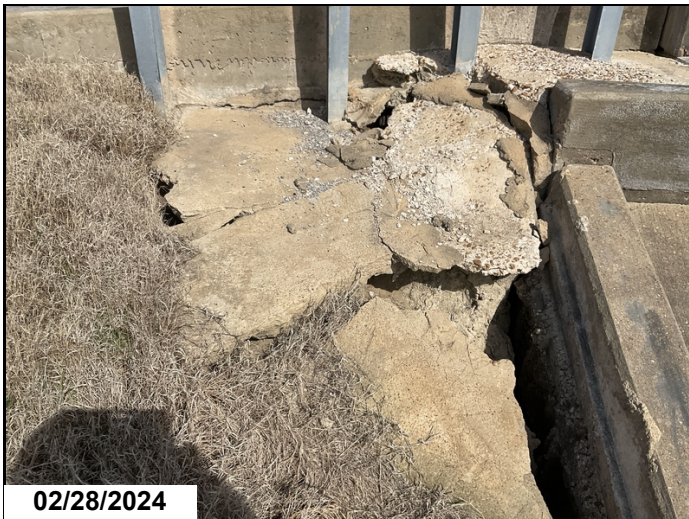
Abutment 1, Approach Roadway & Shoulder, Right: Large void under roadway with a failed old repair.

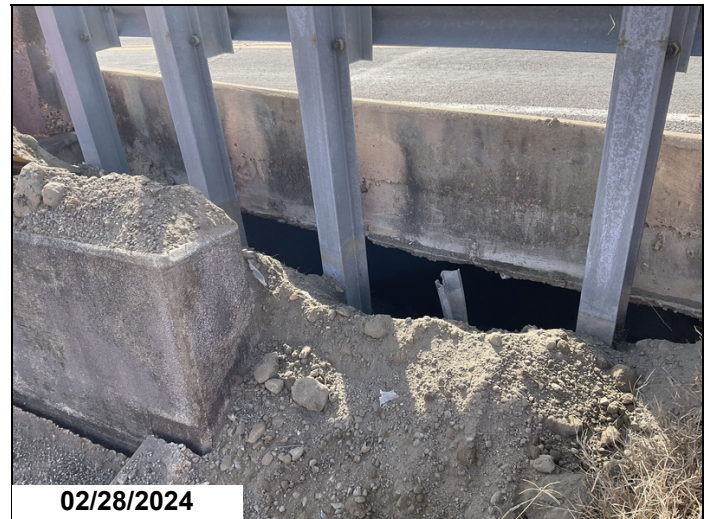
Abutment 1, Approach Roadway & Shoulder, Left: Large void 5' (depth) under roadway.

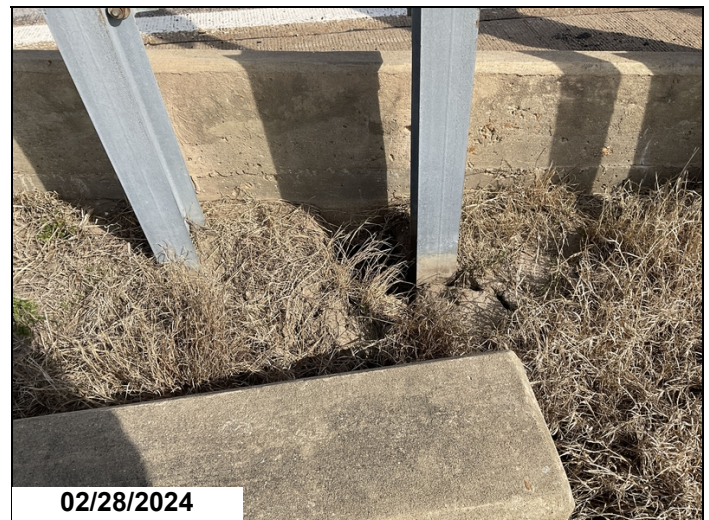
Abutment 2, Approach Roadway & Shoulder, Right: Small void under roadway.

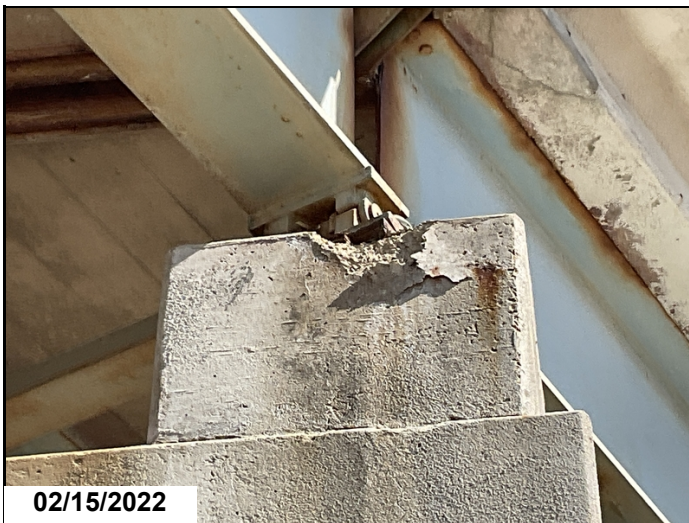
Bent #3 cap back face riser under girder #5 spalled at top.

Bent #3 cap back face riser under girder #5 spalled at t

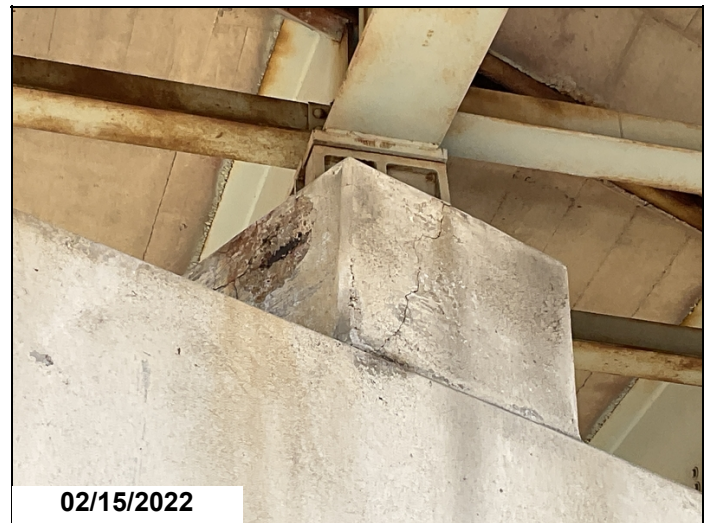
Bent #3 riser under girder #3 cracked and spalled with exposed rebar

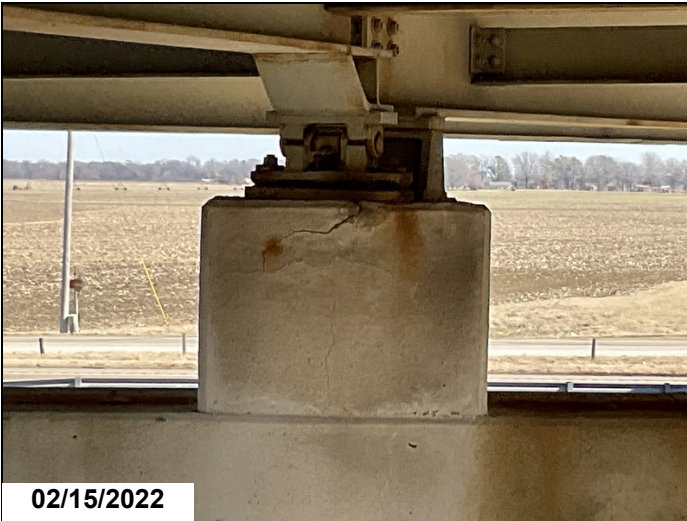
Bent #2 riser under girder #2 cracked and delaminated

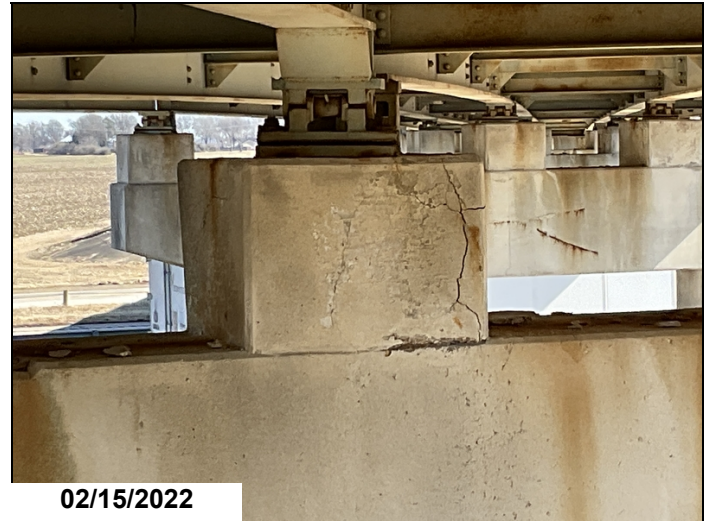
Bent #2 riser under girder #3 cracked and delaminated

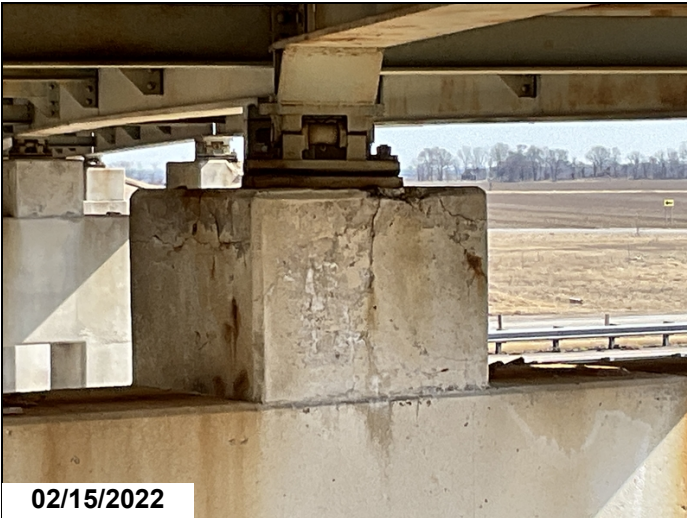
Bent #2 riser under girder #4 cracked and delaminated

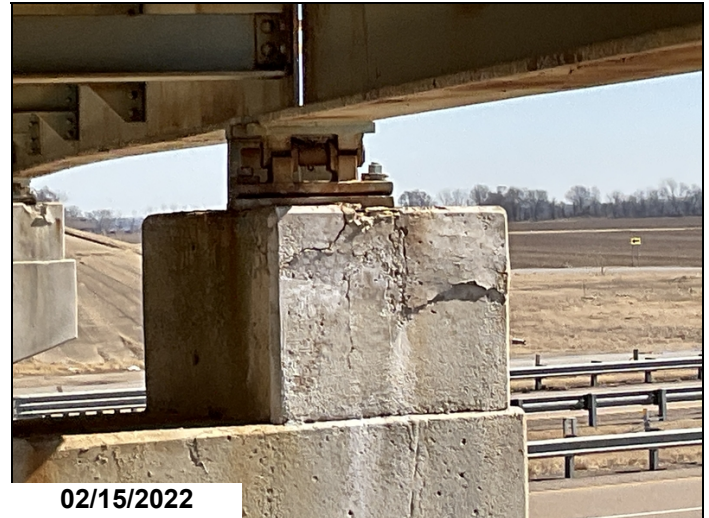
Bent #2 riser under girder #5 cracked and delaminated

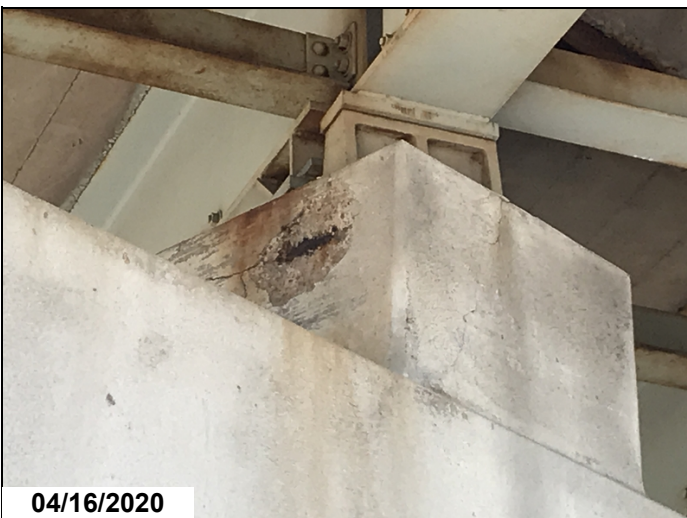
Bent #2 cap under girder #3 right side has one foot spall exposed rebar.

Bent #2 under girder #3 right side has one foot spall exposed rebar.

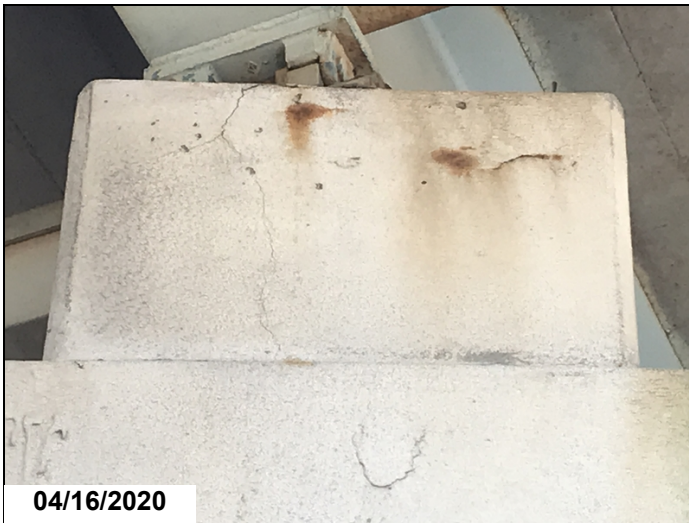
Typical cracked riser under bearing

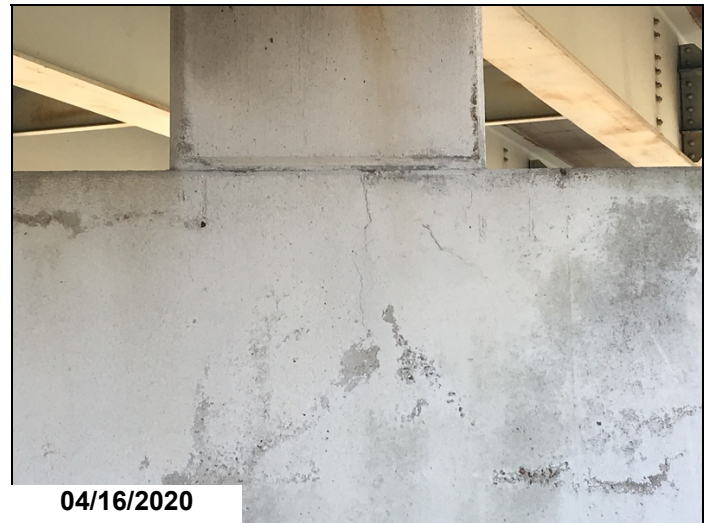
All caps have vertical cracks on right and left ends and under risers

Typical vertical crack in cap under bearing riser.

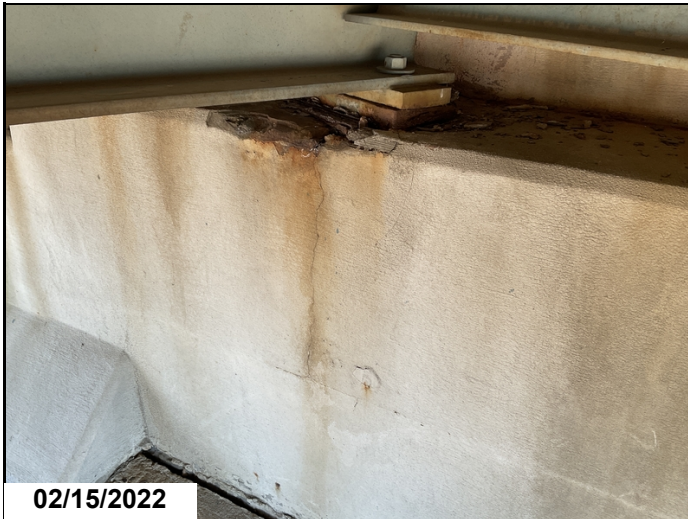
Abutment caps have vertical cracks under bearings.
Top of abutment caps are spalled under bearings.
Abutment #1 left wing spalled at top with exposed rebar

Typical vertical crack and spall under abutment bearing.

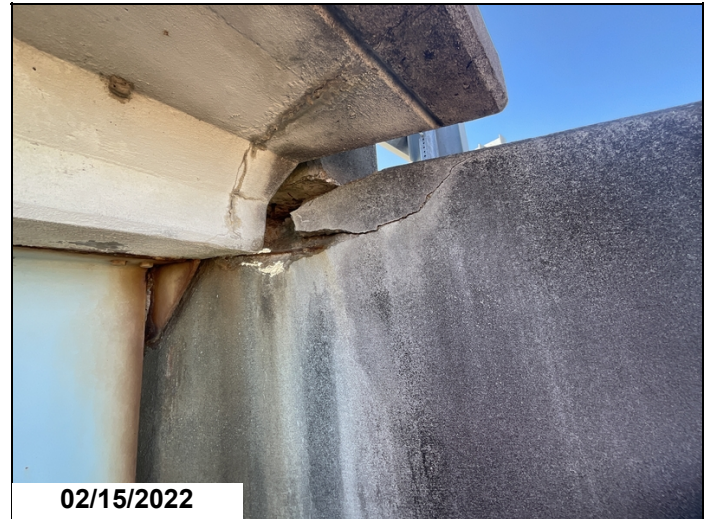
Abutment #1 left wing spalled at top with exposed rebar

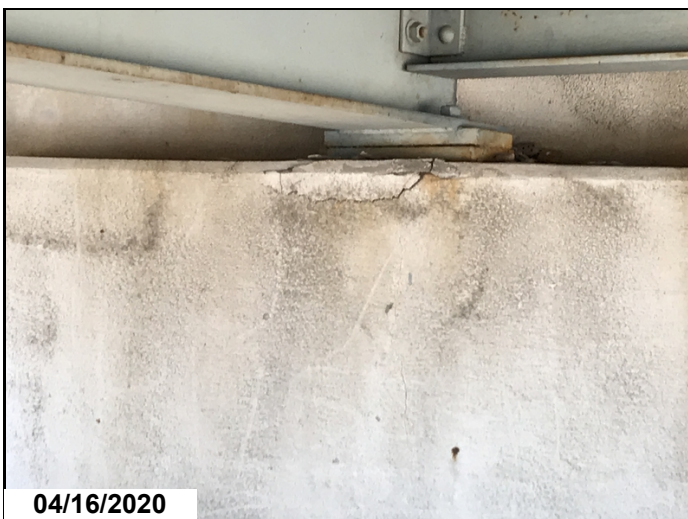
Typical delaminated area, crack, spalled area under bearings abutment #1.

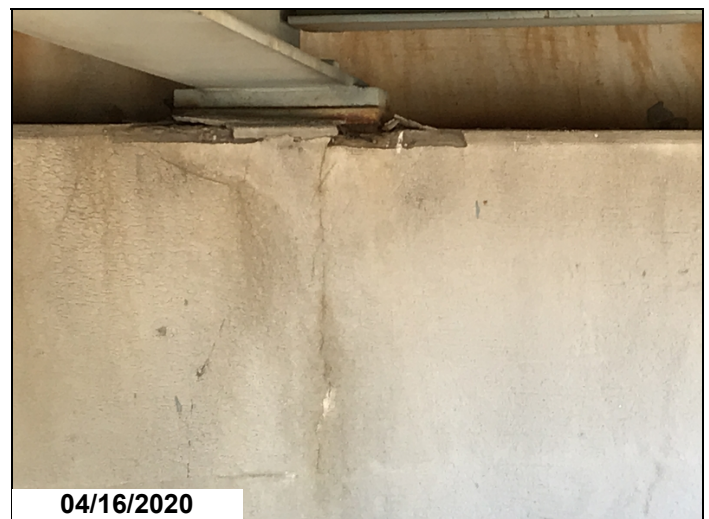
Abutment #2 typical spall and vertical crack under bearing

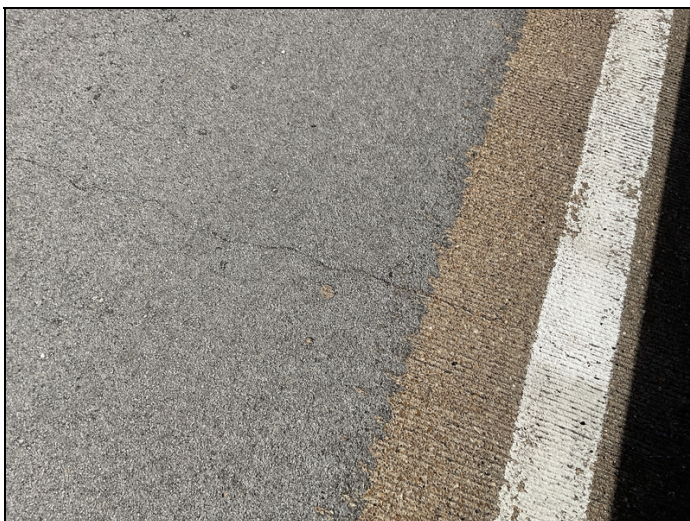
Deck surface, All Spans: CS2 transverse cracks are reflecting through overlay and are in gutters various spacing. 3338SF CS2

Typical deck crack

A-54 - Sealable Deck Cracks (Yes)

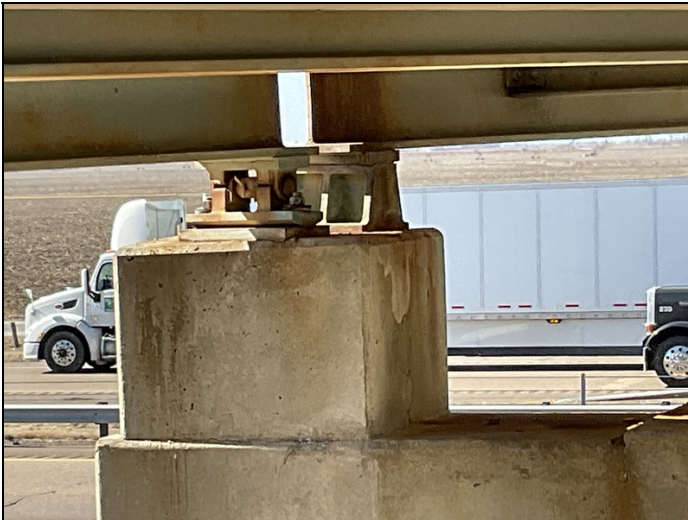
All Movable Bearings, Paint has limited to no effectiveness. 30SF CS3, 30SF CS4
50% of paint missing on fixed bearings.

Abutment bearings are corroded with laminations section loss up to 5%.

Typical bearings

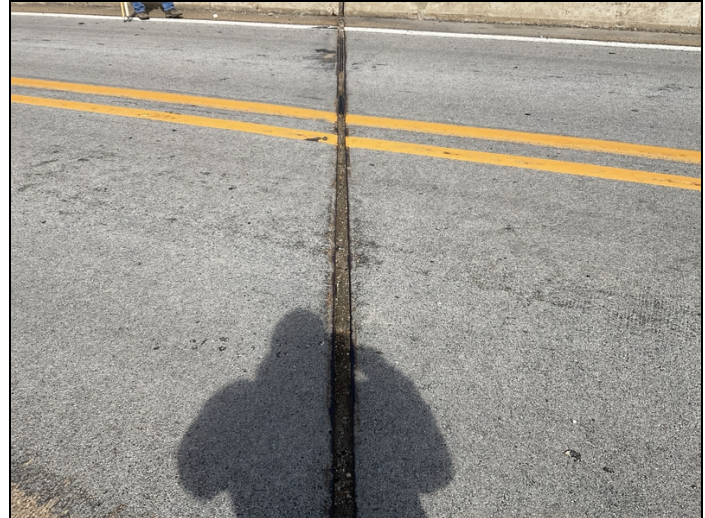
Bent 3, Compression Joint Seal: 14' of lost adhesion seal is sagging. 14LF CS3

A-59 - Joint Repair Needed (Yes)

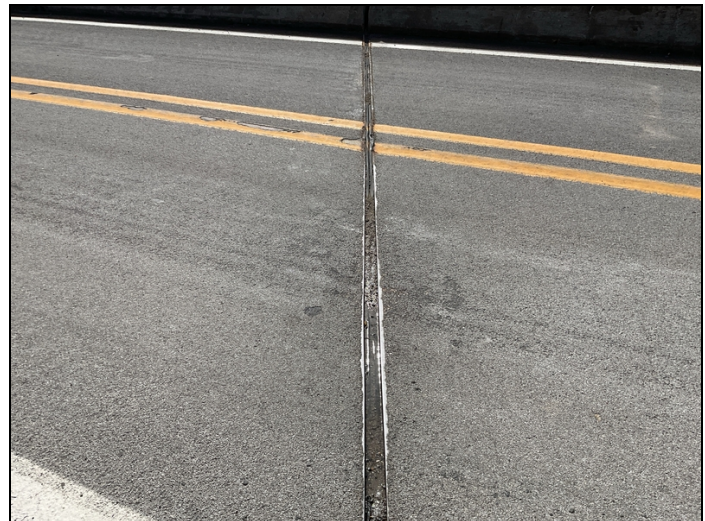
Bent 6, Compression Joint Seal: 10' of lost adhesion seal is sagging. 10LF CS3

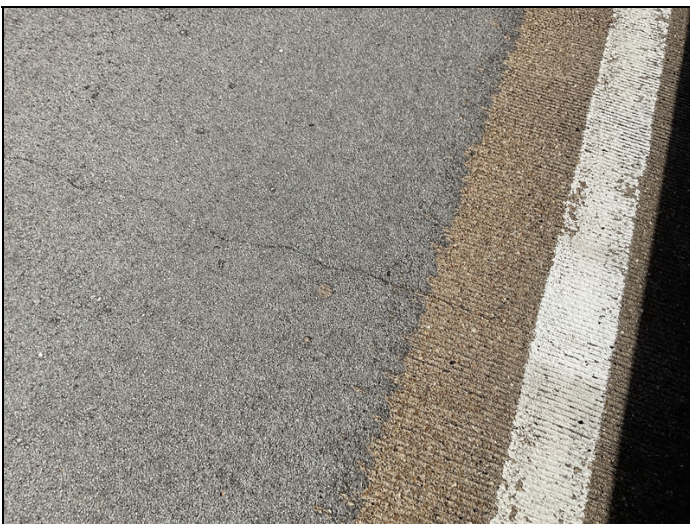
Deck surface, All Spans: CS2 transverse cracks are reflecting through overlay and are in gutters various spacing. 3338SF CS2

Typical deck crack

A-61 - Polymer Overlay Advised (Yes)
