Bridge M4083 Inspection Report

Route:50 Section:04 Log:4.102

Team Lead: Drew Melton, Inspection Date: 09/10/2024

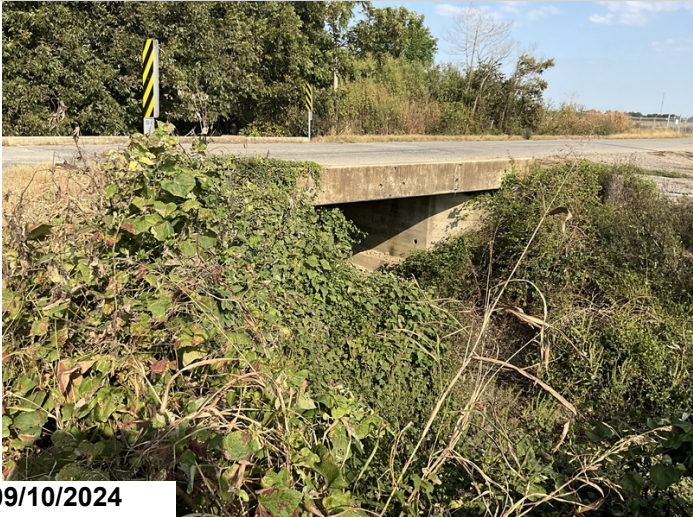
Side view-elevation

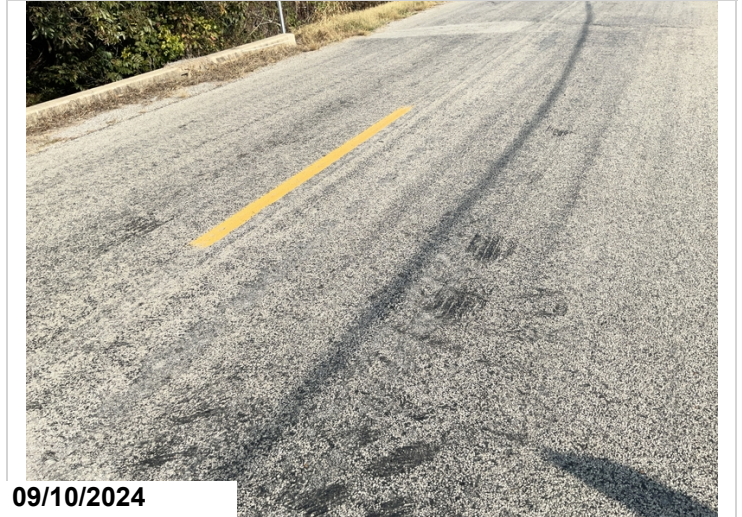
Deck is in very good condition with an asphalt overlay and no note worthy defects.

Typical deck surface

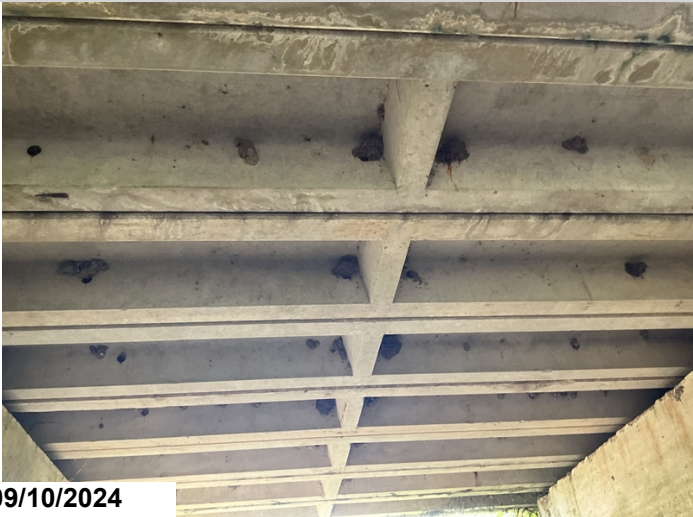
Typical deck undersurface

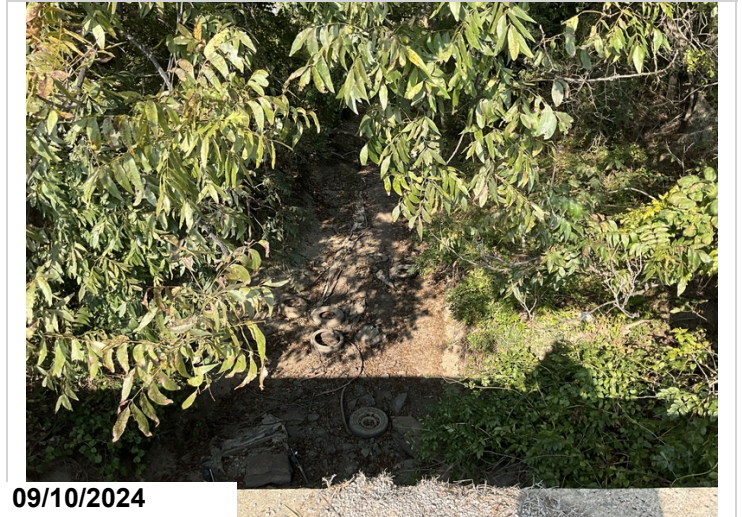
Channel left side

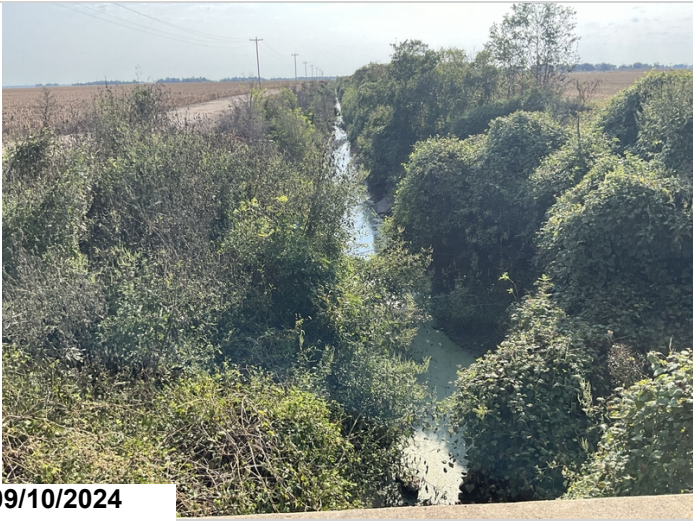
Channel right side

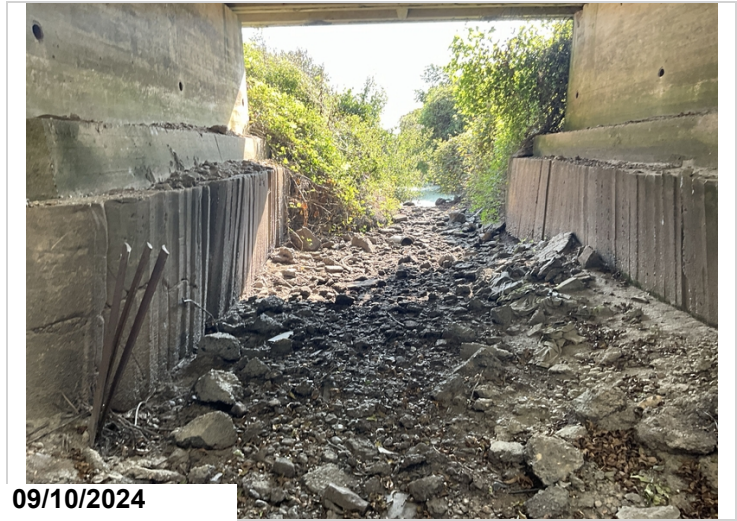
Channel has good alignment with structure. Channel banks are vegetated with minor amounts of erosion. Minor amounts of debris restrict water flow.

Channel under structure

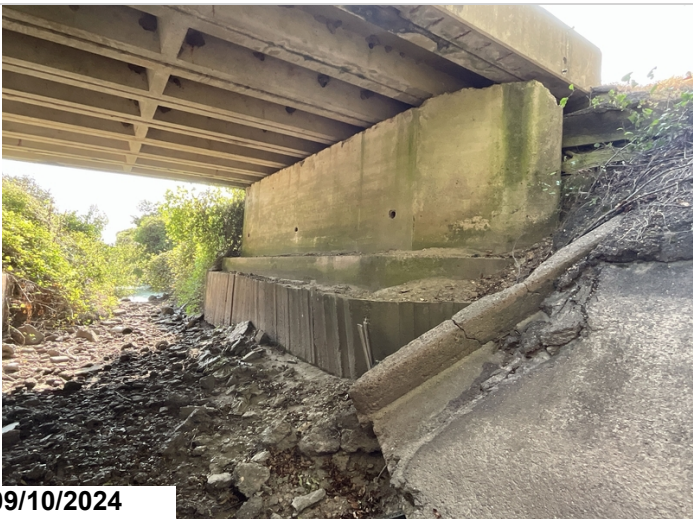
Abutment 1 retaining wall

Minor amounts of scour and erosion are present around retaining walls.

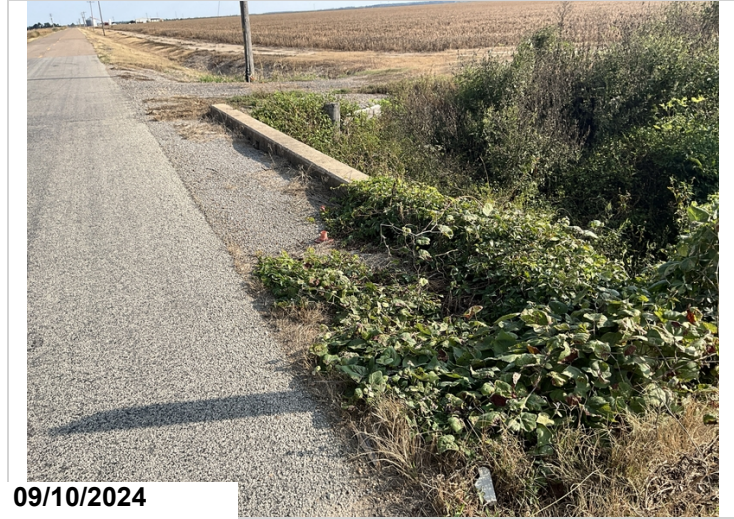
Deck Gutters, Full Length: Dirt and debris.

A-55 - Deck Washing Needed (Y)

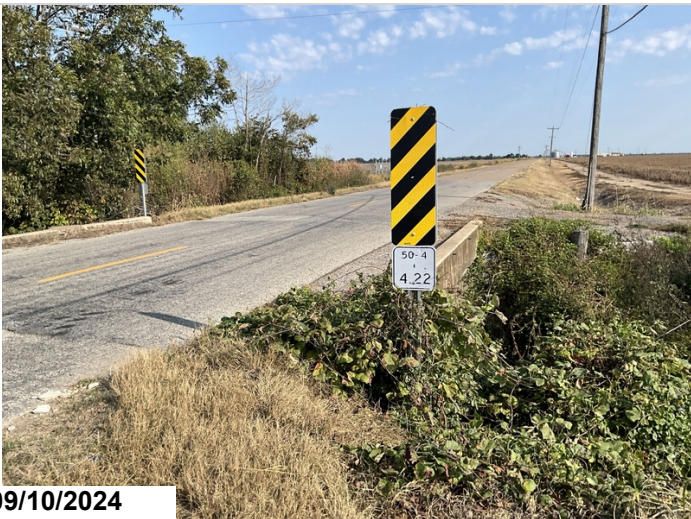
Abutment 1 log mile sign

Log mile sign should be 4.10.

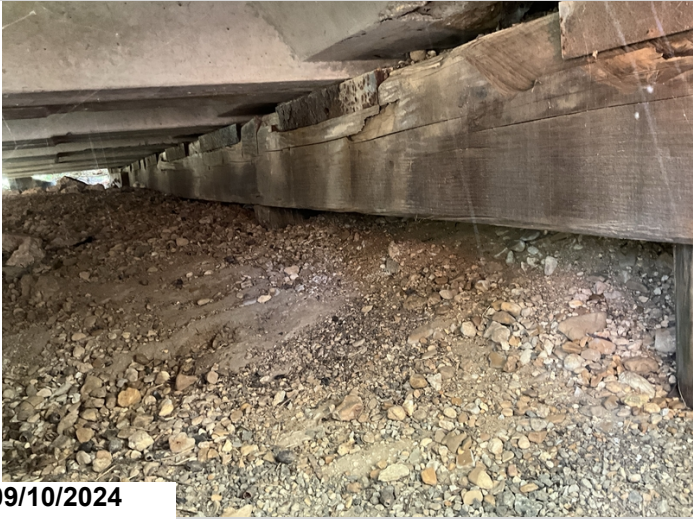
Abutment 1

Substructure is in poor condition. Abutment two cap has severe decay and is crushing onto piles. Abutment one cap has minor decay.

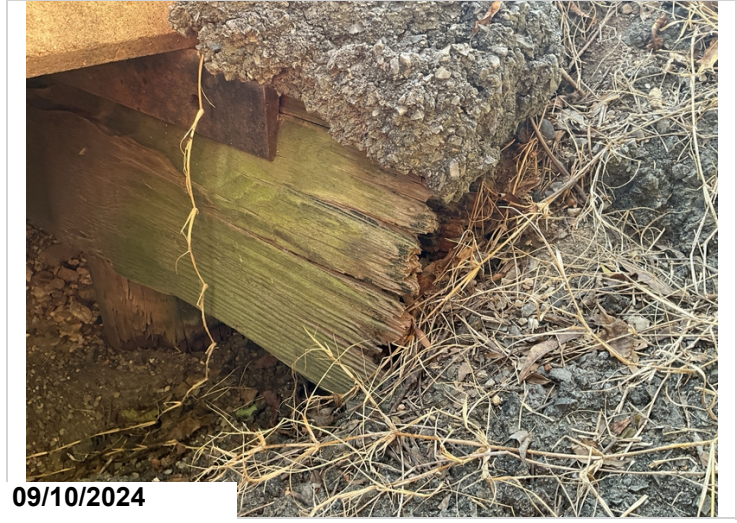
Abutment 1 cap left end.

Both Abutments, Caps, Left End: 1' is decayed with moderate section loss.

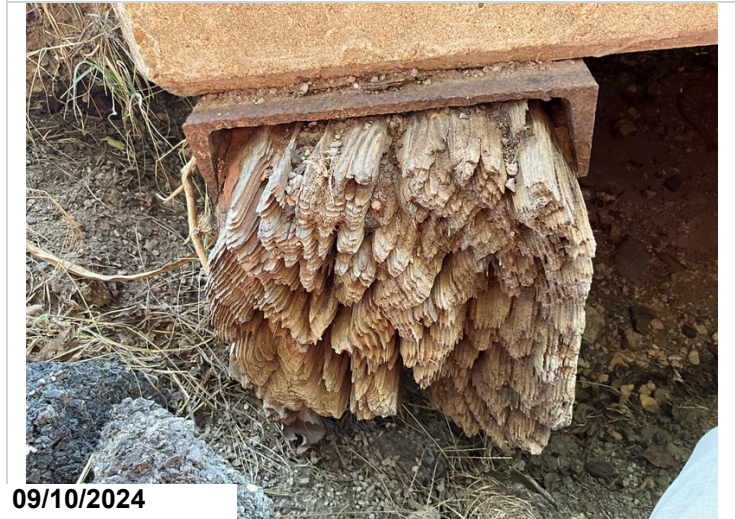
Abutment 2 cap left end.

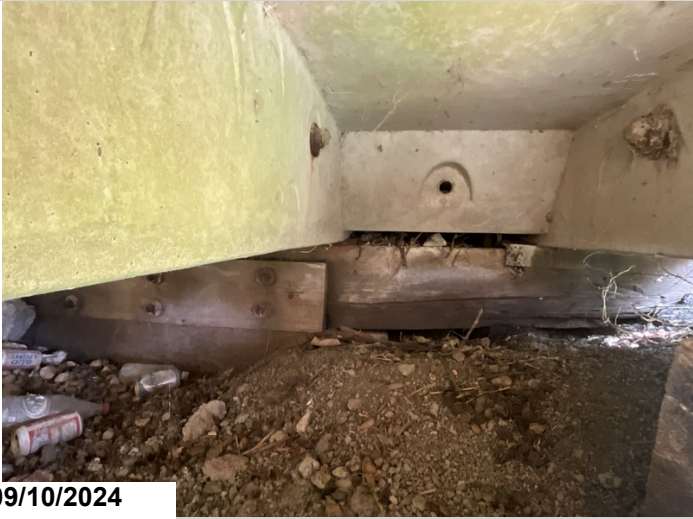
Abutment 2 Cap, Right End, Last 6': Decayed with heavy section loss and crushing up to 2" onto pile 6. Approximately 20% remaining.

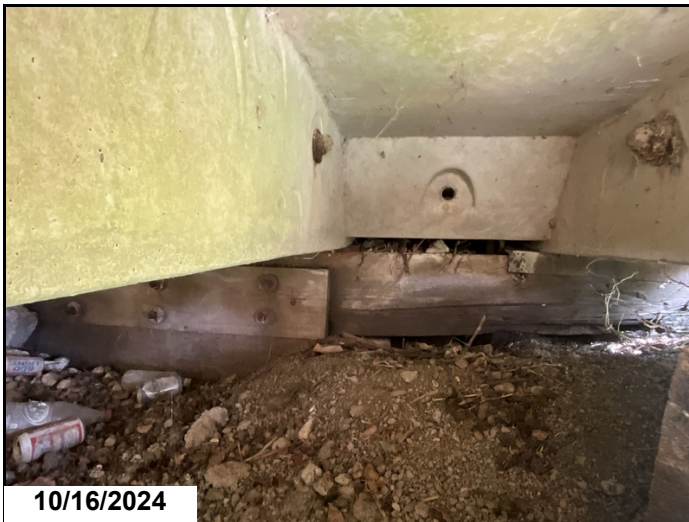
Priority: A - Safety deficiency; requires prompt action

Abutment 2 Cap, Right End, Last 6': Decayed with heavy section loss and crushing up to 2" onto pile 6. Approximately 20% remaining.

Type of Work: Replace (General)

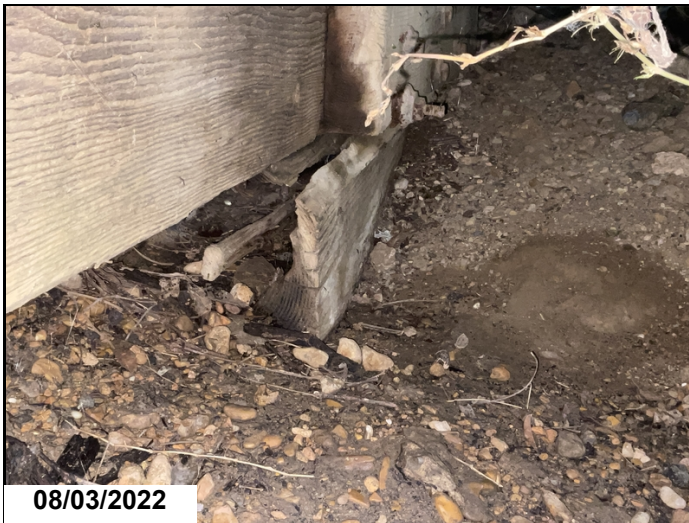
Priority: B - Pressing

Abutment 1: Spacer Between Pile 5 and cap decayed with 50% section remaining.

Type of Work: Substructure Repair

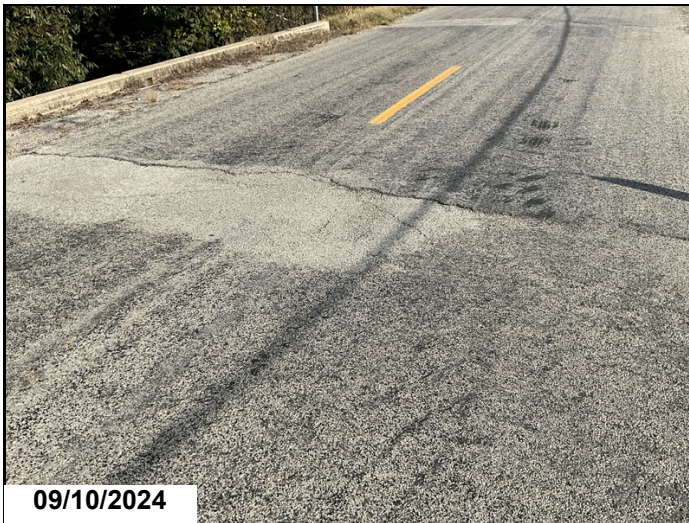
Abutment 1, Approach Roadway: Settled 1" increasing impact loading on bridge.

Abutment 1, Approach Roadway: Settled 1" increasing
impact loading on bridge.

Type of Work: Approach Leveling/Maintenance

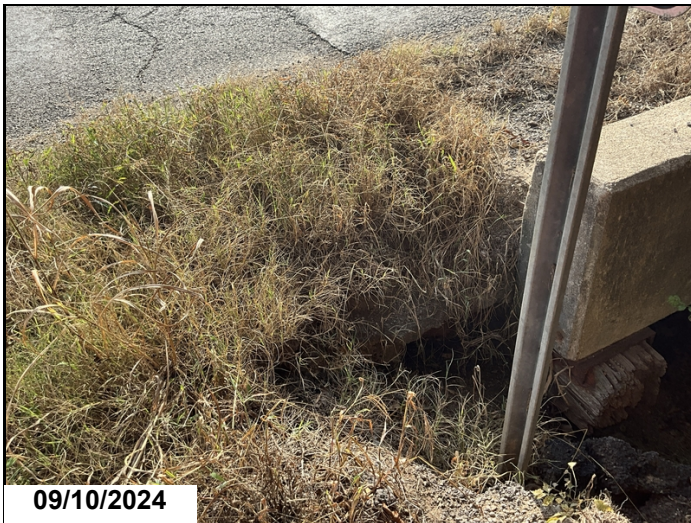
Abutment 2, Approach Shoulder, Left Side: 3' x 3' x 3' void at and under cap extending 2' under approach shoulder.

Type of Work: Approach Leveling/Maintenance

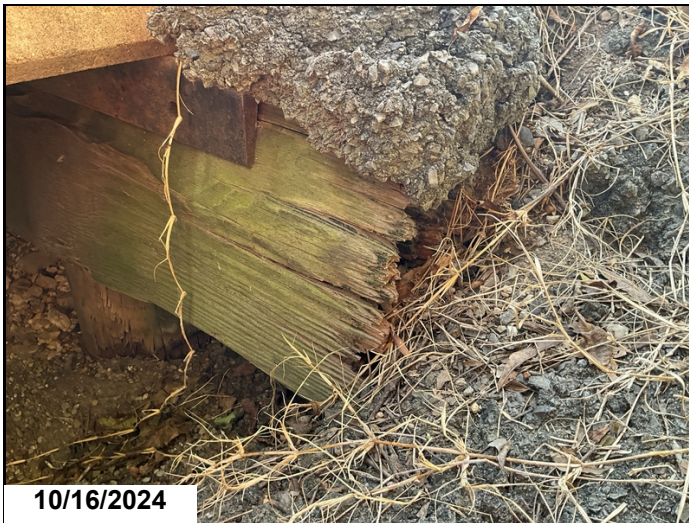
Abutment 1 cap left end.

Type of Work: Substructure Repair

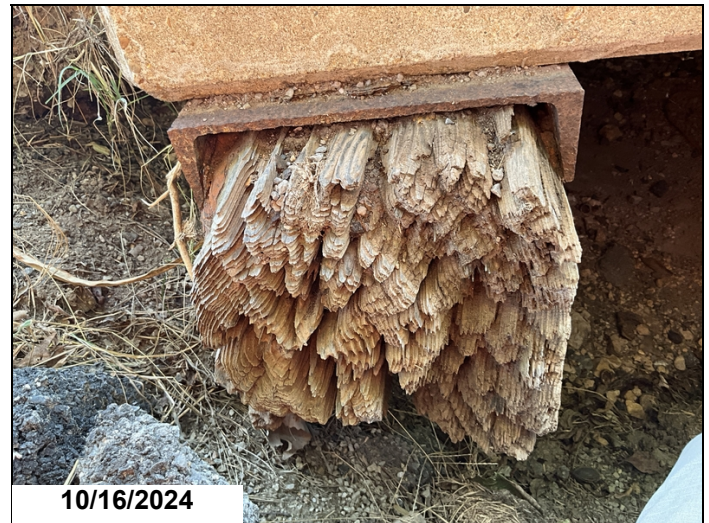
Abutment 2 cap left end.

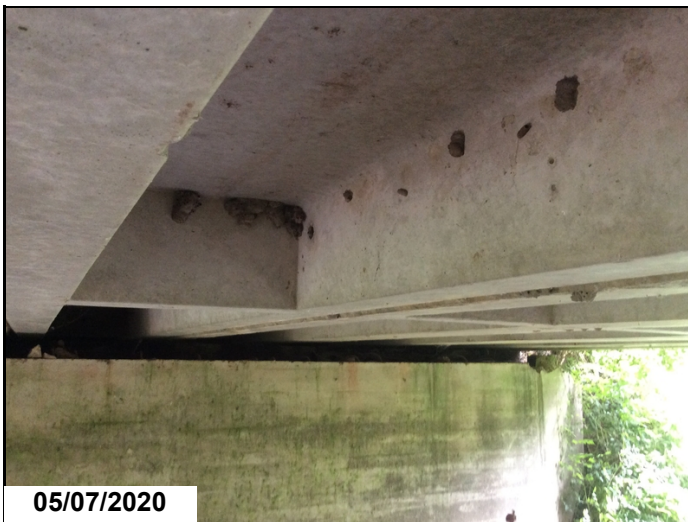
Both Connection Bolts, Center Span, Between Units 4 & 5: Missing.
Both Connection Bolts, Center Span, Between Units 5 & 6: Missing.
Connection Bolt, 3/4 Span, Between Units 6 & 7: Missing.
Connection Bolt, Center Span, Between Units 6 & 7: Backed out.
Unit 6 & 7: Gapped 1" between units and bolt at center span is loose.
Both Connection Bolts, Center Span, Between Units 7 & 8: Missing.

Typical missing bolt at center span.

Type of Work: Repair (General)

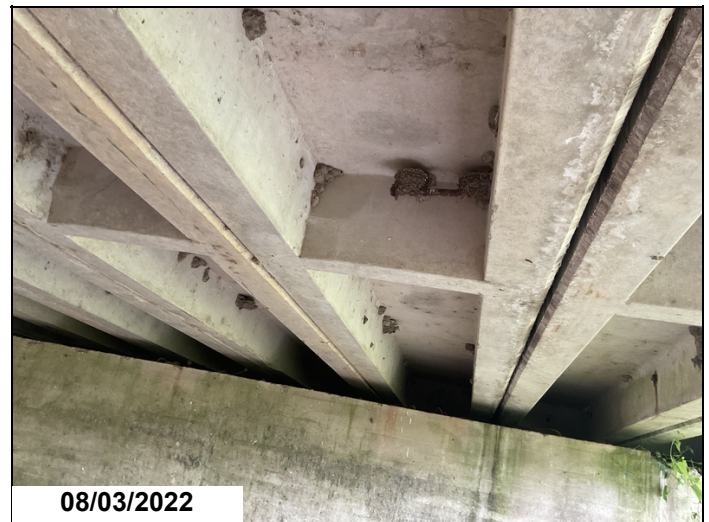
Both Connection Bolts, Center Span, Between Units 5 & 6: Missing.
Connection Bolt, 3/4 Span, Between Units 6 & 7: Missing.
Connection Bolt, Center Span, Between Units 6 & 7: Backed out.

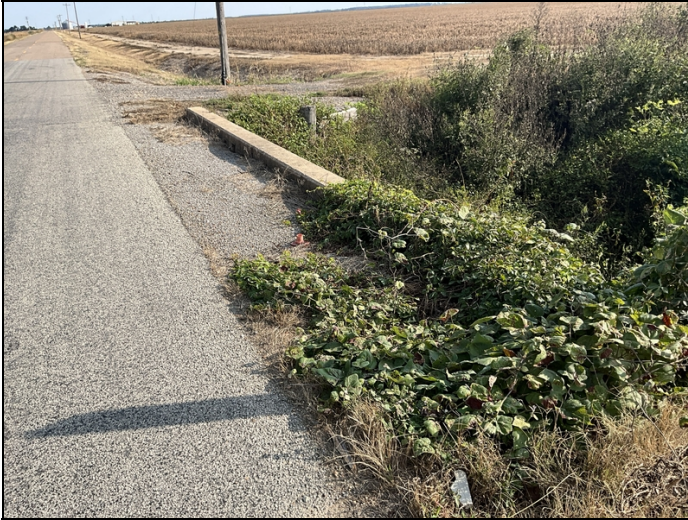
Deck Gutters, Full Length: Dirt and debris.

A-55 - Deck Washing Needed (Yes)

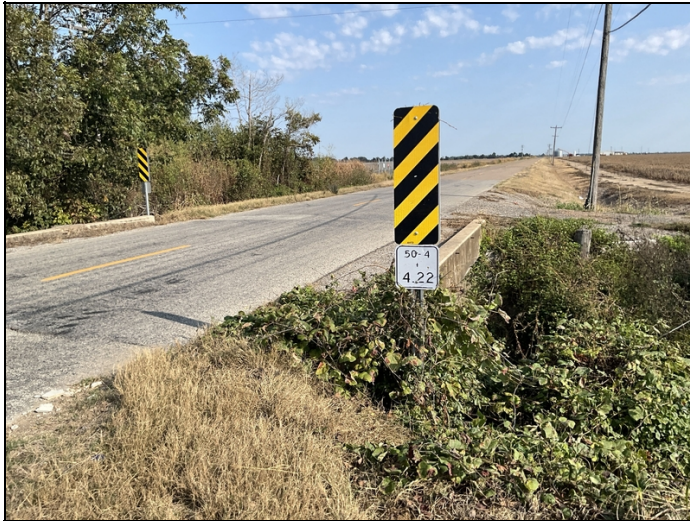
Abutment 1 log mile sign

A-63 - Missing/Incorrect Log Mile Signage (Yes)
Log mile sign should be 4.10.
