Bridge X1738 Inspection Report

Team Lead: Myron Futrell, Inspection Date: 05/14/2025

Asset #X1738(Routine)

Sh-50/Sec-4/L8.421 over Ditch Number 9

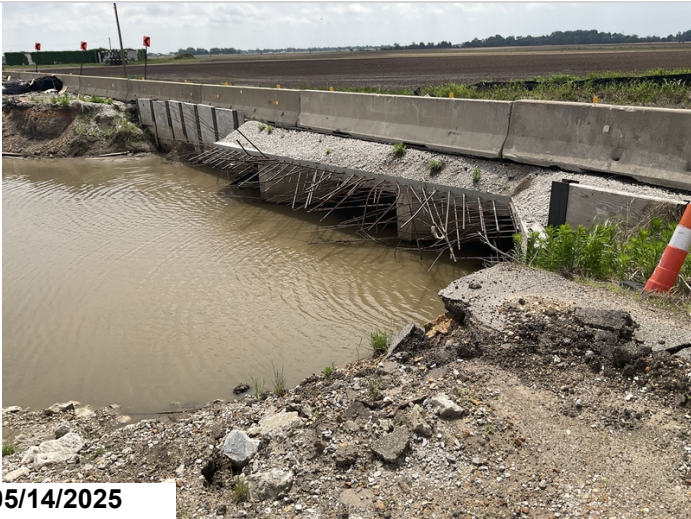
North end of culvert, stage 1 construction.
