## **Bridge 05416 Inspection Report**

Asset #05416(Routine)

Sh-85/Sec-1/L-1.45 over Lick Creek

Team Lead: Lee Swan Inspection Date: 01/08/2025

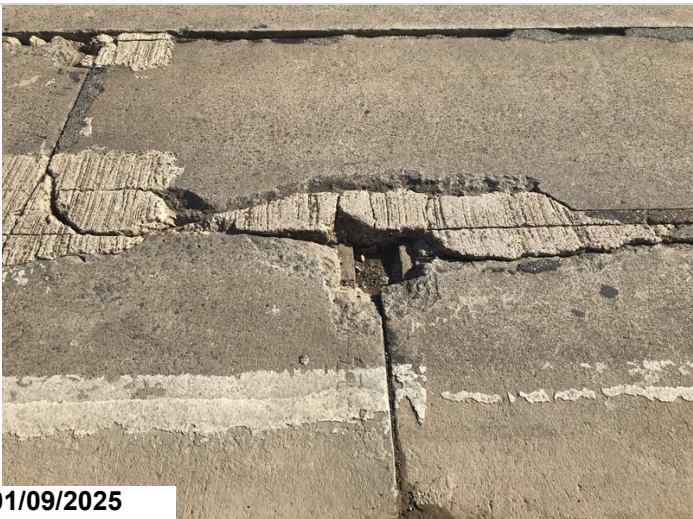
Bent 4 unit 7 spall 2 LF CS3

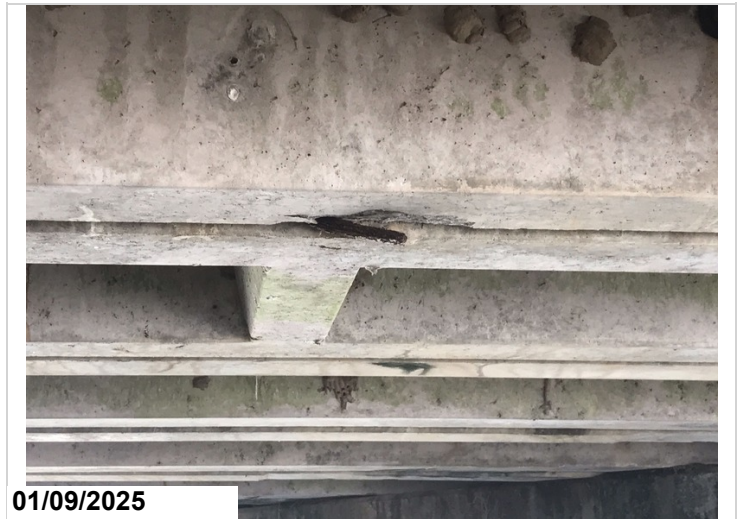
Span 6 unit 3 spalling with exposed rebar 1 LF CS 3

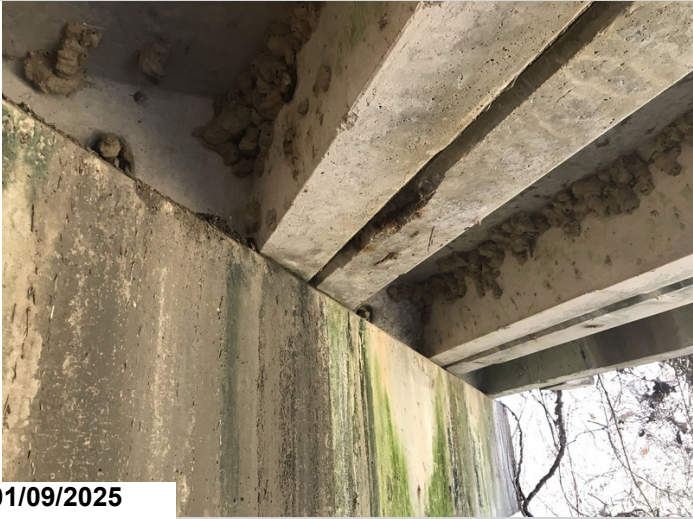
Span 6 unit 7 spall with exposed reinforcing steel 2LF CS3

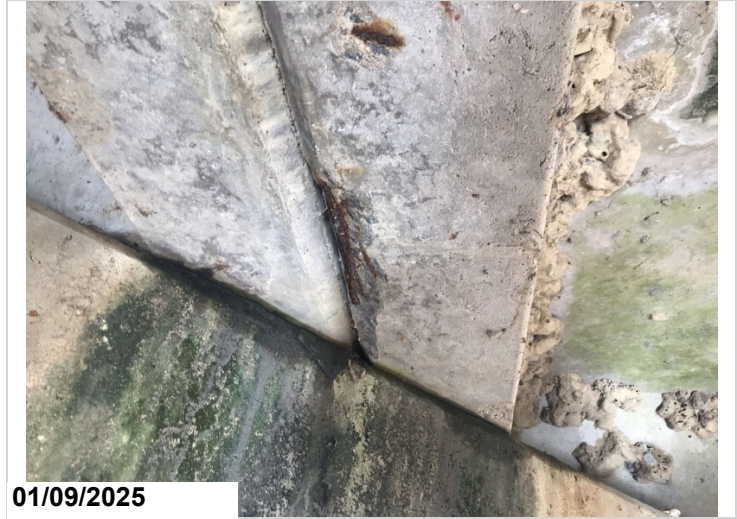
Span 2 bent 1 unit 1 spall with exposed reinforcing 2LF CS2

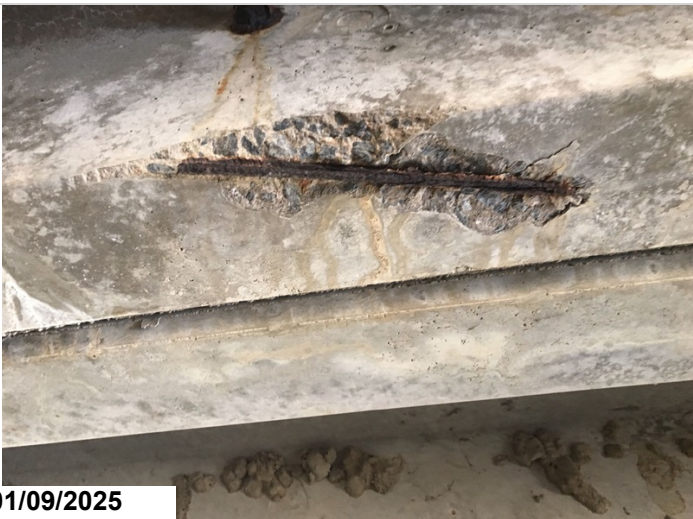
Span 1 unit 7 spalling with exposed rebar 2 LF CS2

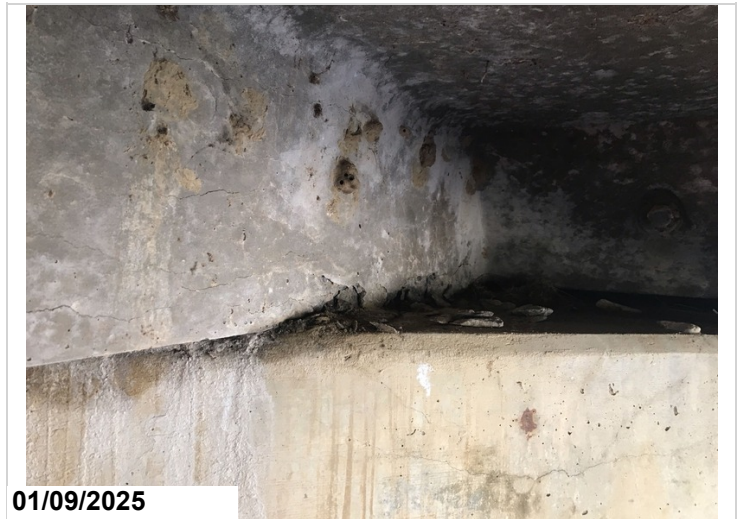
Span 1 bent 1 unit 8 spalling 2 LF CS3

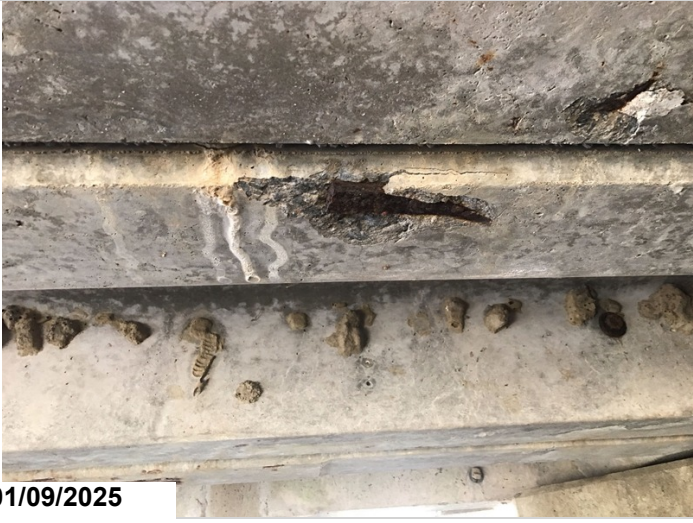
Bent 1 unit 7 spalling with exposed reinforcing steel

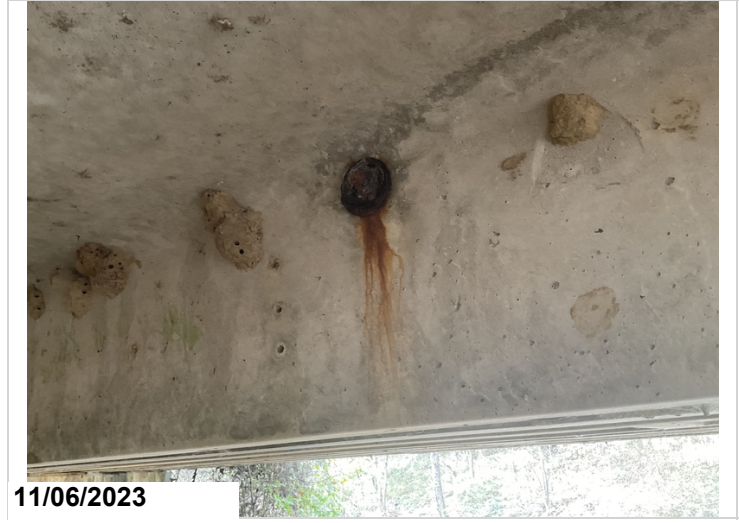
Typical corrosion on connection bolts

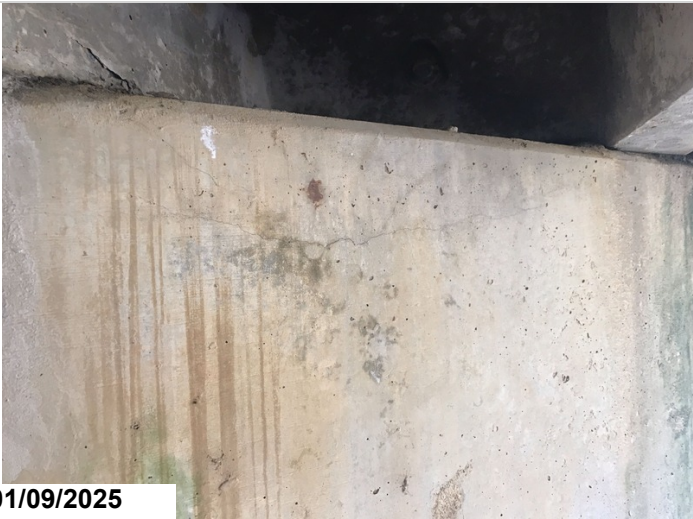
Bent 1 back under unit 8 cracking 2LF CS2

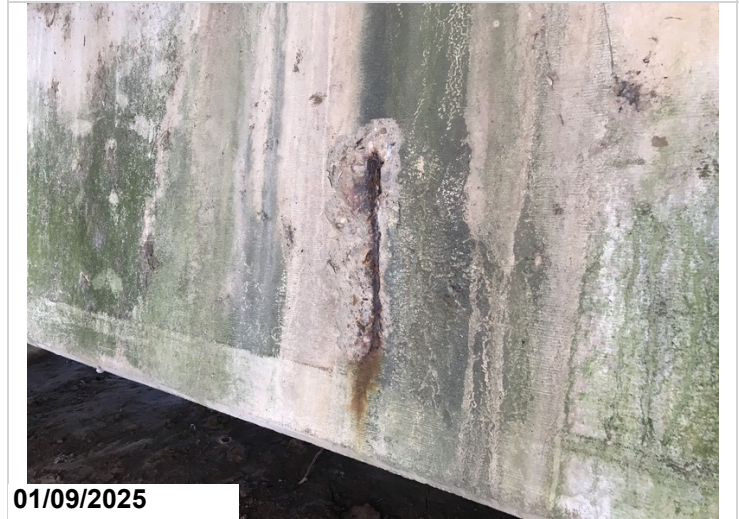
Bent 7 back under unit 4 spall with exposed rebar 1LF CS3

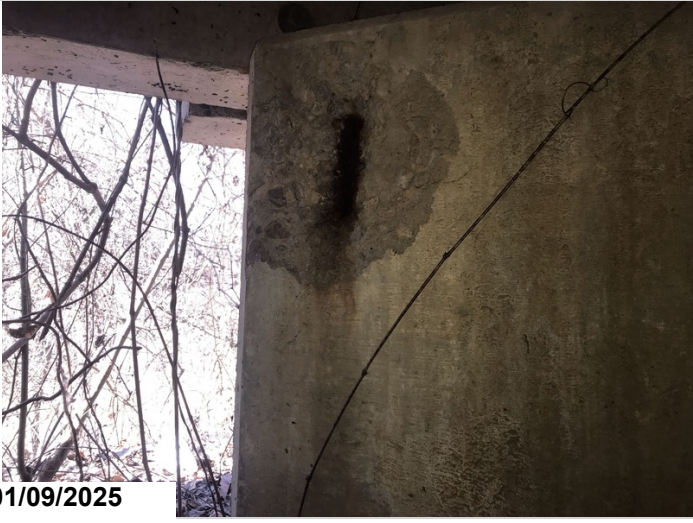
Bent 7 ahead right spall with exposed reinforcing steel 1LF  
CS3

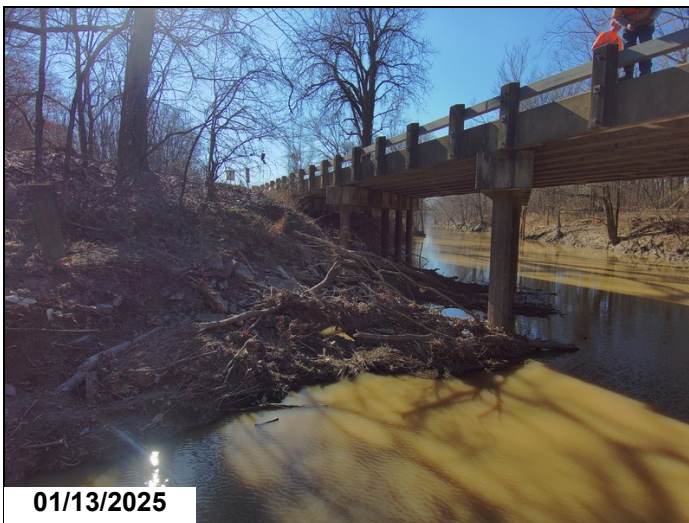
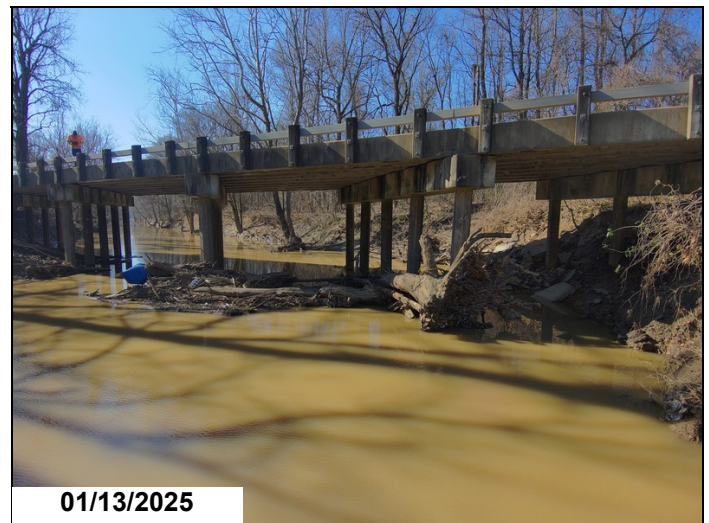
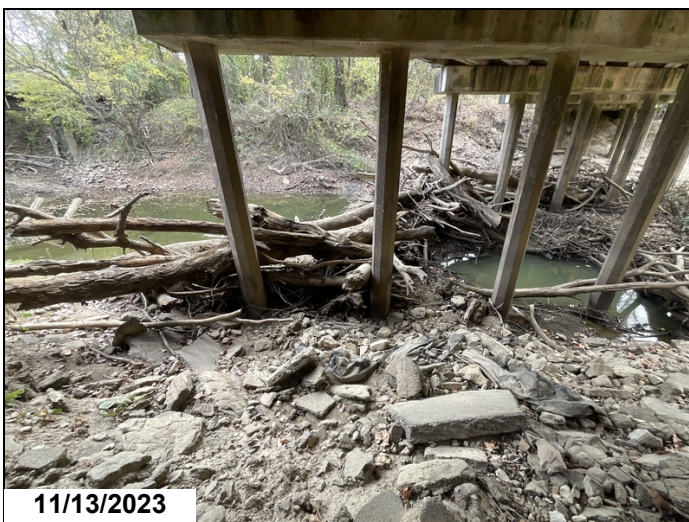
Channel has massive drift left side across channel.

Large drift across channel under bridge spans 2,3,4

Type of Work: Channel Work/Drift Removal

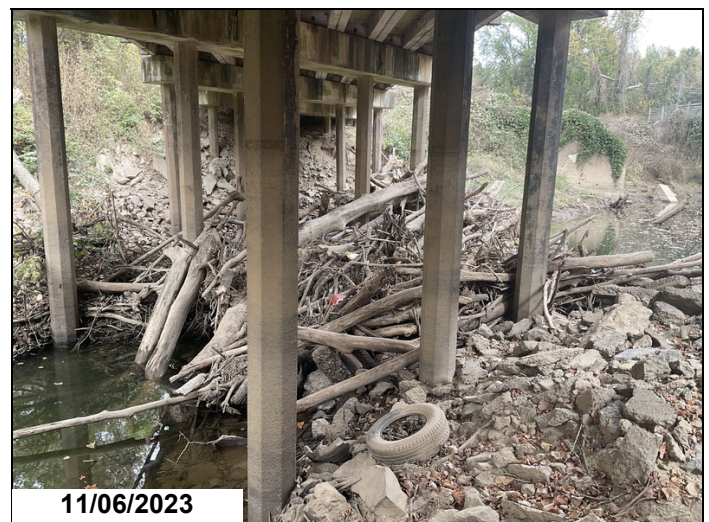
Large drift and debris under bridge spans #3 and 4 blocking channel

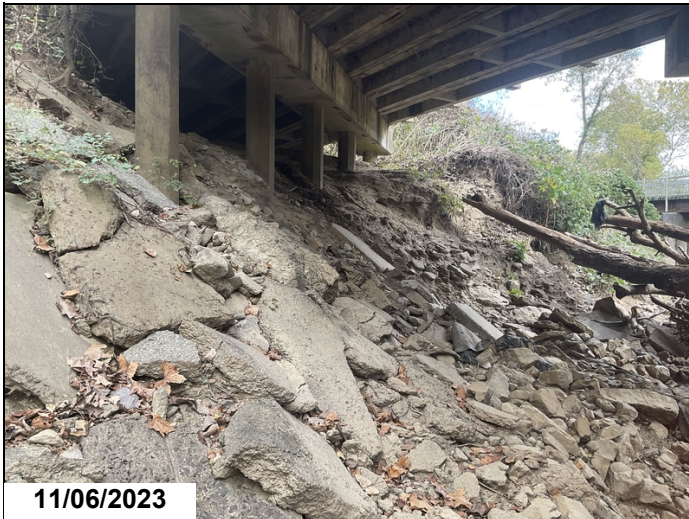
Abutment #1 slope is eroding towards bent #2 with vertical slope near and at bent #2.

Abutment #1 slope erosion

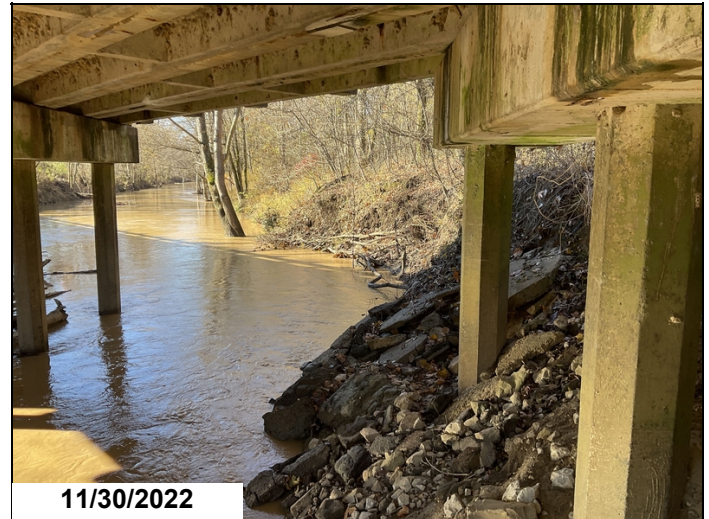
Channel downstream right side of bridge near bent #2 back is eroded several feet towards abutment within 20' of bent #2.

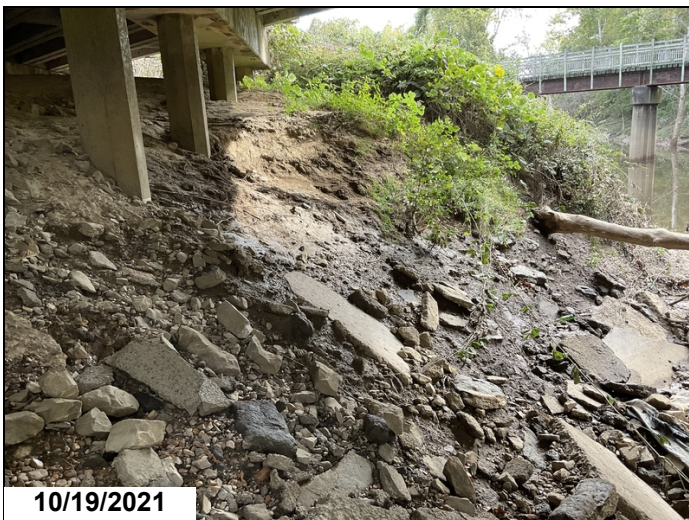
Abutment #1 slope is eroding towards bent #2 with vertical slope near and at bent #2.

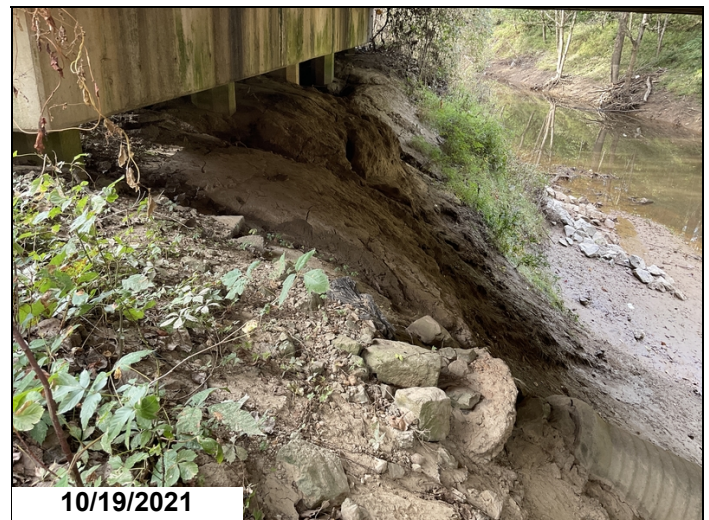
Abutment #2 slope is eroding towards bent #7 to vertical face at and near bent #7.

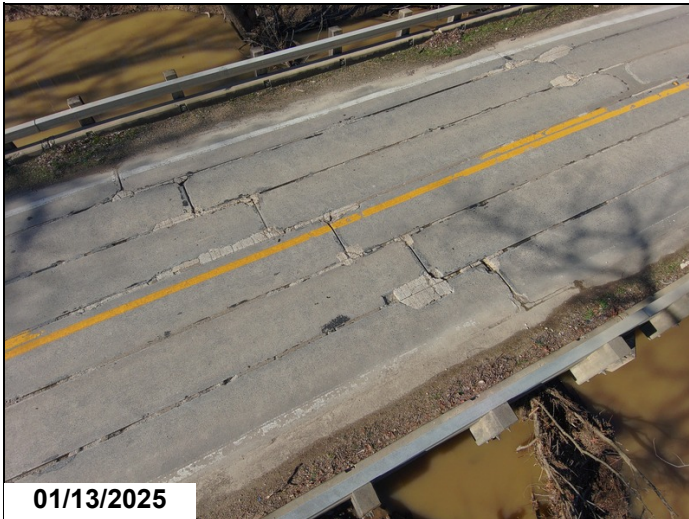
Each span has areas of joints at bents from span to span that are spalled deep into grout keys. Several of these areas have been patched with asphalt and epoxy sand mix with some patches failing. Grout joints between units are spalling down into the grout keys all spans.

Bent 4, grout failure at the joints.

Type of Work: Deck Repair

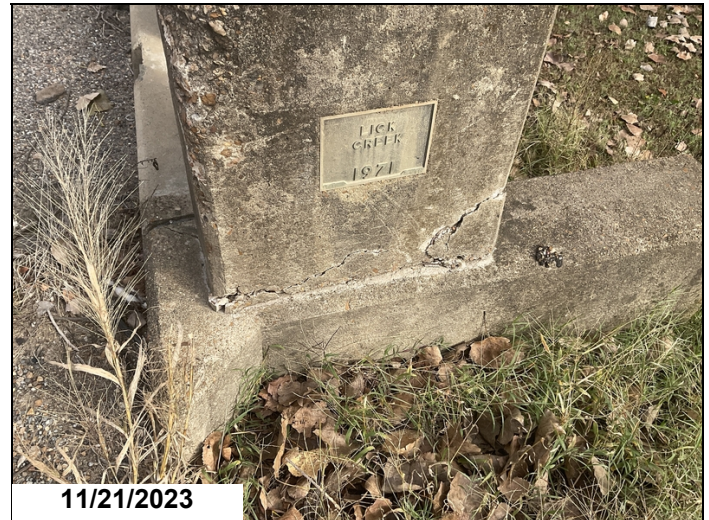
Abutment #2 monument post broken at base

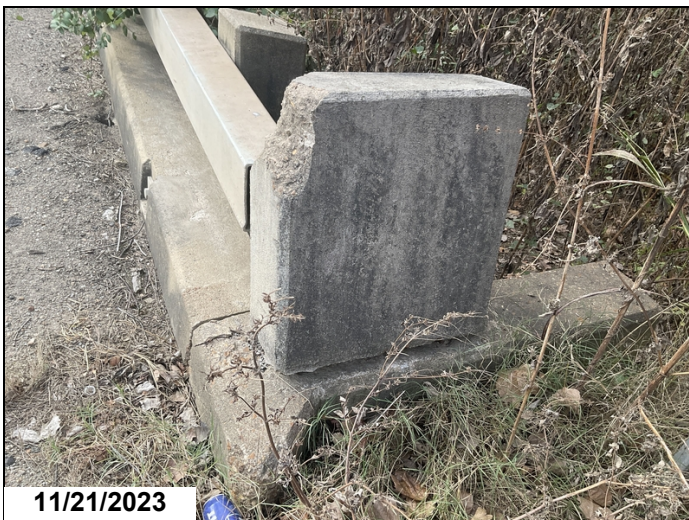
Abutment #1 right monument post spalled and broken at base

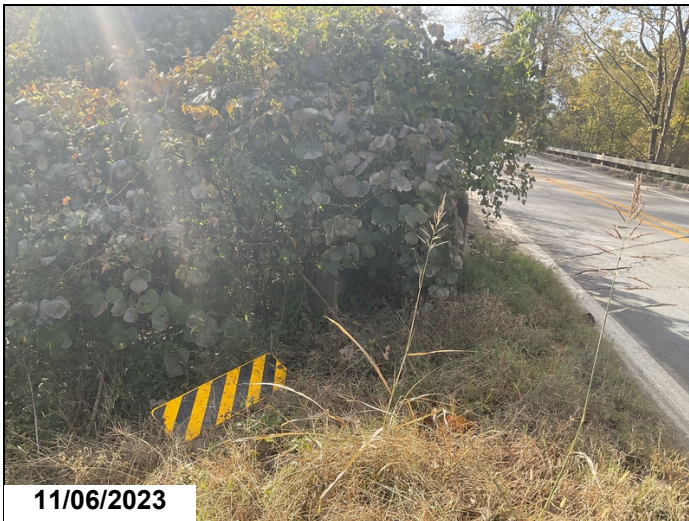
Abutment #1 left flair board knocked down

1/08/2025-RLS- The flair board has been replaced.

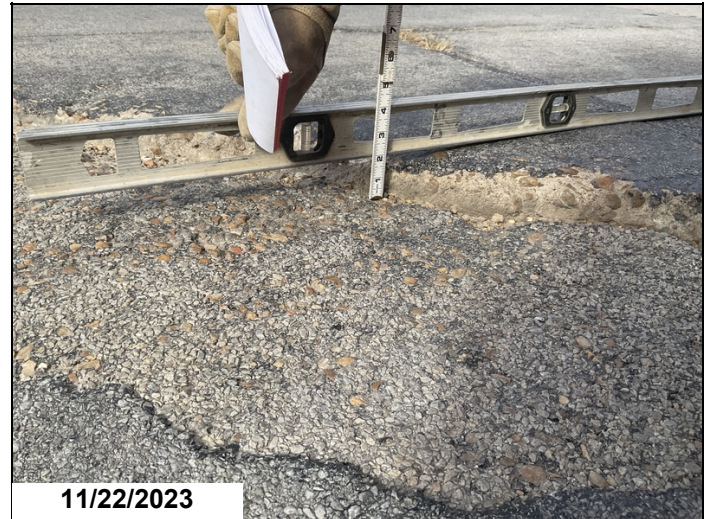
Abutment #2 approach roadway has settled up to 2"

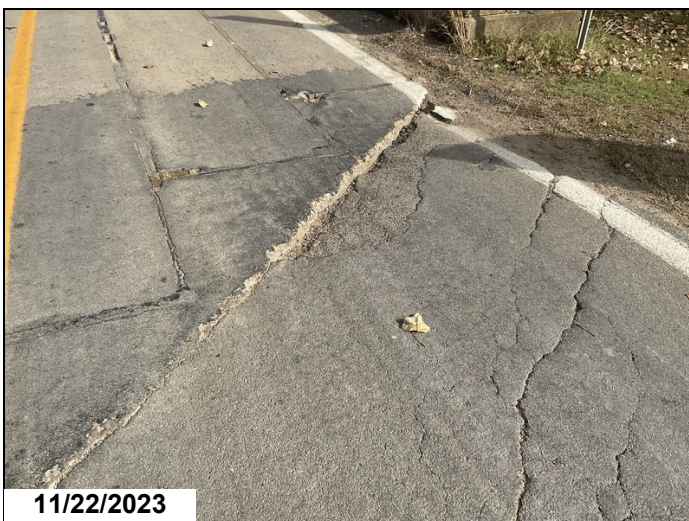
Abutment #2 approach roadway settlement

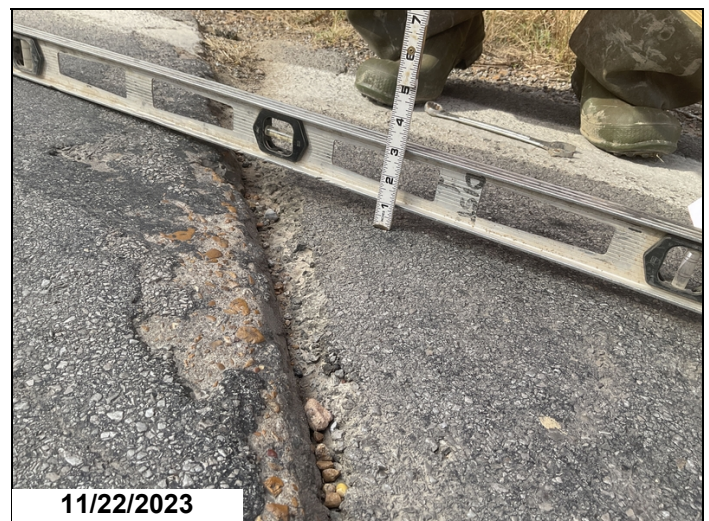
Abutment #1 approach roadway has settled up to 1"

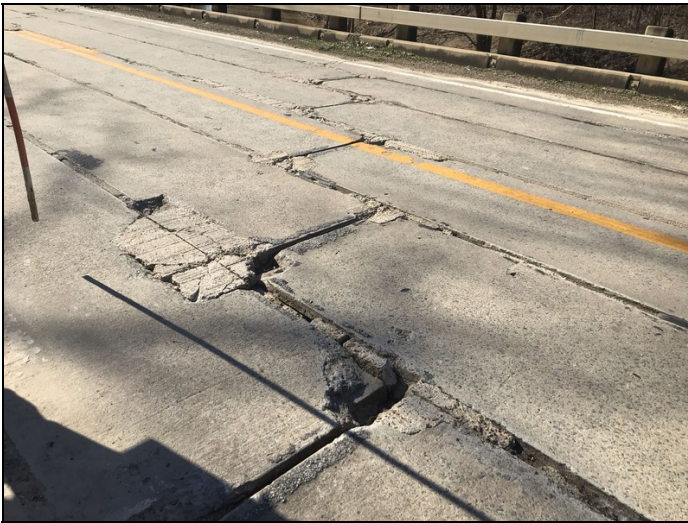
Bent 4

Deck gutters are full of dirt and debris
