Bridge Inspection Report

02071
US 65-20 LM 11.31
over
Bayou Macon

Structure Number: 02071

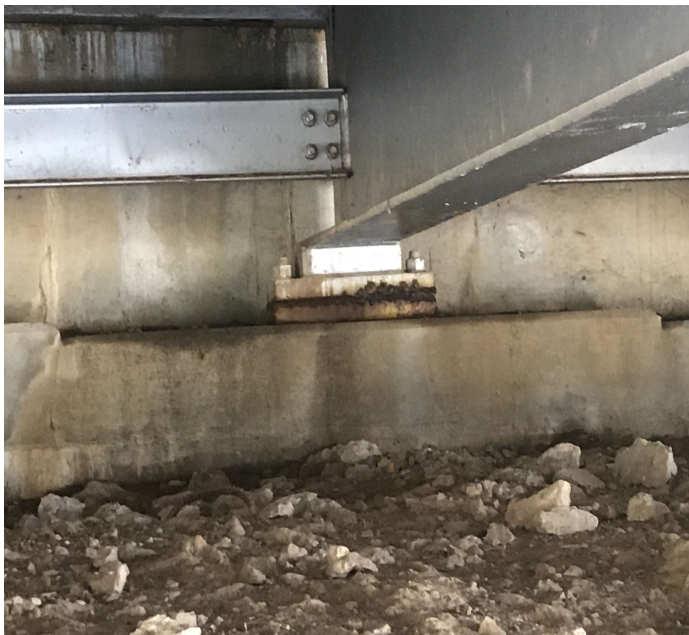
Bearings: most bearing have flaking rust forming due to leaking joint seals.

PHOTO 1 Description Bent 4 bearing 9 has flaking rust due to leaking joint seals.

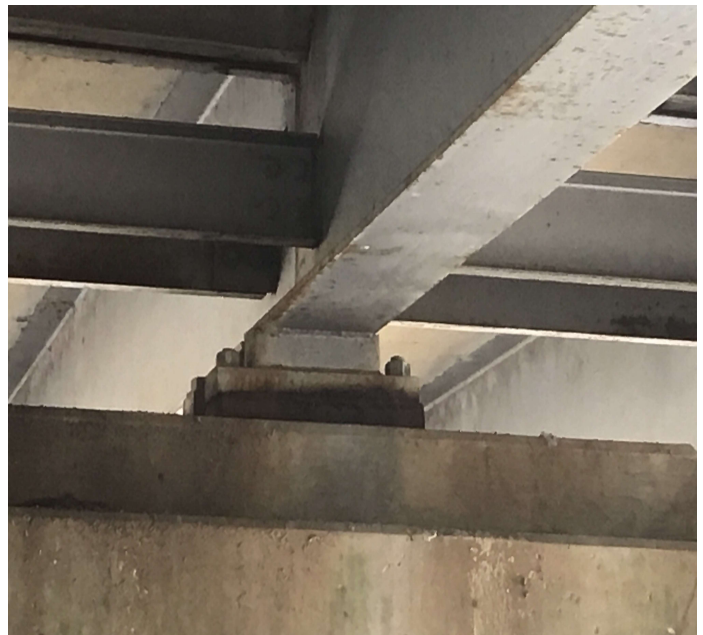
PHOTO 2 Description Bent 2 bearing 9 has heavy corrosion.

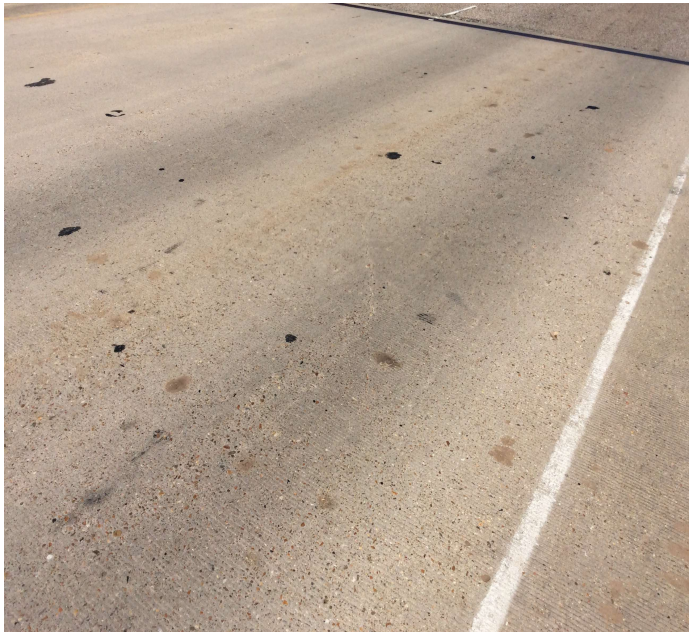
Deck - all spans: Unsealed, minor- to moderate-sized cracks (transverse, longitudinal, and a couple diagonals) - heavier in right (southbound) lanes

PHOTO 1 Description Span 1 left Typical cracking

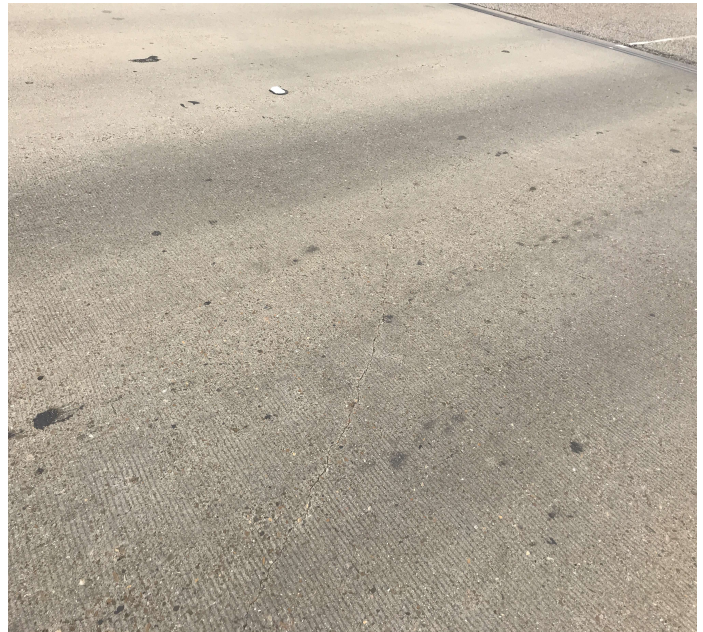
PHOTO 2 Description Span 1 northbound lane has large cracking in deck.

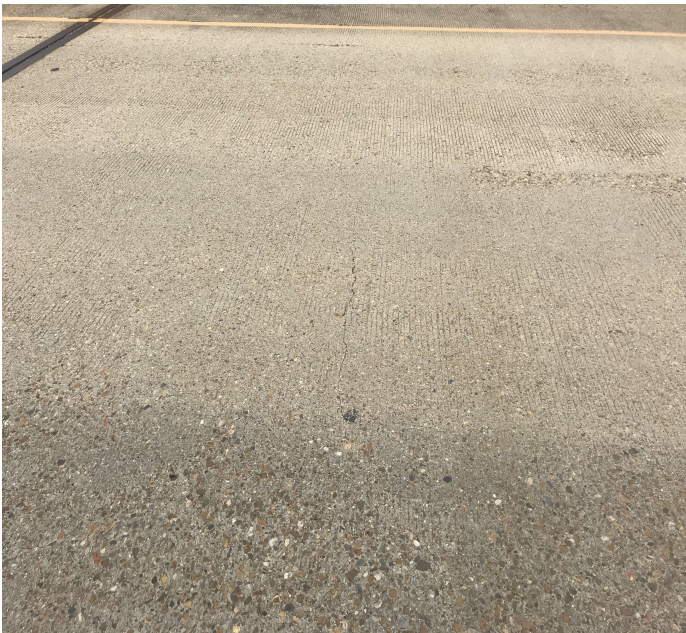
PHOTO 3 Description Deck south bound span 2 nacentrr line
has large urns Alex cracks.

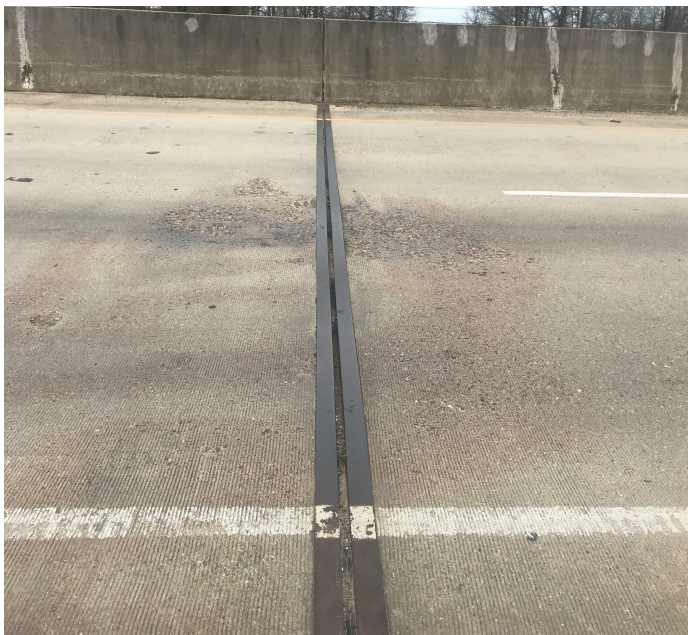
PHOTO 1 Description Bent 2 north bound lane joint seal has debris impacting loss of adhesion and are leaking.(Common on bent 3 also on North bound sides).

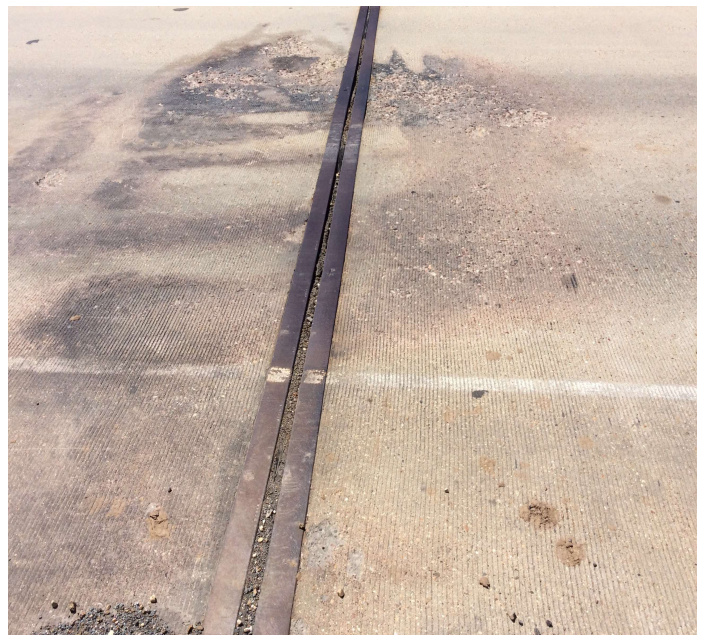
Deck - Bent 2 left (northbound) lanes: Fire damage (shallow spalls and delaminations) (12' x 12' area).

PHOTO 2 Description Deck - Bent 2 left side (northbound lanes): Fire damage

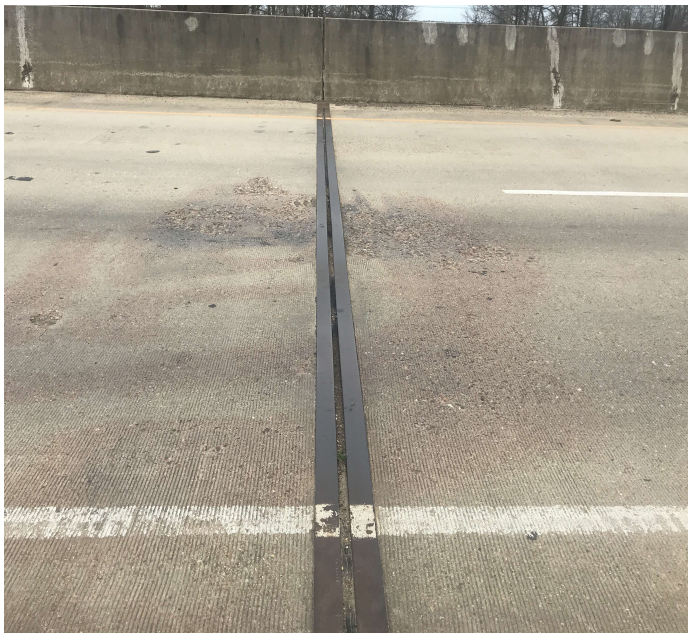
All joints seals have adhesion loss or are torn and or leaking .

PHOTO 1 Description Bent 2 north bound lane joint seal has debris impacting loss of adhesion and are leaking.(Common on bent 3 also on North bound sides).

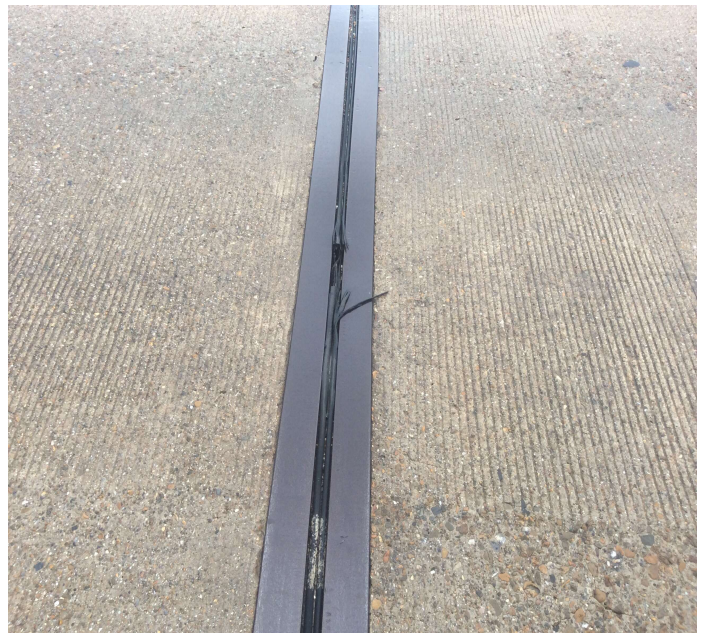
PHOTO 2 Description Bent 2 as approach south bound expansion seal torn and leaking

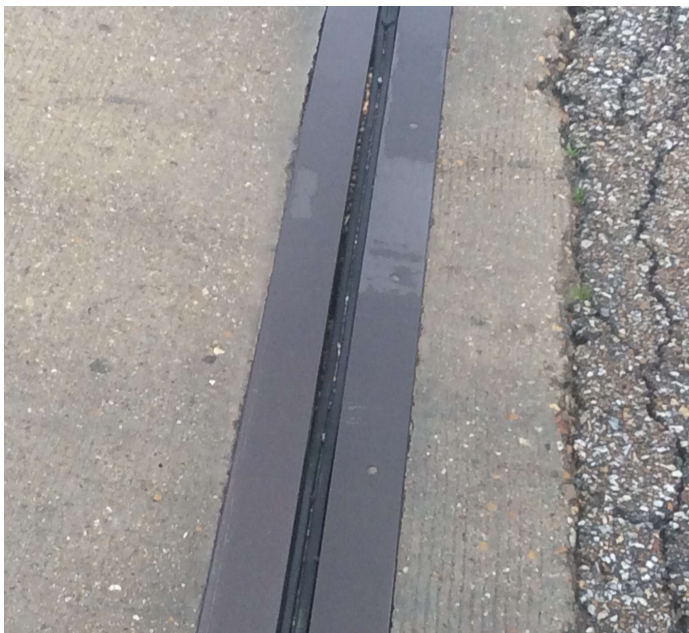
PHOTO 3 Description Joint seal leaking bent 1 north bound lane

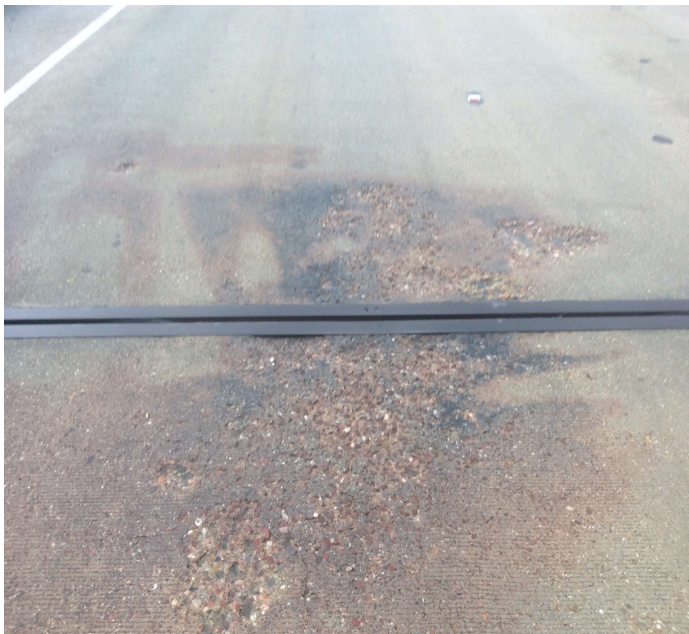
PHOTO 4 Description Fire damage northbound bents 1&2
