# Bridge Inspection Report

**02072**  
**US 65-20 LM 12.41**  
**over**  
**Swift Bayou**

Structure Number: 02072

Facility Carried: US 65-20 LM 12.41

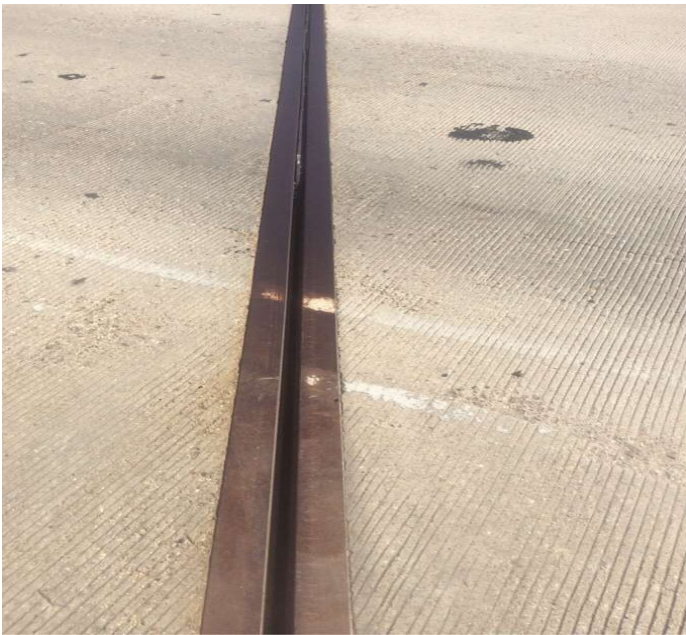
PHOTO 1 Description

Bent 3 left: Joint material has fallen out.

Bent 2: Widespread cracking and damage.

Bent 3 right: Loss of adhesion.

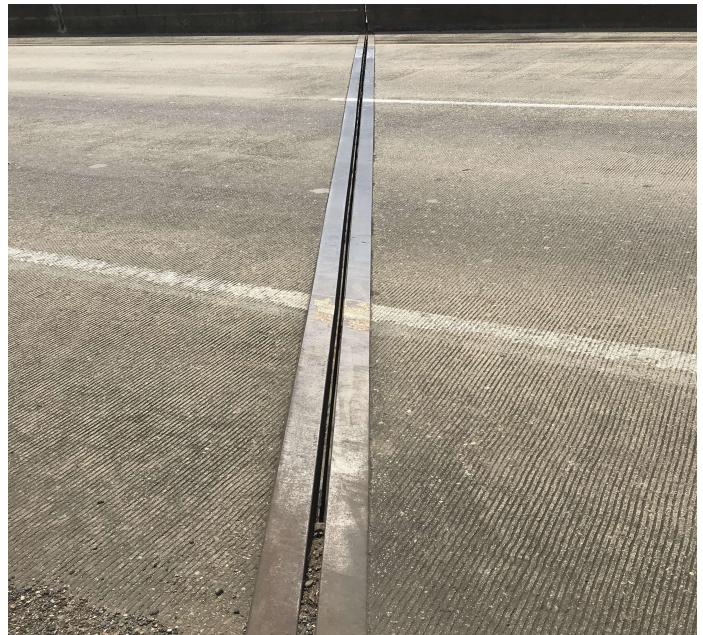
PHOTO 1 Description Joint - Bent 2 Pile 3 Left: Loss of adhesion

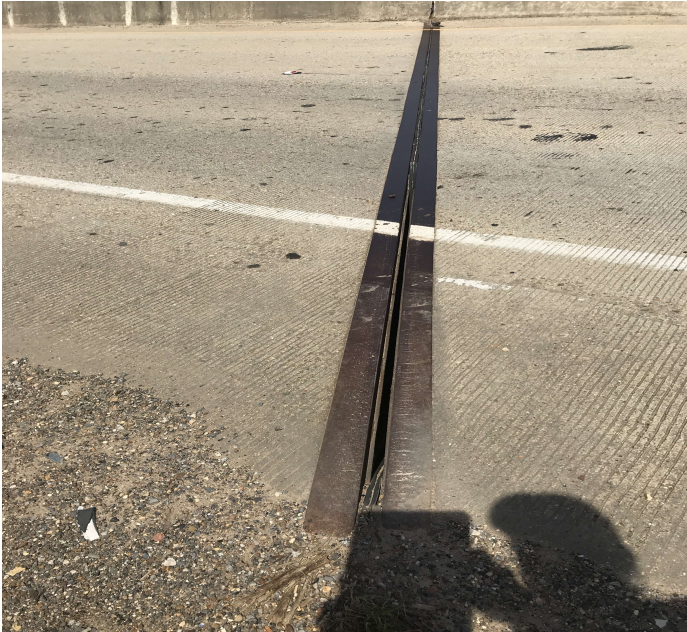
PHOTO 2      Description      Joint - Bent 3 right : Loss of adhesion

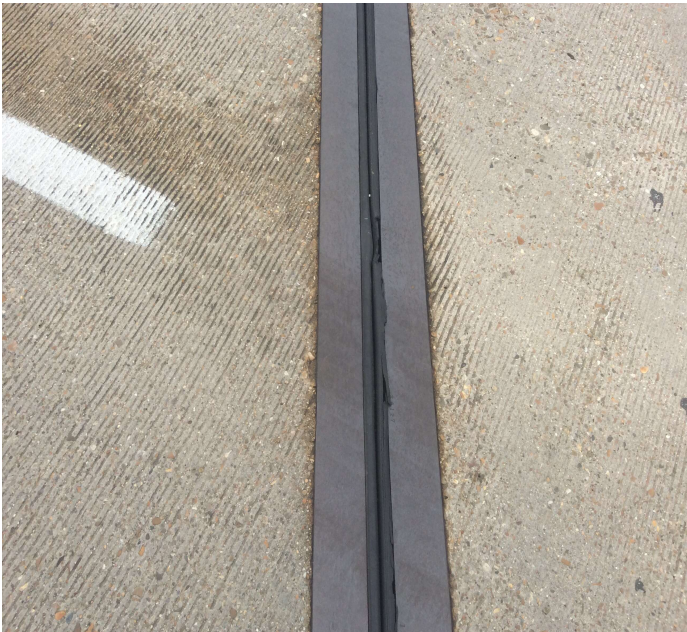
PHOTO 2      Description      Bent 2 north bound joints seal torn and leaking

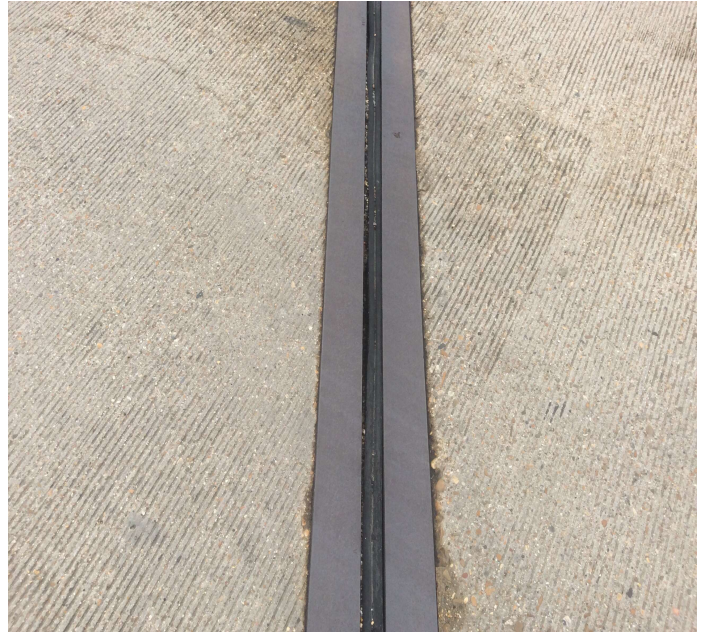
PHOTO 3      Description      Bent 3 north bound joints seals lose of adhesion and leaking

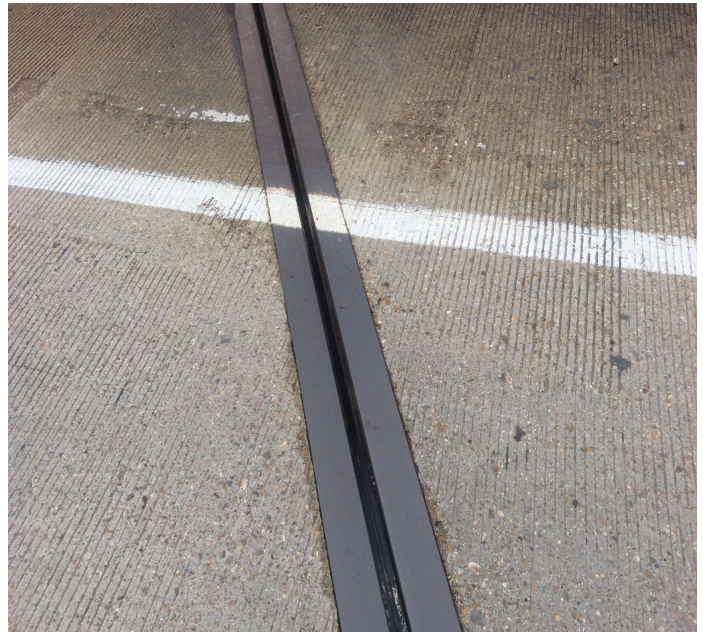
PHOTO 4      Description      Bent 3 south bound joint seal missing and leaking

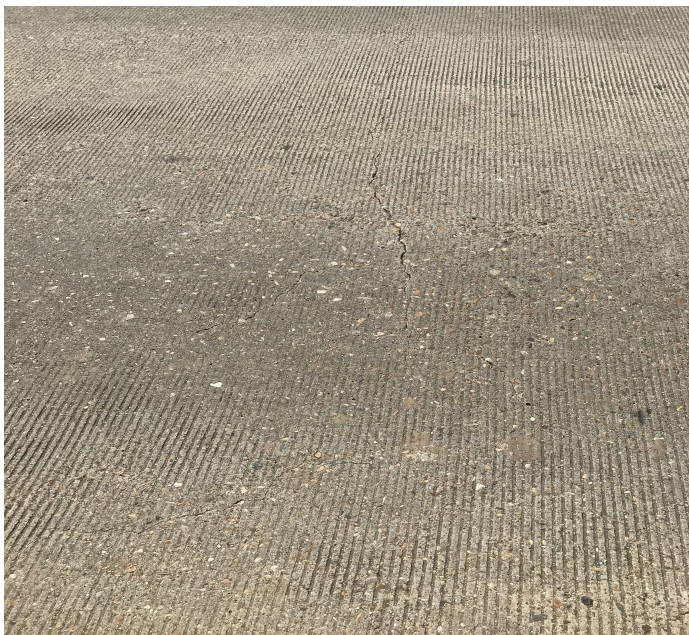
Deck - all spans: Scattered minor- to moderate-sized unsealed longitudinal and transverse cracks with reflective efflorescence on soffit.

PHOTO 1      Description      Deck - Span 2 : Cracking

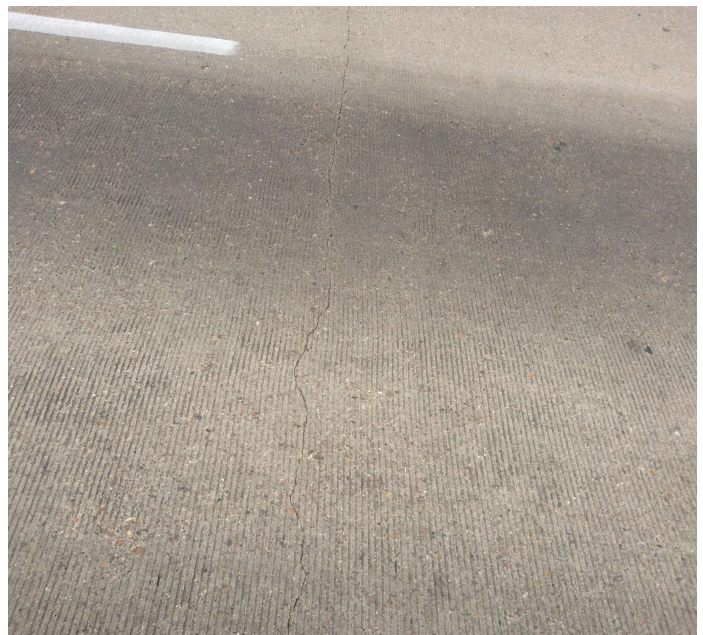
PHOTO 1      Description      Span 4 north bound transversely cracking on deck

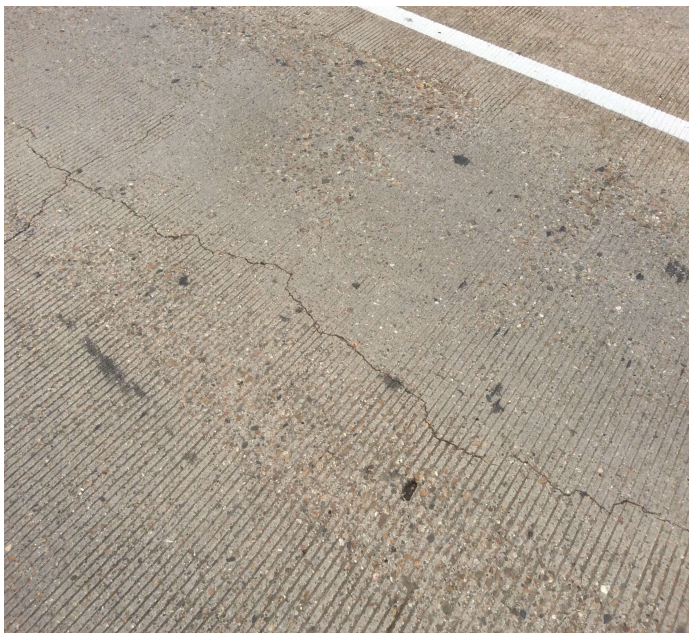
PHOTO 2      Description      Span 2 south bound longitudinal and vertical cracking on deck but common on north bound also

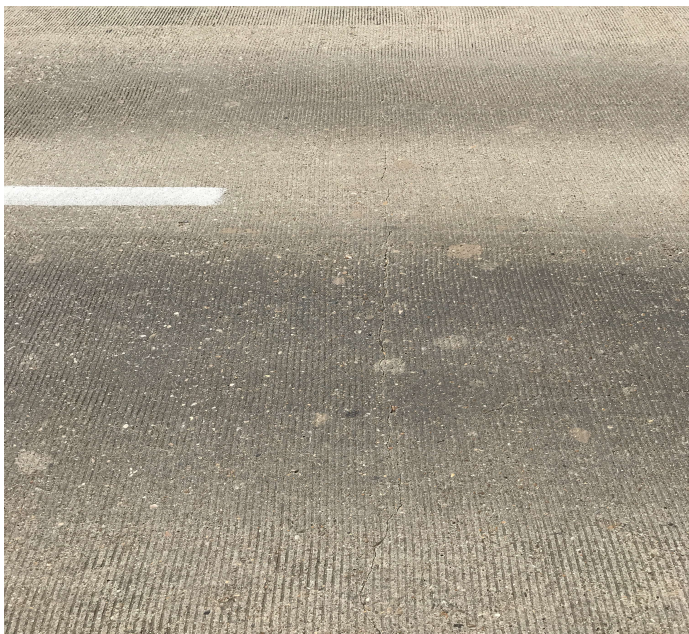
PHOTO 2      Description      Deck - Span 3 : Cracking

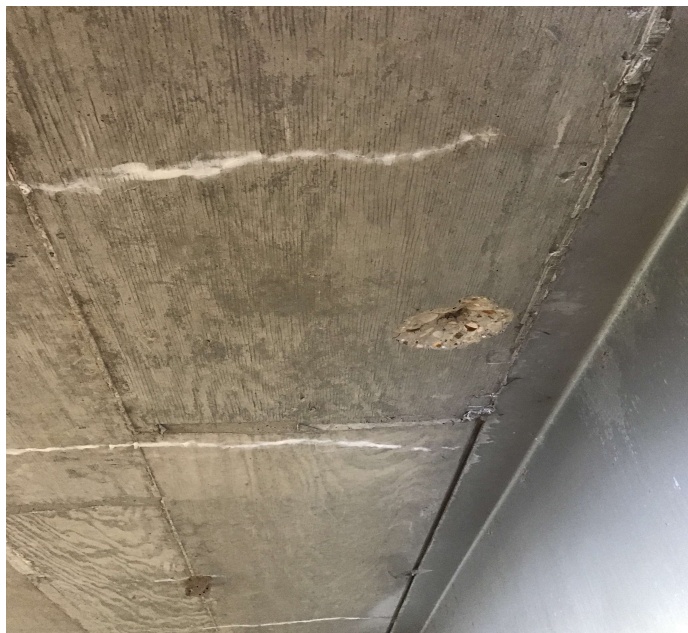
PHOTO 3      Description      Soffit - Span 3 Bay 5: Spall and reflective efflorescence

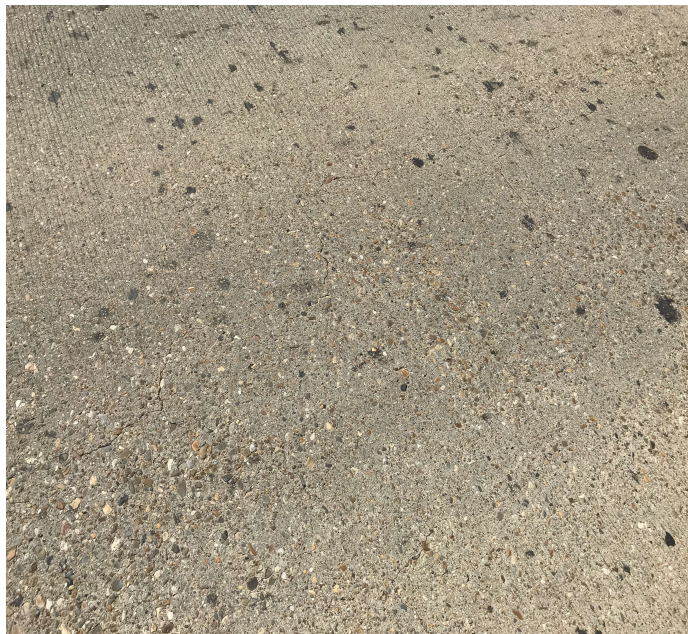
PHOTO 4      Description      Deck - Span 2 right : Cracking

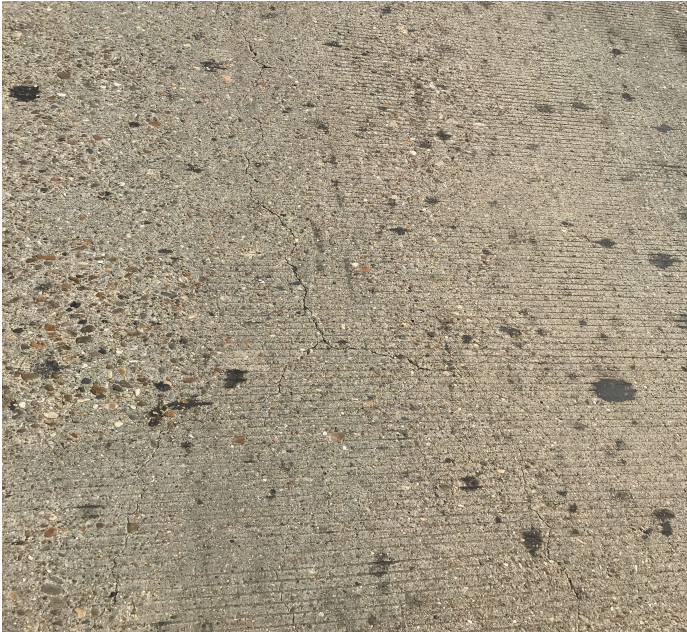
PHOTO 5      Description      Deck - Span 2 right: Cracking

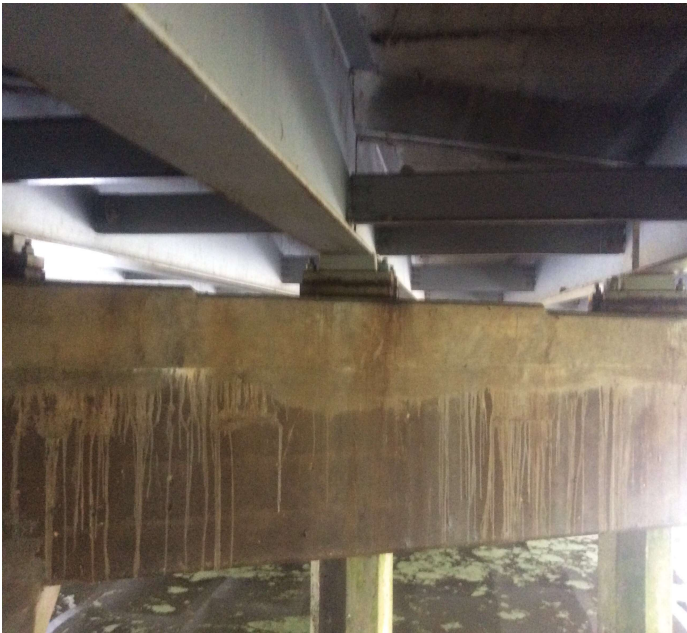
Bearings - all bents: Scattered surface corrosion with a few having minor flaking and pack rust between plates.

PHOTO 1      Description      Bent 2 girder 8 bearing has moderate pack rust between masonry plate and bearing

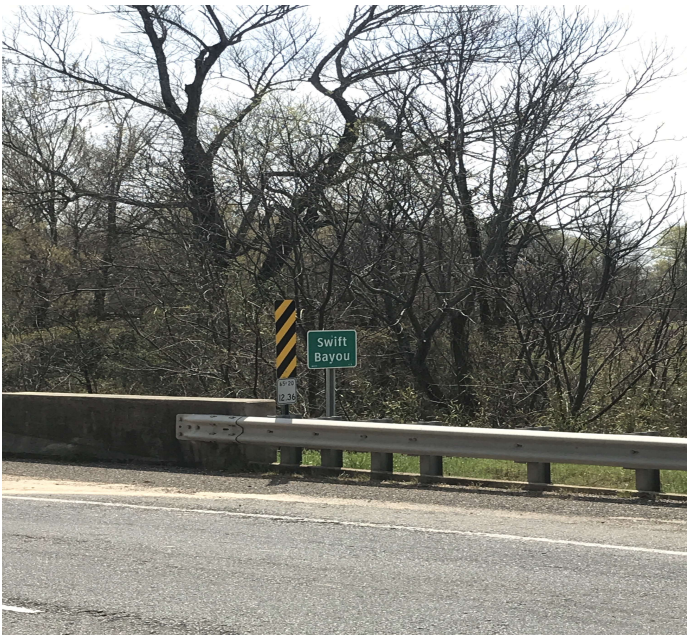
Log mile signs - both ends: Mileage needs correcting - should read "12.41" instead of "12.36".

PHOTO 1    Description    Log mile signs incorrect.
