Asset #A6987(Routine)

US65-18 SB LM 0.32 over Coon Bayou

Location: 0.2 Mi S SH138-Winchester

Team Lead: Greg Loomis, Inspection Date: 07/21/2022

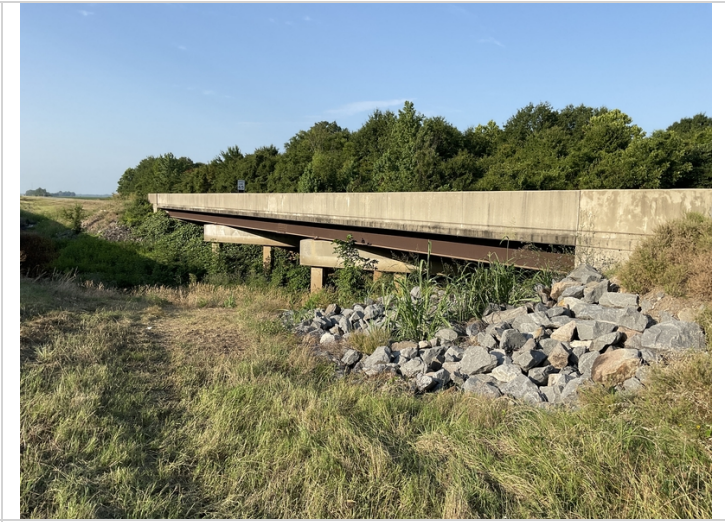
Left side view

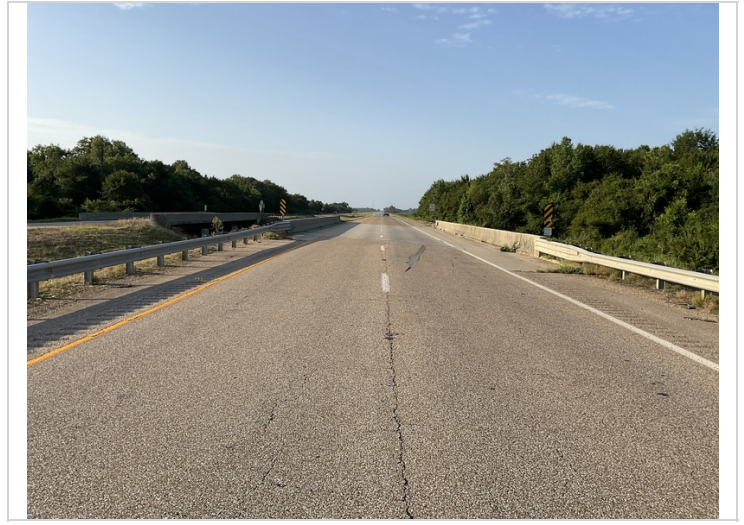
Roadway view

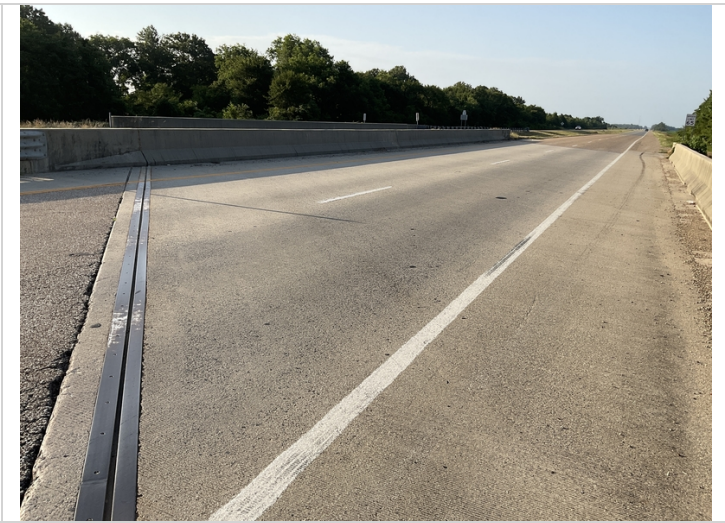
(12) Deck: 41'-2" wide x 123' long = 5063 sqft. Some small longitudinal and transverse cracks, mainly in right (outer) lane - 40 sqft CS2 cracking. Soffit - Some cracking with efflorescence on overhangs - 6 sqft CS2 efflorescence.							
107	Steel Open Girder/Beam	LF	738	738	0	0	0
515	Steel Protective Coating	SF	4472	4322	150	0	0
3430	Oxide Film Degradation Color/Texture Adherence(Steel Protective Coatings)	LF	150	0	150	0	0

Deck - Spans 1-3: Typical

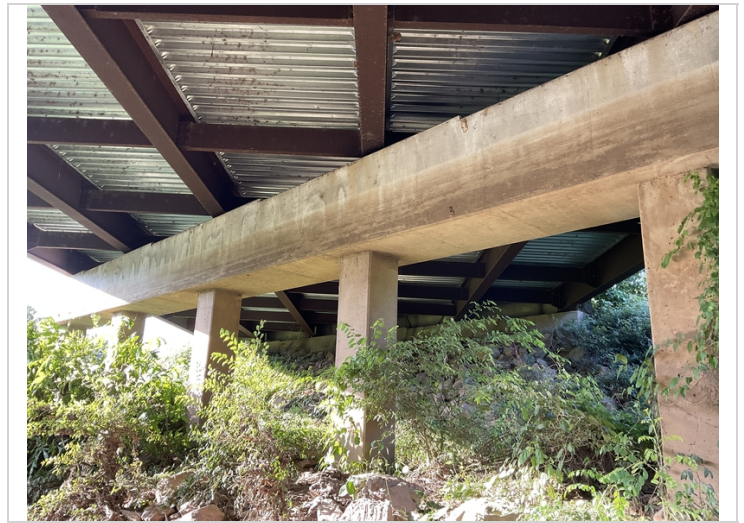
Soffit - Spans 2 & 3: Typical

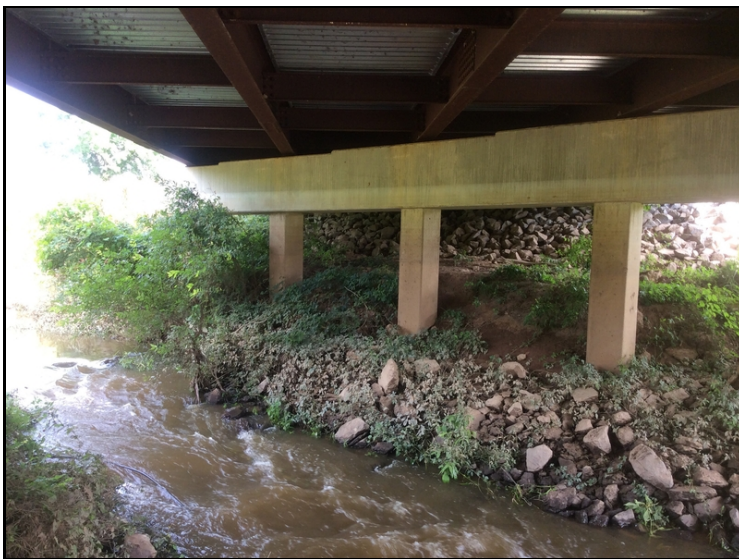
Channel - Spans 1 - 3: Small trees, bushes, vines, and other vegetation growing on and under bridge.

Endslope - Span 1 (vegetation)

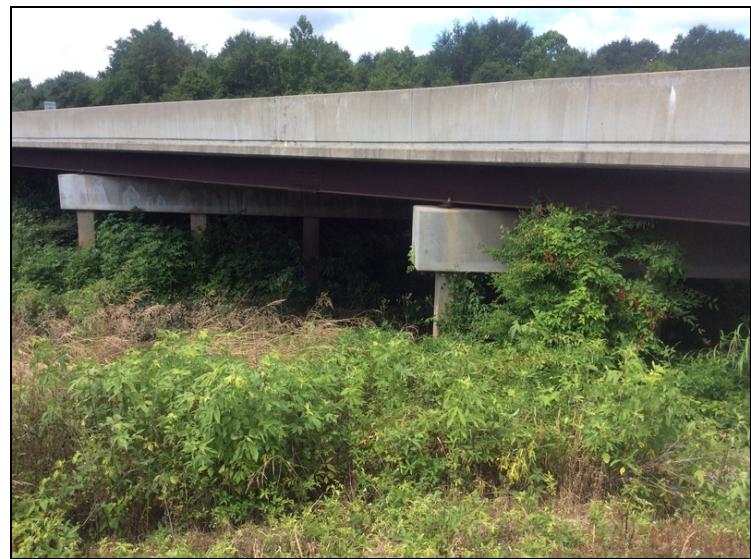
Endslopes @ Bents 2-3 left (vegetation)

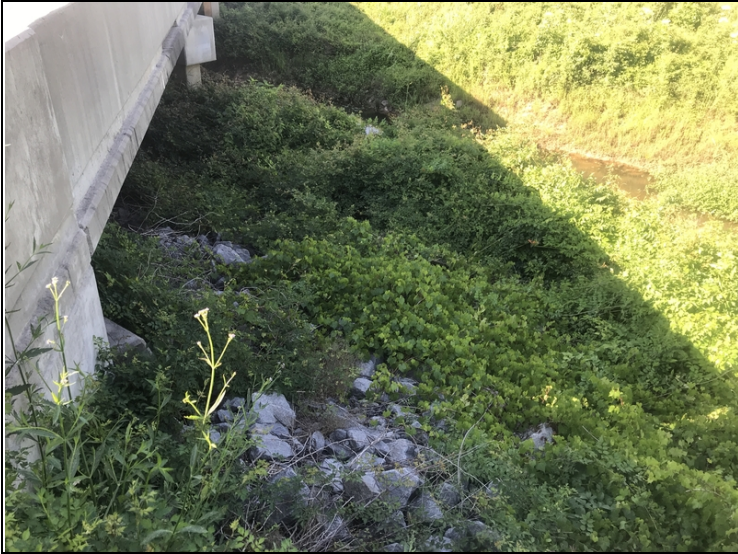
Vines and vegetation growing beside and under bridge.

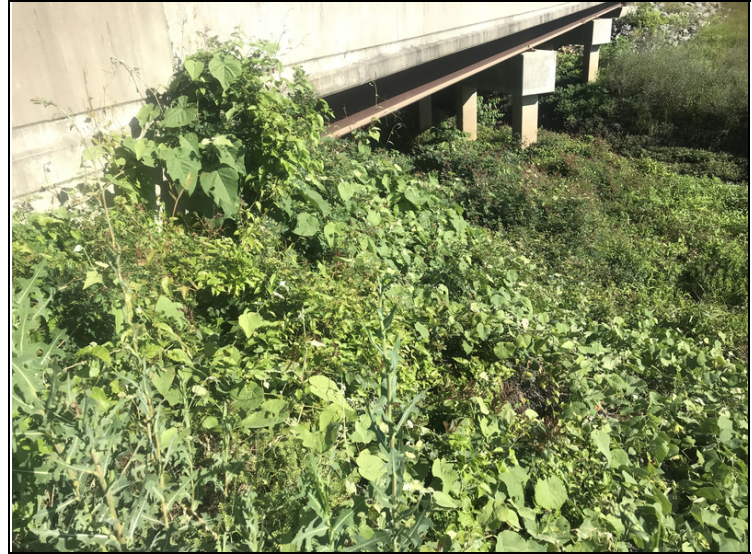
Vegetation.

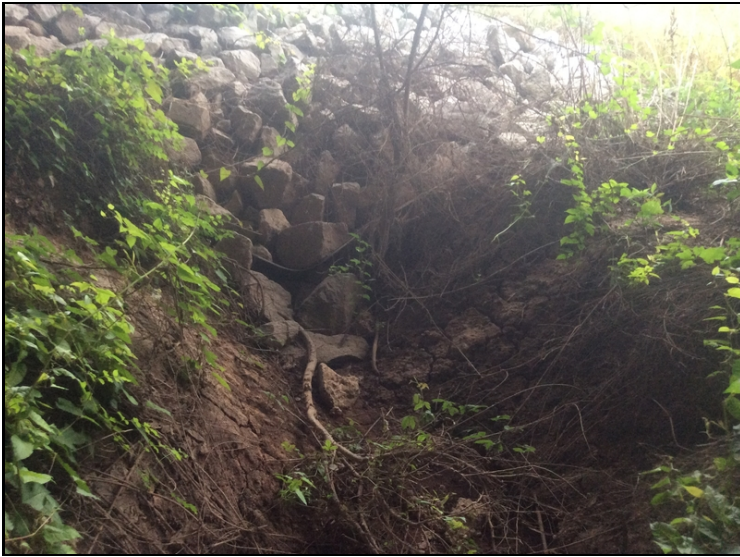
End-slope - Span 1 left: Erosion from center ditch to Bent 2 Pile 3.
