Bridge #03700(QA Routine)
SH 277-01 LM 4.33 over Bayou Bartholomew
Location: 2.2 Mi SW US 65-Tillar

Team Lead: Monty Frazier Inspection Date: July 20, 2020

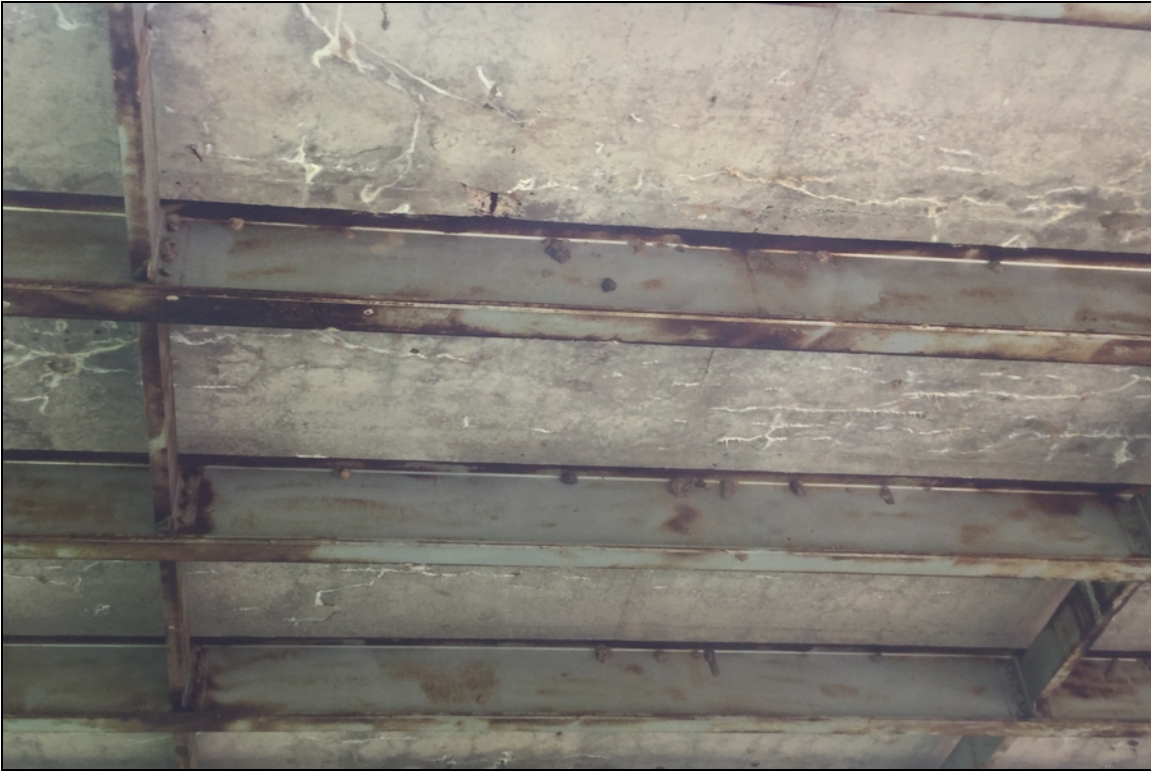
Span 2 girder 4 active Cs3 corrosion

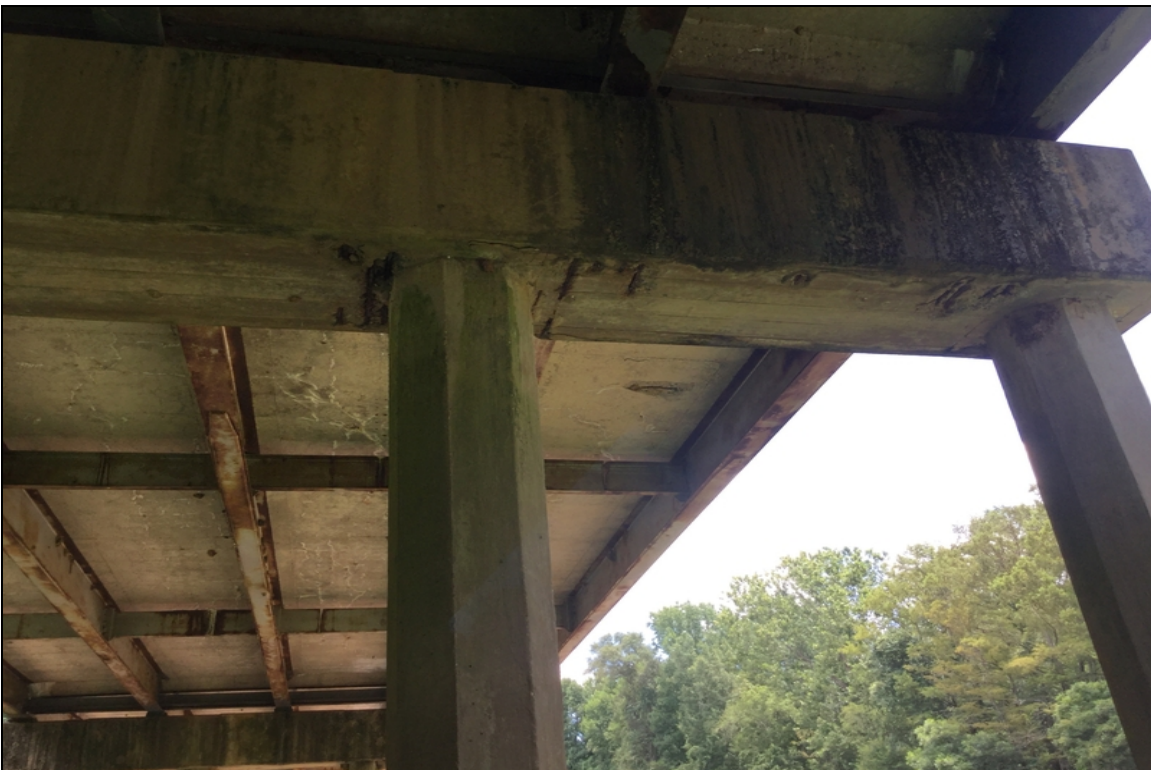
Cap 1 has cs3 rebar spalls on the under face of cap.

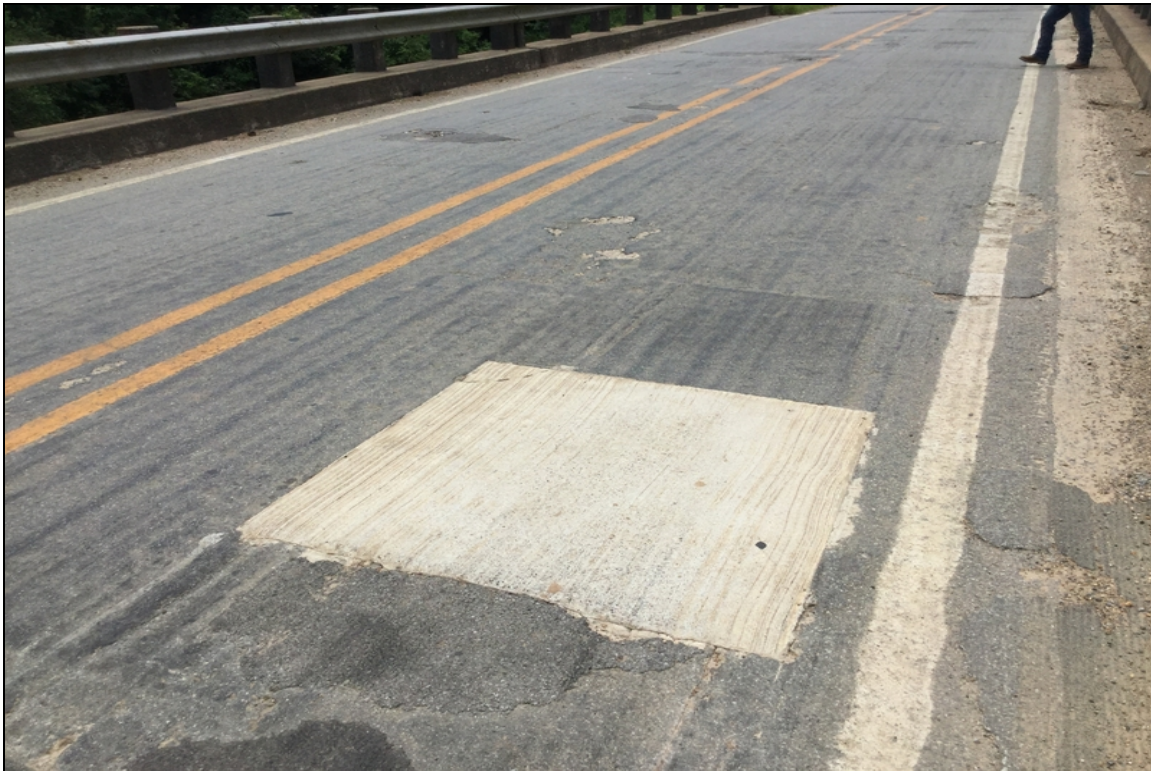
Span 2 Wearing surface has reflective cracking throughout and appears to have a lot of patched areas under asphalt. There is efflorescence cracking throughout under surface.

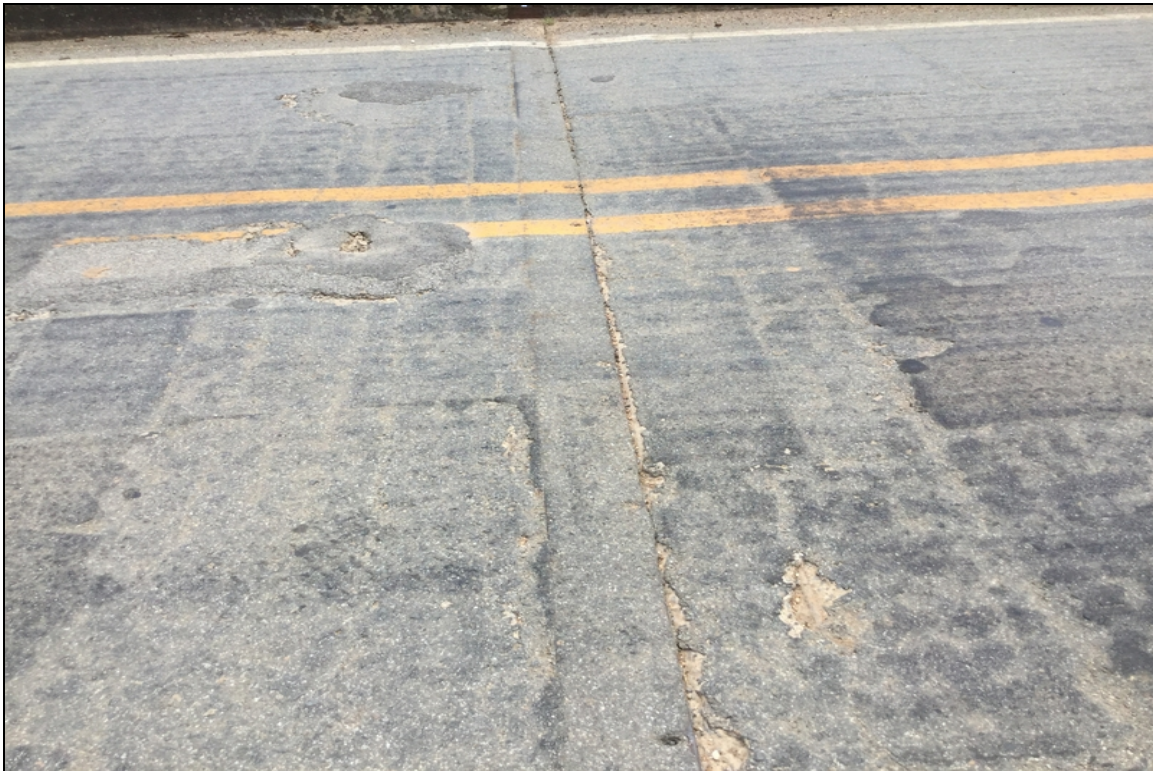
Bent 3 assembly joint typical

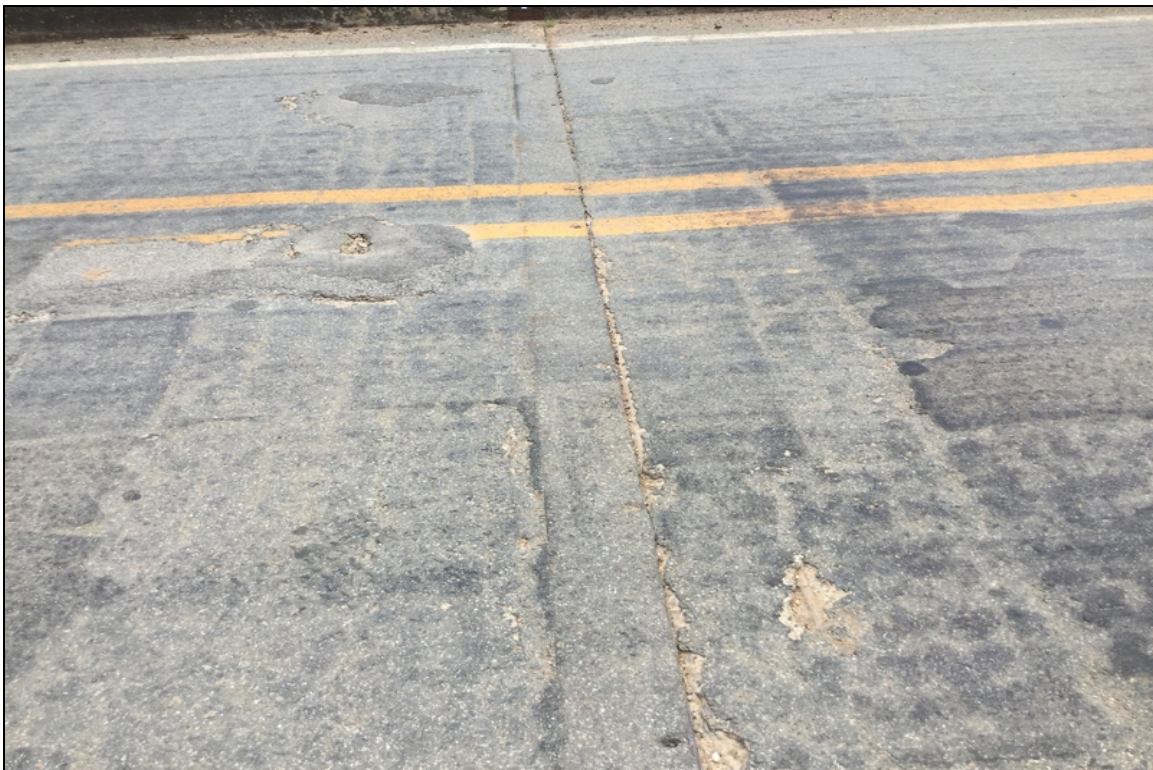
Bent 3 assembly joint typical

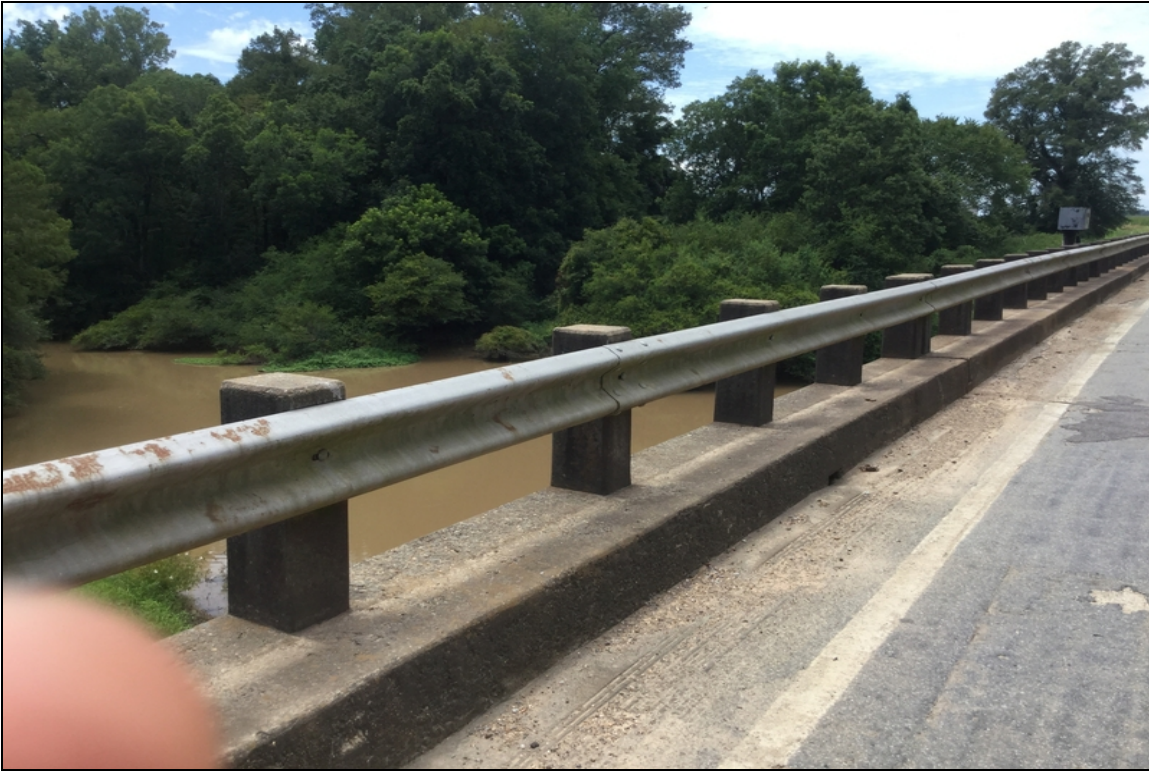
Typical bridge railing

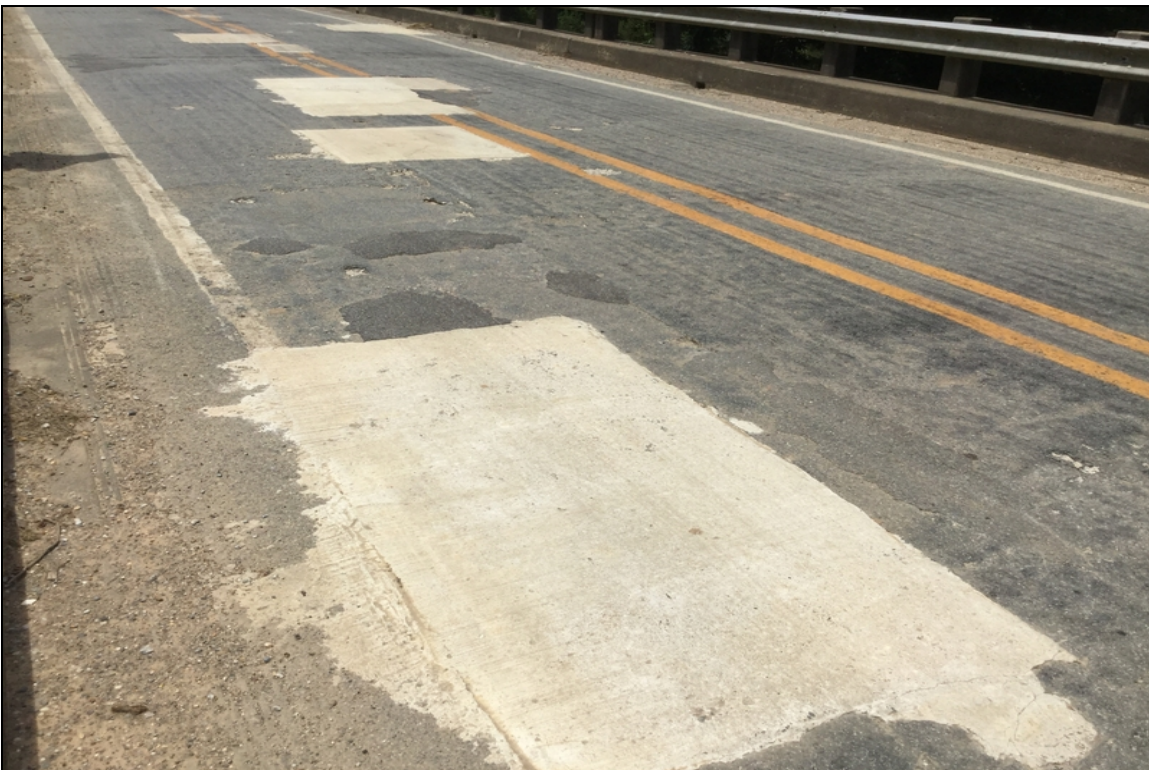
Span 6 repaired deck patches

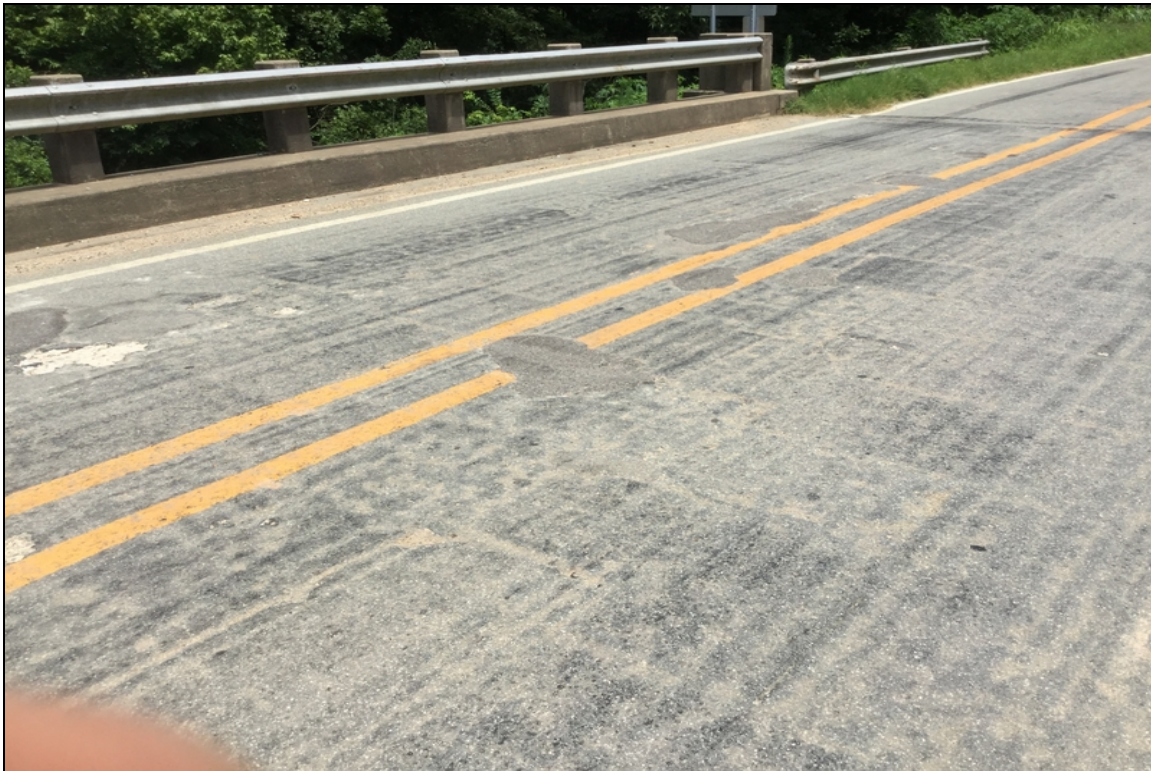
Span7 Cs3 spalling

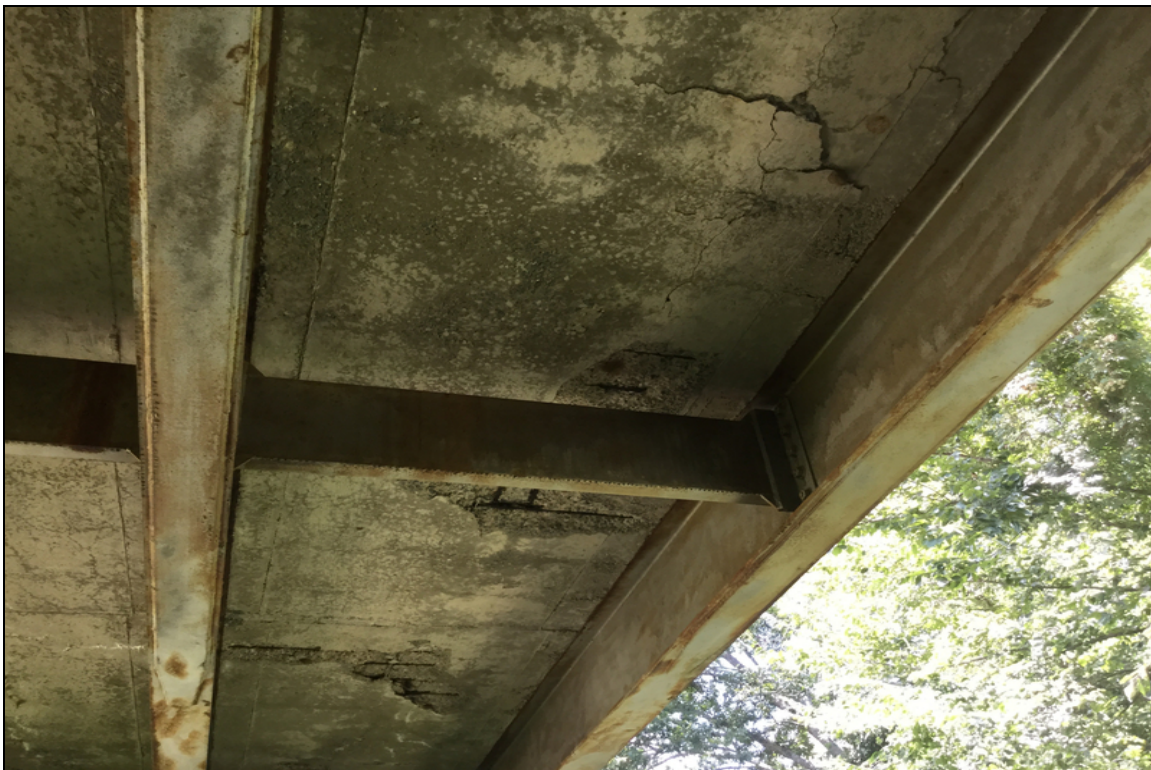
Span 7 bay 1 large Cs3 rebar areas and delam. This is typical in all spans

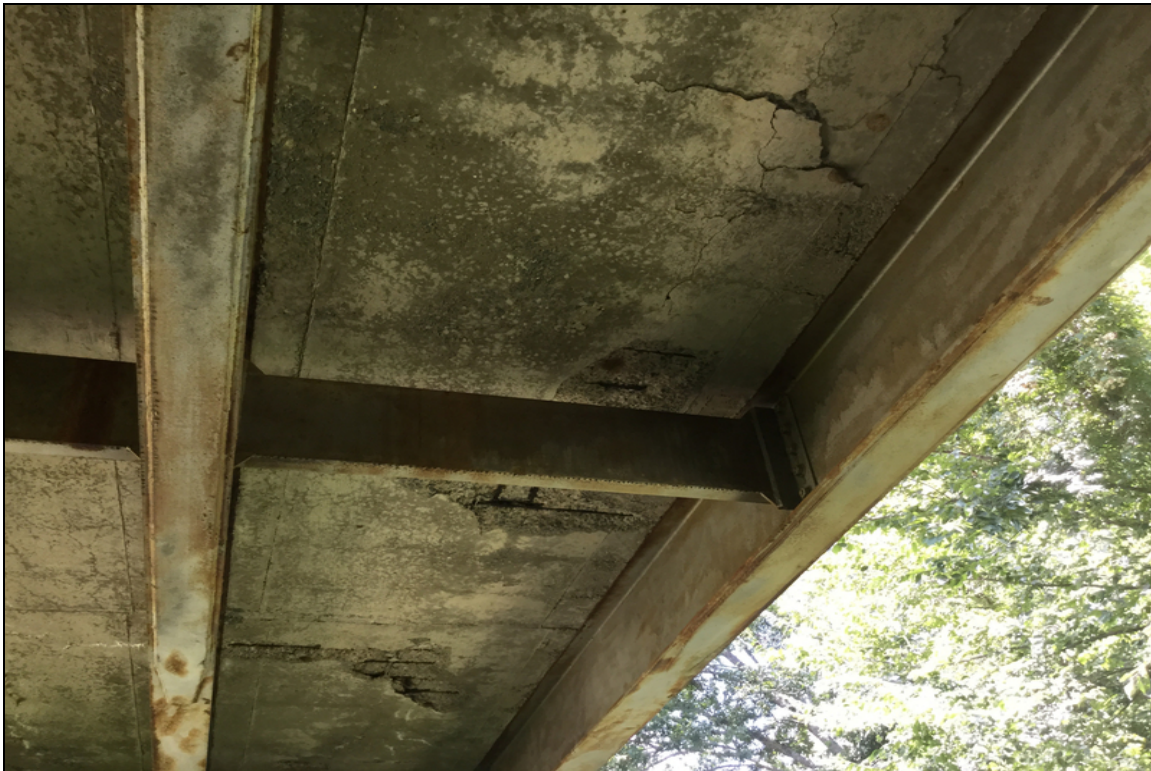
Span 7 bay 1 large Cs3 rebar areas and delam. This is typical in all spans

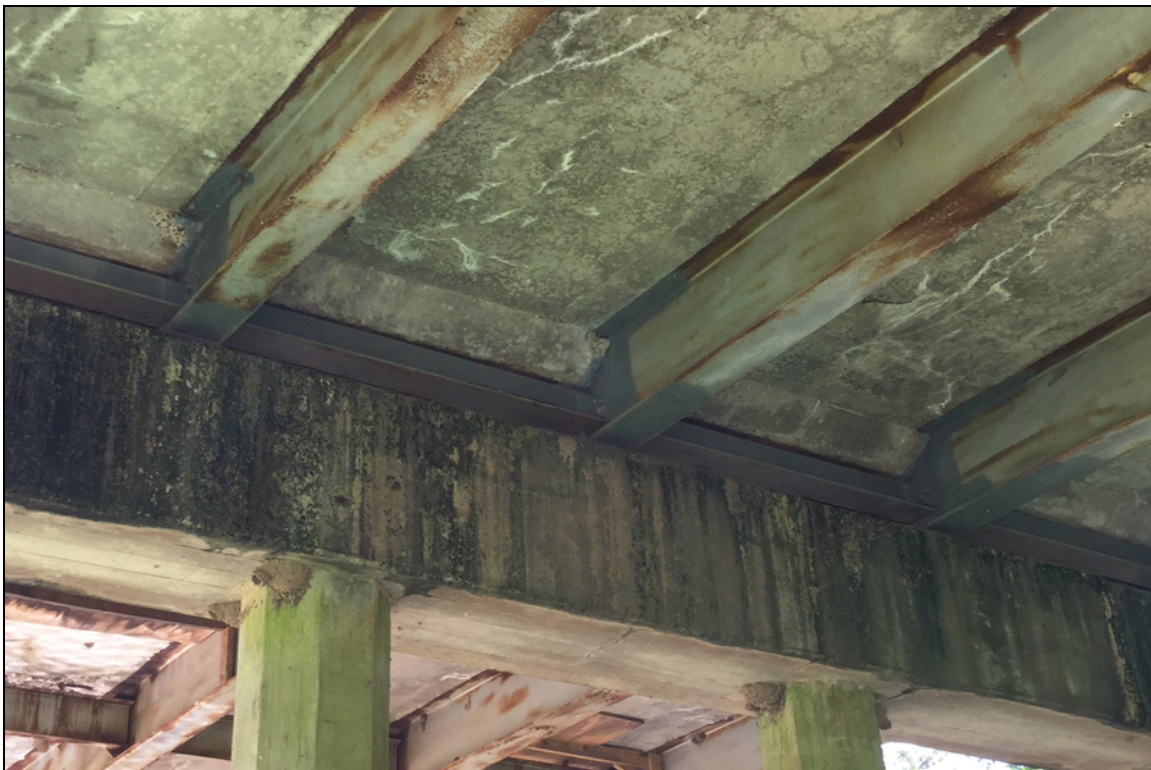
Ends of girders have had rust removed and repainted

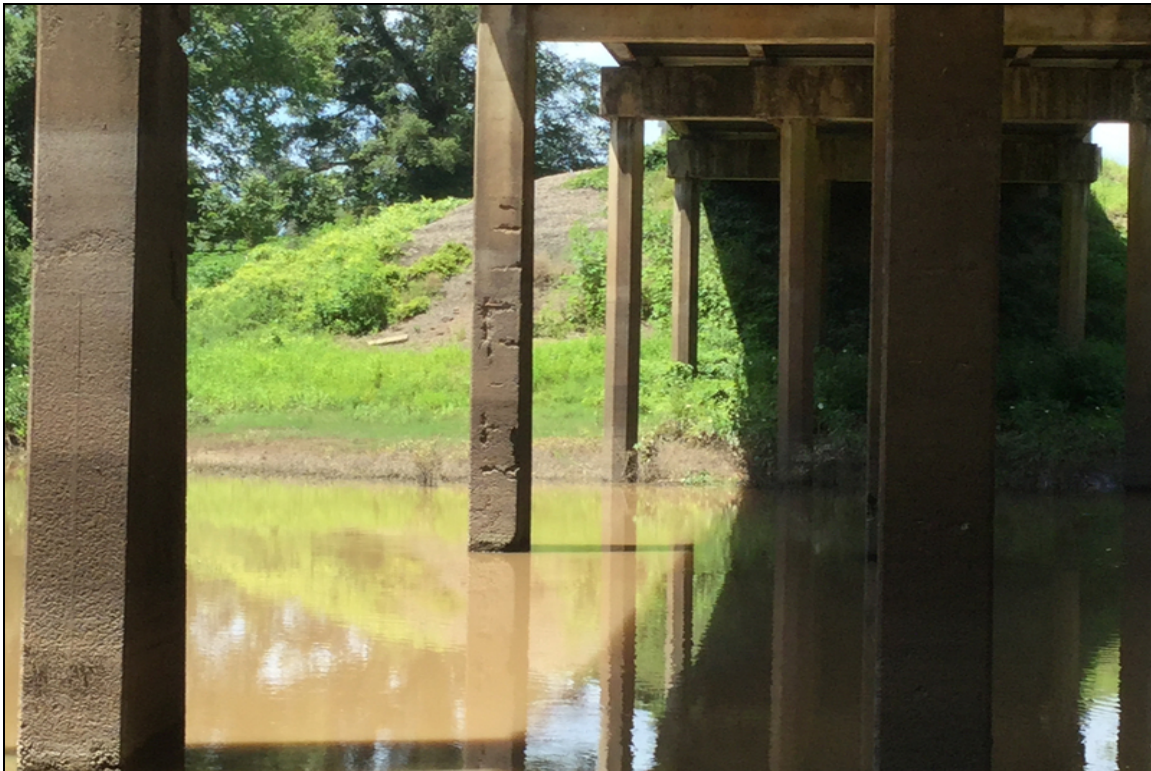
Cs3 rebar at bent 3 Column 3,2 bent 4 column 3,1;
Bent 3 column 1 is CS2 rebar

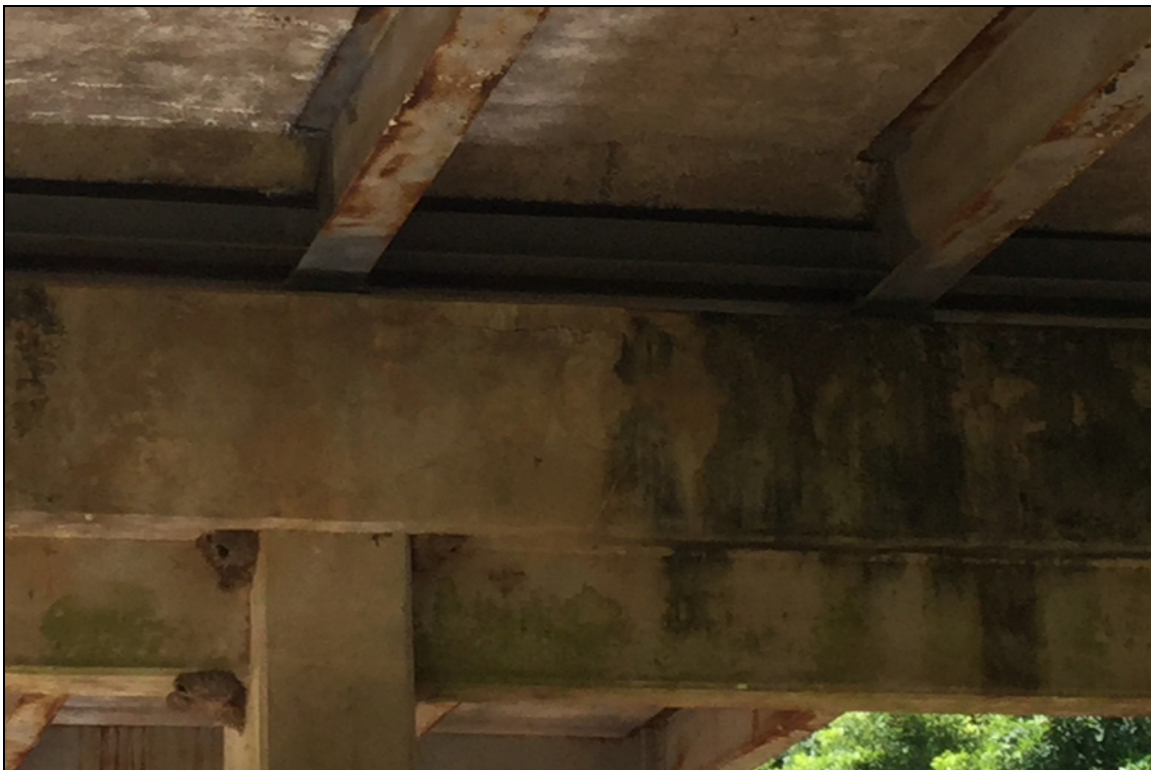
Cs3 cracking in cap 4 AHD side above column 2 this is typical at cap 3

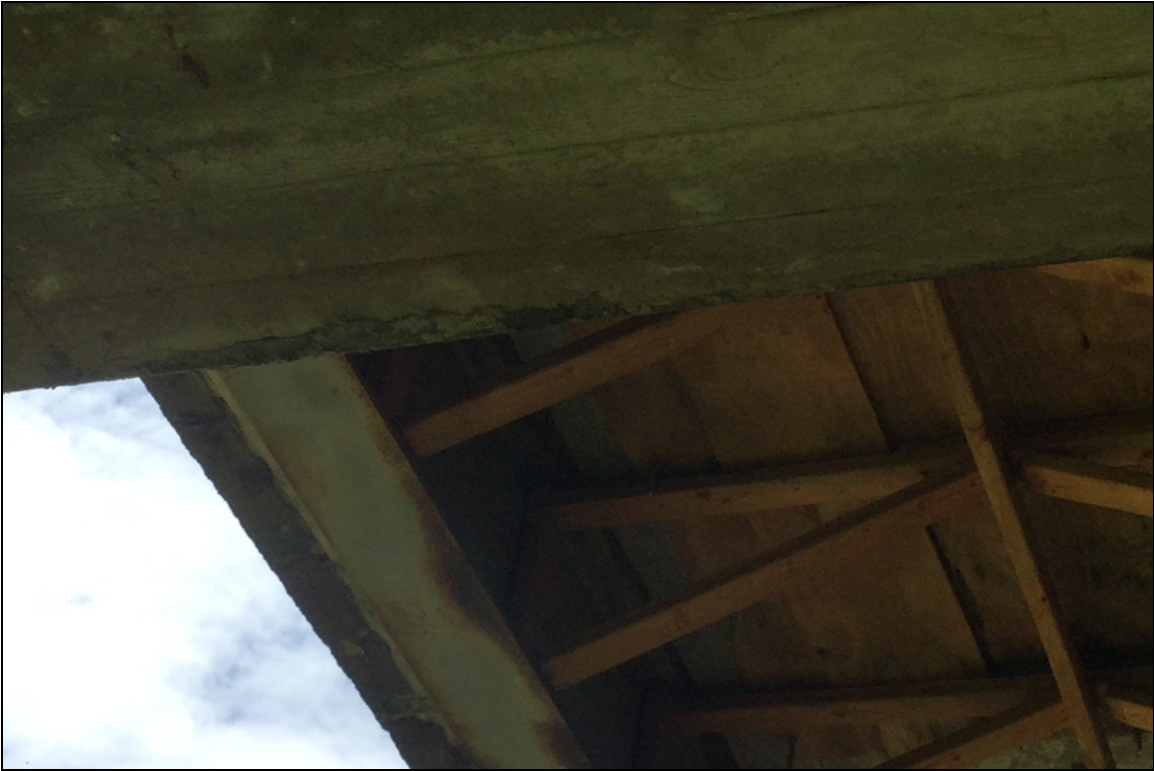
Cs3 cracking at bent 6 left side.

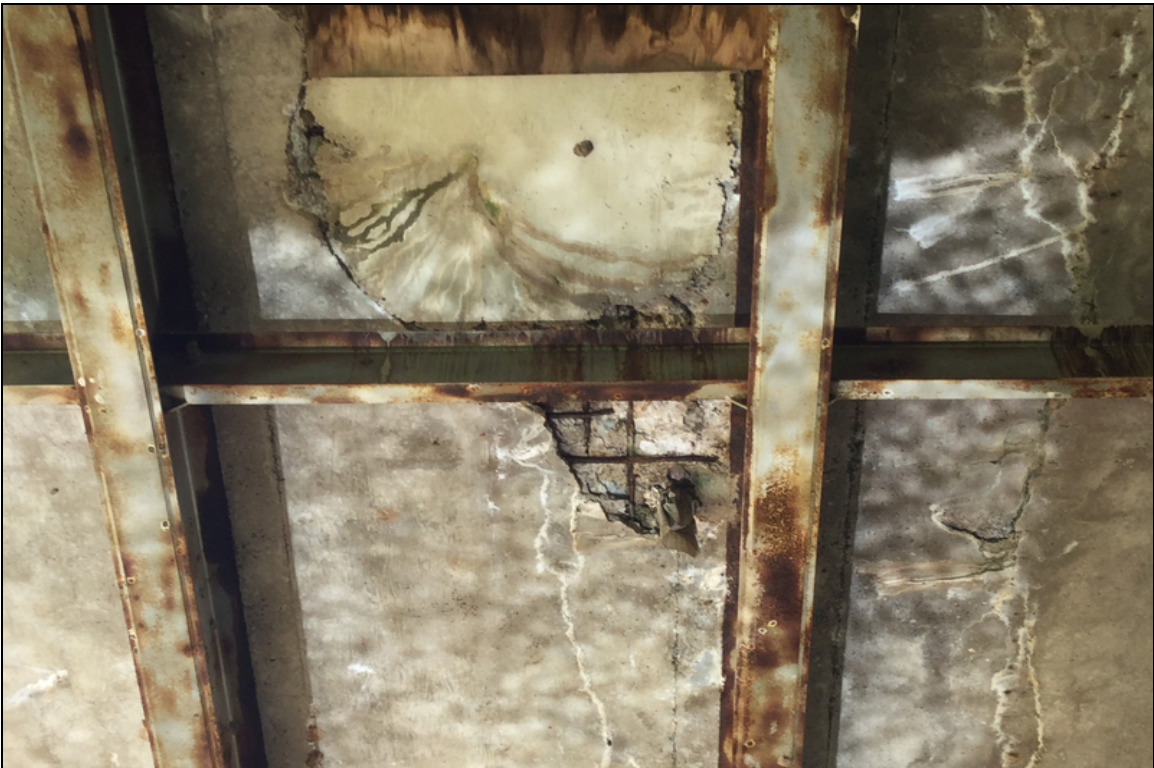
Span 5 rebar and repaired full depth failures

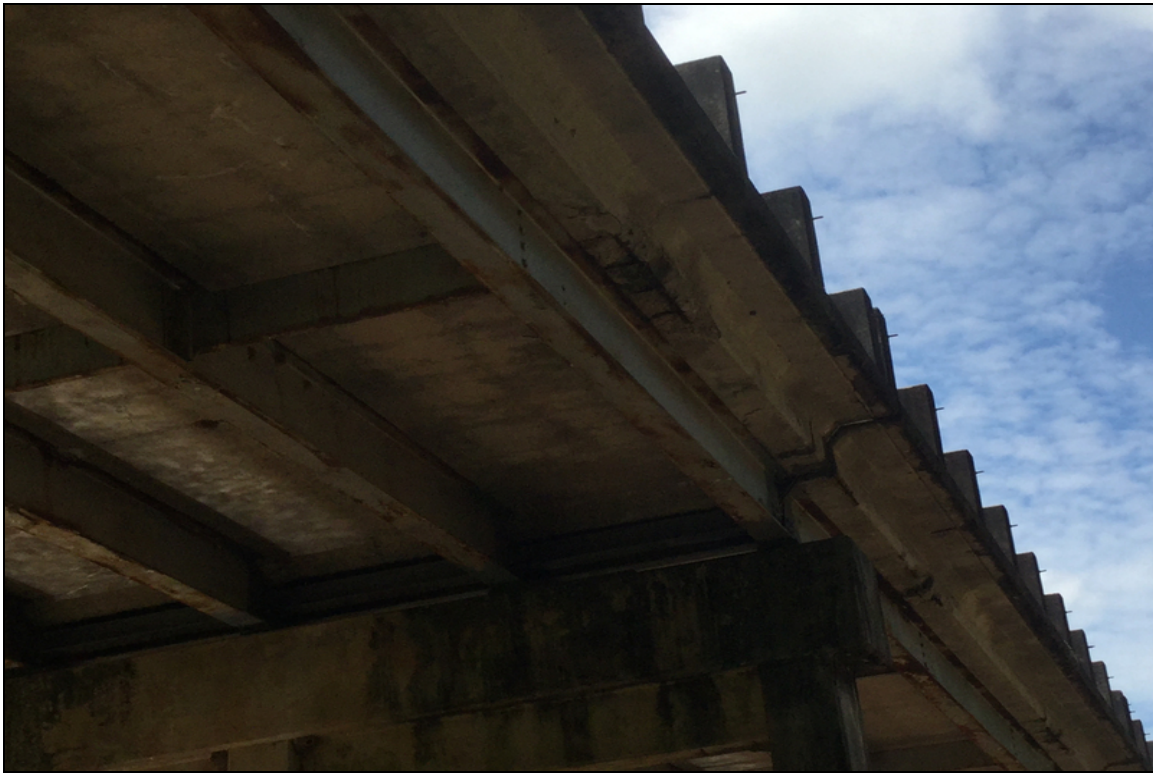
Typical Cs3 rebar on edges of soffit scattered throughout

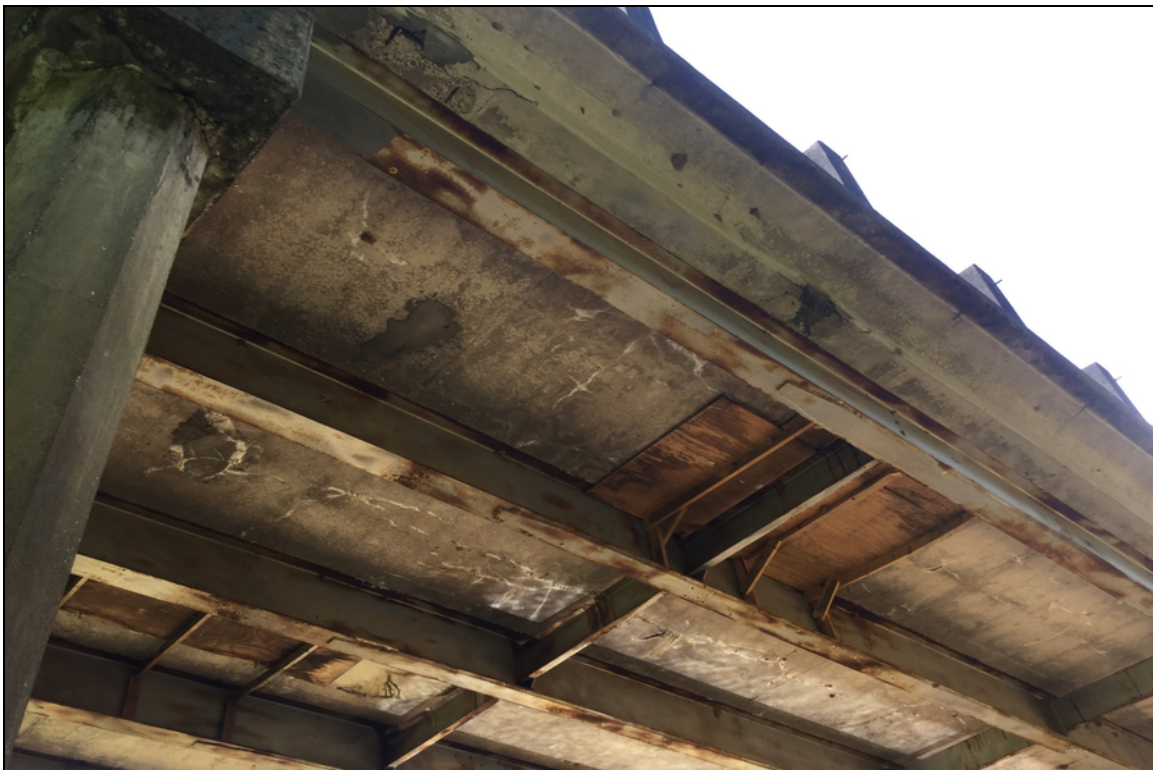
Span 5, 6 have three large repaired full depth failures

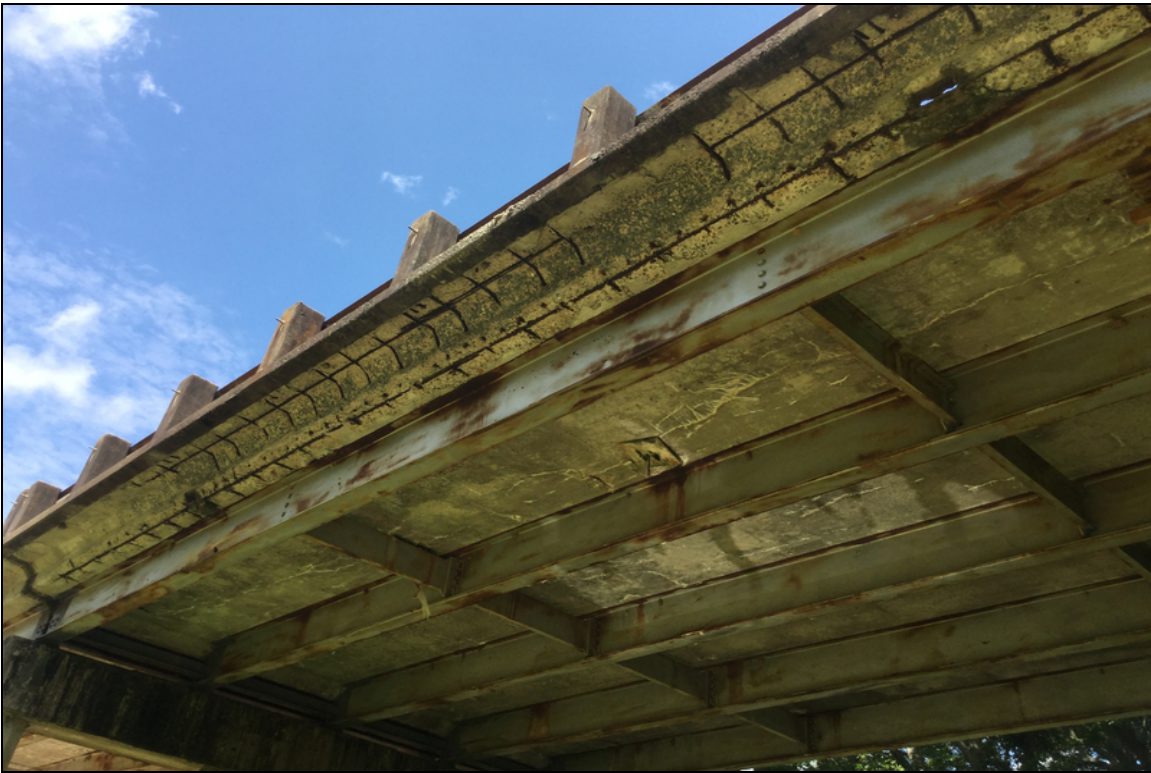
Span 6 right side soffit Cs3 rebar

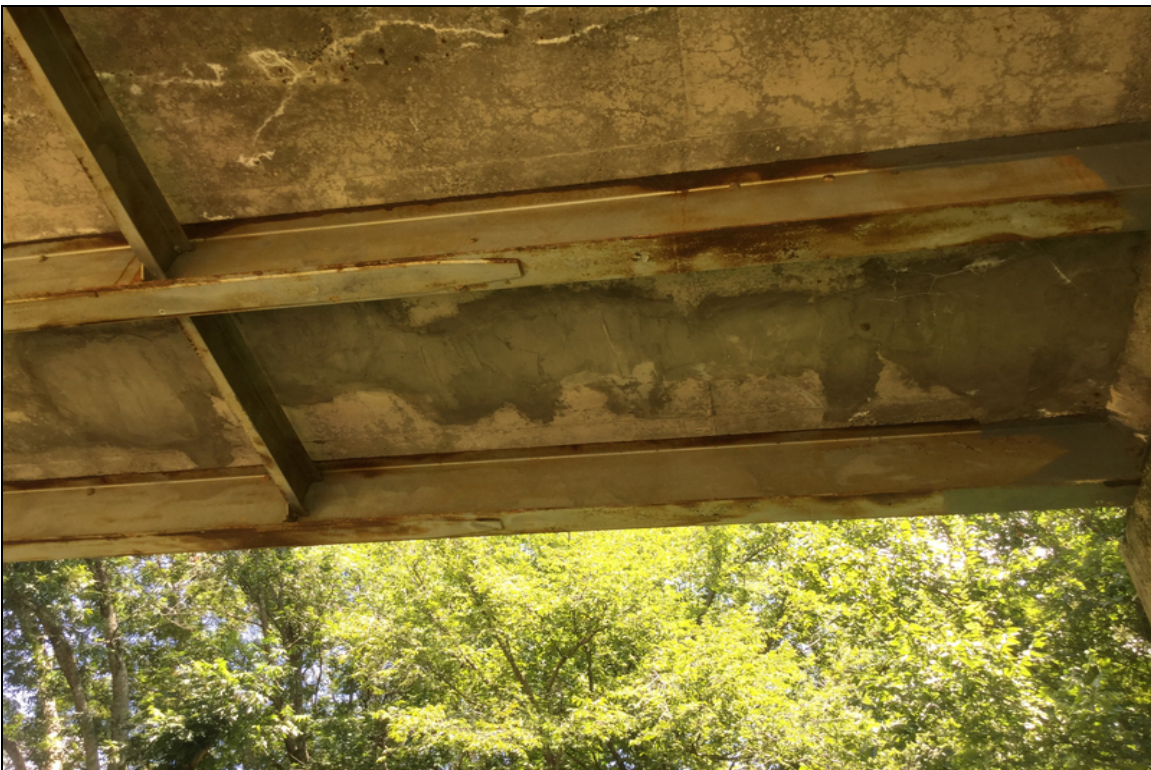
Span 6 left side patched area with grout

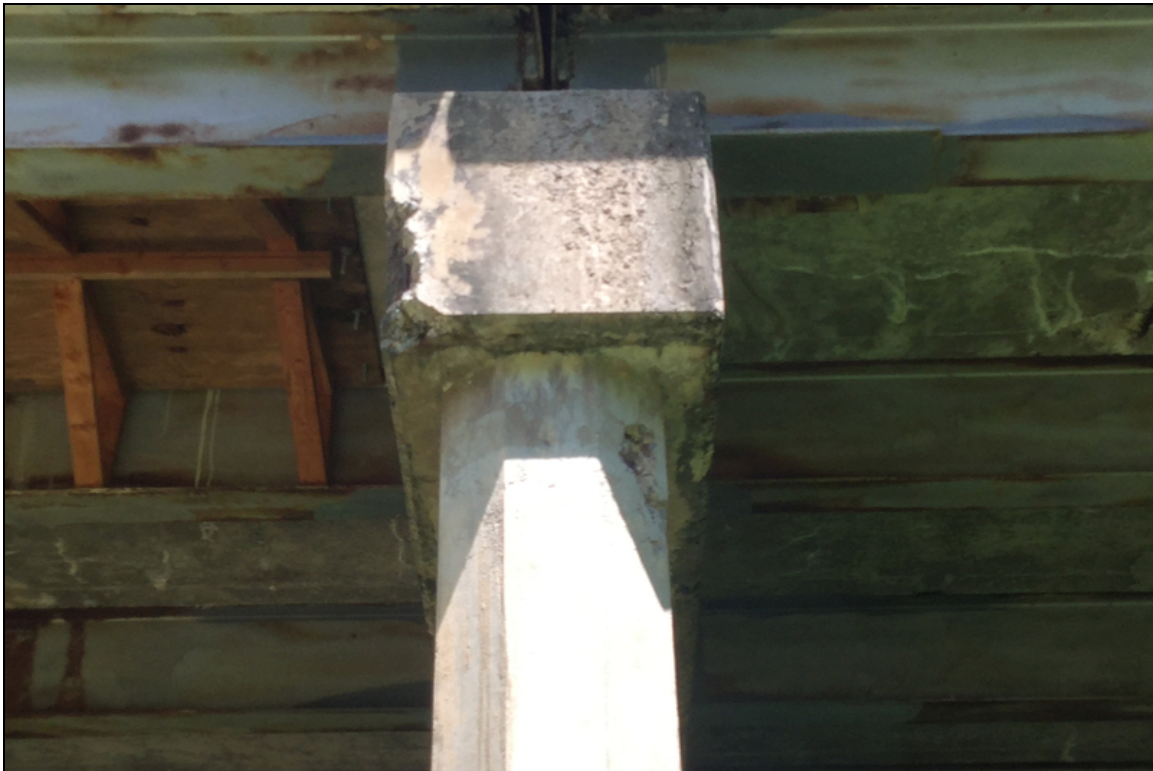
Bent 6 pile 4. Cap 6 spalling Cs3

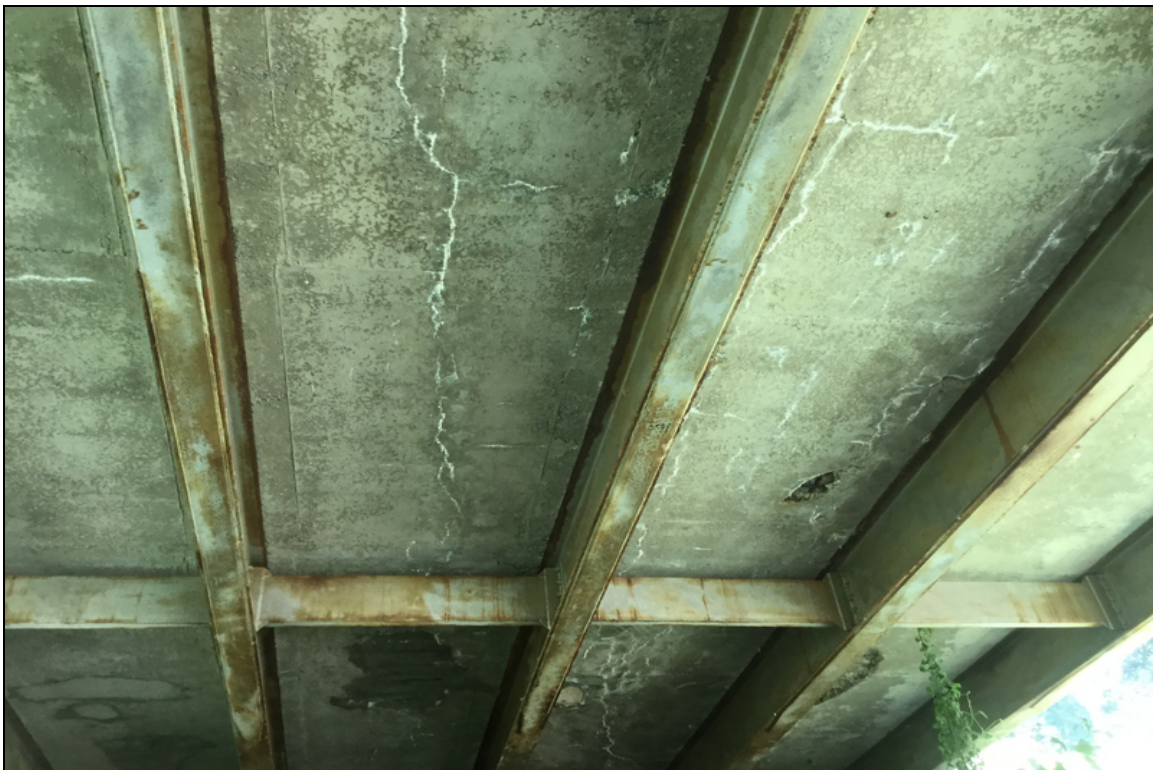
Span 7 cs3 efflorescence this is typical throughout under surface of the deck.

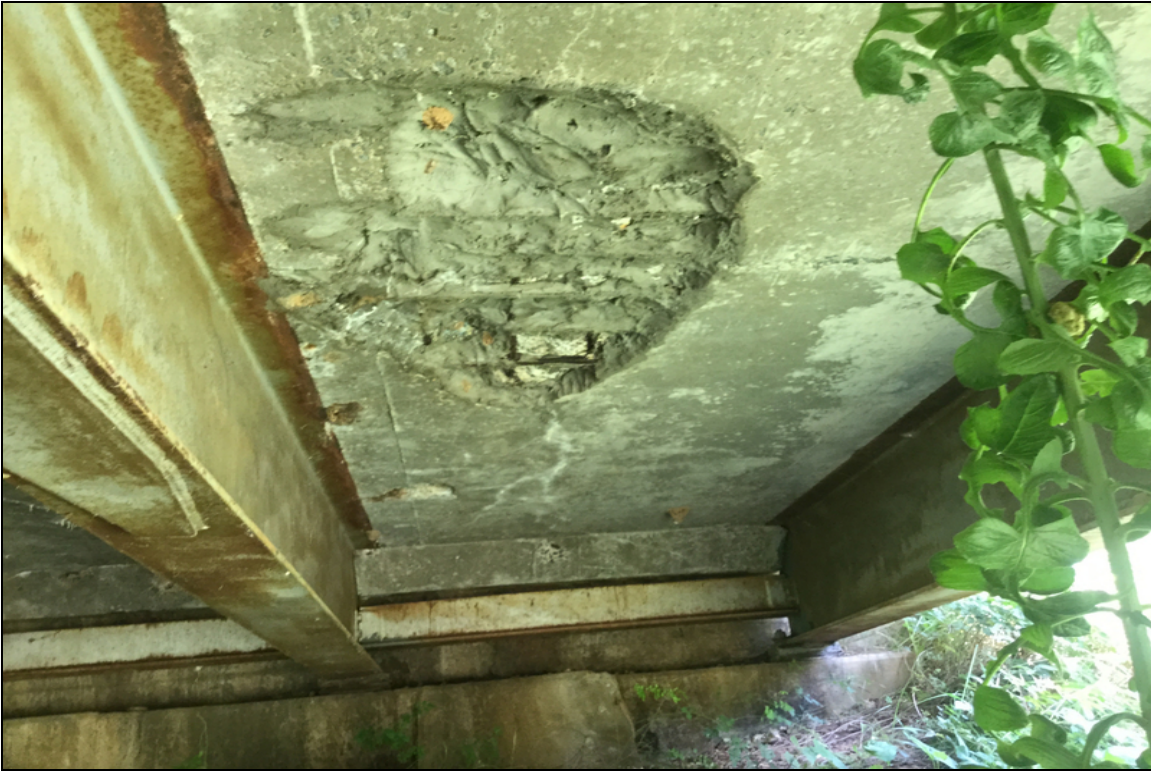
Span 7 bay 4 Cs3 rebar

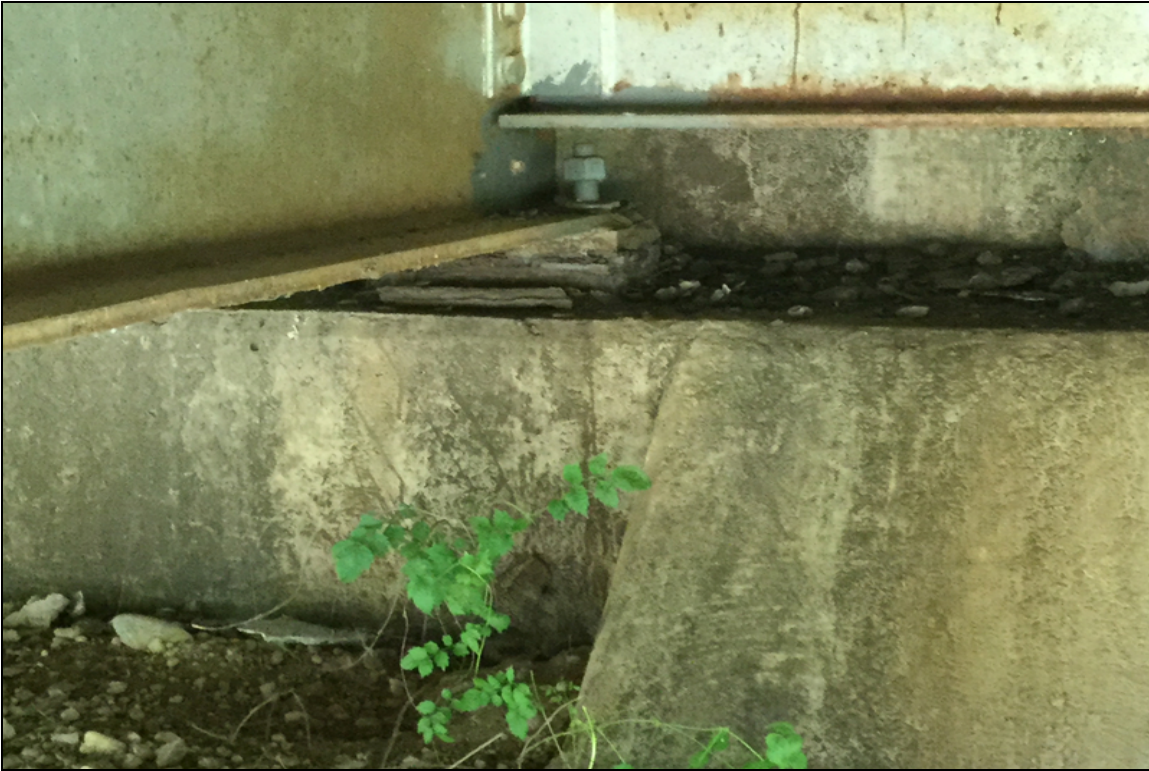
Abutment 2 bearing 4 pack rust Cs3 typical
