**Bridge #05470**(Routine, Underwater type 2)  
**SH 190-04 LM 5.53 over Derriousseaux Creek**

**Location: 5.53 Mi E SH 35-Ain**

**Team Lead:** Sharon Hooks **Inspection Date:** September 28, 2021

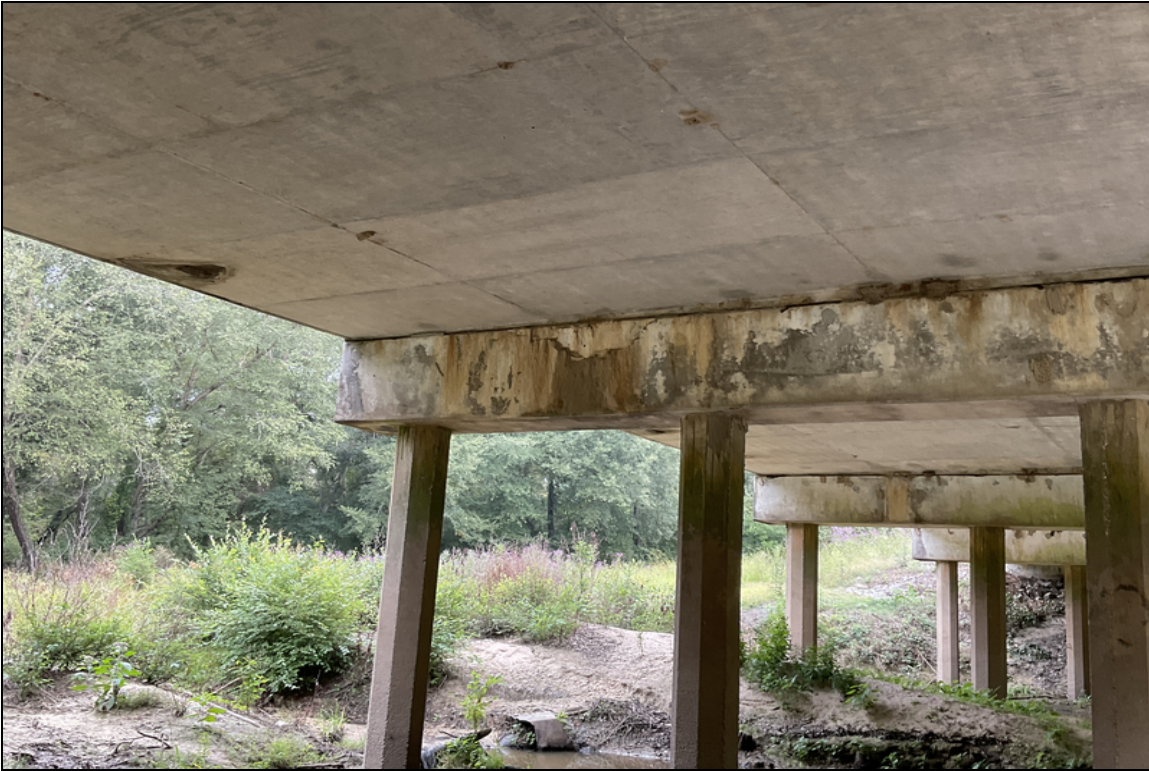
(234) Caps: 29' each / Bents 2-6. Bent 2 left end: Some minor-sized cracking. (2') Bent 4 back: Cracking/delaminations at top of cap around keyways. (8' total) Bent 5 back: Cracking/delaminations at top of cap around keyways. (6')							
301	Pourable Joint Seal	LF	130	0	0	130	0
2320	Seal Adhesion	LF	130	0	0	130	0

Bent 4 cap left back has delam.

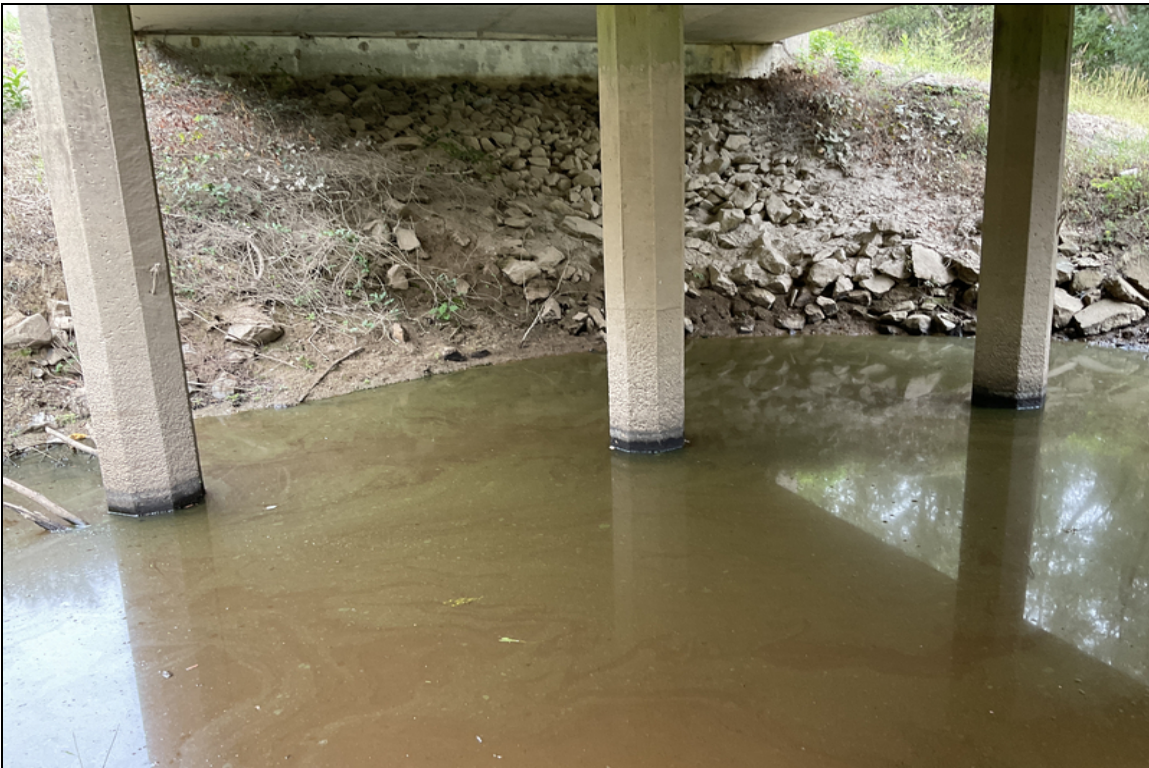
Abrasion on piles at Bent 2. Common on most piles at bents 2-5.

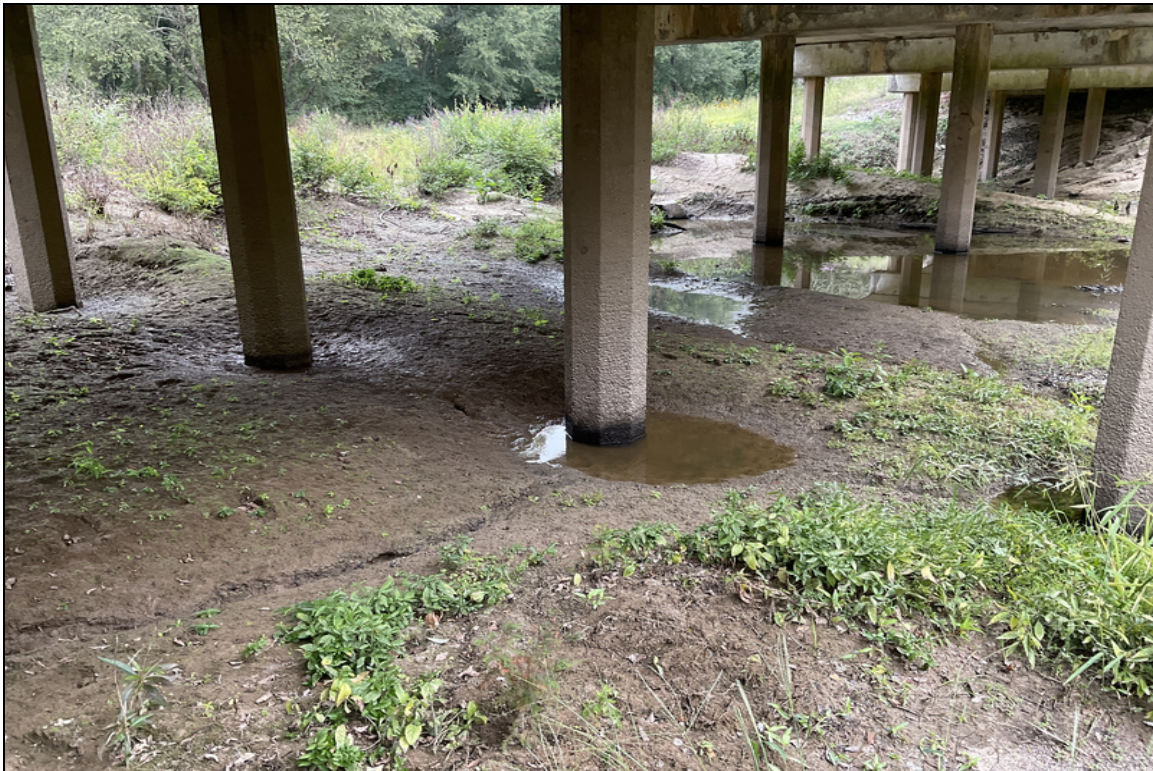
Localized scour at Bent 3. Common on most bents.

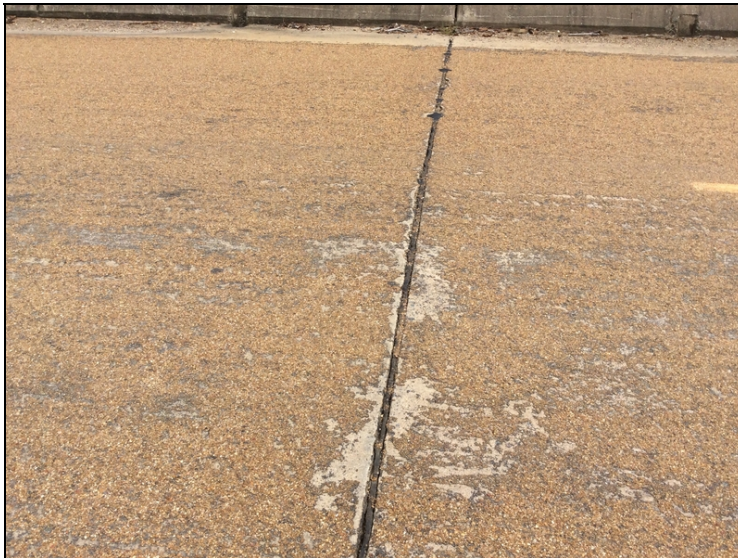
Joints – Bents 2-6: Poured joint material is intact but has lost adhesion, allowing stormwater to leaking through joint and onto cap.

Joint - Bent 2: Loss of adhesion

Repair, and advise when complete

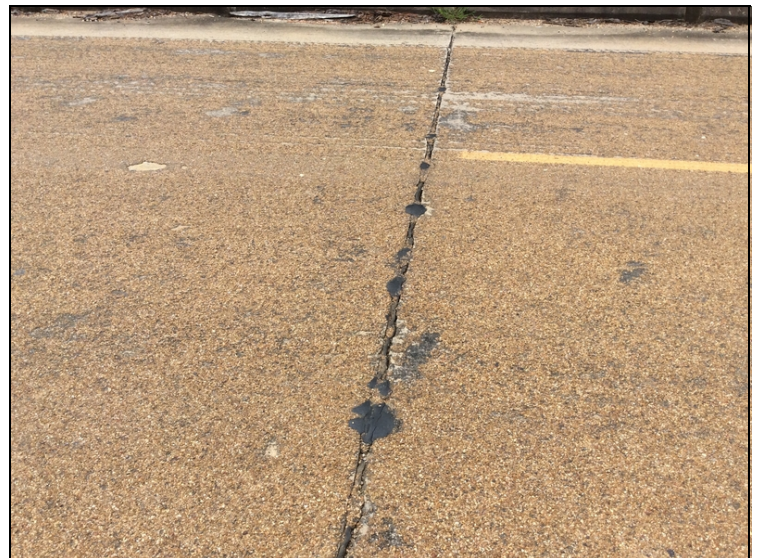
Joint - Bent 5: Loss of adhesion

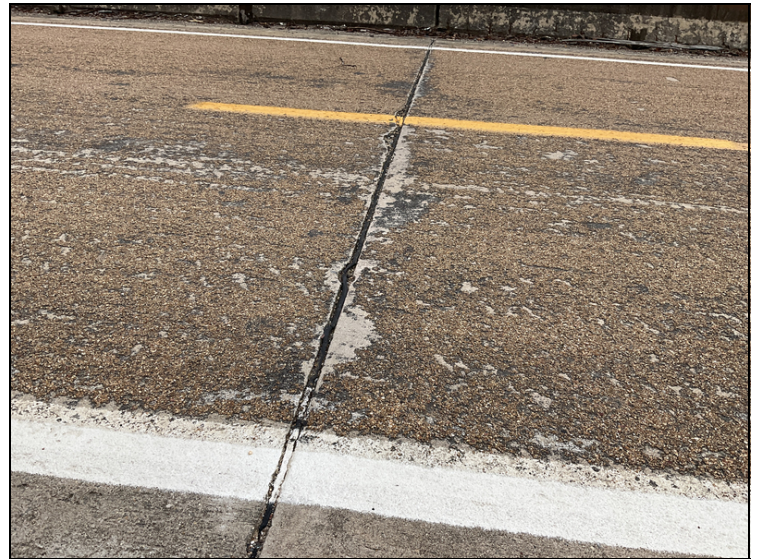
Bent 6 joint seal has loss of adhesion. Common on most joint seals.

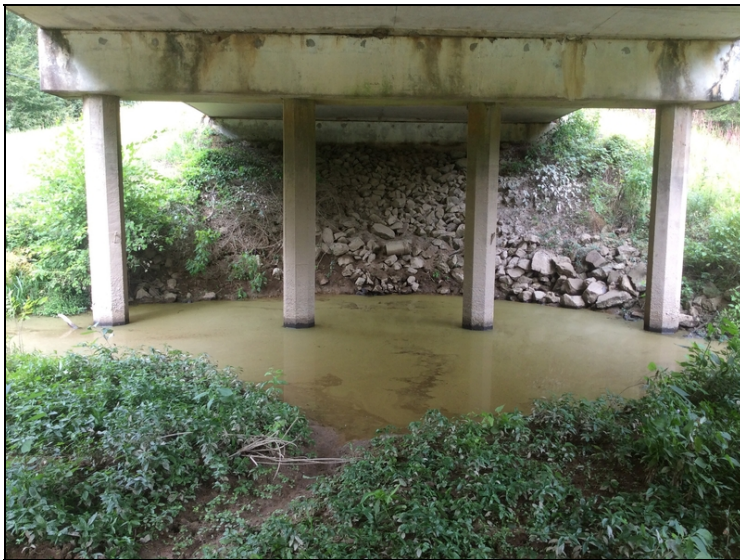
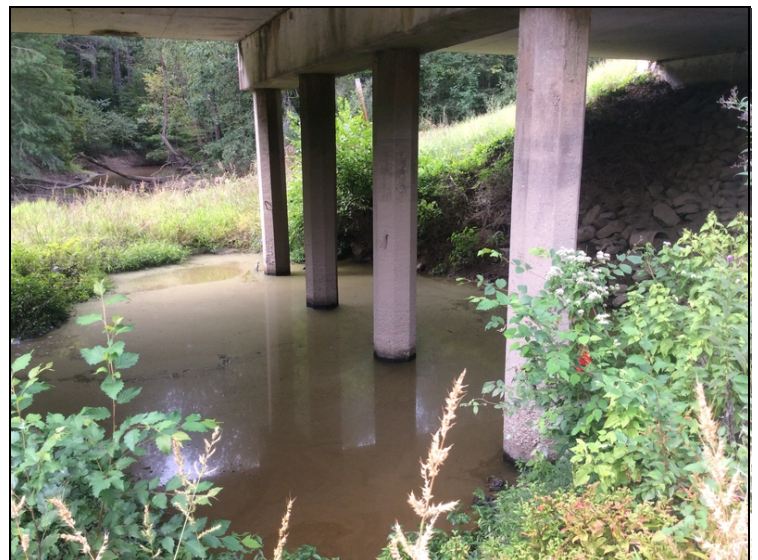
Channel - Bent 2: Significant localized scouring across entire bent - 16-18' to bottom of channel from bottom of cap.  
(Piling records show 32' pile - 13' remaining in ground.)

NOTE: Water in hole as of 09/11/2017 & 9/23/2019 inspections is about 8' deep at Piles 2 & 3.

David: Called Mike Hill - Heavy Bridge, he said the cure for this was to dump either rip or buttress stone on the upstream side of the concerned bent. Use rip if the water velocity is always slow, or go with buttress stone if the flow is high.

Charlie: might consider getting with Ronnie and haul and place rip in this area- we've got lots of it now.

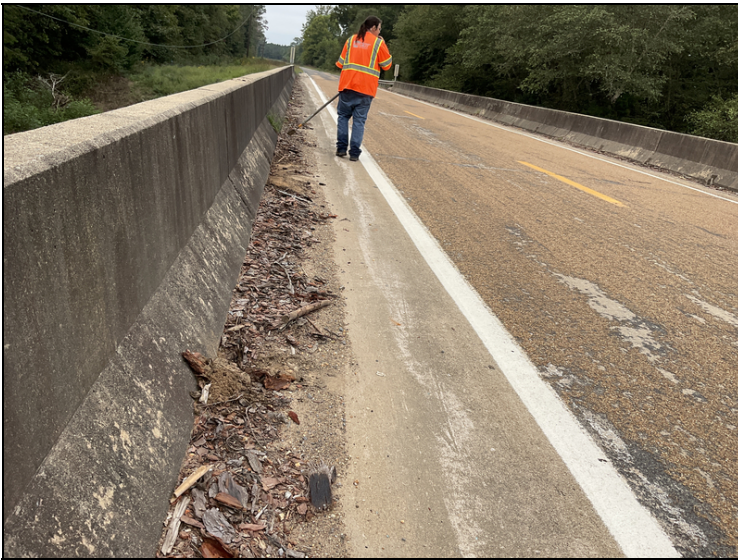
Gutter line both sides of deck filled with debris.

Gutter rlns full of debris blocking Drainage from  
deck.
