Bridge #06225(Routine)
US 63B-13 LM 4.15 over Bayou Bartholomew

Location: 0.34 Mi N I-530-PineBluff

Team Lead: Sharon Hooks Inspection Date: November 19, 2020

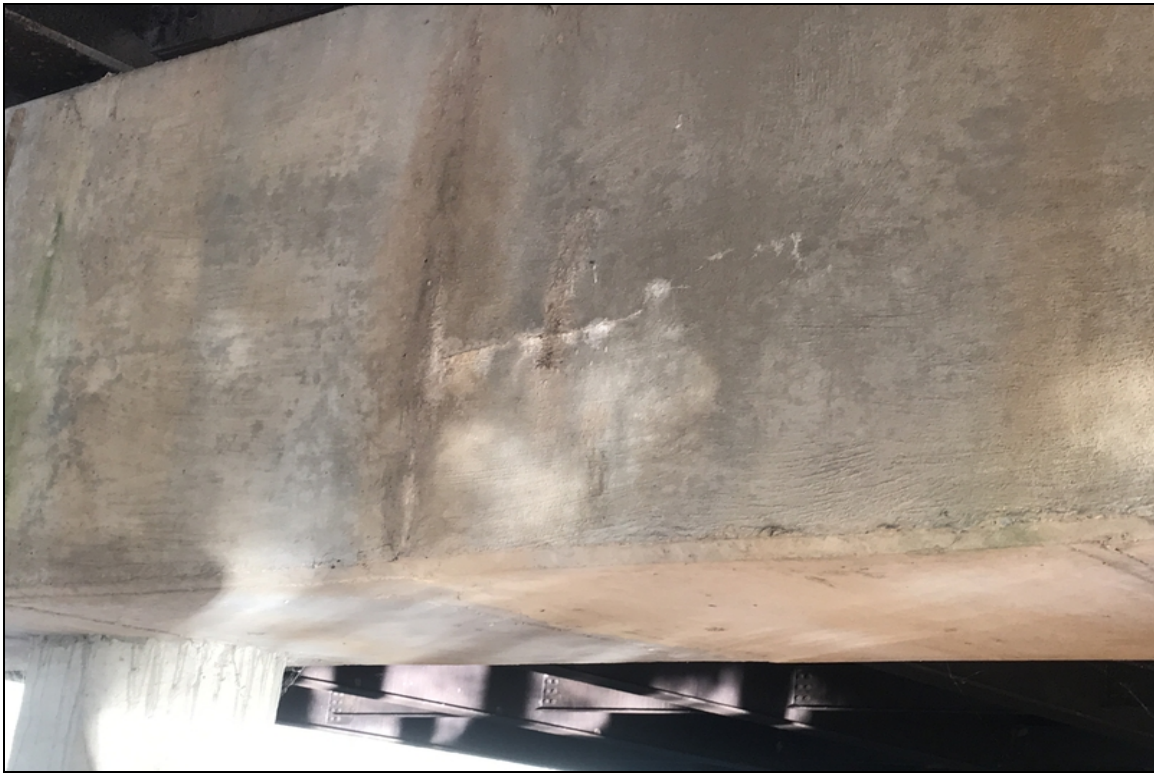
ELEM	DESCRIPTION	UNITS	TOTAL	CS1	CS2	CS3	CS4
(234)							
Caps: 68' each / Bents 2-6. Bent 2 ahead has small horizontal crack near cold joint. Bent 3 has light efflorescence at cold joint.							
302	Compression Joint Seal	LF	448	0	146	214	88
2320	Seal Adhesion	LF	20	0	8	0	12
2330	Seal Damage	LF	152	0	0	76	76
2340	Seal Cracking	LF	276	0	138	138	0

Bent 2 ahead has small horizontal crack with light efflorescence near cold joint.

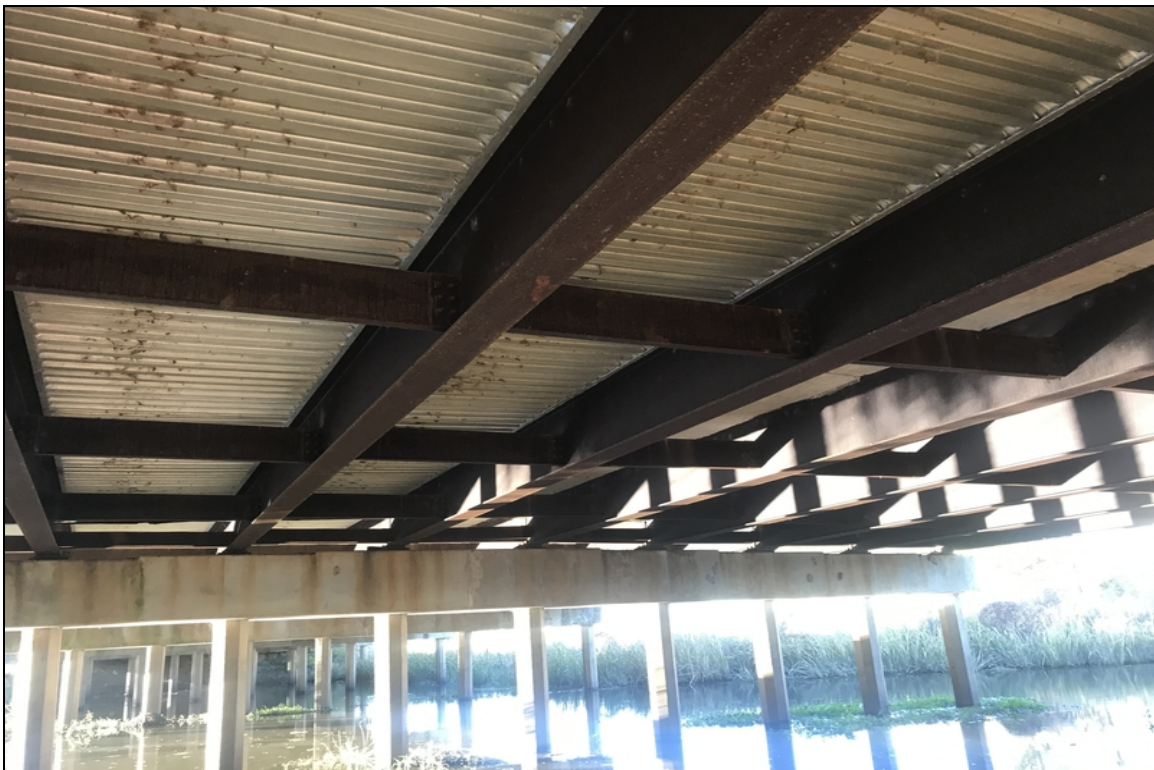
Overview of soffit and girders.

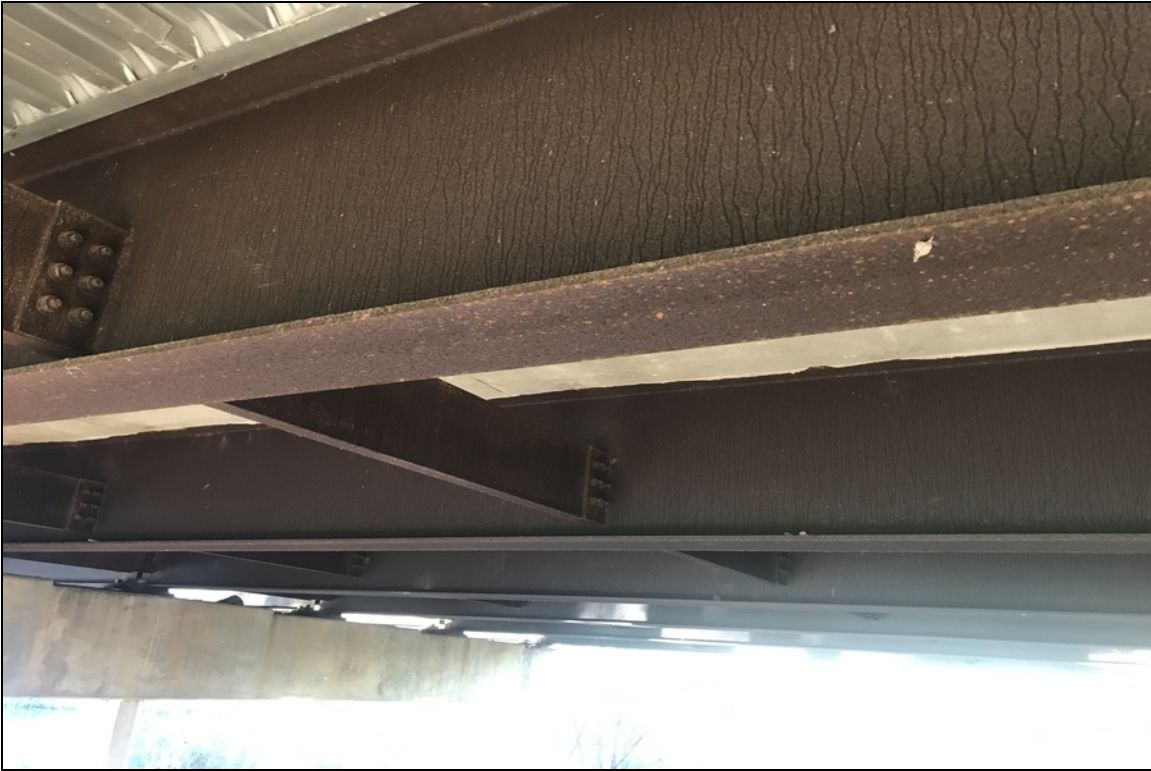
(107)	<p>Girders: 10 per span / 297.3' total.</p> <p>Coating: (W 27 x 84) 6.78 square feet per linear feet of girder.</p> <p>Some scattered corrosion beginning where stormwater is leaking through joints.</p> <p>Girders are brown with light granular texture.</p>						
215	Reinforced Concrete Abutment	LF	140	140	0	0	0

Typical girder condition.

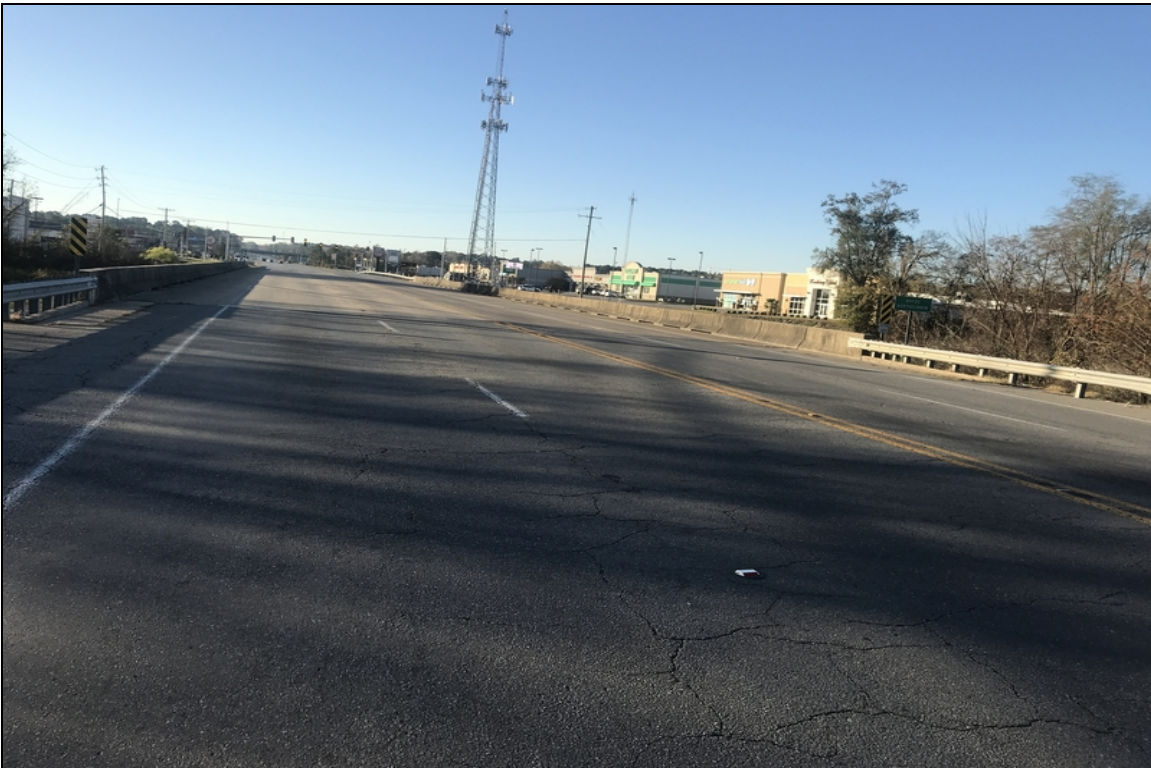
Approach.

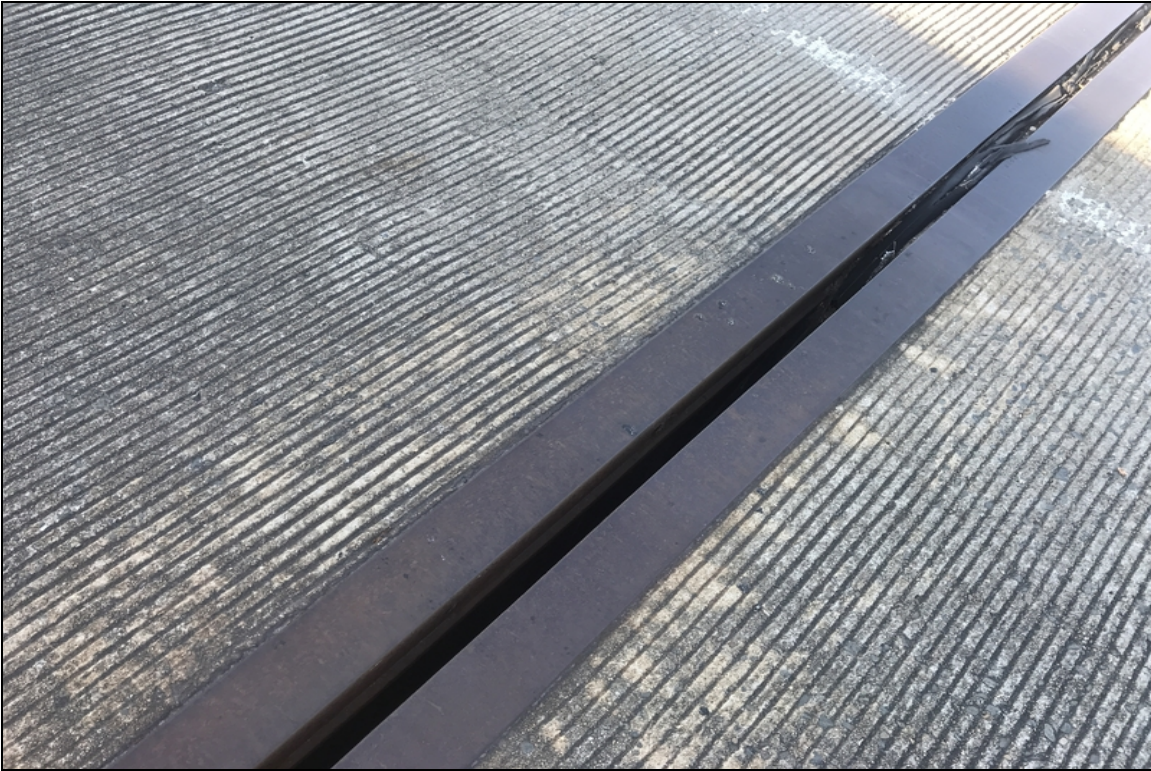
Bent 4 left seal missing in shoulder area.

Bent 4 left: Joint material has fallen out of place on left shoulder. Heavy tattering and damage to remaining joint material.

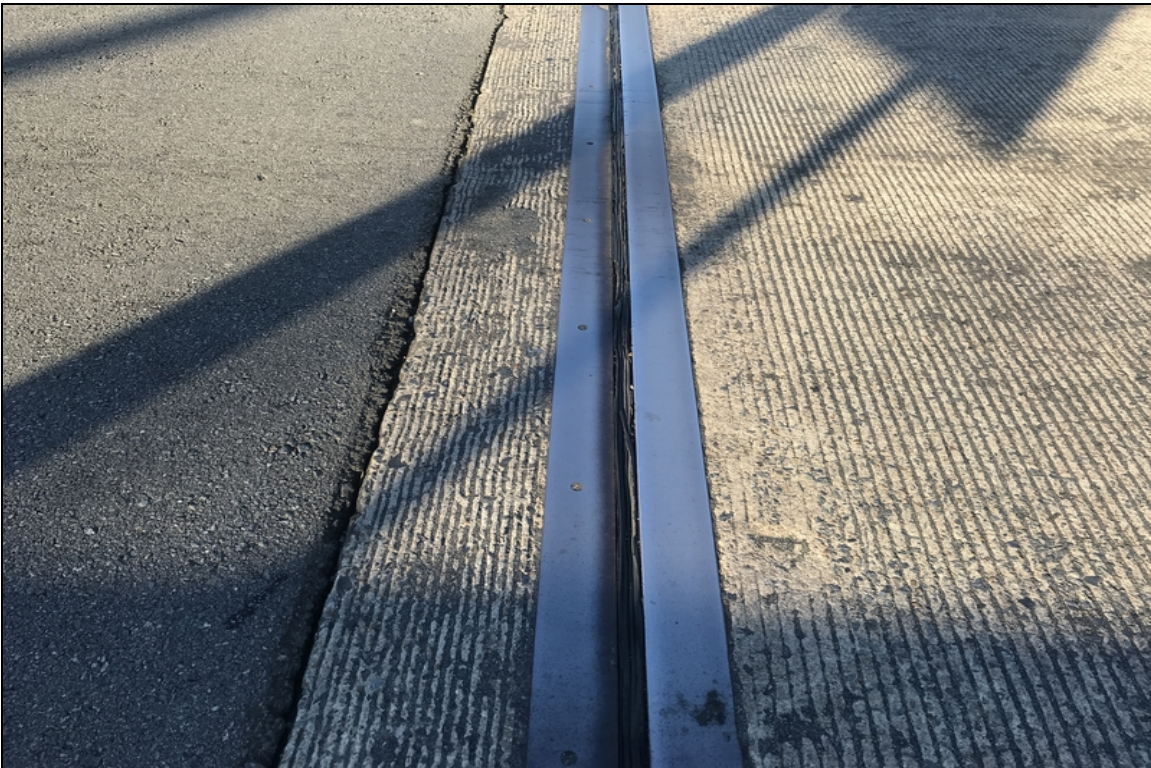
Joint seals torn and leaking.

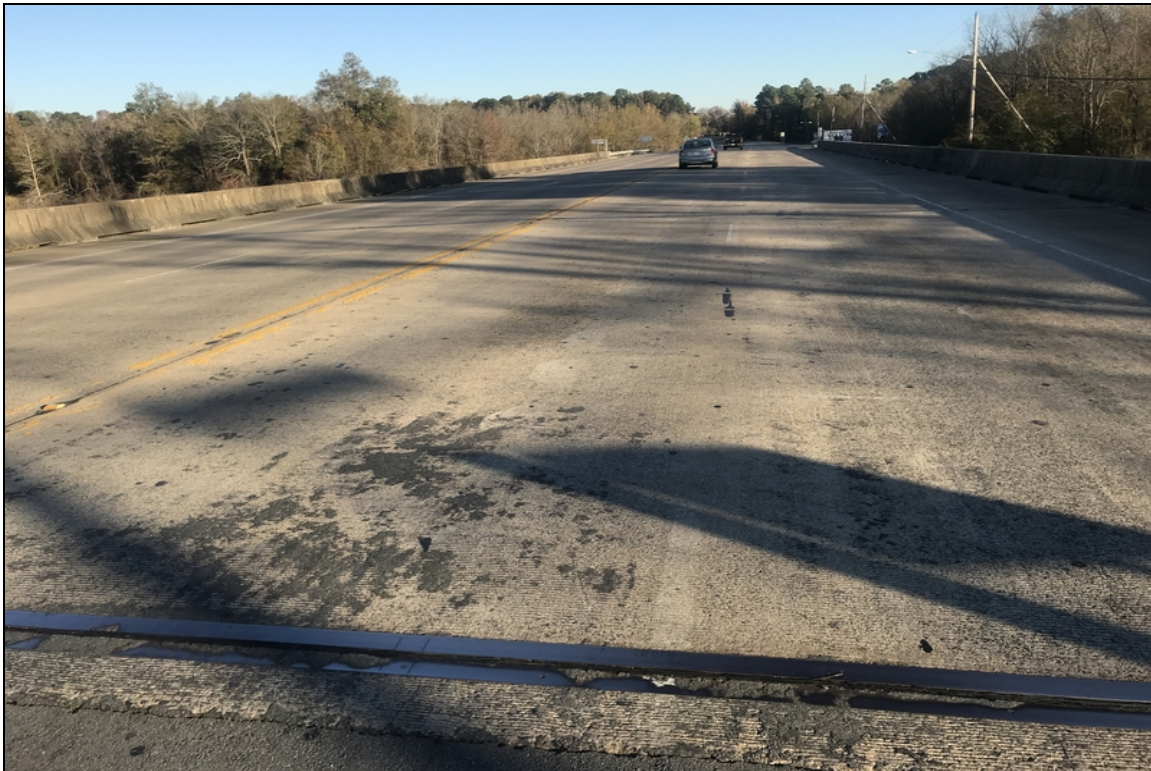
Deck overview.

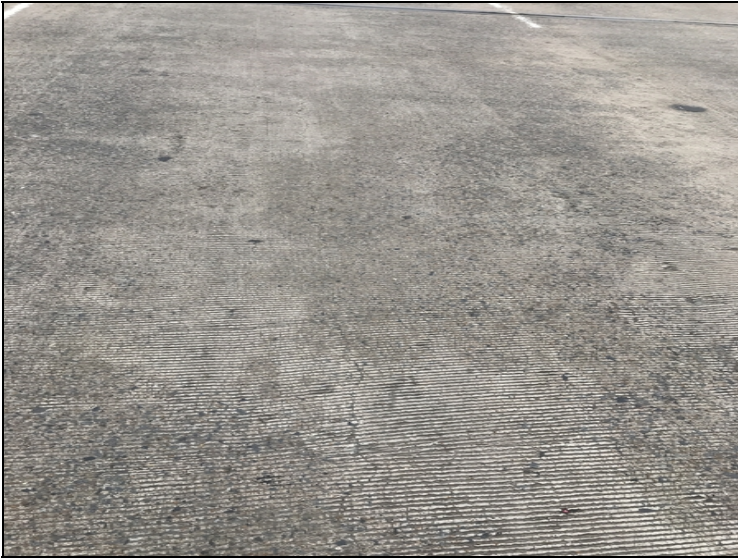
Deck – all spans: A few unsealed, minor-sized longitudinal cracks, mainly in outside lanes.

Deck - Span 2 left : Cracking

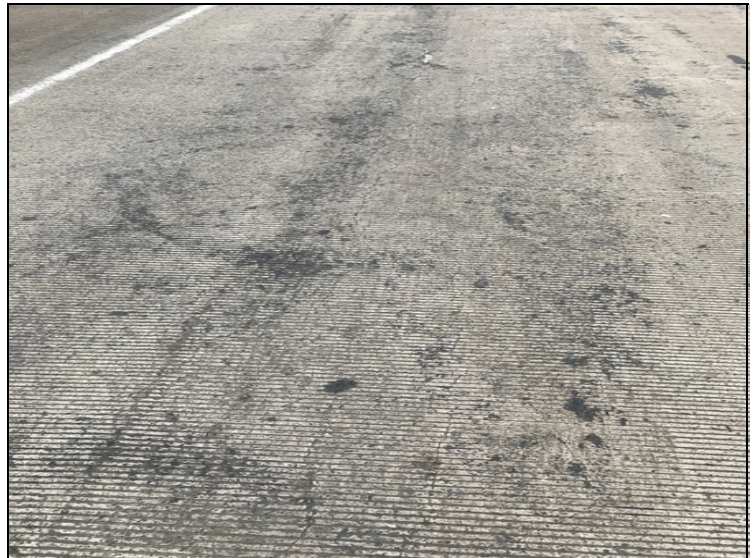
Deck - Span 6 left : Heavy cracking

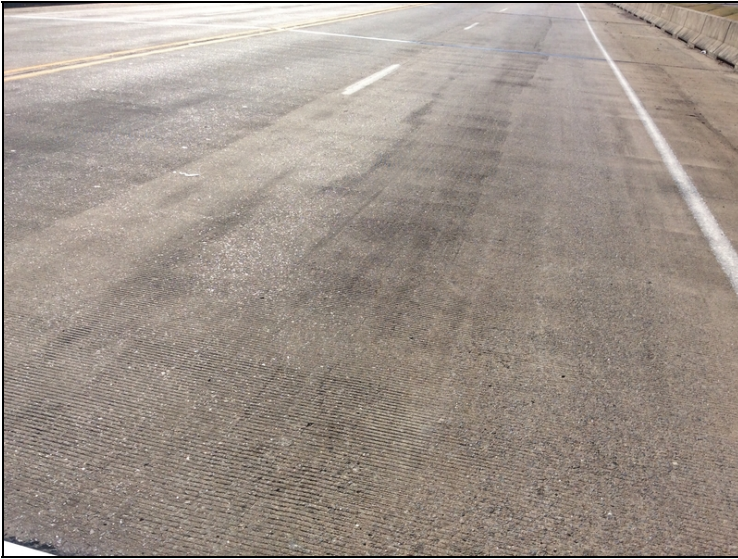
Deck - Span 1 (longitudinal cracking)

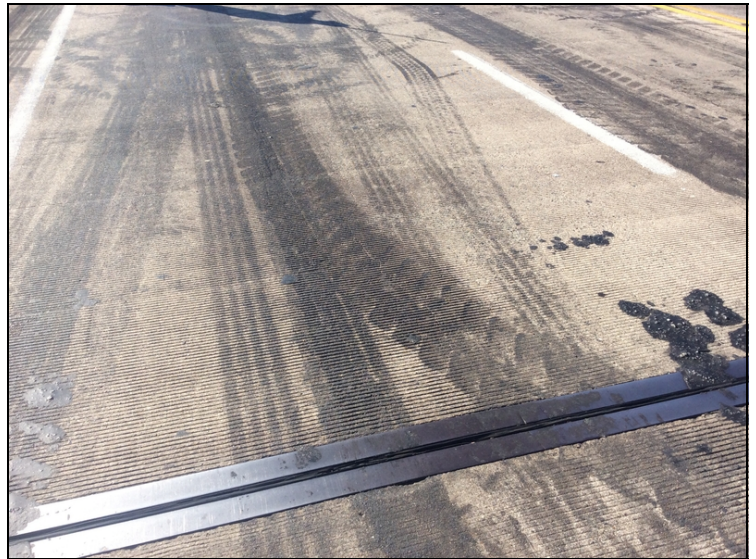
Deck - Span 6 left (longitudinal cracking)

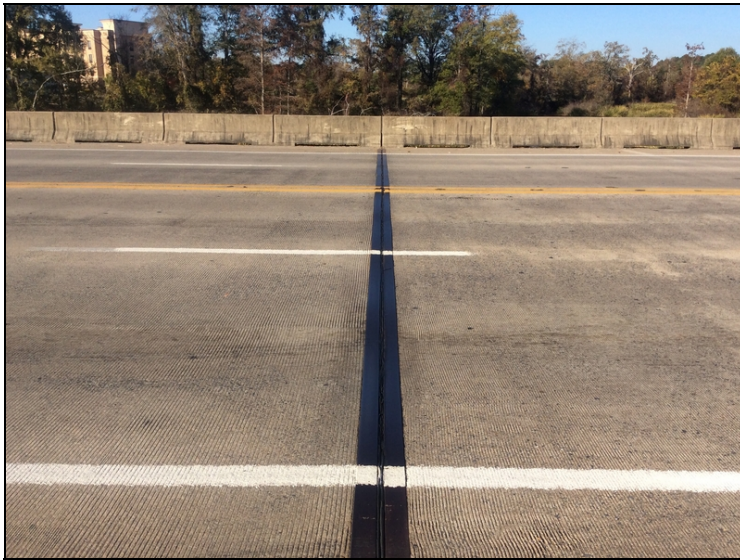
Bent 3: Significant tattering and damage to joint across travel lanes and right shoulder.

Joint - Bent 3 (damage)

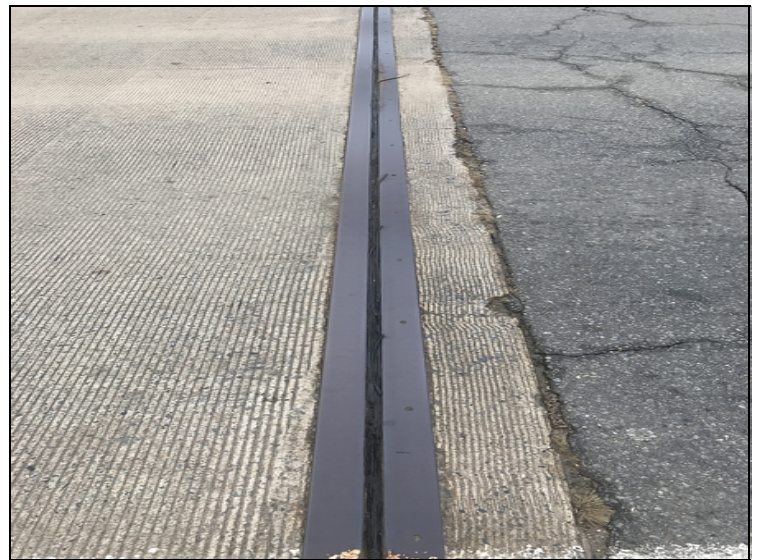
Bent 1: Some tattering and damage to joint, mainly on right shoulder and right outer lane.

Joint - Bent 1 : Tattering

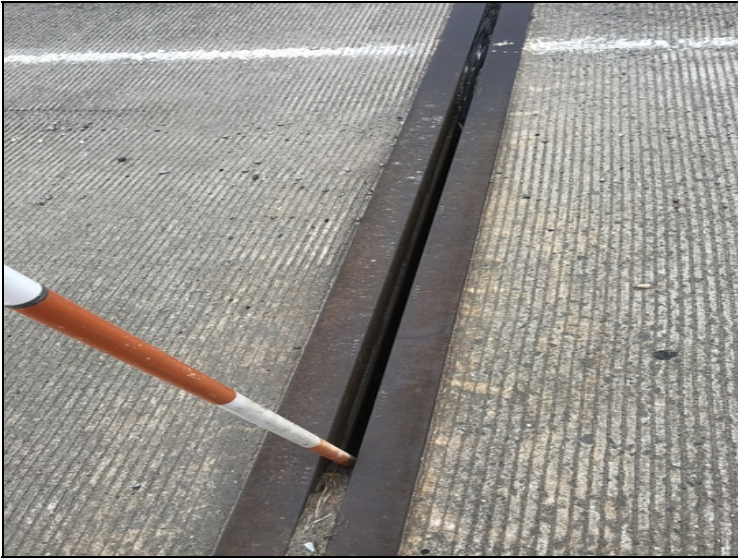
Joint - Bent 4: Loss of adhesion

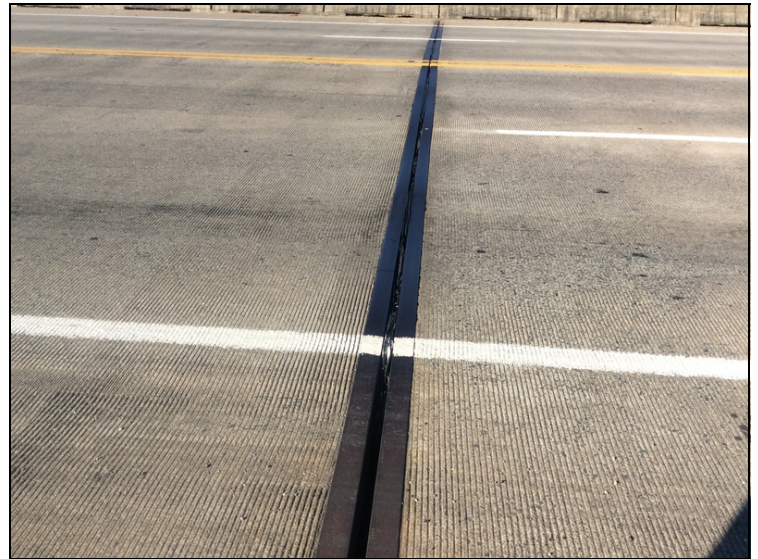
Joint - Bent 4 (damage & loss of adhesion)

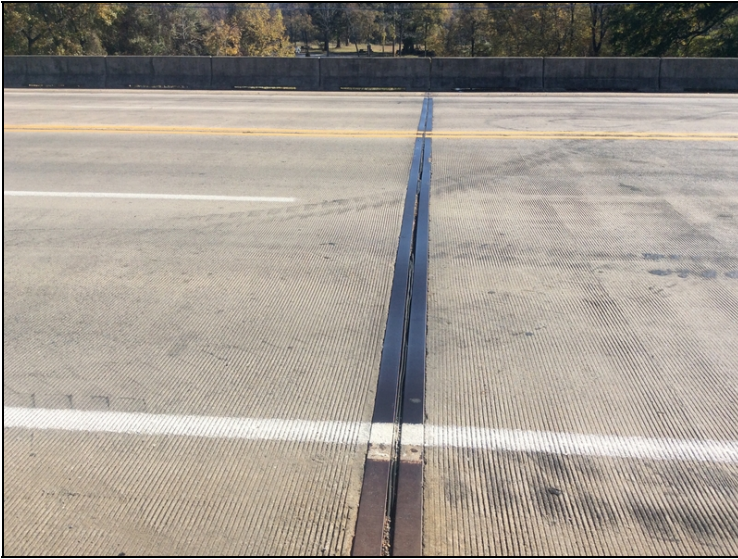
Bent 5: A couple areas of sagging with debris build-up on top of joint material, mainly in right side travel lanes.

Joint - Bent 5 (loss of adhesion)

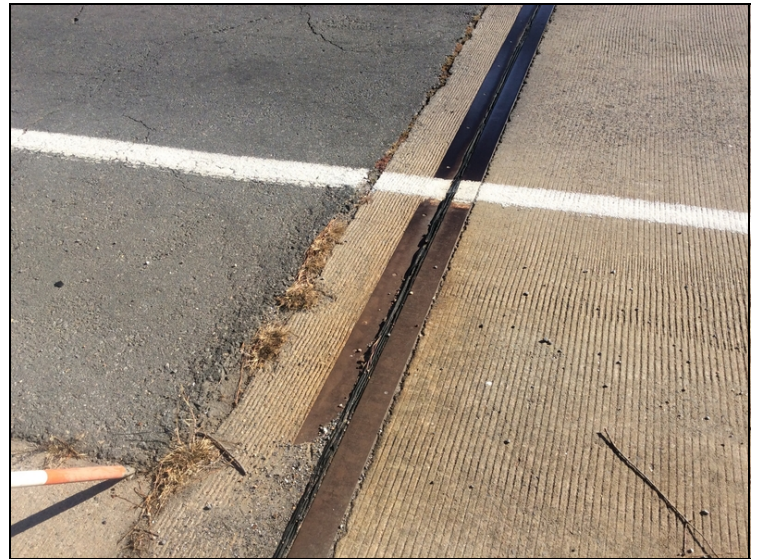
Joint - Bent 1 right (damage)

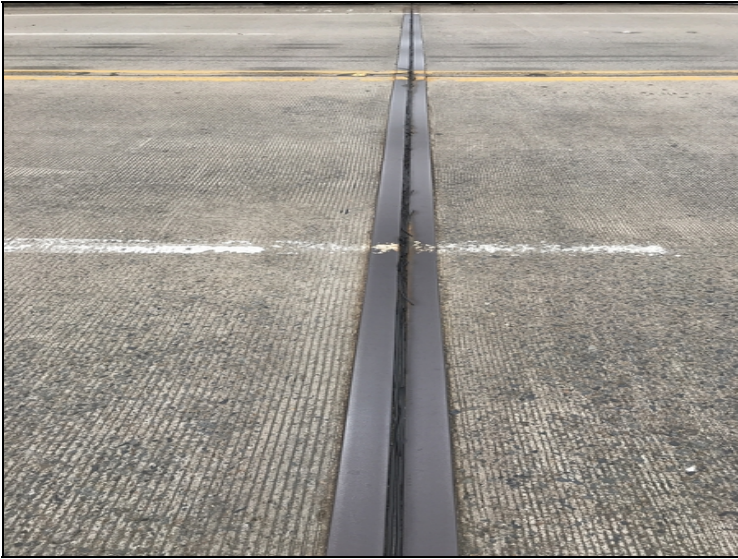
Bent 2: Significant tattering and damage to joint in center of right side travel lanes.

Joint - Bent 2 : Damaged

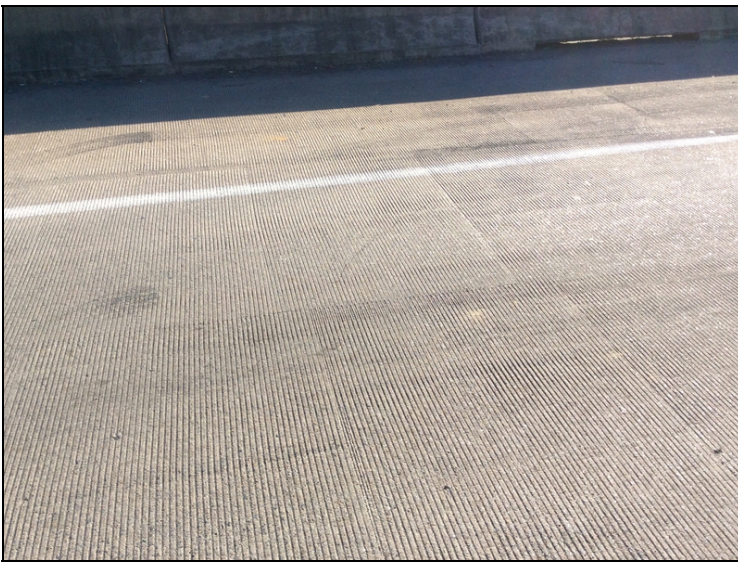
Deck – Span 1 left: One unsealed, hairline- to minor-sized diagonal crack, in outside (left) lane near Bent 1.

Deck - Span 1 left (diagonal crack)

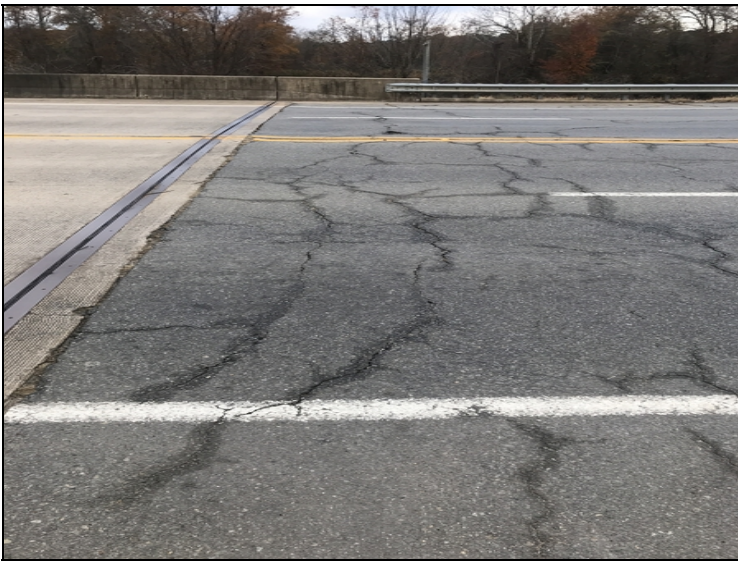
Approach roadway – Bent 1: Some deterioration and minor settlement of roadway right at bridge ends, resulting in a slight bump going onto or coming off bridge.

Gap between asphalt and backwall is allowing stormwater to leak down behind backwall and abutment and cause minor erosion on end slope.

Approach roadway - Bent 1 : Pot hole and cracking

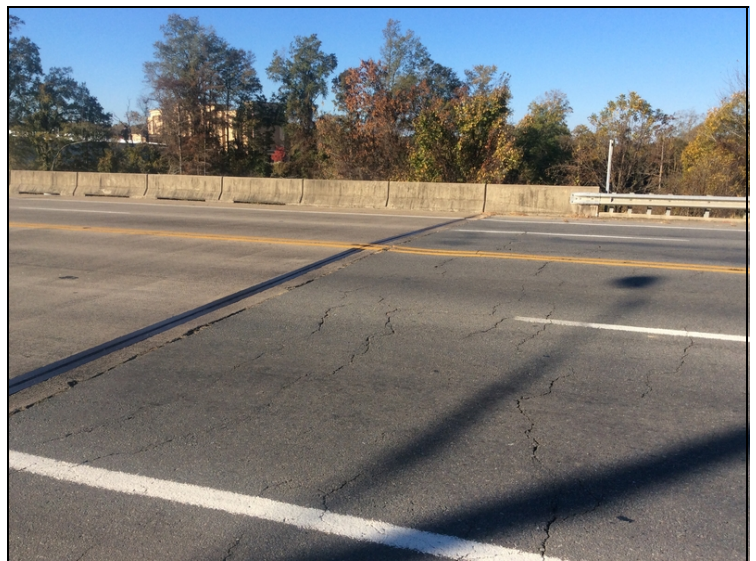
Approach roadway - Bent 1 (settlement)
