Bridge #05436(Routine, Underwater type 2)
SH 138-03 LM 20.94 over Bayou Bartholomew
Location: 2.8 Mi W US 65-Winchester

Team Lead: Sharon Hooks **Inspection Date:** July 13, 2021

Bridge #05436(Routine, Underwater type 2)

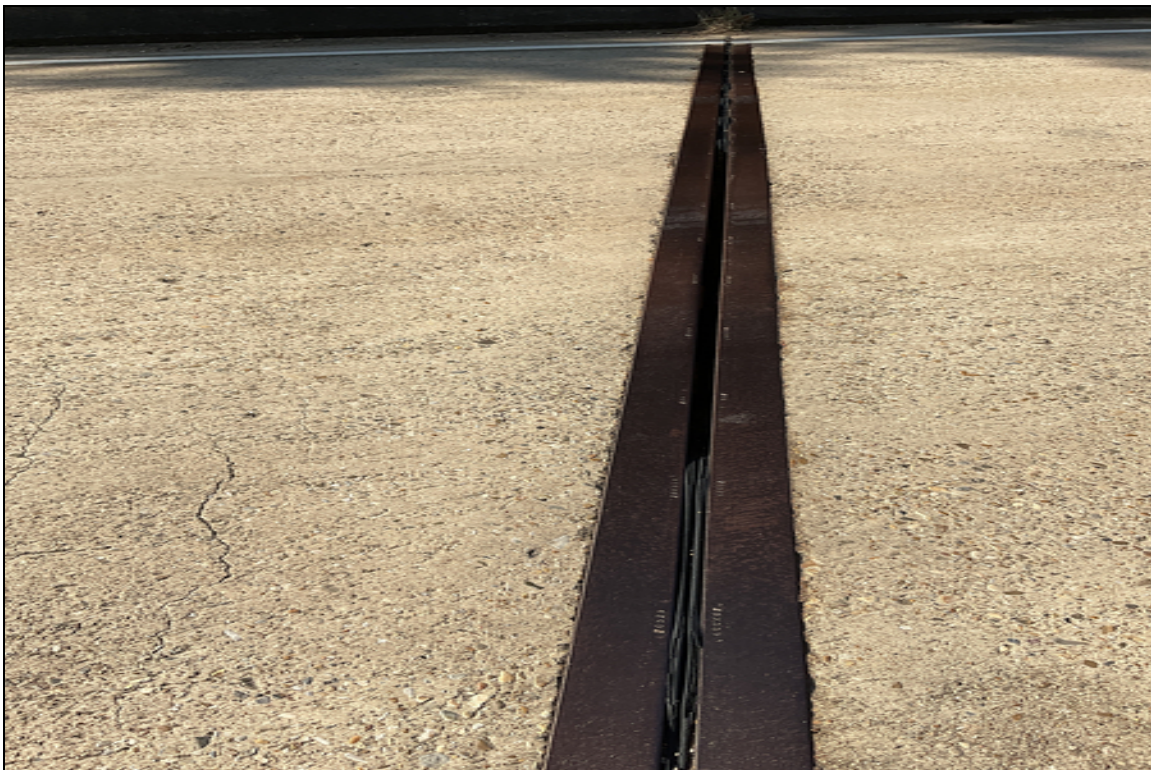
Bent 6 joint material missing.

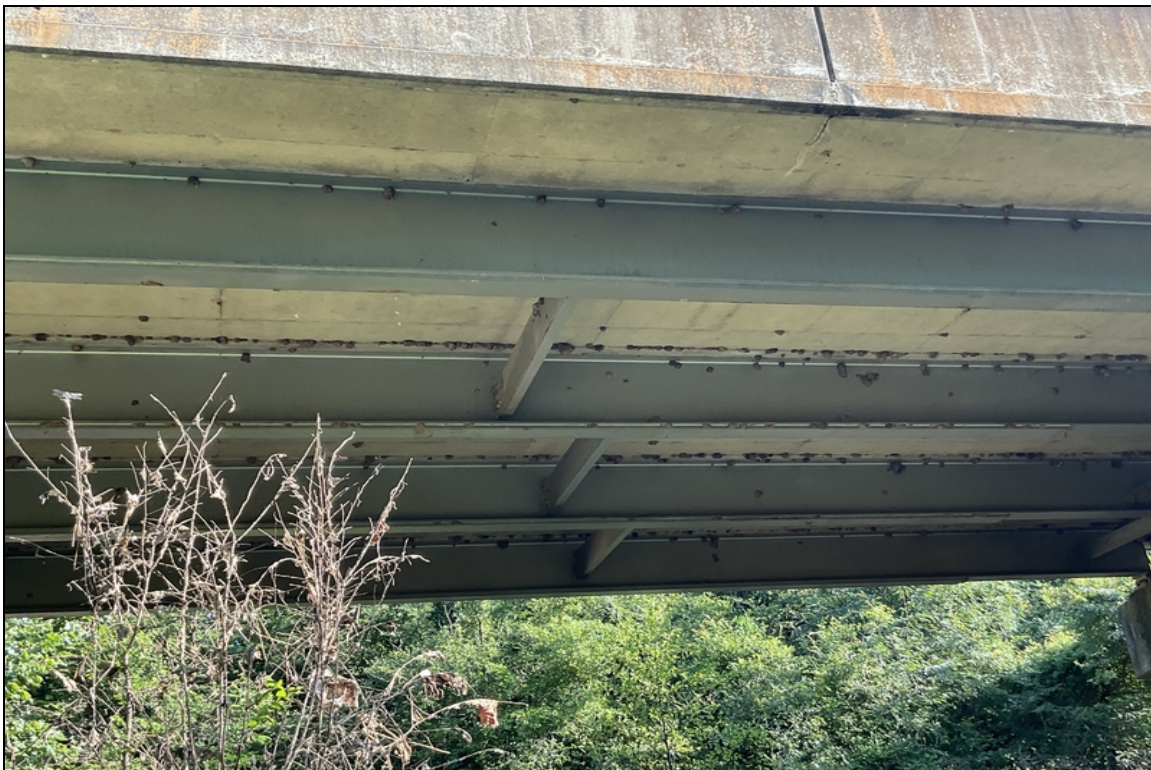
Typical paint condition.

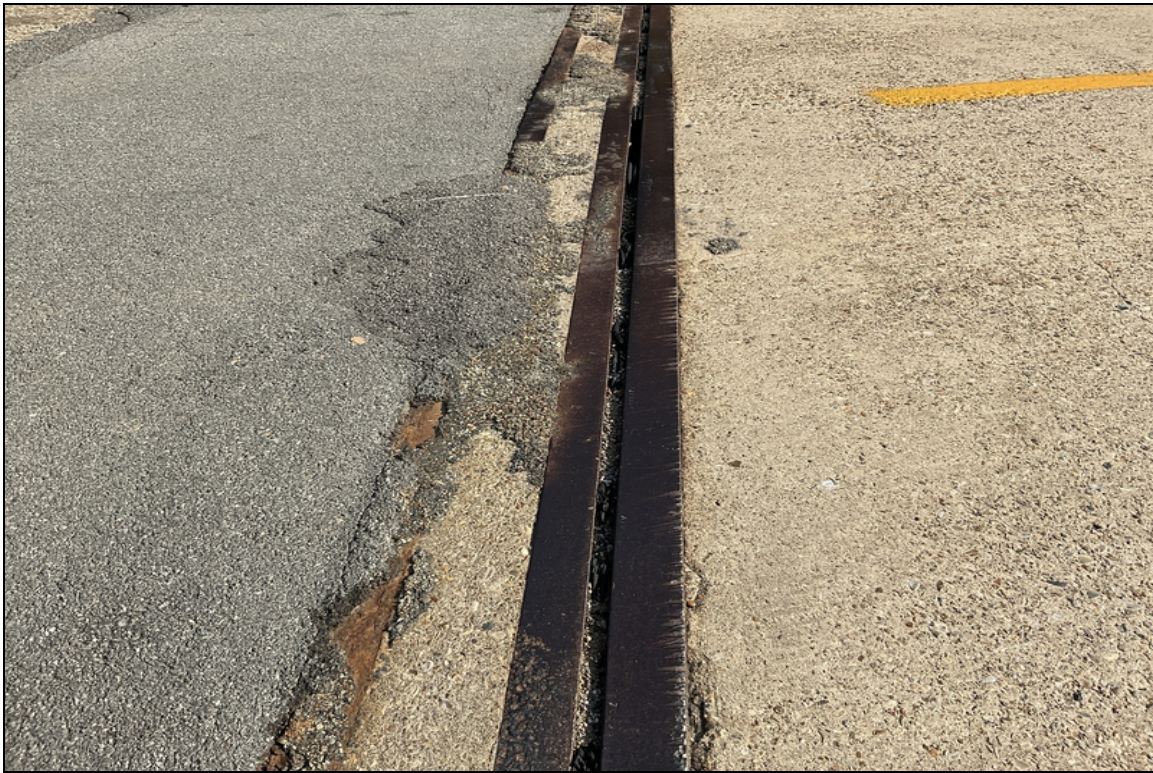
Span 1 joint seals are torn with small areas missing and have debris impactation.

Remove the old joint material, clean the joint thoroughly, and replace.

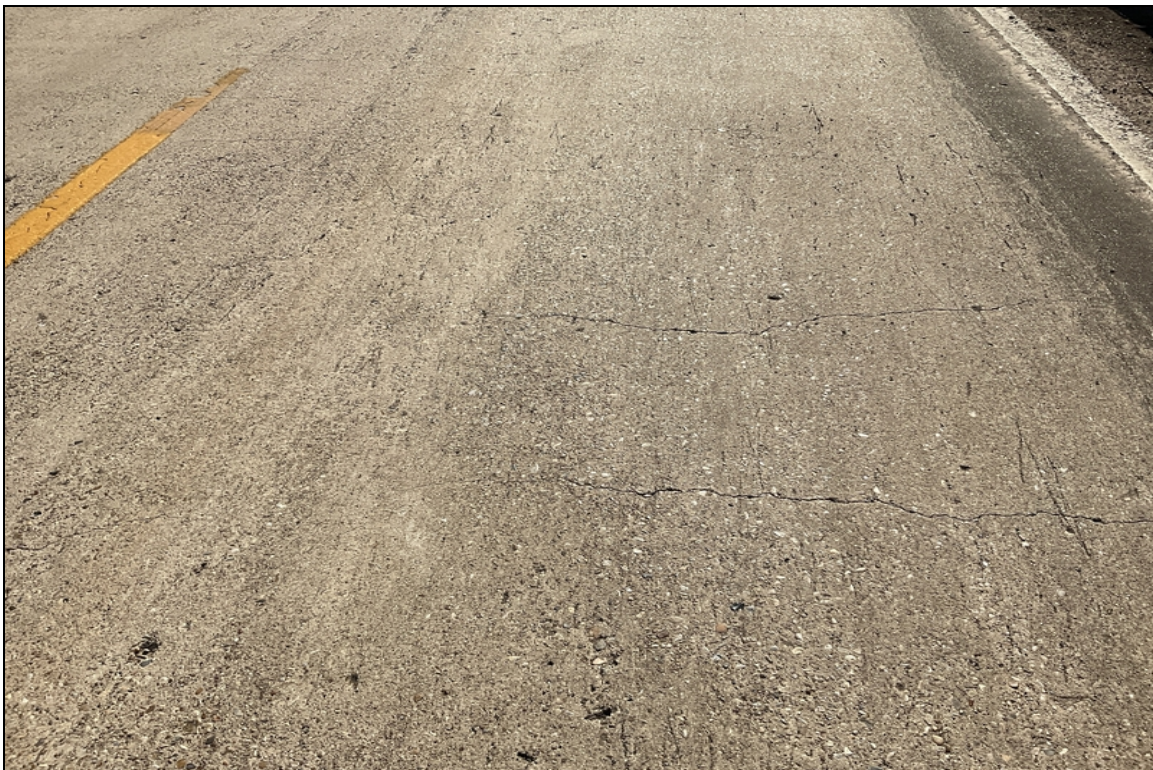
Deck span large unsealed cracks.

Deck – Spans 1- 6: Numerous unsealed, moderate to large sized transverse cracks (spacing – 2-4').
No evidence of cracking or efflorescence on soffit.

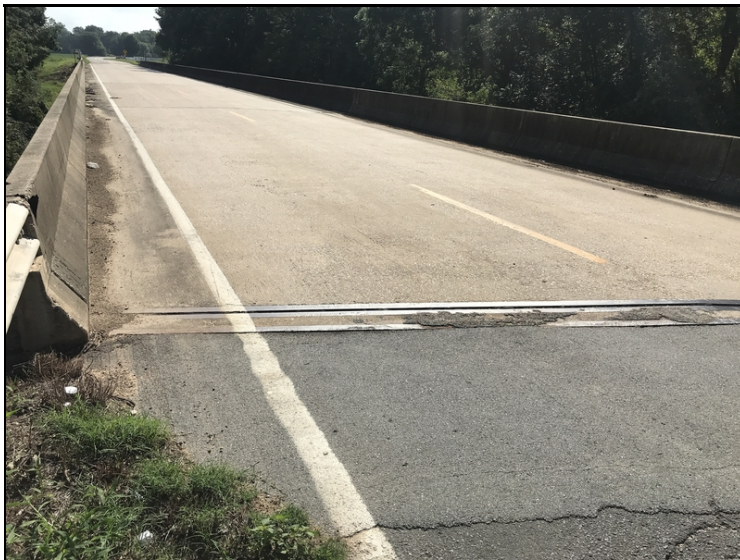
Deck - Spans 1-6: Typical

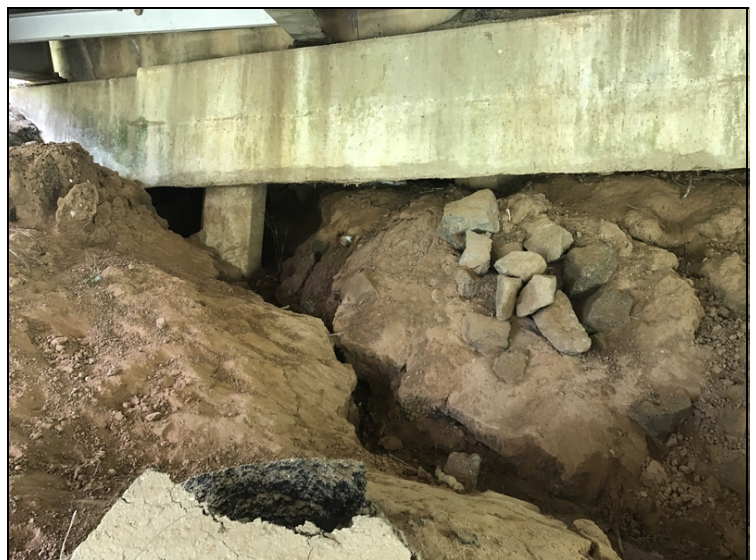
Abutment - Bent 1 right

Endslope - Span 1: Significant erosion under abutment cap and down slope - exposing bottom of cap and pile back to approach roadway.

Erosion appeared to have been caused by a hole eroded at the right side of bridge end and along side of roadway, allowing stormwater to flow down and under abutment - hole has been filled and roadway patched at bridge end, but voids still exist in endslope.

Existence of voids is evidenced by settlement of left lane roadway surface just inside edge line, right at bridge end.

"Let's look at this one and see if we can form up and replace some of the lost material with flow able select material. Let me know if you have additional ideas on a repair? We also possible could core through the roadway and see if the void is there. Would be a good place to pump??? Gerald / Ronnie: I think this is a hold over note from David Henning??? I say lets pack rip up against and under the cap. Advise when complete"

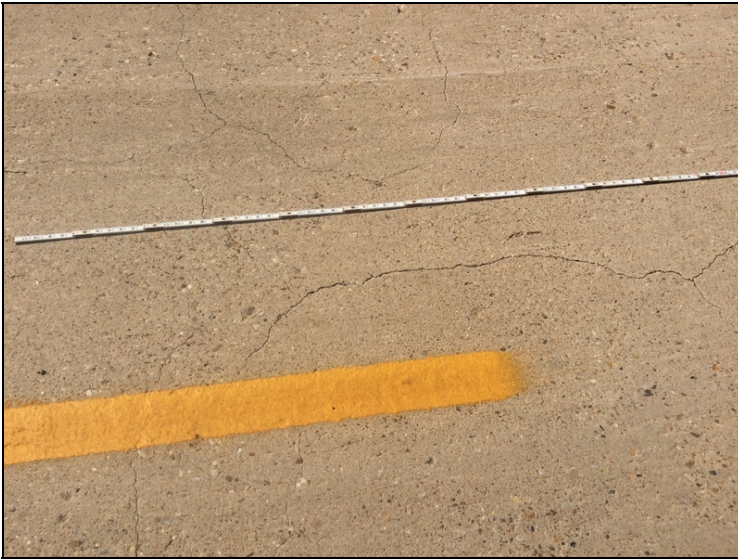
Span 5 deck cracks

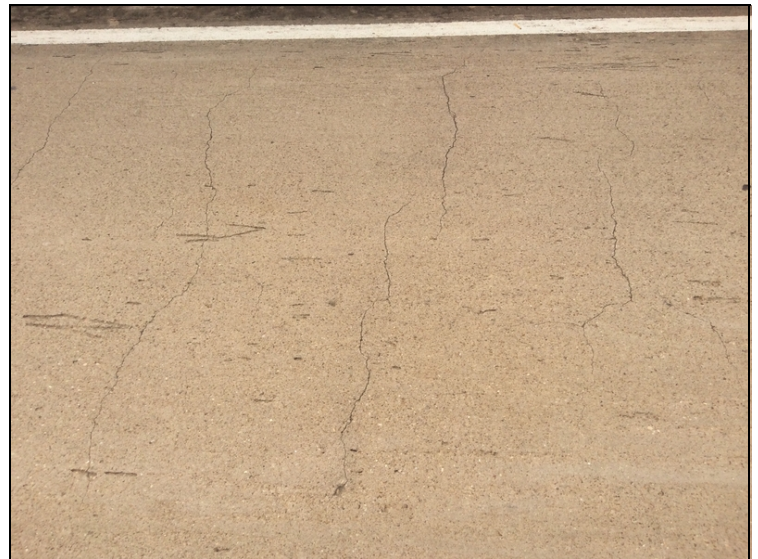
Deck span 4 has large unsealed cracks up to 0.060"

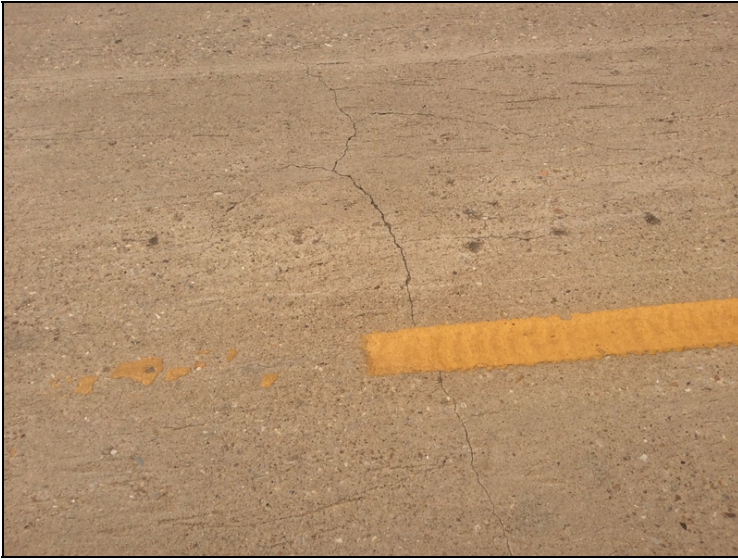
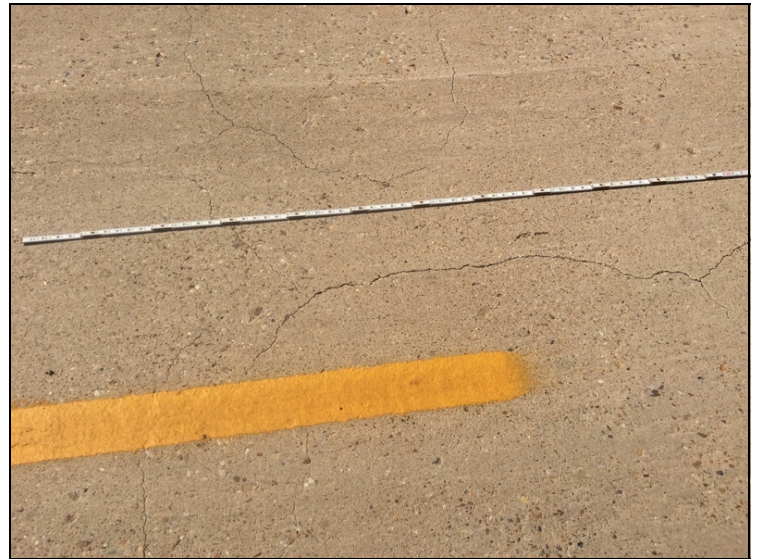
Span 5 deck has unsealed cracks up to 0.060"

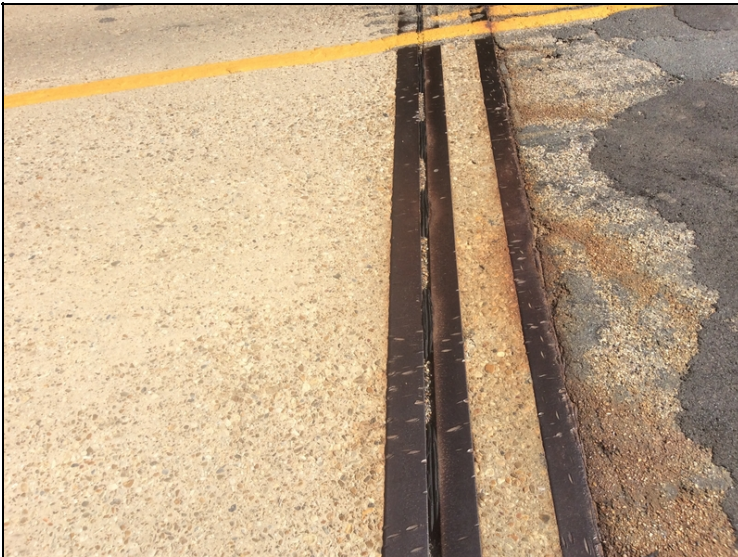
Preformed joint material is worn and tattered in places - with material missing in several places, and is beginning to leak stormwater down through onto ends of girders and caps.

Joint seal

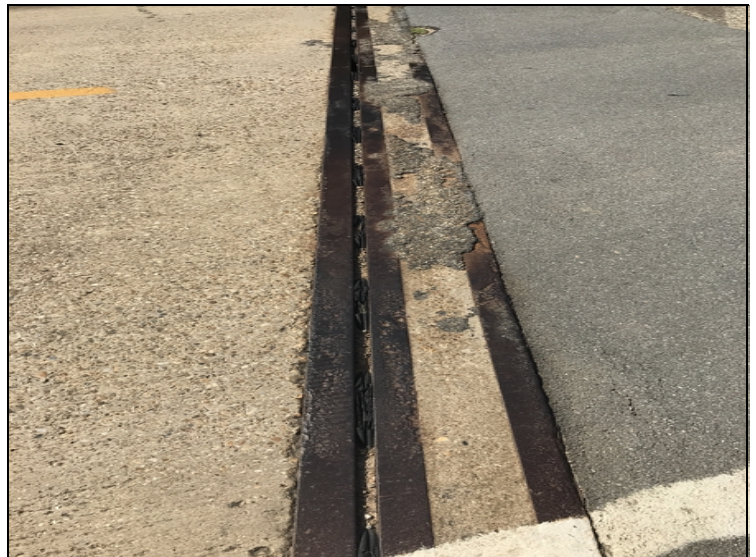
Bent 1: 1' piece of material missing @ centerline.

Joint - Bent 1

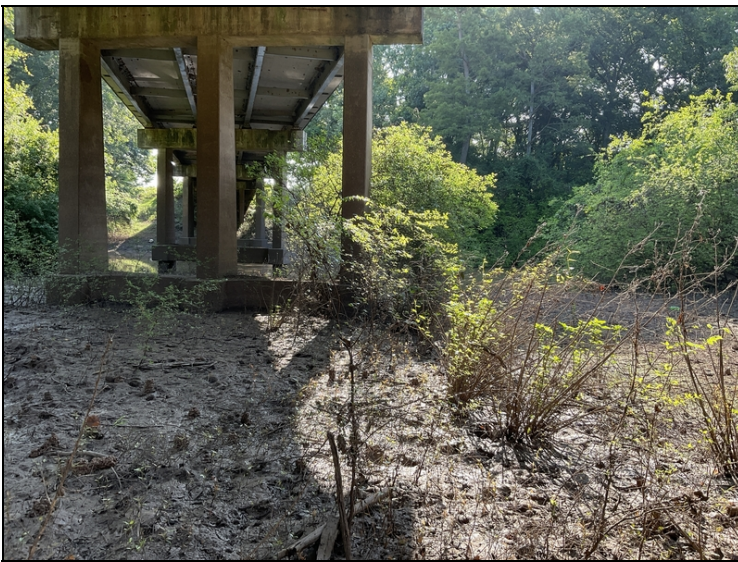
Trees growing under bridge.

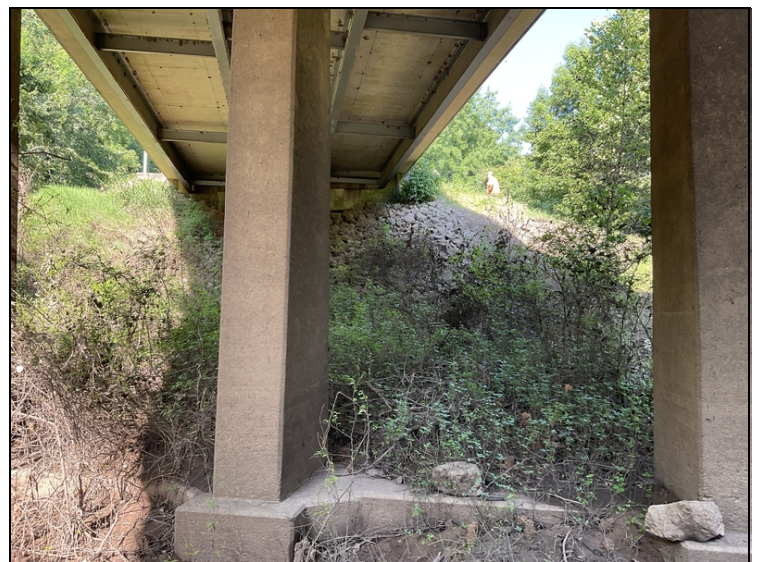
Trees and vegetation growing under bridge.
