Bridge #05437(Routine, Underwater type 2)

SH 138-03 LM 22.42 over Coon Bayou

Team Lead: Sharon Hooks Inspection Date: July 13, 2021

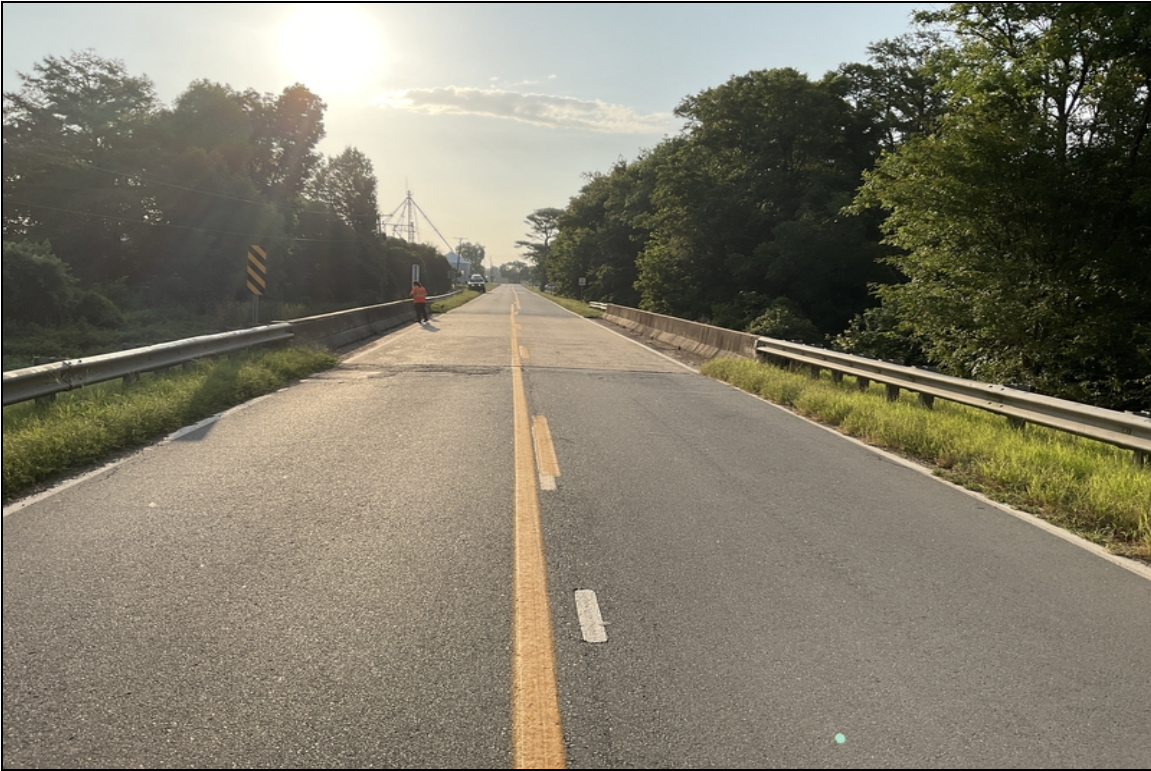
Approach.

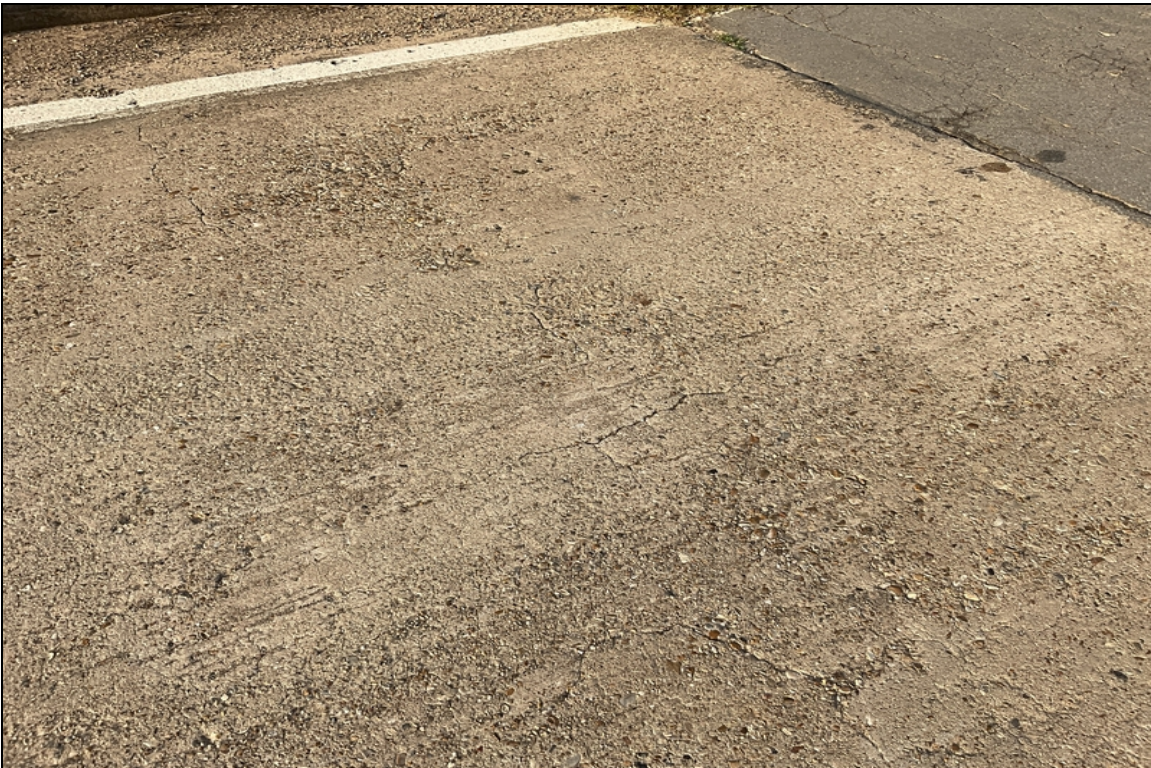
(38)							
Deck: 29' wide x 90' long = 2610 sqft. Spans 1 & 3: Widespread, moderate-sized cracks - cracking CS2 714 sqft, CS3 720 sqft. Span 2 : A few scattered cracks - cracking CS2 50 sqft. Span 3 @ Bent 4: Small shallow delamination/spall on right side @ end of slab - spalling CS3 6 sqft							
Cracking on outside of slabs on side face over bents.							
215	Reinforced Concrete Abutment	LF	74	74	0	0	0

Moderate deck cracking at span 1 right lane. Common all spans.

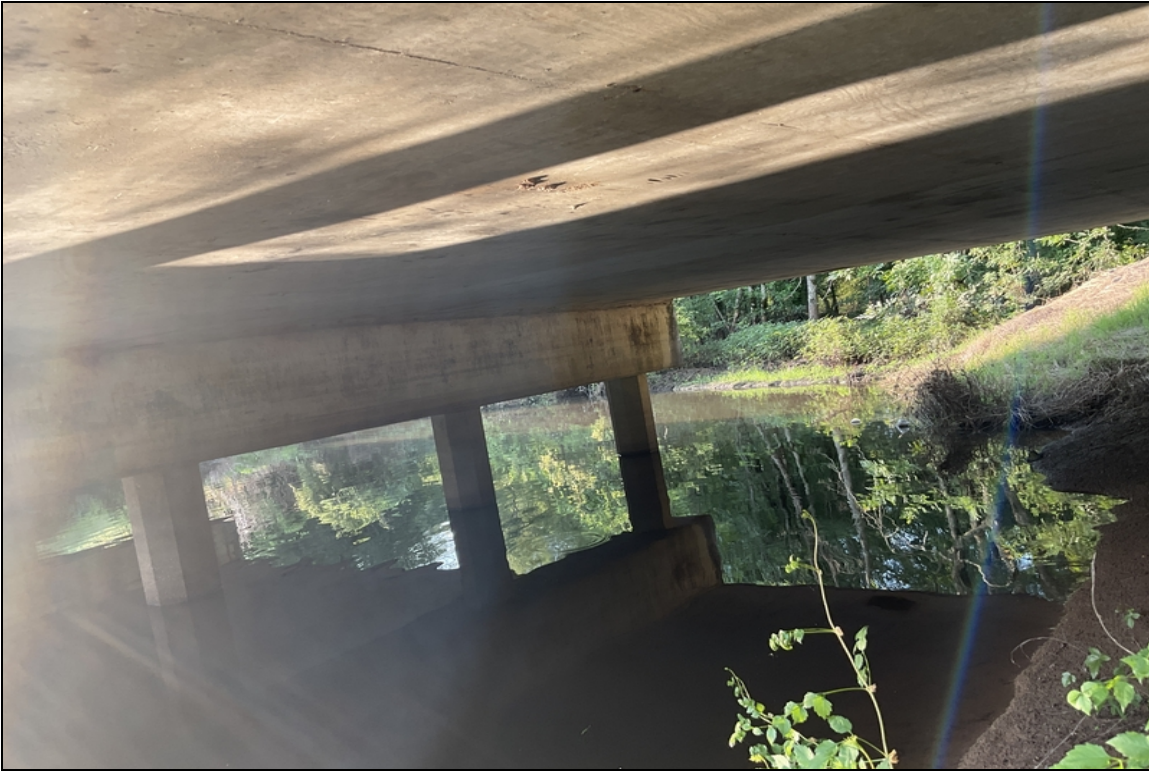
Under view of span 1.

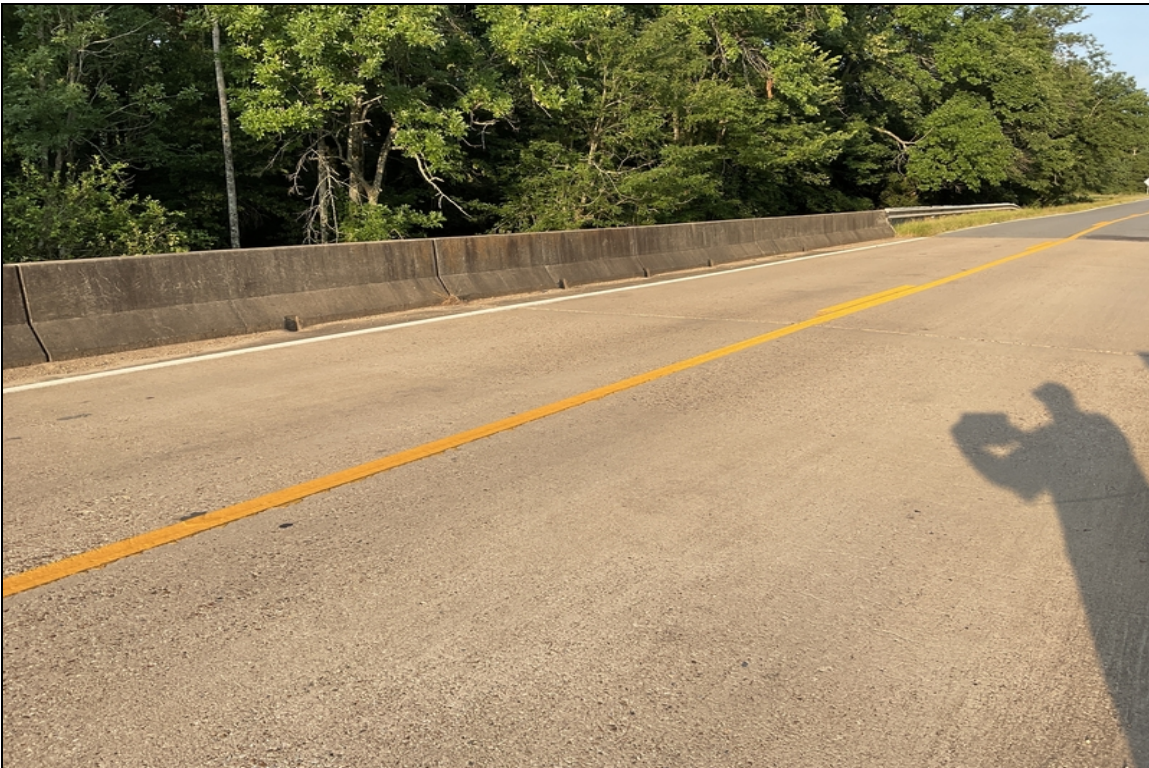
Deck overview.

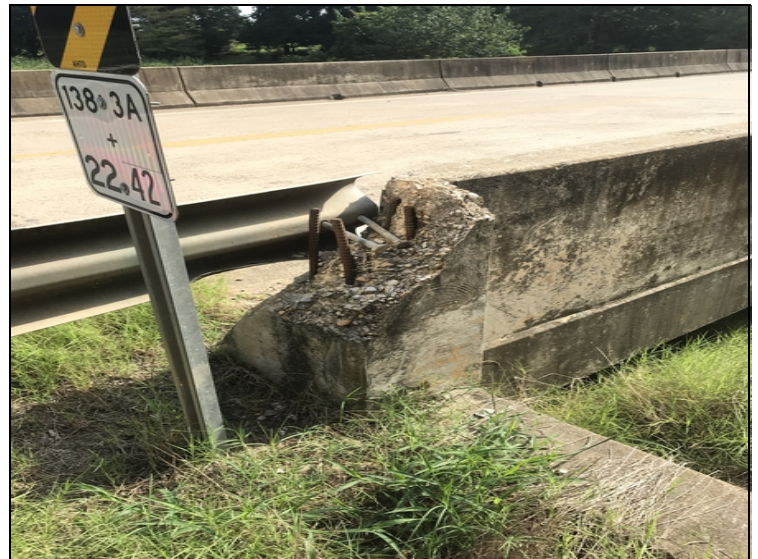
(331)							
Railing: 90' each side. Bent 1 right: End of parapet rail/transition post has extensive spalling/scaling with exposed rebar.

Railing - Bent 1 right: End of parapet rail/transition post has extensive spalling/scaling with exposed rebar.

Bent 1 - Right : Damage

Work on this as soon as your schedule permits

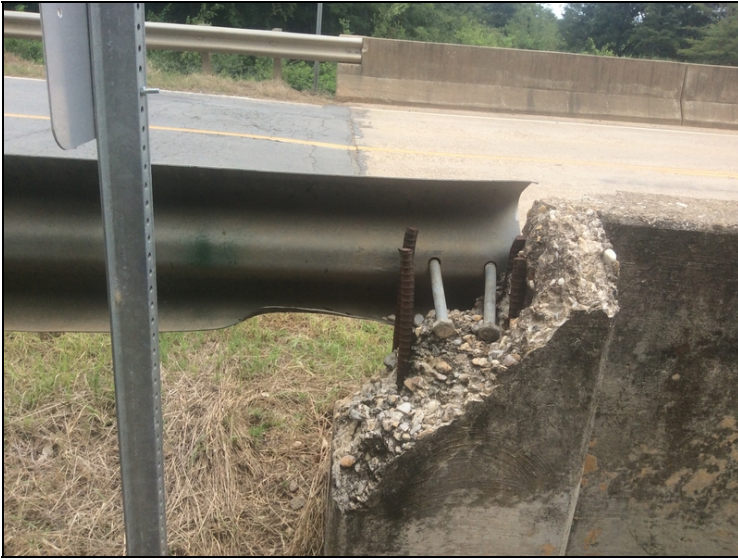
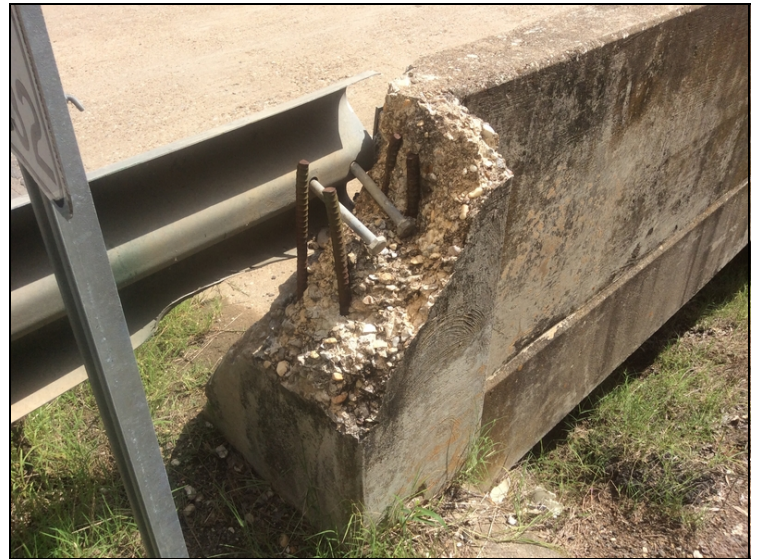
Bent 1 right side end rail has spall with exposed rebar.
