Bridge #M3076(Routine)
SH 138-03 LM 7.59 over Lower Cut-Off Creek

Location: 7.59 Mi N US278-Pine Hill

Team Lead: Sharon Hooks Inspection Date: August 02, 2021

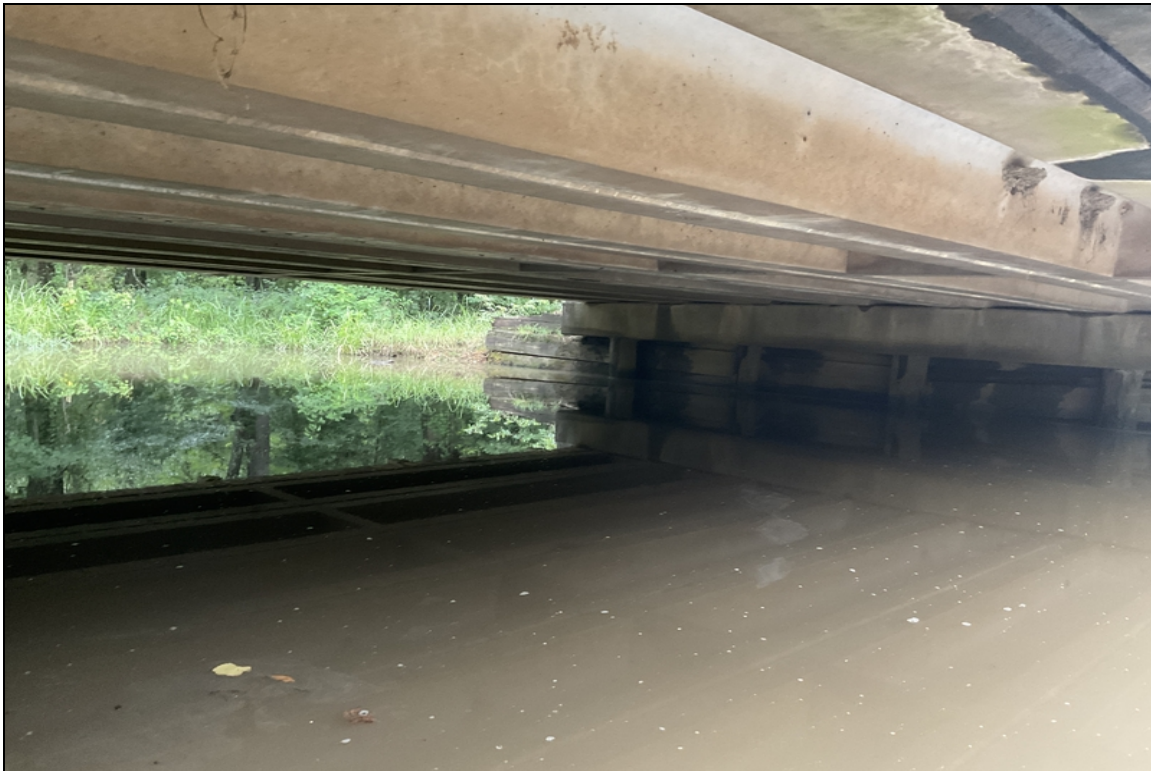
(110)							
Girders: 7 precast channel beam units per span / 31' span. Units are bolted transversely - no noted missing or loose bolts. Scattered small vertical and horizontal cracks in channel legs. Unit 6 has very small spall on side of leg.							
216	Timber Abutment	LF	64	54	10	0	0
1140	Decay/Section Loss	LF	10	0	10	0	0

Overview of soffit and girders.

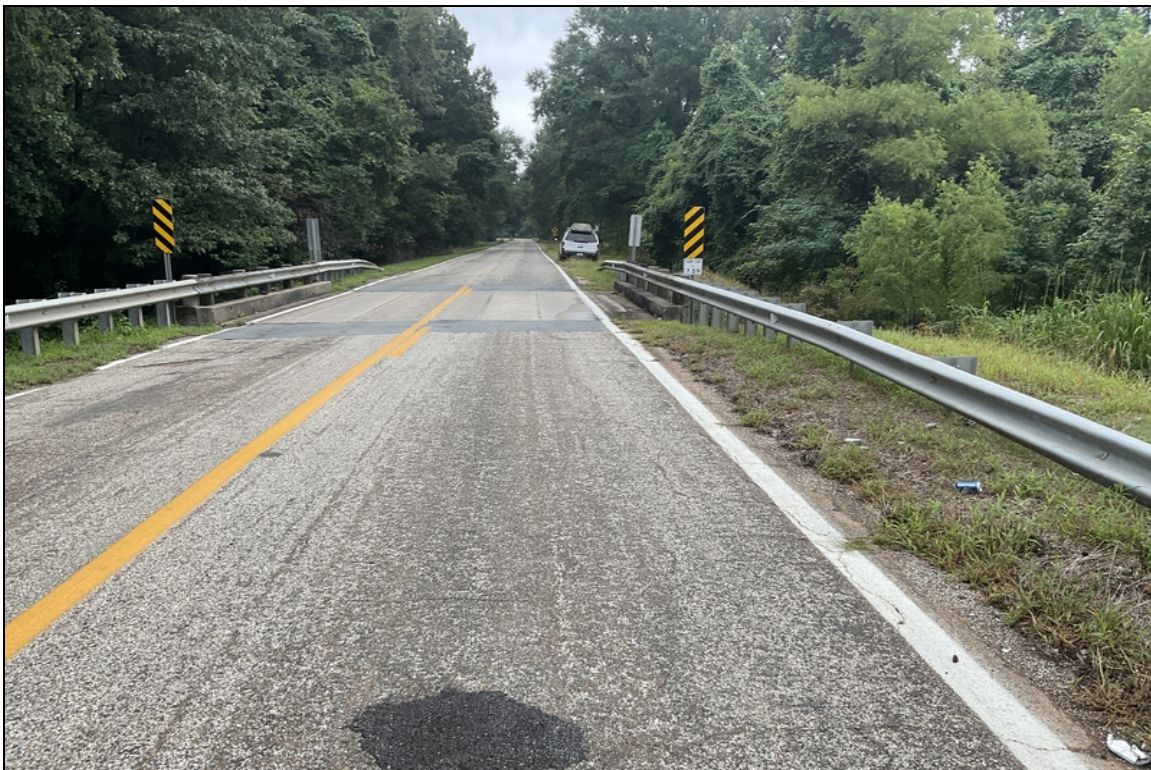
Approach.

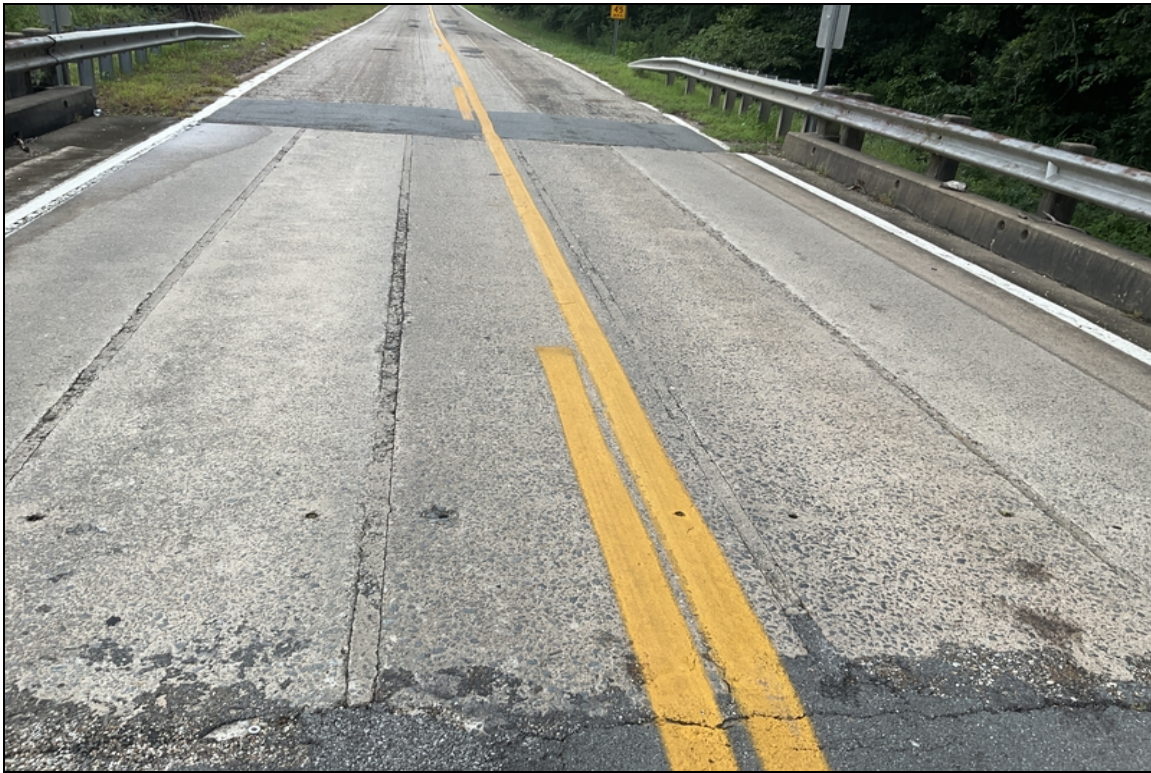
ELEM	DESCRIPTION	UNITS	TOTAL	CS1	CS2	CS3	CS4
16	Reinforced Concrete Top Flange	SF	806	804	2	0	0
1080	Delamination/Spall/Patched Area	SF	2	0	2	0	0
(16)							
Deck: 26' wide x 31' long.. Joints are completely grouted and grout is in good condition.							
110	Reinforced Concrete Open Girder/Beam	LF	217	196	21	0	0
1080	Delamination/Spall/Patched Area	LF	1	0	1	0	0
1130	Cracking (RC and Other)	LF	20	0	20	0	0

Deck overview.

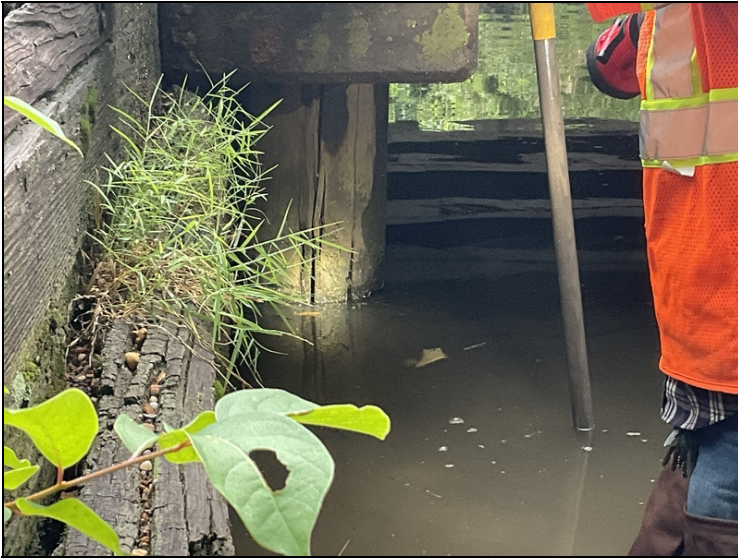
(228)							
Pile: 5 per bent / Bents 1 & 2. Bent 1 pile 4 has outer shell decay and spongy at water line. Bent 1 pile 5 large checks with a hollow area near cap. Bent 2 Pile 1: Moderate- to large-sized checking with some decay and hollow on left side. Bent 2 pile 2 very heavy decay from cap down 3'. Bent 2 pile 3 light hollow sound near cap. Bent 2 pile 4 outer shell decay. Remaining piles have minor-sized checking with some decay to the exterior around waterline.							
234	Reinforced Concrete Pier Cap	LF	52	52	0	0	0

Bent 2 pile 1 has large checks.

Bent 1 pile 4 has outer shell decay and spongy at water line.
Bent 1 pile 5 large checks with a hollow area near cap.
Bent 2 Pile 1: Moderate- to large-sized checking with some decay and hollow on left side.
Bent 2 pile 2 very heavy decay from cap down 3'.
Bent 2 pile 3 light hollow sound near cap.
Bent 2 pile 4 outer shell decay.
Remaining piles have minor-sized checking with some decay to the exterior around waterline.
Changed priority from "G" to "C" SDH 2019.
Changed priority from "C" to "B" SDH 2021.

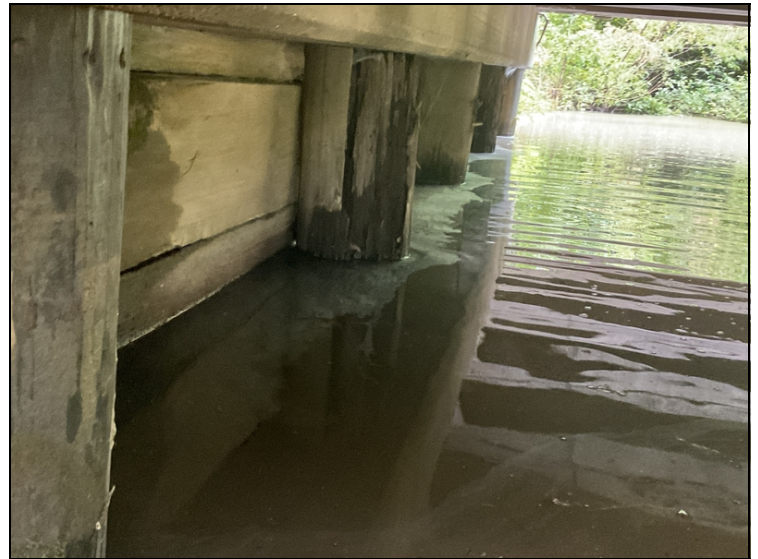
Bent 2 pile 2 has outer shell missing with heavy decay.
