Bridge #M3078(Routine)
SH 138-03 LM 7.70 over Lower Cut-Off Creek

Location: 7.70 Mi N US278-Pine Hill

Team Lead: Greg Loomis Inspection Date: August 03, 2021

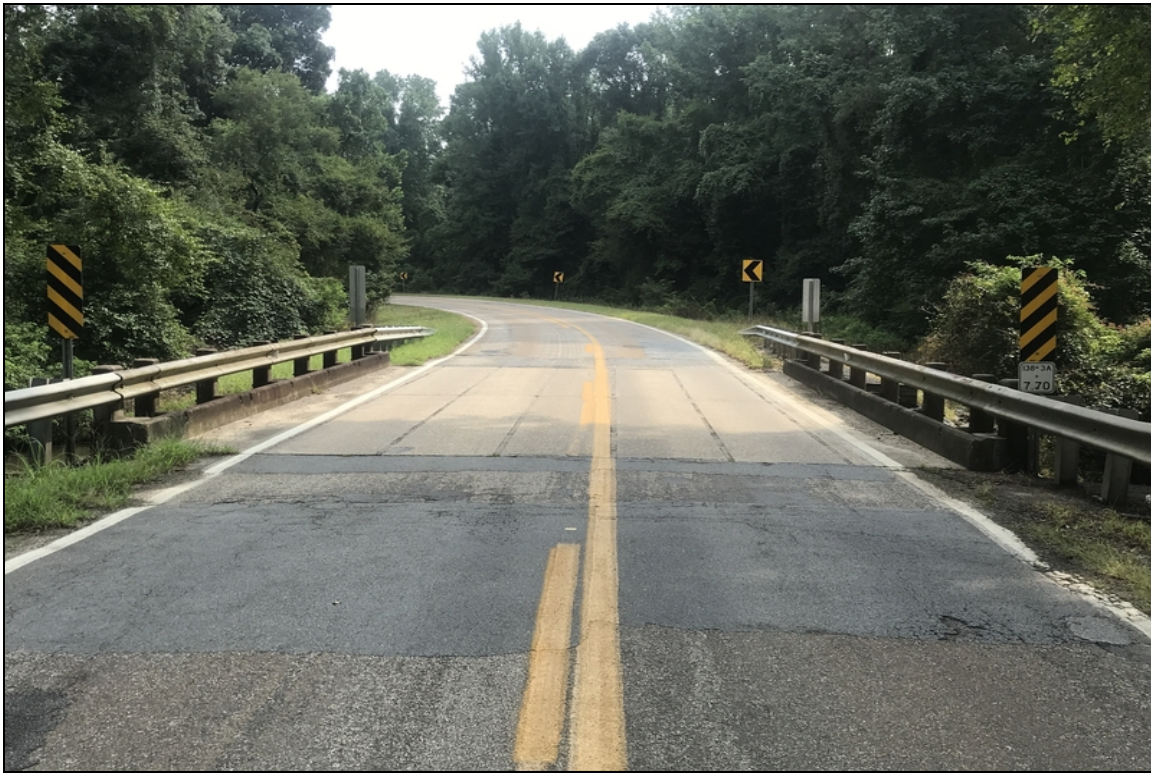
Roadway view

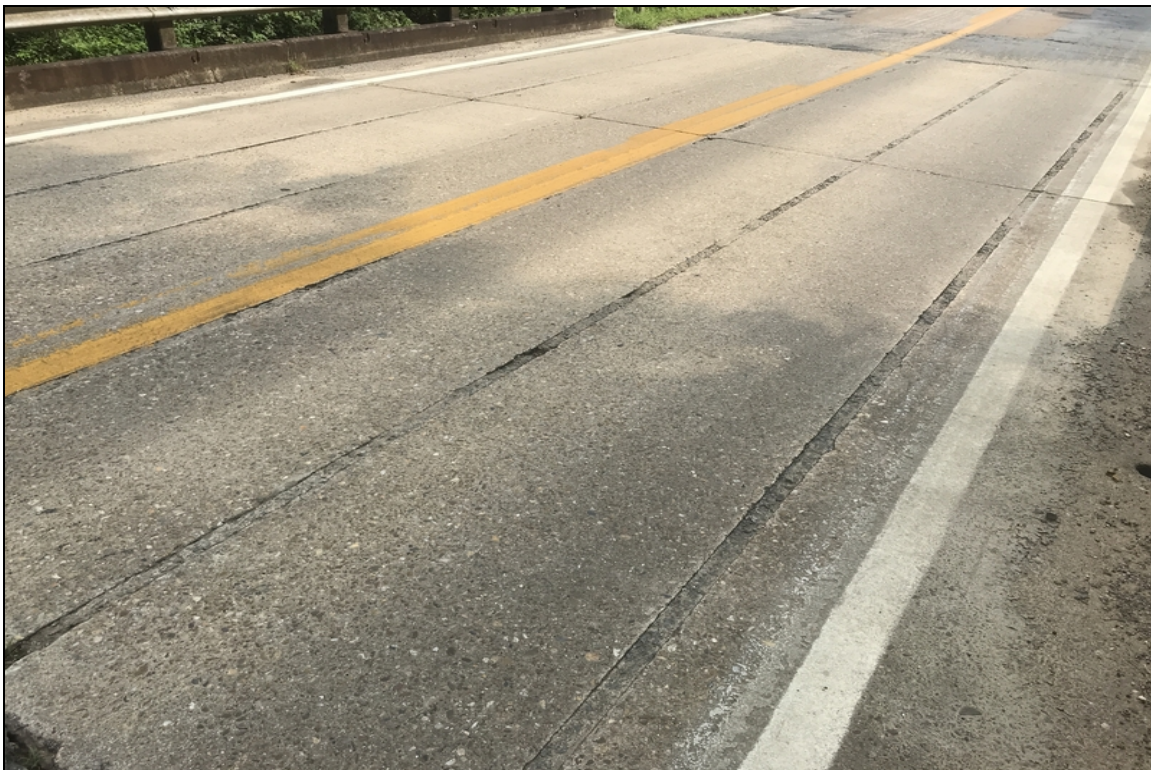
Deck - Spans 1-2: Typical

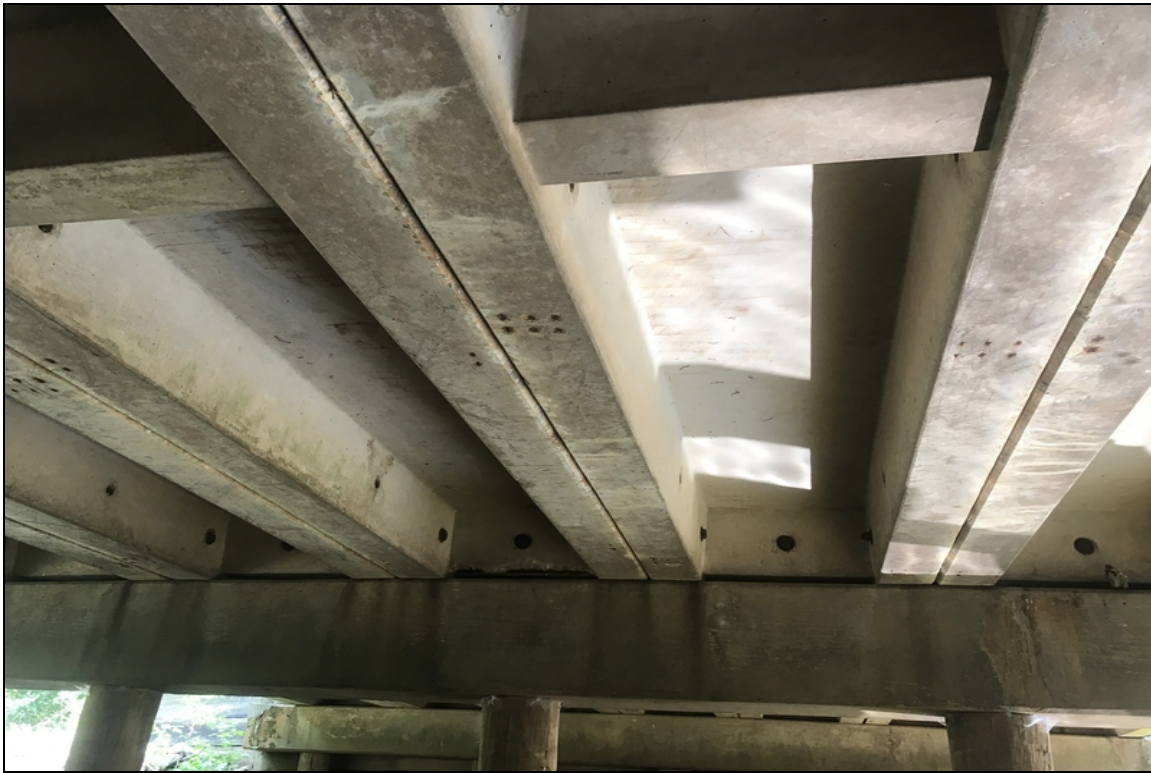
Soffit - Span 1: Typical

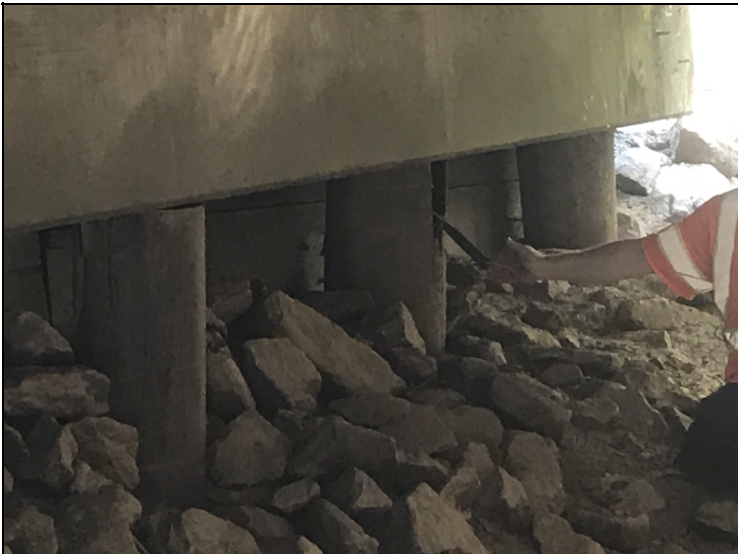
Date Reported: 08/20/2019
Priority: A - Safety deficiency; requires prompt action
Type of Work: Repair
Status: Assigned
Inspection Direction W to E
Component: 228 - Timber Pile

Bent 1 Pile 2: Hollow/decayed from cap down to ground – REDUCED BEARING CAPACITY – CS4 decay.

Bent 1 pile 2 hollow from cap down to ground line.

1/28/2021 checked on bridge water to high to make repairs. CRM per JRB

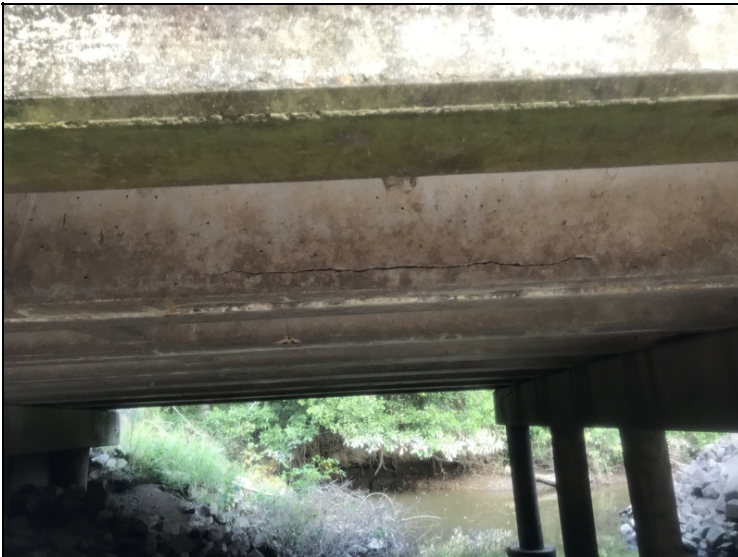
(110)	Girders: 7 precast channel beam units per span / Spans 1 & 2 (19' each = 38' total). Units are bolted longitudinally and transversely - no noted missing or loose bolts. Small vertical and horizontal cracks in channel legs. Span 1 Unit 7: Spall with exposed rebar and cracking at mid-span. Span 2 Unit 1: Small spall with exposed rebar at mid-span.						
216	Timber Abutment	LF	64	64	0	0	0

Girders (precast channel beam legs) -
Span 1 Unit 7: Spall with exposed rebar and cracking at mid-span.
Span 2 Unit 1: Small spall with exposed rebar at mid-span.
Some cracking/delaminations in various locations.

Girder 7 left leg has large cracking on channel legs.
